F-3-115  
Granville Dutrow Farmstead  
Frederick vicinity  
Private

F-3-115  
Granville Dutrow Farmstead  
Frederick  
Frederick County

# Maryland Historical Trust State Historic Sites Inventory Form

The Granville Dutrow Farmstead is a well-preserved farmstead built principally between 1917 and 1925 centered on a frame two-story dwelling with 8 frame outbuildings including a summer kitchen, two chicken houses, a garage, a dairy, a hog barn, and a bank barn. A concrete block milk house adjoining the bank barn was built about 1935. The farmstead is located on the west side of Walter Martz Road about one mile south of Opossumtown Pike near Frederick (City), Frederick County, Maryland. The house faces east toward the road and the outbuildings are arranged in a rough semi-circle south of the house with the bank barn and the hog barn at the south end of the grouping. Most of the buildings have german, vertical board, and tongue-and-groove siding with standing seam and corrugated metal and composition gable roofs. The buildings are in good condition except for the hog barn and the chicken houses which are in fair condition. Dates of the structures were provided by Mr. Lemuel D. Shafer,

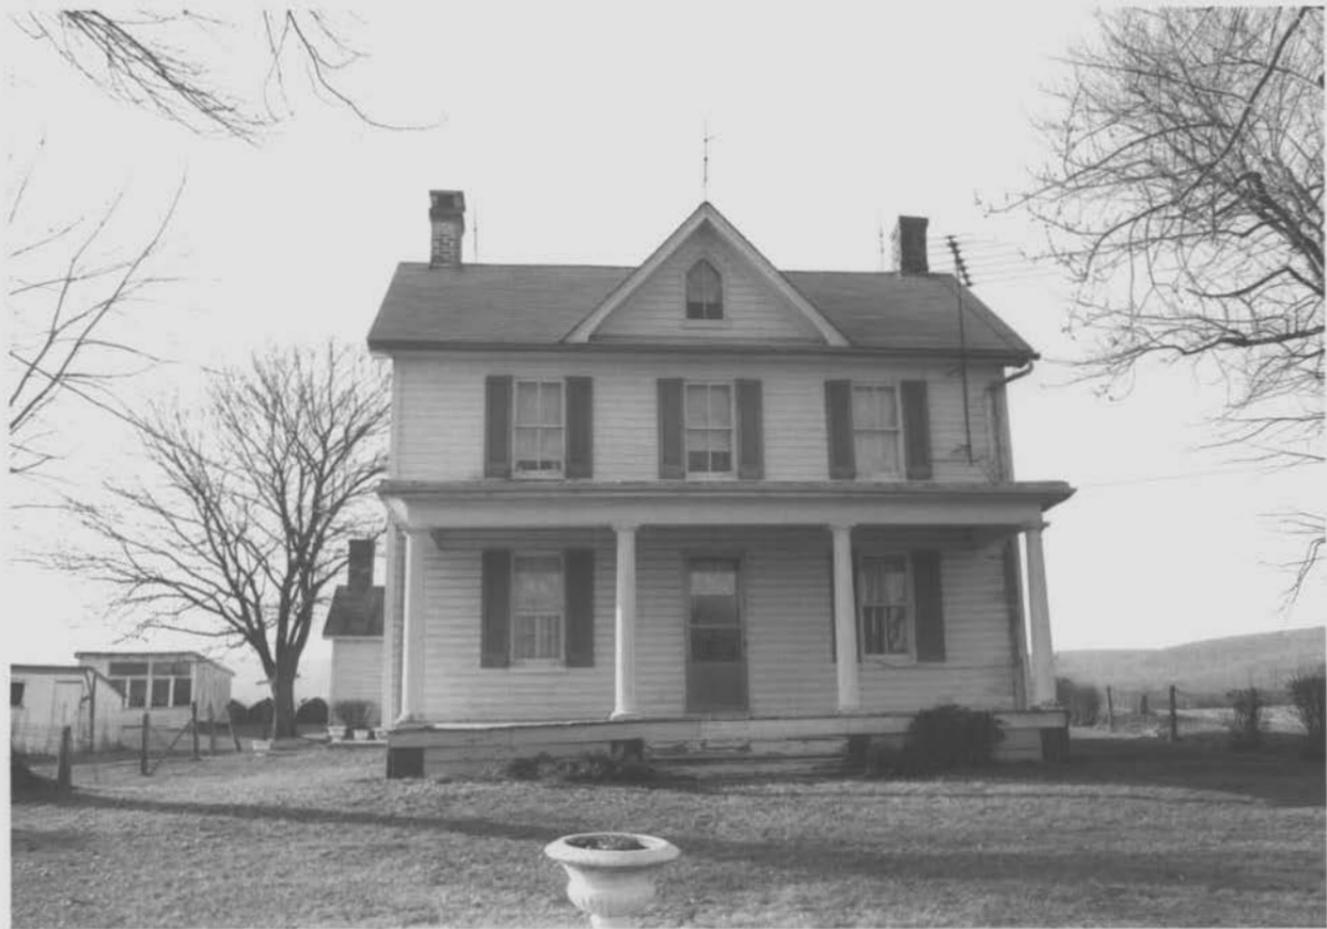
1/7

The dwelling, built in 1918 according to Mr. Shafer, has a three-bay east elevation with a one-story porch and a center cross gable. The house has a two-story rear wing extending from the northwest corner. The exterior is covered with german siding on the east and south elevations and vinyl on the north and west elevations. Mr. Shafer intends to complete the covering of the exterior in artificial siding in 1993. The gable roof is covered with composition material and has interior chimneys at the north and south elevations. A third chimney is located at the west end of the rear wing. The sash is 2/2 with louvred shutters. The center entrance on the east elevation has a glazed panel door. In the cross gable is an arched 2/2 attic window. The north and south elevations have two bays each. The porch has Tuscan columns and a wood deck. On the south side of the rear wing is an integral two-story open porch. The interior plan of the house has two rooms on the first floor of the main section and a single large kitchen in the rear wing. The door and window trim is varnished oak with 5-panel doors. The two mantelpieces in the north and south rooms are wood painted and sponge-grained to resemble marble.

East elevation

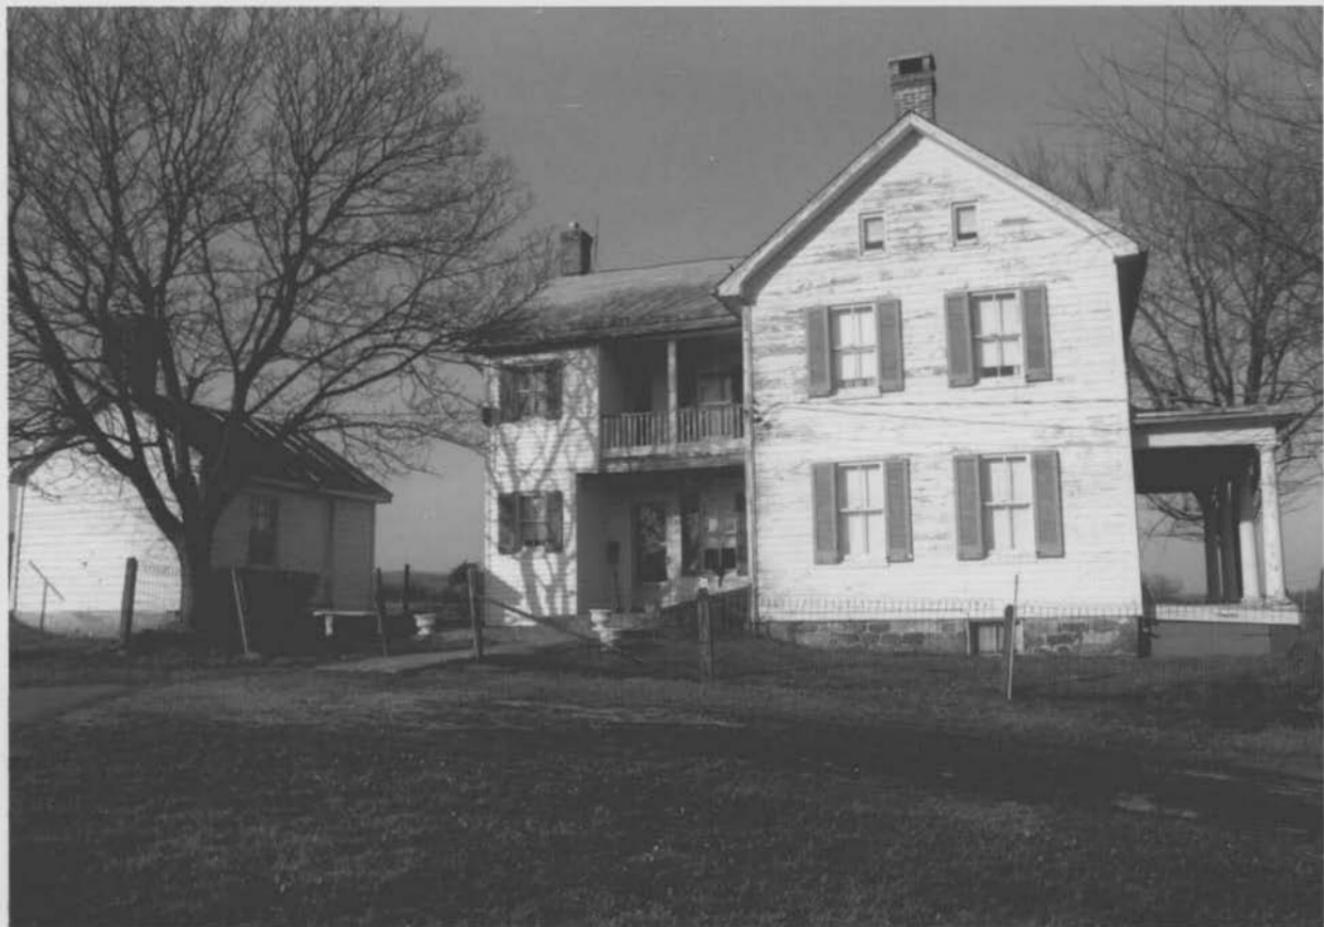
2/7

Summer kitchen: The frame summer kitchen is located immediately southwest of the rear wing of the dwelling and was built at the same time. The rectangular one-story building has german siding and a standing seam metal roof. An interior end chimney is at the south gable end. On the east elevation is a 4-panel door and a 6/6 window. The west elevation has a single 6/6 window and the north and south elevations are without openings. The foundation is concrete.

South elevation and summer kitchen

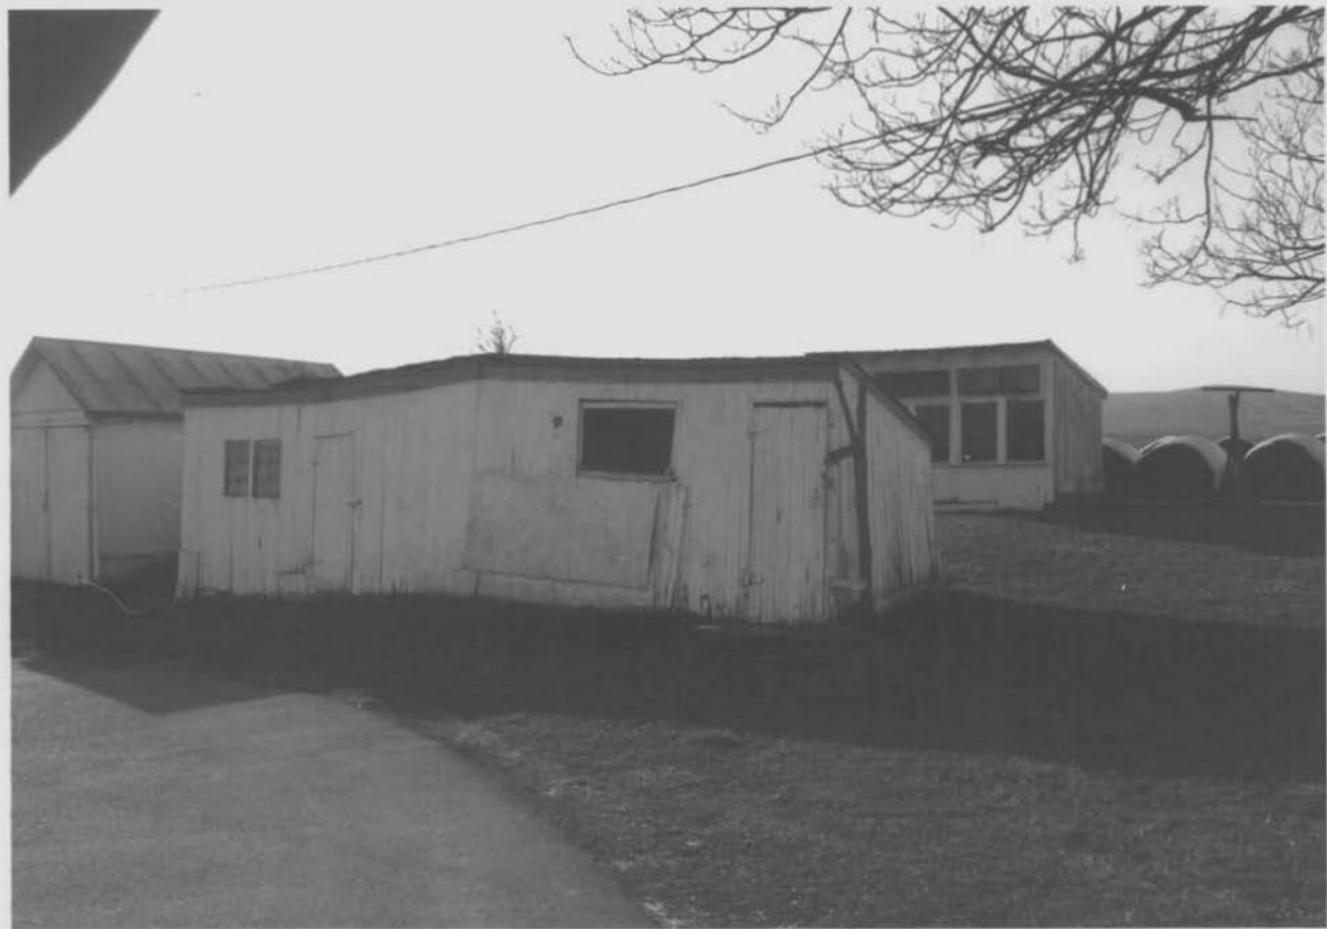
3/7

Chicken houses: The frame chicken houses are in two separate structures south of the summer kitchen, with one standing behind the other. The easternmost has two sections, with vertical and tongue-and-groove siding and tongue-and-groove doors at each end on the east elevation. Between the two doors is a row of wire screened windows. The shed roof is corrugated metal. The second chicken house is located west of the first, and is a smaller version of it. It has vertical siding and a corrugated metal shed roof. A tongue-and-groove door is located near the southeast

corner and the windows in the east elevation are glazed with a strip transom above the multiple panes of the windows. The chicken houses are currently used for storage and Mr. Shafer estimates their ages as in the early 1920's. One may have been moved to the Dutrow property from another farm.

Chicken houses, east elevation

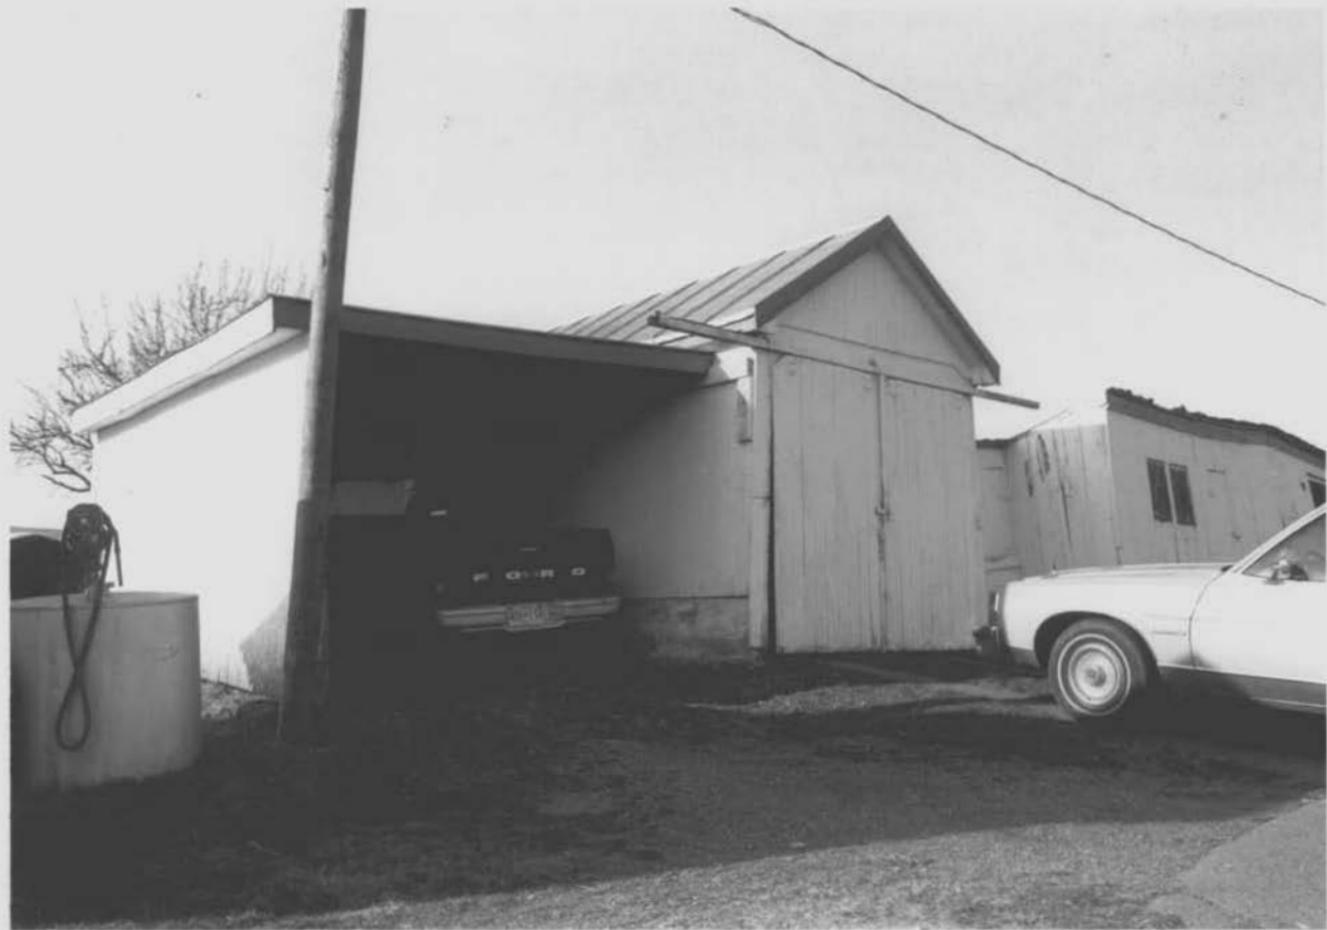
4/7

**Garage:** The small frame garage is located just south of the chicken houses. It is a simple, frame rectangular building with tongue-and-groove siding, a standing seam metal roof, and sliding doors on the east elevation. An open shed was added to the south elevation in more recent times to shelter a larger vehicle. The size of the garage indicates that it was built about 1925 for the smaller cars of that period.

Garage, east elevation

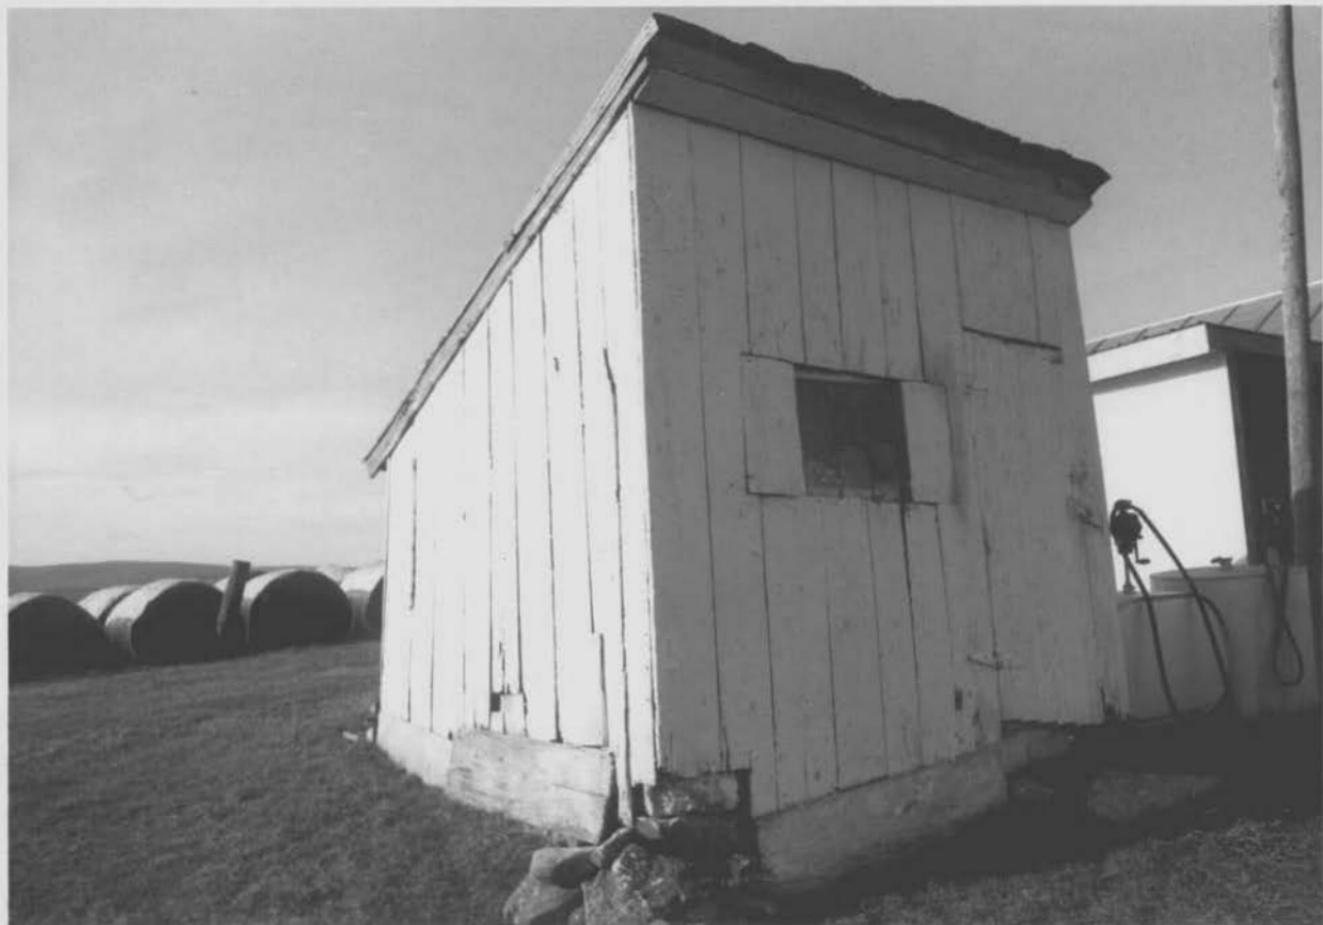
5/7

**Dairy:** The small frame shed located south of the garage was built about 1935 according to Mr. Shafer for storage of milk cans prior to the construction of the concrete block milk house adjoining the barn. The dairy has vertical siding, a corrugated metal shed roof, and a tongue-and-groove door in the east elevation. A single 3/3 window is located next to the door.

Doity, southeast corner view

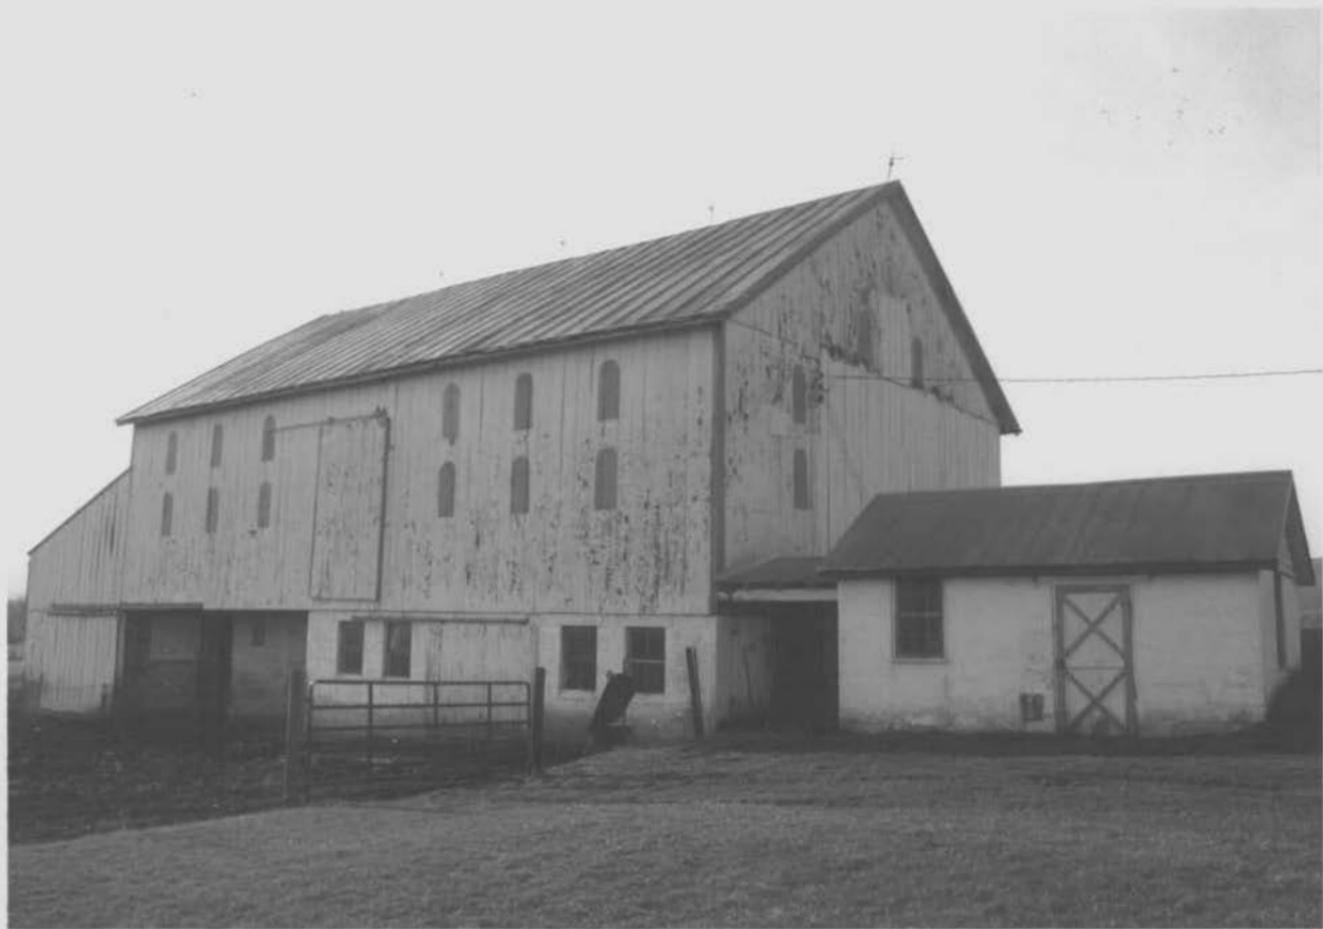
6/7

**Bank barn:** The frame bank barn was built in 1917, before the completion of the dwelling, as Mr. Shafer recalls. It is in the traditional German style, with a stone foundation and a ramp on the west elevation to the barn floor. It has vertical board siding and a standing seam metal roof. Painted arched "windows" are on each elevation. The exposed lower level on the east elevation is enclosed with flush horizontal siding. A concrete block milk parlor was built on the north end of the lower level probably in the 1930's at the time the adjoining milk house was erected. On the south elevation is a wagon shed with corn crib. The milk house has a corrugated metal gable roof and german siding in the north and south gables. A tongue-and-groove cross braced panel door is located on the east elevation and a 6/6 metal sash window flanks it.

Barn and milk house, east elevation

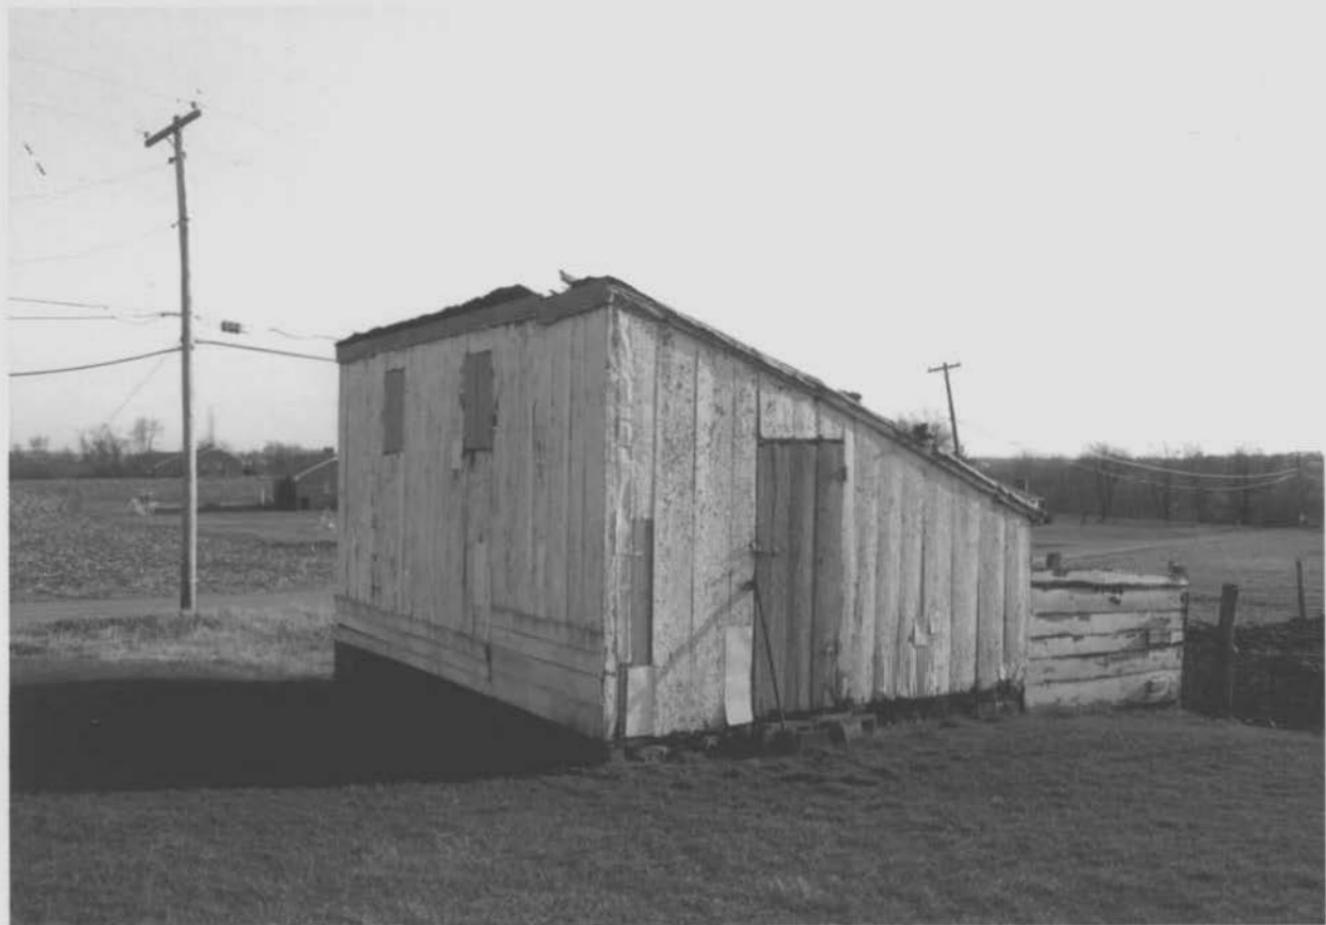
7/7

**Hog barn:** The frame hog barn is located near the road east of the barn. It is somewhat deteriorated and has vertical siding, a corrugated metal shed roof, and a stone foundation. Two shuttered openings are located on the north elevation and a fenced wallow is on the south adjoining the fenced barnyard. A vertical board door on the west elevation. The hog pen appears to be contemporary with the barn. Mr. Shafer intends to demolish the structure during 1993.

Hog bath, northwest corner view
