F-3-121
Christopher Stull Farmstead
Frederick vicinity
Private

F-3-121
Christopher Stull Farmstead
Frederick
Frederick County

Maryland Historical Trust State Historic Sites Inventory Form

Survey No. F-3-121

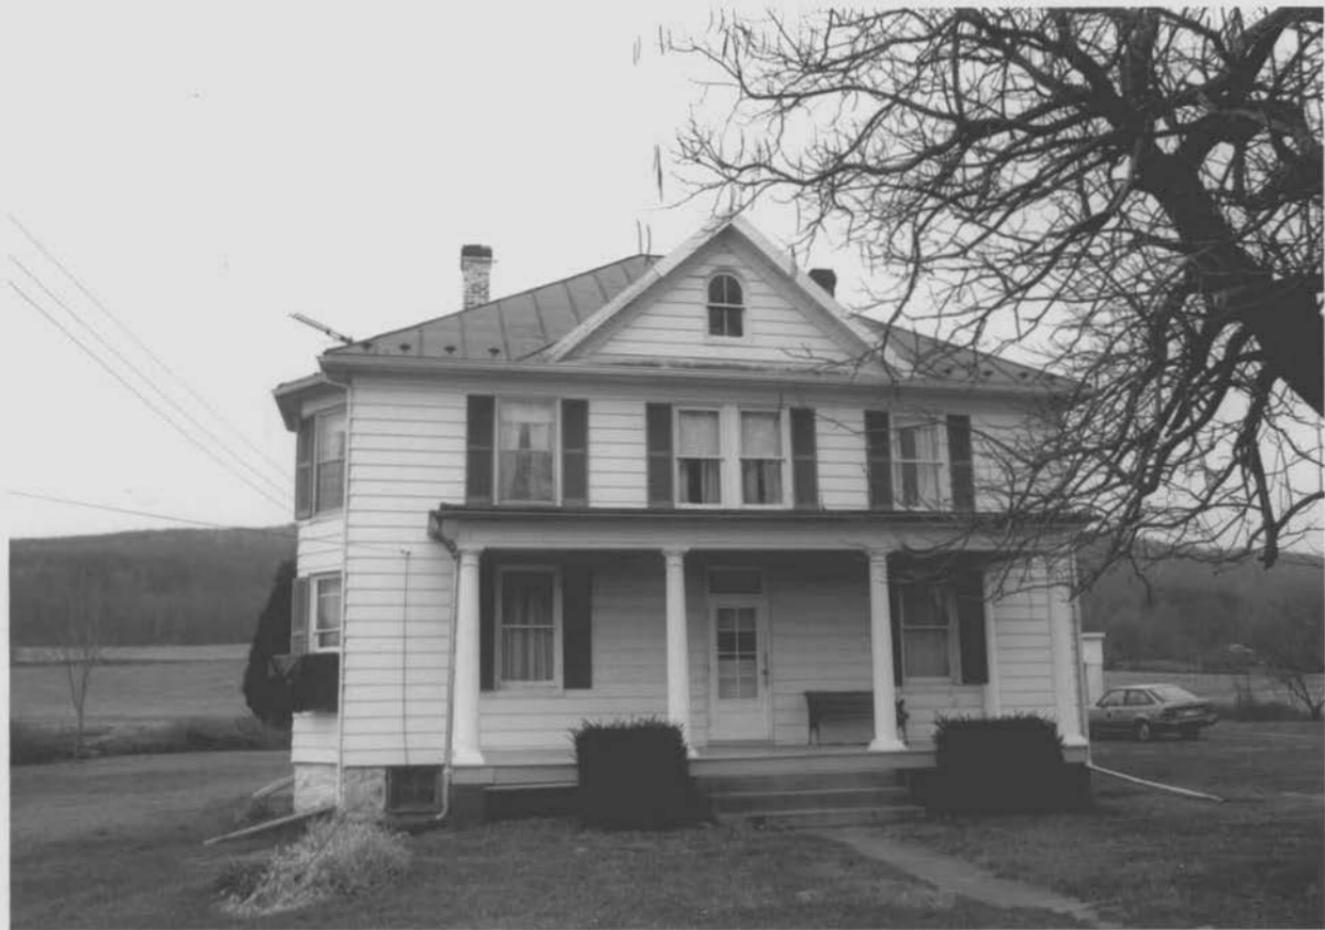
1/9

The house is a two-story frame structure with a hipped standing seam metal roof and a cross gable on the principal elevation facing east. The exterior is covered with aluminum siding, probably over german siding. Two interior brick chimneys rise above the roof and a polygonal two-story bay is located on the south elevation. The raised foundation is stone with raised pointing and is painted. The east elevation has three bays with a one-story porch. The porch has Tuscan columns and a wood deck on brick piers. The entrance is in the center bay and has a panel door with a glazed upper section under a plain transom. The windows are 1/1 with replacement shutters. The second story center bay has a pair of smaller windows. The cross gable has an arched 2/2 window. The north elevation has two bays with 1/1 windows. The west elevation has three irregular bays and a rear entrance with a one-story porch. This porch has plain square posts. On the first story, two of the windows still retain the original louvred shutters. The interior of the house has a center hall with two rooms on each side. The window and door trim is varnished oak and chestnut. In the north and south main rooms are two wood mantels with simple Tudor arches which are painted and grained to resemble marble. The fireplace openings are closed.

East elevation

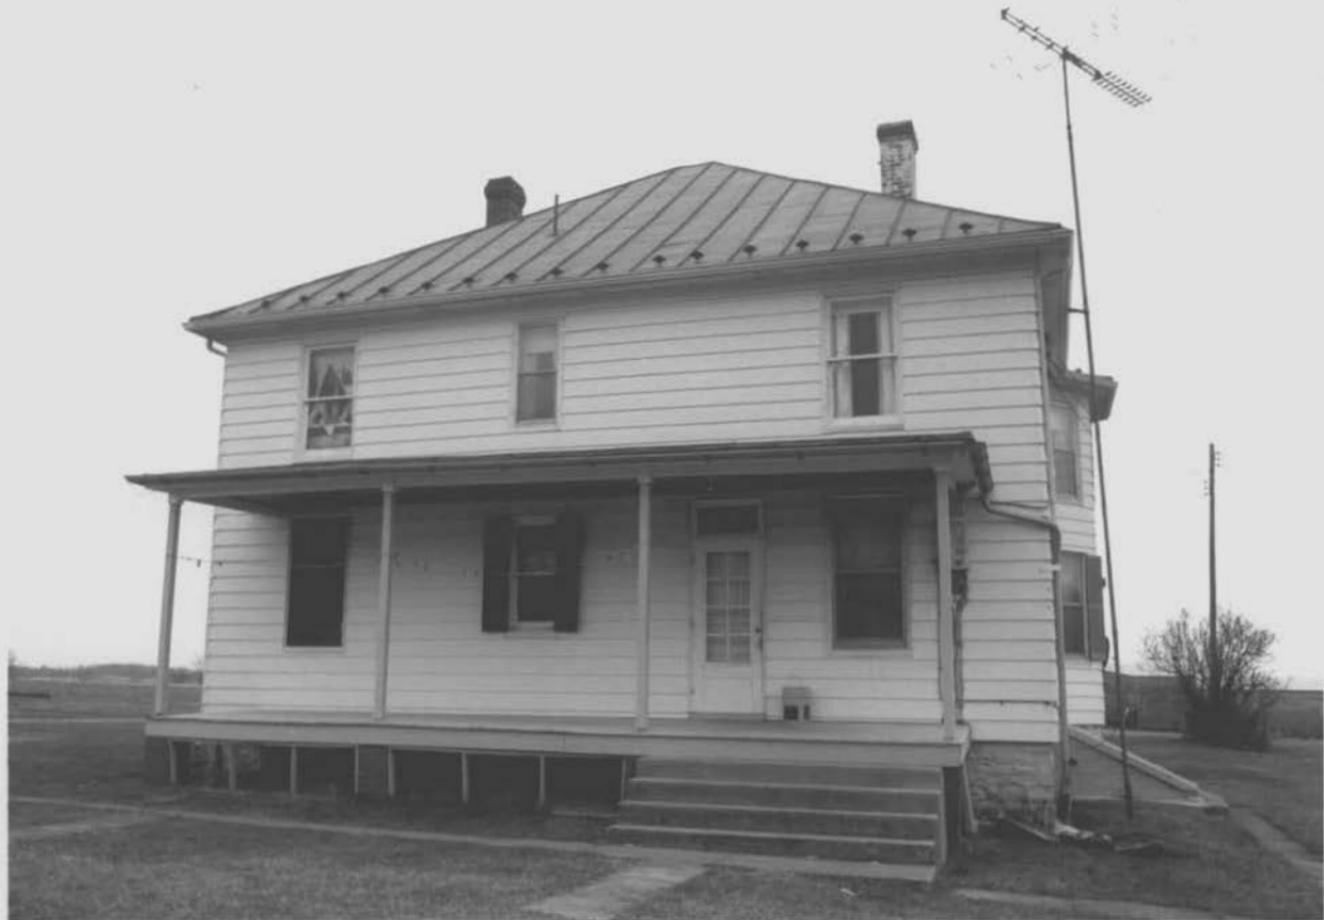
2/9

West elevation

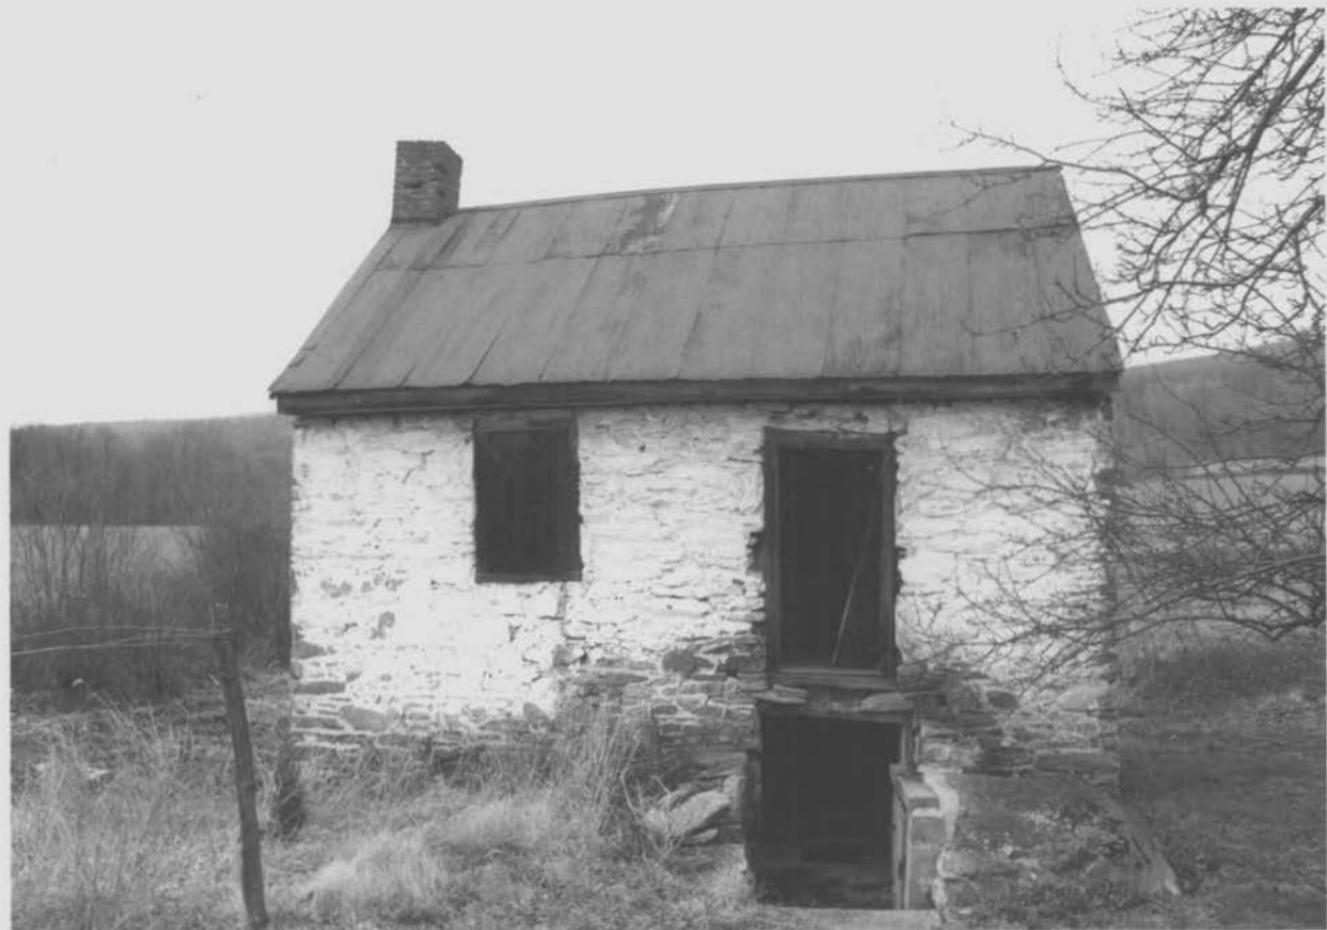
3/9

Springhouse: The two-level stone springhouse is in somewhat deteriorated condition, with some openings missing doors and windows. It is located south of the house and sited at an angle to the road in response to the natural flow of the spring toward the southeast. An interior chimney is located at the southeast gable. The northeast elevation is whitewashed and has a door and a window opening on the upper level. The lower level door is directly below the upper doorway and the spring is visible as a square depression in the lower level floor, which was covered with concrete at a later date. The spring's source is adjacent to the stone steps to the lower level with a door set into the stone abutment. The upper level of the springhouse has plaster walls and a chair rail. The vertical boarded door is off its hinges and the window opening is also boarded with vertical planks. T^r

cornice is boxed and the roof is covered with corrugated metal. On the southwest elevation are window openings on both levels, both of which are boarded. The northwest gable end has a door-sized empty opening in the top of the gable and a partially boarded window just below it on the main level. Another small window is located at the base of the wall. The only opening on the southeast elevation is the outfall of the spring at ground level. The three subsidiary elevations were apparently whitewashed, but weathering has removed most traces of the finish. According to Mr. Long, a dated 1772 stone formerly was located near the gable, but has fallen out of location and is missing.

Springhouse, northeast elevation

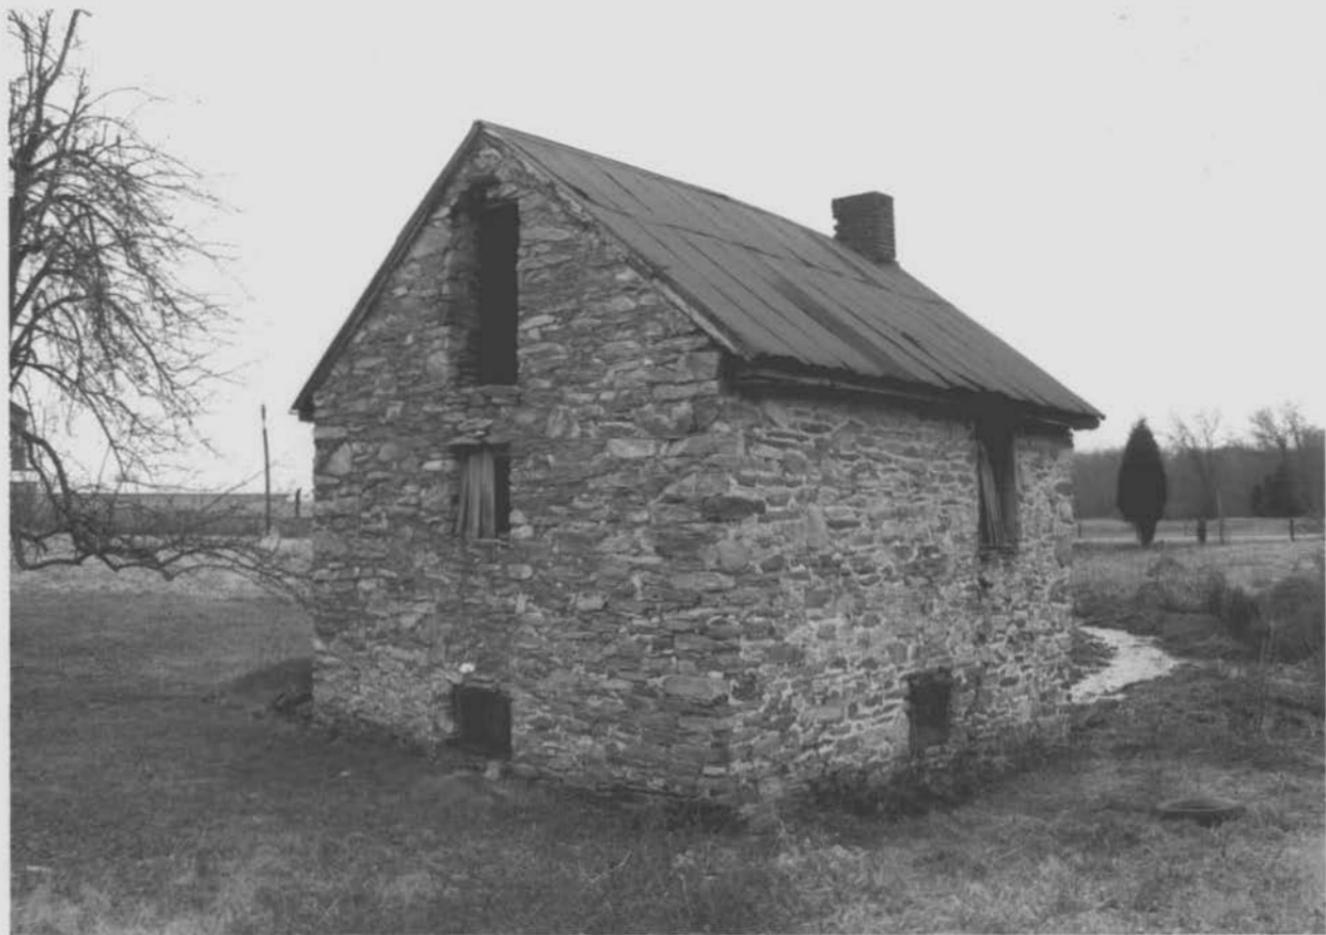
4/9

Springhouse; northwest corner view

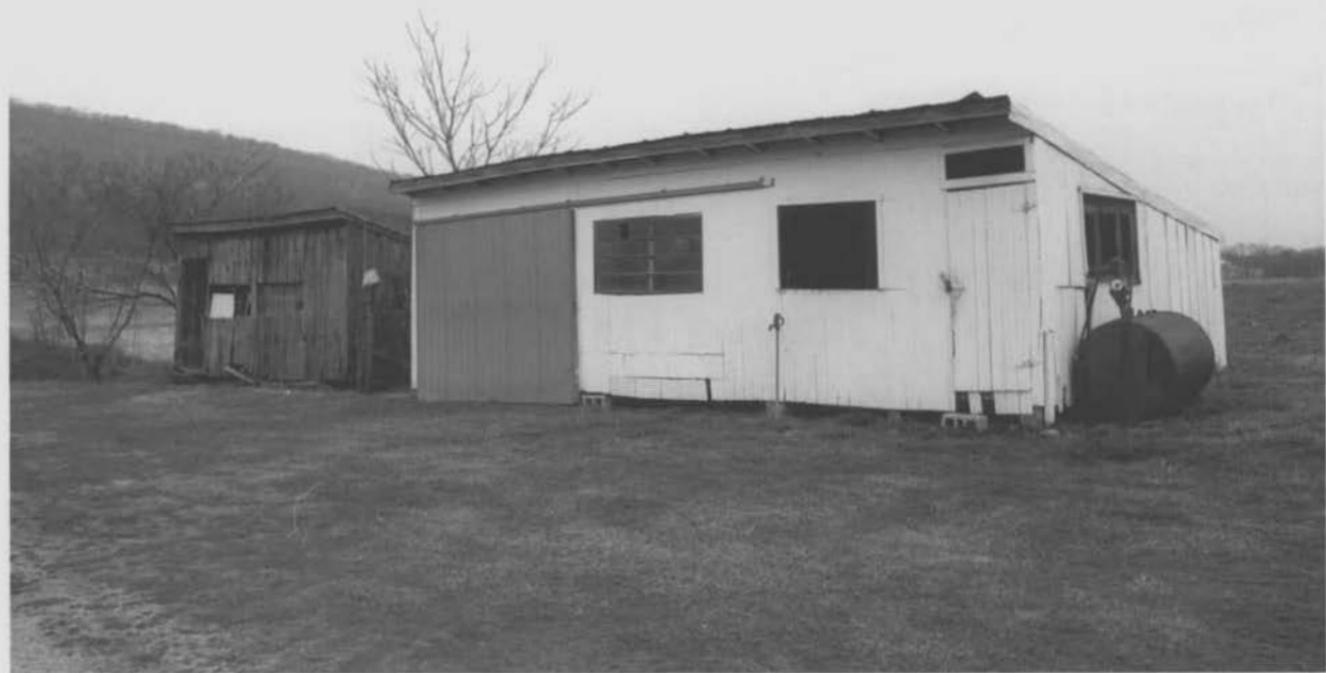
5/9

Chicken houses: The two chicken houses are located north of the house and a non-contributing concrete block garage. The older of the two is a small frame building with vertical siding and a corrugated metal shed roof. An open doorway and two multiple pane windows are located in the south elevation. Currently used for storage, the building is somewhat deteriorated. Its date is probably about 1900. Located immediately east of the first chicken house is a second, larger structure which was built about 1920 on another farm and relocated to the Stull farm about 1940, according to Mr. Long. It has tongue-and-groove siding and a corrugated metal shed roof. The south elevation of this building has a large sliding metal door near the west end and a vertical board door at the east end. Two wired and glazed rectangular window openings are in the area between the two doors.

Neg. loc.: Md. SHPO, Crownsville, Md
Chicken houses. south elevation

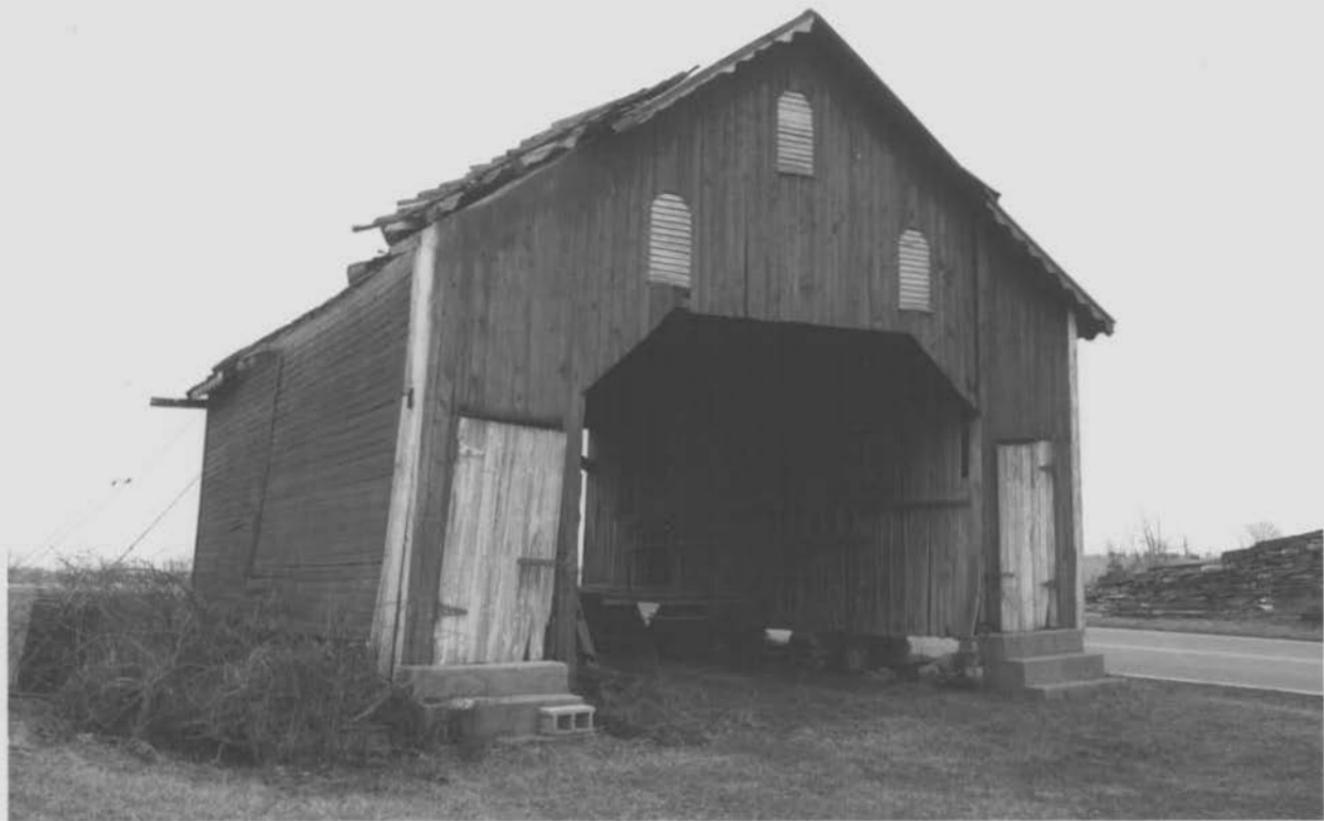
6/9

Wagon shed/corn crib: The frame wagon shed is located immediately adjacent to Bethel Road and faces south. Built about 1875-1900, the structure has vertical siding on the north and south elevations and horizontal siding on the east and west sides. In the north and south gable ends are three louvred arched vents and the deteriorated roof reveals that the original roofing was wood shingles, with a later covering of standing seam metal. Much of the roof on the west side has been destroyed by wind. Traces of serpentine bargeboards are still visible on the north and south elevations. A sliding door covers part of the north end opening. The building is in deteriorated condition and is braced with guy wires from the west.

Wagon shed/corn crib, south elevation

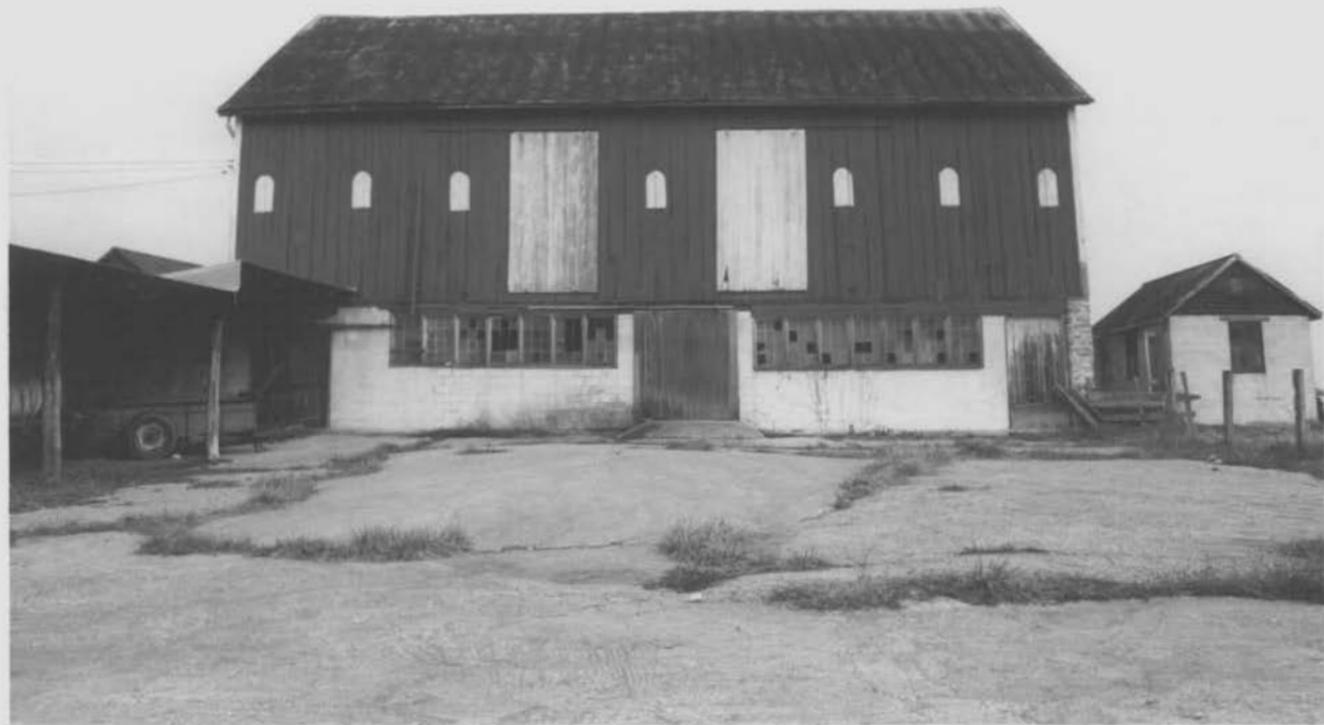
7/9

Barn: The frame bank barn located on the east side of Bethel Road was built in 1907 to replace an earlier barn located further south, according to Mr. Long. The design is that of a traditional German style barn, with a field stone foundation and hand-hewn timber frame. The exterior is covered with vertical boards and painted arched "windows" are on each elevation. The north elevation has sliding doors and the upper loft section of the south elevation has two large sliding doors painted white against the red of the exterior siding. On the south elevation, the recess under the forebay was enclosed with concrete block to form a milking parlor in about the 1920's. The concrete block wall has multiple paned metal sash. At about the same time, a separate concrete block milk house was built just east of the barn. It has composition covered gables, a standing seam metal roof, and metal sash windows. Near the ramp on the north elevation is a concrete silo, built possibly in the 1930's. A non-contributing loafing shed built after 1945 is attached to the southwest corner of the barn.

Barn, south elevation

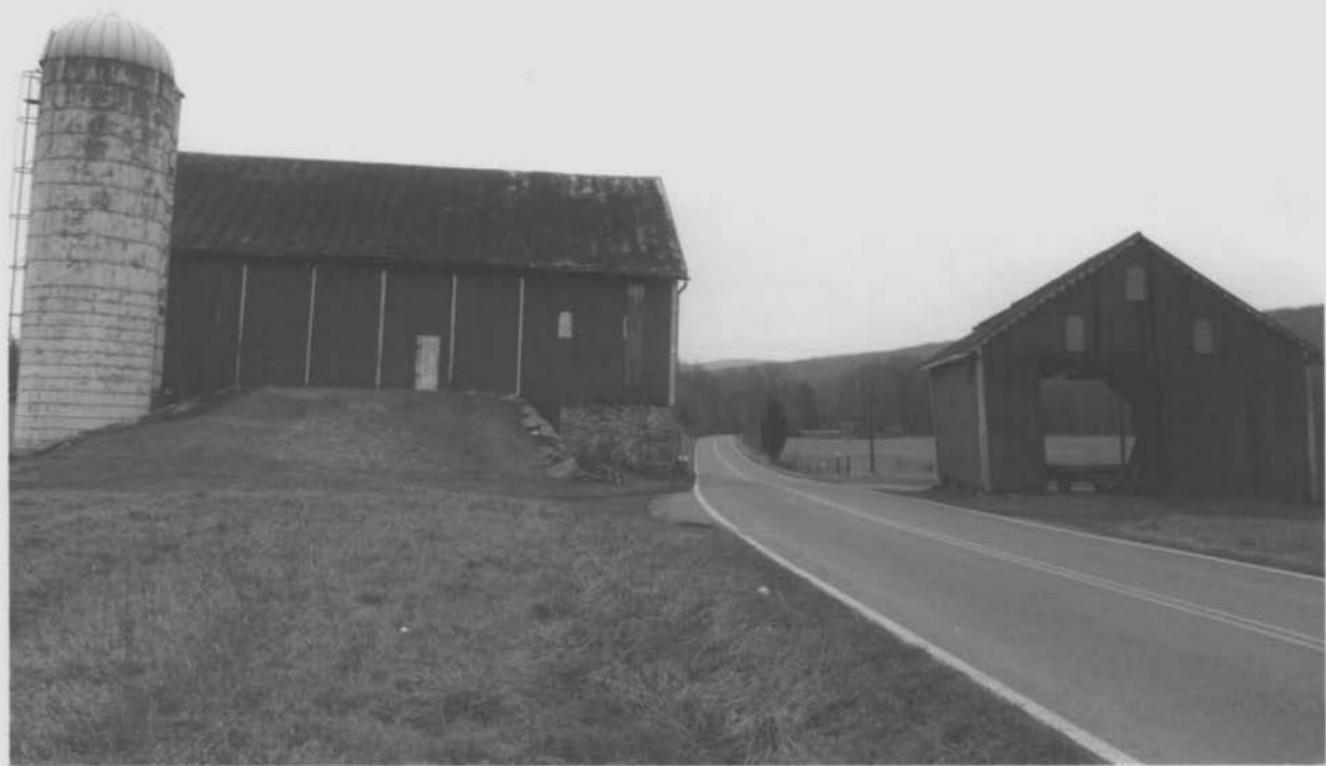
View of barn and wagon shed from north
8/9

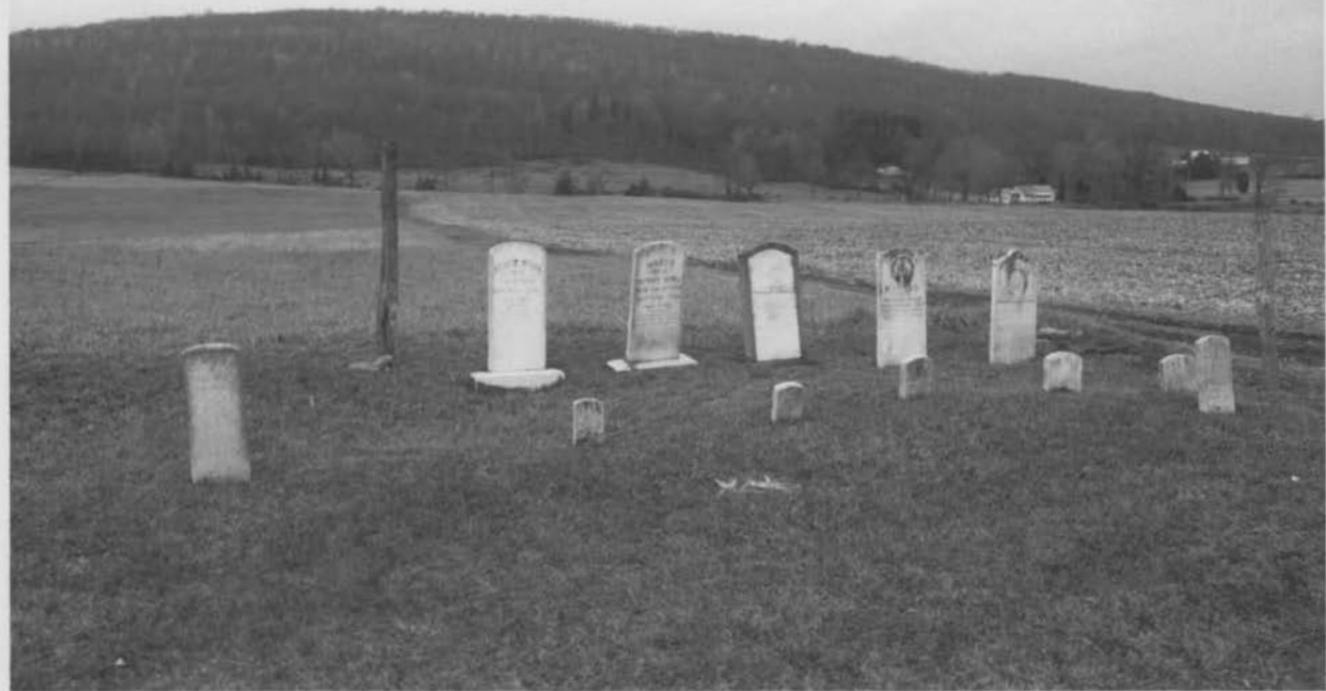
9/9

Cemetery: Although the cemetery does not meet the criteria for individual historic significance, as a common element in rural farmsteads of the 18th and 19th century, the small private family burying ground is considered a contributing element in the Stull farmstead. It is located on open ground north of the rest of the farmstead structures and has a wire fence around it. Approximately 7 headstones are visible with death dates ranging from 1859 to 1917, one of which is a Civil War period marble stone of the 1st Maryland Cavalry.

Neg. loc.: Md. SHPO, Crownsville, Md.
Stull family cemetery, view from east
