INDIVIDUAL PROPERTY/DISTRICT
MARYLAND HISTORICAL TRUST
INTERNAL NR-ELIGIBILITY REVIEW FORM

Property/District Name: Birely-Roelkey Farmstead Survey Number: F:3-134

Project: I-270/US 15 Multimodal Study, Montgomery and Frederick Co. Agency: SHA

Maryland Historical Trust State Historic Sites Inventory Form

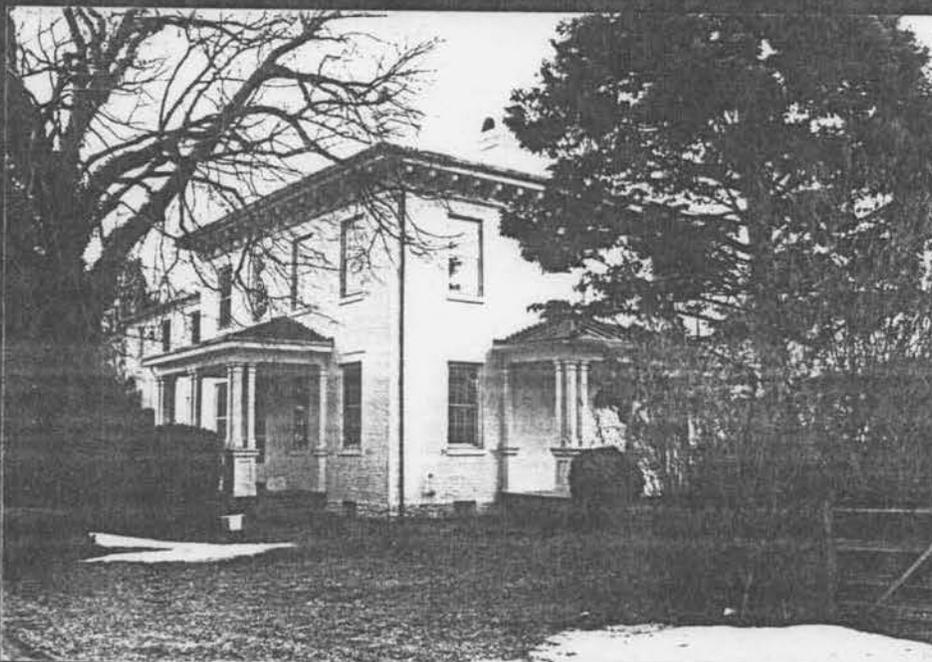
House,
west Elevation

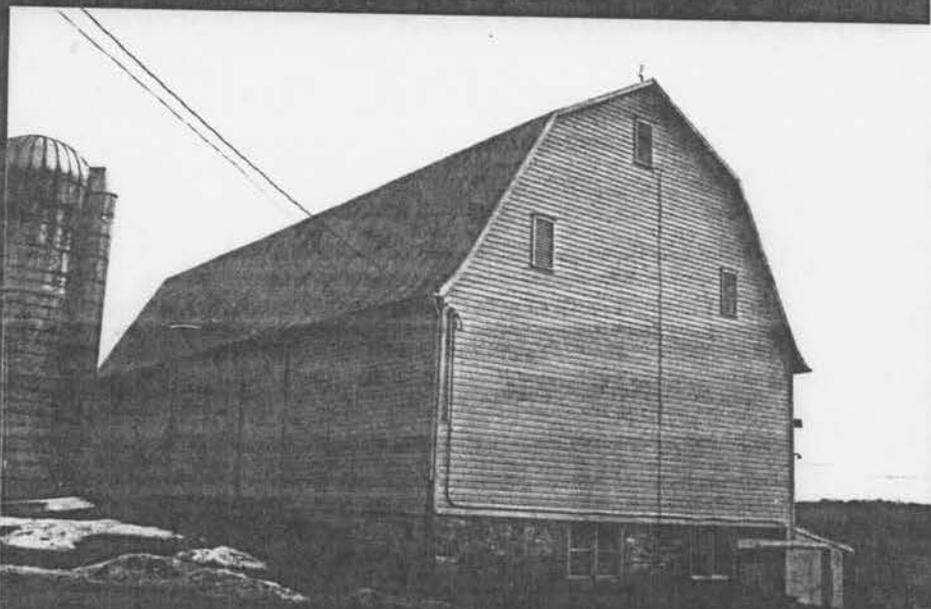
Northwest Corner

Bank barn

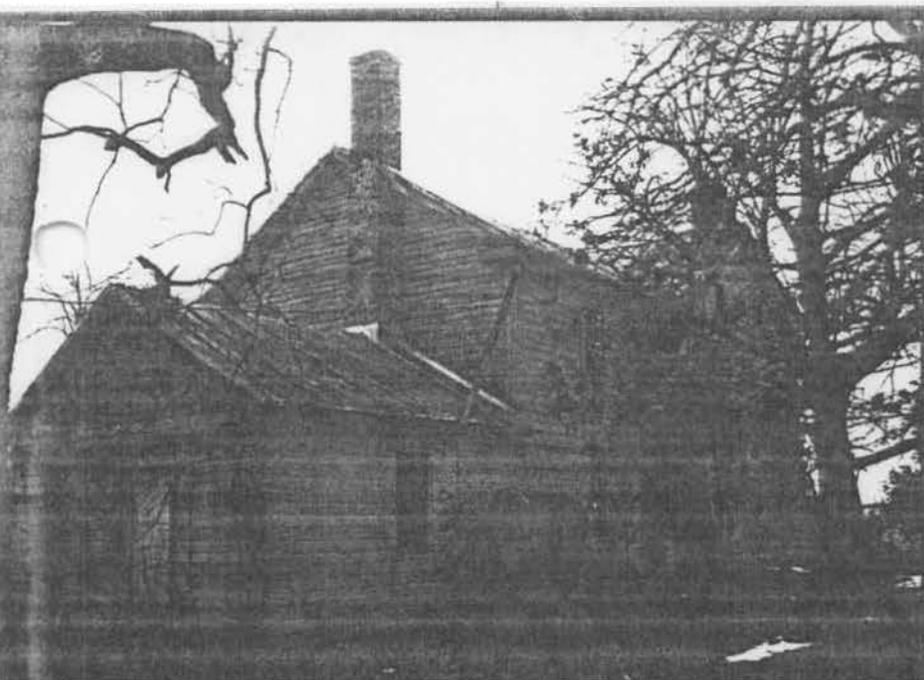
Dwelling, W.E. Corner

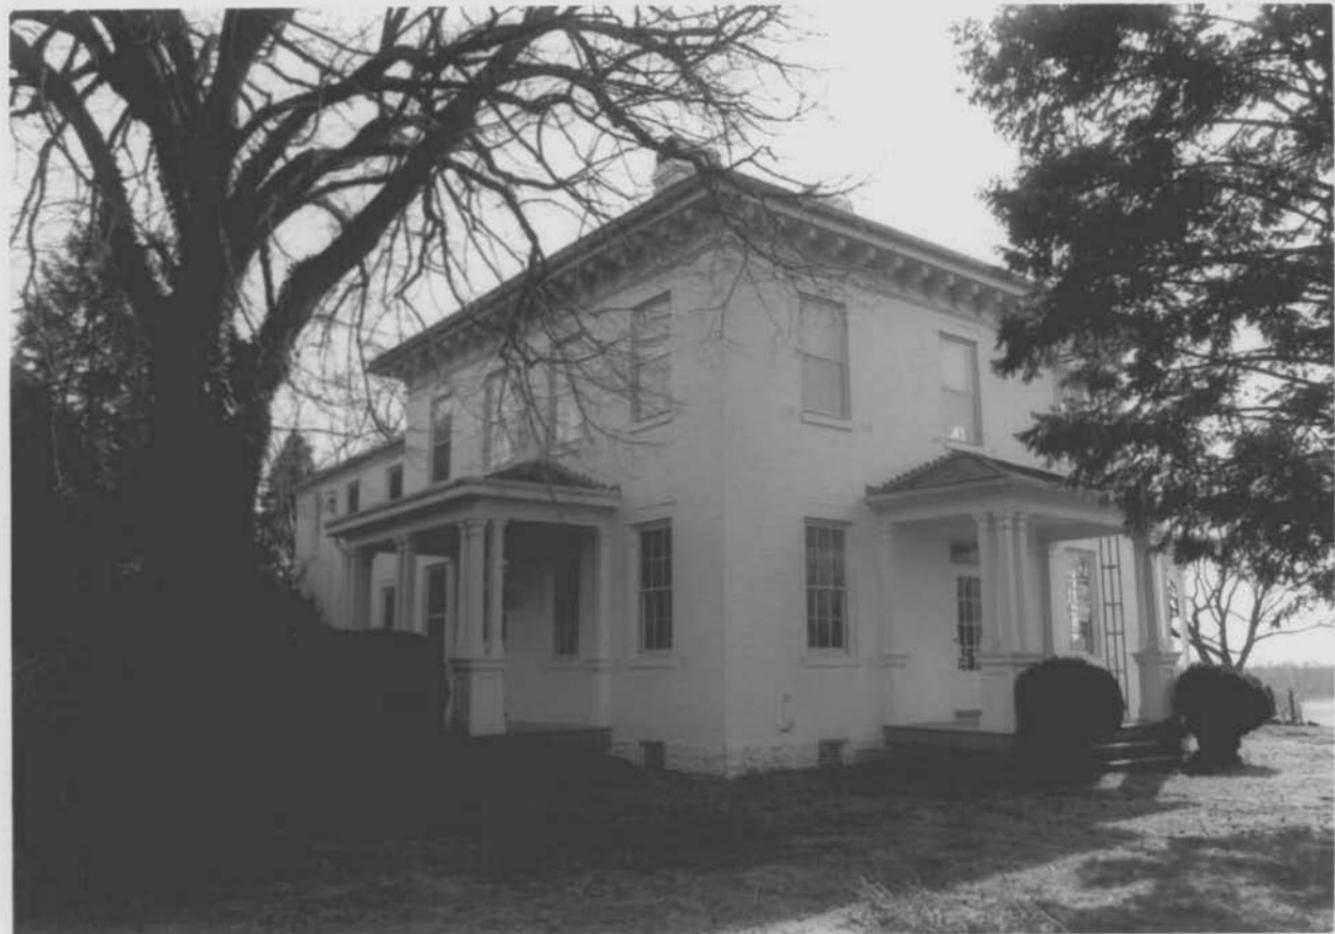
1/10

Northwest corner view

The farmstead is grouped at the end of a driveway running south from Biggs Ford Road. The drive originally led directly east from the former Frederick-Emmitsburg Turnpike which was replaced by the current right-of-way of U.S. 15. The brick main dwelling has two two-story sections, a generally square plan main section adjoined by a lower height service wing on the east elevation. Both sections are painted white. The main section has 5:1 bond with a prominent bracketed Italianate cornice and a low-pitched standing seam metal hipped roof with two central chimneys with arched caps. The principal entrance elevation is on the north side, which faces the driveway. This elevation has four bays with the entrance in the eastern inner bay. An entry porch with grouped square piers on paneled bases shelters the central two bays. The door has four heavily molded raised panels and a two-light transom. The windows are 6/6 with bullnose frames, plain wood lintels and sills. Shutter hardware is in place, but the shutters are missing. The west elevation has three bays and a central entrance covered by an entry porch which is a smaller version of the north porch. The south elevation has a full width one-story porch with chamfered posts with scroll-sawn brackets in an ogee curved profile. The elevation has four bays with a door in the west inner bay and a jib window in the east inner bay. The two-story service wing is recessed on the south elevation and slightly recessed on the north elevation. The south elevation has an integral two-story porch with plain square posts and a plain balustrade on the second story. An enclosed section at the northeast corner of the wing may be a storage area because it has an exterior vertical board door in the east side and a barred window in the north elevation. The interior of the house was inaccessible for this survey, but the owners were agreeable to a later interior documentation.

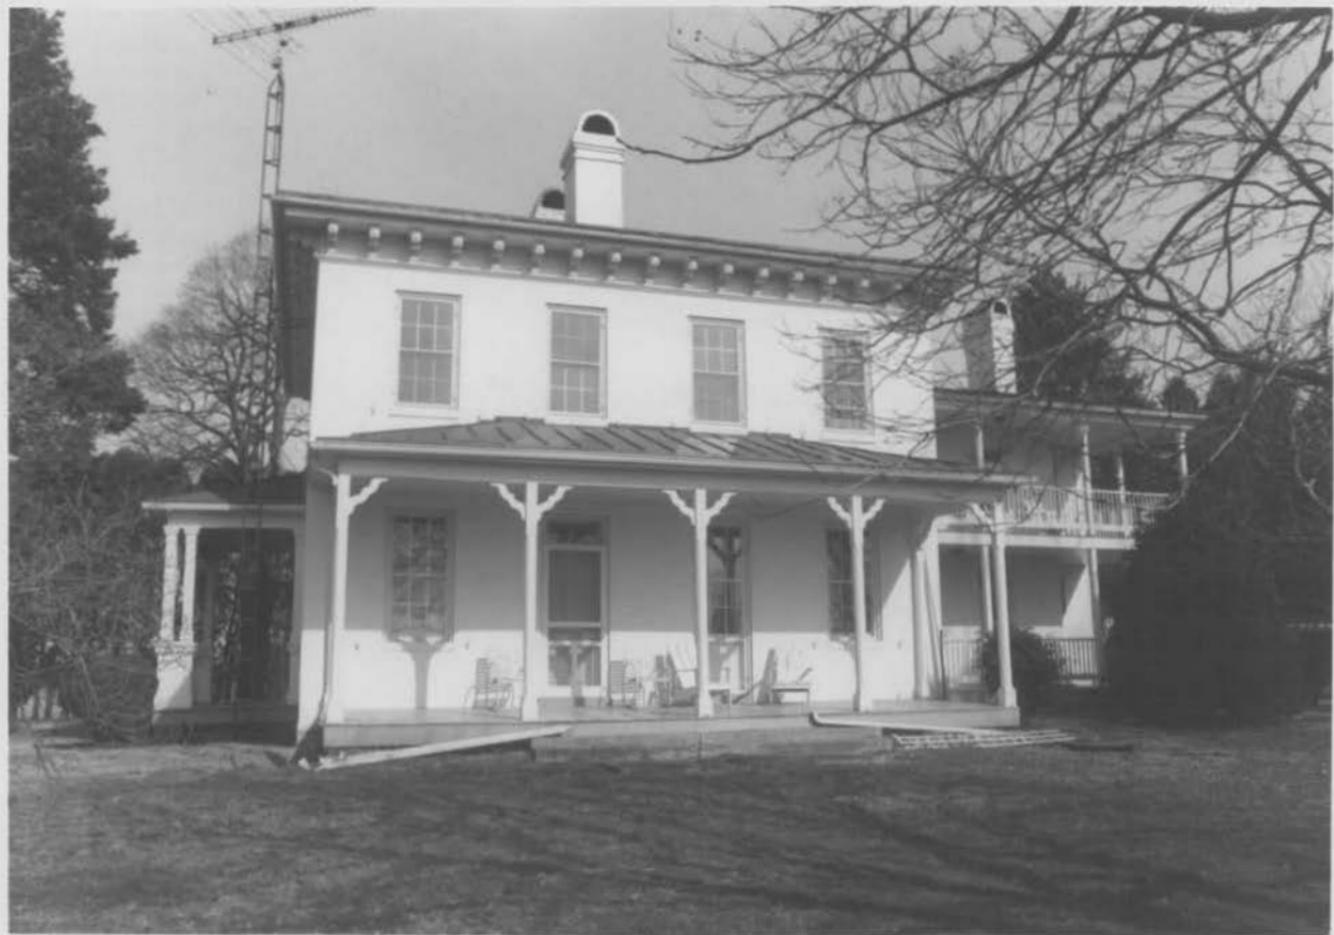
2/10

South elevation

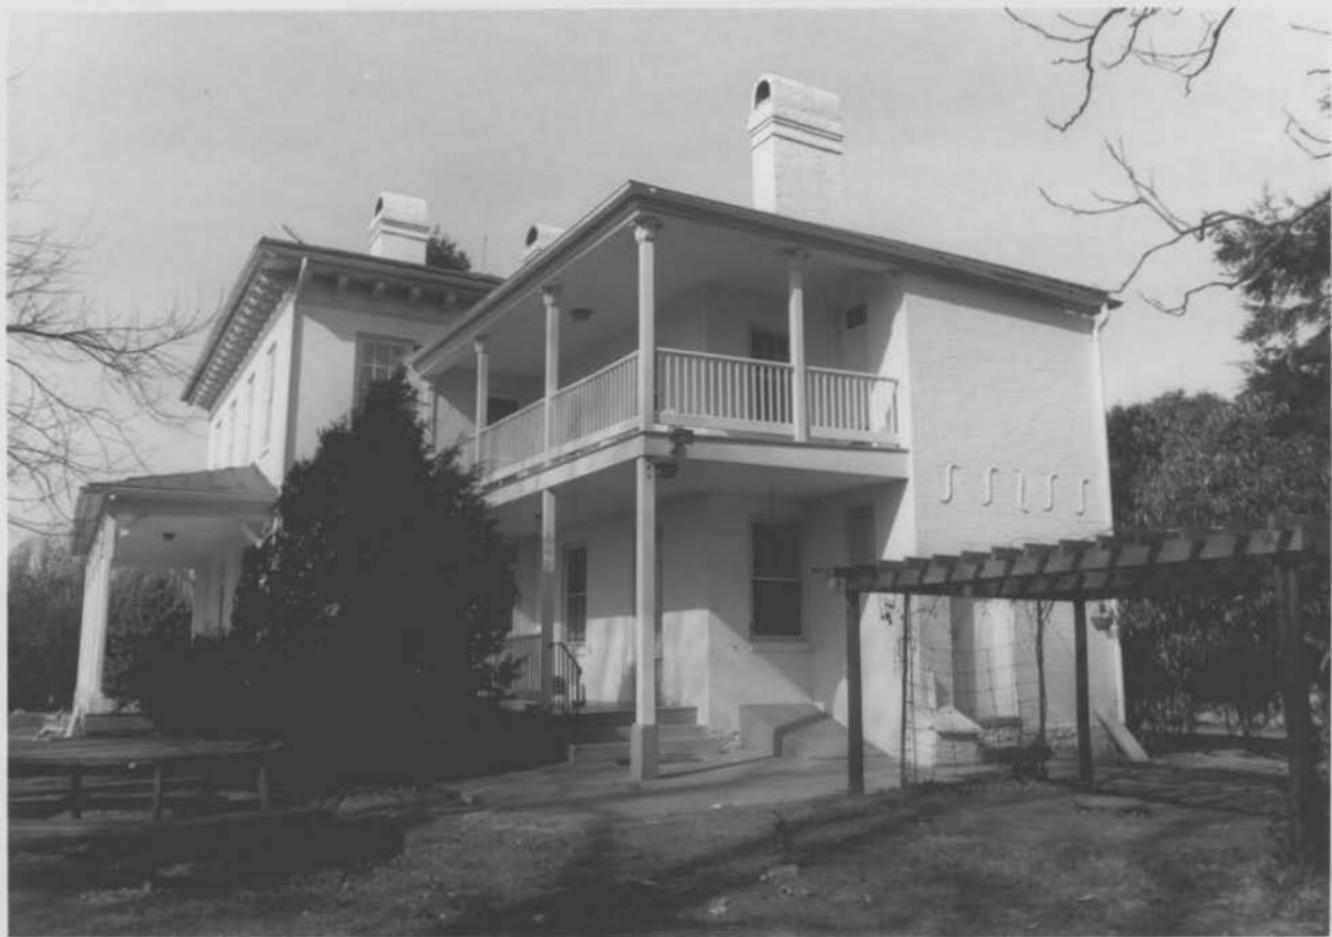
3/10

Southeast corner view

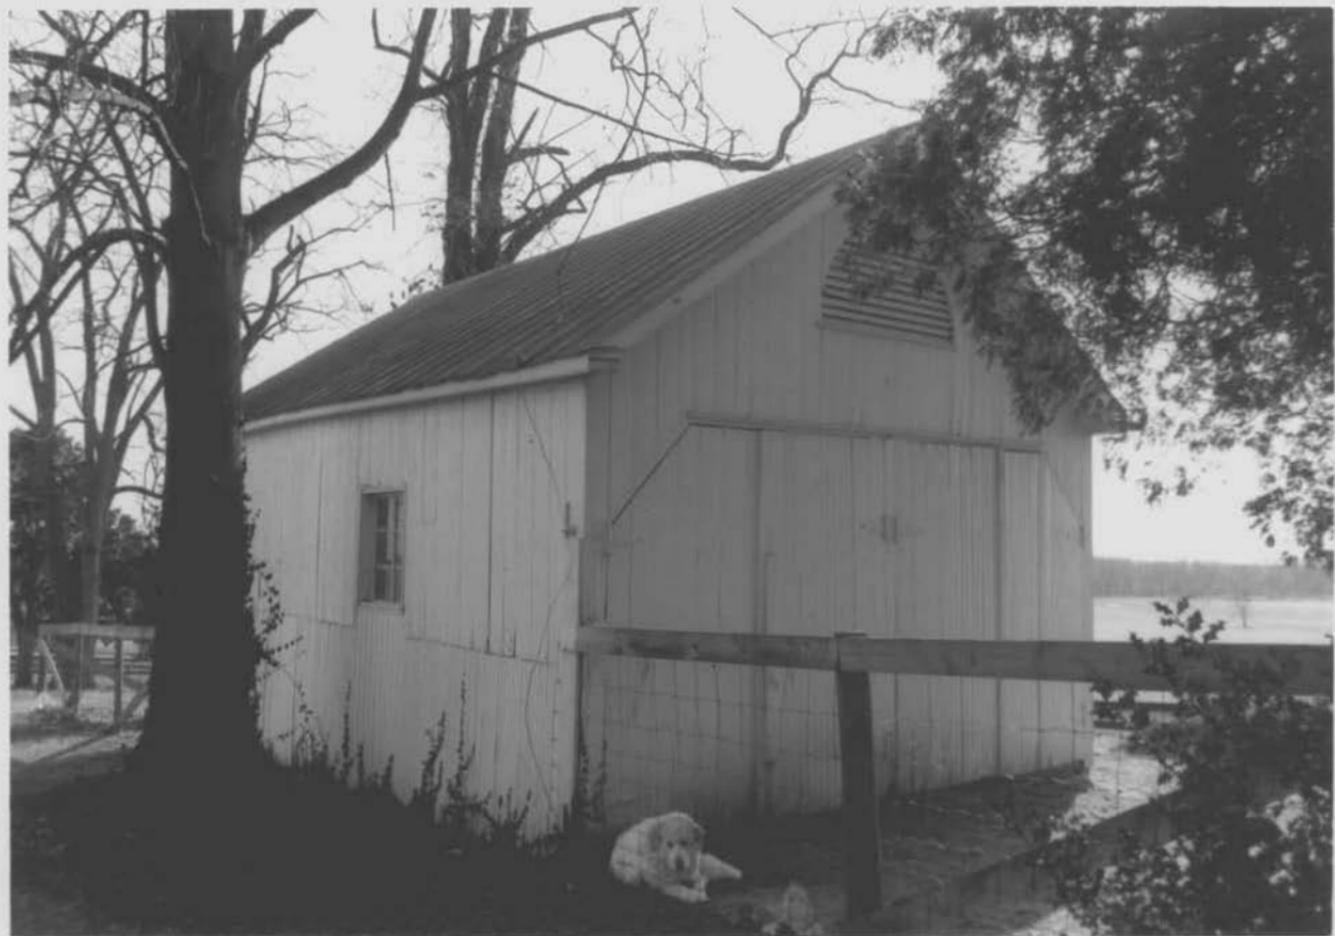
4/10

Carriage house: The frame carriage house is located southeast of the dwelling and is currently used as a dog kennel. According to Mr. Gary Thatcher, one of the current owners, the driveway originally circled the house, running past the west-facing double swing doors of the structure. It has both vertical and tongue-and-groove siding and the doors are also tongue-and-groove. A large louvred fan vent is in the gable of the west elevation and 6-light vertical windows are located in the north and east elevations. The gable roof is covered with standing seam metal. The carriage house probably dates from about the same period as the house.

Carriage House, northwest corner view

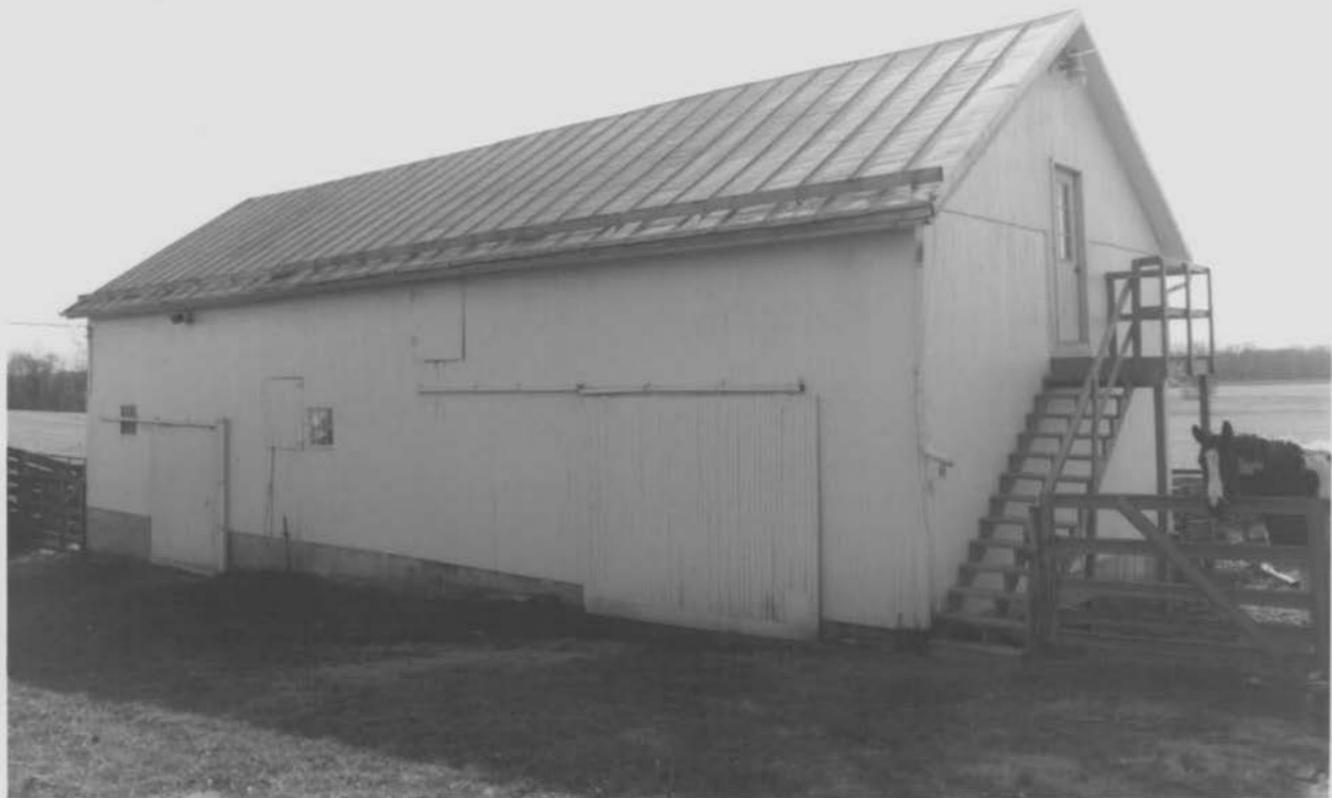
5/10

Horse barn: The frame horse barn appears to be an early 20th century structure. It is located southeast of the carriage house and has a concrete foundation with vertical tongue-and-groove siding. The long rectangular barn has a standing seam metal roof and sliding doors in two openings on the north elevation. The upper level of the barn is currently reached by an exterior wood stairway and a modern glazed panel door in the west elevation.

Horse barn, north elevation

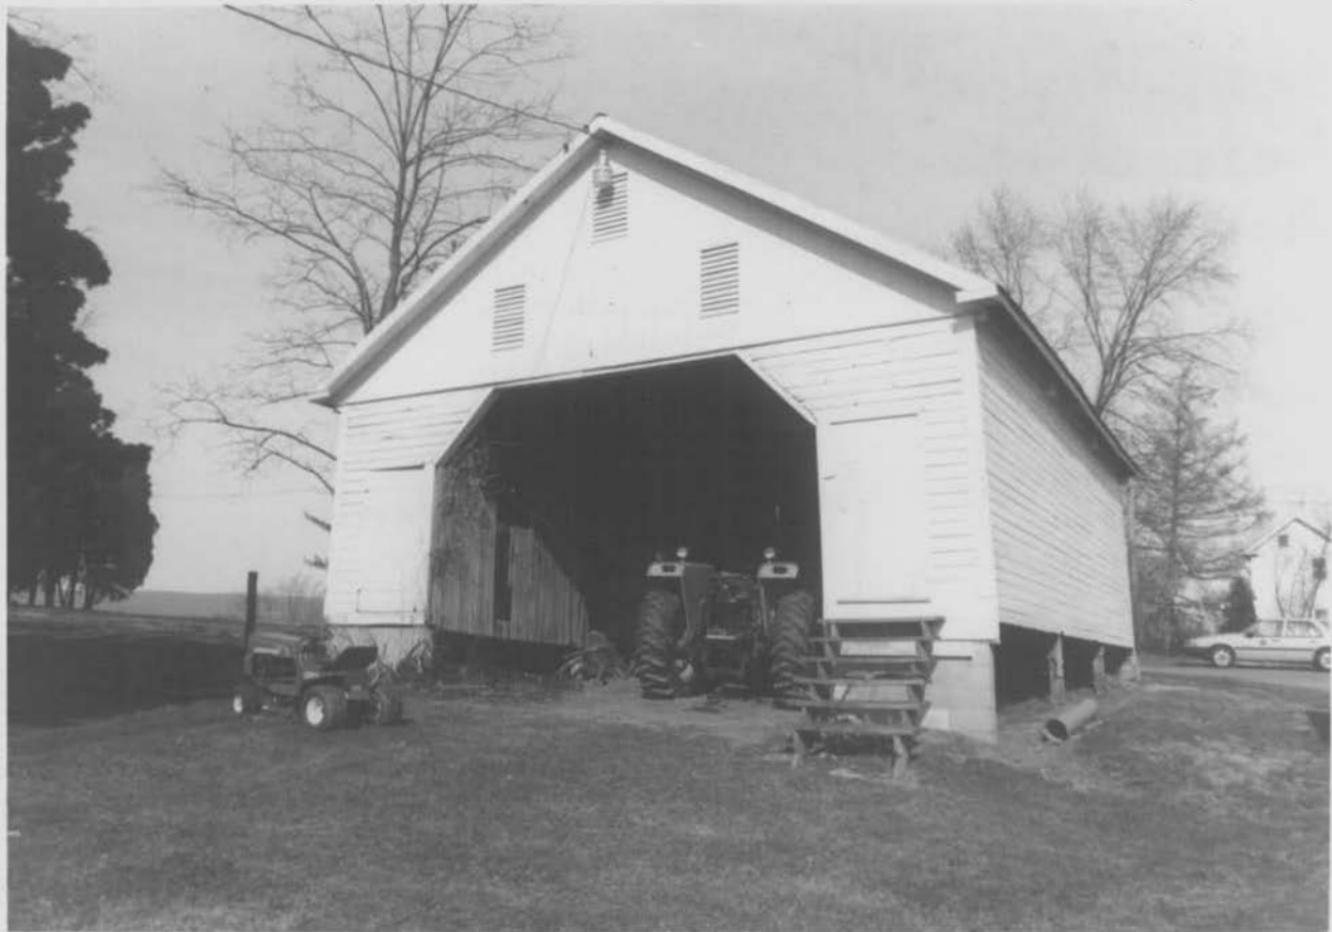
6/10

Wagon shed/corn crib: The frame wagon shed with corn cribs is located northwest of the carriage house with the drive-through on a north-south axis. The building is on concrete block and stone piers, indicating some repair and alteration in the 20th century, although it was probably built in the 1890's, based on its materials. The exterior is covered with german siding and the gables have vertical beaded siding with three louvred rectangular vents. The gable roof is covered with corrugated metal.

Wagon shed/corn crib, south elevation

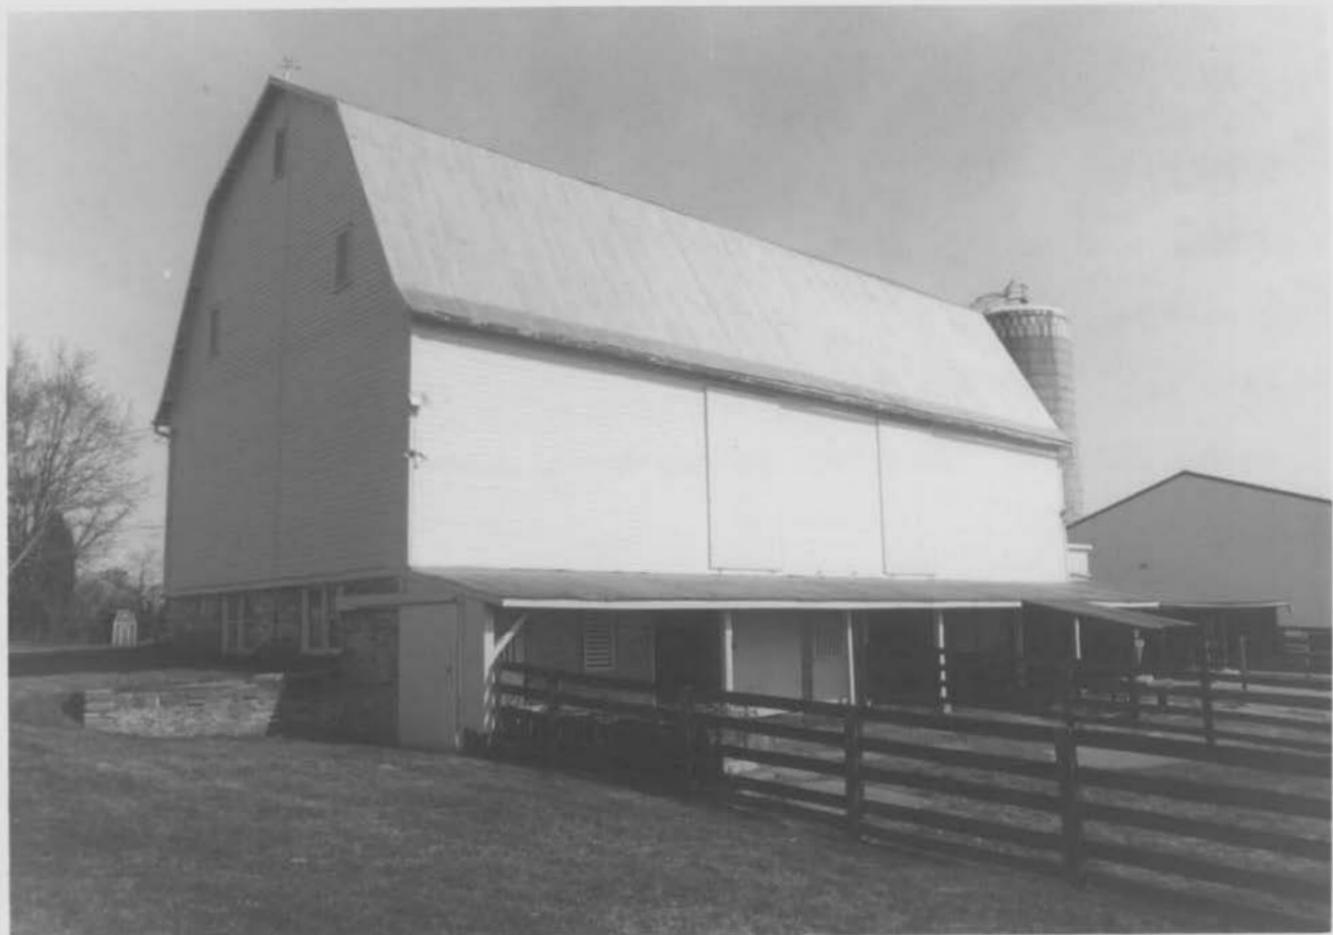
7/10

Bank barn, concrete silo, and milk house: The original frame bank barn burned in the 1920's and was rebuilt on the old stone foundation, located east of the wagon shed. The present upper structure is a gambrel-roofed building with german siding and a corrugated metal roof. The forebay was not rebuilt, but an open shed over the stone stall level extends to the south. Two sliding doors are located above on the south wall. A concrete silo built in the 1930's or 1940's is located adjacent to the ramp on the north elevation. The concrete block milk house was built after the 1920's fire and has both rusticated and plain concrete block sections. The one-story rectangular building is located near the northeast corner of the bank barn. A non-contributing metal barn is located east of the bank barn and milk house.

Neg. loc.: Md. SHPO, Crownsville Md.
Bank barn, south elevation

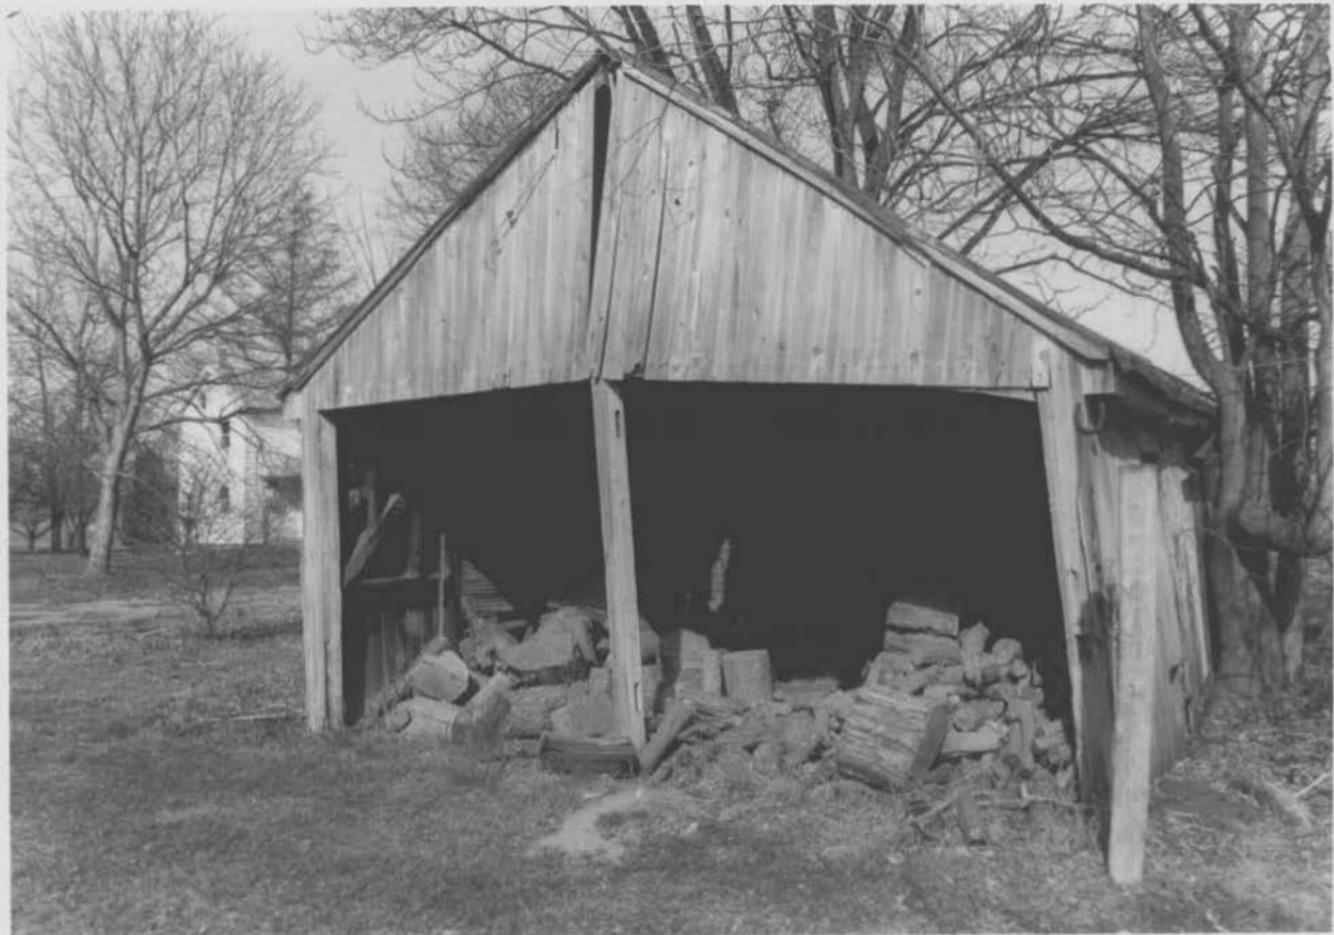
8/10

Blacksmith shop: The frame blacksmith shop is located north of the bank barn. It was probably erected in the 1870's or 1880's and has vertical beaded siding and a standing seam metal roof over wood shingles. On the open south elevation is a center support post and boarded window openings are on the east, north, and west elevations. The brick and concrete forge is located in the northwest corner. Currently used as a wood shed, the blacksmith shop is in deteriorated condition.

Blacksmith Shop, south elevation

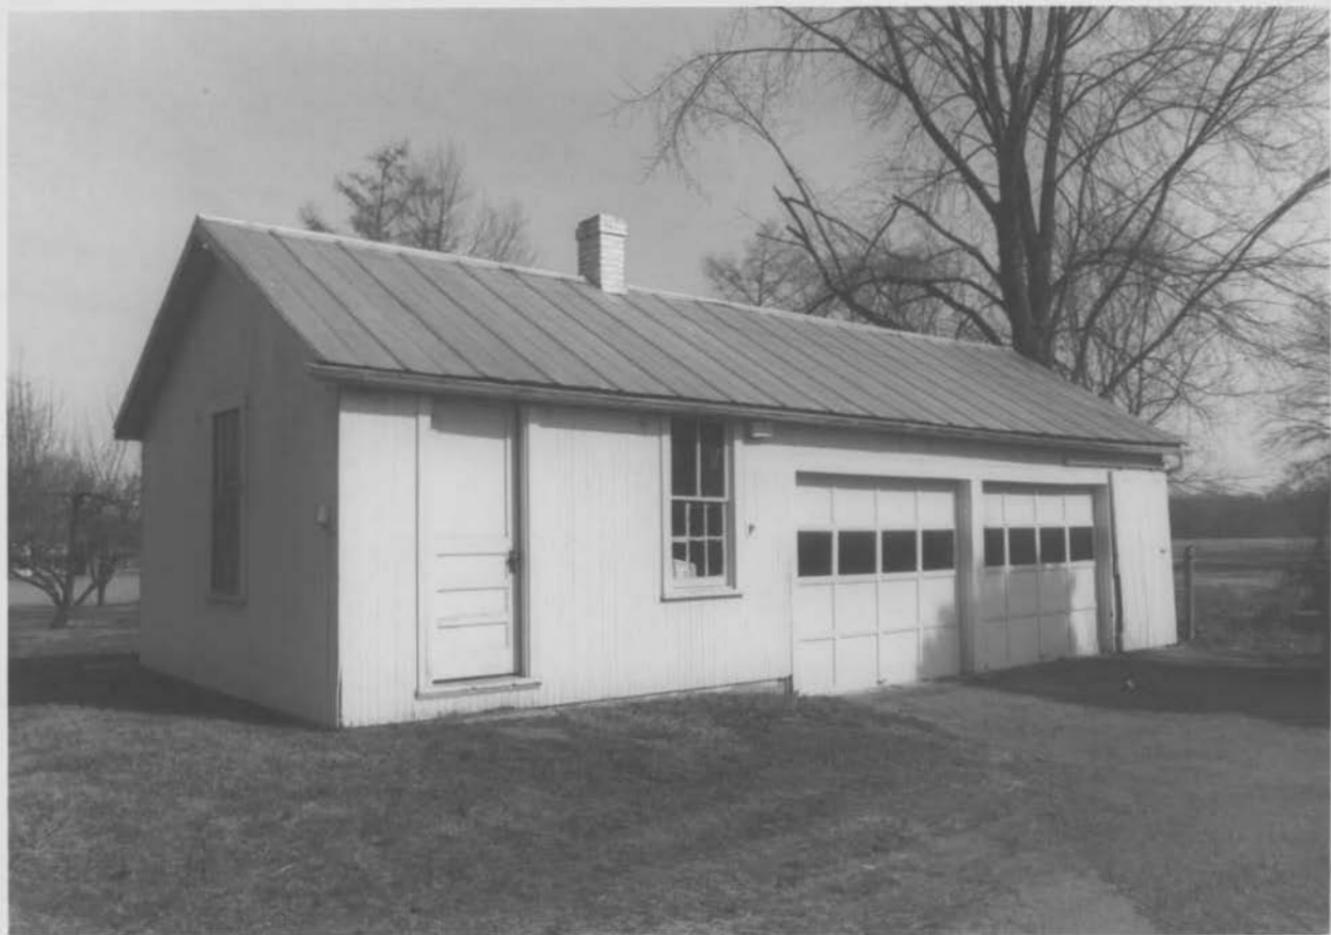
9/10

Garage: The one-story frame garage is located west of the blacksmith shop and appears to have been built in the early 1930's or 1940's. It is rectangular, with vertical tongue-and-groove siding and a corrugated metal roof with an off-center brick chimney. The west end is a small storage area with a panel door on the south elevation and a window with composite sashes, one 2/2 and one 3/3. At the east end is a two-bay garage, possibly added later to the existing western section. Lift-type doors and a salt box roof profile characterize the garage section.

Garage, south elevation

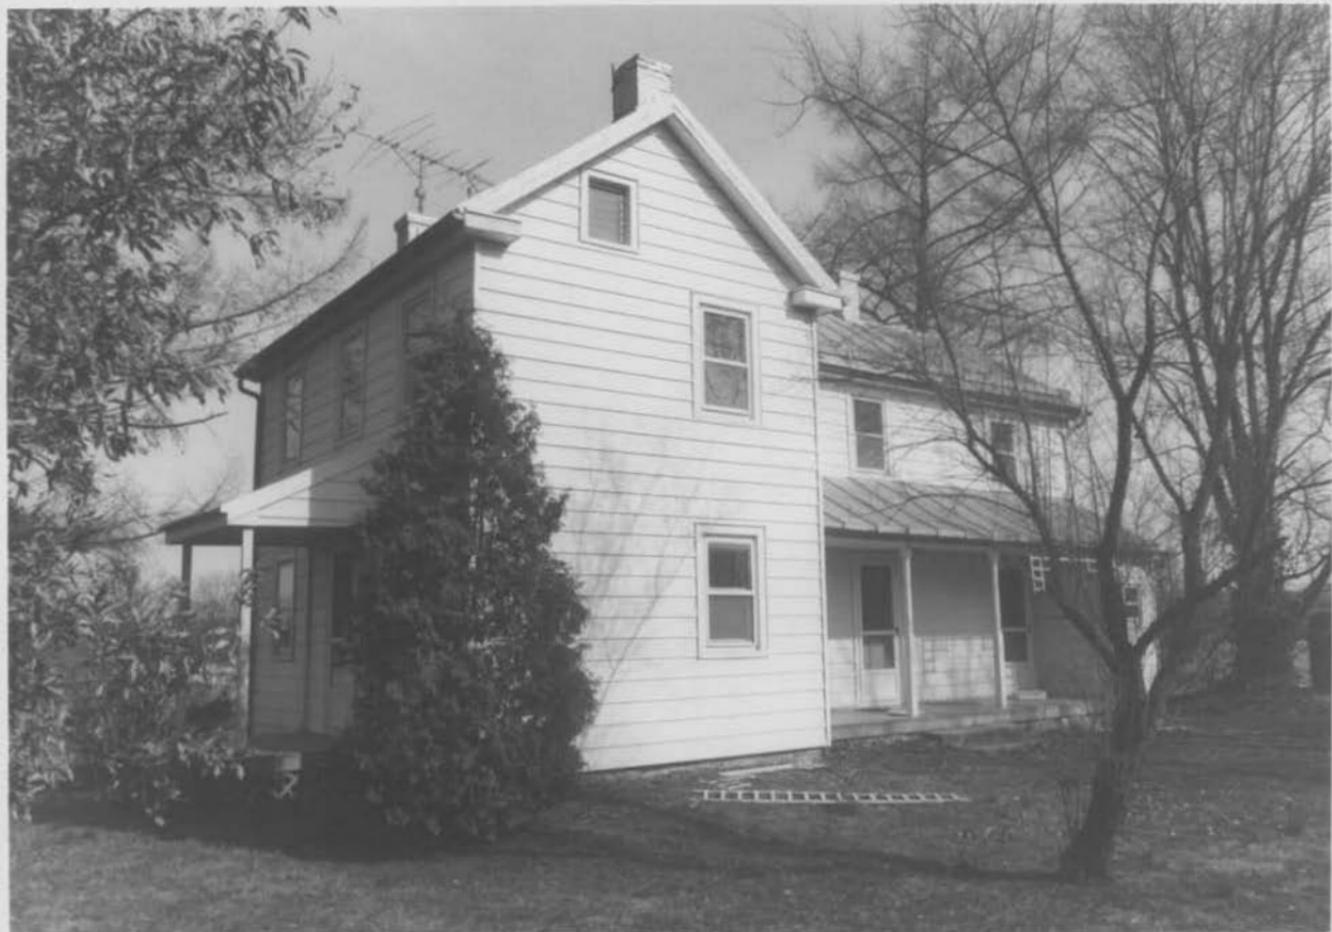
10/10

Tenant house: The two-story tenant house is the northernmost building in the farmstead and is a typical vernacular farmhouse of the second half of the 19th century. It may have some log structure as well as frame, and the exterior is covered with vinyl siding. The three-bay west elevation has an entry porch over the central entrance and the windows are 1/1 replacement sash. Other windows in the house have 1/6 or 1/2 sash. The roof is covered with standing

seam metal and interior end chimneys rise above the gable ends. A two-story rear wing with a one-story porch on the south elevation extends to the east from the front section. The rear wing porch has turned columns. A third interior chimney is located at the east end of the wing.

Tenant house, southwest corner view
