F-3-137
Hime-Castle Farmstead
Feagaville vicinity
Private

**Maryland Historical Trust
State Historic Sites Inventory Form**

historic Hime-Castle Farmstead

7.1 Description (Continued)

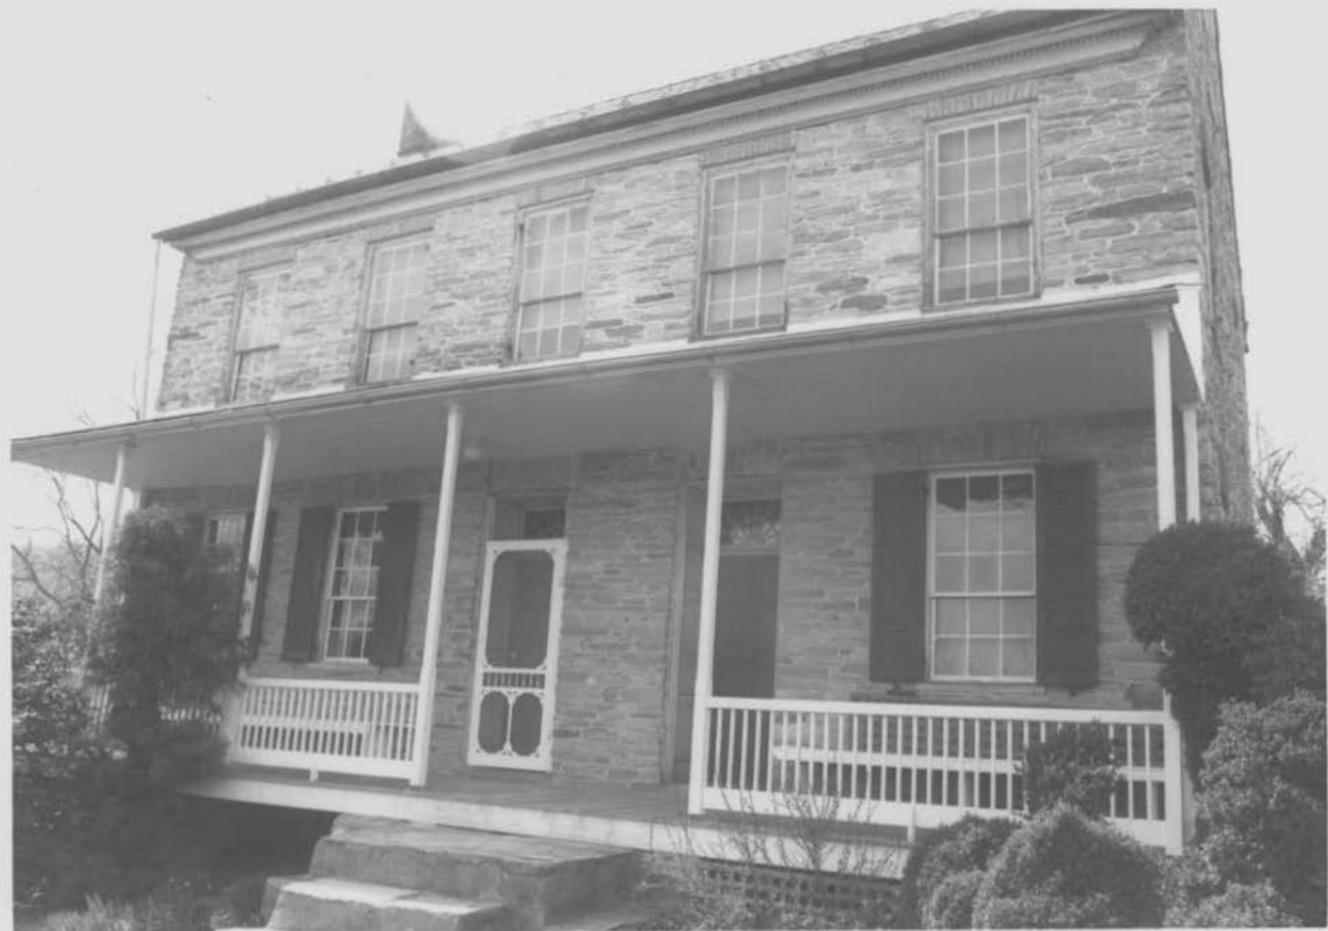
1/14

East elevation

The house has a five-bay main section and a perpendicular two-story wing extending from the northwest corner. The roof is covered with composition material and the walls are coursed fieldstone. The south elevation has a one-story porch across the entire facade. It has slender chamfered posts and a plain balustrade. The design and materials suggest that it is an early 20th century replacement of an earlier porch. The two entrances are in the second and third bays from the right or north end of the facade. The recessed doors have matching fanlights in the rectangular transoms, paneled soffits, and 8-panel doors. The window and door arches are gauged brick. The sash is 9/6 on both stories and louvred shutters are in place on the first story. Above the second story windows is a wood mold cornice with both guilloche and an unusual variant of dentil moldings. The north and south gable ends each have two bays with 6/6 sash. On both the north and south gables are inscribed stones reading "David Hime 1815". Each end has two attic windows with 2/2 sash. The south elevation also has a vertical board door leading into the cellar. The rear wing has three bays on the south elevation with a central door on the first story flanked by 2/2 sash. The second story has two 6/6 windows and one 2/2 window. The roof of the rear wing is corrugated metal. An interior end chimney is located at the north end and a heavily repointed patch in the stone wall at the first story level suggests that an oven projection was removed at this location. A fourth chimney rises near the junction of the wing and the main section. On the east side of the wing, the roof projects over what was probably once a full width, two-level porch. The current porch only incorporates the two bays nearest the main section and the lower level is partially enclosed, probably as a pantry or storage room. The second story porch has plain chamfered posts and a horizontal board railing. The windows on the east side of the wing reflect the variety found in the rest of the house, the first story having both 9/6 and 2/2 windows and the second story having 6/6 sash. The interior of the house was inaccessible for this survey.

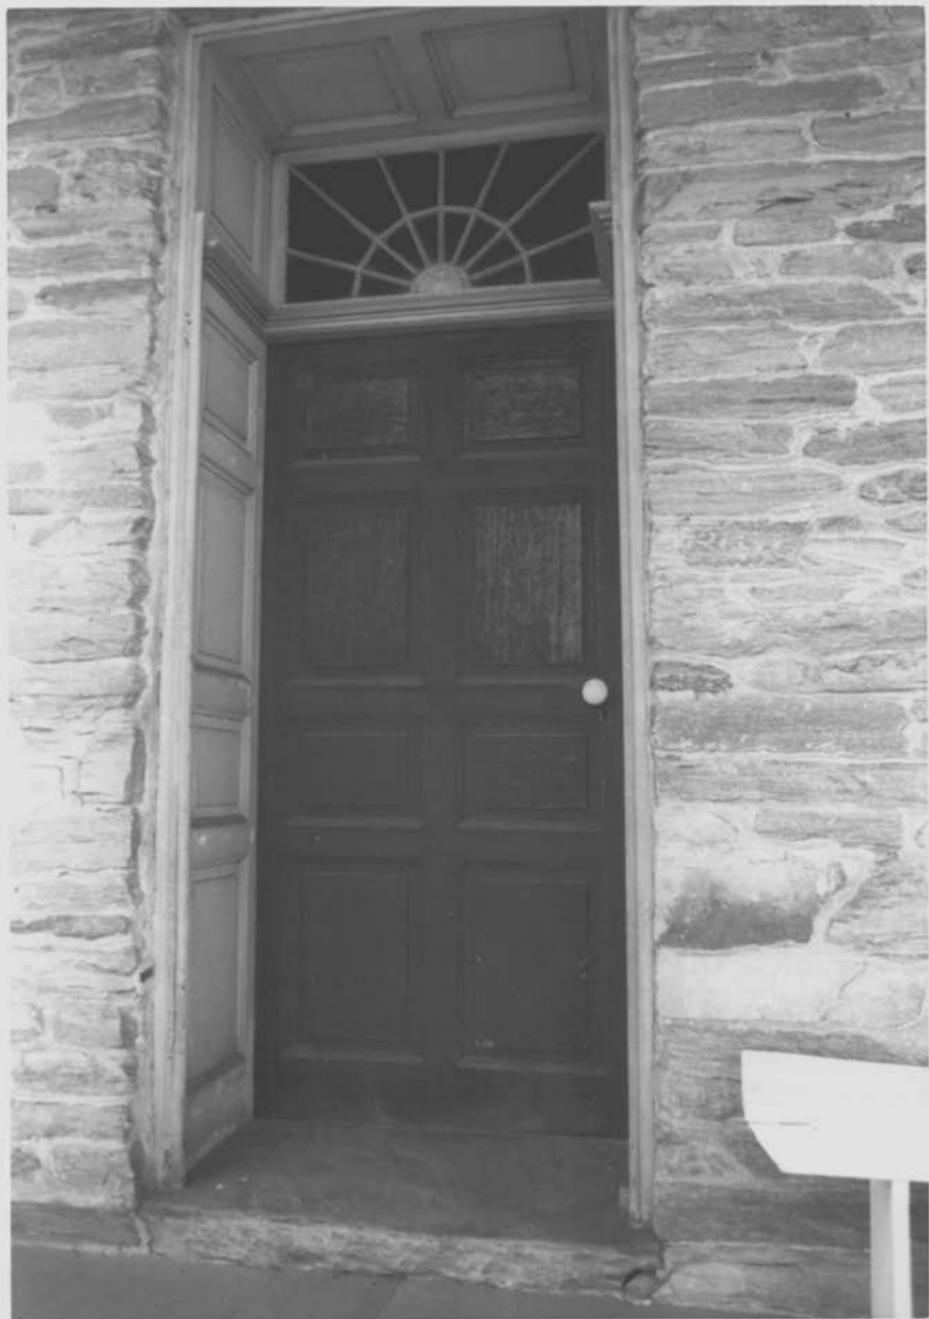
2/14

Doot detail, east elevation

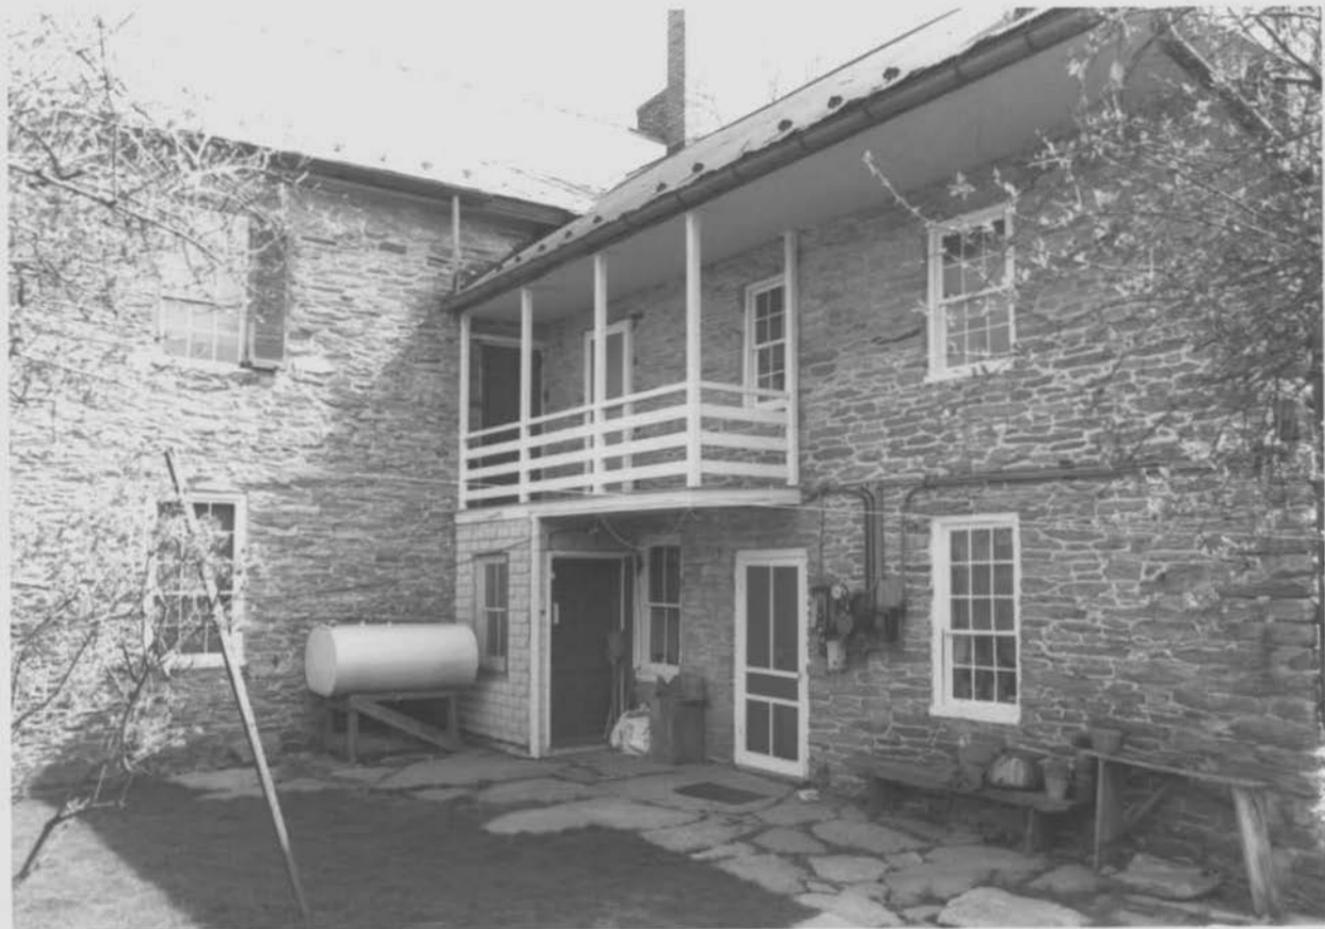
3/14

Northwest corner view

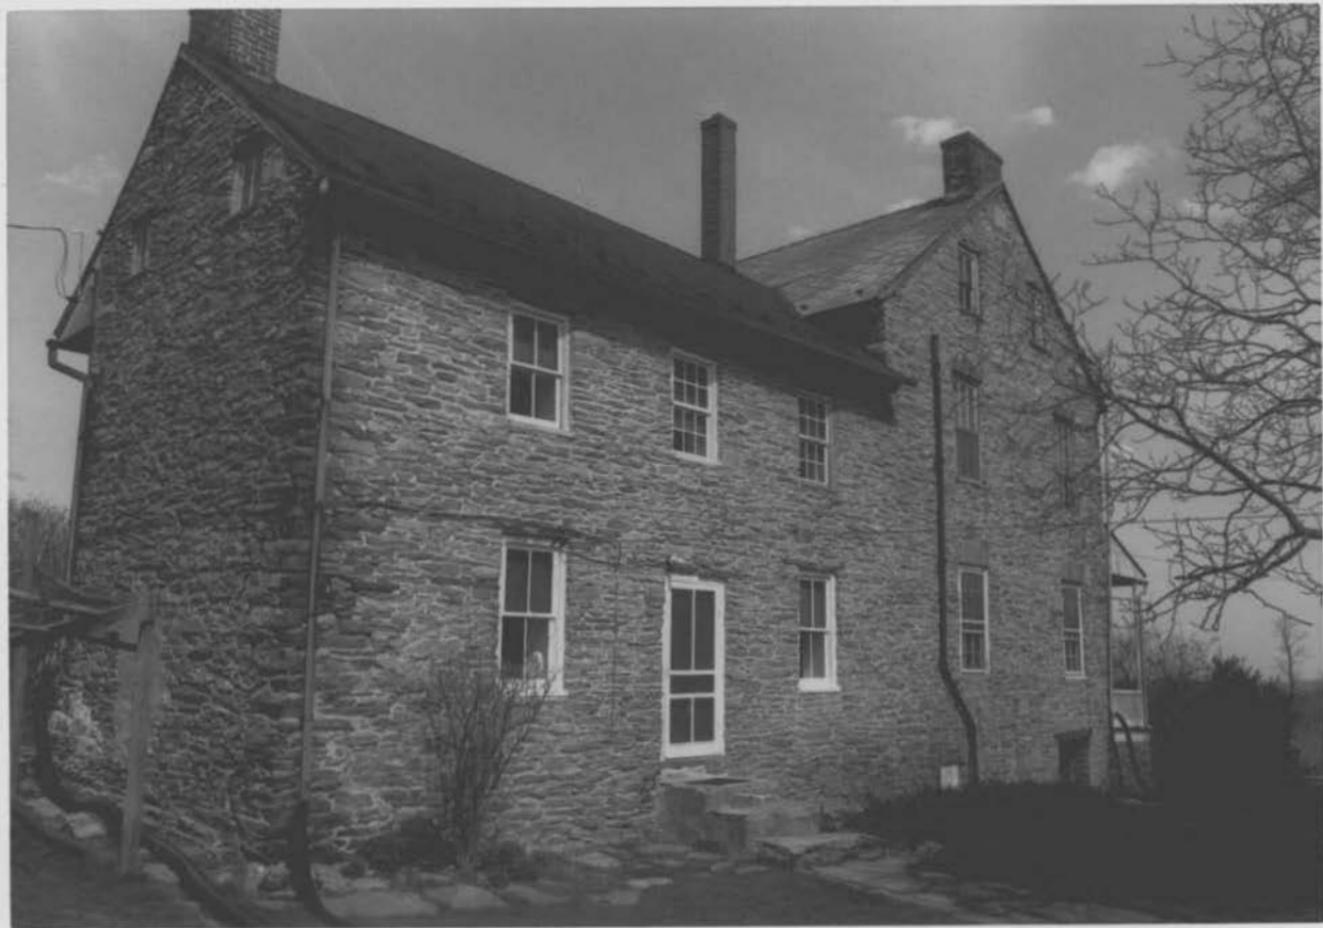
4/14

South elevation

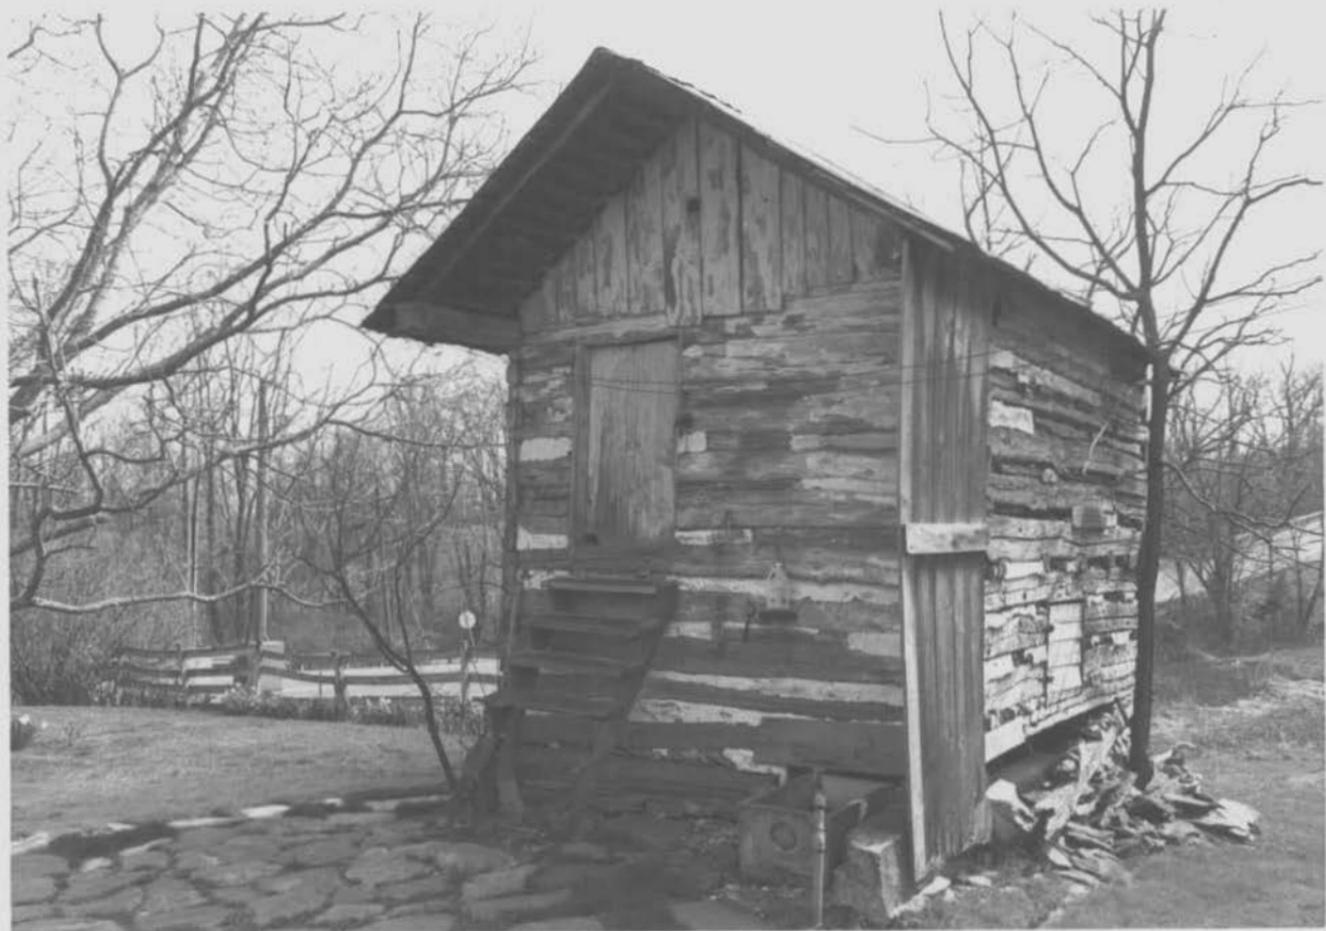
5/14

Springhouse: The log springhouse is located south of the wing of the house. It is in generally deteriorated condition, but retains most of its original appearance. It has two levels, with the upper level reached by an off-center vertical board door at the top of a small open stair. The corrugated metal roof extends over the north

elevation and a vertical board wind break projects from the northeast corner. A concrete trough protrudes from the lower level at the northeast corner and a concrete trough is visible through the logs where the chinking has fallen away. The use of the upper level is unknown, but its lack of openings suggests a meat storage room. The springhouse was probably built about the same time as the dwelling.

Springhouse, north elevation

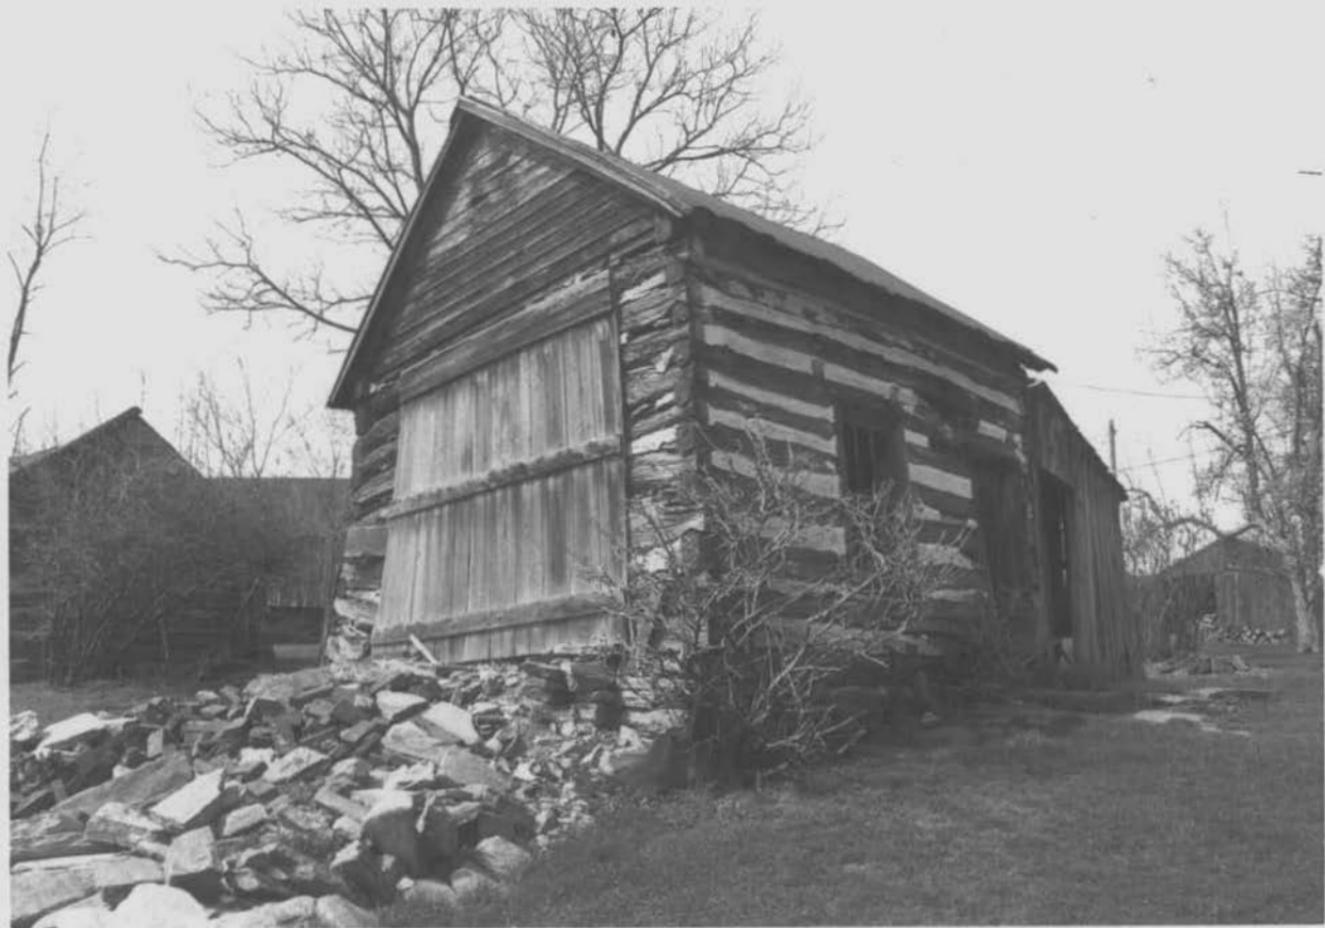
6/14

Summer kitchen: The log summer kitchen is located just north of the springhouse. It is a one-story building which originally had an exterior brick and stone chimney, as indicated by the boarded south elevation where it joined the log wall and the debris pile of stone and brick next to the base of the south elevation. The kitchen has one room with a vertical board door near the northeast corner flanked by a 6/6 window. The gable roof is covered with corrugated metal and the gable ends are covered with german siding. On the north gable end is a frame shed. The entire building is in deteriorated condition, but, like the springhouse, retains much of its original appearance except for the destroyed chimney. Its date is also probably contemporary with the house.

Summer kitchen, south elevation

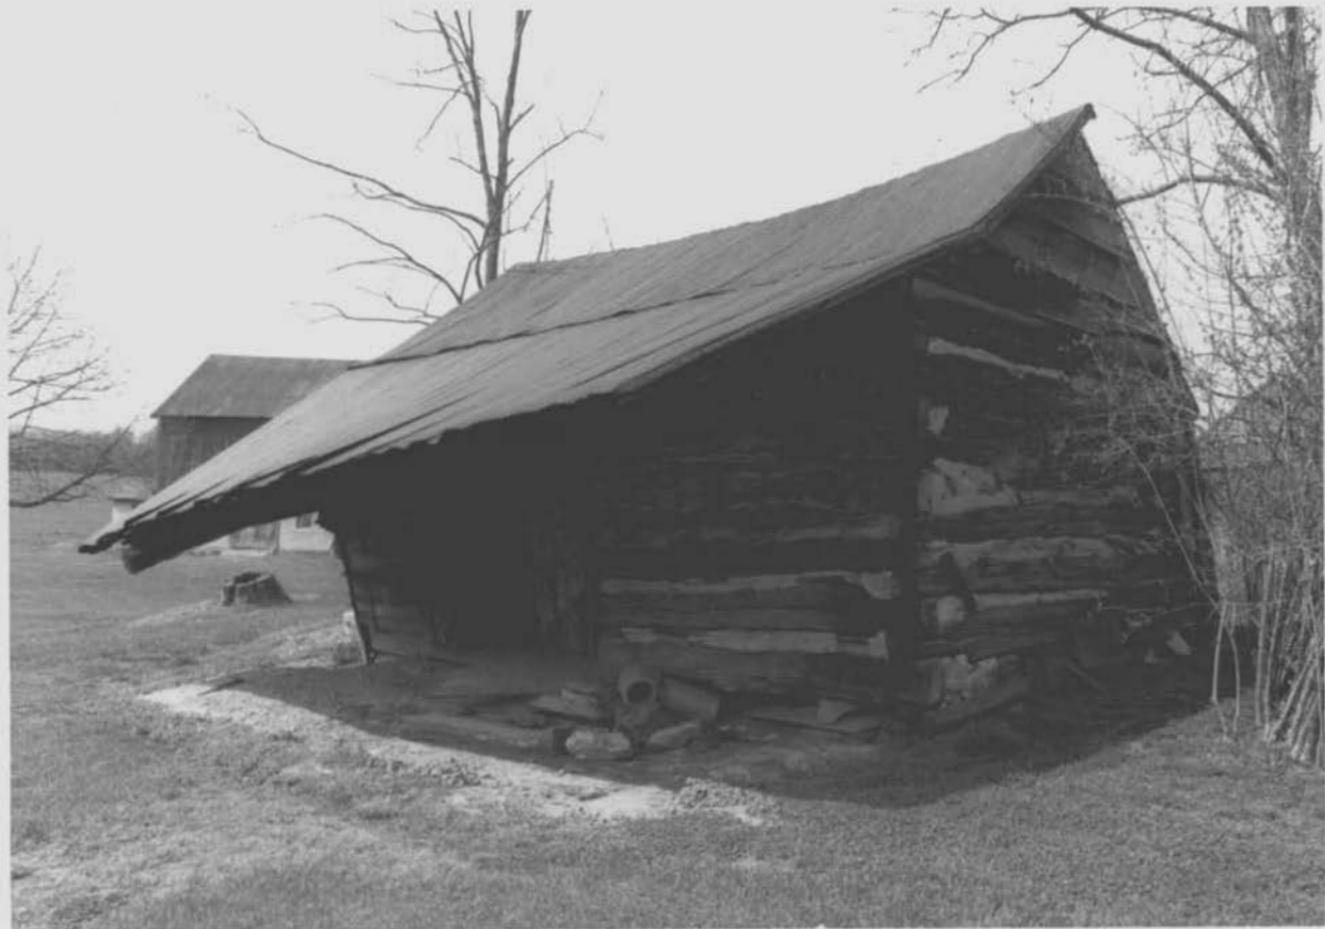
7/14

Chicken house: The deteriorated log structure north of the summer kitchen may have been a chicken house or pig pen. It has a low roofline with an extended shed roof on the south elevation sheltering a low vertical board door in the center of the elevation. A single low opening is also located on the north elevation. The building sags near the northwest corner of the shed overhang and is in precarious condition. Its log structure matches that of the springhouse and summer kitchen and thus is estimated to be of the same period in the first quarter of the 19th century.

Chicken house, south elevation

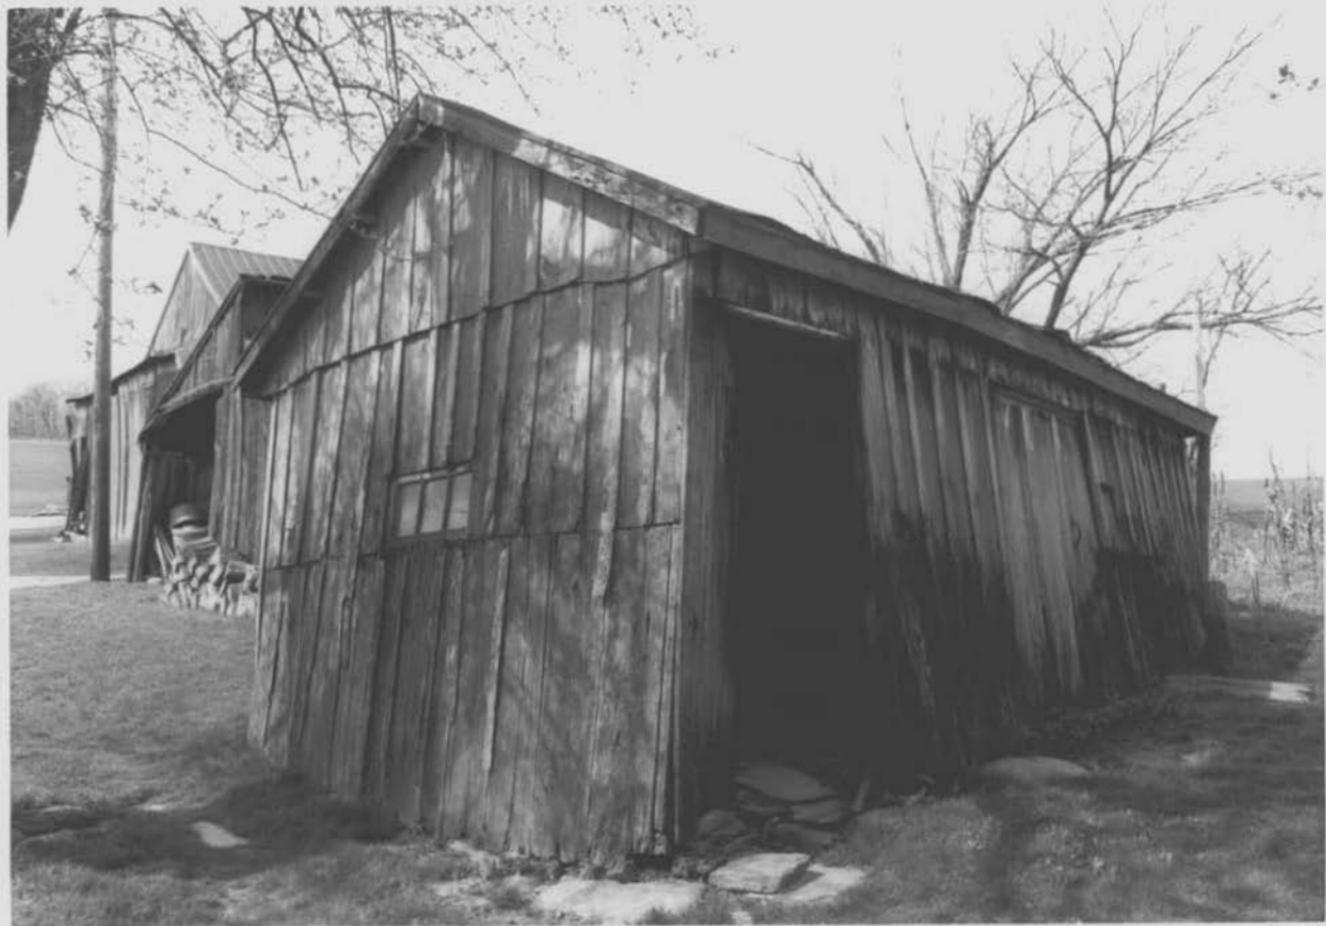
8/14

Frame shed: A one-story rectangular frame shed with board and batten siding and evidence of weathered whitewash on the exterior is located northeast of the house. It is deteriorated, as are most of the outbuildings, and has a corrugated metal roof and two vertical board doors on the south elevation. Its location in the domestic group suggests that it may have been a feed shed or storage shed for tools. Its materials suggest that it was built in the last quarter of the 19th century.

Shed, southeast corner view

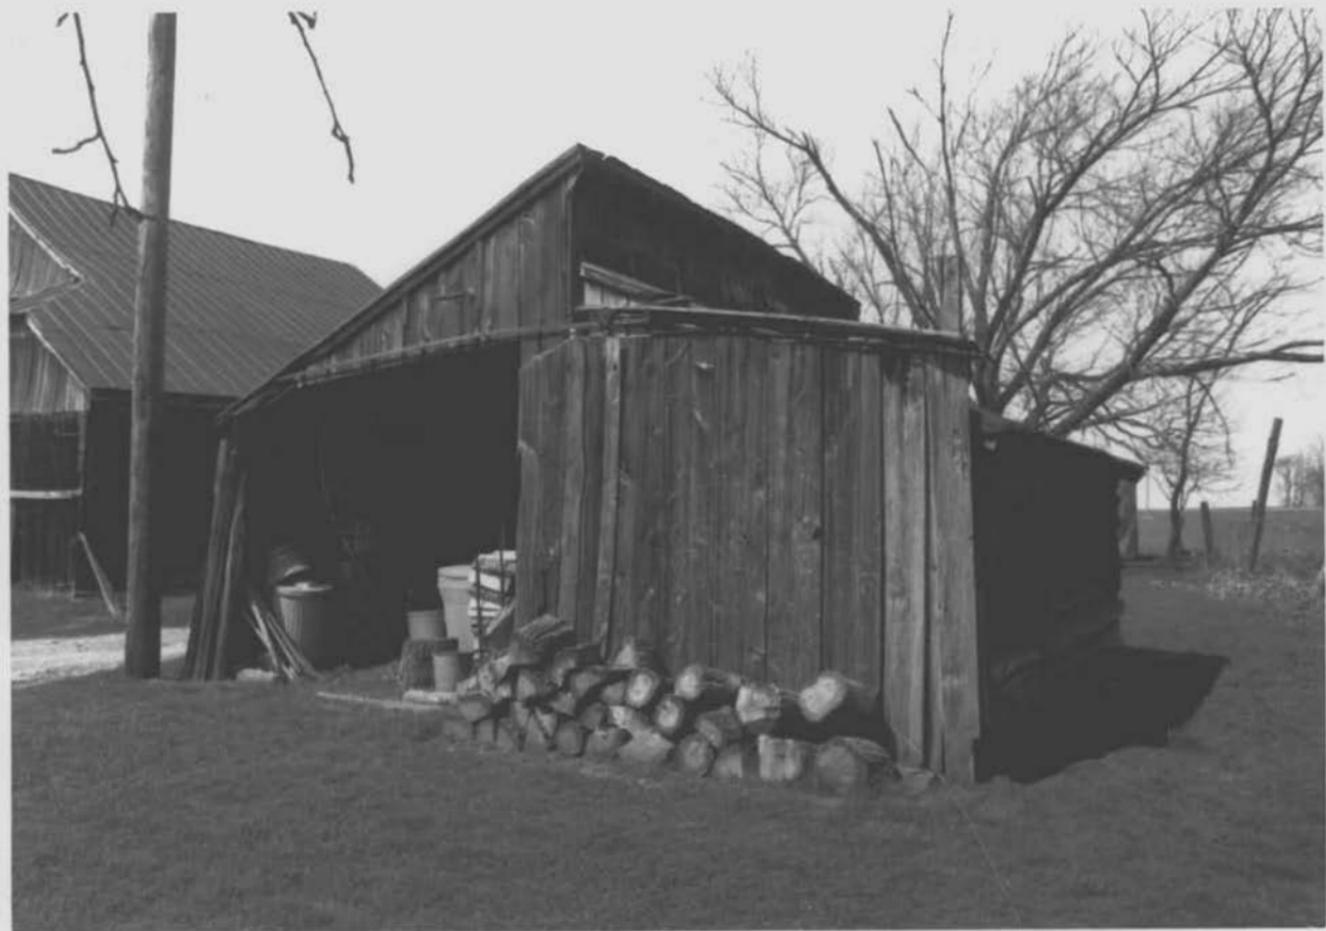
9/14

Wood shed: The frame wood shed is located northwest of the board and batten shed. It has two sections with opposing roof slopes covered in corrugated metal. The north side is an open storage section with both vertical and board and batten siding and the south side is an enclosed shed, possibly for storage of axes and other tools. The south wall is covered with weatherboards. Its date is also estimated as in the period 1875-1900.

Wood shed, south elevation

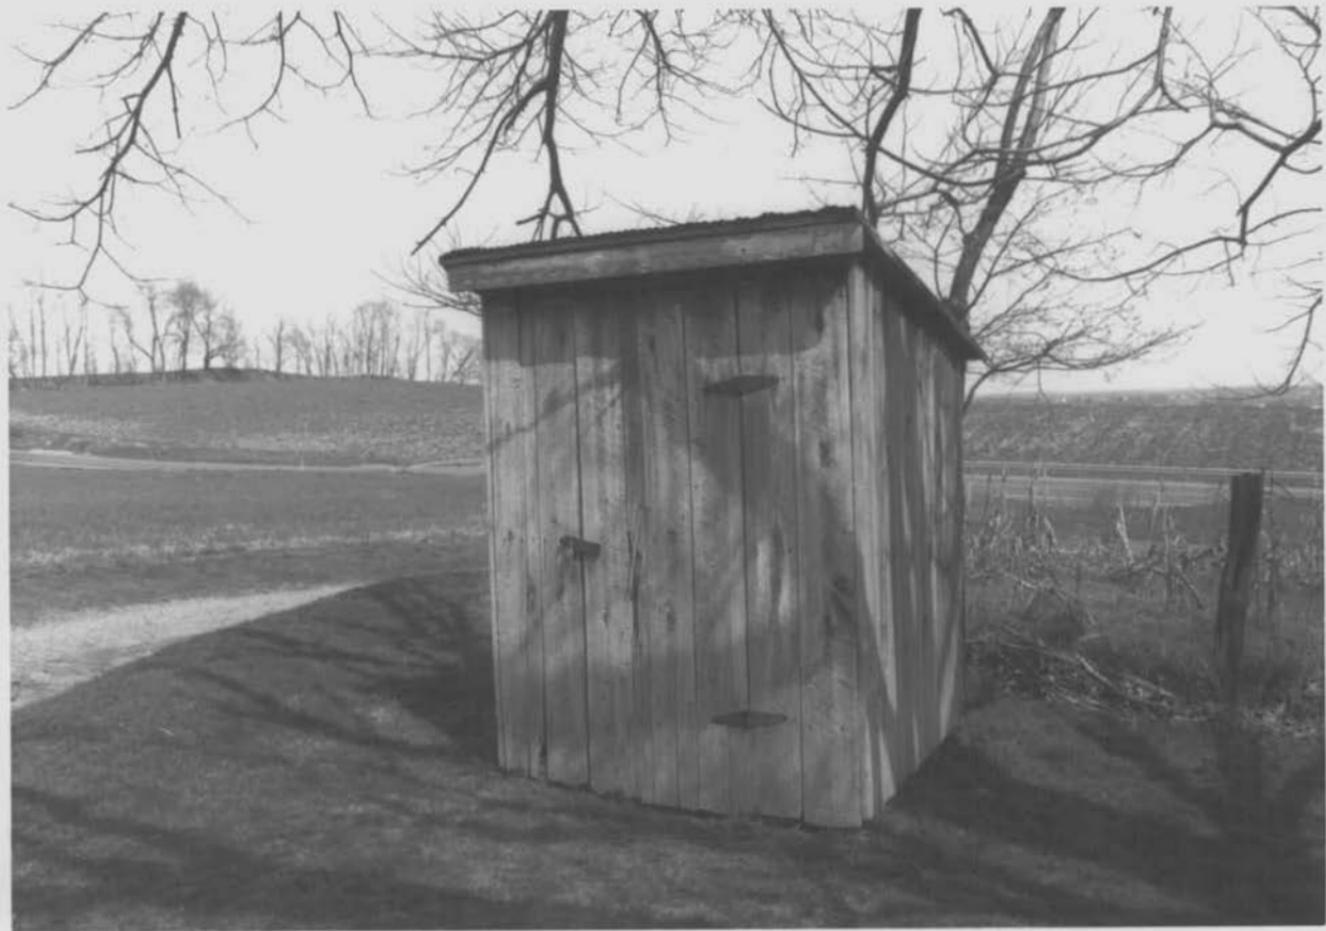
10/14

Privy: The small square frame shed near the entrance drive to the farmstead may have been a privy, although its location some distance from the house suggests that it may have earlier been in another location. It has a shed corrugated metal roof, vertical board siding, and a single door on the north elevation. Circular saw marks on the siding suggest that it dates from the early 20th century.

Privy, northwest elevation

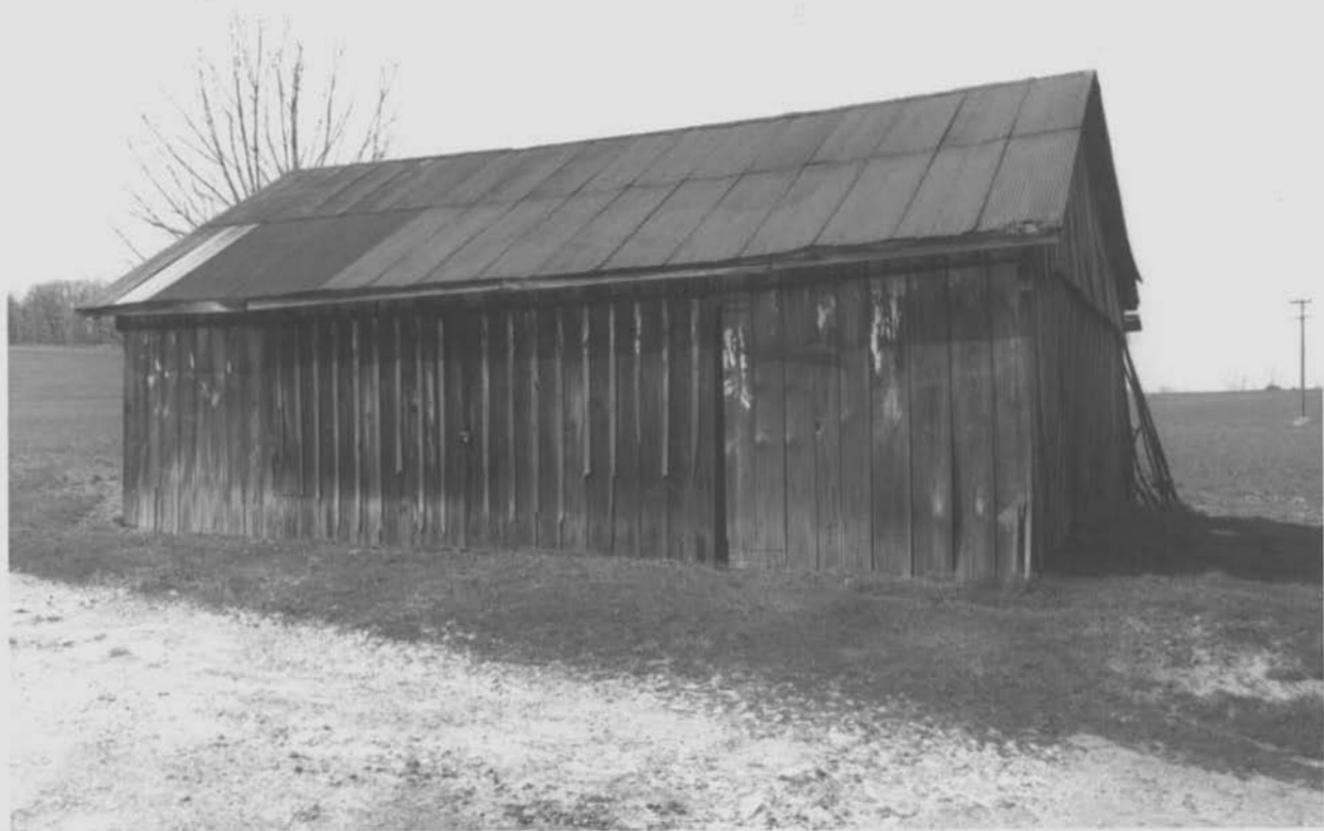
11/14

Equipment shed: The frame equipment shed is the northernmost building in the farmstead, being located on the north side of the entrance driveway. It has vertical board siding, a corrugated metal roof and board and batten sliding doors on the south elevation. It was once whitewashed, as all the outbuildings appear to have been, and the date is probably about 1900-1910.

Equipment shed, south elevation

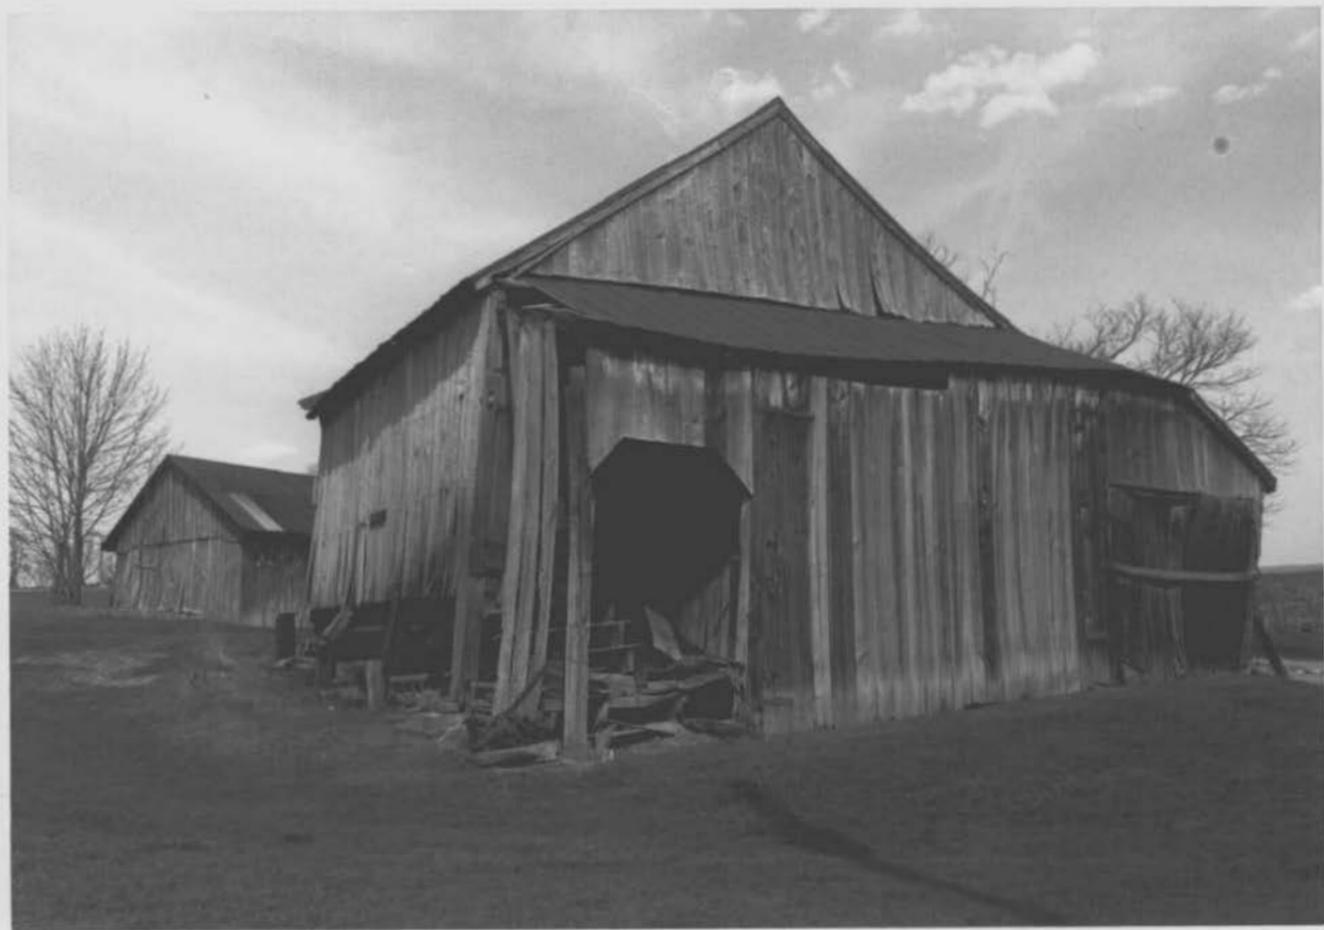
12/14

Wagon shed/corn crib: The frame wagon shed corn crib is located northwest of the wood shed. It has been altered, but the basic form of the drive-through with flanking cribs on each side is still generally apparent. The southwest elevation of the building was extended with a shed addition and another shed addition adjoins the south elevation. The siding is vertical boards and the roofing is corrugated metal. The northwest side crib is reached by open covered steps installed at the same time as the shed extension. The wagon shed was probably originally built about 1890-1900.

Wagon shed / corn crib, south elevation

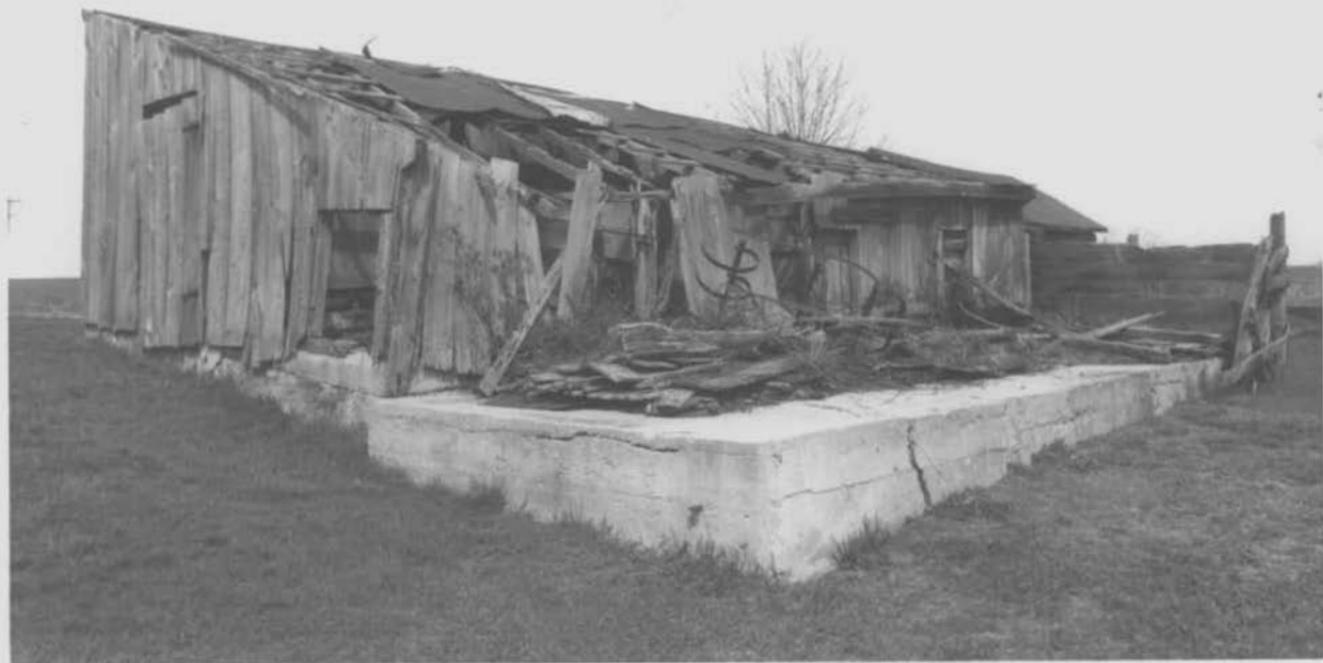
13/14

Hog pen: The hog pen is the most deteriorated outbuilding in the farmstead. Located northwest of the wagon shed, it is a rectangular structure with a sloping shed roof which is almost completely destroyed from neglect. The exterior walls of vertical board are also in very deteriorated condition. The concrete base of the wallow is still in place, but most of the encircling fence has fallen down and the members stacked on the concrete slab. The hog pen has the typical form of a long feeding aisle on the high side of the building with the pens on the lower roofed section. It was probably built in the early 1920's when dairy activity in the bank barn became more intensified.

Hog pen, southwest corner view

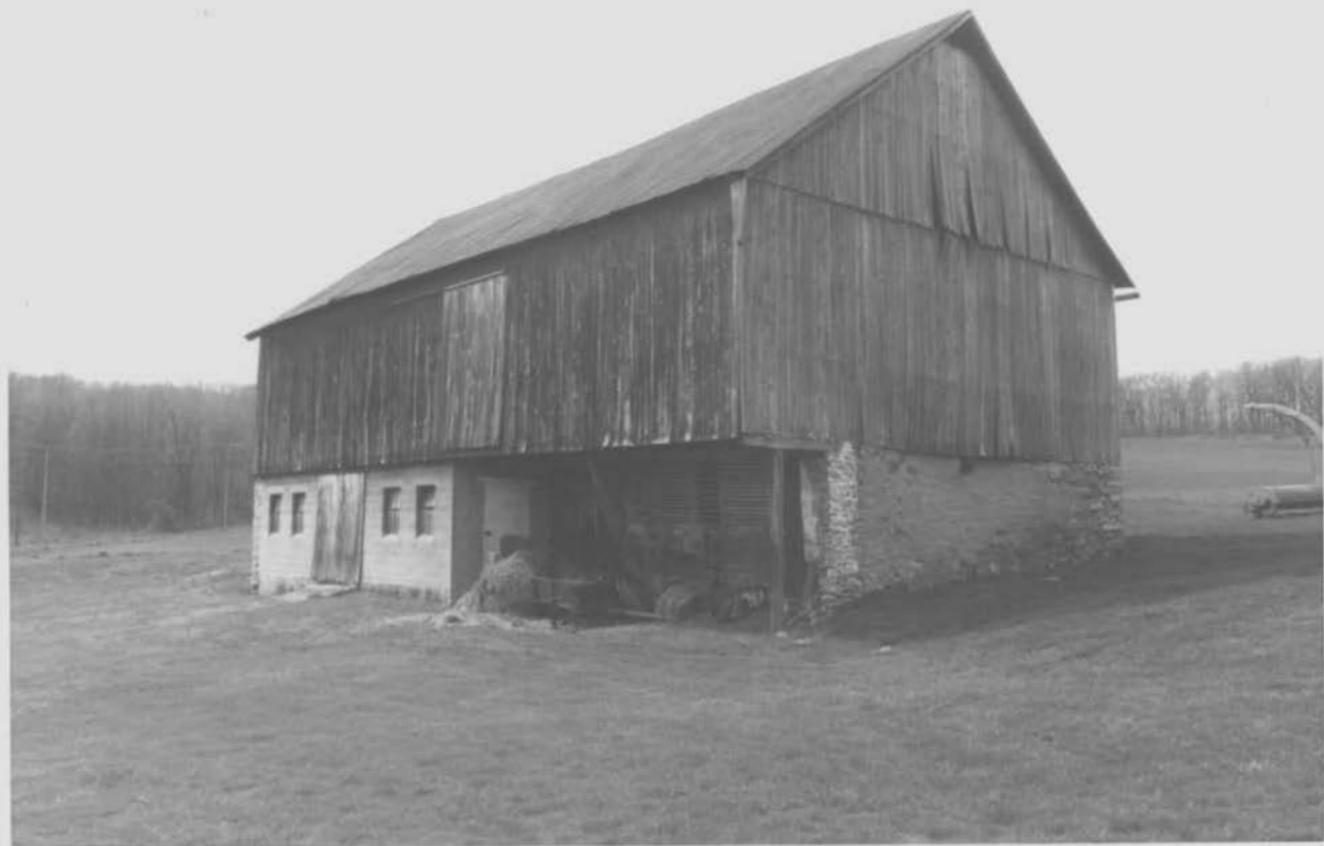
14/14

Bank barn: The frame bank barn is the westernmost building in the farmstead. It has a stone base with vertical boards covering the upper frame structure. The roof is covered with corrugated metal. The stall level is partially enclosed with concrete block as a milking parlor. The unaltered section of the stalls has horizontal laths above a flush board base. The barn was probably originally built in the first quarter of the 19th century, although its exterior siding and the unaltered stall enclosure suggest that it may have been rebuilt in the late 19th century on an older base. The concrete block enclosure for milking was undoubtedly an alteration of about 1925-1930.

Bank barn, east elevation
