Maryland Inventory of Historic Properties Addendum

MIHP Number: F-3-148

Property Name: Witter-Mercer Farm
Property Address: Trading Lane, Frederick, MD

Project: I-270/US 15 Multimodal Study, Montgomery and Frederick Co. Agency: SHA

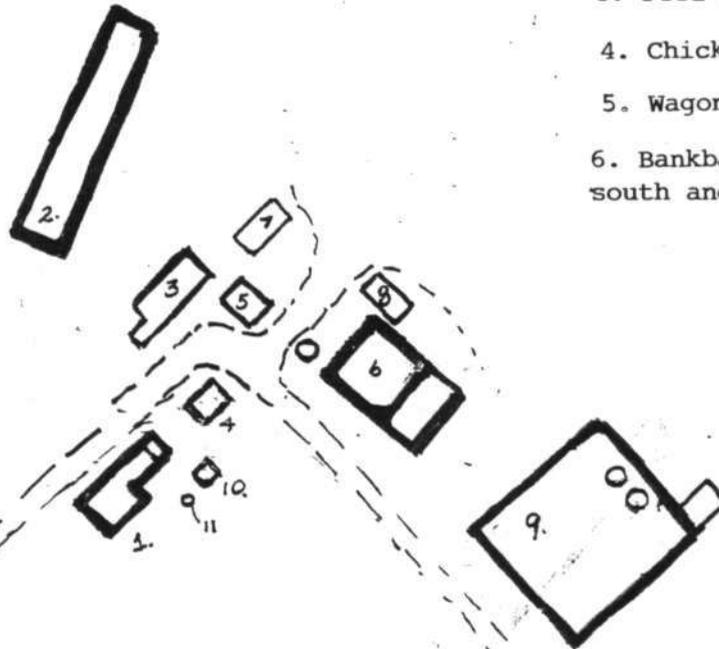
1. Dwelling
2. Loafing Shed
(ca. 1955)
3. Feed Shed, Shop
4. Chicken House
5. Wagon Shed/Corncrib
6. Bankbarn (Extension on
south and Silo built ca. 1955)

7. Concret block Equipment
Shed (ca. 1955)
8. Milking Parlor
(ca. 1890 with ca. 1955 ext.)
9. Loafing Shed and Silos
(ca. 1955)
10. Smokehouse
11. Root Cellar

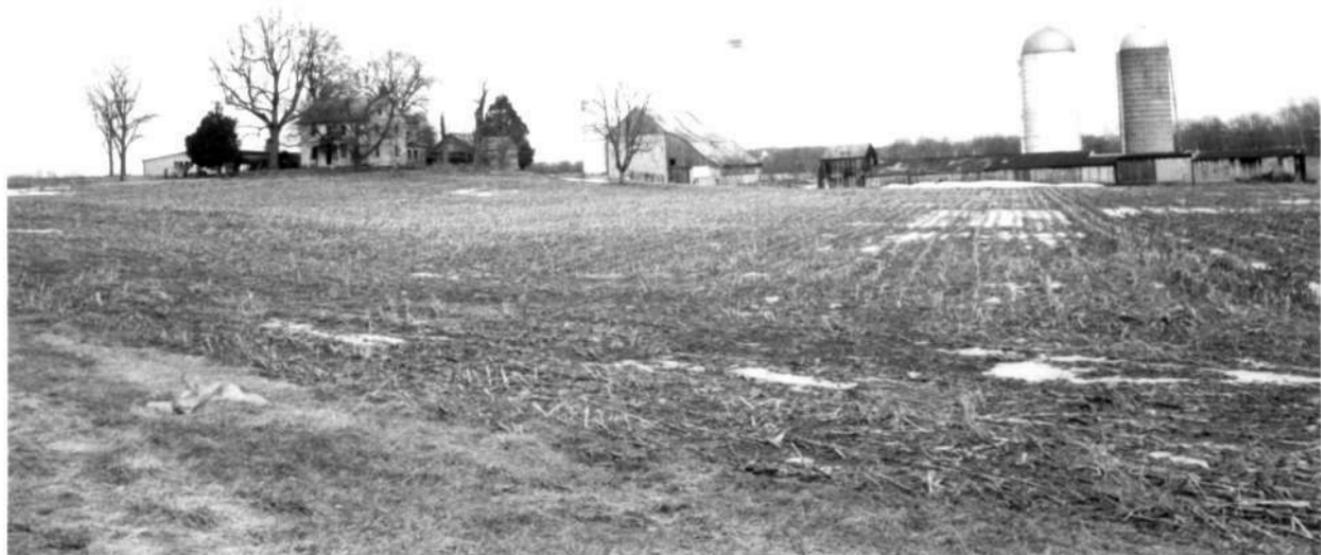
1/10

Overall view of farm looking
east

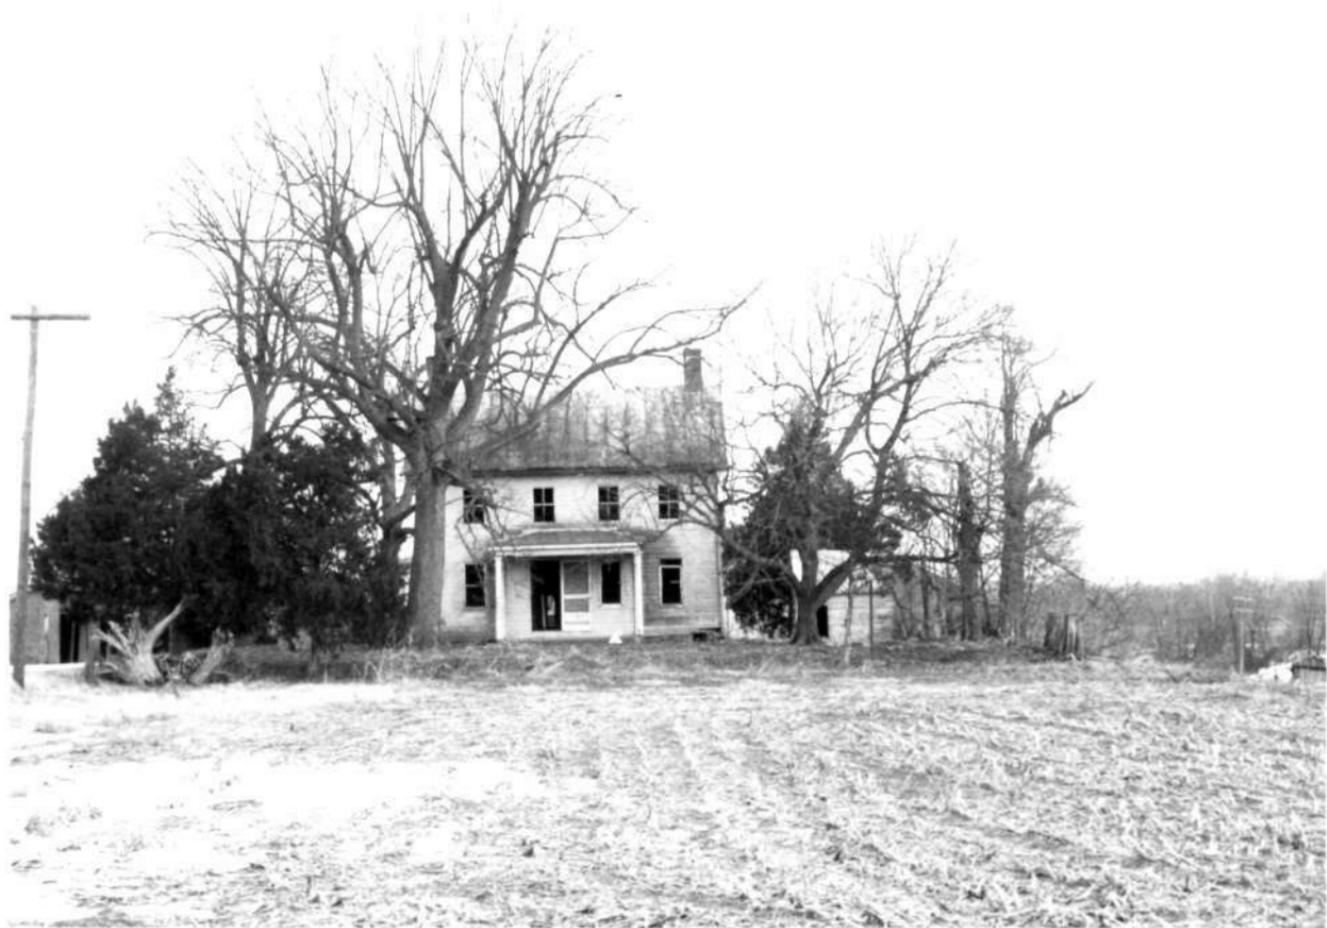
2/10

The main structure consists of two sections, roofed with standing seam metal, forming an L-shaped structure. The two-and-one half story gable-roofed front section faces US 15 on the west and contains the primary entrance. It is four bays wide on the principle (west) elevation with the doorway offset to the north. Sheathed with German siding, it features two-over-two lights, boxed cornice and return and cornerboards. Built on the rubblestone foundation, two chimneys, emerging at the peak are located inside of the north and south end walls. The interior of this main block, stripped of decorative trim, plaster and mantles, is characterized by two large rooms with stripped and closed brick fireplaces on each end wall. An open staircase is located in the northeast corner.

Dwelling (i)

West (Entrance) Facade

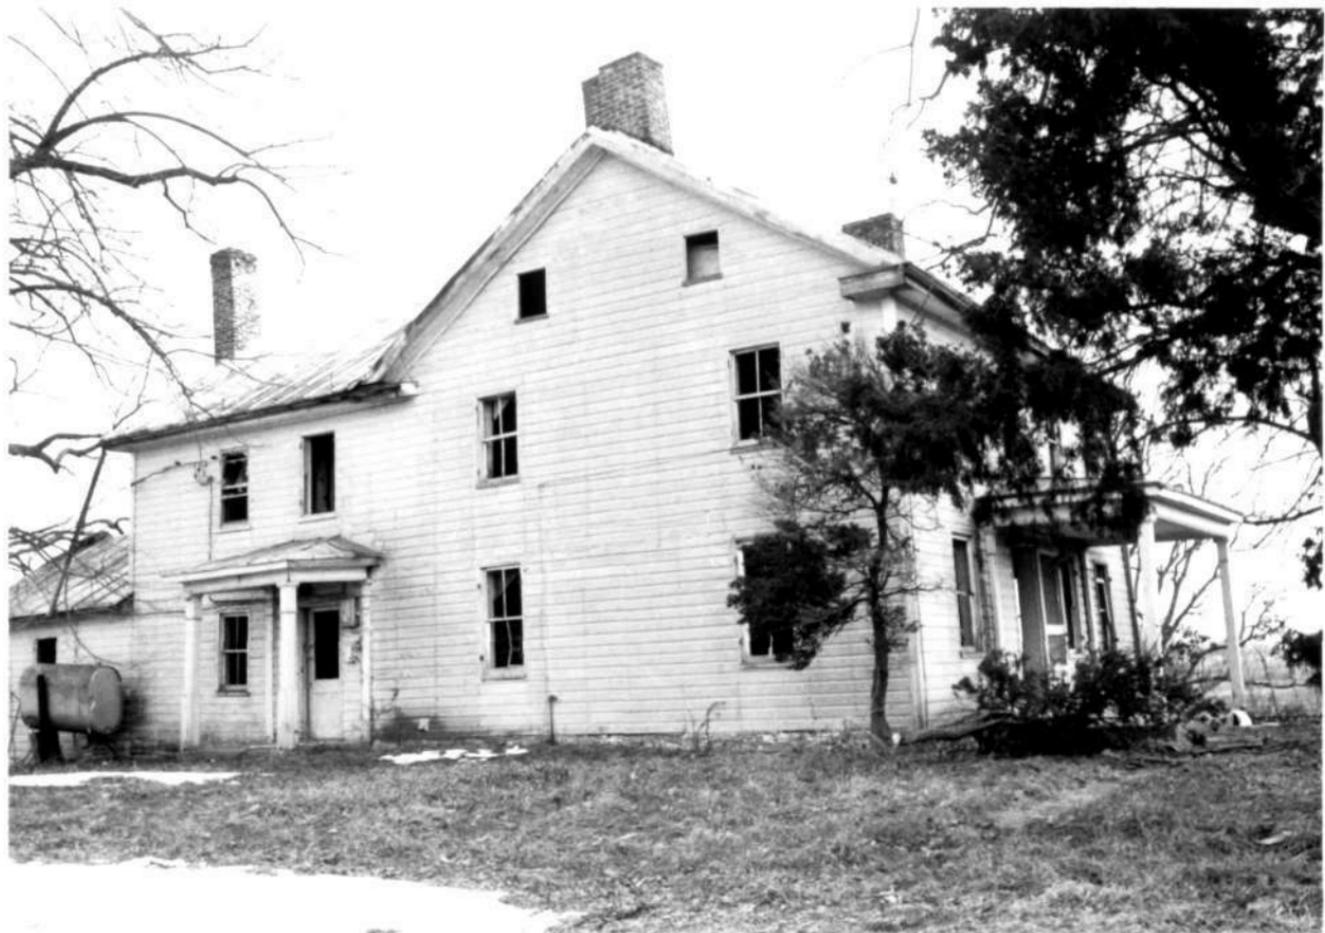
3/10

Dwelling

NW corner

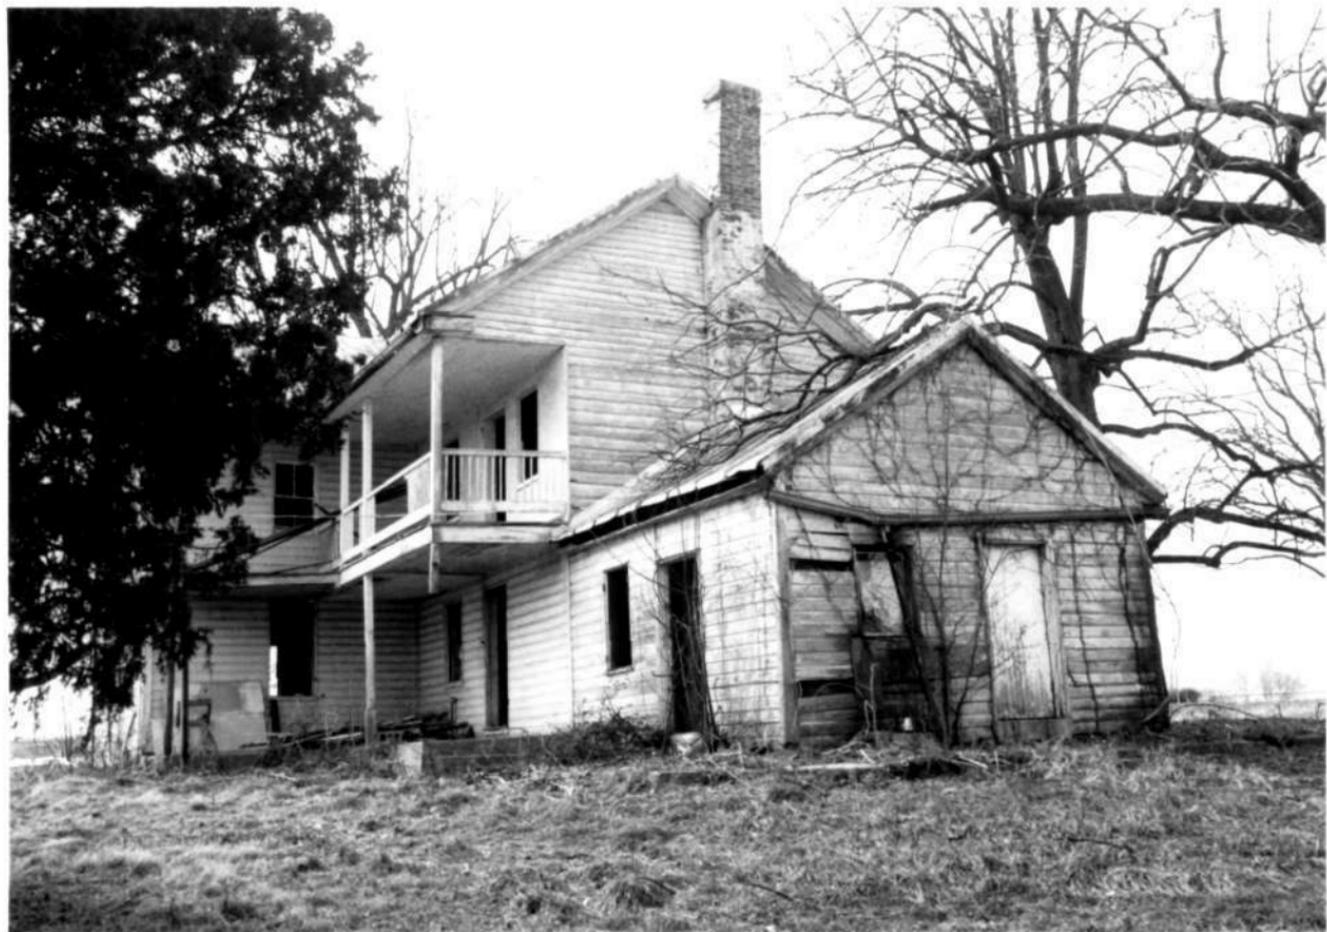
4/10

Dwelling

SE Corner

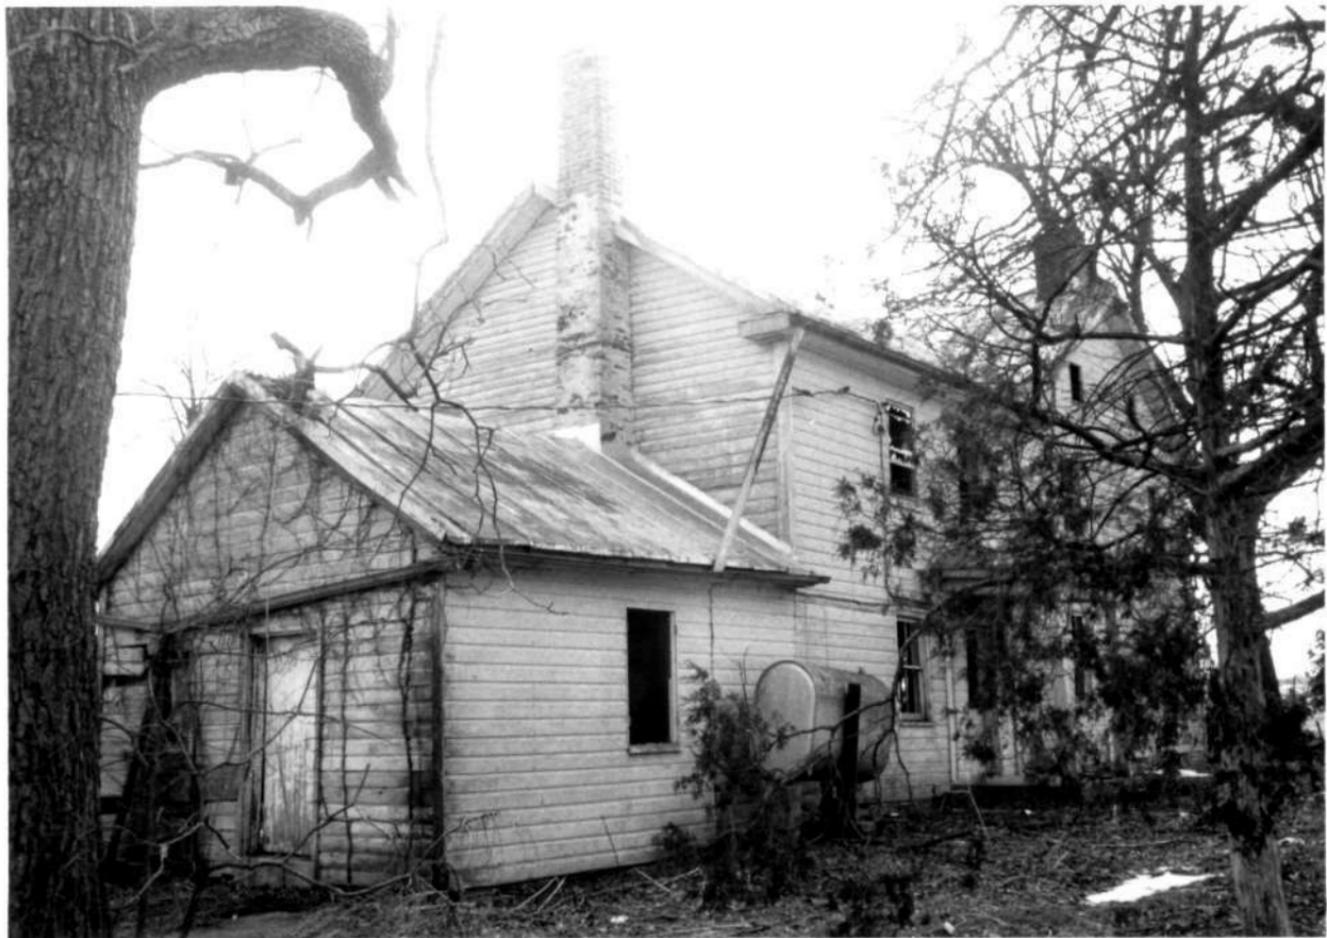
Dwelling

NE Corner

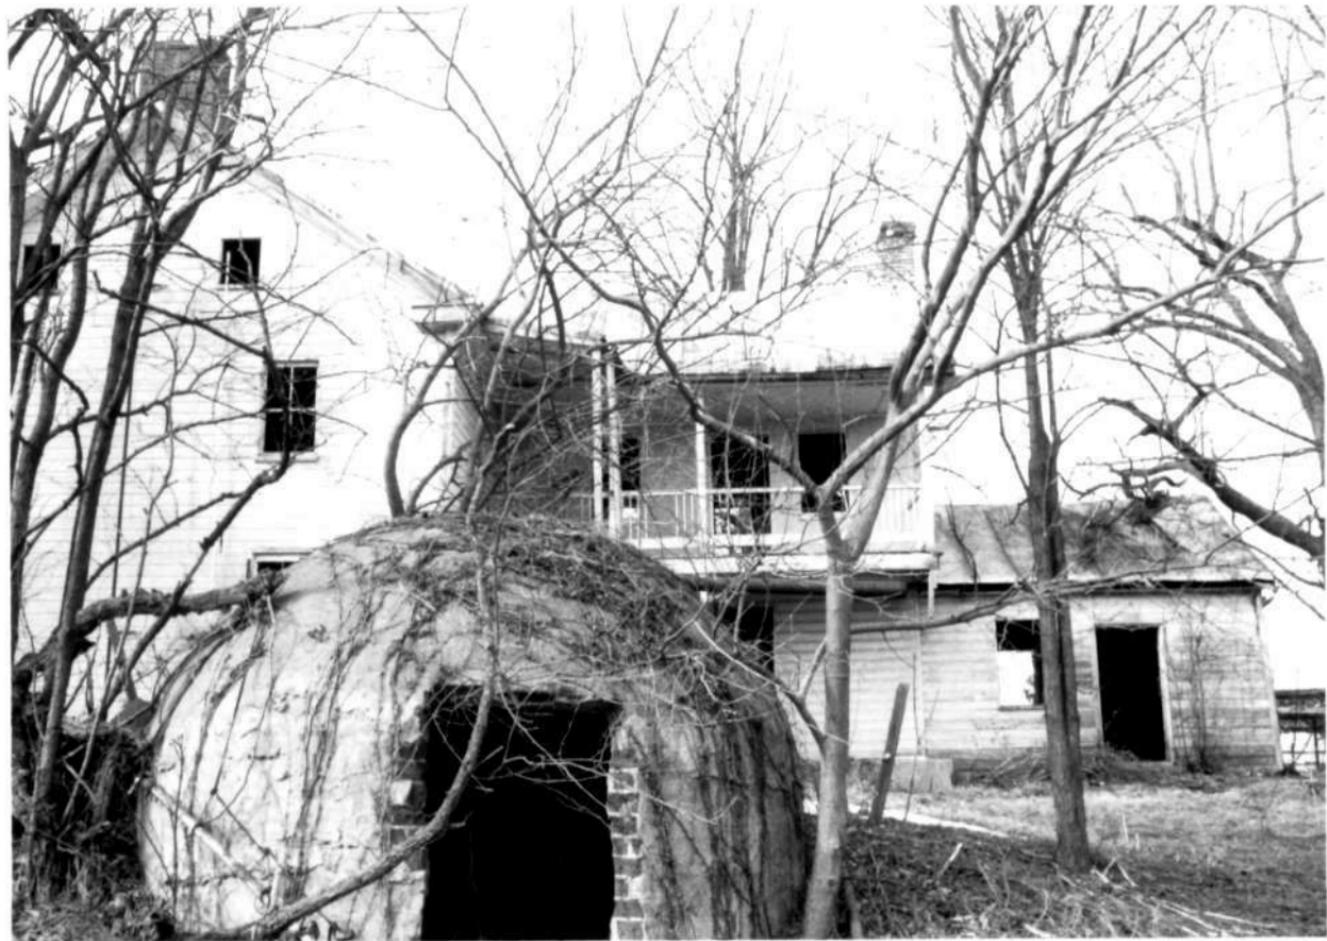
6/10

Dwelling

South Elevated

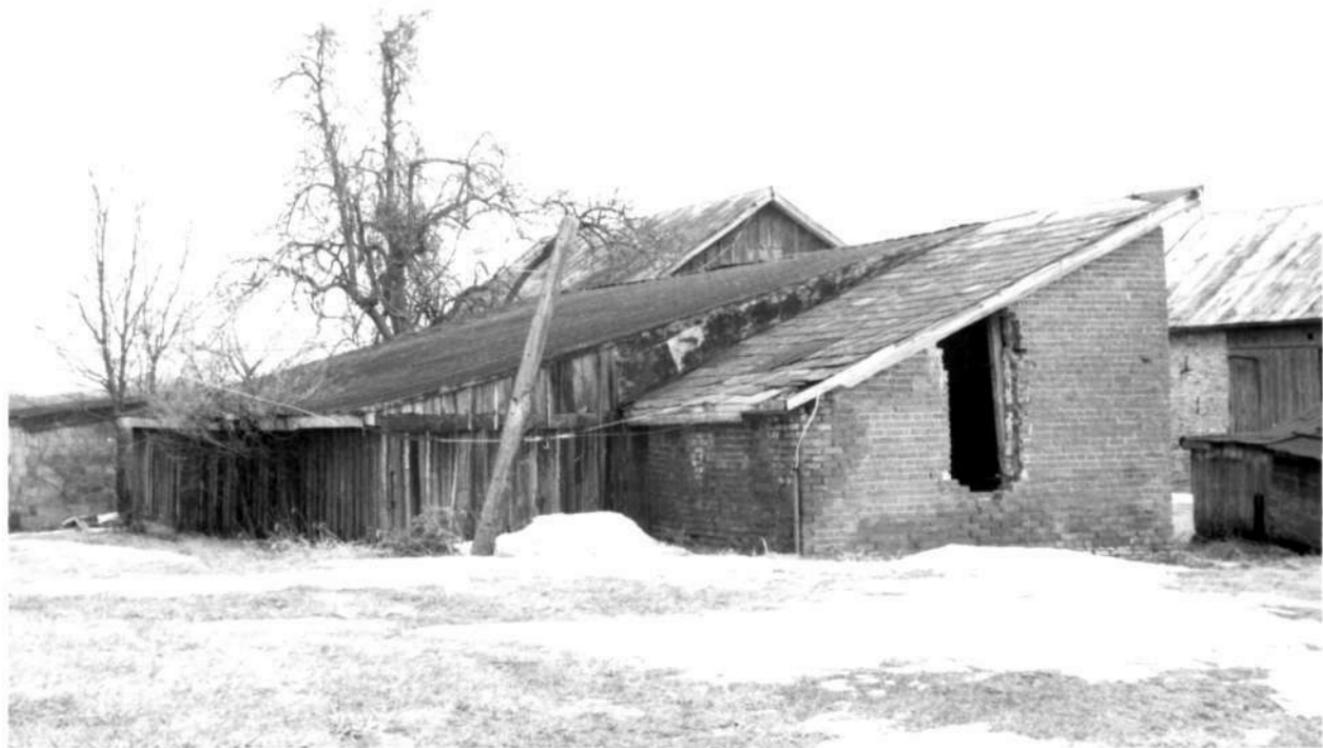
8/10

Oriented east-west and located off the northeast corner of the house, this long structure is composed of two sections: the westernmost is a brick, shed roofed brick feed shed with a deteriorated window in the west elevation and an entrance offset to the west in the south face. A decorative feature (a soldier brick course), set in a dogstooth pattern is centered on the south wall five courses below a deteriorated notched wooden cornice. The garden bond pattern characterizing the brick work has five rows of stretcher courses between the header rows.

Feedhouse / Shop

NW corner

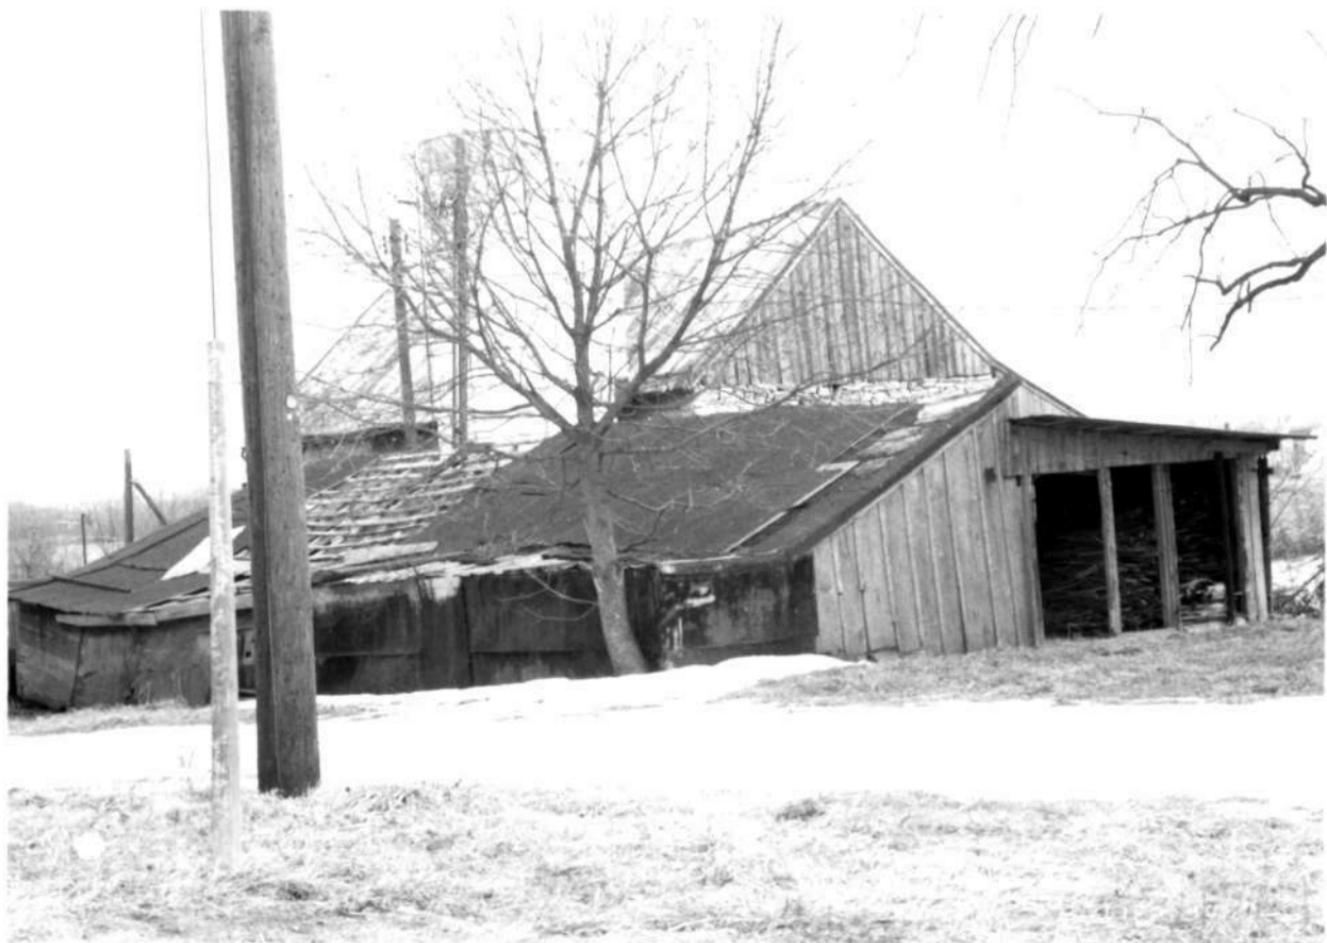
8/10

This large, one-story heavily deteriorated, largely board and batten structure is composed of two blocks whose shed rooves rise to two different levels creating a vertical clerestory area between them. There are large areas of metal sheathing and a partially destroyed corrugated metal roof.

Church house, NW corner (foreground)
Bank barn in background

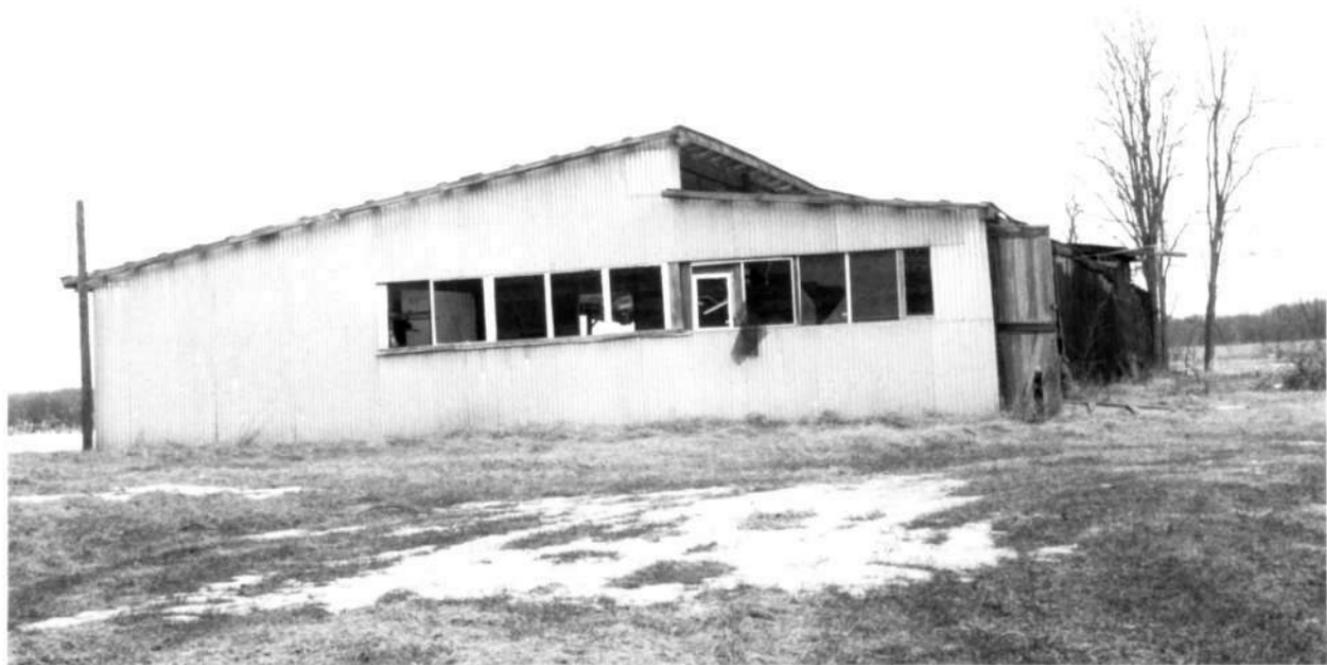
9/10

Identified as a loafing shed by a descendent this building was constructed by Grayson Mercer, Jr. in 1950 after the older Mercers retired. It is a very large, one-story frame, metal sheathed structure composed of two blocks whose shed-rooves intersect to form a clerestory in the vertical strip between the two roof levels. Much of the corrugated metal and wood sheathing is missing. A horizontal band of windows is located at eye level on the west elevation (gable end).

Loafing shed - west elevation

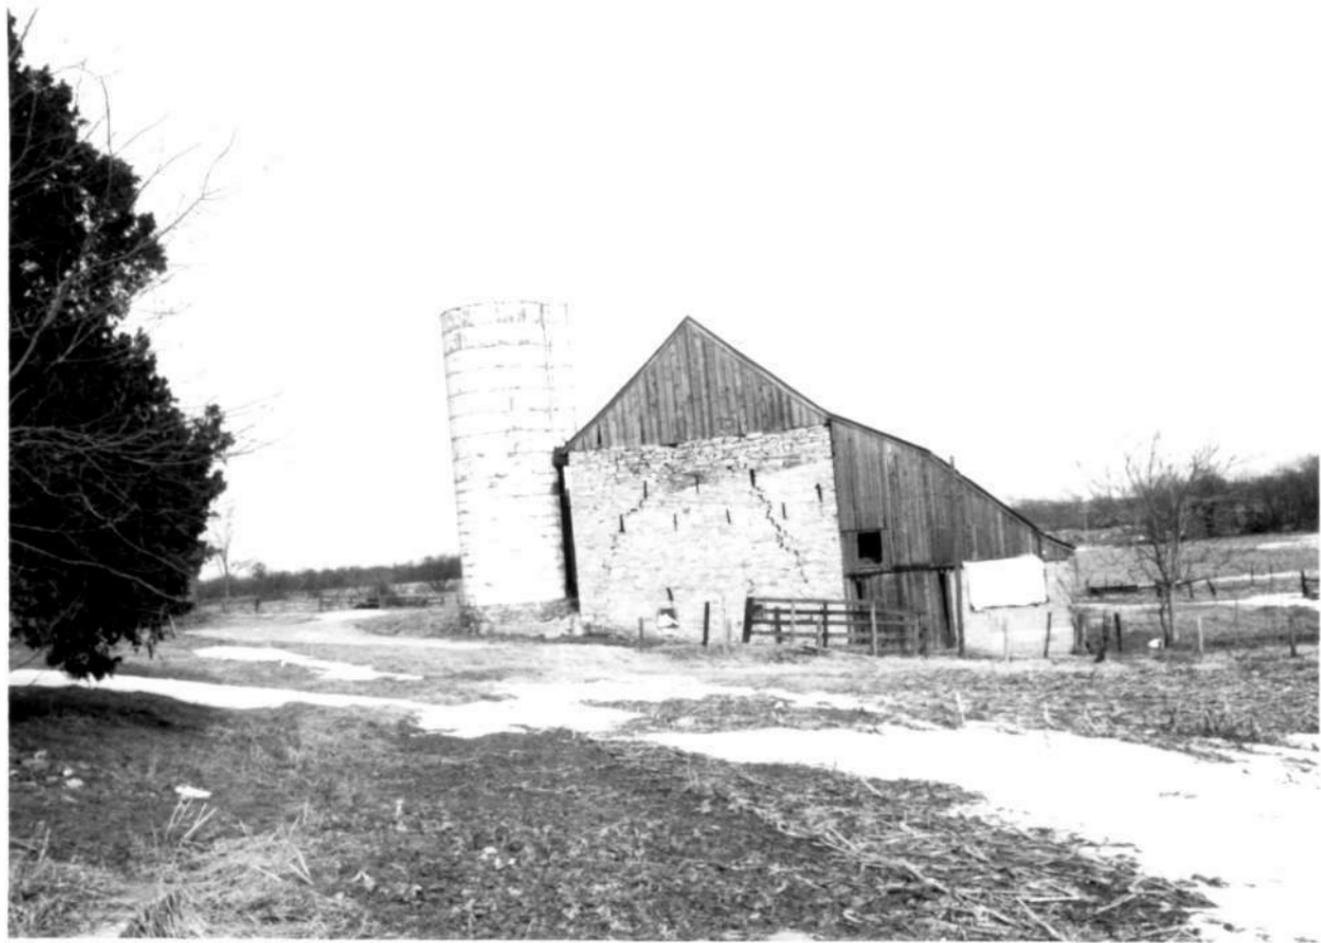
10/10

This large stone bank barn is built into a hill on the north where the earthen ramp gives access to the interior area through large wooden doors on strap hinges. The gable roof is corrugated metal oriented east-west, and the gable ends at the roof level are frame, resting on uncoursed rubble stone walls with vertical slits. The east wall has partially collapsed and the northeast corner has been reconstructed with concrete block. The barn has been extended on the south side with a large gambrel roofed addition, with walls constructed of concrete block and frame. A ca. 1950 silo is located immediately adjacent to the northwest corner.

Bank barn, S.W. Corner
