**Maryland Historical Trust
State Historic Sites Inventory Form**

Survey No. F-3-163

historic John Derr House

street & number 8401 Liberty Rd. not for publication

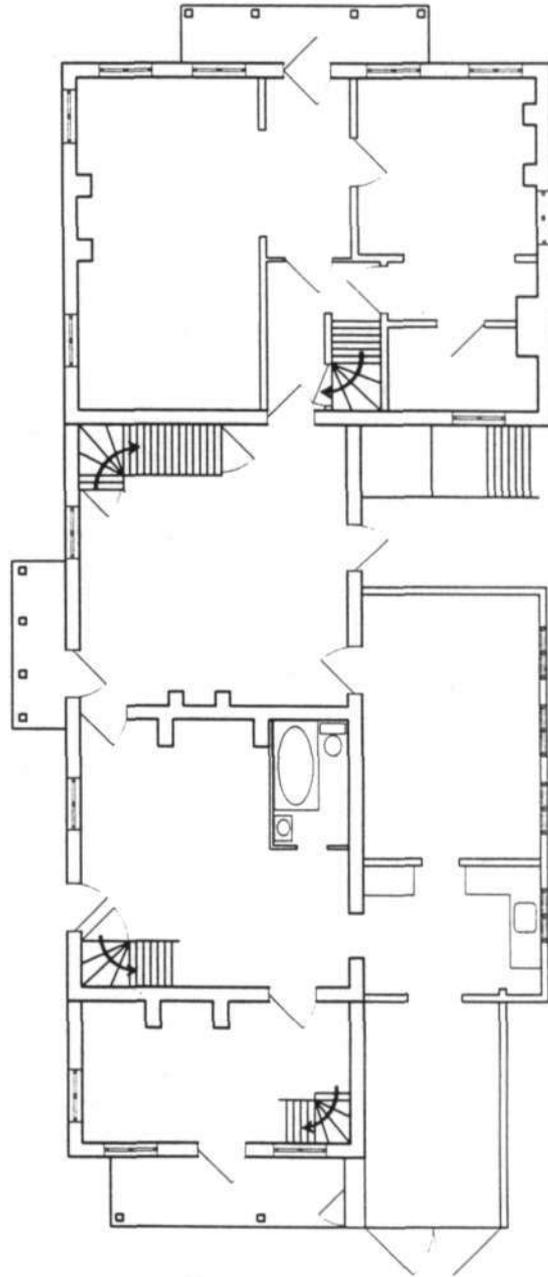
First Floor Plan

The main block of the house adopts a formal central-hall plan flanked by parlors with the ell extending directly behind the central hall and east parlor. The main block retains many of its original interior finishes, including plaster, tongue and groove flooring, woodwork, and hardware. The central hall is

The symmetry and formality of the main block contrasts with the less formal spatial arrangements and simple finishes of the ell. The ell contains two rooms on each floor. The kitchen and dining room comprise the first floor. The dining room features a fireplace with wood mantel on the south wall. Exterior doors are found on the east and west walls of the dining room. An interior door on the north wall connects the main block. The original kitchen features a monumental brick cooking fireplace on the north wall. A west wall door provides exterior access. A doorway on the east wall leads to the modern kitchen addition. A boxed staircase with simple beaded vertical panels connects the dining room and original kitchen with the second floor.

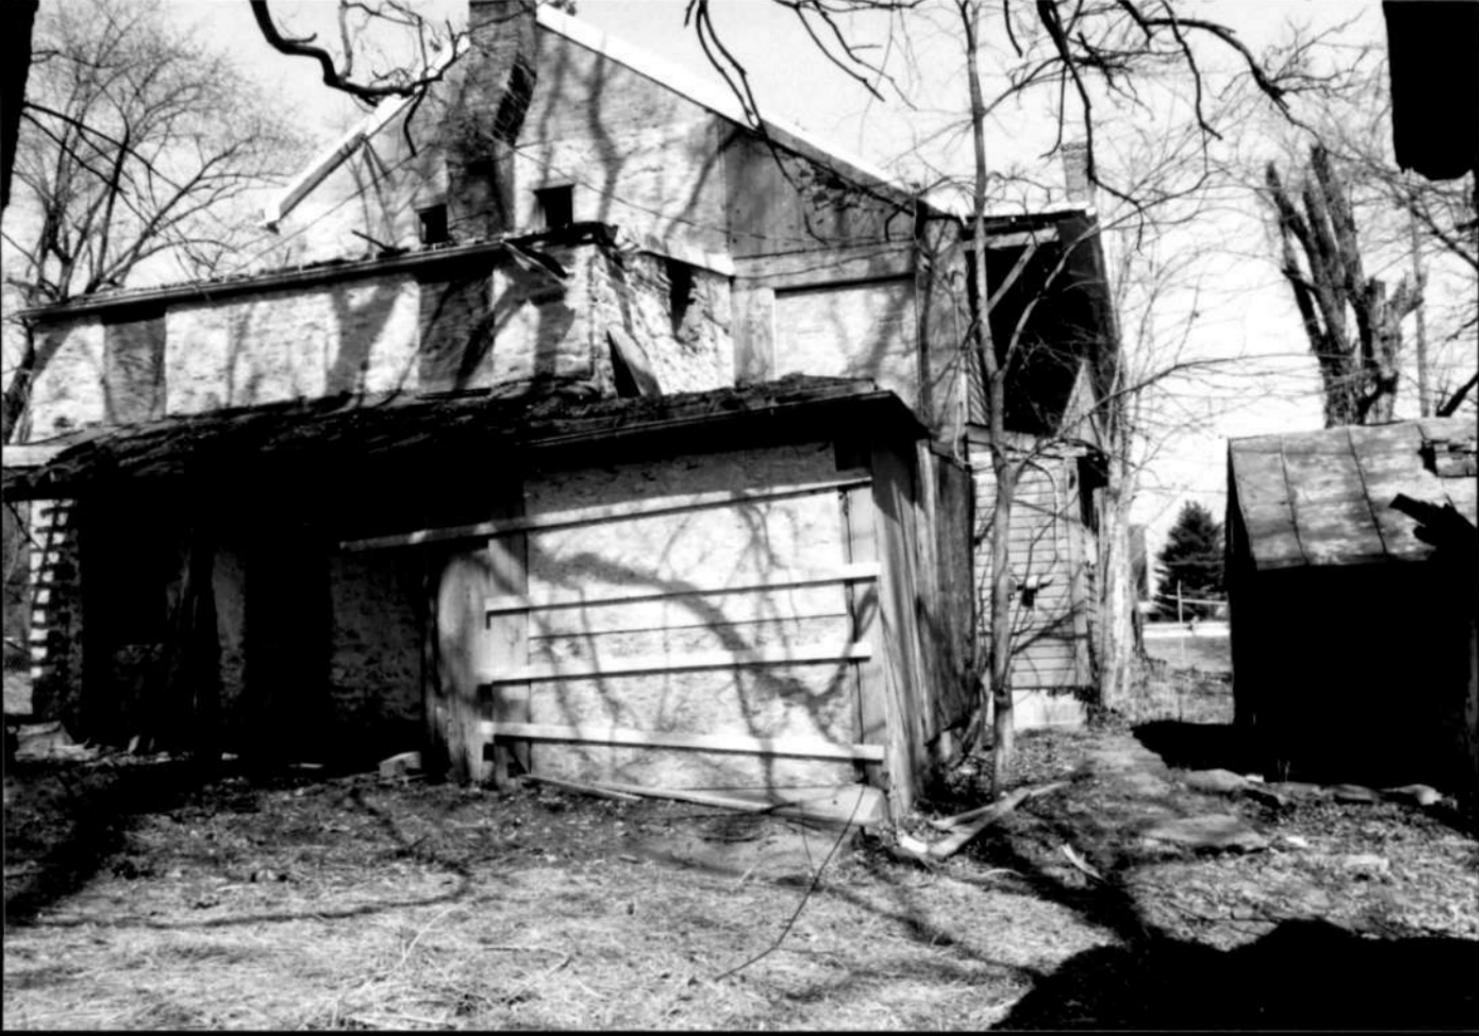
5 of 16

Principal Dwelling, view northwest

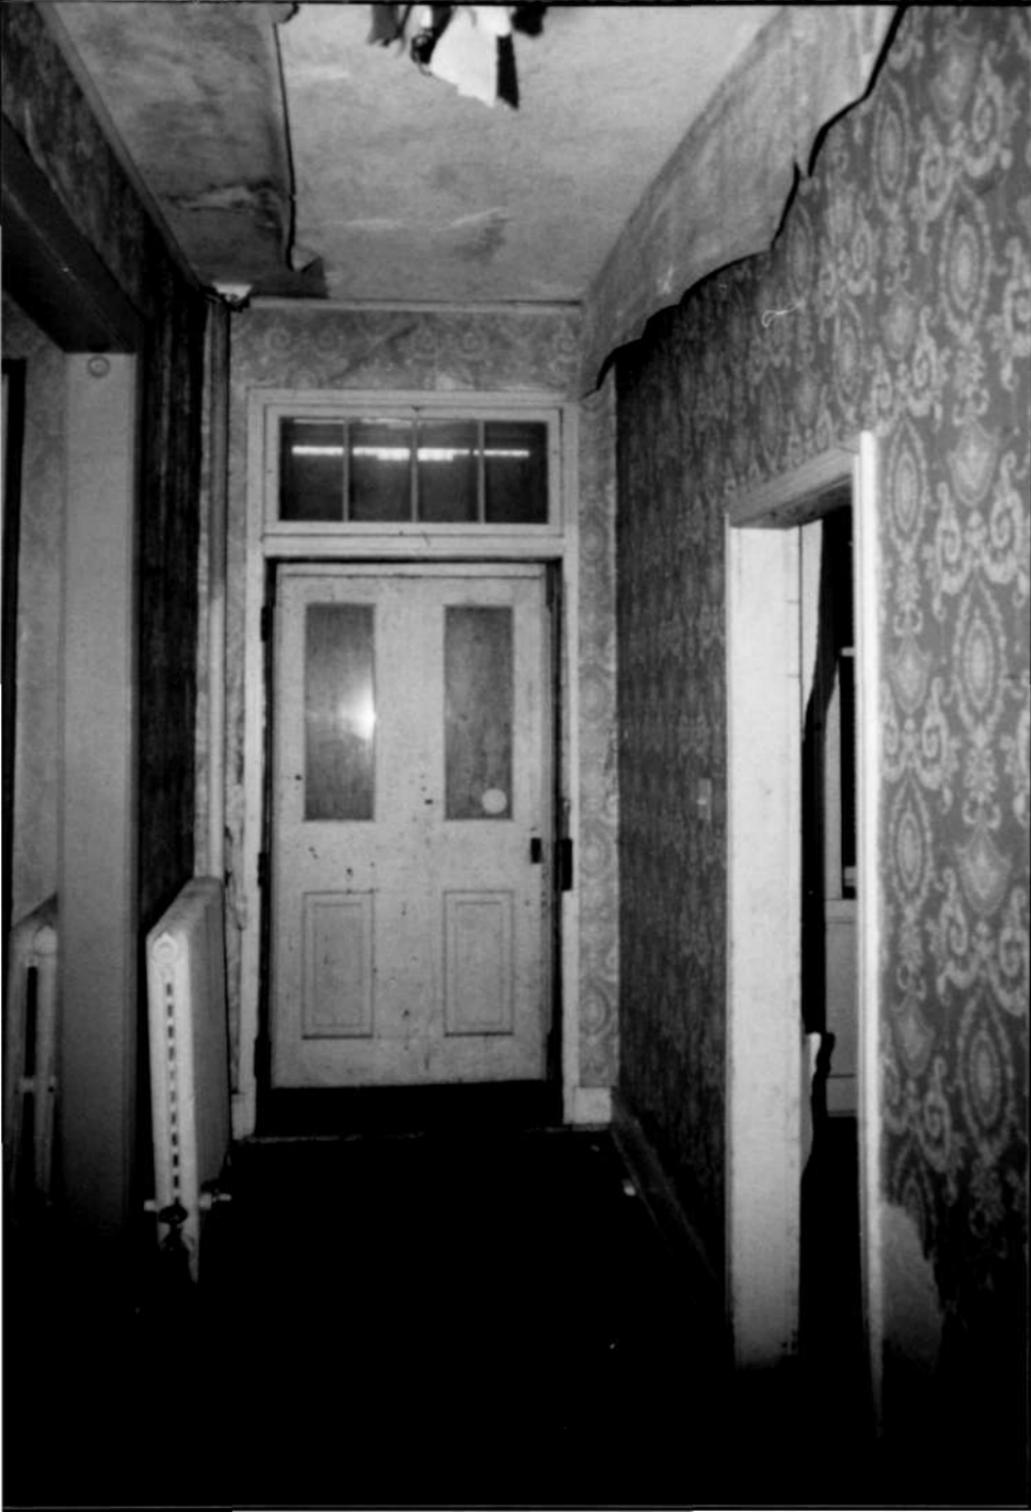
6 of 16

divided into two spaces separated by a modern wood partition wall with a fiber core door surmounted by a plexi-glass transom. The hall contains an open rear stairway with landing that ascends the east, south and west walls. The stairs feature a closed stringer with turned balustrade and newel posts. The balustrade is surmounted by an oval hand rail. The stairway ascends to the second floor and attic. The stairway is a late nineteenth century replacement. The flanking parlors contained central fireplaces with simple wood surrounds and wood mantels comprised of a plain entablatures with shelves. The fireplace surrounds and mantels were modified or replaced during the early nineteenth century. The fireplace surrounds and mantels were removed by vandals in 1999.

Principal Dwelling, first floor, main block, hallway, view north

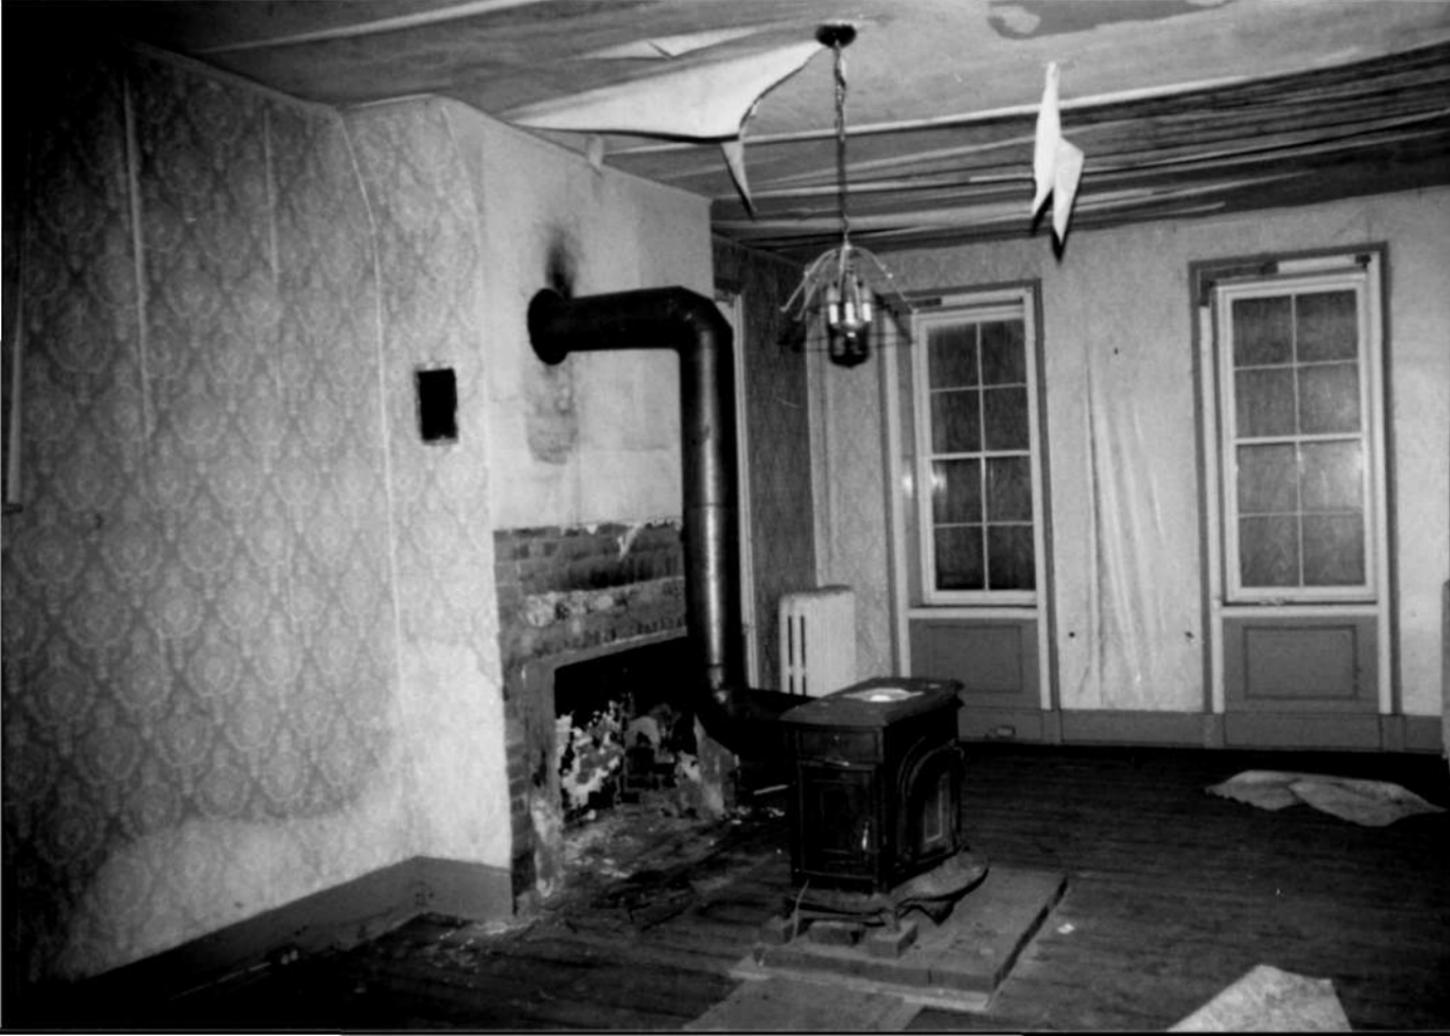
7 of 16

Each parlor also features four-over-four light, double hung wood sash windows. A small room is located to the rear of the east parlor. The room features a single six-over-nine light, double hung wood sash window on the south wall and a fireplace on the west wall.

Principal Dwelling, first floor, main block, western parlor, view northwest

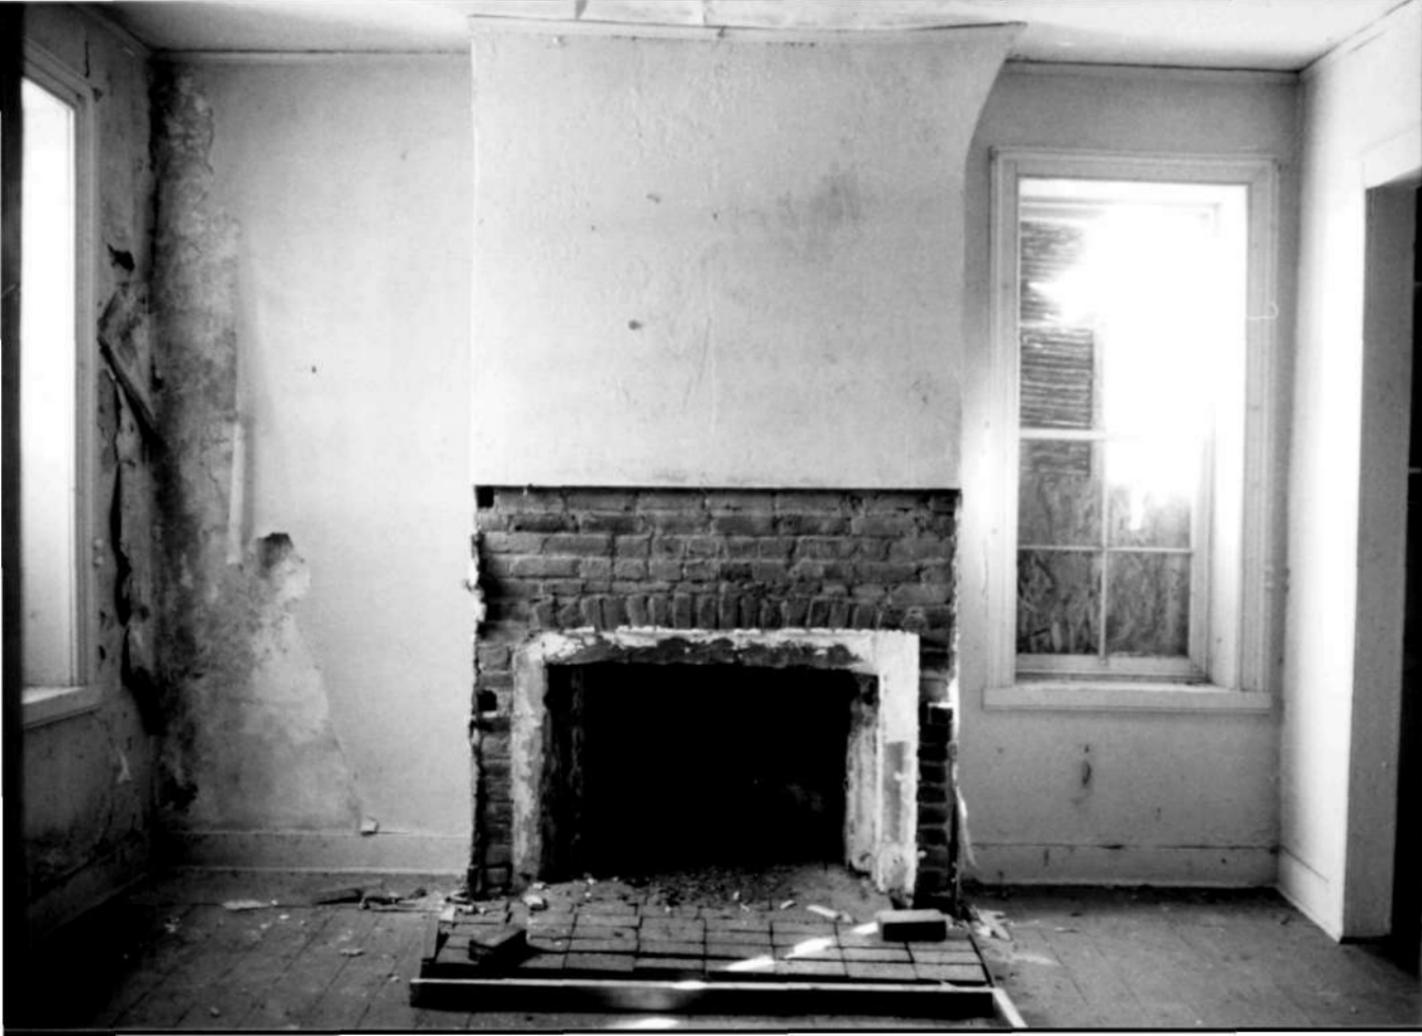
8 of 16

Principal Dwelling, first floor, main block, eastern parlor, view southeast

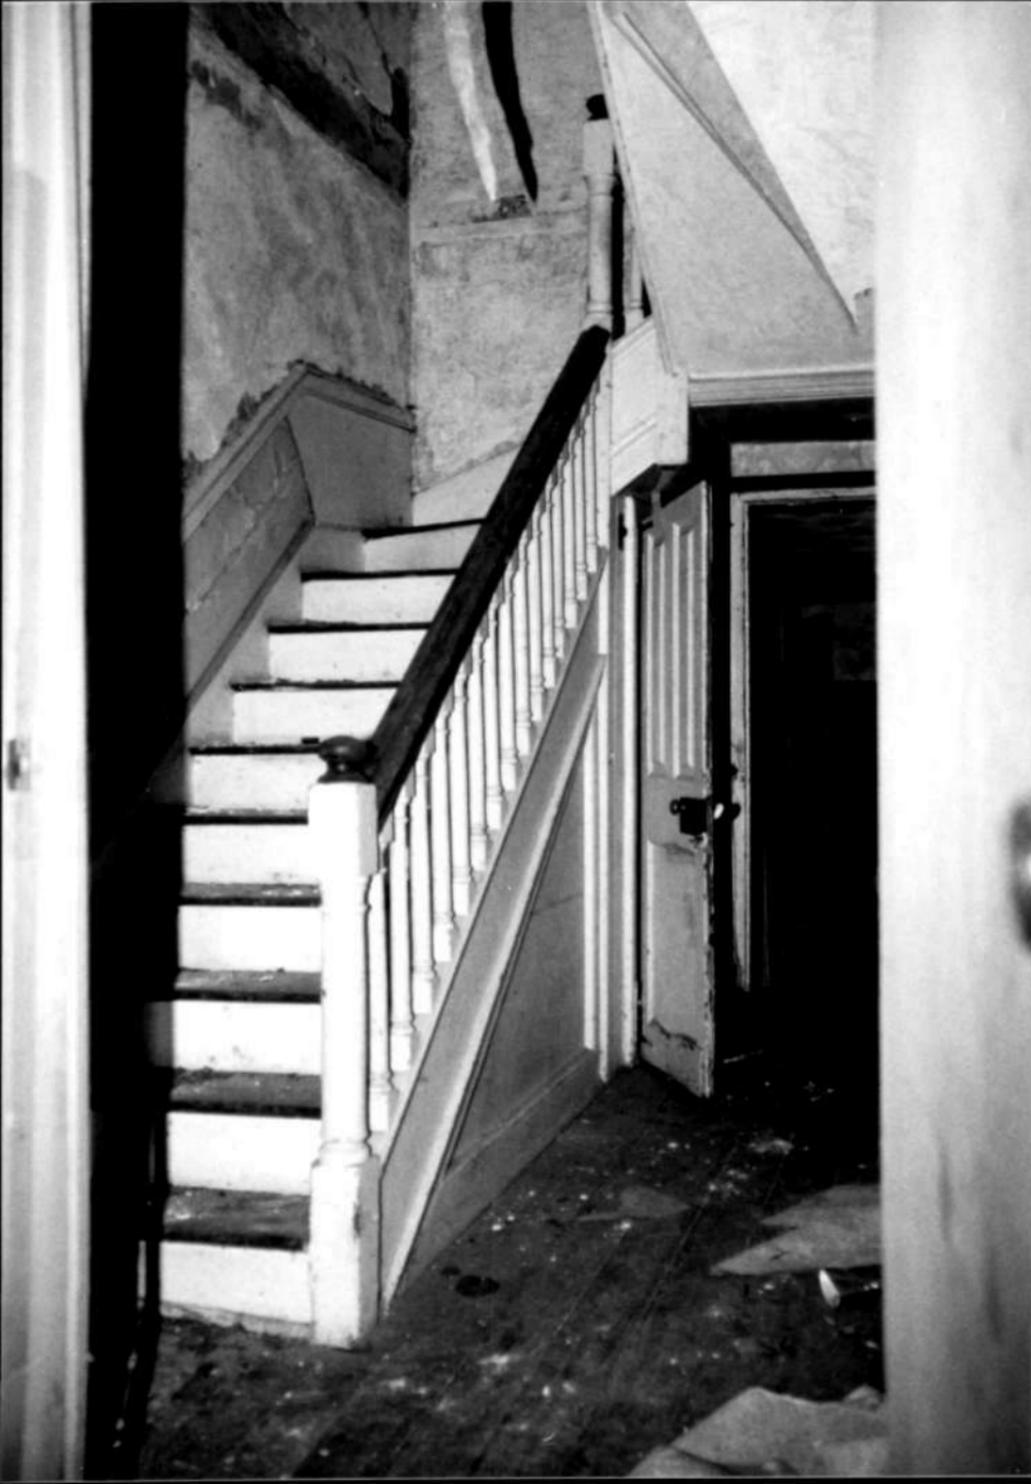
9 of 16

Principal Dwelling, first floor, main block, hall stair, view south

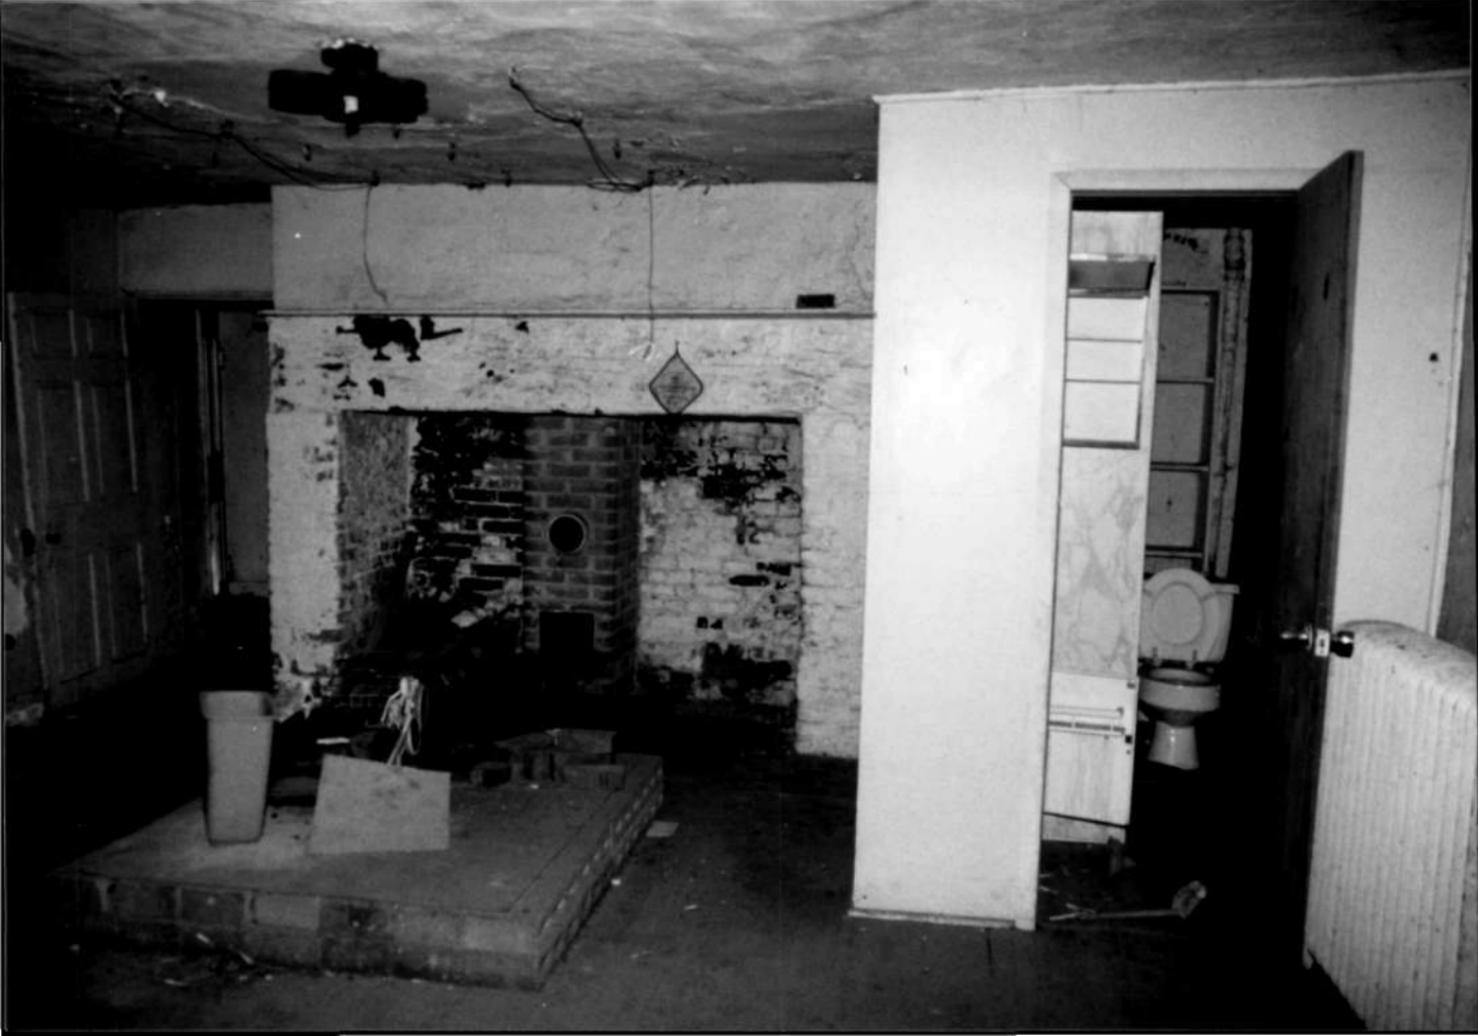
10 of 16

Principal Dwelling, first floor, rear ell, kitchen hearth, view northwest

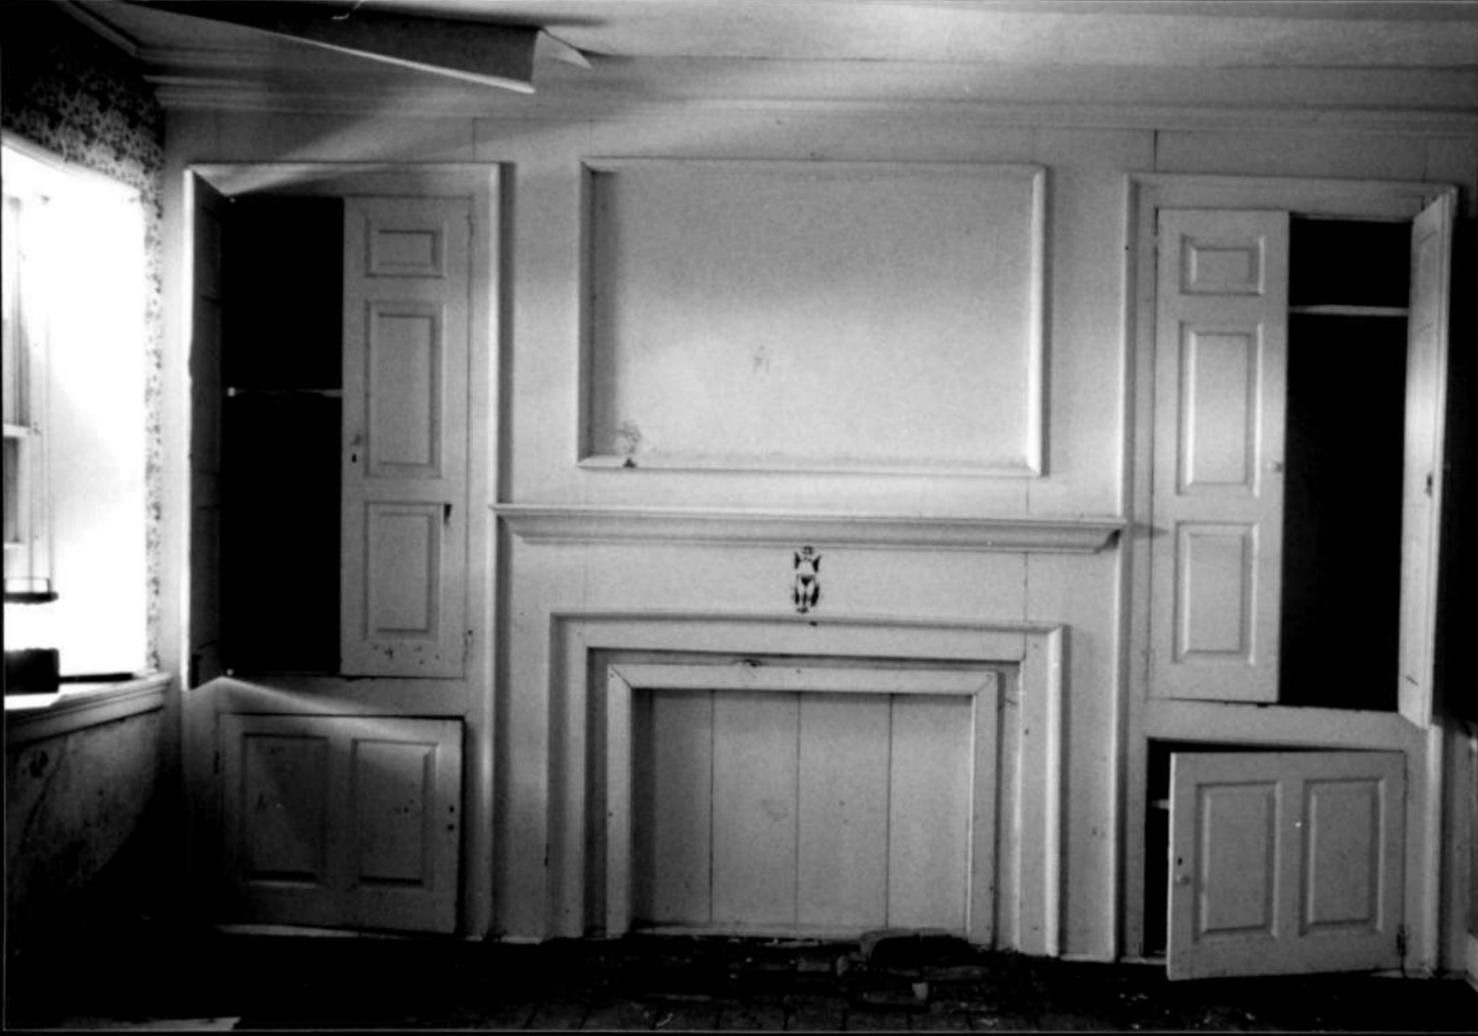
11 of 16

The second floor of the main block was utilized as bed chambers. The floor plan of the second floor reflects that found on the first floor with the exception of the central hallway. All rooms are accessed from the stair landing. The northeast chamber features a central fireplace with wood mantel comprised of a simple entablature and shelf with a paneled wood overmantel with molding. The chimney piece is flanked by built-in wood cabinets with raised panel doors. The massive cabinets, fireplace surround, and overmantel are original late eighteenth-century features of the house. This is the only room that retains its original woodwork.

Principal Dwelling, second floor, main block, eastern bed chamber, view east

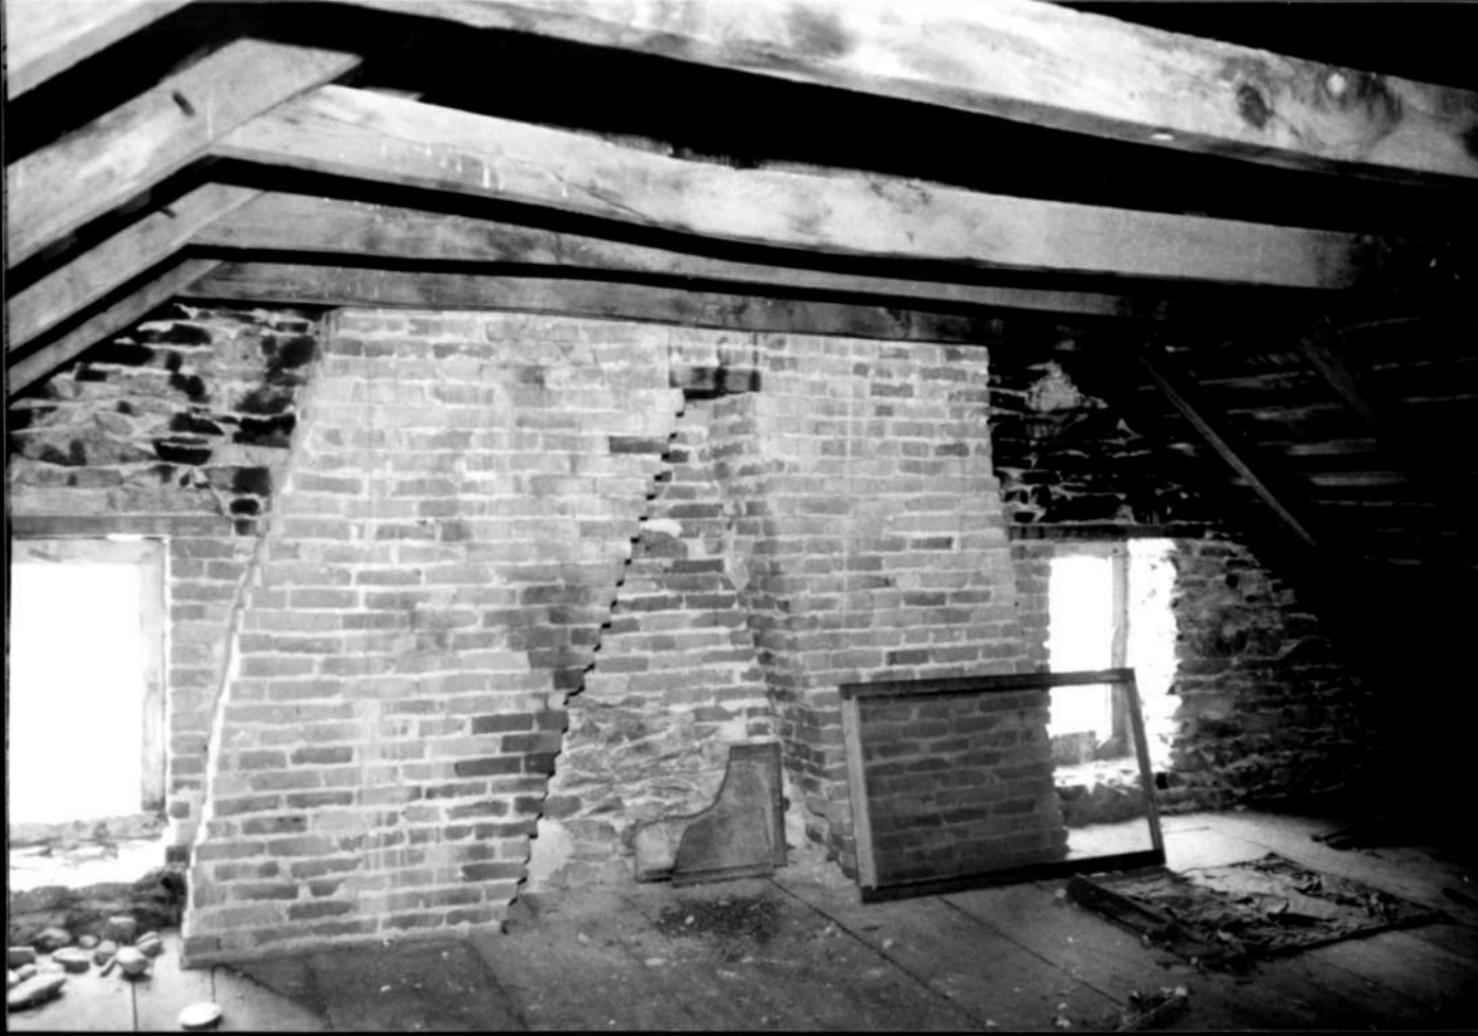
12 of 16

The attic of the main block is accessible from the central stairway. The attic features wide, random-width floor boards. The brick flues of the interior end chimneys rise along the gable end walls. The roofing system consists of hewn rafters, which are lapped and pinned at the ridge line and joined by pinned collar

beams. The rafters are attached to the top plate with a bird's mouth joint. Roof sheathing is secured to regularly spaced horizontal nailers. A layer of wood shingles is attached to the nailers. The exterior face of the shingle roof now is sheathed with standing seam metal.

12. g. Principal Dwelling, attic, main block, view east
13. g. Summer Kitchen, view northeast
14. g. Meat House, view southwest
15. g. Meat House and Shed, view east

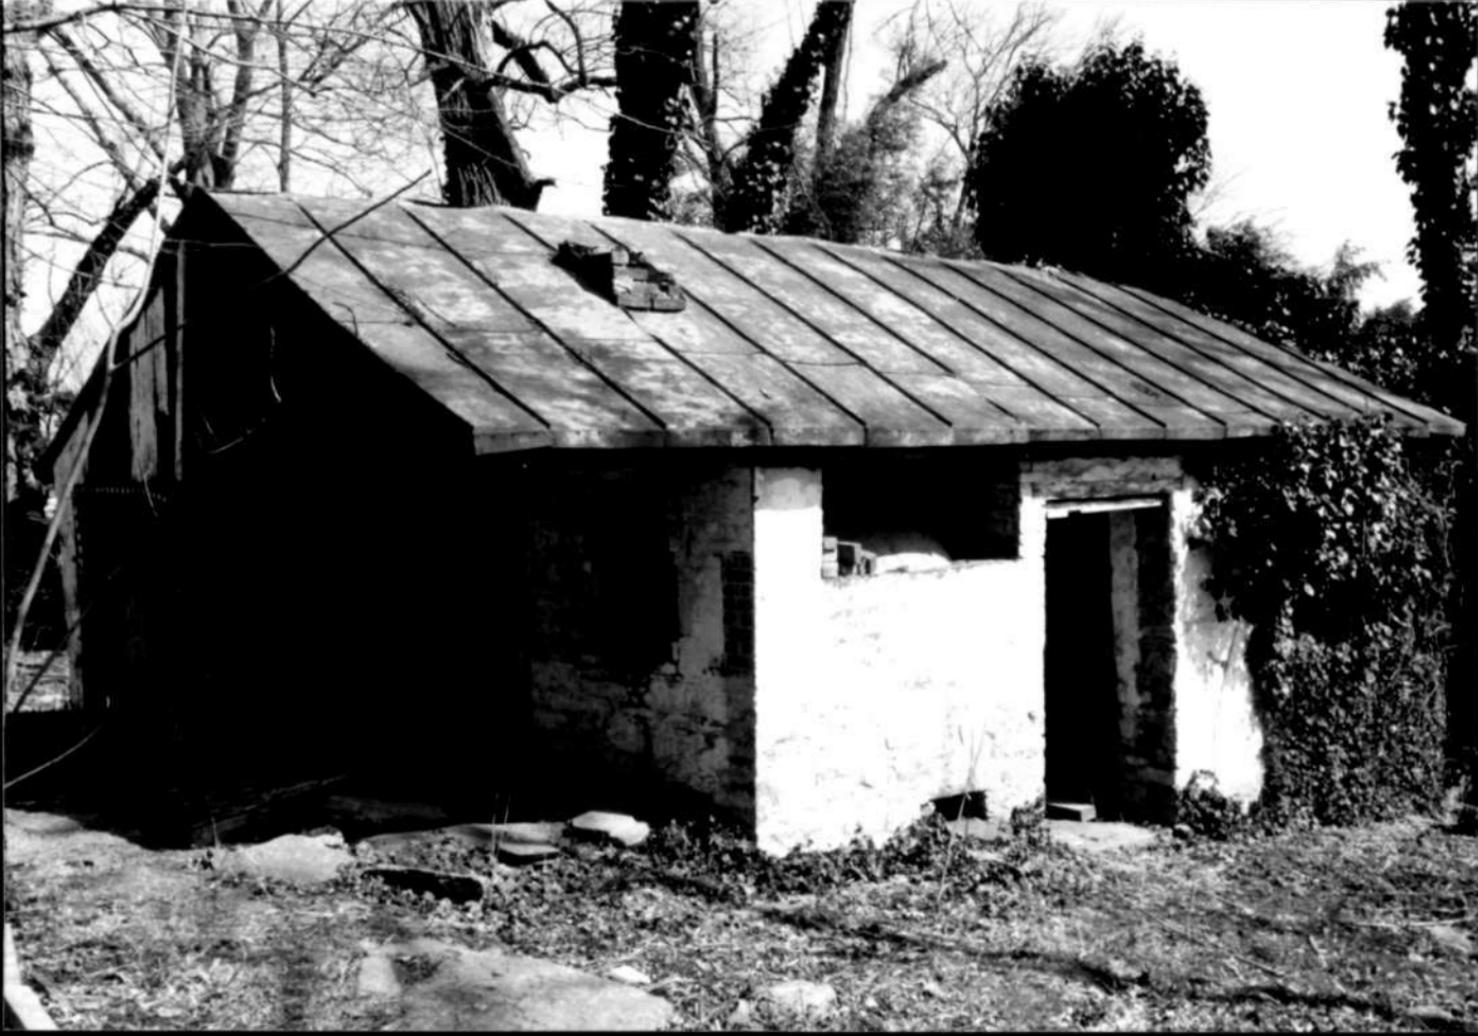
13 of 16

The summer kitchen (ca. 1790-1800) is located to the rear and east of the dwelling. The one-story, one-bay rectangular structure terminates in a side gable roof sheathed with standing seam metal. The structure is divided into three sections composed of beehive oven, drying room and kitchen.

The brick beehive oven is located on the west elevation of the structure. The beehive oven rests on a brick foundation with rubble infill. The bake oven is constructed of brick with a vaulted interior. The flue is located in the rear of the bake oven and rises along the dome of the roof to the mouth of the oven to the chimney flue. North of the beehive oven is a drying room, which contains shelves of sliding wooden trays. The entrance to the beehive oven and drying room are sheltered by a projecting gable roof extension.

The kitchen abuts the east wall of the beehive oven and rests on a coursed stone foundation. The walls are constructed of coursed stone. The kitchen is accessed from a doorway on the south elevation; a window is located on the north elevation. Both the door and window units have been removed. The interior of the kitchen features a dirt floor with a large cooking fireplace in the northeast corner. The fireplace is vented through an interior end chimney. The walls and ceiling of the room are plastered.

Summer Kitchen, view northeast

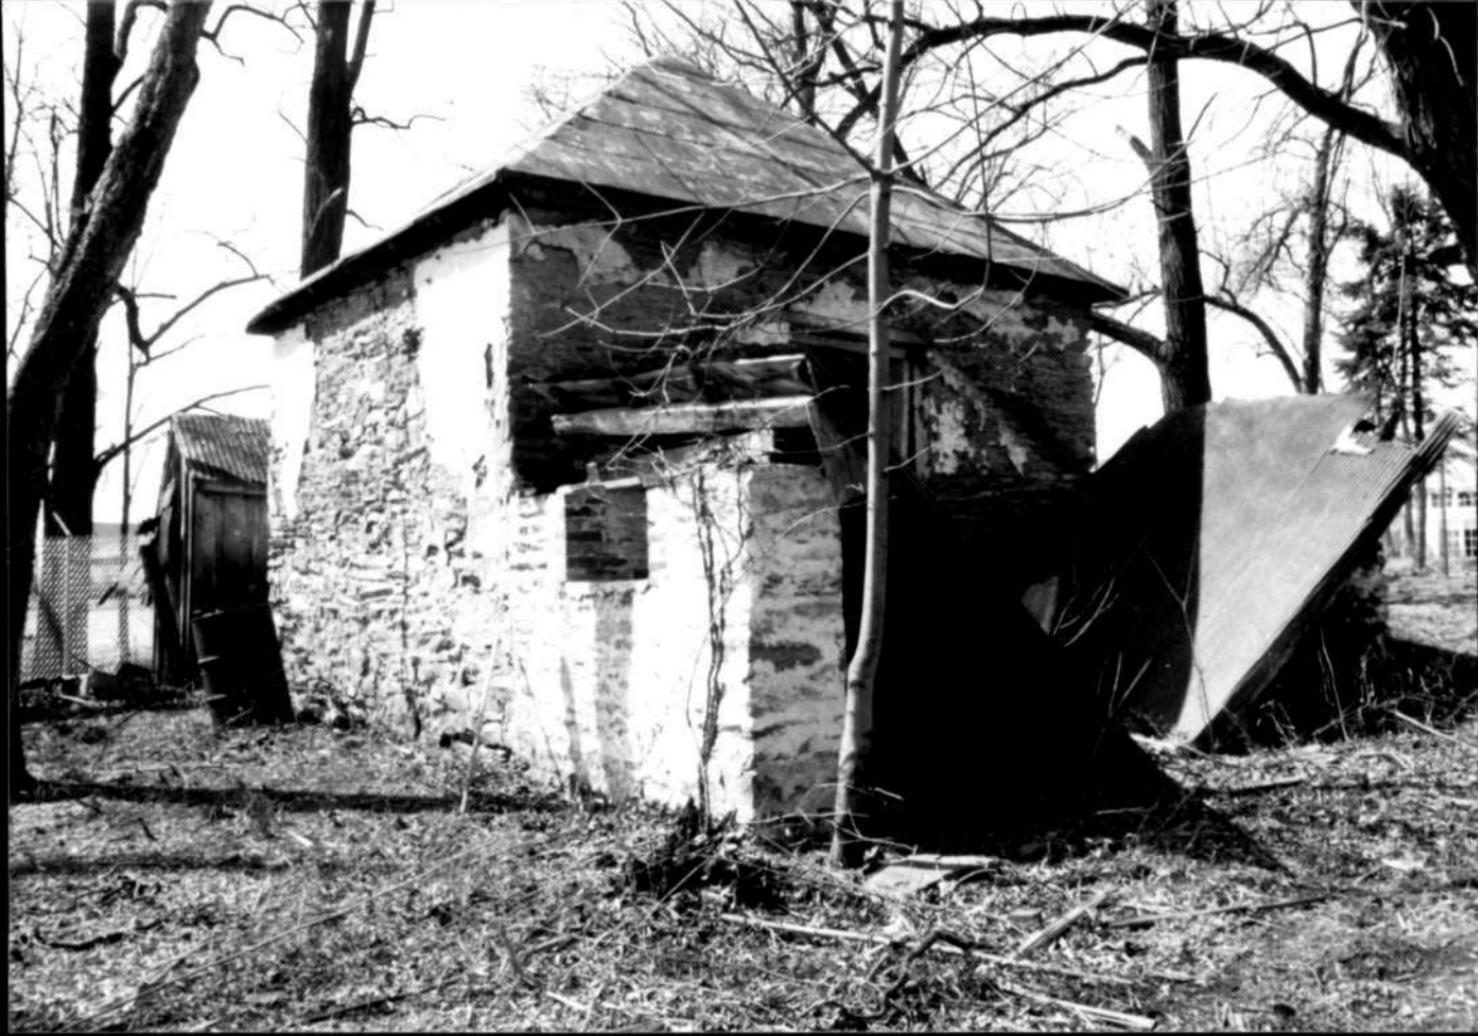
14 of 16

The meat house (ca. 1790-1800) is located southwest of the rear of the principal dwelling. The meat house is a one-story, rectangular-plan structure, built of coursed stone covered with white washed stucco. The structure terminates in a pyramidal metal roof. The structure rests on a raised stone basement. The cold cellar, located in the basement level, is accessed by a central exterior stairway on the primary (north) elevation. The interior of the cold cellar is well insulated. The basement walls are parged

with a thick layer of clay. The ceiling of the cold cellar is constructed of rough but laid logs that form the floor of the main level and insulate the cellar. Large timbers set into the stone walls support these logs.

The meat house, located on the first floor level, is accessed by a flight of stairs above the basement door. The entrance was sheltered by a steeply pitched front gable roof supported by stone wing walls. The collapsed gable roof was sheathed with corrugated metal. The meat house is accessed from the landing of the stairway through a central doorway supported by a heavy timber frame. The door has been removed but the forged metal pintles remain in the door surround. A narrow ventilation slot is located in each wall. The ceiling features a series of wood poles and metal hooks from which meat was hung.

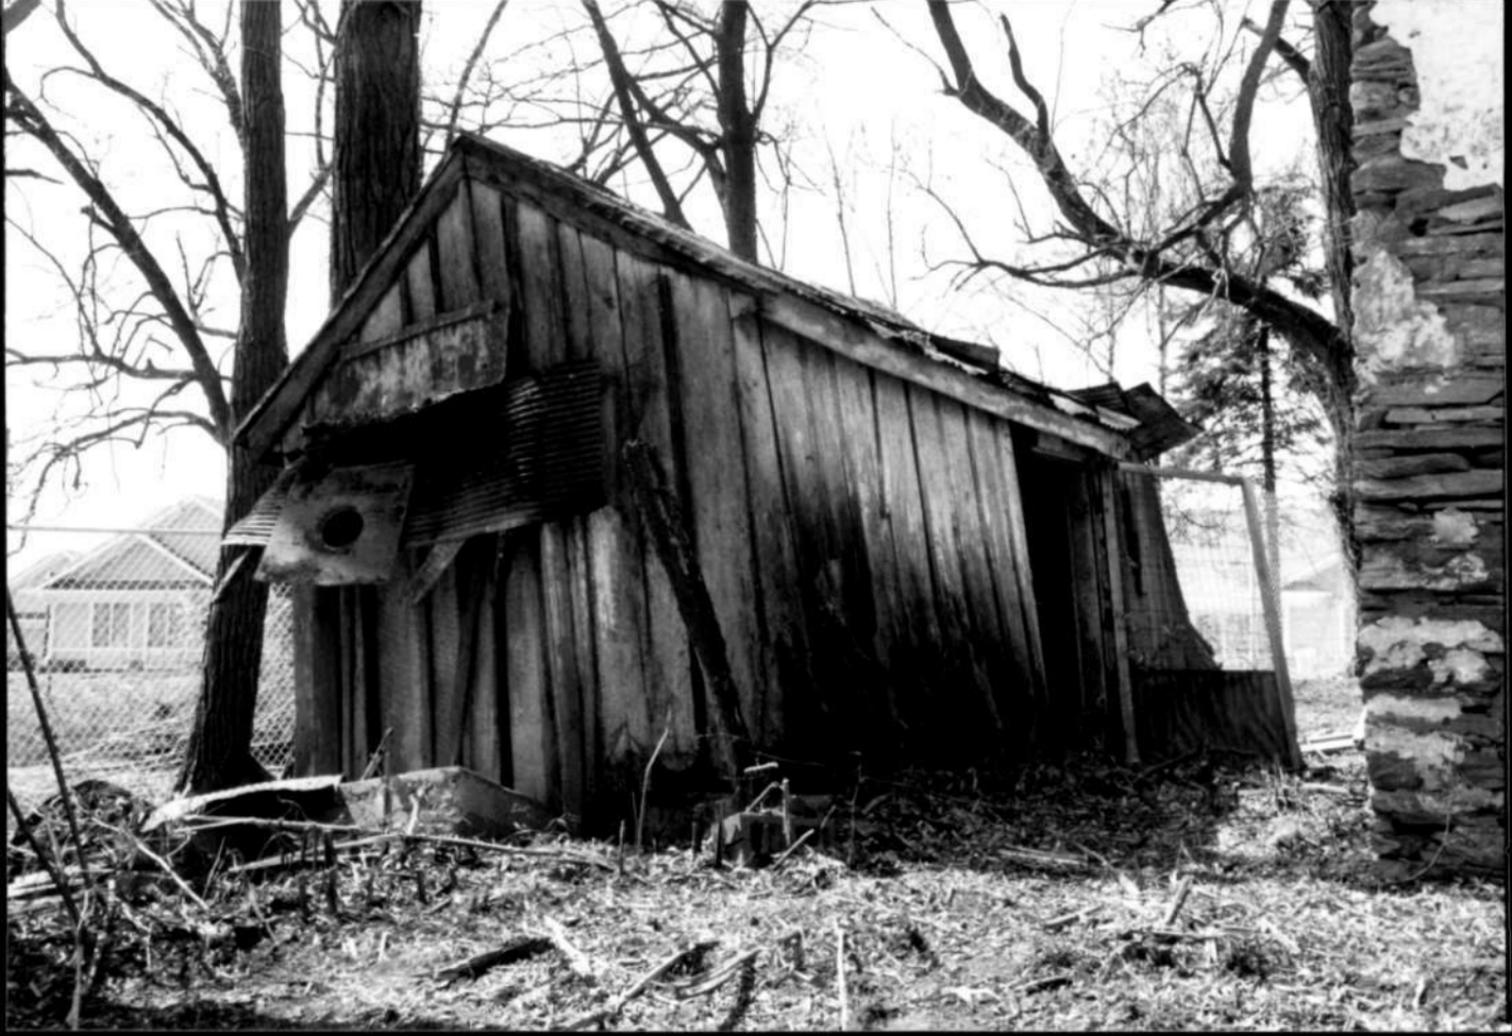
16 of 16

A wood-frame shed (ca. 1930) is located south of the rear of the meat house. The wood-frame shed is a one-story, post-in-ground, rectangular-plan structure clad with vertical board siding. The structure terminates in a side gable roof sheathed with corrugated metal. The building is in an advanced state of deterioration. A one-story addition, of unknown usage, appended to the west gable end of the structure has collapsed.

Shed, view southwest
