**MARYLAND HISTORICAL TRUST
NR-ELIGIBILITY REVIEW FORM**

F-3-168
Lease-Myers Farm
Frederick County, Maryland
Frederick
Ca. 1895
Private

Maryland Historical Trust Maryland Inventory of Historic Properties Form

historic Lease-Myers Farm

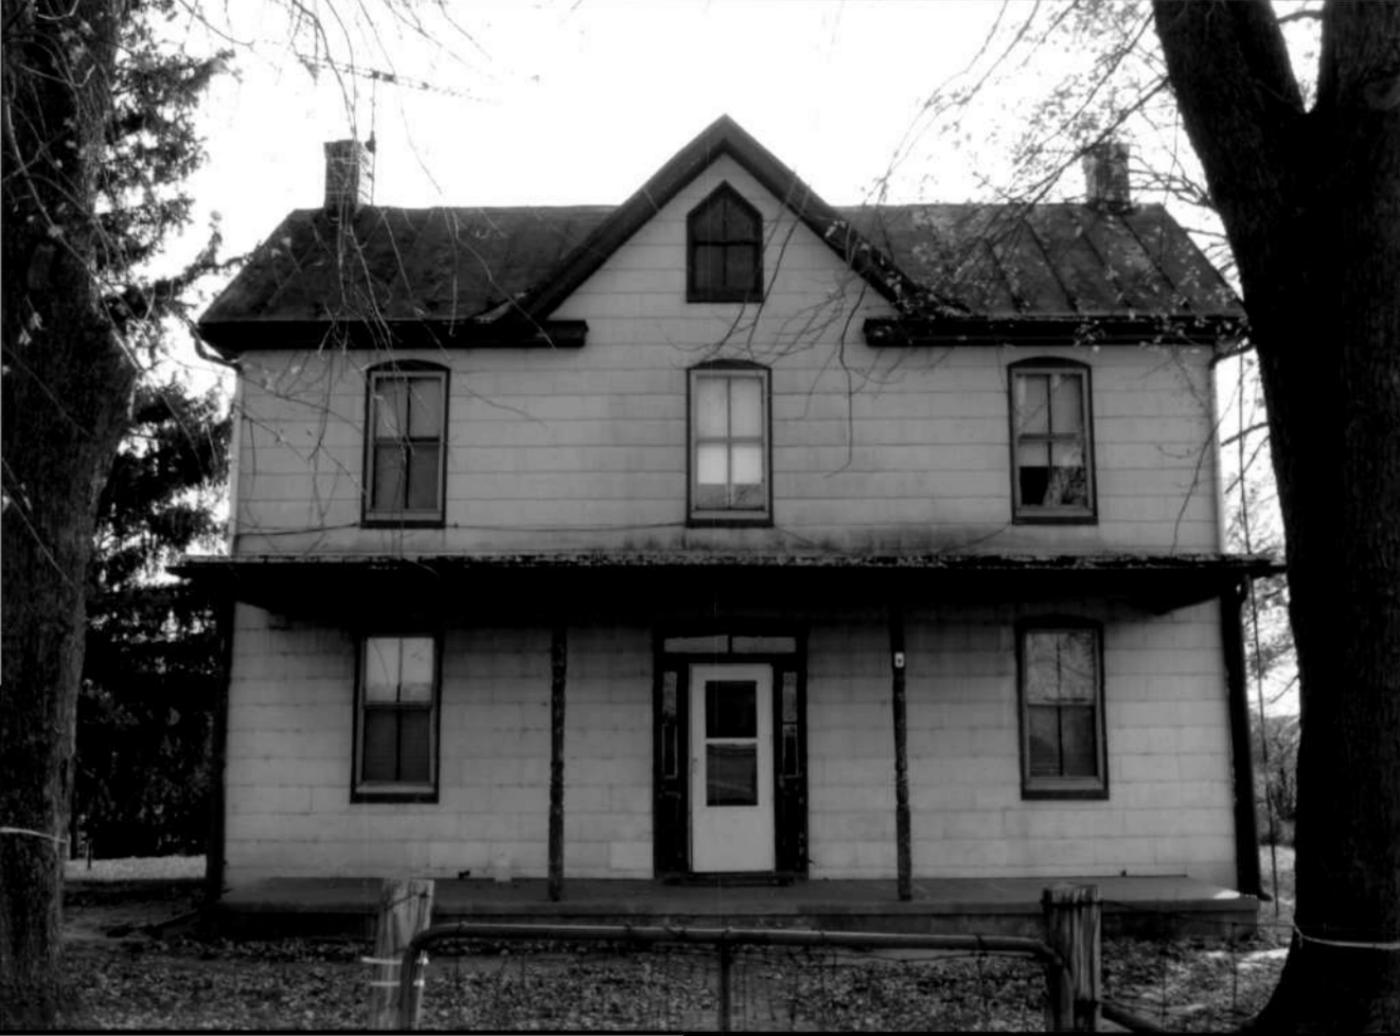
2 OF 17

The ca. 1895 wood-frame, two-story dwelling faces west. The building adopts a center hall plan with ell. The principal block is three-bays-by-two bays. The dwelling rests on a stone foundation faced in brick. The building terminates in a cross-gable roof with gable returns that is sheathed in standing-seam metal. Four brick chimneys pierce the roof. Two interior chimneys are located at each gable, one is centrally located in the ell, and one is located in the ell's gable. The building is clad in asbestos shingles over German lap siding. Two-over-two-light, double-hung, wood-sash windows are employed throughout the building. Simple wood trim surrounds the window openings, and the windows on front (west) elevation have slightly arched window moldings. Other window ornamentation includes slip sills. A Gothic arched window is found in the center gable peak of the front elevation. The primary entrance is centered on the west elevation and consists of a five-panel wood door with a vinyl screen door. Sidelights and a two-light transom define the entrance. The door opening mimics the front elevation window openings.

A full-width porch is found on the front elevation. The full-width front porch rests on a poured-concrete foundation supported by concrete-block piers. The underside of the porch's flat roof is beaded-board. Turned columns and dentils characterize the porch. A two-tiered porch is located along the south elevation of the ell.

DWELLING, WEST FRONT

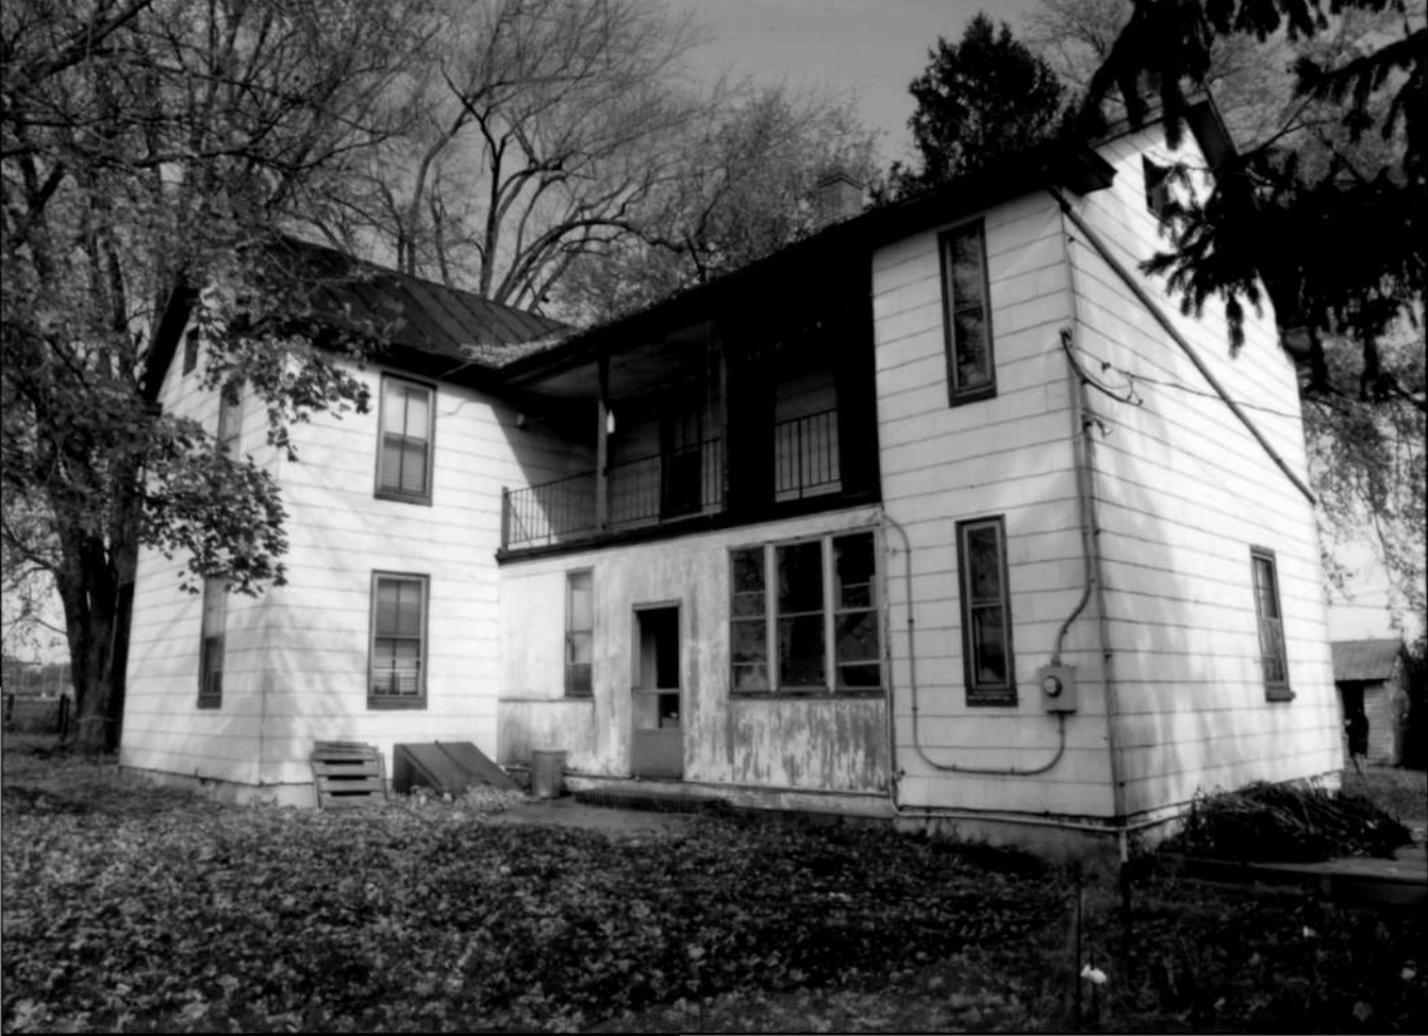
3 OF 17

The two-tiered porch defines the ell's south elevation. The porch is enclosed on the first floor. The enclosure consists of vertical wood boards. One one-over-one-light, double-hung, aluminum sash window is found in the west end of the enclosed porch. An aluminum door is centered in the elevation. Three one-over-one light, double-hung aluminum sash windows are located in the east end of the elevation. Square wood replacement posts are employed on the second floor porch. The porch has a metal balustrade. Two doors flanked by two two-over-two-light, double-hung, wood-sash windows are found on the second floor. Two narrow one-over-one-light, double-hung wood-sash windows are in the easternmost end of the ell's south elevation. A small concrete patio is located off the enclosed porch. The ell's rear (east) elevation contains one six-over-six light, double-hung, wood-sash window at the north end of the elevation and two four-light, fixed-sash, wood windows in the gable. The ell's north elevation is three bays and consists of two two-over-two-light, double-hung, wood-sash windows on each the first and second floors. The first floor windows flank a four-paneled wood door with an aluminum storm door. The entrance is defined by a shed-roof hood supported by unornamented brackets and a poured-concrete step.

DWELLING, SOUTH ELEMENT

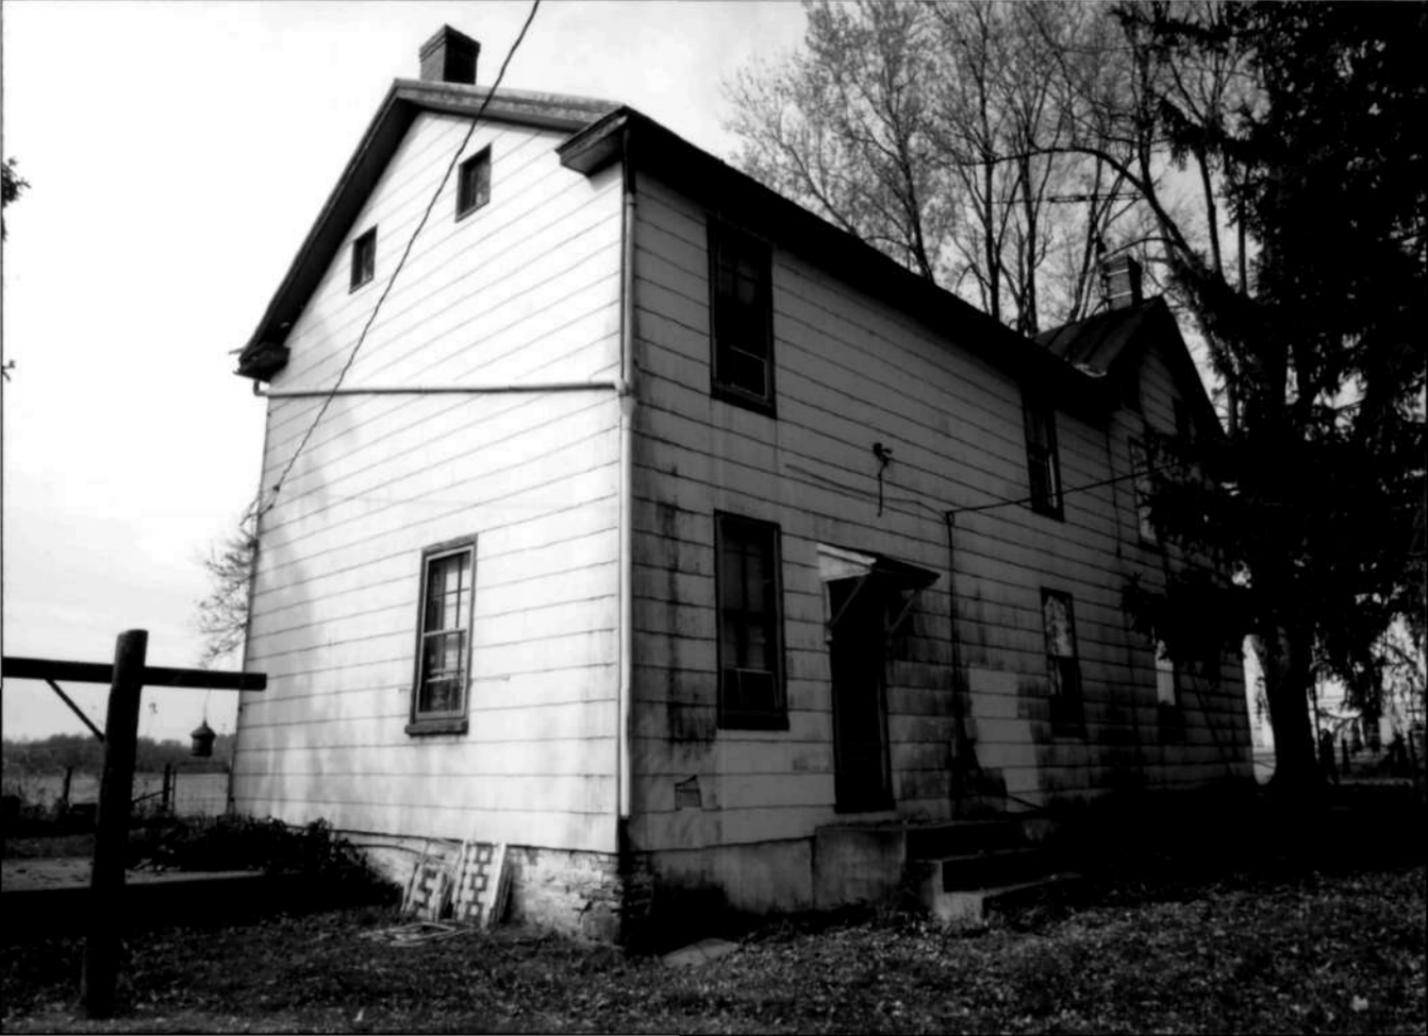
4 of 17

One window is located on each the first and second floors of the north and south elevations of the principal block. Two four-light, fixed-sash wood windows are found in each gable. A window well is located at the basement on the north elevation.

DURING, NORTH ELEVATION

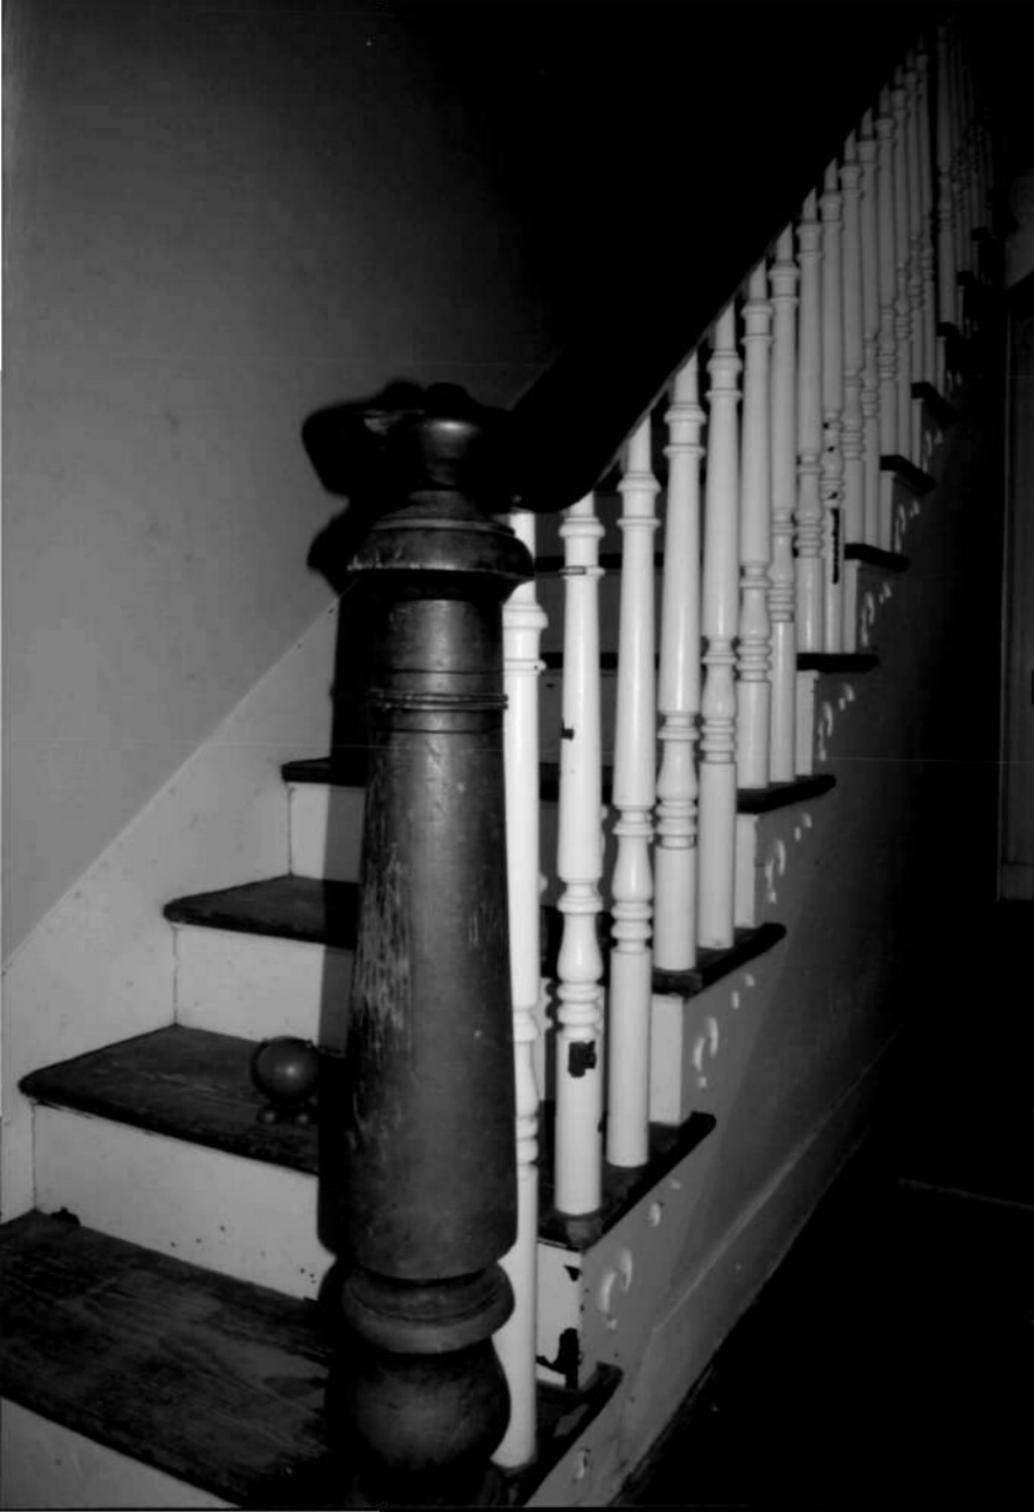
6 OF 17

The central hall features a staircase along the east wall. The staircase has a decorative, rounded newel; turned balusters; and, scrollwork along the open string. A wood mantelpiece is located in each parlor. The mantelpiece in the west parlor is more decorative than the mantelpiece in the east parlor, suggesting that the west parlor originally was the more formal room. The dining room is decorated with a wood mantelpiece and wood wainscotting. The dining room and kitchen have vinyl flooring. Painted wood cabinets are installed in the kitchen.

DRAWING, INTERIOR, NEWEL POST

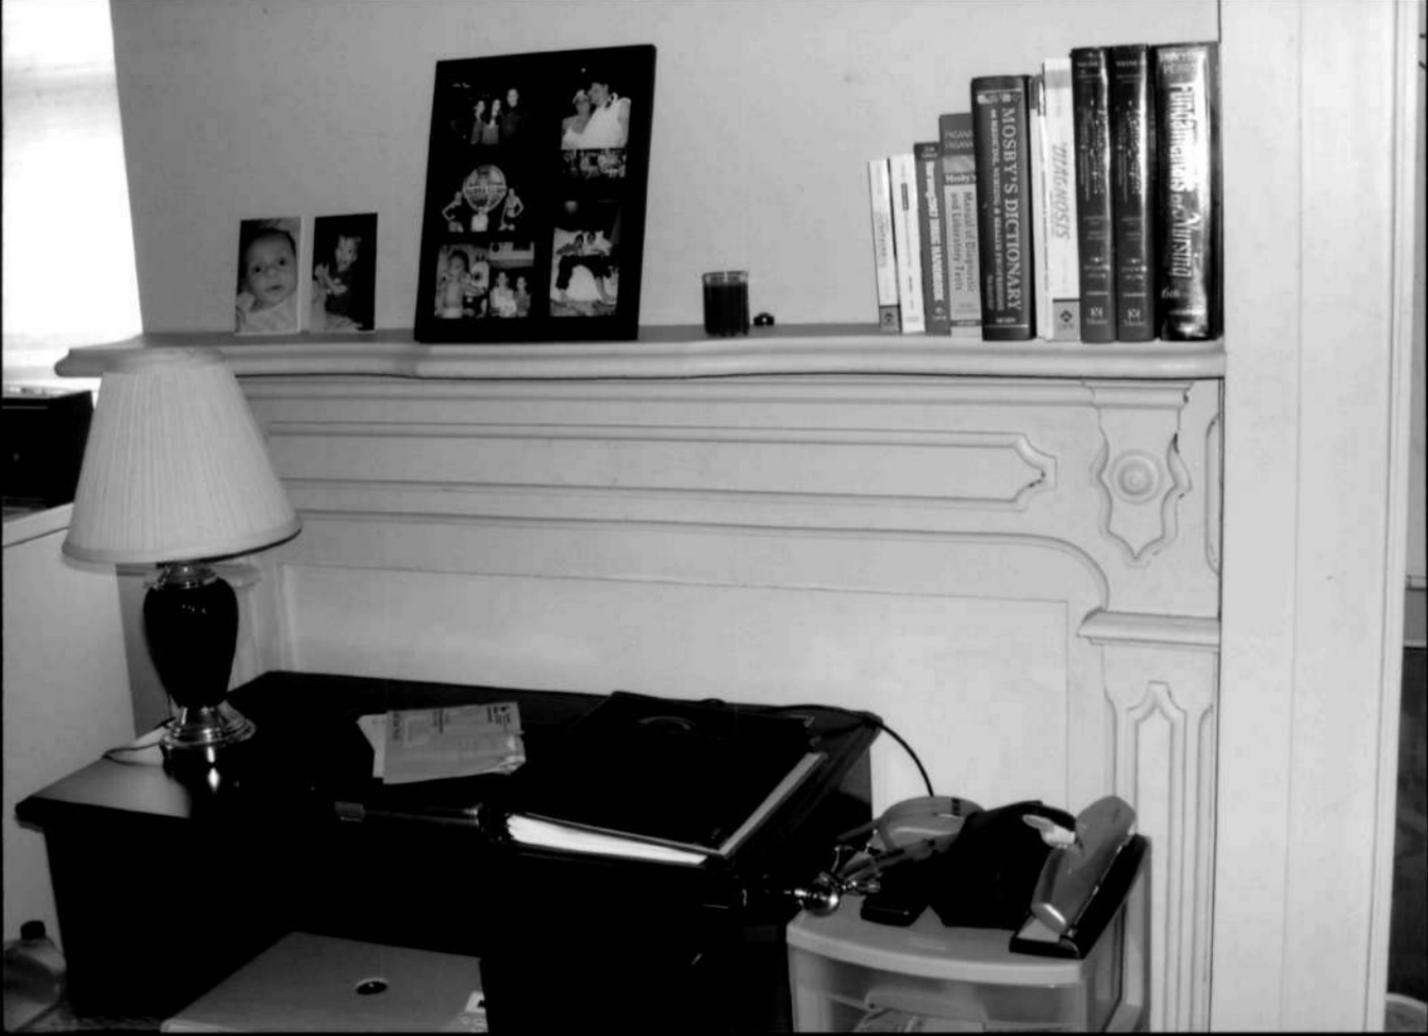
7 OF 17

DWELLING, MANTEL IN WEST PARLOR

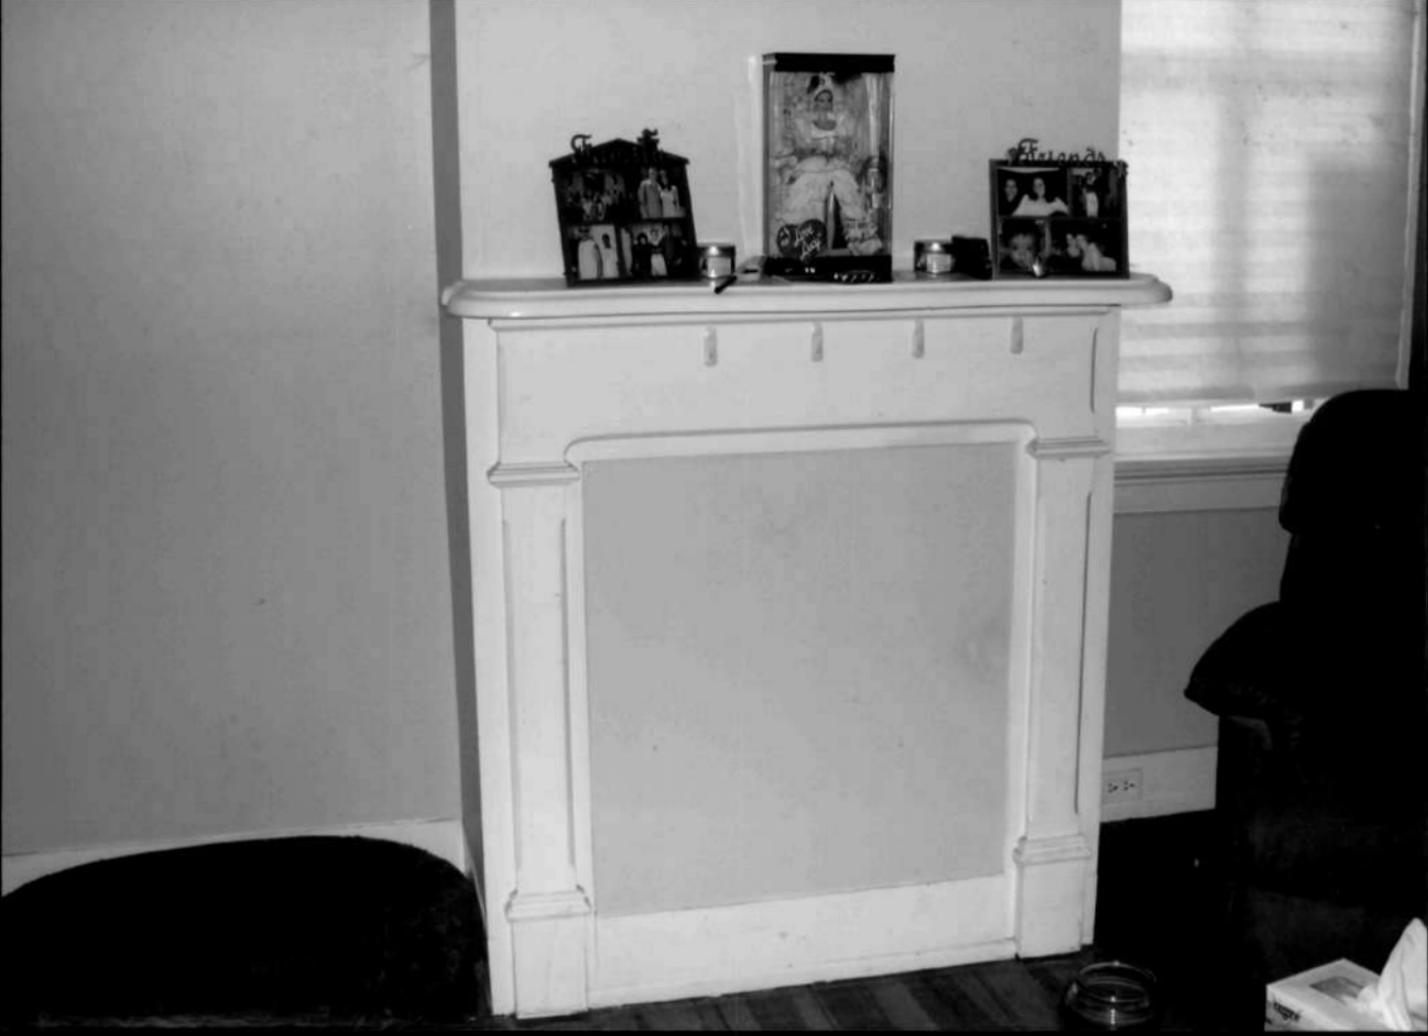
8 OF 17

DRAWING, MATHE IN EAST PARLOR

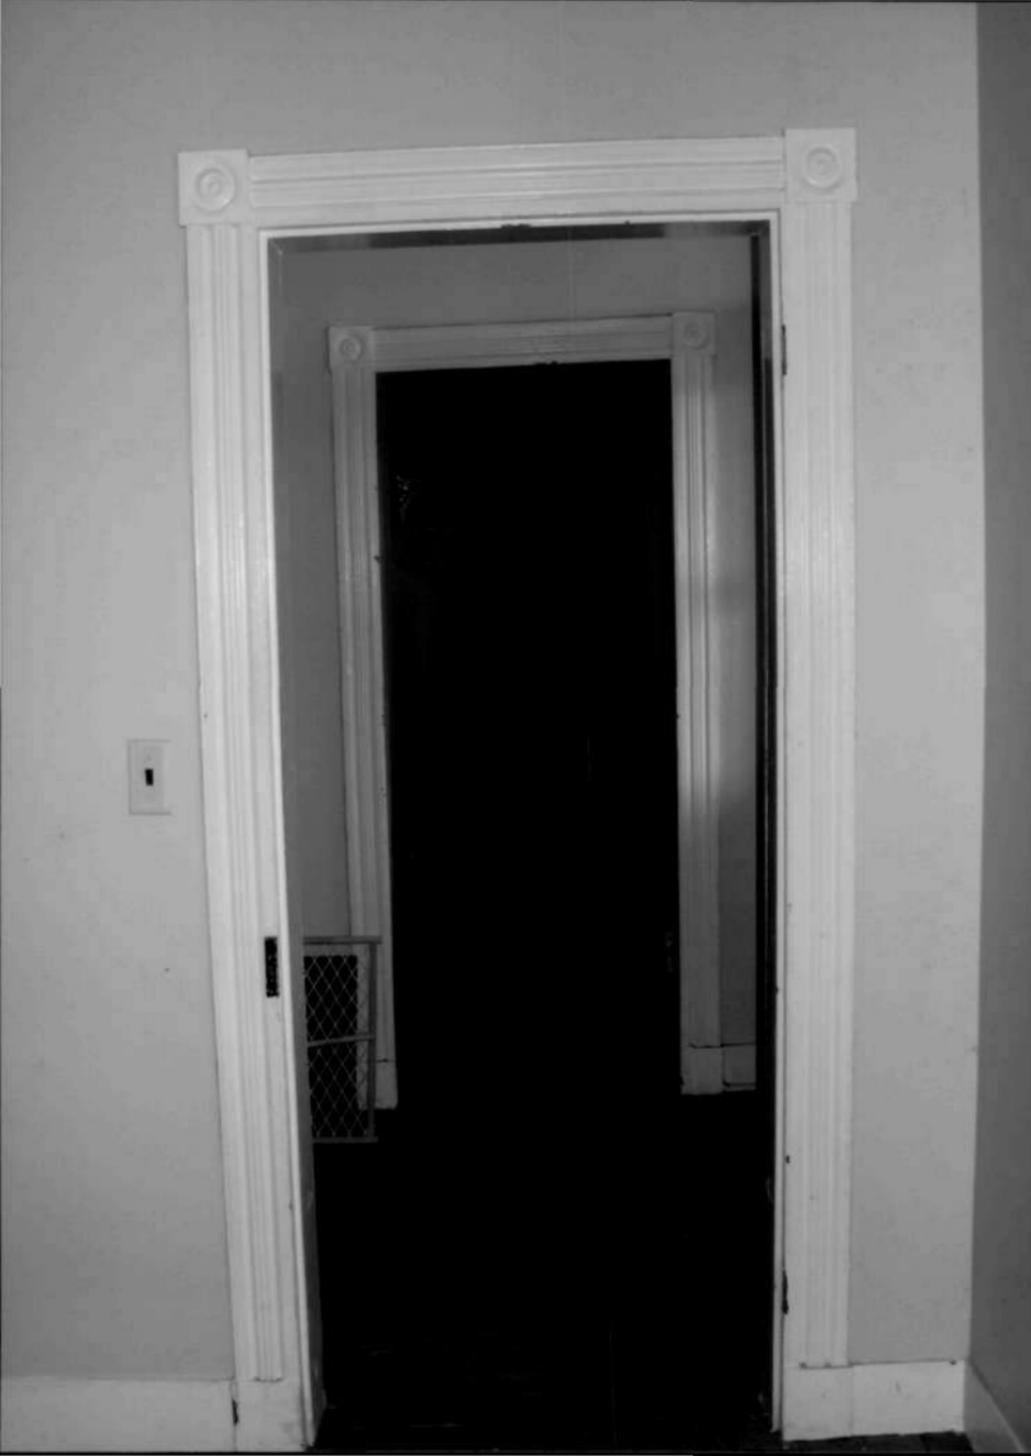
9 OF 17

Window and door trim in the first-floor formal rooms is fluted and ornamented with bull's-eye corner blocks. Unornamented six-inch baseboards trim the first-floor rooms except for the kitchen, which has a molded baseboard. The first floor has four-panel wood doors with box locks and porcelain knobs; the doors from the central hall to each parlor have been removed.

DWELLING INTERIOR DOORS

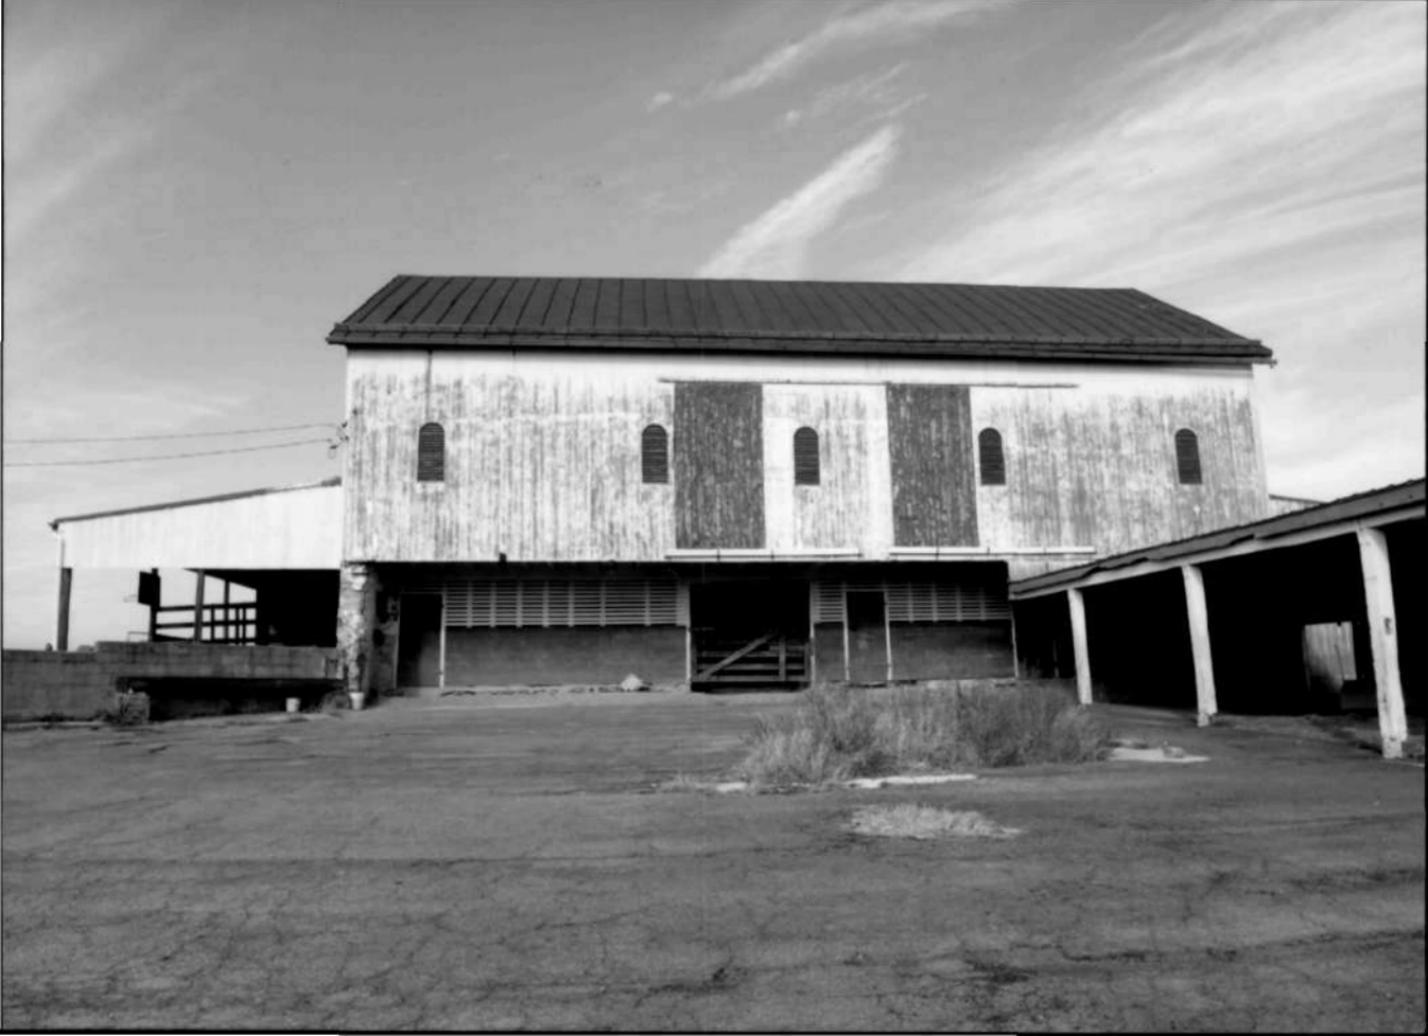
The lower level of the east elevation has five openings consisting of four beaded-board doors and a gated opening centered on the elevation. Two of the doors are on each side of the gated opening. The upper level has five asymmetrically placed arched openings with louvered vents. Two sliding track doors are centered on the elevation. The north elevation has eight arched openings similar to those found on east elevation. Four openings are located at each the loft level and the gable. The west elevation is defined by an earthen ramp supported by a stone foundation with a poured-concrete cap. A three-leaf, beaded board sliding track door is centered on the elevation. Two sets of arched openings with louvered vents are located on each side of the door. The north elevation has eight arched vents, two of which are paired in the gable.

F. 3-168
LEASE-MINERS FARM
FREDERICK COUNTY, MARYLAND
PCGA, INC
NOV 2006
BANK BAPT, EAST ELEVATION
10 OF 17

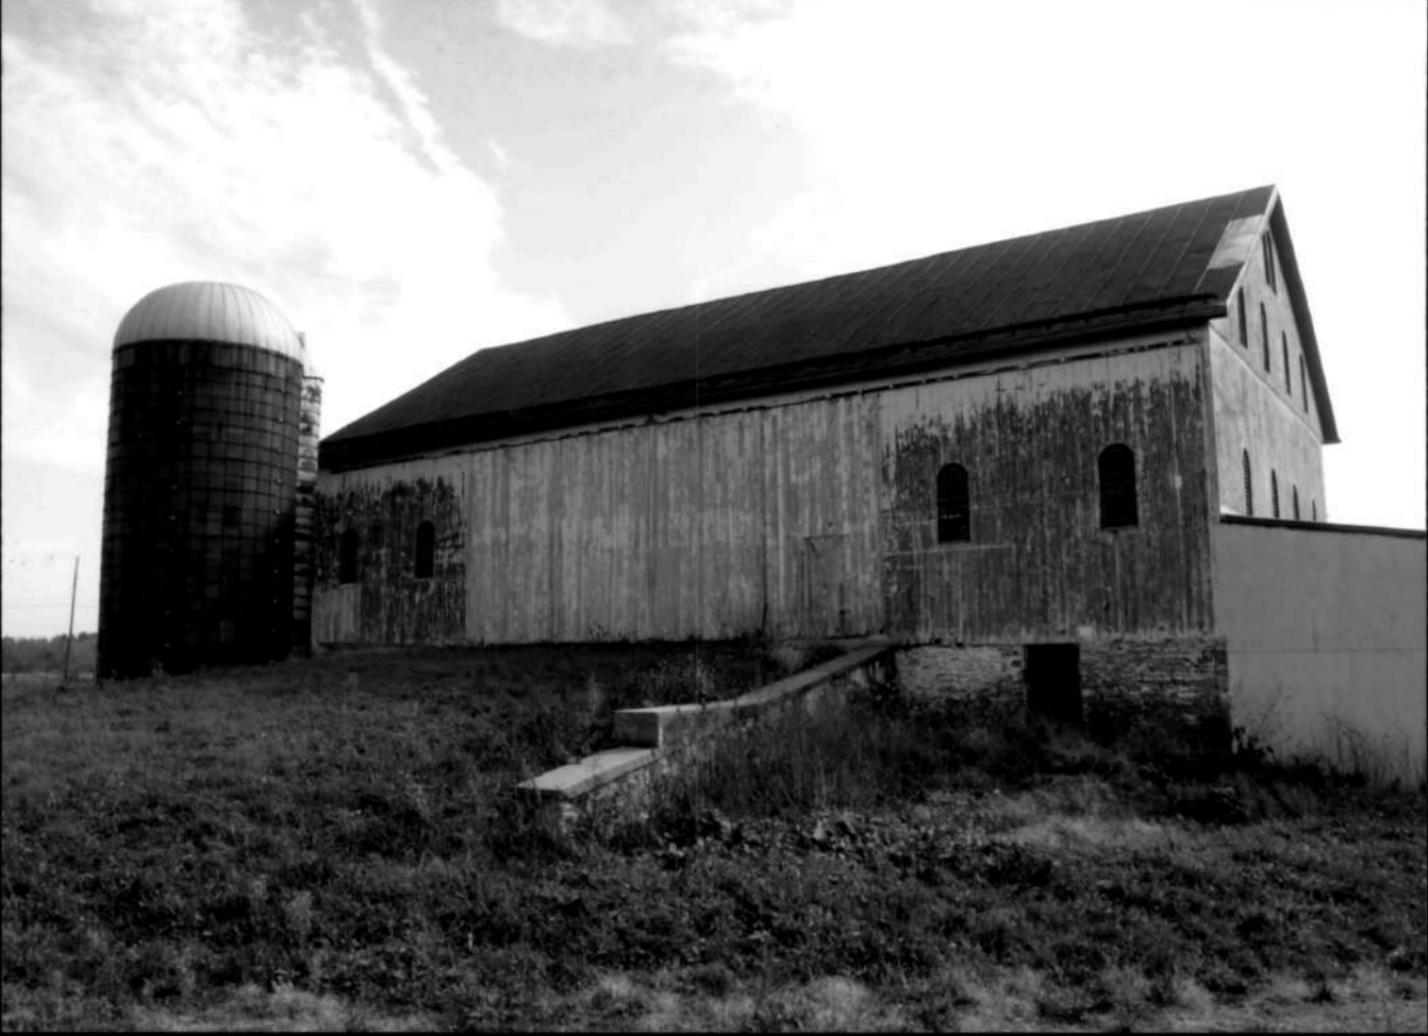
11 of 17

A ca. 1900 glazed tile silo with a metal roof and metal compression bands is located on the west elevation of the bank barn. A single-story, concrete block building connects the silo to the barn. The building terminates in a side-gable roof sheathed in v-groove prefabricated metal panels. A beaded-board door provides access to the building's interior.

BANK BIRTH & SUC, WEST ILIATION

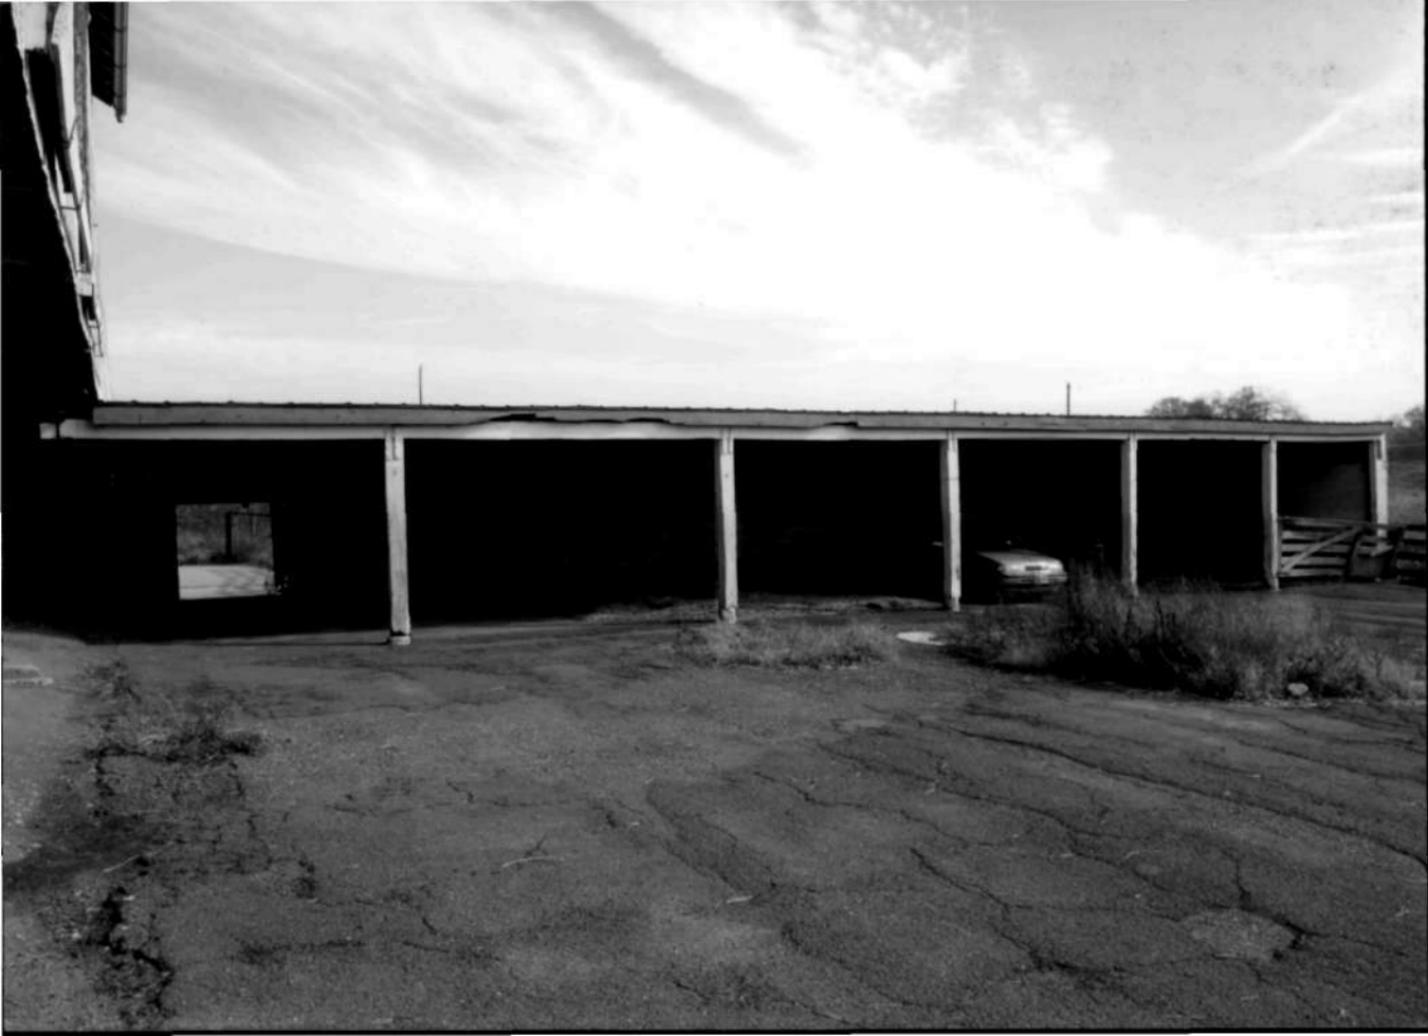
12 FT

A corrugated-metal open shed is attached to the building's south elevation. The shed rests on a concrete-block foundation. It terminates in a shed roof sheathed in corrugated metal. A wood-frame, metal panel tractor shed is located on the north elevation. The addition rests on a concrete-block foundation and terminates in a shed roof sheathed in v-groove, prefabricated metal panels. Three beaded board sliding track doors define the north elevation. The building has a gravel and dirt floor with a poured-concrete apron.

BANK BARN ATTACHED SHED, SOUTH ELEVATION

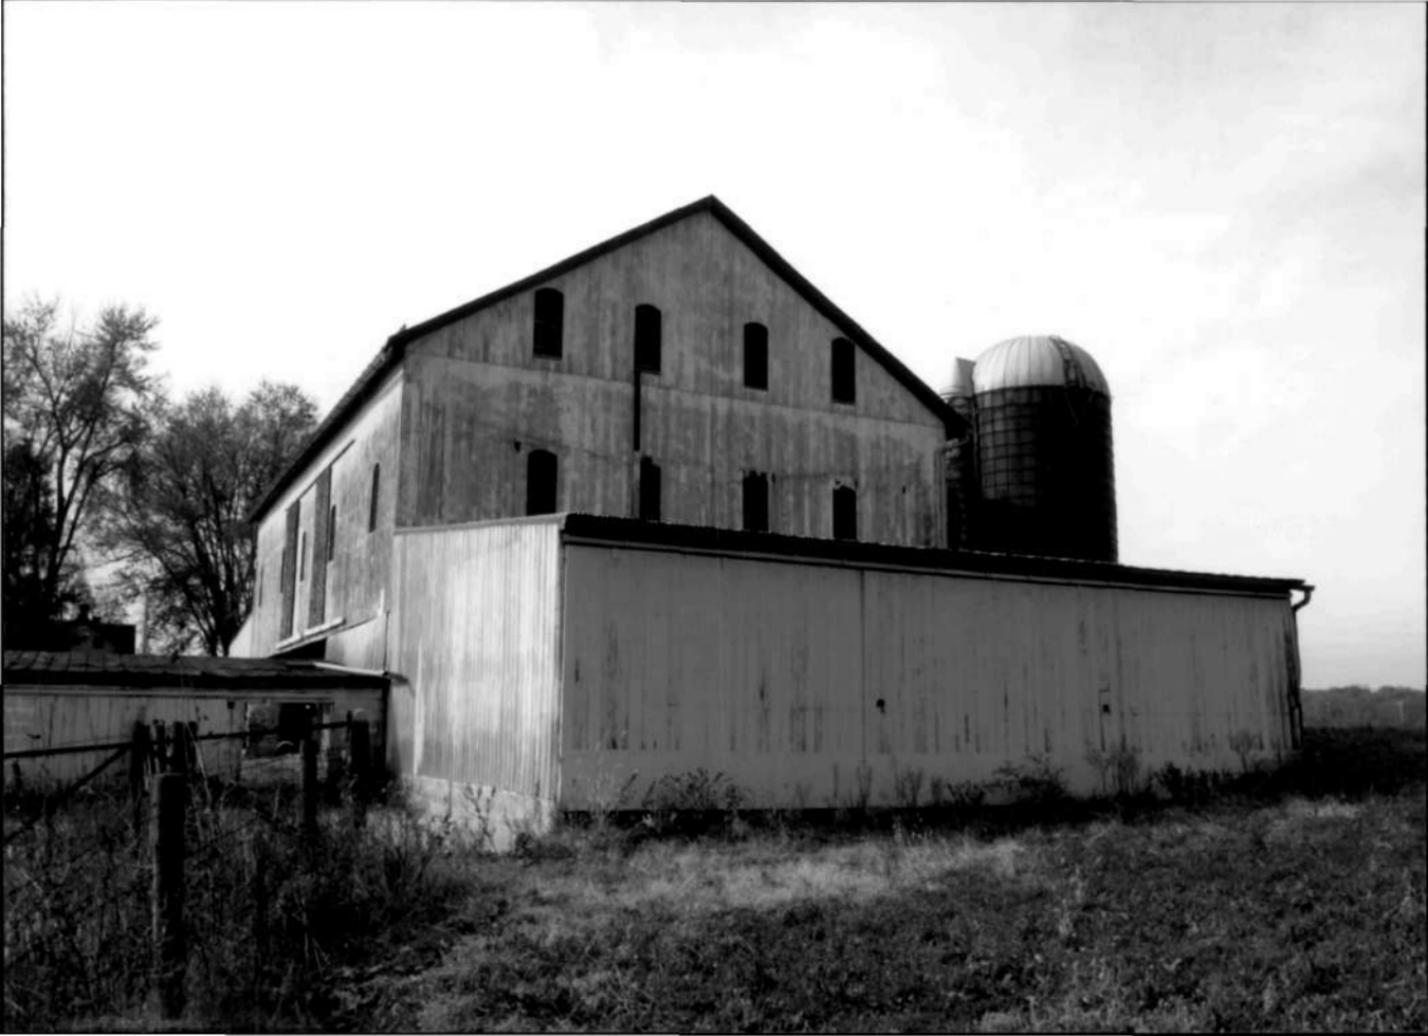
14 of 17

BANK BAPT, ATTACHED METAL SHED, NORTH ELEVATION

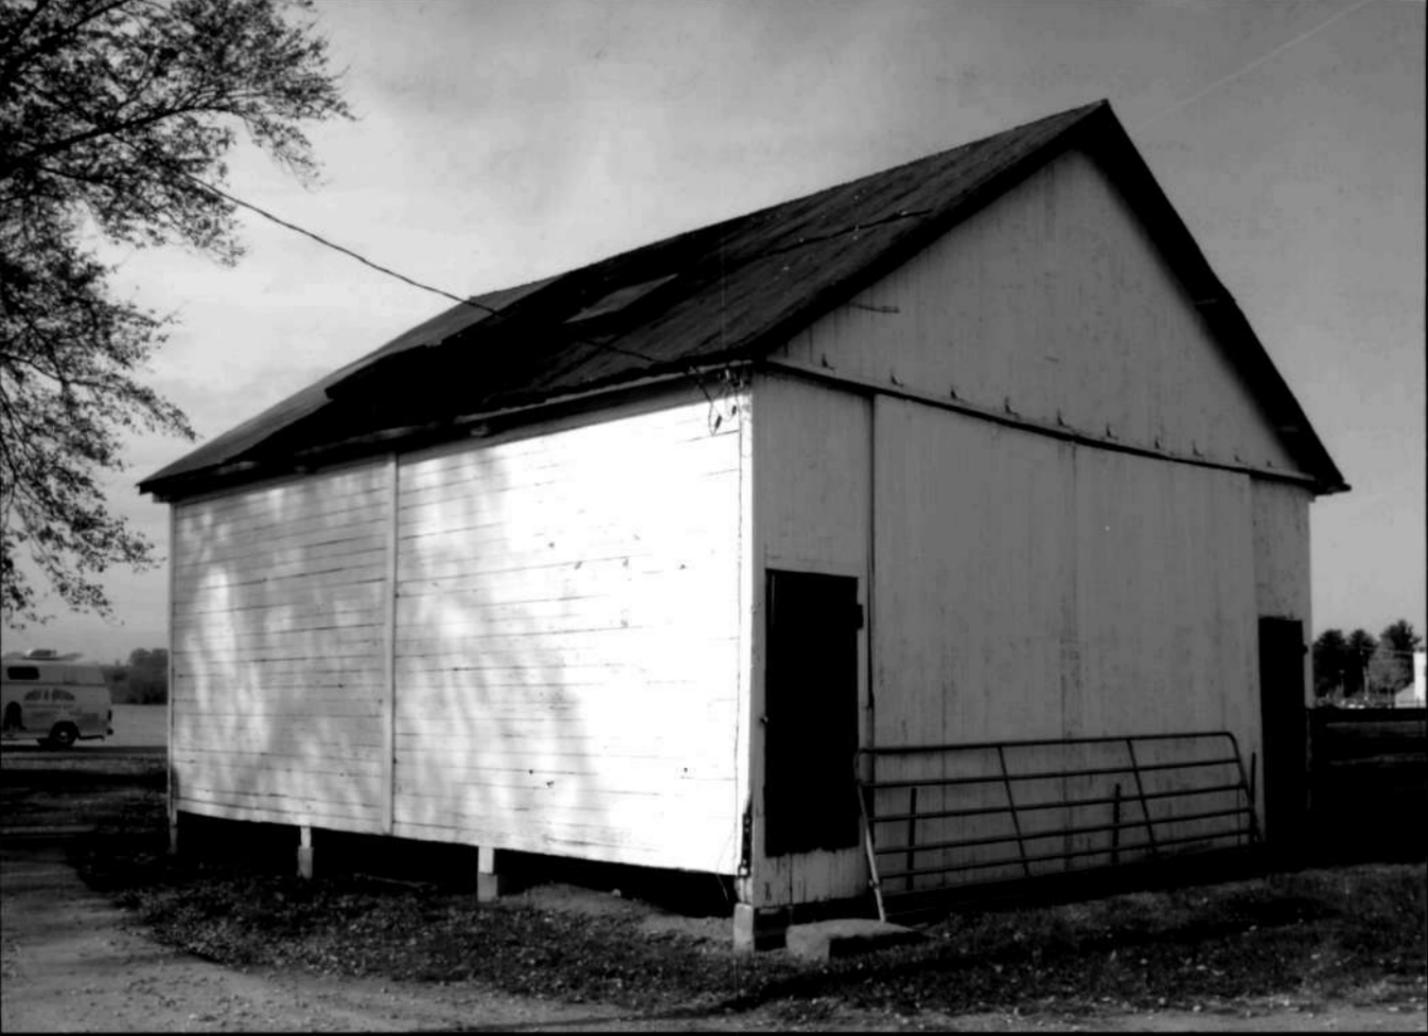
15 OF 17

The ca. 1900 corn crib/wagon shed is located north of the dwelling. The building is aligned on a north/south axis. The building occupies a rectangular plan and terminates in a front-gable roof sheathed in corrugated metal. Two vents pierce the roof. The wood-frame, mortise-and-tenon, four-bent, three-bay building rests on replacement concrete-block piers. Clapboard wood siding clads the building on the east, west, and south elevations; vertical boards were employed on the north elevation. Beaded-board, sliding track doors are found on the north elevation. Two passage doors, one beaded-board door, and one vertical board door, flank the sliding track door on the north elevation. The doors on the south elevation are no longer extant.

CORNER, N + E ELEVATIONS

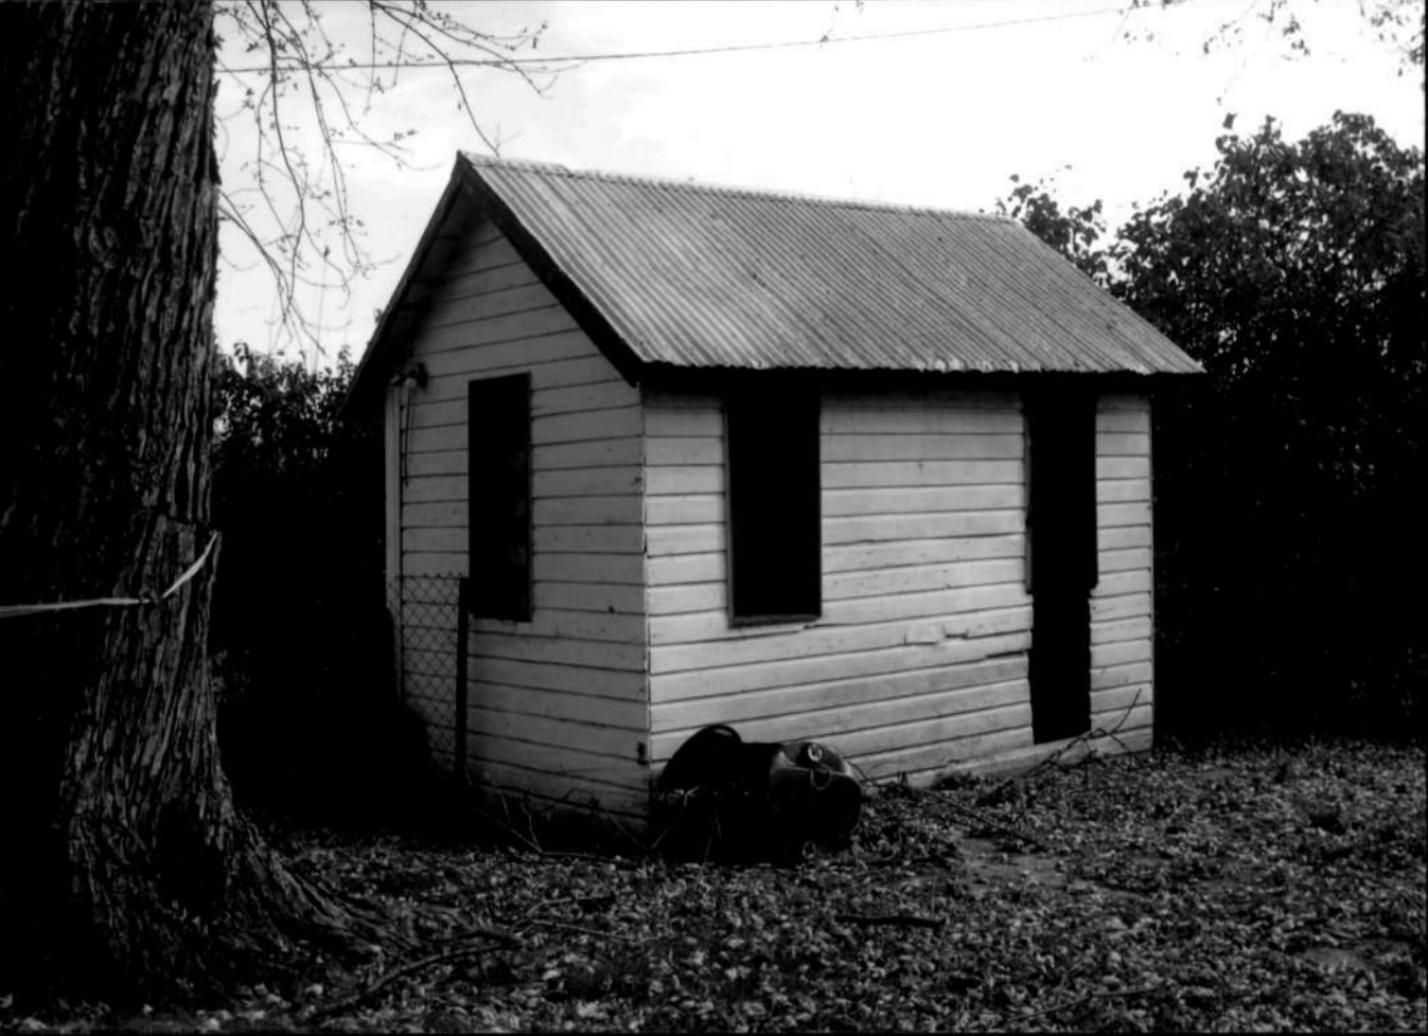
18 FT FT

An early twentieth-century, wood-frame outbuilding is located east of the house and within the side yard. The one-story, two-bay-by-one-bay building has a rectangular footprint and terminates in a gable roof sheathed in corrugated metal. The building rests on a concrete-block foundation and has a poured-concrete floor. Wall and roof framing is circular-sawn; rafters meet at a ridge board. All exterior walls are clad with German lap wood siding except the south wall, which is clad with narrow, vertical-board siding. A door opening is located off-center on the east elevation. The opening contains a four-panel wood door with a porcelain knob; this door is similar to the interior doors of the dwelling. The building has three wood-frame windows openings with no window units. One window opening on the west elevation has been elongated to create an unfinished door opening.

OUTBUILDING, WEST ELEVATION
