**MARYLAND HISTORICAL TRUST
DETERMINATION OF ELIGIBILITY FORM**

Property Name: Shaver Farm Inventory Number: F-3-242

Project: Monocacy Boulevard Central Section Agency: Army Corps of Engineers

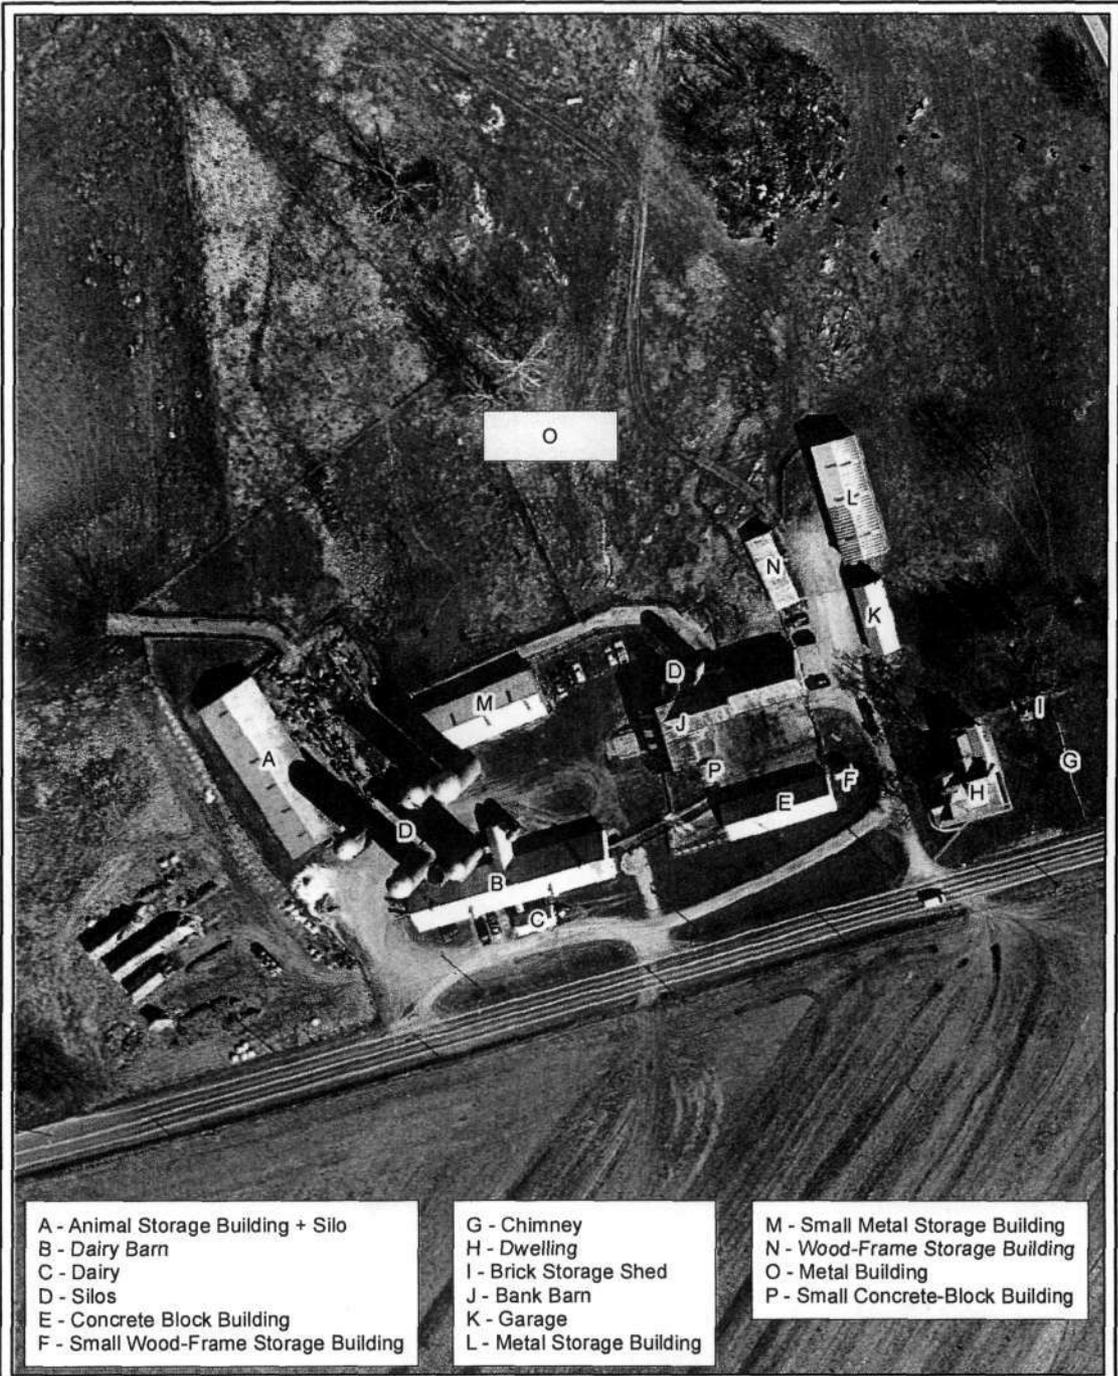
A - Animal Storage Building + Silo
 B - Dairy Barn
 C - Dairy
 D - Silos
 E - Concrete Block Building
 F - Small Wood-Frame Storage Building

G - Chimney
 H - Dwelling
 I - Brick Storage Shed
 J - Bank Barn
 K - Garage
 L - Metal Storage Building

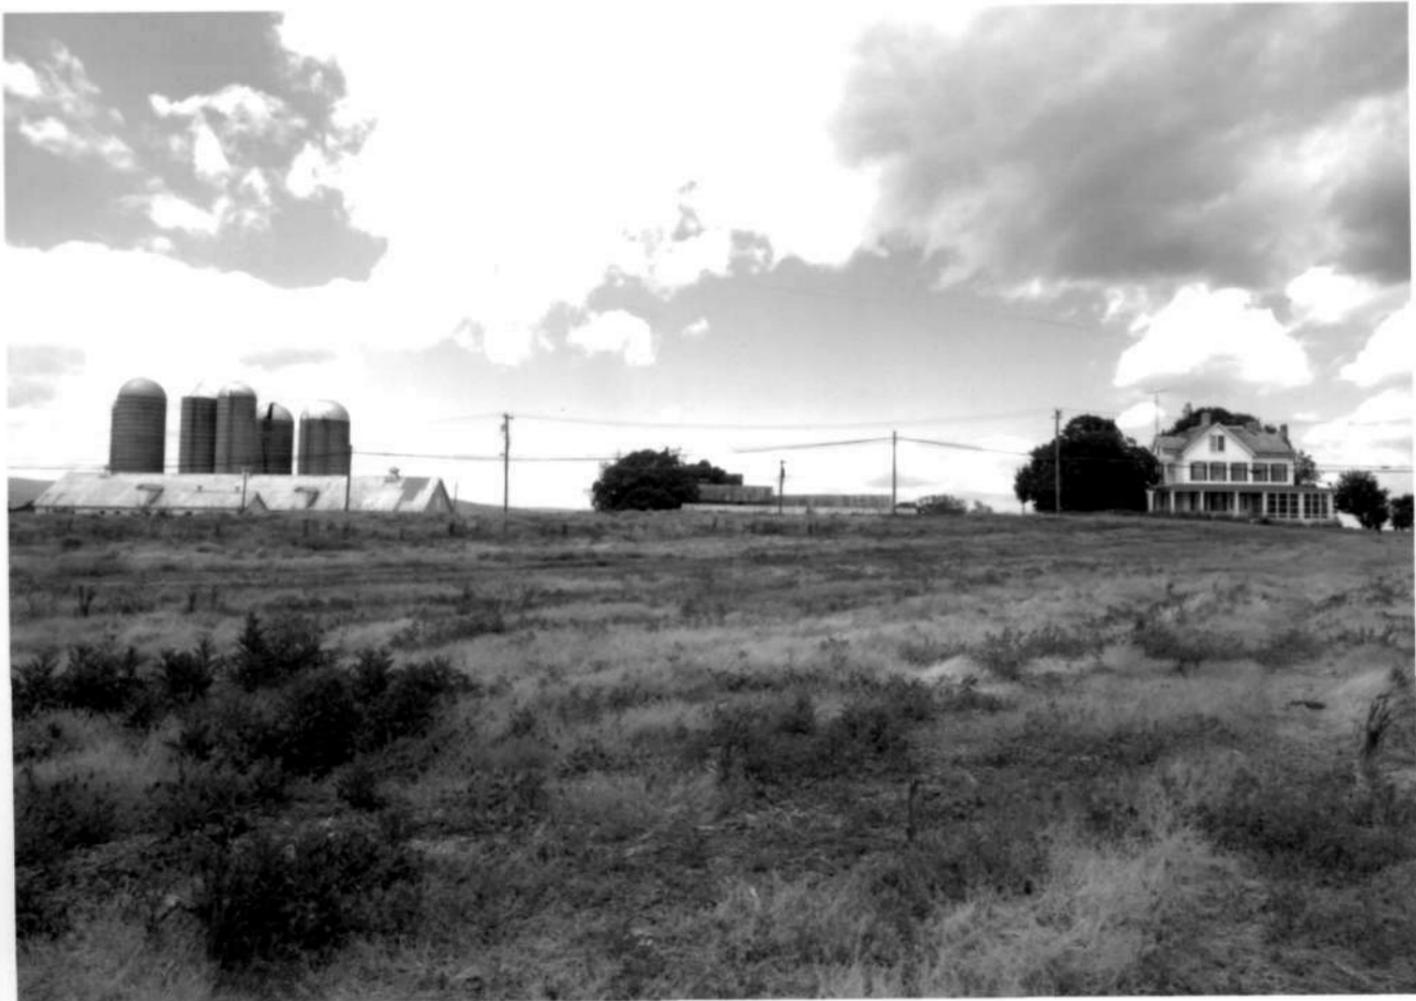
Photo # 1 of 12

F-3-242_2008-05-13_01 - Setting, looking north

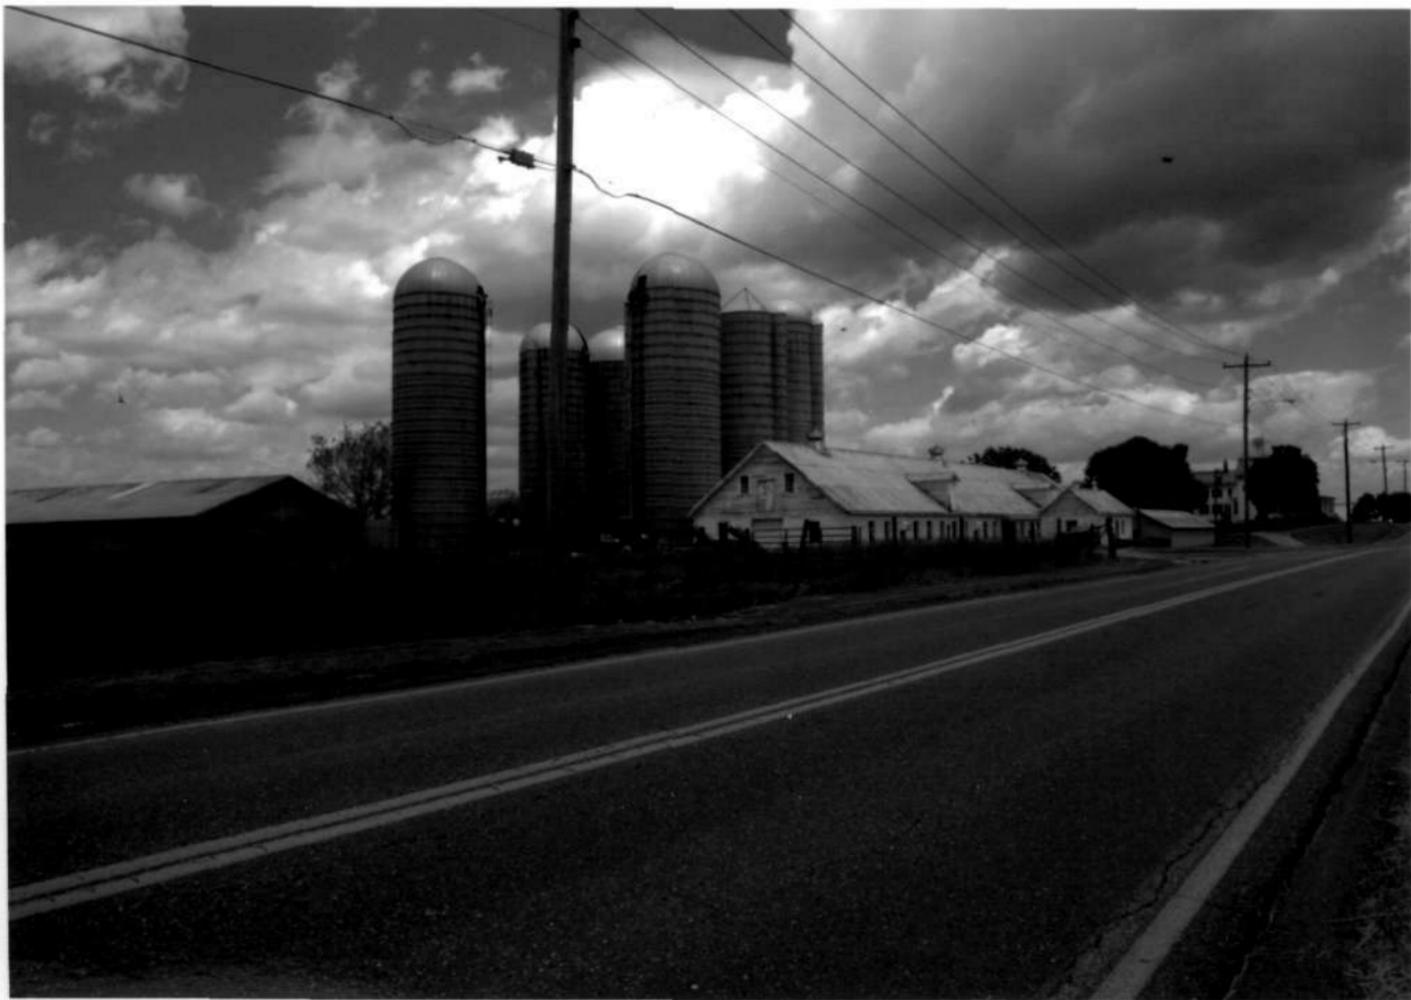
Photo # 2 of 12

F-3-242_2008-05-13_02 - Setting, looking east

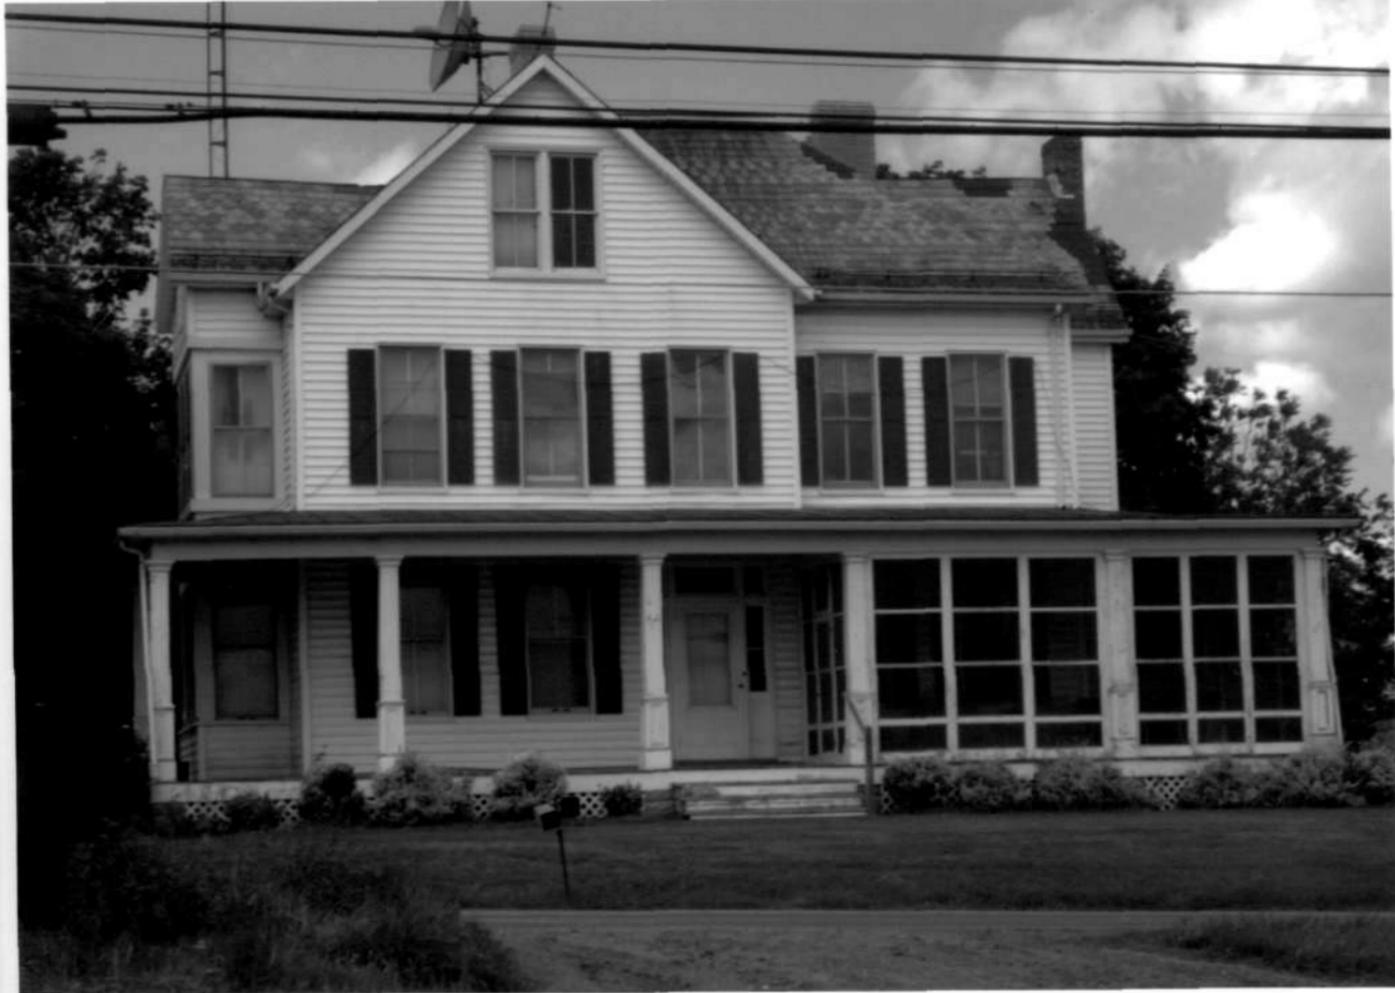
Photo #3 of 12

The ca. 1912, three-story dwelling fronts Hughes Ford Road. The building occupies an irregular footprint; the foundation is not visible. The dwelling has complex massing and roof forms. Roofing materials are variegated slate cut in rectangular and fishscale patterns. The foundation is not visible. The building has a front-gable roof on the south (front) elevation with a mansard roof on the building's east elevation. A gable intersects the mansard roof and a gable covers the ell. Four brick chimneys pierce the roof. A replacement chimney is centered in the gable; a replacement chimney is located on the east slope of the hipped roof; an exterior, gable-end chimney is found on the east elevation; and a chimney is centered in the gable roof of the ell. A lightning rod also is located at the peak of the dwelling's front gable. The dwelling is clad in vinyl siding. Generally, windows are two-over-two light, double-hung, wood-sash units; vinyl louvered shutters flank the windows on the south elevation. Primary access to the dwelling is by the off-center front entrance. A wraparound porch that has been screened on the east end defines the south elevation. Wood steps lead to the porch.

The asymmetrical south elevation is seven bays. Windows are two-over-two light, double-hung, wood-sash units. The dwelling's main entrance is located in the east bay of principal block. A screened, paneled wood door provides access to the dwelling's interior. Two-light sidelights with a panel flank the entrance. A three-light transom is above the door. Paired, two-over-two light, double-hung, wood-sash units are located in the gable end. The five-bay wrap-around porch terminates in a standing-seam flat roof. Square posts support the porch roof. The posts rest on paneled bases and are capped with simple cornices.

F-3-242_2008-05-13_03 - Dwelling, south elevation

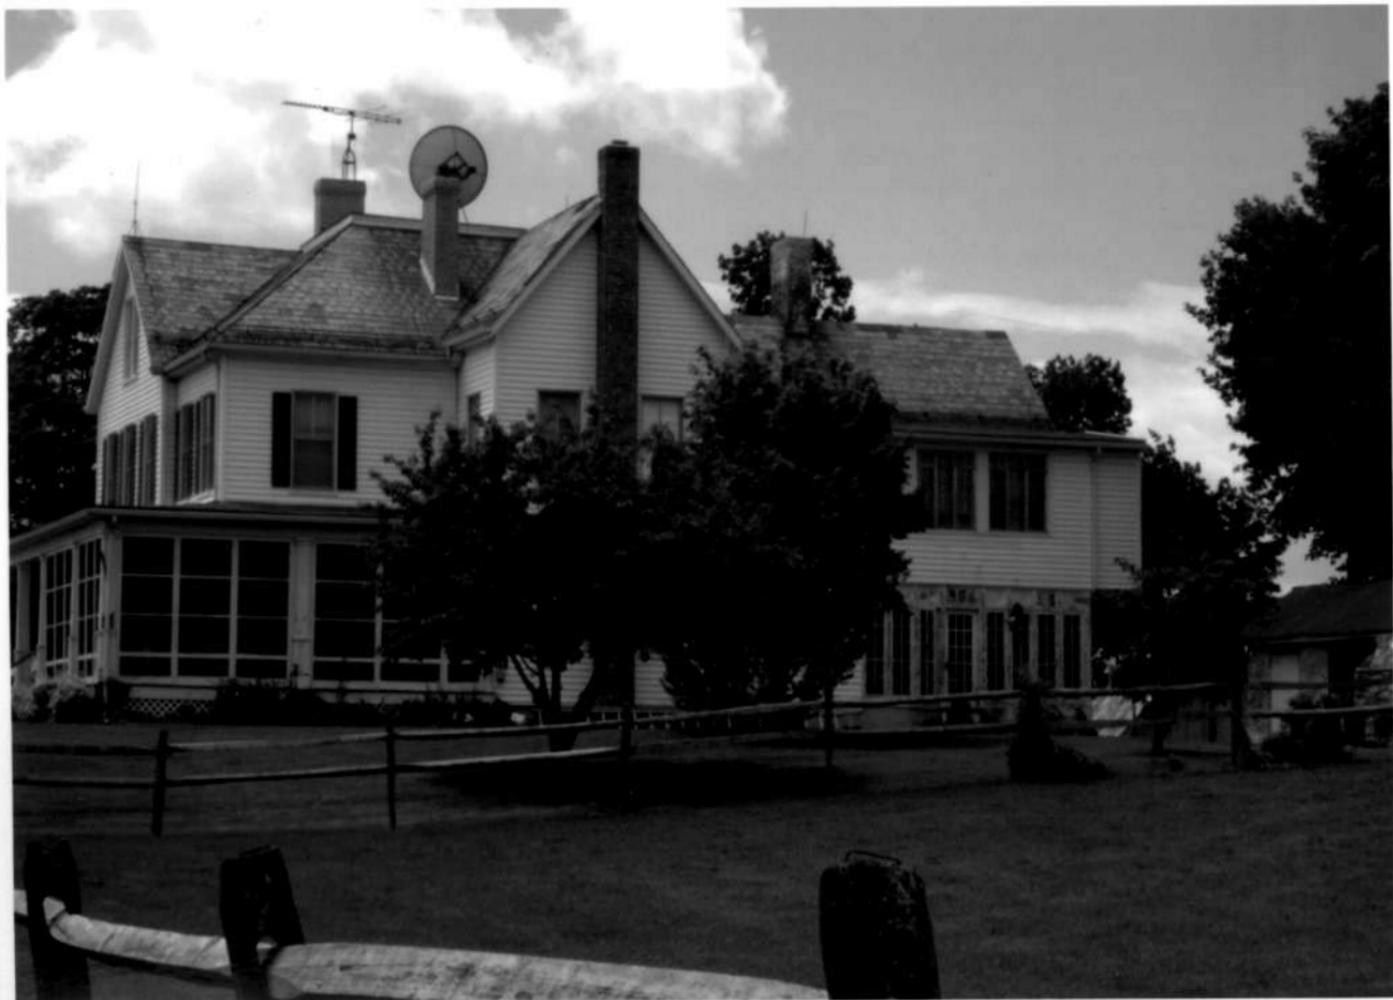
Photo # 4 of 12

Two-over-two light, double-hung, wood-sash windows flank the exterior brick chimney on the first and second floors of the east elevation of the projecting gable. Three two-over-two light, double-hung, wood-sash windows characterize the first and second floors of the west elevation of the projecting gable.

F-3-242_2008-05-13_04 - Dwelling, east elevation

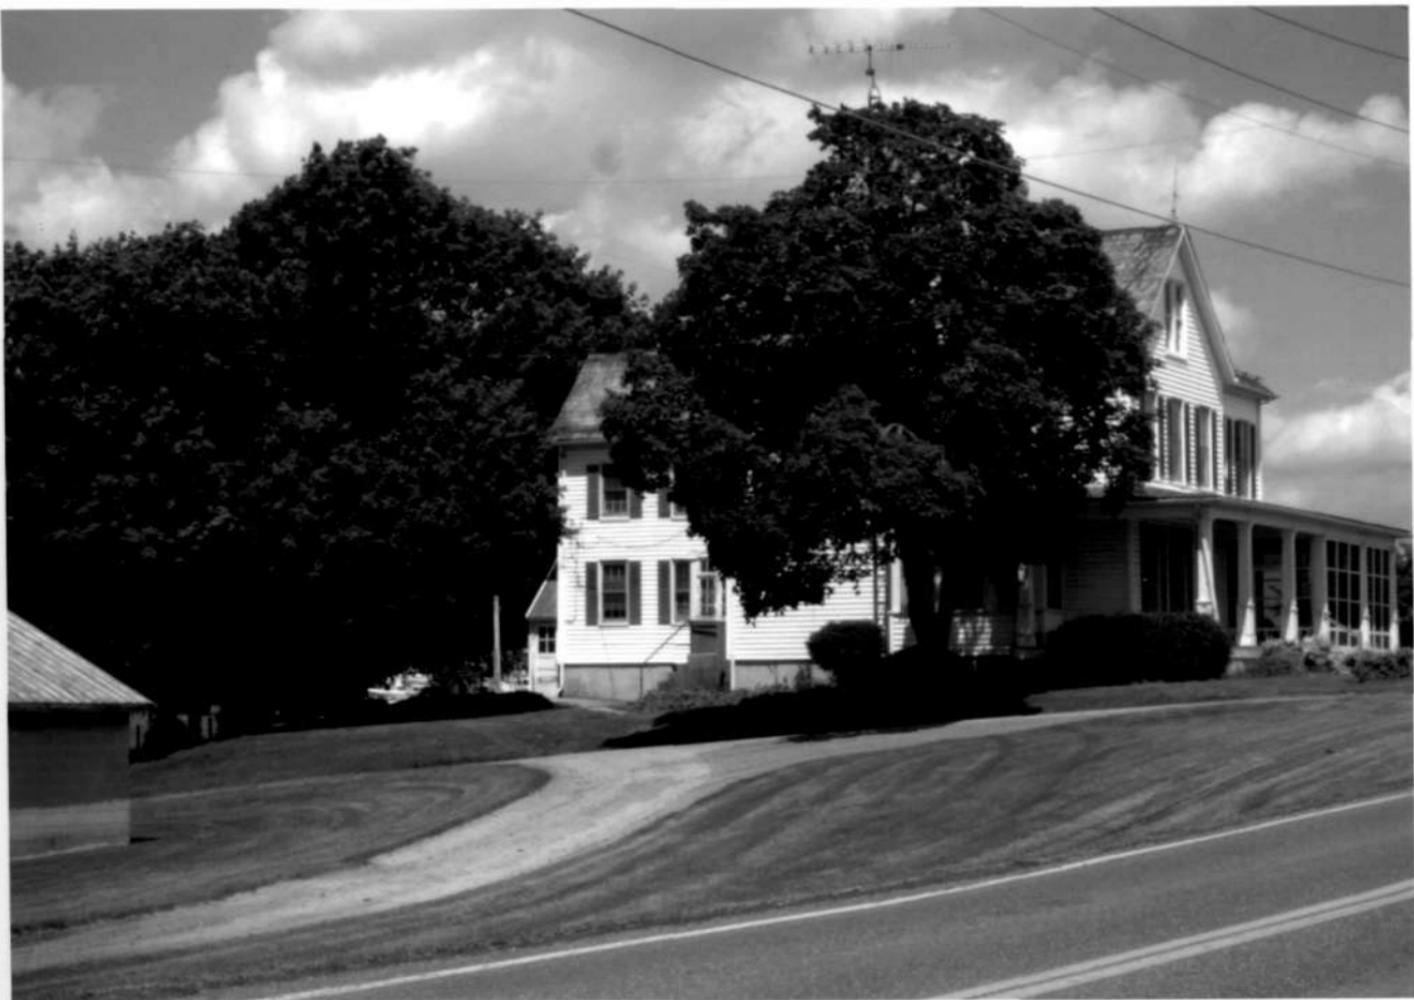
Photo # 5 of 12

F-3-242_2008-05-13_05 - Dwelling, west and south elevations

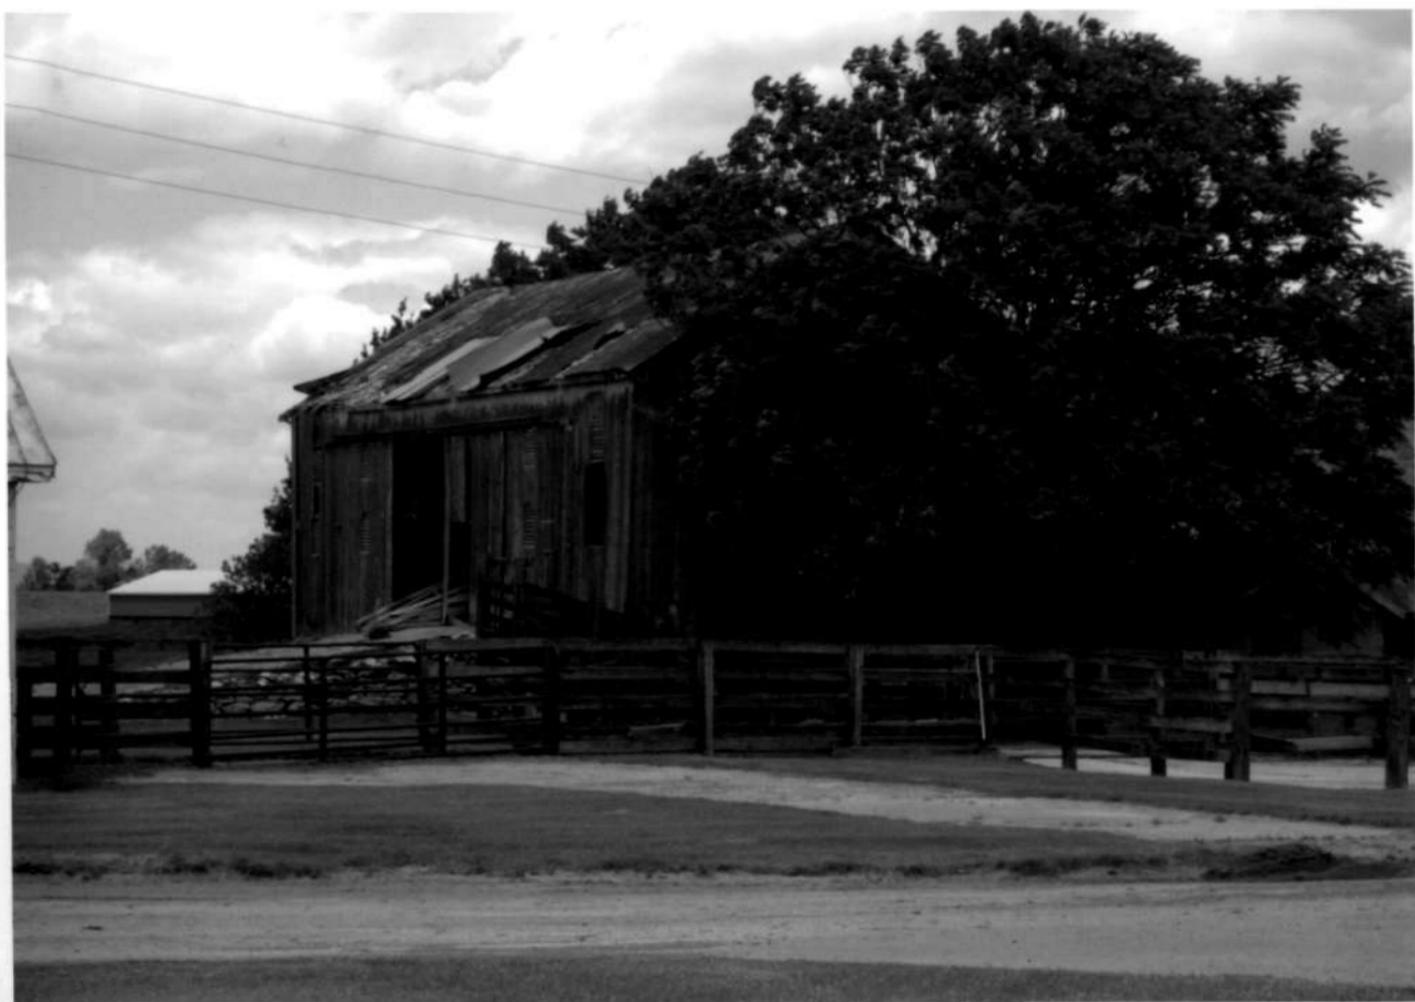
Photo #6 of 12

An early-twentieth century bank barn is west of the dwelling. The wood-frame building terminates in a side-gable roof sheathed in metal panels. Wood shingles are visible in places where the metal panels have come loose. The building is clad in vertical wood boards. A door opening defines the west elevation. The sliding tract remains extant; however, the door is no longer present. A stone ramp covered with grass leads to the door. Four arched, louvered vents flank the door on the first and second floors. A large tree blocks the south elevation of the barn from view from the public right-of-way. What appears to be a single-story with loft, wood-frame, gable-roof addition was constructed off the barn's east elevation. Cladding materials are vertical wood boards. Metal panels are used to sheath the roof. Most of the addition's south elevation is obscured by a tree and the concrete-block building to the south. A large opening is located on the first floor. A similar opening on the north elevation is visible. Arched, louvered vents pierce the south elevation at the loft left. The east elevation gable end has paired arched wood louvered vents.

An addition extends from the west elevation of the bank barn's addition. The addition has a steeply pitched gable roof sheathed in metal panels. The addition has a concrete-block base with vertical wood siding above. South elevation openings consist of a sliding tract door and two window openings. One window opening is missing its sash and the other opening contains a four-light sash. The remainder of the south elevation is blocked from view by the concrete-block building located to the south. The east elevation contains two window openings at the north and south ends of the elevation. The openings have been enclosed.

F-3-242_2008-05-13_06 - Bank barn, west elevation

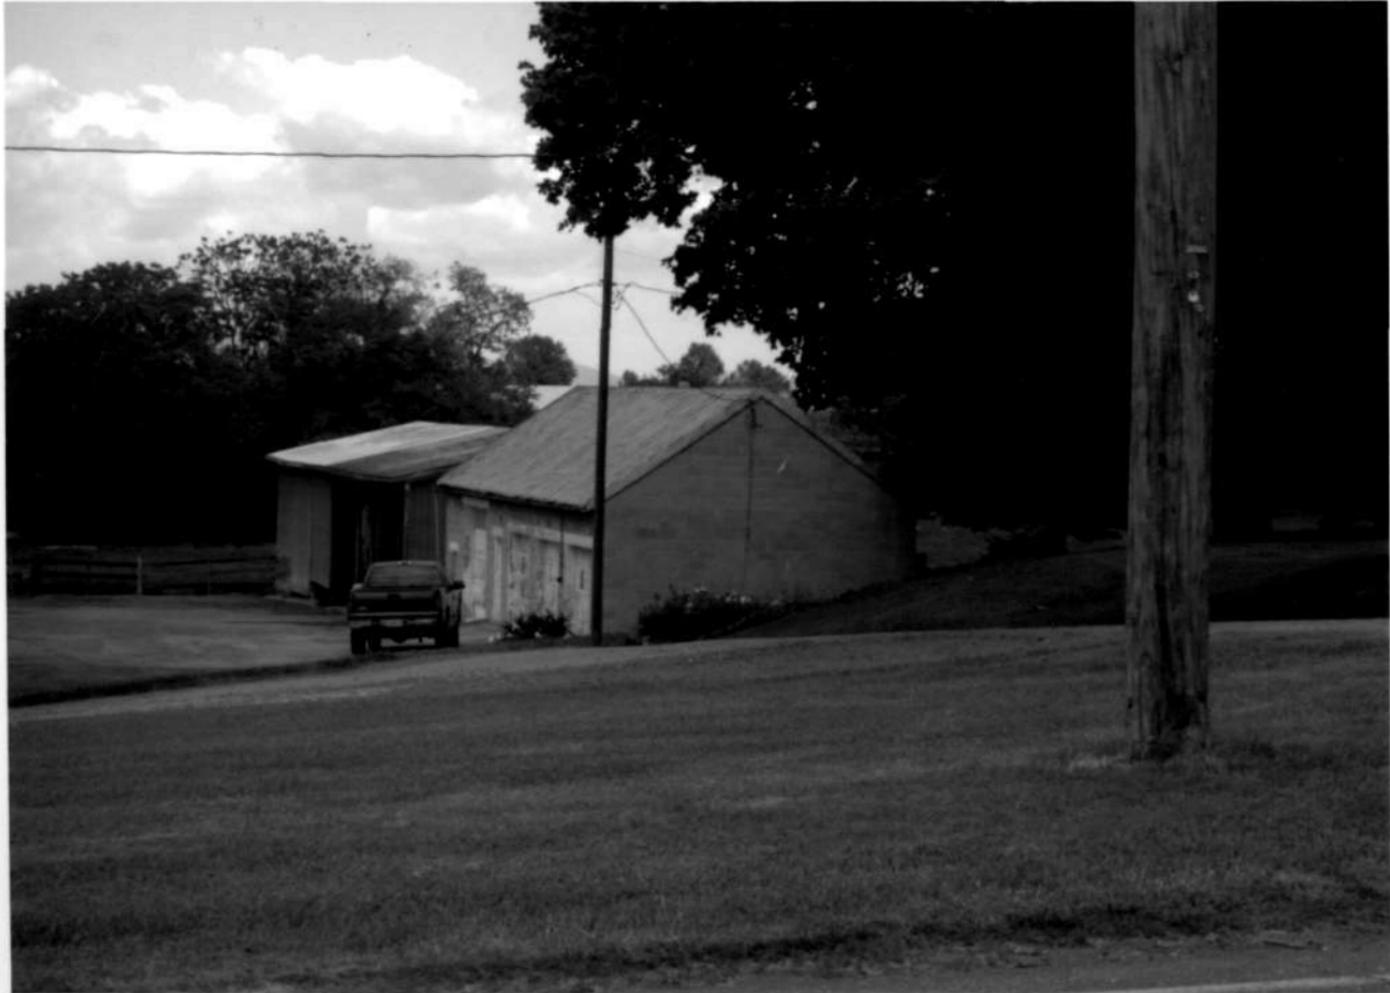
Photo #7 of 12

A one-story, side-gable, concrete-block garage is located northwest of the dwelling. The roof is sheathed in standing seam metal and faces west. The mid-twentieth century building has four overhead garage doors of various sizes and two passage doors on the west elevation. The south elevation is blind. There was no access to the north and east elevations.

A late-twentieth century metal storage building is located north of the concrete-block garage. The side-gable building is sheathed with metal panels and faces west. Wood posts divide the building into three bays. A sliding tract door appears to be present in the north bay of the west elevation. Wood siding also appears to be present on the north end of the west elevation. The north and east elevations are not visible.

F-3-242_2008-05-13_07 - Garage and metal storage building, west elevation

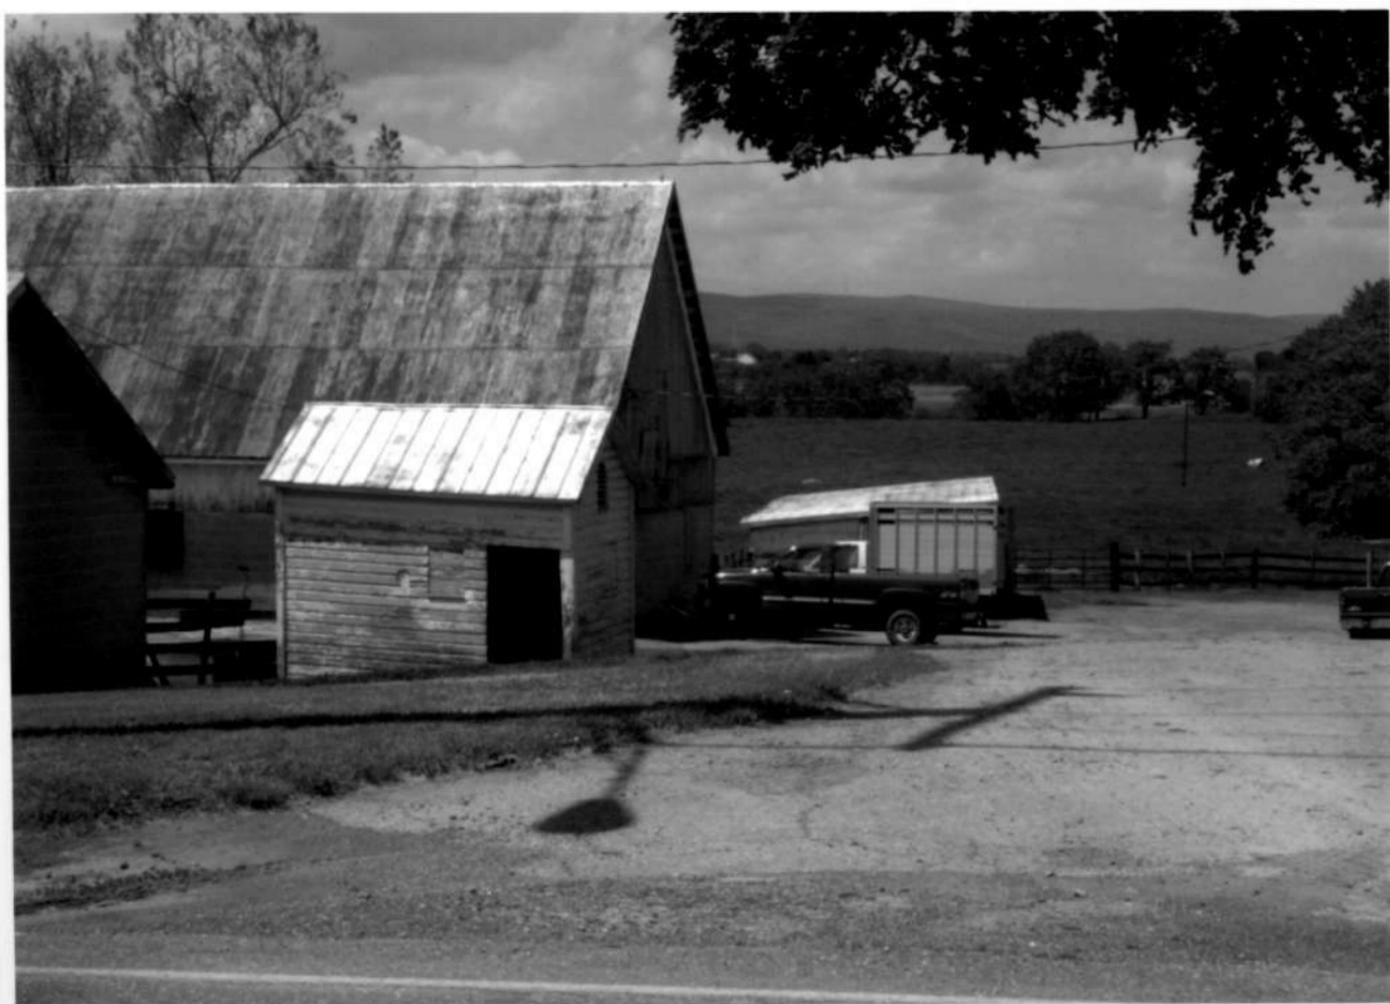
Photo # 8 of 12

A side-gable, wood-frame building is found west of the dwelling. The building faces south. Roofing materials are standing-seam metal. Openings are present on the south and east elevations. A door and a window opening are found on the south elevation. The window opening has been boarded over. An arched, louvered vent is located in the gable end of the east elevation. The east elevation also has a window opening that has been covered over. The west elevation is blind. There is no access to the north elevation.

A wood-frame storage building is west of the garage. The building faces east and terminates in a shed roof sheathed in metal. Remaining features could not be identified as only a part of the building's south elevation is visible from the public right-of-way.

F-3-242_2008-05-13_08 - Small, wood-frame storage building and wood-frame storage building, south elevation

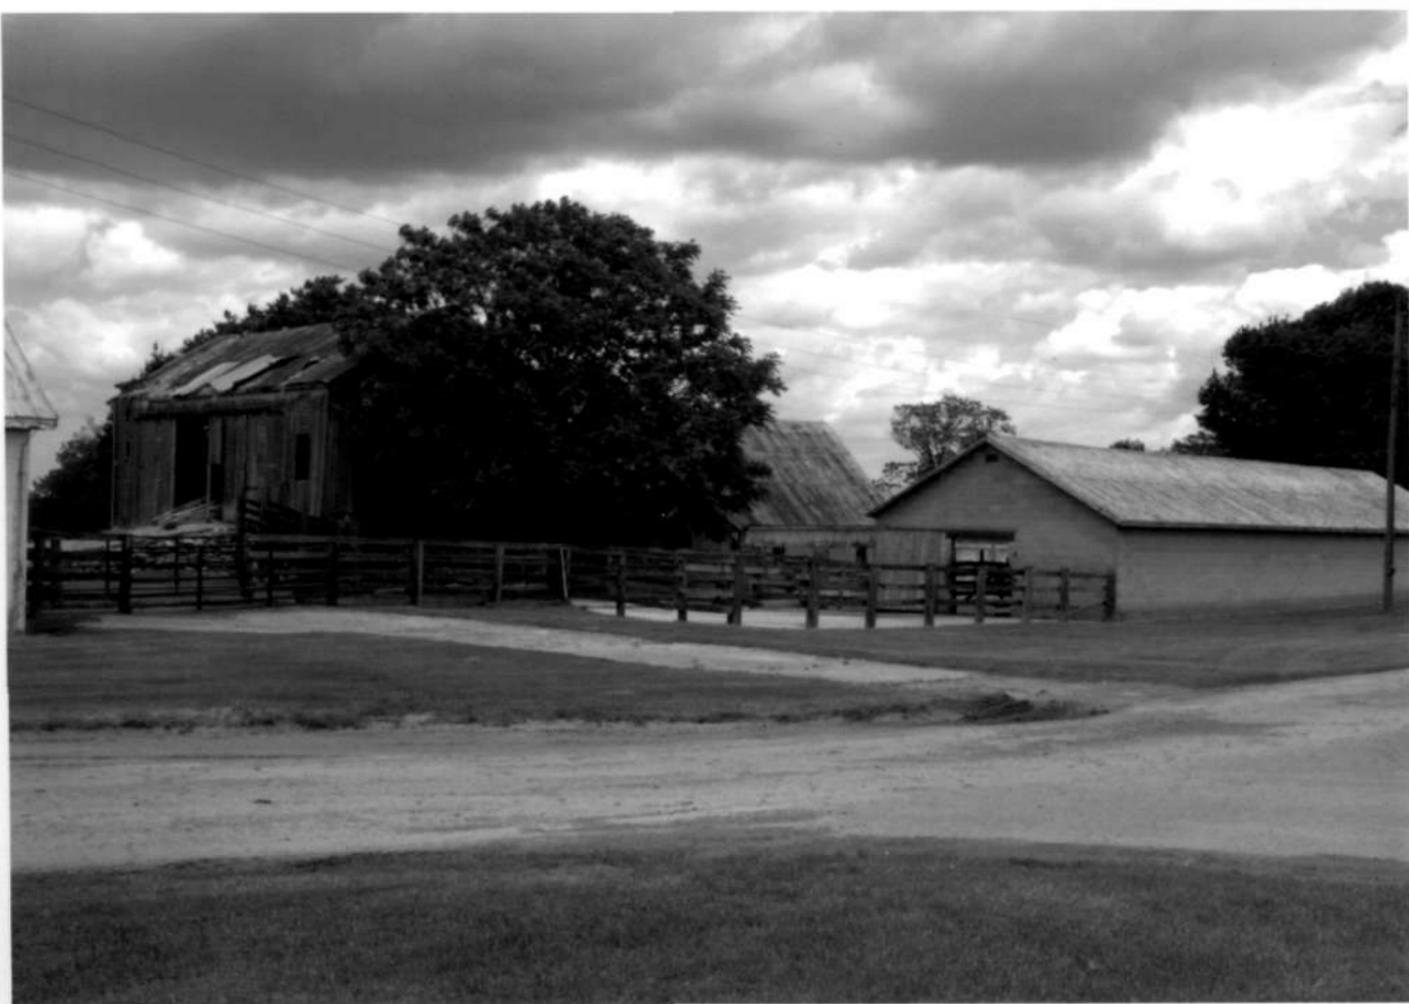
Photo # 9 of 12

A late-twentieth century concrete-block building sits west of the dwelling and close to the road. Mowed lawn is between the building and the public road. The side-gable, single-story building occupies a rectangular footprint and faces north. A sliding tract wood door defines the west elevation. The south and east elevations are blind. The north elevation is not visible.

A small concrete-block building is located south of the bank barn. The building terminates in a gable roof; roofing materials are not visible. Horizontal wood siding is found in the south elevation gable end. A door opening occupies the south elevation; the door is not visible. An opening, the type of which is not visible from the public road, also is located on the west elevation. The building appears to be connected to the bank barn on the north elevation. The east elevation is not visible from the public right-of-way.

Bank barn, small concrete-block building, and concrete-block building,
west and south elevations

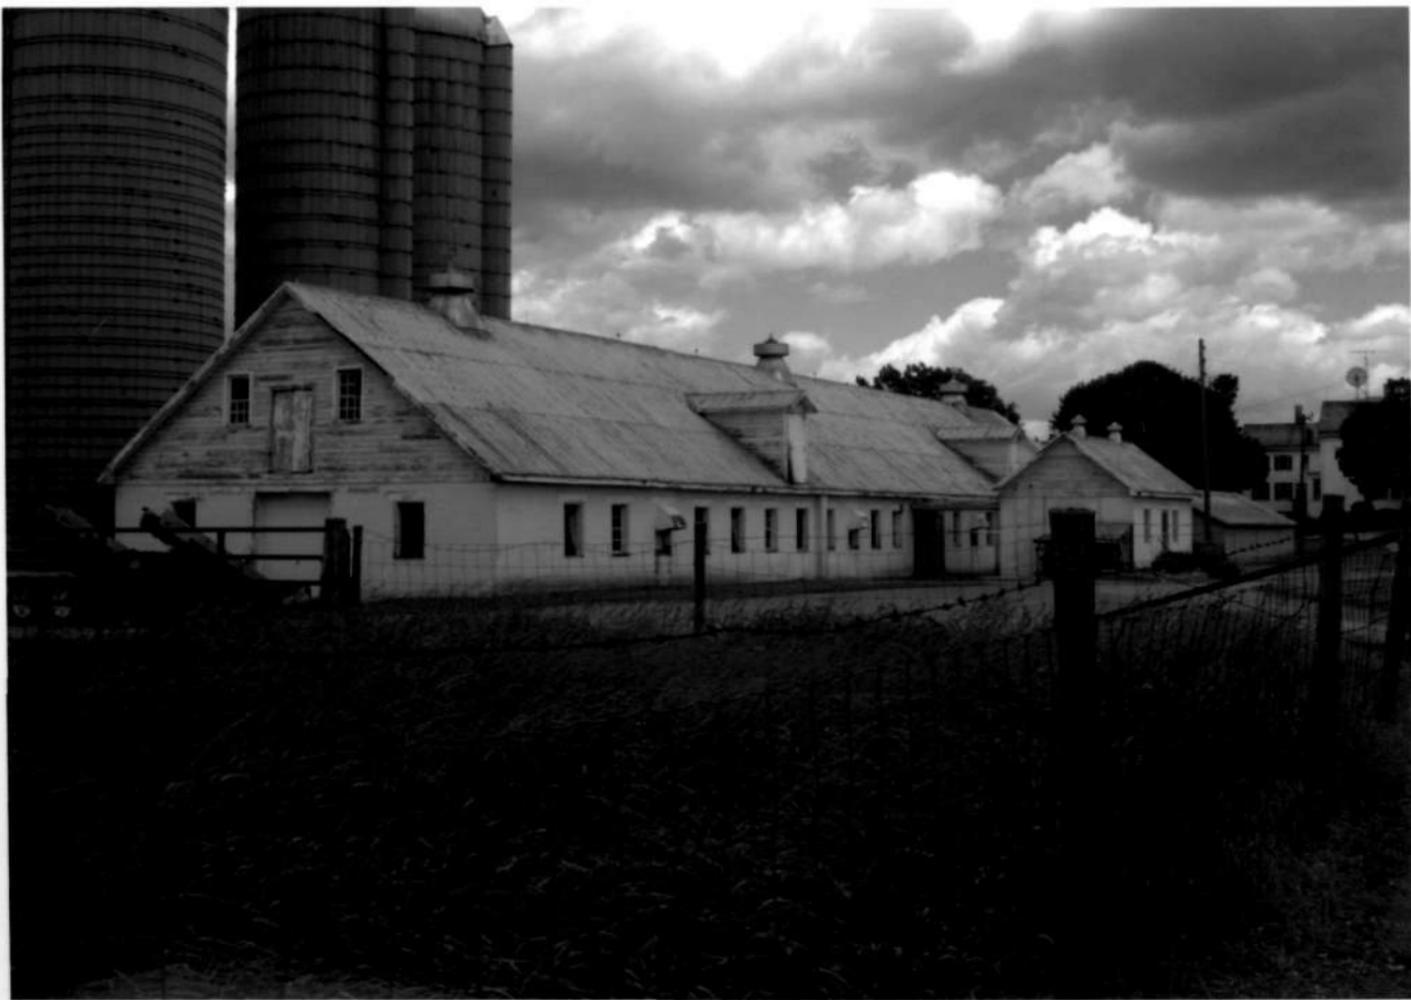
Photo # 10 of 12

A mid-twentieth century concrete-block dairy is sited parallel to Hughes Ford Road. The building terminates in a front-gable roof sheathed in standing-seam metal. Both east and west elevation gable ends are constructed of horizontal wood siding. The south elevation contains twenty-three openings consisting of twenty-two windows and one entry that connect to the dairy. Generally, windows on the south elevation are six-over-six light, double-hung, wood-sash units. The sash for some windows are no longer extant, while other openings are boarded shut. Metal hoods are located above some of the windows. Two six-over-six light, double-hung, wood-sash window units flank large rolling tract doors on the first floor of each the east and west elevations. Two six-over-six light, double-hung, wood-sash window units flank a vertical wood, hinged door in the loft of the east and west elevations. Two gable dormers pierce the roof on the south elevation. The dormers have vertical wood, hinged doors and terminate in a standing seam metal roof. Roof features include eight finials, three metal circular vents with finial cones, and three weathervanes.

A single-story, concrete block dairy is located south of the dairy barn. The mid-twentieth century building faces south and terminates in a side-gable roof sheathed in standing-seam metal. Horizontal wood siding is found in the east and west gable ends. The south elevation contains two two-over-two-light, double-hung, wood-sash windows flanking a metal door with two lights. One two-over-two-light, double-hung, wood-sash window is centered in each the east and west elevations. All of the window and door lintels are wood. Two circular metal vents finials are located at each gable end of the roof. The dairy is attached to dairy barn by a walkway located on the dairy's north elevation.

Five mid-twentieth century metal silos are located north of the milking parlor. The silos terminate in round roofs sheathed in metal. The roof of one silo is no longer extant.

F-3-242_2008-05-13_10 - Dair barn, dairy, and silos, west and south elevations
