F-3-68
Frederick Cronise Farmstead
Lewistown vicinity
Private

Frederick Cronise Farmstead

Maryland Historical Trust State Historic Sites Inventory Form

MARYLAND INVENTORY OF
HISTORIC PROPERTIES

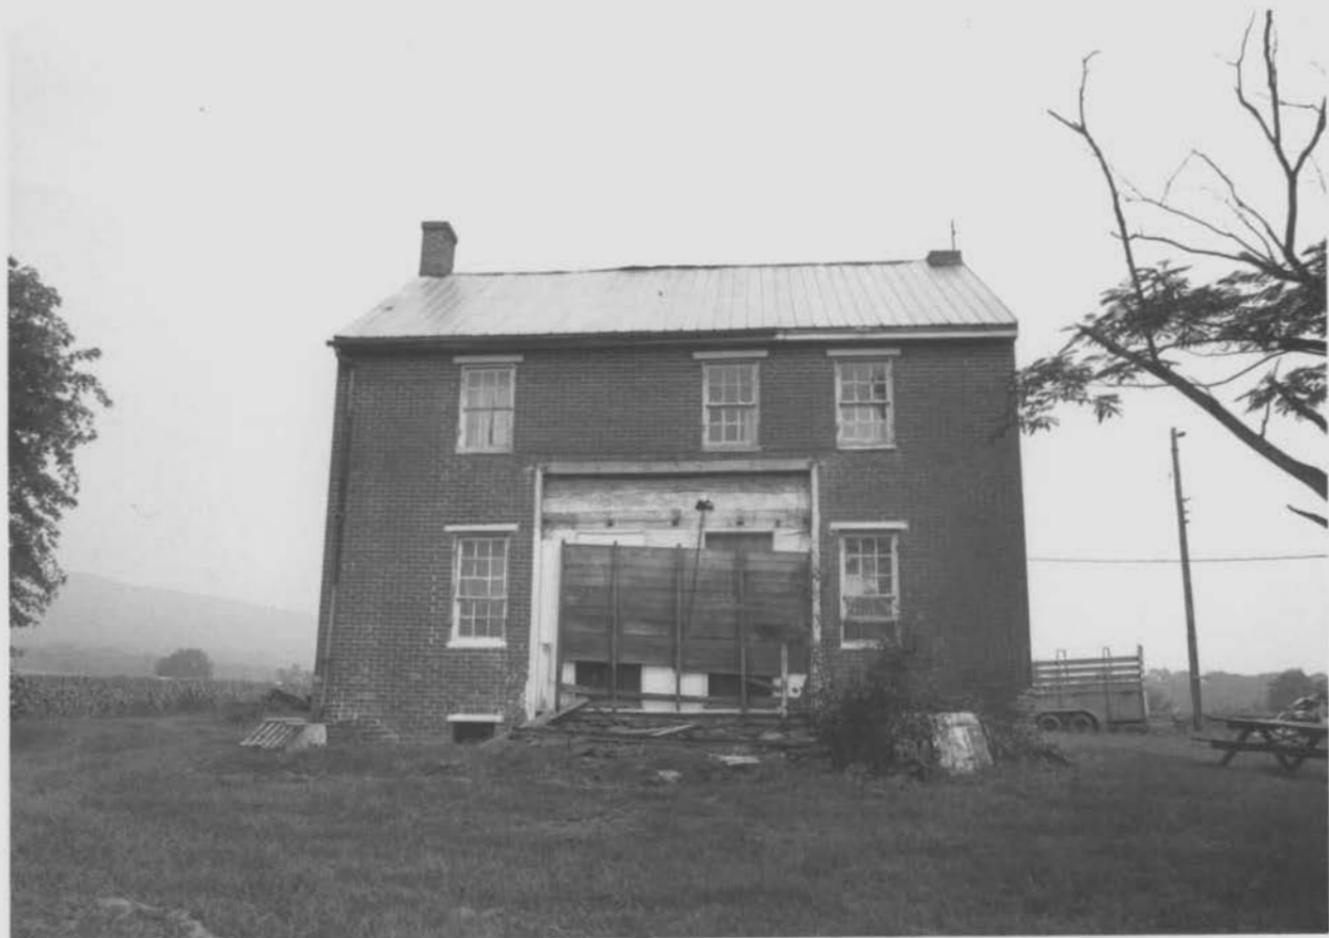
1/9

South elevation

The dwelling has two stories and an irregular bay arrangement on the south elevation. The first story has four bays and the second story has three. Double entries are located in the inner bays and the exterior covering of stretcher brick veneer is missing over the entrances, leaving the outline of an entry porch which has been removed, revealing the log structure of the house. Both entries are boarded, but a four-light transom is visible above one of the doorways. The windows are 6/6 with wood lintels and sills. The roof is covered with corrugated metal and standing seam metal on the north slope and the cornice is boxed. Interior end chimneys rise at each gable end. On the west elevation are two bays with 6/6 windows and 2/2 attic windows flanking the chimney. The east elevation has a single bay at the rear of the main section with 6/6 sash. A two-story rear wing extends from the northwest corner of the main section. It has 5:1 American bond and gauged arches, suggesting that it may have load-bearing brick walls and was added to the original log section in the second quarter of the 19th century. The wing has both 6/6 and 2/2 sash and a composition and pressed metal roof with a boxed cornice. Two chimneys are located in the wing. On the east elevation of the wing is a two-story integral porch which is enclosed on the first story and covered with german siding.

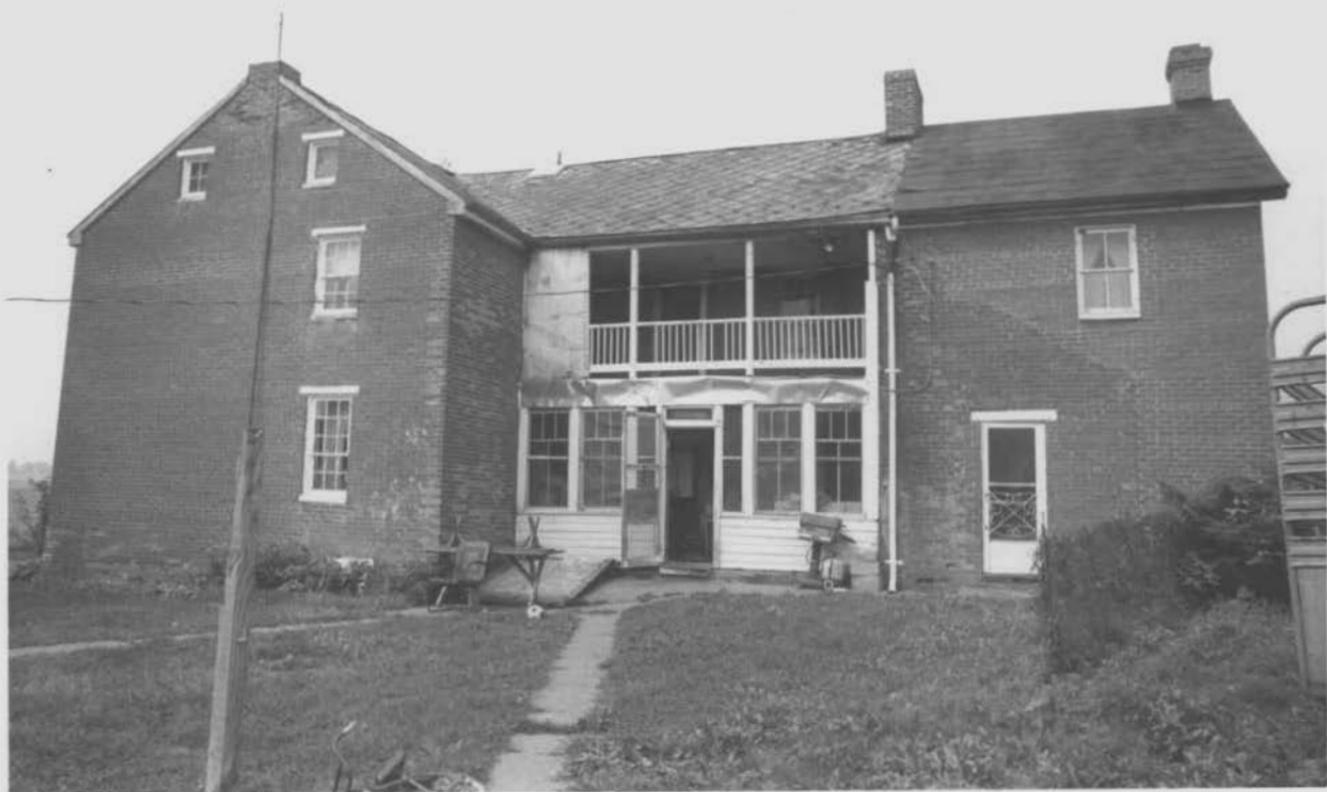
2/9

East elevation

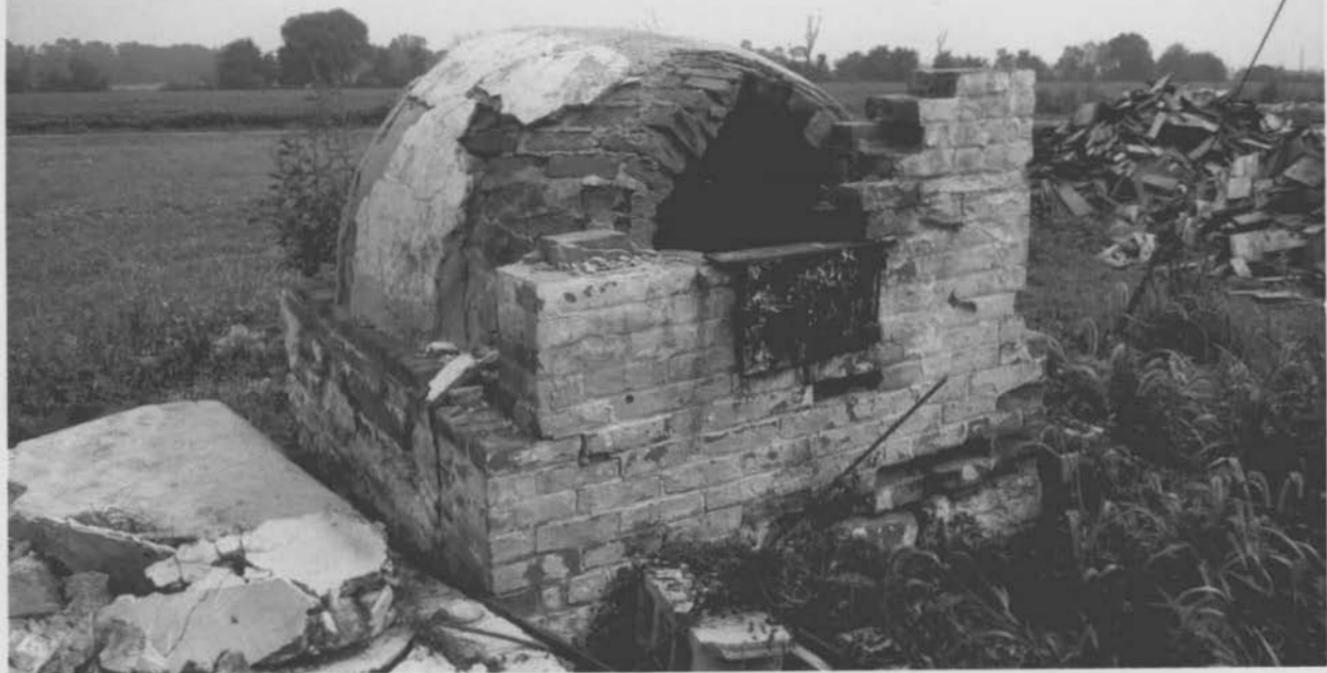
3/9

Bake oven, south elevation

Bake oven: The separate bake oven is a rare surviving feature of the farmstead, although it is in deteriorated condition. It formerly had a frame gable roof protecting the domed top, but the roof is missing and the oven top shows the effects of exposure in missing bricks and plaster. On the south elevation is an iron door. Part of the wall structure in which it is set has fallen away, exposing the interior of the oven. The north side of the oven has the firebox and flue, both of which are in poor condition. The bake oven may date from about the late 1830's to the mid-1840's and was probably built at the same time as the house.

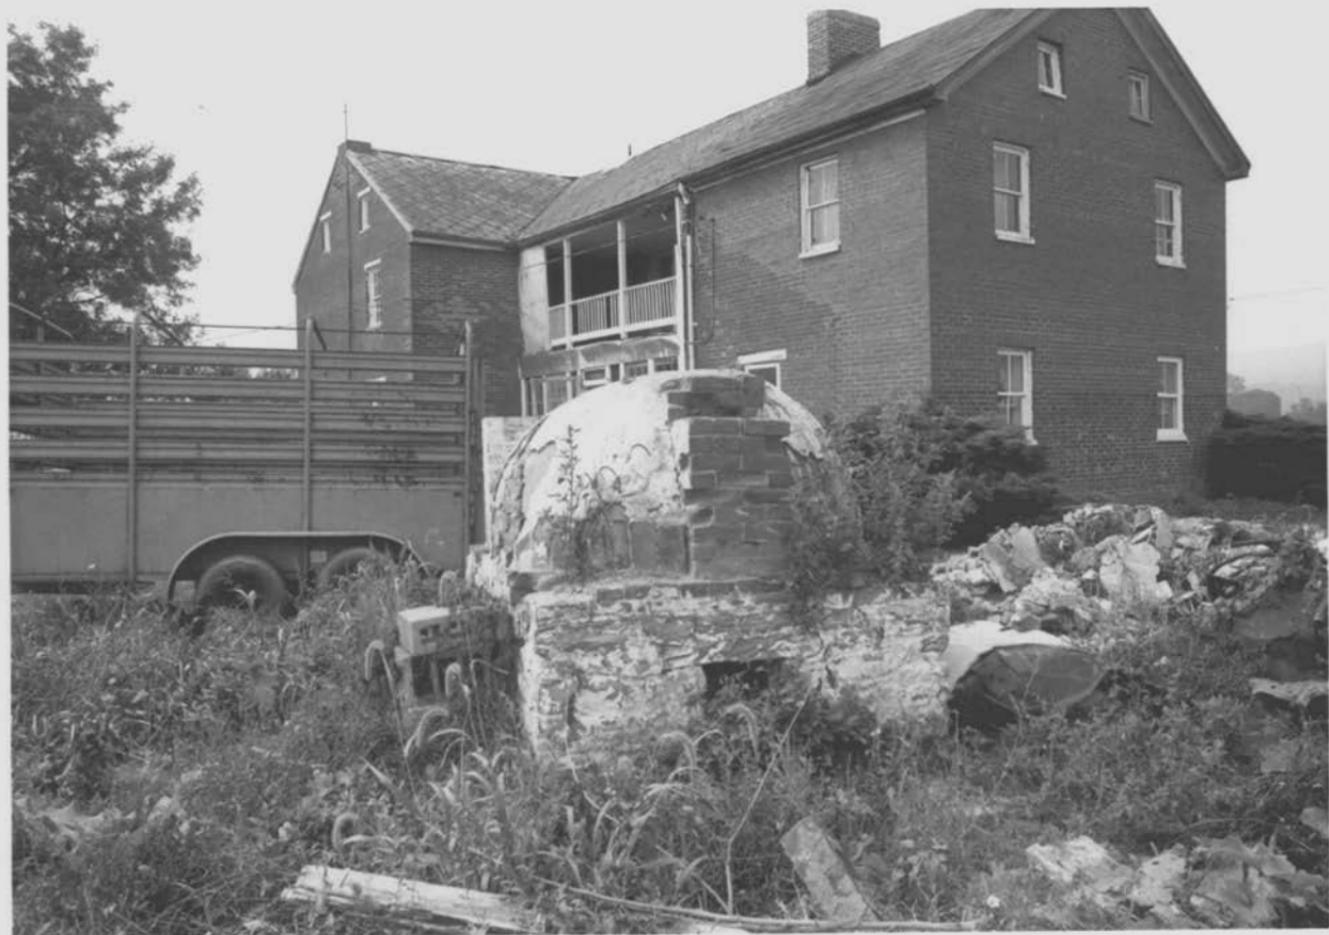
4/9

Bake oven, north elevation

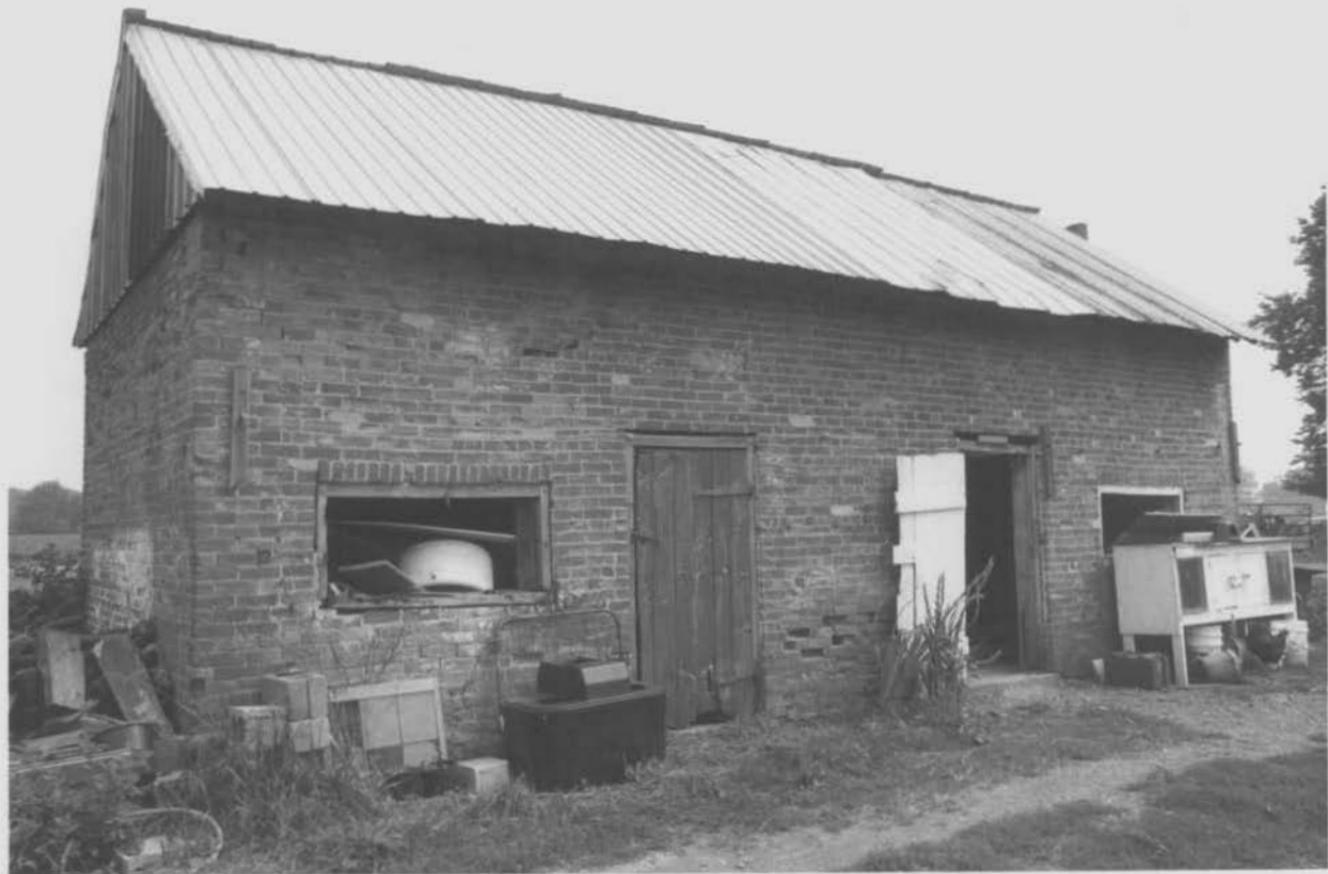
5/9

Blacksmith Shop + Summer Kitchen, south elevation

Blacksmith shop and summer kitchen: The brick combination building is located east of the bake oven. It has one story with two rooms. A loft above the east room is believed by the owner to have been slave quarters. The lower space has a large stone fireplace opening and an exterior stone and brick chimney is located on the east gable end. The west room apparently served as a blacksmith shop, with a forge enclosure still in place in the northeast corner. Both rooms are accessed through vertical board doors in the south elevation. The window openings are altered in a horizontal shape on this elevation and the north elevation has small 2/2 windows in each room. The gable ends are covered with board and batten siding and the roof is corrugated metal.

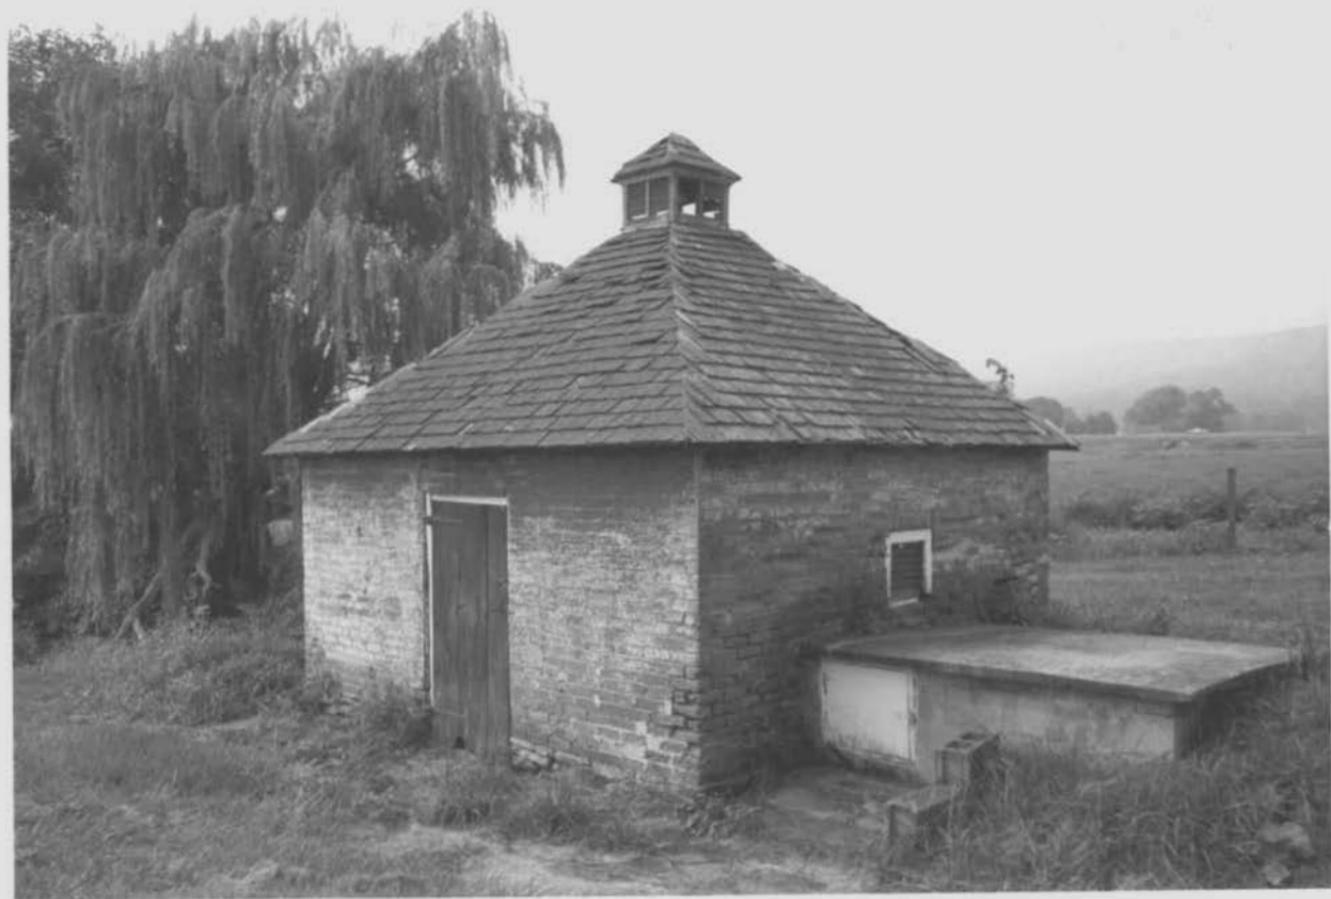
6/9

Springhouse, northeast corner view

Springhouse: The square plan brick springhouse is located south of the house, while the other domestic outbuildings are located in a line extending east from the rear wing of the house. The springhouse has 5:1 brick walls and a hipped shingle roof with a central cupola. A vertical board door is located in the east elevation, and louvred windows are in the south and north elevations. The design of the building and its materials suggest that it dates from about 1850. The spring itself is covered by a modern concrete enclosure just north of the springhouse.

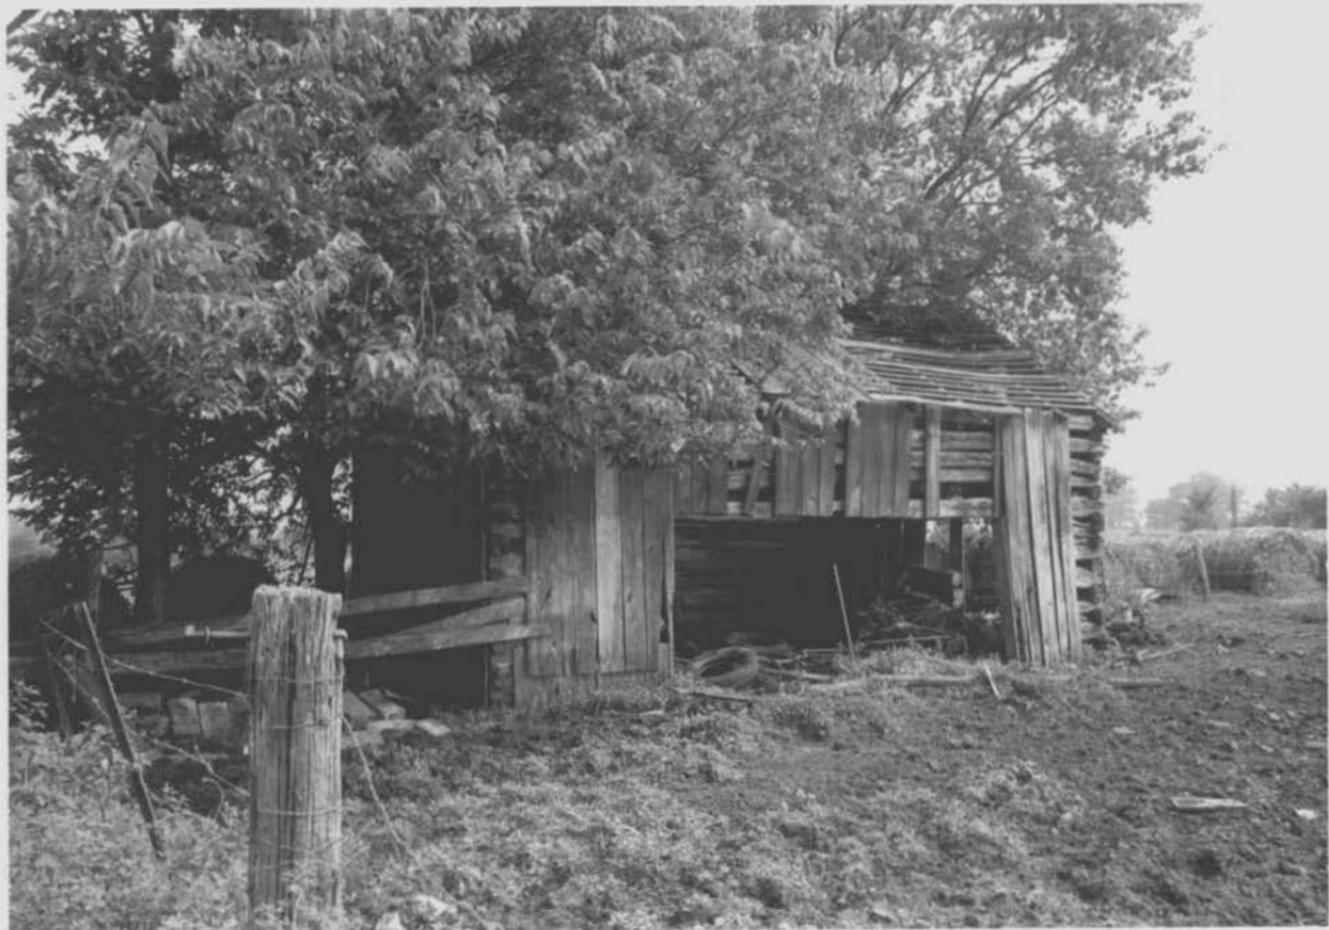
9/9

Log barn, south elevation

Log barn: The log barn is located east of the wagon shed and is not in use. The log structure is open, without chinking, and the roof is missing. Vertical siding apparently once covered the barn, but is only partly in place. A low opening on the south elevation suggests that it may have been used as a hog barn. Its date is probably about 1840-50.
