Devilbiss-Whitmore Farmstead  
Lewistown vicinity  
Private

Ca. 1826-1930

F-3-71  
Devilbiss-Whitmore Farmstead  
Lewistown  
Frederick County

# Maryland Historical Trust State Historic Sites Inventory Form

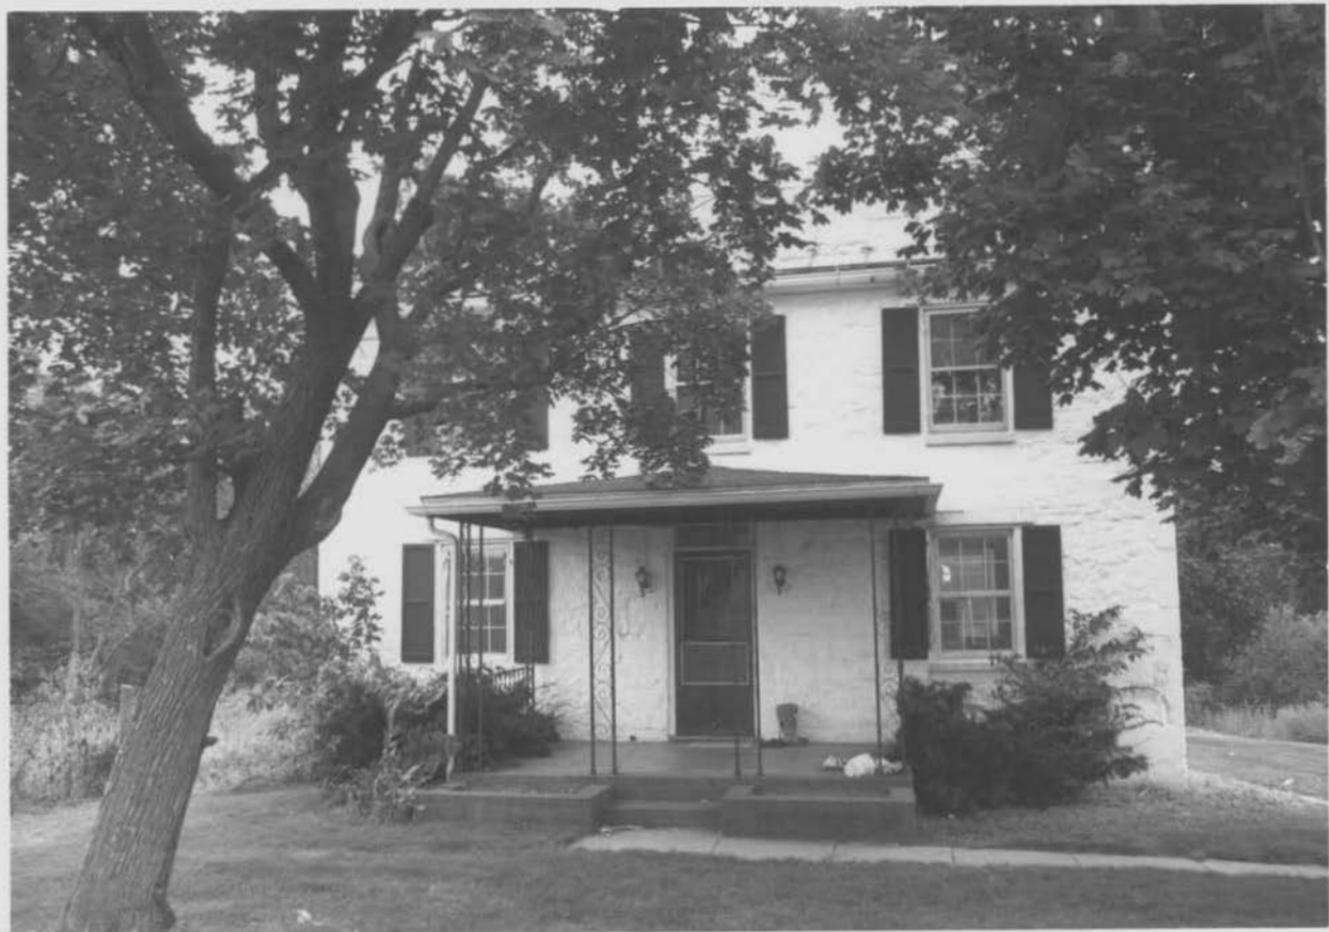
1/6

West elevation

The house has two stories and is painted white. The west elevation has three bays and shows evidence in the surface texture of the stone underlying the paint of a one-story porch which was removed. The present porch is a modern entry type, with a flagstone deck and cast iron columns. The entrance is in the center bay and has a replacement door with a glazed upper panel and an exterior storm door below a three-light transom. The windows are 6/6 with replacement metal shutters. The window heads have plain wood lintels and corner blocks and rebuilt brick sills. The roof is standing seam metal and interior end chimneys rise at the north and south gable ends. The north elevation has two bays with 6/6 sash and the south elevation has only two attic windows, one a louvred vent and the other 2/2. A two-story rear wing extends from the northeast corner of the main section. It has a corbeled brick cornice and a modern addition on the south side, undoubtedly replacing an open two-level porch. The addition has an exterior concrete block chimney on the east end. The interior of the house was inaccessible for this survey; however, views through the front door reveal that considerable changes in plan and wall surfaces have taken place, apparently in the early to mid-20th century.

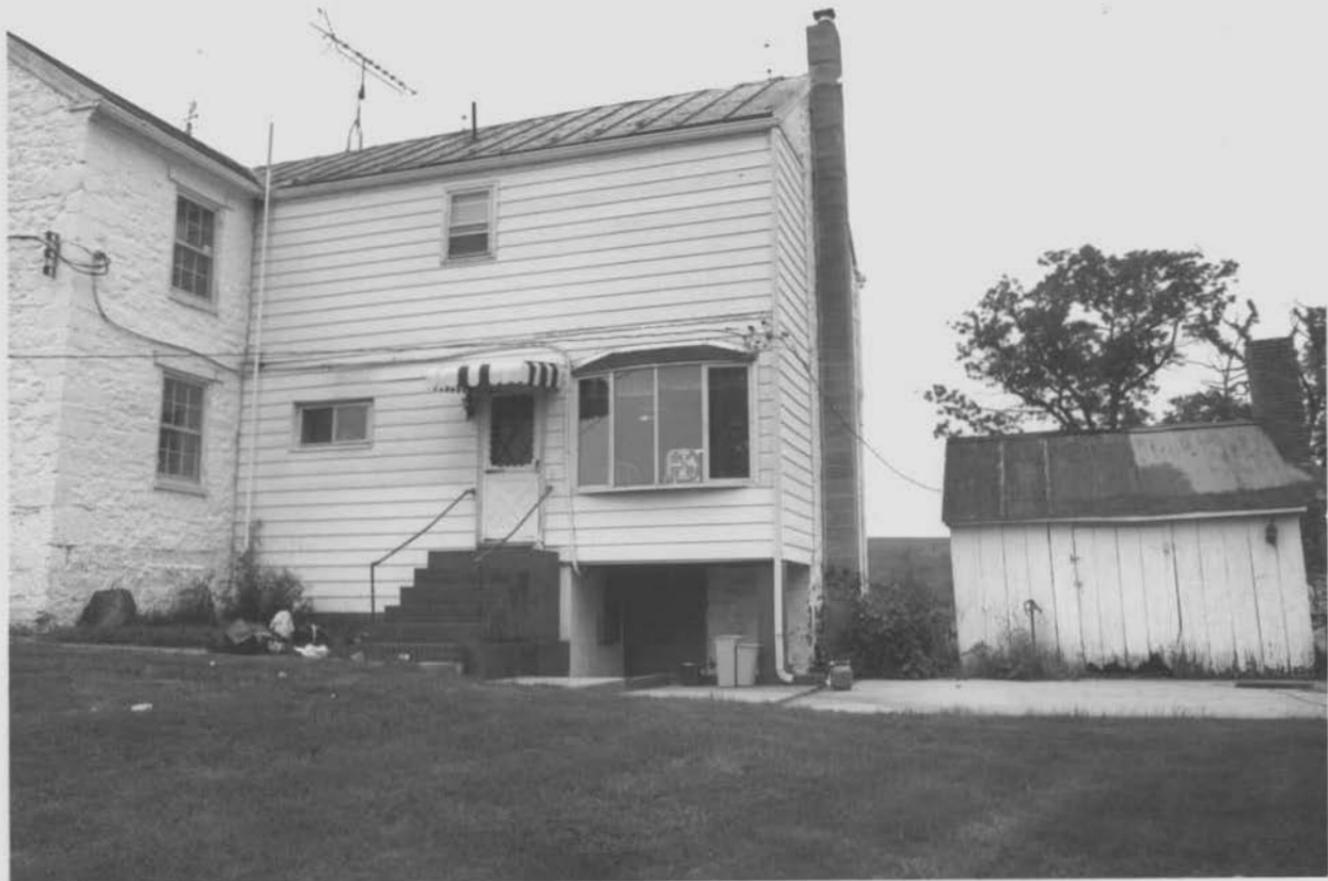
2/6

Rear wing and summer kitchen, view from south-  
east

Summer kitchen: The summer kitchen is a one-story rectangular structure located immediately east of the rear wing of the dwelling. It is covered with white-painted vertical siding of wide flush boards and may have log structure under the siding. A vertical board door is located in the south elevation and an exterior brick and stone chimney is located at the east gable end. The roof is covered with corrugated metal. The building was possibly built about the same period as the house, as similar structures are common on farmsteads of the first and second quarters of the 19th century, and frequently on later farmsteads.

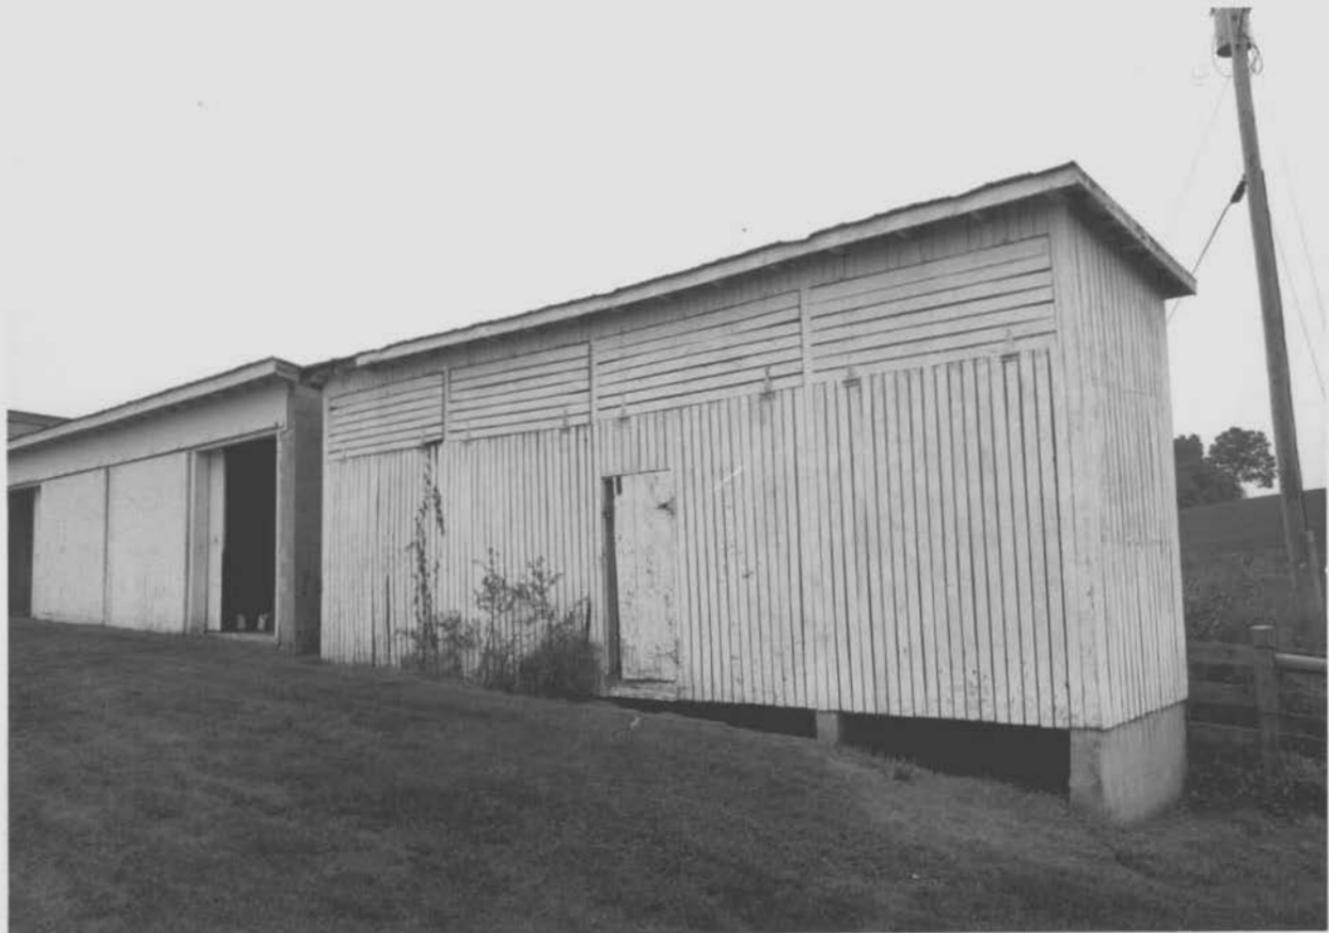
3/6

Neg. loc.: Md. SHPO, Crownsville, Md  
Cotr crib, view from east

Corn crib: A frame, free-standing corn crib is located west of the house next to a non-contributing concrete block equipment shed. Built about 1900, the rectangular structure has horizontal open lath structure with three bays marked by dropped doors near the top of the crib for loading. The roof is a standing seam metal shed sloped toward the north. Although most corn cribs of the late 19th and early 20th century were part of a wagon shed, a few of the free-standing type such as this remain standing. Its location may have been shifted within the agricultural group, as the light structure renders the building type almost portable. The crib may have been moved to this location after the construction of the equipment shed, about 1945-50.

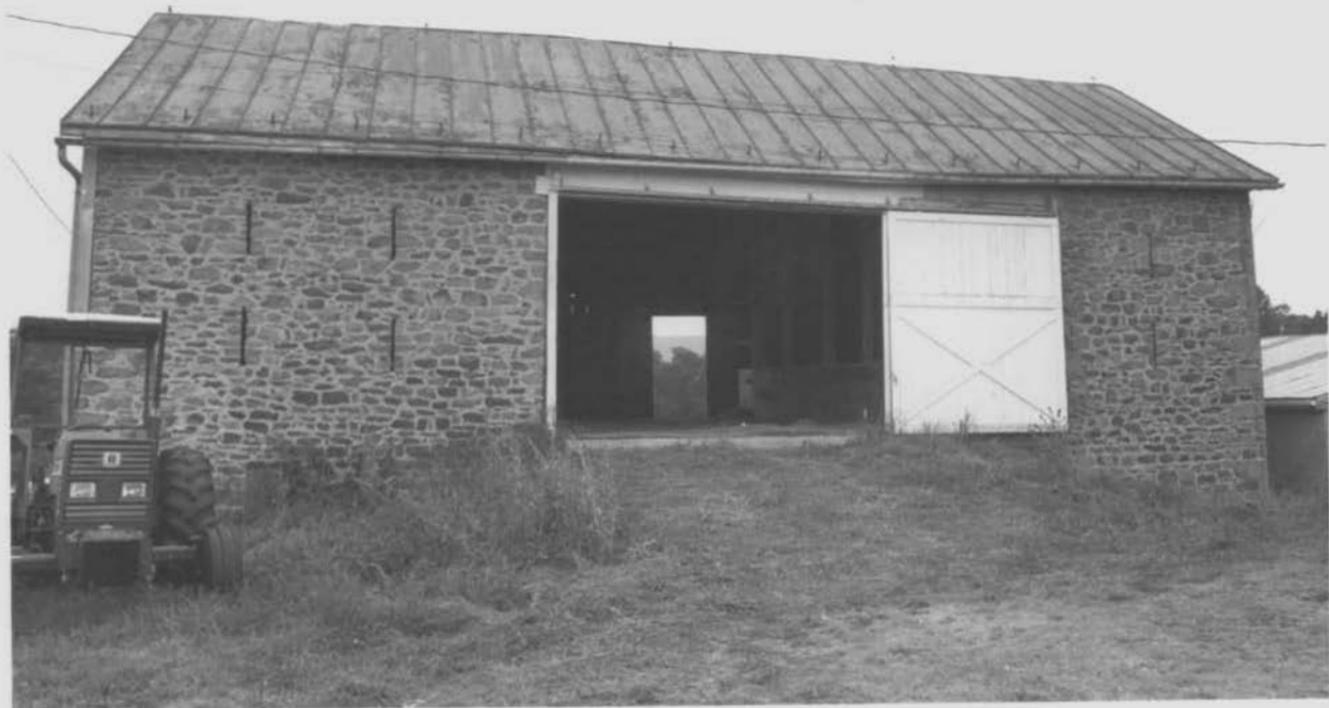
4/6

Bank barn, west elevation

where a modern concrete block wall has replaced the original stone. The forebay on the east elevation has vertical siding. The stall level is enclosed by a carefully cut stone wall, rather than the more random rubble walls of other barns of the 19th century which have stone enclosures of the stalls. The aisle openings have been widened during the early 20th century and later, and infilled with concrete block and brick at the new jambs. At the north end of the stall level is an arched entry. The north elevation of the barn has a metal covering over the gable section of the wall. The west elevation has narrow vertical vent openings in the wall and sliding doors over the entrance at the top of the ramp. The interior framing appears to date from about 1890. The roof is both standing seam and corrugated metal. Modern non-contributing loafing sheds in concrete block extend eastward from the north and south ends of the barn, and are connected by roofed open sheds.

Stone barn: The stone bank barn is located southwest of the house and appears to have been built originally about the same period as the house, but has had considerable rebuilding, especially in the interior framing and the south gable end,

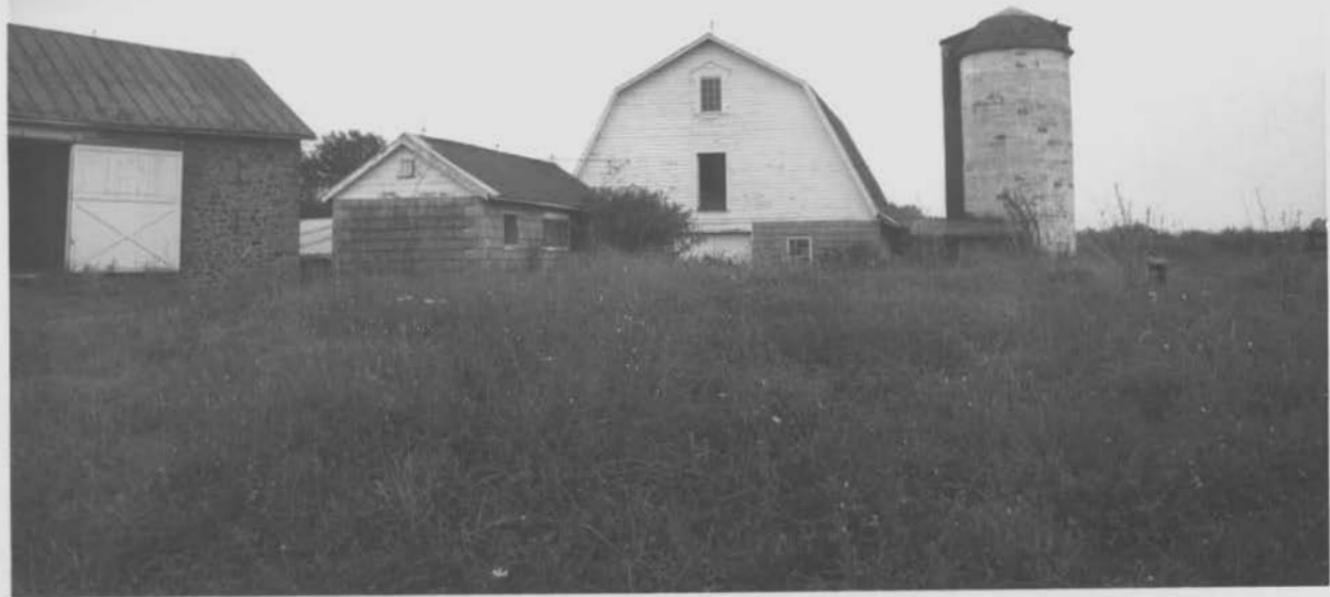
Dairy barn and milk house, north elevation  
6/6

Dairy barn and milk house: The rusticated concrete block dairy barn is located west of the stone barn. It appears to have been built about 1920-1930, during a period when many barns of the same design appeared on farms throughout the county. The upper frame structure is covered with german siding and the roof is gambrel with standing seam covering. The concrete block has corner quoins. The gable window in the north elevation has scroll-sawn decorative trim. The milk house was built at the same time just north of the barn. It has similar materials as the barn, but with a gable roof. The sash in both buildings is metal industrial sash. A non-contributing concrete block silo is located west of the dairy barn.
