F-3-75
Pittinger-HitesheW Farmstead
Lewistown
Frederick County

Maryland Historical Trust State Historic Sites Inventory Form

The Pittinger-Hiteshew Farmstead is an agricultural complex centered on a circa 1840 brick two-story dwelling with a two-story side wing which has been altered in the mid-20th century, with associated agricultural outbuildings including a frame and stone bank barn of about 1850, a 1916 frame wagon shed/corn crib, dated on the structure, a circa 1890-1900 frame butchering shed with an exterior stone and brick chimney, a frame garage of about 1890-1900, and a rusticated concrete block dairy barn and matching milk house, both built about 1940. The farmstead is located on the east side of Links Bridge Road about 1-1/2 miles west of the Monocacy River near Lewistown, Frederick County, Maryland. The building dates were estimated by architectural features and land record research. The farmstead is surrounded by cultivated fields at the end of a driveway leading northeast from Links Bridge Road. The house is located southernmost in the farmstead and the outbuildings are arranged to the north of the house except the garage which is on the driveway northwest of the h

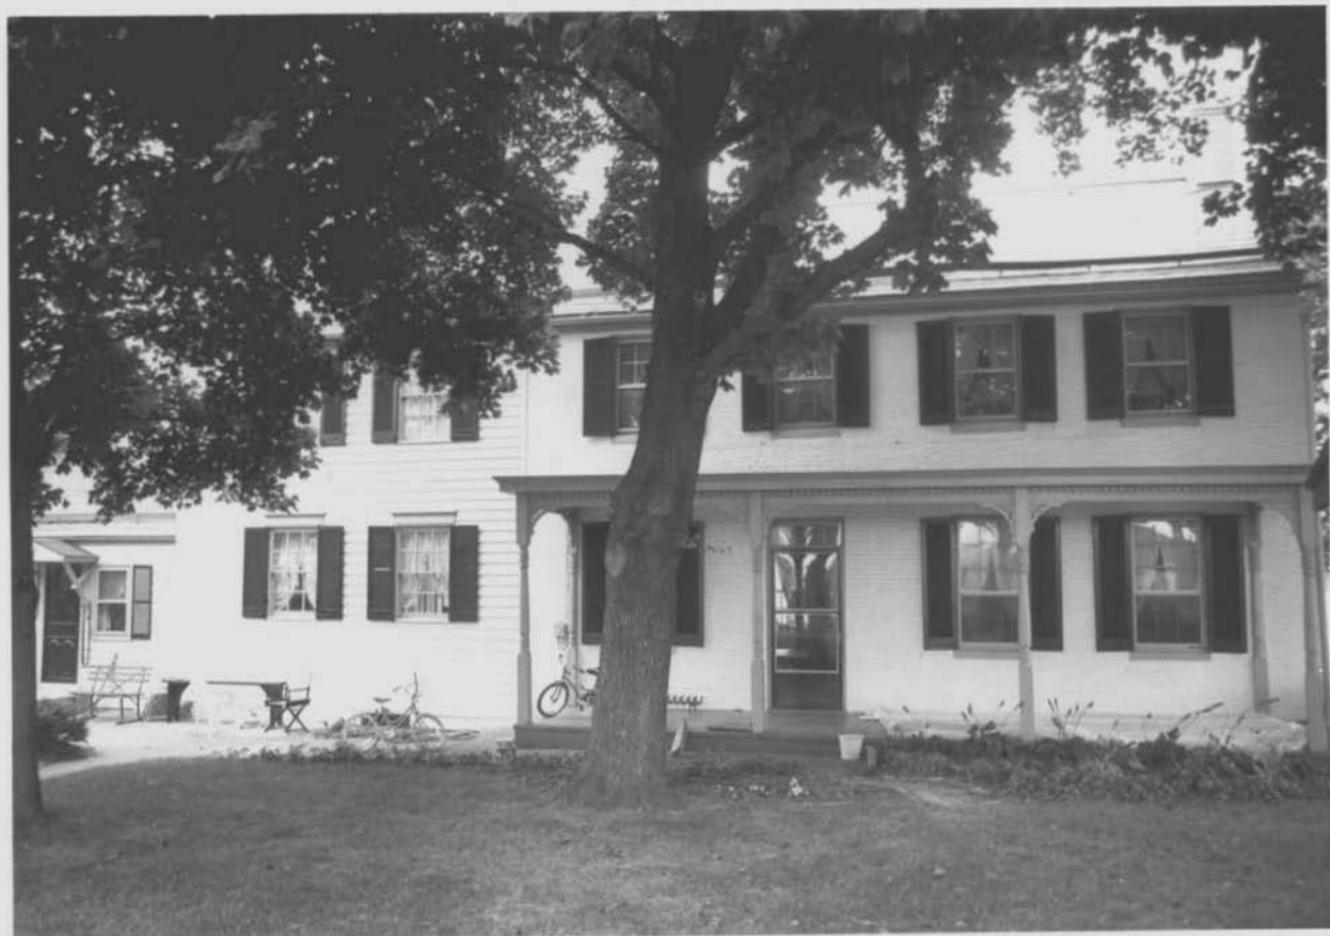
1/7

West elevation

The dwelling has a four-bay west elevation on the main section with a late 19th century one-story porch with brackets, a dentil molding, and turned columns. The flemish bond brick is painted. The cornice is corbeled and the slate roof is patterned, indicating that it may be a late 19th century replacement of an original roof. The chimneys are located at the north and south gable ends. The north chimney is enclosed by the adjoining two-story wing. The main elevation originally had double entries, but the southernmost entrance was converted to a window, possibly in the early 20th century. The remaining doorway has a paneled door. The windows are 9/6 on the first story and 6/6 on the second story, with working louvred shutters and gauged arches. The south elevation has no openings except two 2/2 attic level windows. The east elevation and the south elevation are in 5:1 American bond. On the east elevation of the side wing is a modern addition which also extends to part of the main section. The west elevation of the wing originally was built as a recessed front wall with an exterior two-level open porch in the traditional vernacular style of German houses. In the early 20th century, the upper level was enclosed and in the mid-20th century, the lower level was also enclosed to be converted to a bathroom. The present exterior wall is flush with the elevation of the main section and faced with weatherboard siding. Attached to the wing on the north is the modern kitchen in what was probably a summer kitchen which may have been free-standing or linked to the side wing of the dwelling. This section is one story in height and has a plain slate roof. The original chimney may have been located on the north gable end and was moved to the east elevation in the early 20th century. With the modern sun porch addition on the rear of this section, all interior traces of the original or later location of the chimney have been removed.

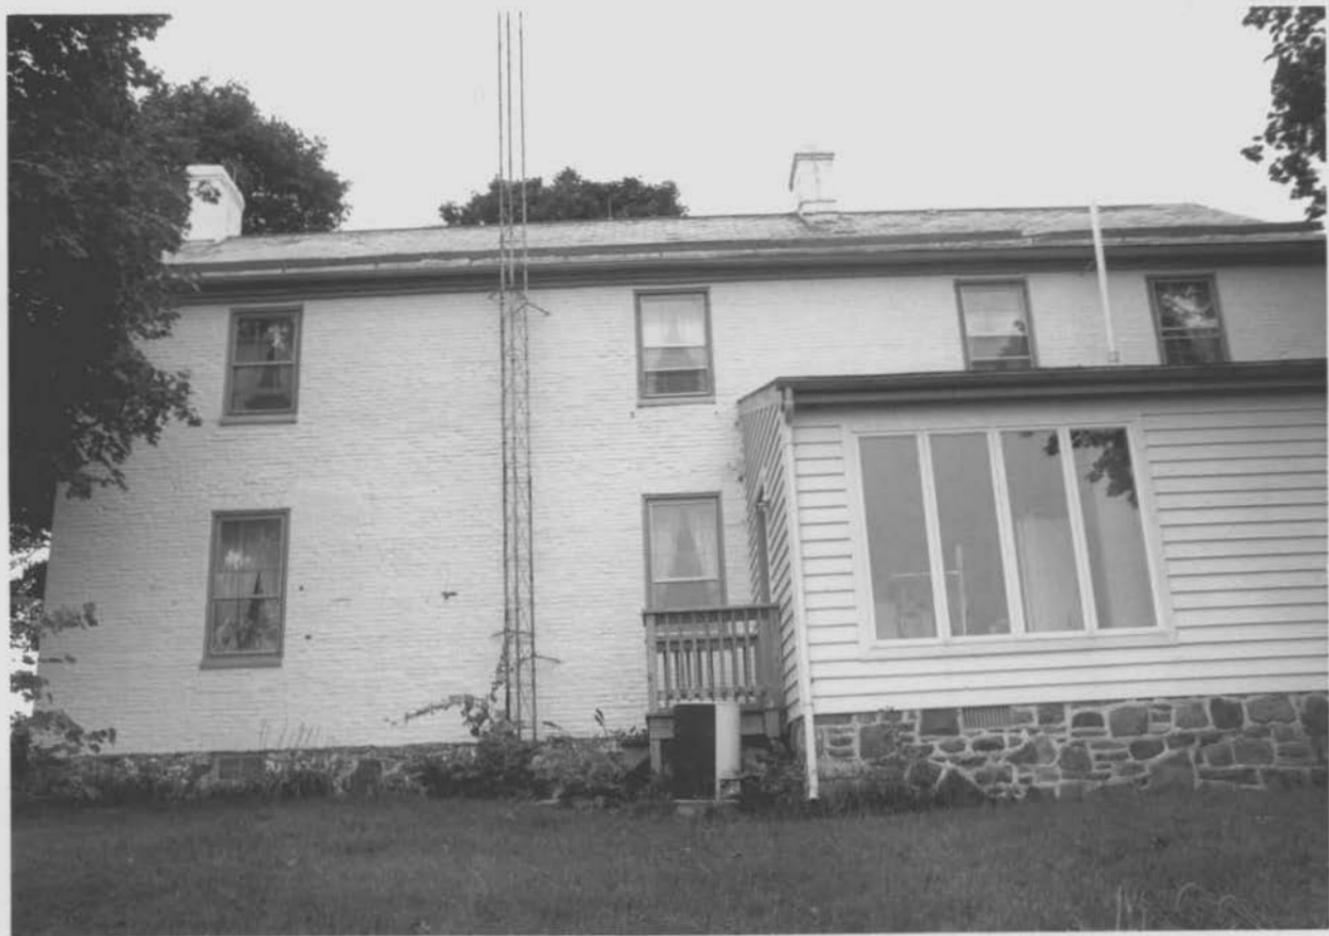
2/7

East elevation

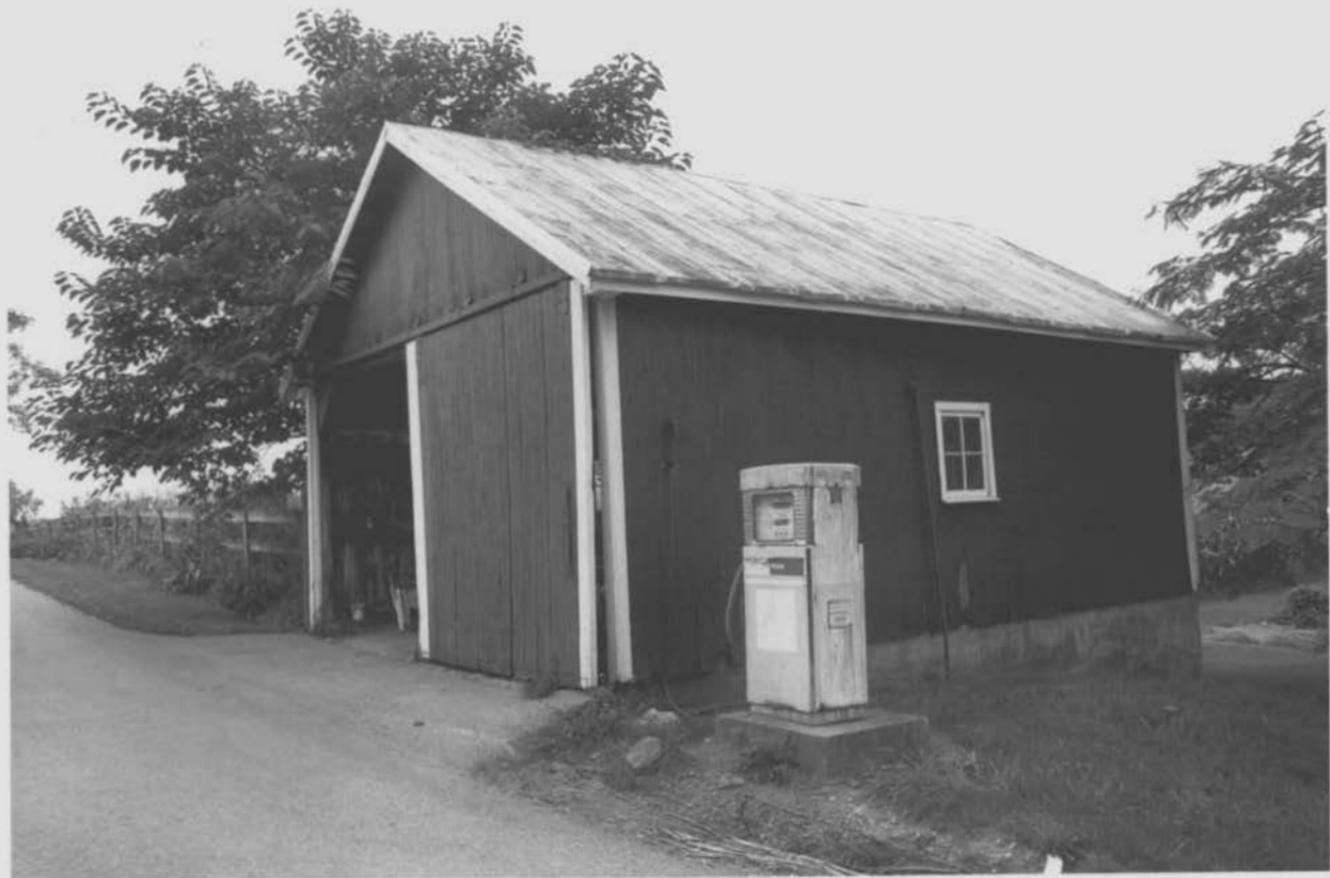
3/7

Garage, view from east

Garage: The frame garage appears to have been built about 1890-1900. It has tongue-and-groove siding and sliding doors on the south elevation. A 2/2 window is located in the east elevation and the roof is standing seam metal.

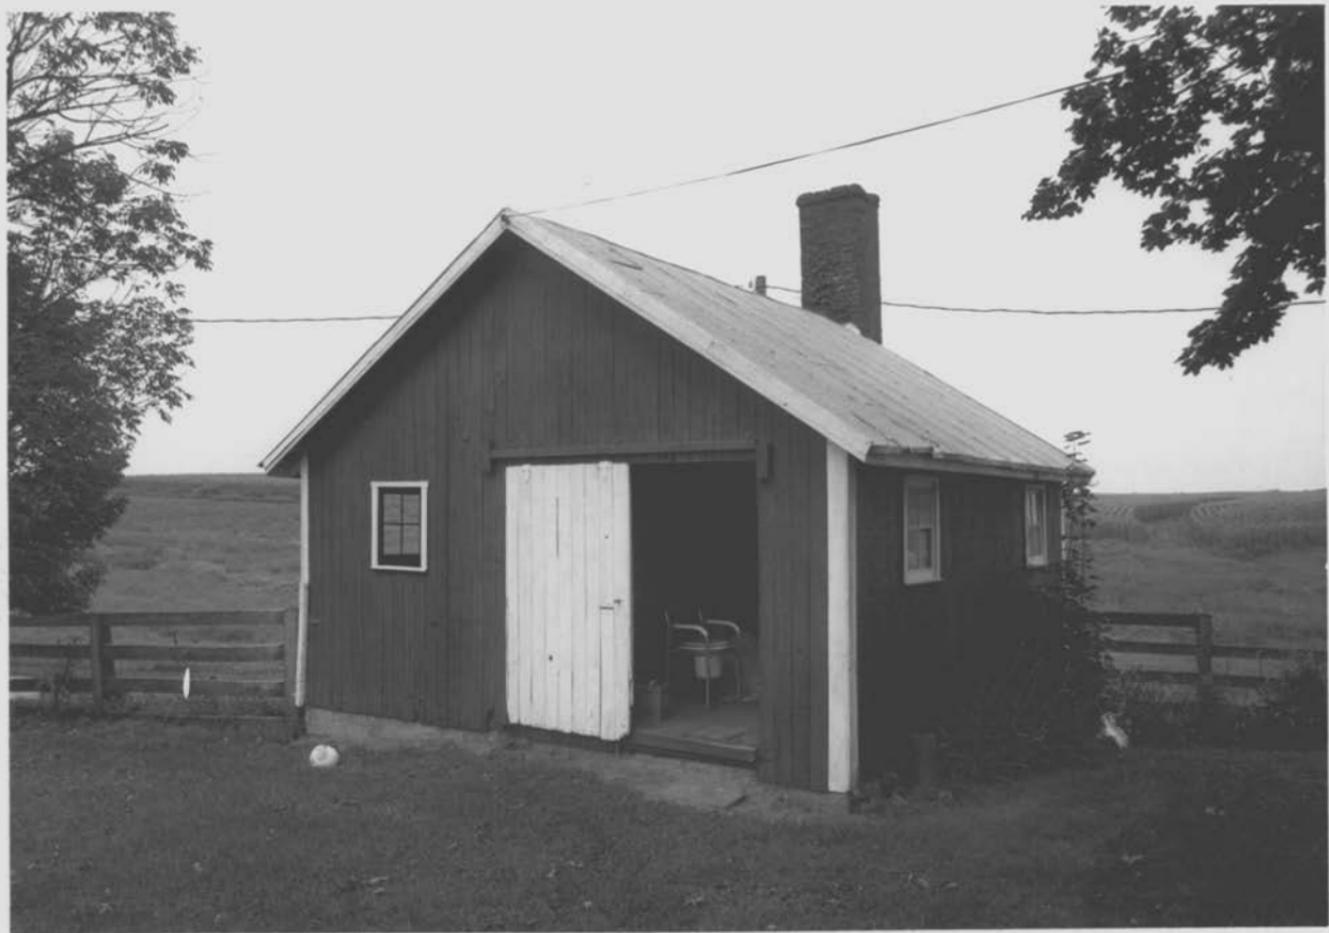
4/7

Butchering shed, west elevation

Butchering shed: The frame shed now used as a farm shop may have been built about 1890-1900 as a butchering shed. It is located just north of the house and a smokehouse, now demolished, stood between the house and the shed. The one-story frame building has tongue-and-groove siding and a standing seam roof with a stone and brick chimney located on the east gable end. A vertical board door is in the west elevation and 2/2 windows are in the north and south elevations. A trap door in the interior floor leads into a stone cellar under the building.

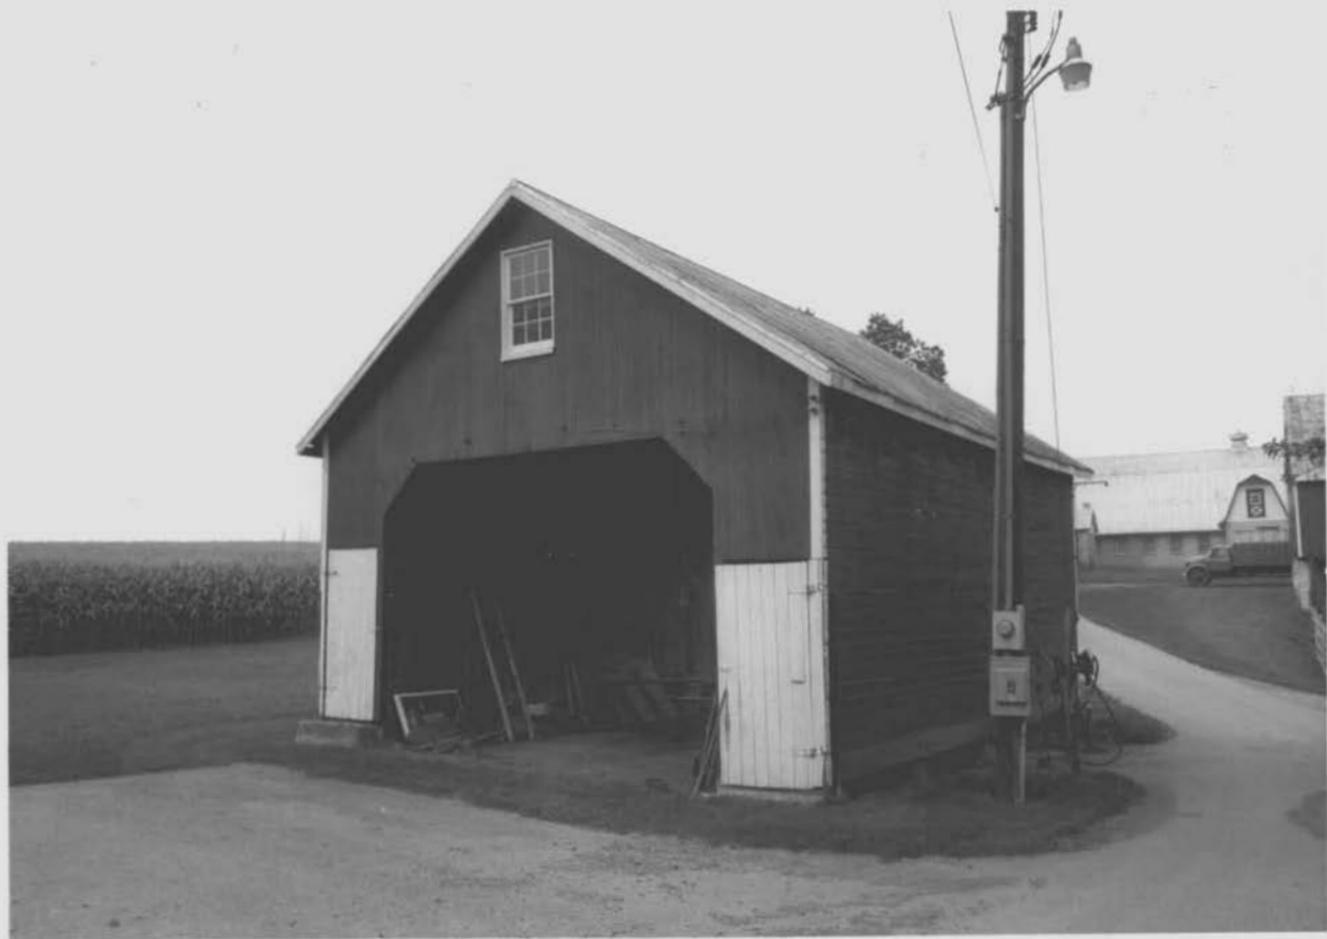
5/7

Wagon shed / corn crib, south elevation

Wagon shed/corn crib: The frame wagon shed/corn crib was built in 1916, according to an inscribed concrete support pier, which has the date May 22, 1916 and the name Everett Stull. Since John H. Whitmore was the owner of the farm at that date, Stull was probably the farm tenant at the time. In the 1940's, the Stull family acquired the farm in its own name. The wagon shed has vertical tongue-and-groove siding on the south elevation and horizontal flush boards on the east and west elevations. The roof is covered with corrugated metal. In the south gable is a 6/6 window.

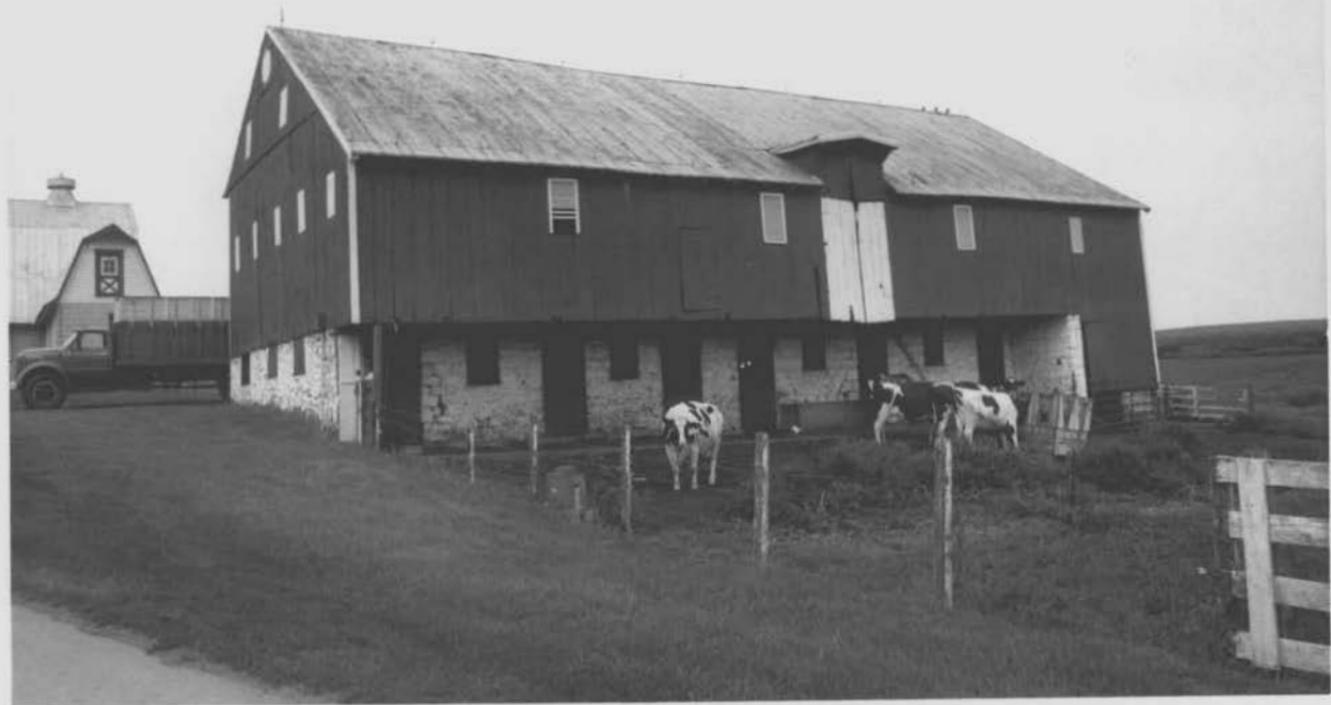
6/7

Bank barn, south elevation

Bank barn: The stone and frame bank barn was probably built about 1850 or approximately contemporary with the main dwelling. It has a stone-enclosed stall level on the south elevation with vertical board dutch doors to the stalls and feeding aisles. The upper structure has vertical siding and a projecting loading door from the loft is in the south elevation, a late 19th century addition to the structure. The east and west elevations have louvred vents. The roof of the barn is standing seam metal.

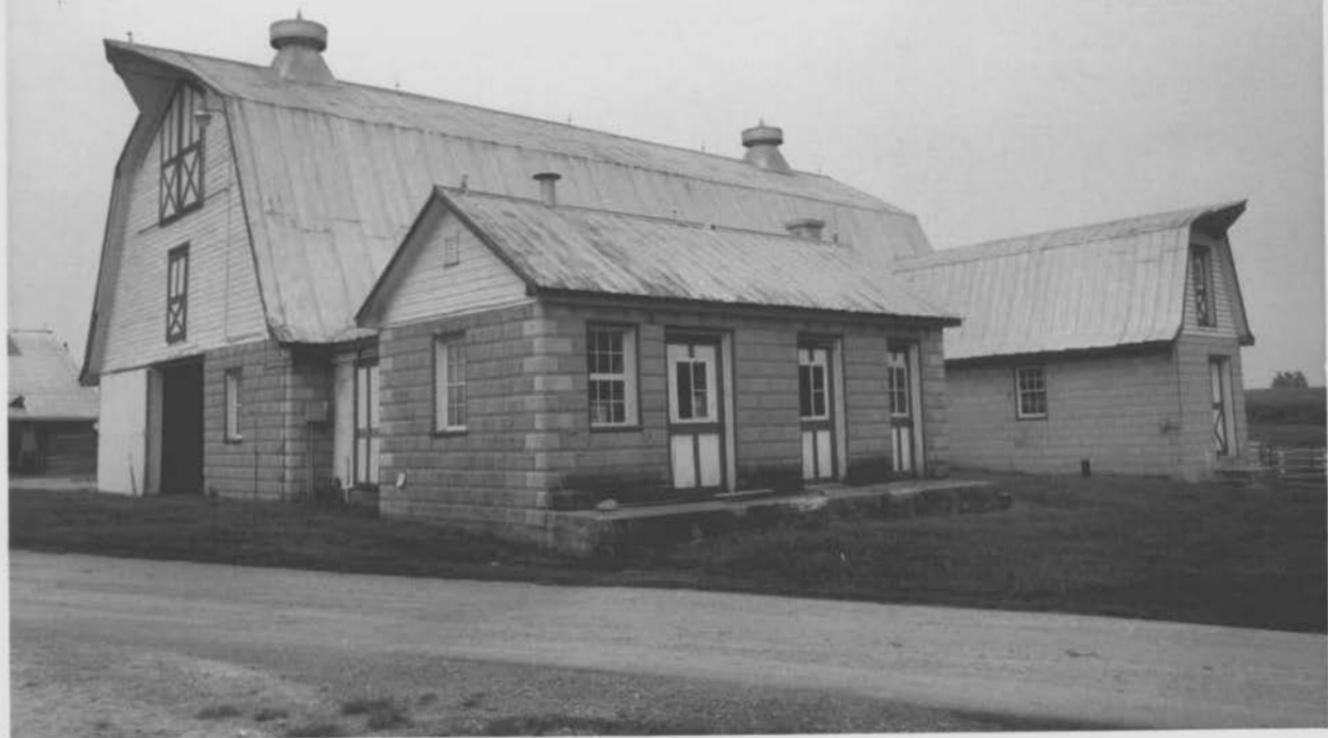
7/7

Dairy barn and milk house, southwest corner view

Dairy barn and milk house: The rusticated concrete block dairy barn and its matching milk house were built about 1940 and are the northernmost contributing structures in the farmstead. Non-contributing concrete block and metal farm buildings are located north and west of the dairy barn. Built in two sections, the rear or eastern end of the dairy barn is in plain concrete block and has a second entrance on the south elevation. This addition probably took place after 1945. The gambrel roof over both sections is standing seam metal with ventilators along the ridgeline. The rusticated concrete block section has quoins. The sash is 6/6. The small milk house located south of the dairy barn was built at the same time and has similar materials and features, except for a gable roof.
