F-3-82  
Schley-Ramsburg Farmstead  
Lewistown vicinity  
Private

# Maryland Historical Trust State Historic Sites Inventory Form

historic Schley-Ramsburg Farmstead

street & number 11614 Hessong Bridge Road  not for publicationcity, town Lewistown  vicinity of congressional district 6th

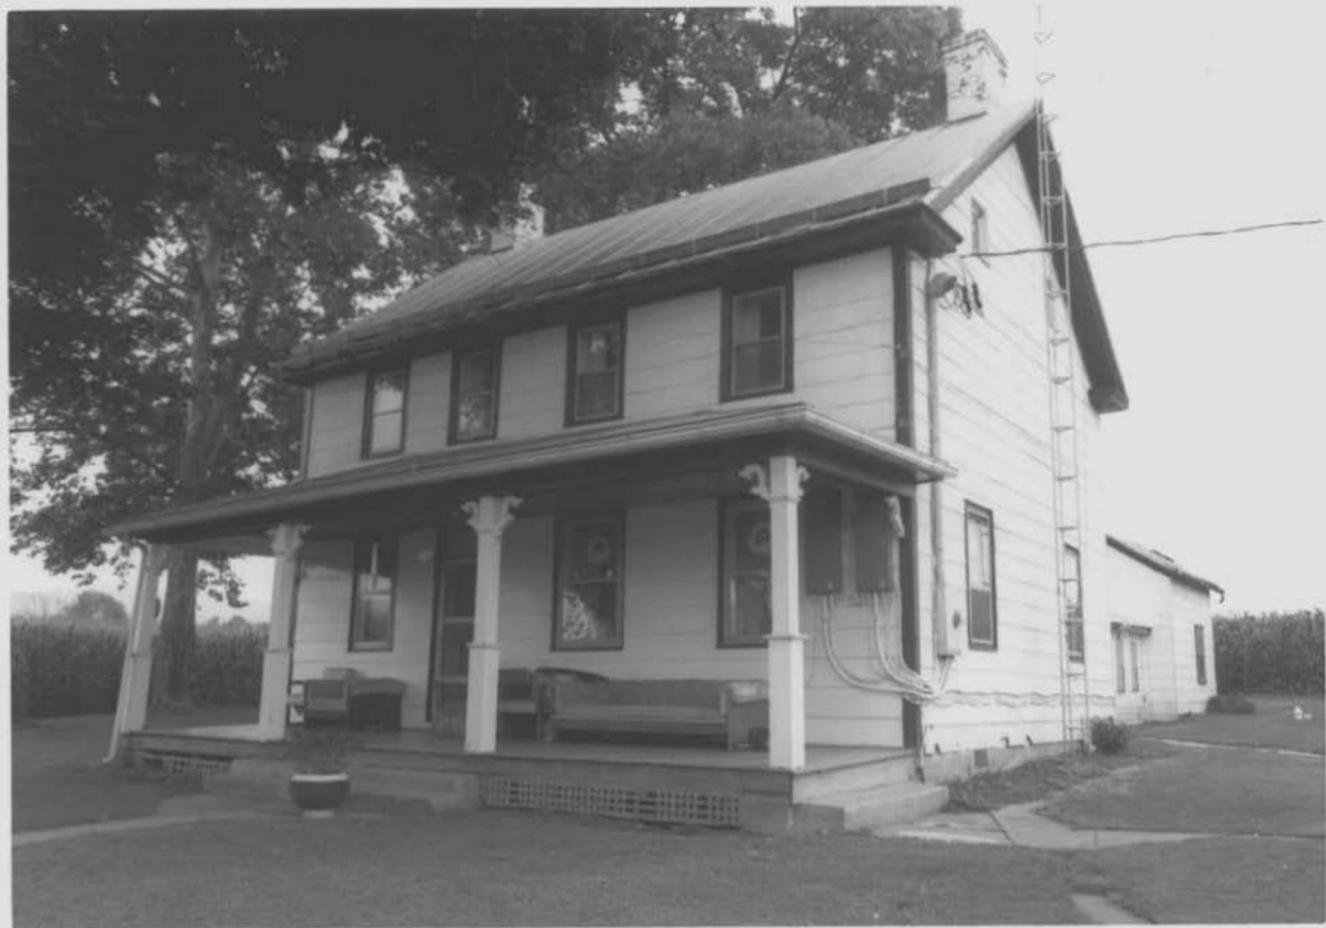
1/5

Neg. loc.: Md. SHPO. Crownsville  
Southeast corner view

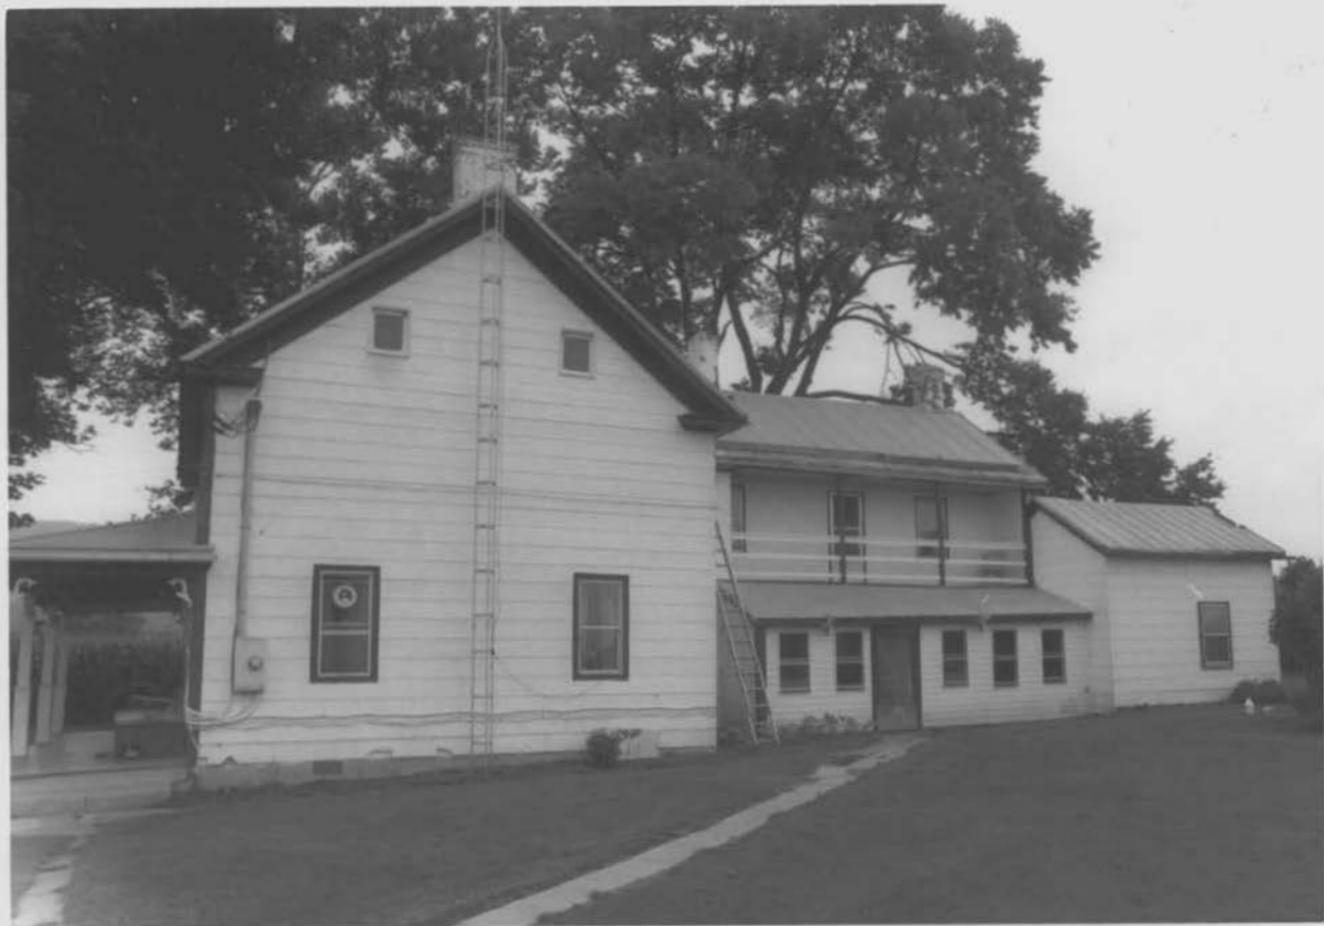
2/5

East elevation and rear wing

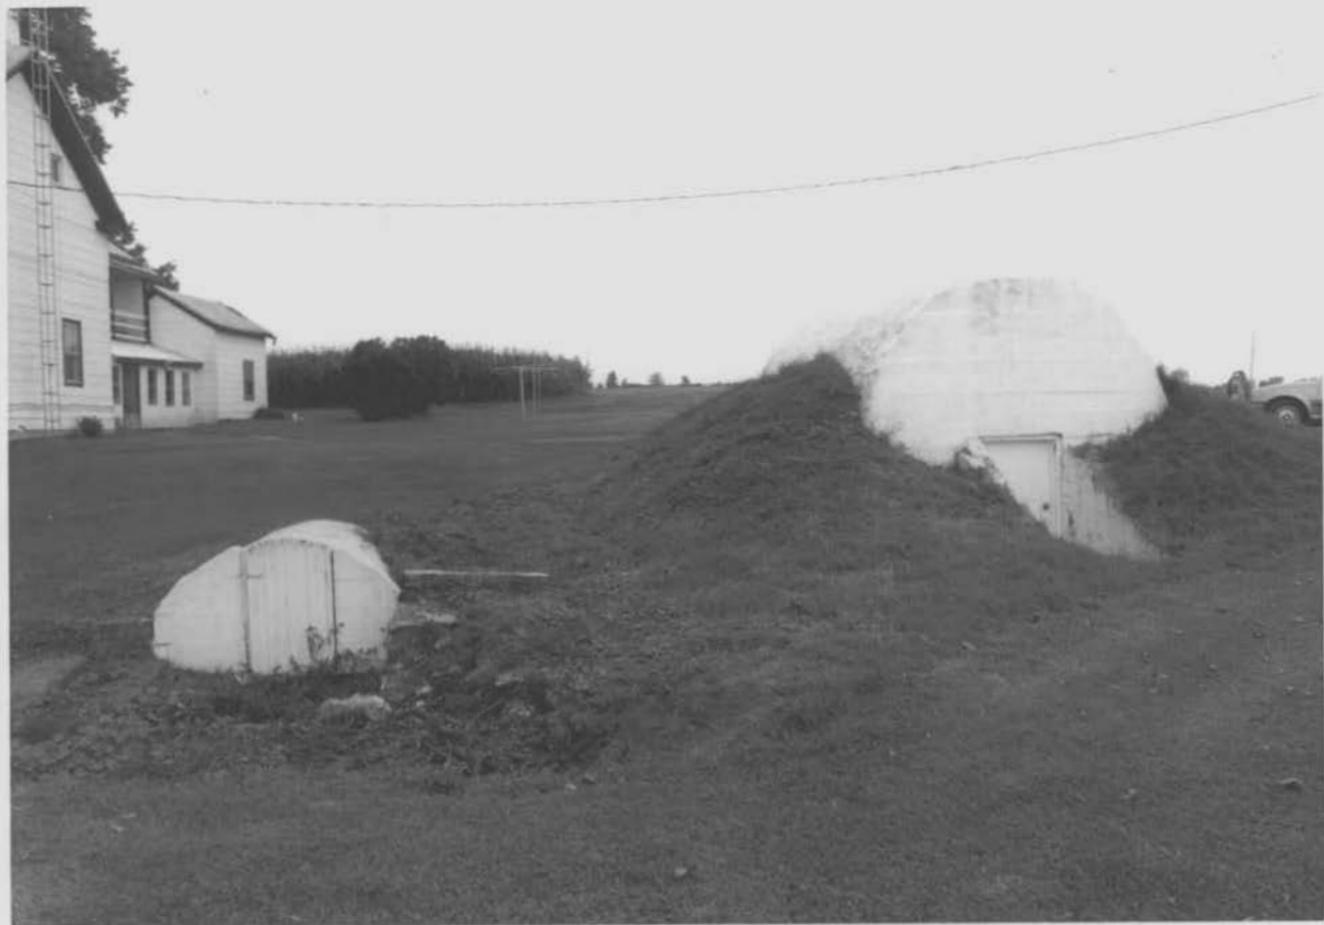
3/5

Root cellar and spring enclosure: The root cellar and the spring enclosure are located southeast of the house near the site of the springhouse noted in the James Survey inventory form (F-20-7) of about 1968, which has since been demolished. The root cellar is a partially earth-covered mound with a whitewashed stone and concrete roof and south elevation, where a vertical board door leads into the below-ground cave. The spring enclosure is a lower mound with a similar enclosure on the south side and the remains of the stone-lined trough which ran through the lower level of the springhouse. Both structures are difficult to date, although the spring would be the most likely to be contemporary with the house. The root cellar site may have been in use since the same period, but its present appearance with the concrete block enclosure probably dates from the early 20th century.

Spring and root cellar, view from south

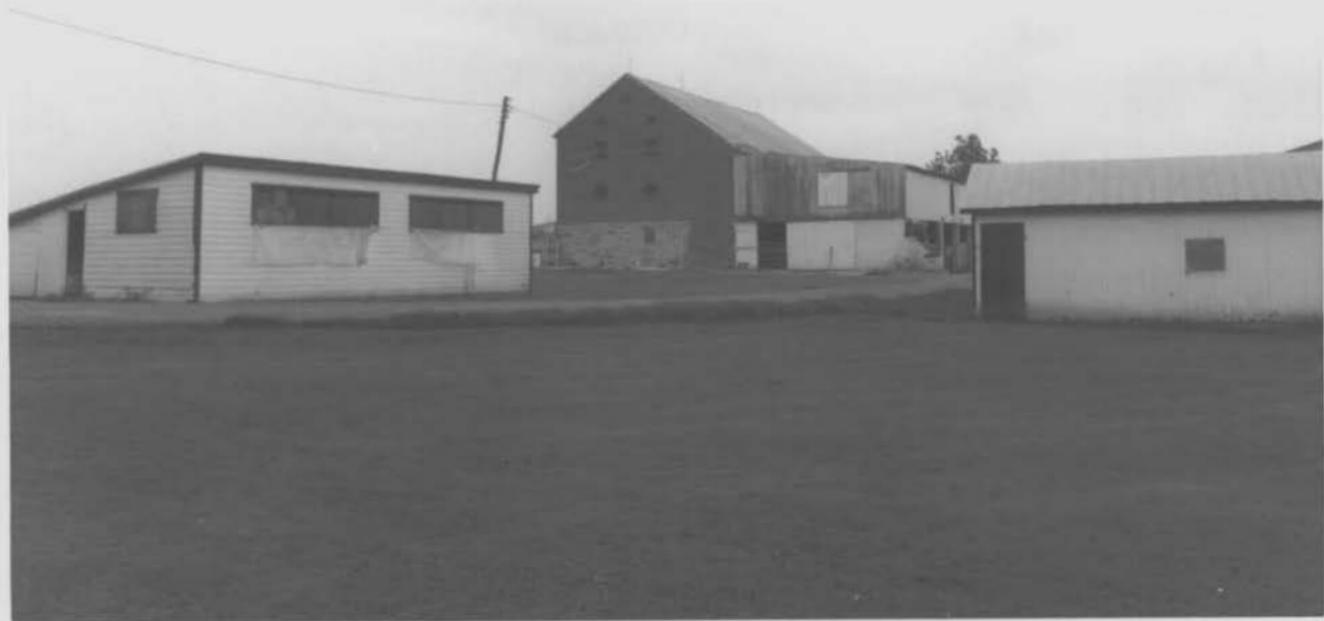
4/5

Chicken house: The frame chicken house is located east of the house on the farm drive from Hessong Bridge Road. Built about 1900-1920, it has a shed roof with corrugated metal covering and german siding. The south elevation has ribbon windows across the entire elevation.

Garage: The frame garage is also apparently a circa 1920 structure. Located southeast of the chicken house, it has tongue-and-groove vertical siding and a vertical board door on the west elevation. The gable roof is covered with standing seam metal.

Agricultural outbuildings, view from southwest

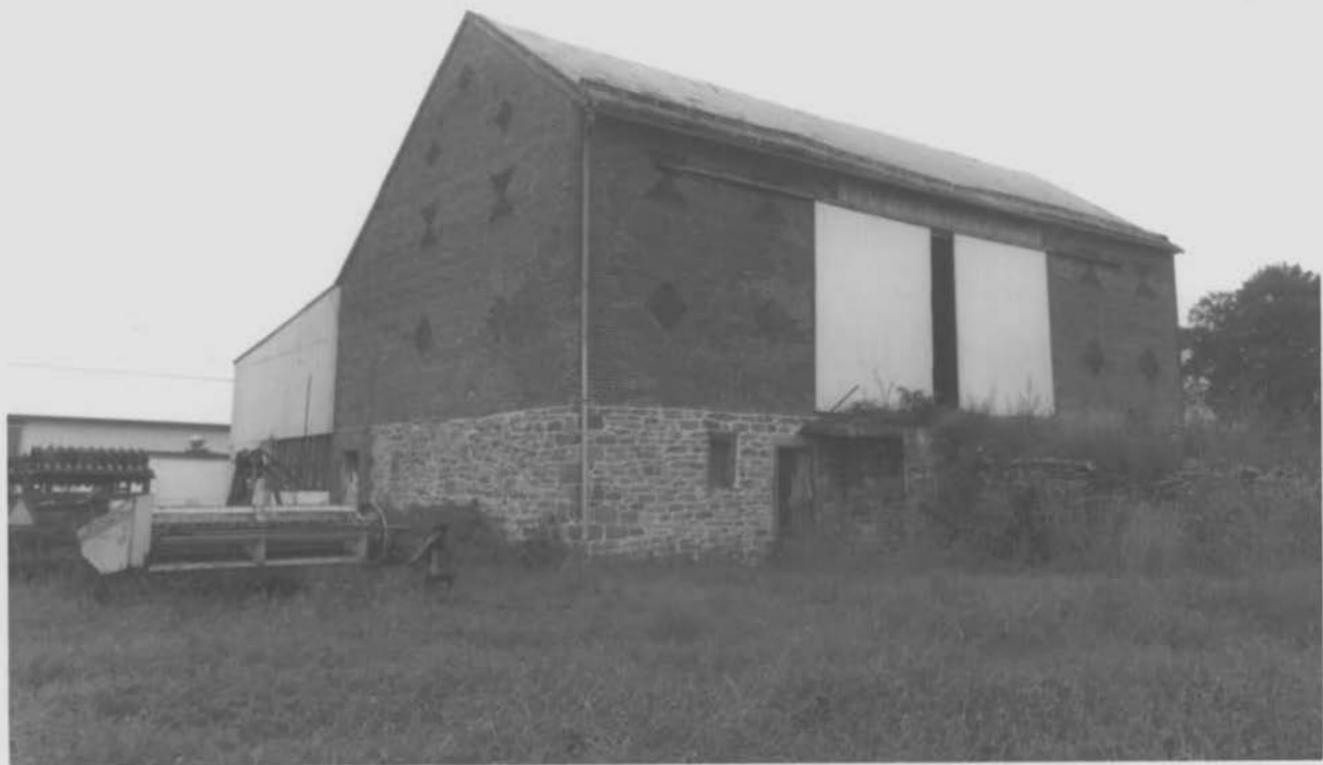
5/5

Brick barn: The bank barn is the most visible structure in the farmstead from the road. The foundation is field stone which has been repointed and the upper structure is 5:1 American bond with wheat sheaf and diamond pattern vent openings on the gable ends and the north elevation. The north side has large vertical board sliding doors and the roof is standing seam metal over wood shingles. The south elevation is dominated by a two-level extension of the hay loft supported above an open first level by concrete block columns. The extension has modern siding. The original forebay over the stalls is still visible from the open first level, with the vertical board ends just below the extension's second level floor. The original stall enclosure is also in brick, painted white, but the openings have been altered to some extent to allow access to the modern pens under the extension. The stone end walls show that the forebay side walls were built out with brick, interweaving with the stone quoins of the barn base. This alteration may have taken place in the period 1875-1900, judging by the apparent weathering of the brick in the original end wall and the forebay extension.

Bank barn, northeast corner view
