F-3-83
Jacob Rice Farmstead
Lewistown vicinity
Private

Maryland Historical Trust State Historic Sites Inventory Form

historic Jacob Rice Farmstead ←

Survey No. F-3-83

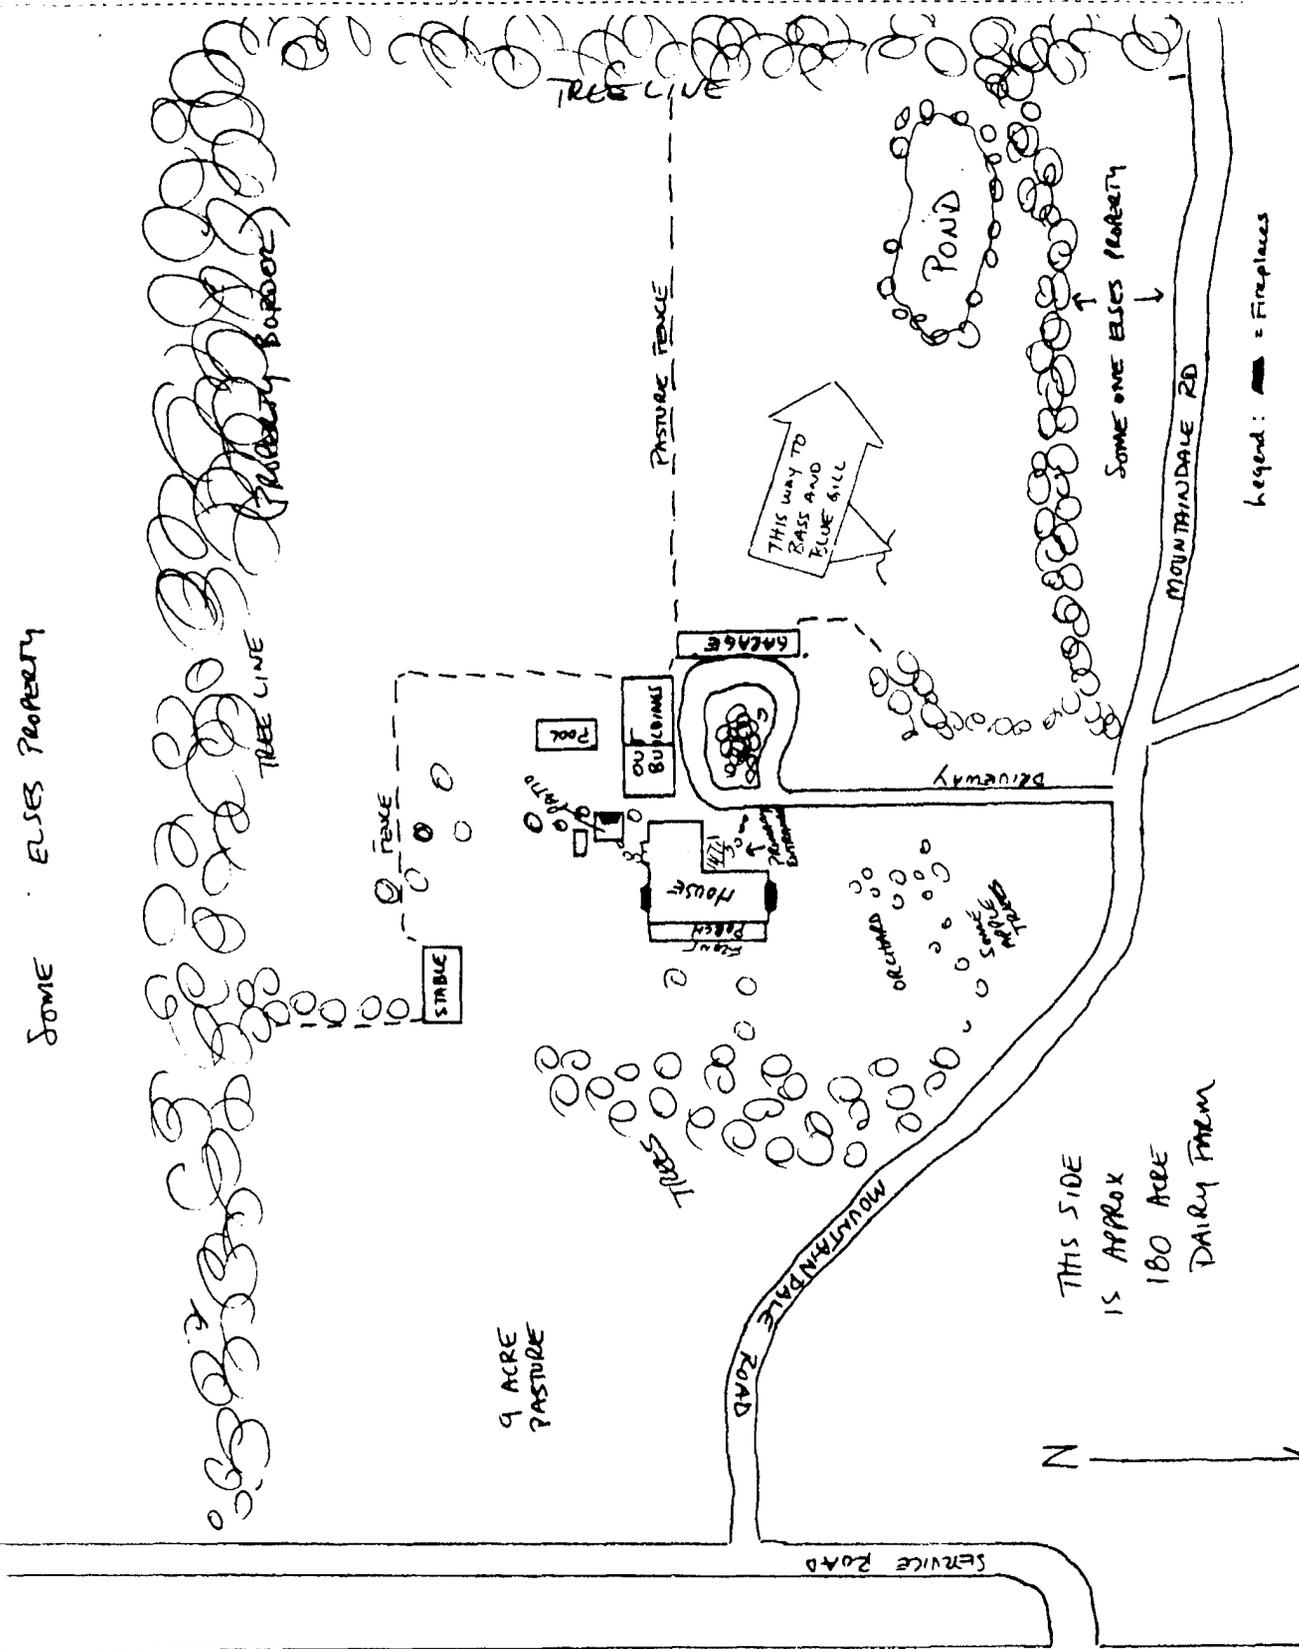
F-3-83
Jacob Rice Farmstead
Frederick County Site
Plan prepared by
Malcolm I. Nagle

The Jacob Rice Farmstead is an originally agricultural complex, now principally a private residence, centered on an 1876 frame dwelling, enlarged in the early 1900's, and its remaining domestic and agricultural outbuildings, which include a frame smokehouse, a frame chicken house, and a frame hog barn with granary and tool shed. The outbuildings appear to date from the period 1876-1910. The farmstead is located on the south side of Mountaindale Road just west of Hansonville Road and U.S. 15 near Lewistown, Frederick County, Maryland. The buildings are located in a grove of trees at the end of a short driveway running south from Mountaindale Road and the principal elevation of the house faces east.

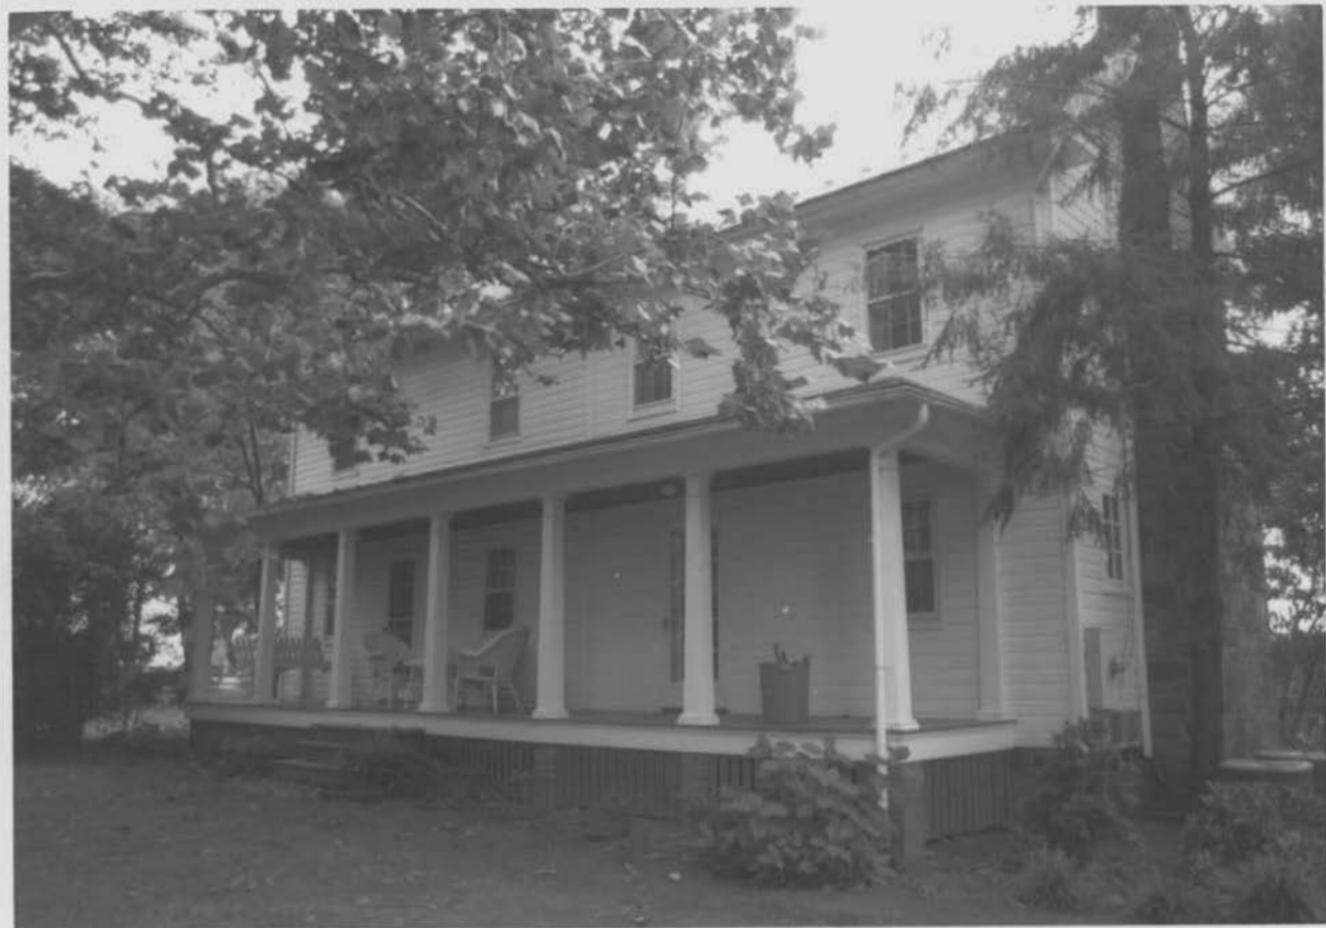
1/4

The dwelling is a two-story structure with two distinct sections apparent on the east elevation by a vertical batten over the german siding at the junction of the two parts. The siding differs slightly in profile as well. The south section was probably the original part. It has three bays on the first story and two on the second story, with 6/6 sash and a multi-panel glazed replacement door in the center bay of the first story. The northern section has two bays with a second entry and the same type of replacement door, and the 6/6 windows. A one-story porch extends across the entire elevation. It has a wood deck with square, tapered columns and a standing seam metal roof. The main roof is also standing seam metal and the molded cornice returns on the gable ends. Exterior brick chimneys are located at each gable end, replacing the probable original interior chimneys. Two bays flank the chimney on the south elevation, with 2/2 attic windows. A two-story rear wing is attached to the west elevation, with the original two-story integral open porch on the south side enclosed on both levels and extended on the first story. The north side of the ell has a sidelighted doorway with a 6-panel door. The doorway appears to be a late 19th century design with fluted verticals. The west elevation of the wing has a modern door and frame entry stoop and a small group of casement windows flanking the door. A third door is located in the extended first story of the south side of the wing. The interior of the house has two first floor parlors in the main section, each with a fireplace. The south fireplace is a stone structure, probably built in the 1930's. The north mantelpiece is an early 20th century reproduction Adamesque style with fluted elliptical panels. The interior door and window trim is simply molded and the walls are covered with modern wallpaper and the floors with wall to wall carpet.

East elevation

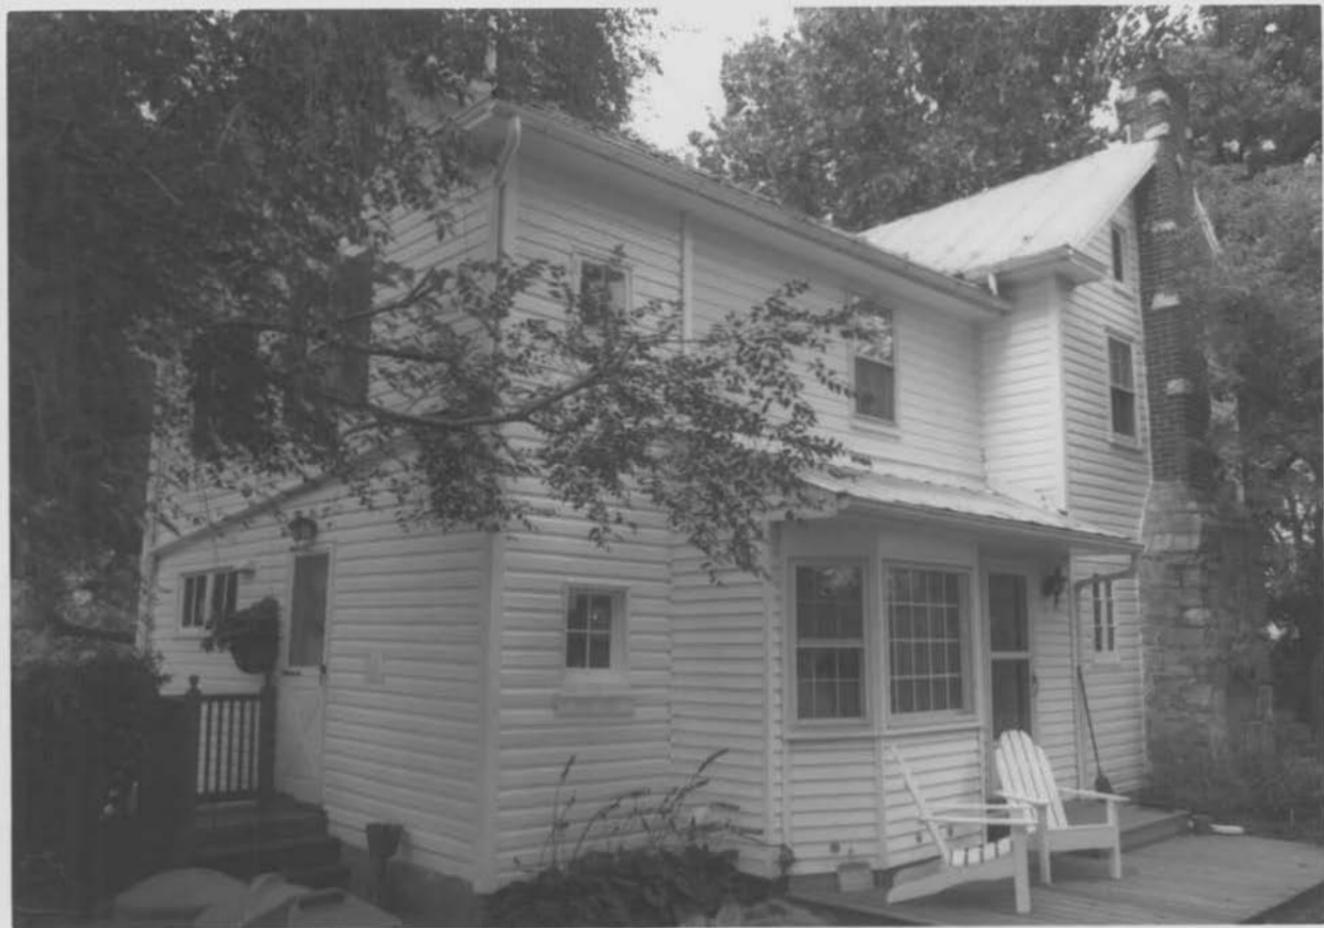
2/4

Southwest corner view

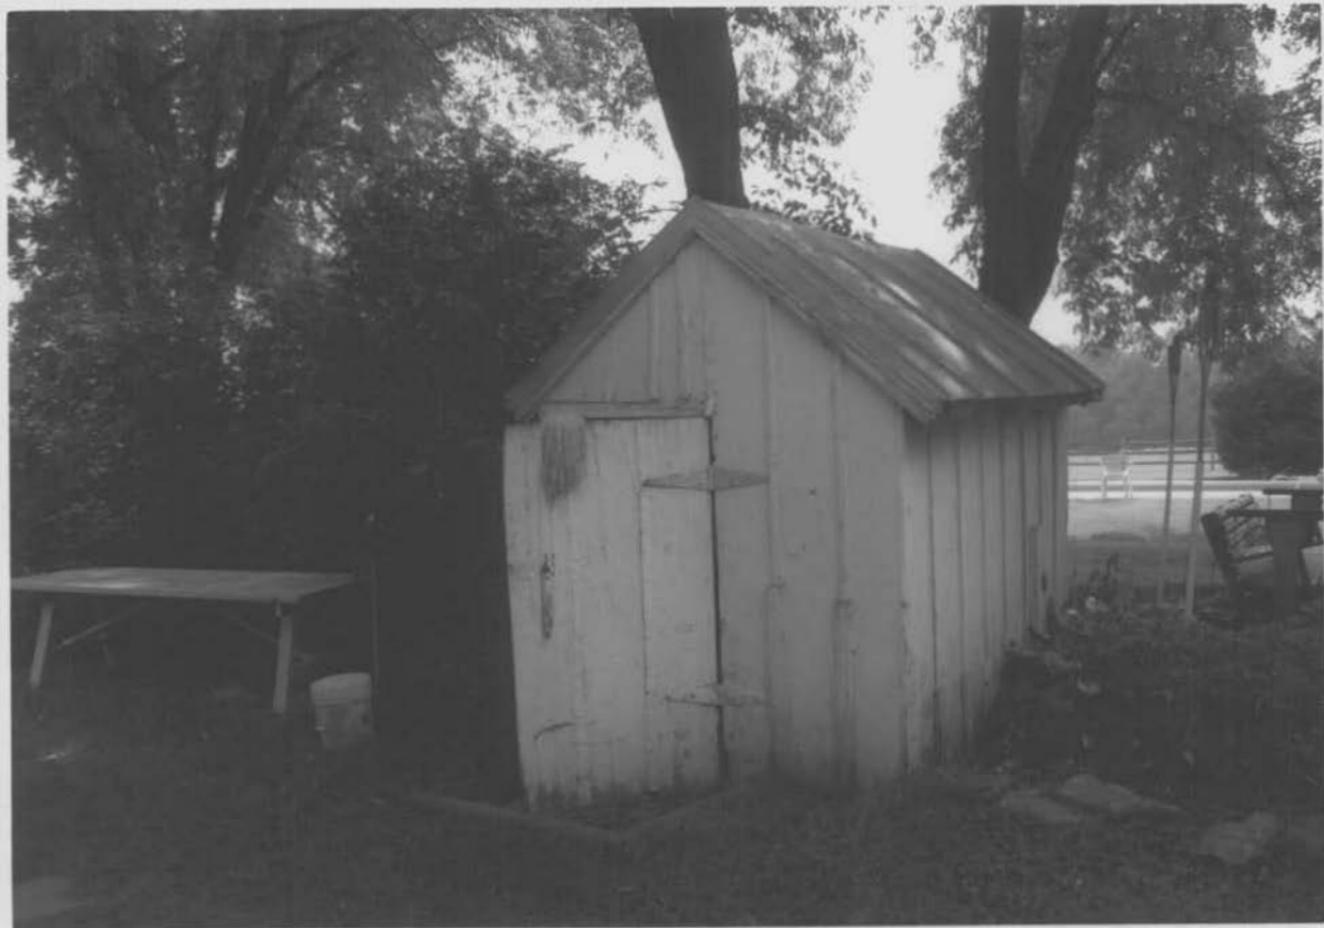
3/4

Smokehouse: The frame smokehouse is located south of the rear wing, next to a modern brick patio with a large rebuilt brick fireplace, apparently the site of a demolished summer kitchen. The smokehouse is a one-story rectangular building with board-and-batten siding and a vertical board door in the east elevation. The gable roof is standing seam metal. The interior walls and ceiling beams are blackened and nails protrude as meat hooks from the upper beams. The smokehouse was probably built about the same time as the house.

Smokehouse, east elevation

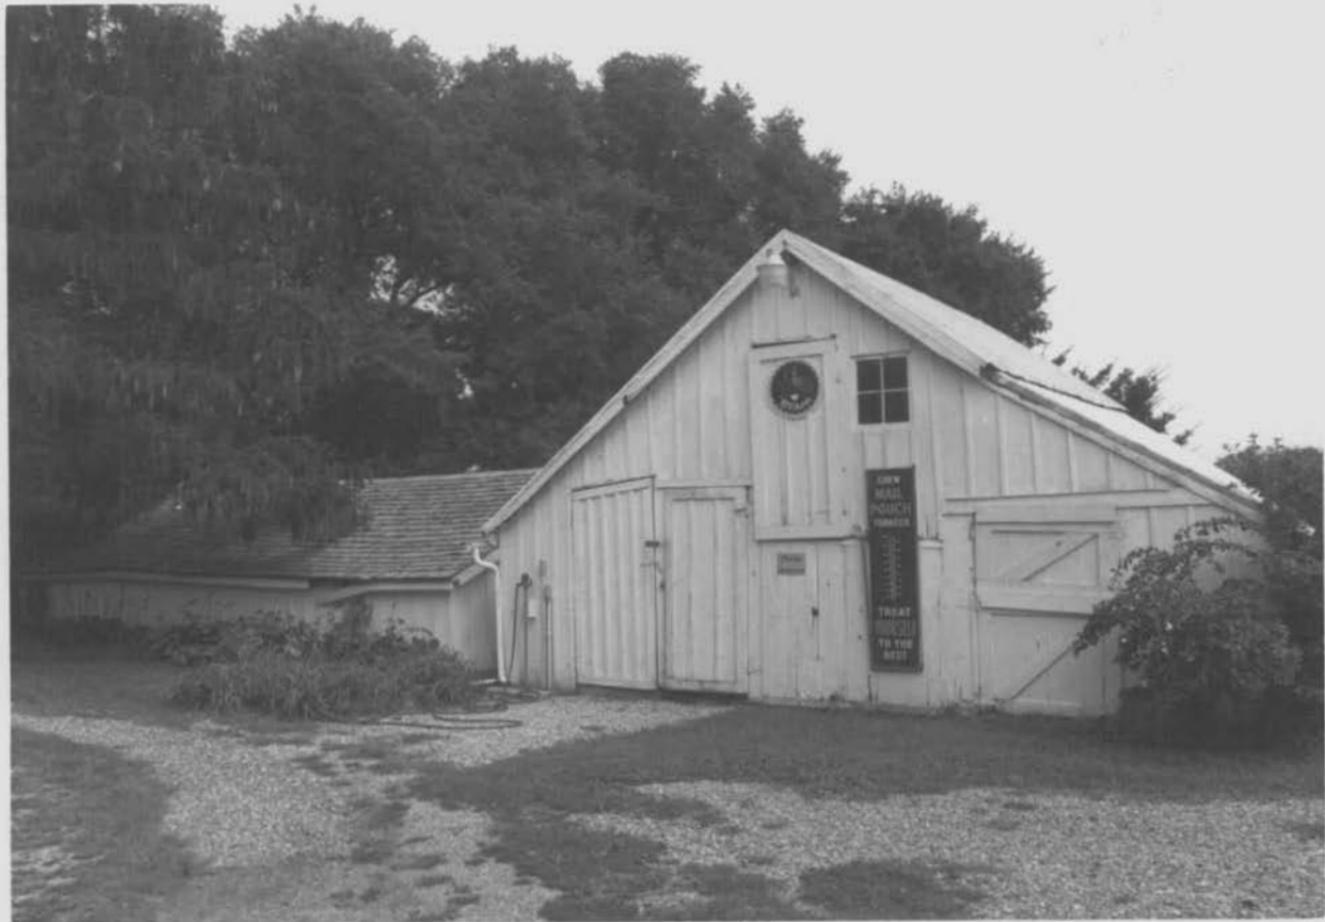
4/4

Chicken house: The frame chicken house is located west of the house and currently serves as a pool house for the modern swimming pool located just to its south. The chicken house has a shed corrugated metal roof over wood shingles. The exterior is vertical boards with window openings on the south and a feed shed is located in the center of the building between an enclosed section and an open section which is currently being remodeled. A door in the east elevation probably once opened into a feeding access aisle across the front of the building. The chicken house may date from about 1900-1910.

Hog barn with granary and tool shed: The frame hog barn with its associated uses is located immediately west of the chicken house. It has a gable roof with extended eaves on both the east and west sides. The center section is a granary with a winding stair leading to a grain storage loft above the level of the hog barn located on the west side. A dutch door in the barn section is located in the north elevation. A vertical board door next to it on the east opens into the granary section and a third door in the east section leads into a tool shed. The roof of the building is standing seam metal and the siding is board-and-batten. A loading door is located above the granary door, opening into the loft, and a 2/2 window lights the loft space. The hog barn and shed also date from about 1900-1910.

Smoker house and hog barn, north elevation
