Maryland Historical Trust State Historic Sites Inventory Form

historic Pettingall/Bussard Farm

Survey No. F-4-114

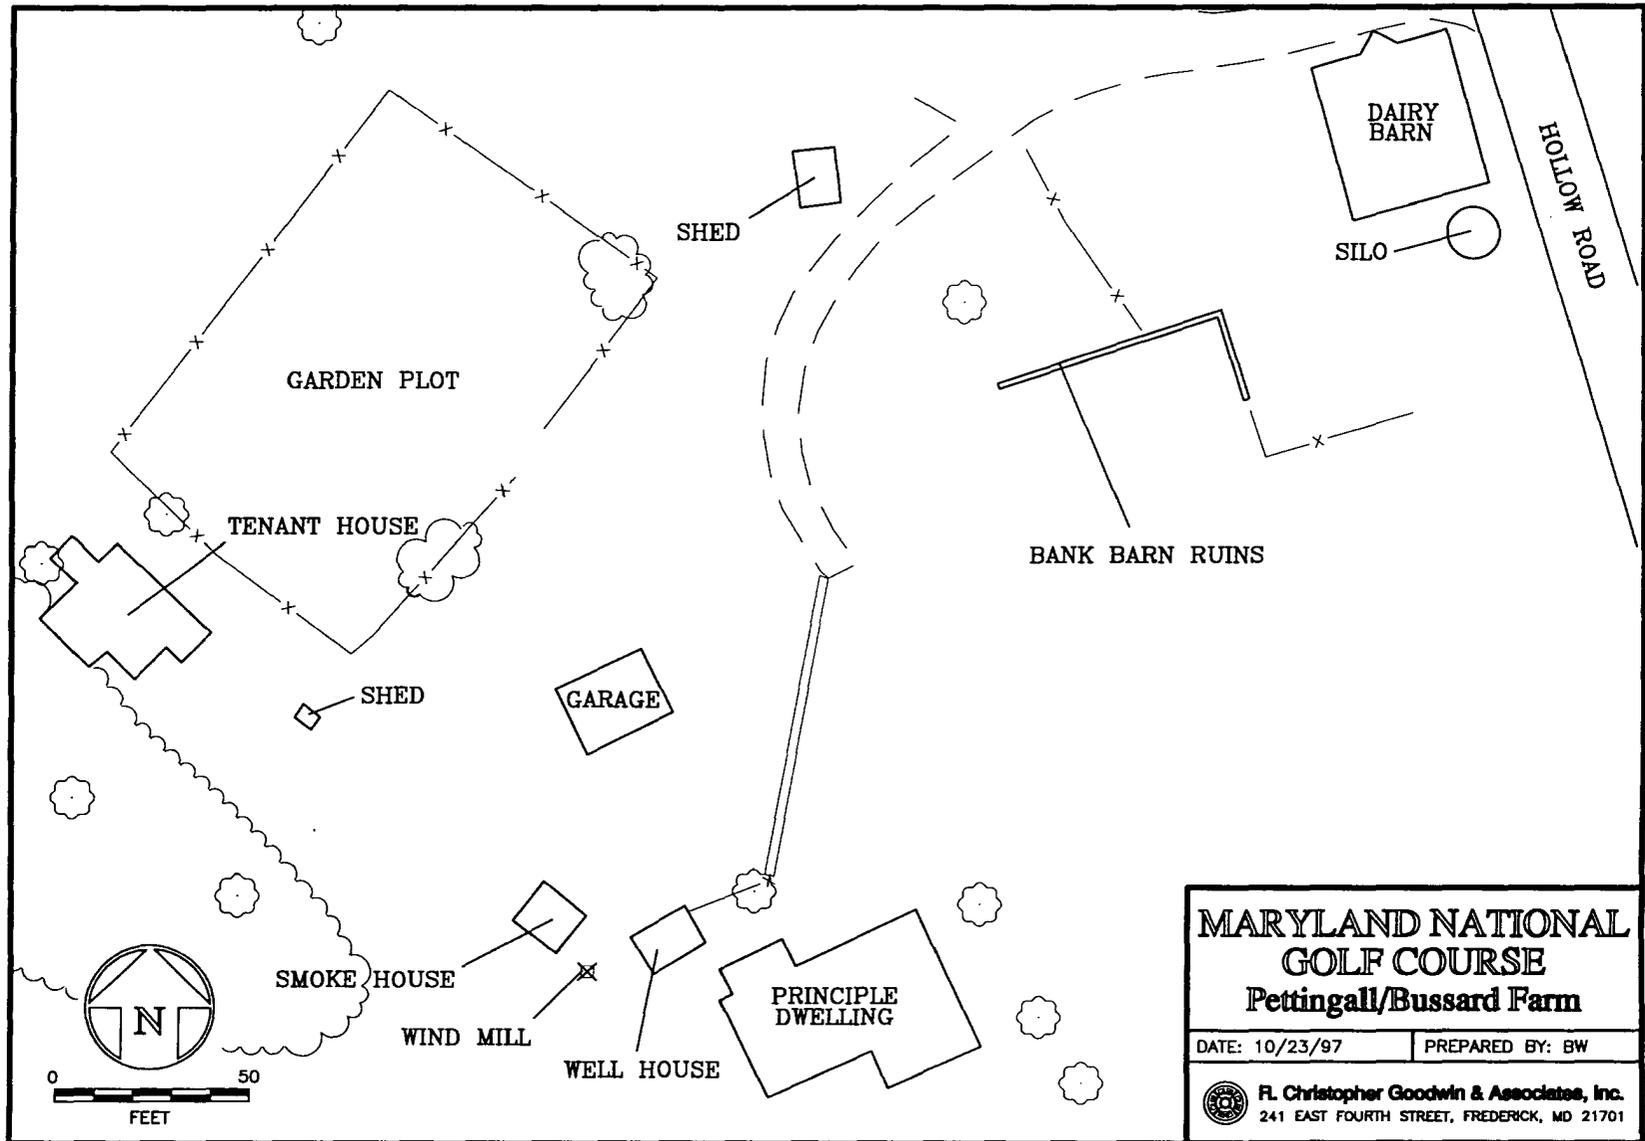
F-4-114

Sketch map of Pettingall/Bussard Farm.

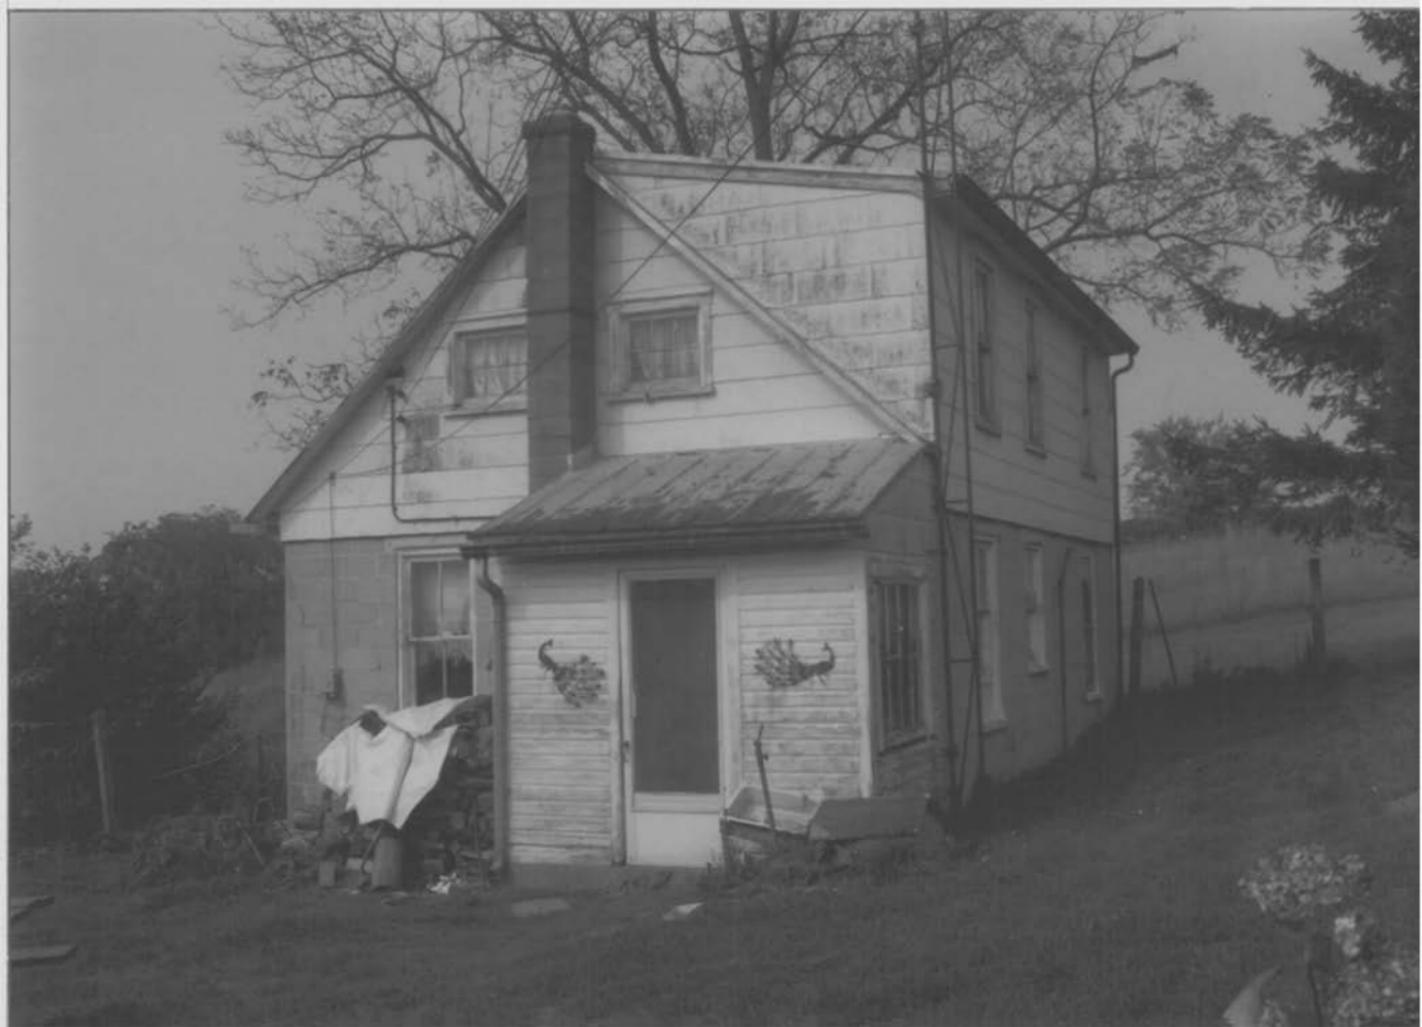
12 of 16

A tenant house is located northwest of the principal dwelling on a low slope. The tenant house, ca. 1930, faces south towards open agricultural fields. The one-and-one-half-story, rectangular tenant house is three bays wide and one room deep. The first floor is constructed of concrete block, while the upper floor is wood frame clad with asbestos siding. The house rests on a poured concrete foundation. A metal bulkhead provides access on the west elevation. A three-bay shed roof dormer is located on the north elevation. The principal entrance, on the south gable elevation features a metal storm door within an enclosed porch. The one-bay, wood-frame porch is clad with asbestos siding and terminates in a front gable roof sheathed in corrugated metal. A two-bay, one room addition is located on the west elevation. This wood-frame addition, clad with asbestos siding, terminates in a shed roof sheathed with corrugated metal. The building features two-over-two-light, double-hung, wooden-sash windows.

12. g. Tenant House, view north
13. g. Tenant House, view southeast
14. g. Foundation Ruins of Bank Barn, Dairy Barn and Silo, view northeast
15. g. Shed, view northwest

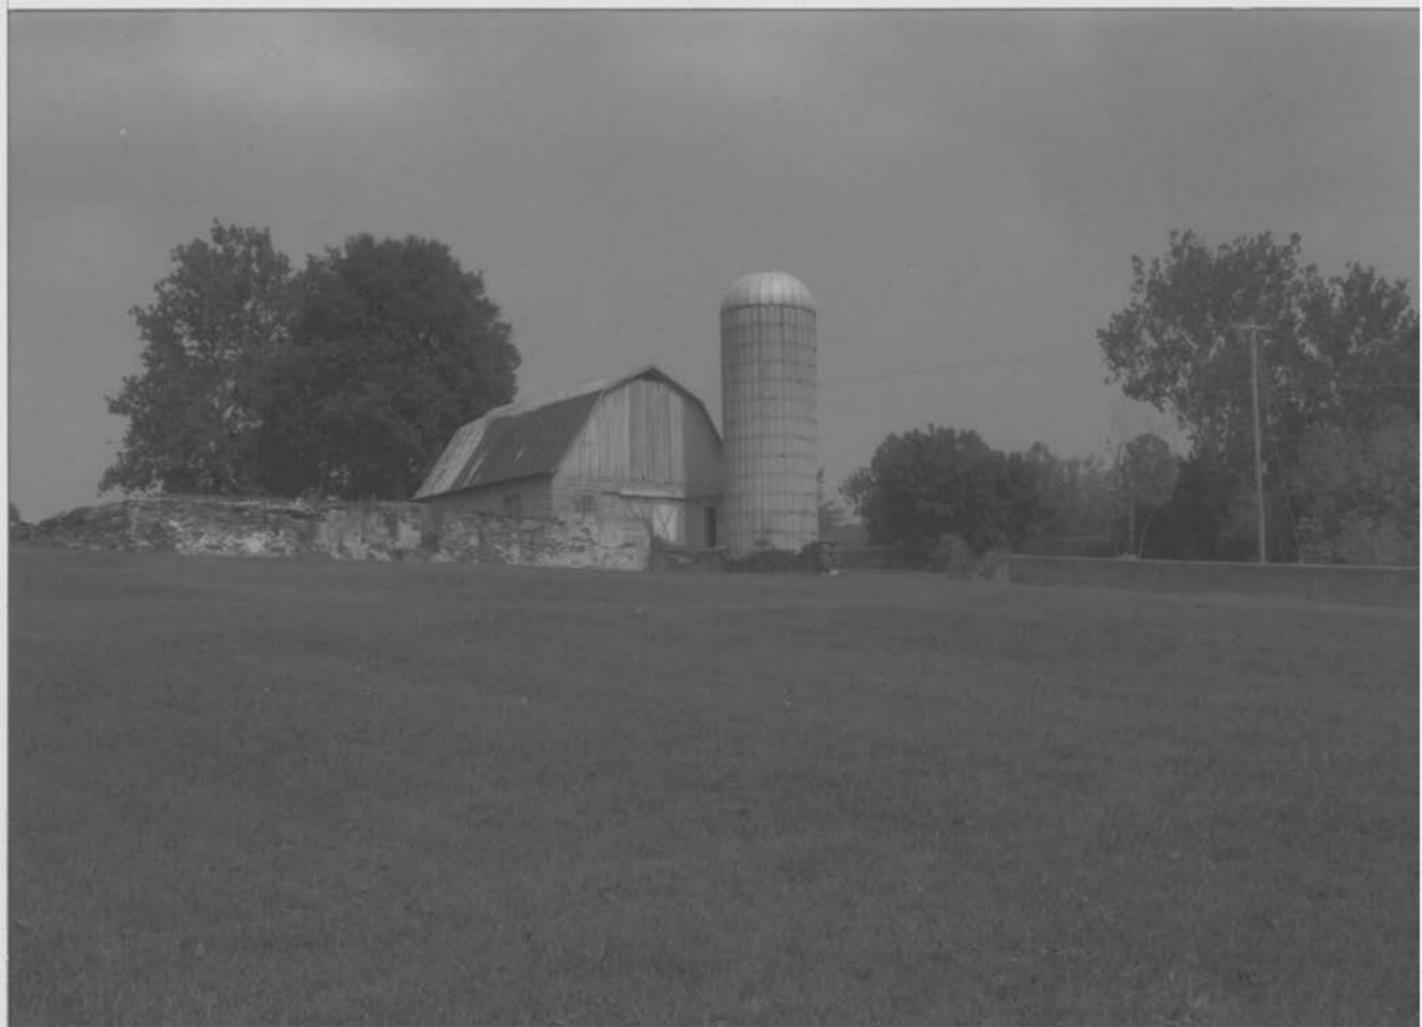
14 of 16

The foundation ruins of a bank barn (ca. 1860) are located northeast of the principal dwelling. The bank barn was destroyed by fire in 1957. The primary (north) elevation is defined

by an earthen ramp supported by a stone foundation wall on the ground level. The remaining foundation walls of the former bank barn have been removed. The foundation ruins of a bank barn predate the extant principal dwelling.

The dairy barn is located in the northeast portion of the building complex. The barn is a rectangular plan, two-and-one-half story, three-bay building constructed ca. 1930. The barn, constructed of rusticated concrete block, rests on a poured concrete slab. The front and rear elevations on the first floor level feature a central wood sliding track door constructed of vertical wood boards, flanked by 12-light, wood-frame hopper windows. The side elevations feature two 12-light, wood-frame hopper windows. The barn terminates in a gambrel roof clad with corrugated metal. The hayloft is accessed from either gable end by sliding track doors located on the second floor level. The hayloft openings are sheltered by a gable roof extension which originally housed a block and tackle.

A circular precast concrete silo (ca. 1930) is located southeast of the barn. The circular plan silo is approximately 15 feet in diameter and 30 feet tall. The silo terminates in a standing seam metal dome roof. The silo was constructed using precast concrete sections joined by exterior, metal turn buckles. A metal ladder is attached to the side of the silo. The ladder provides access to metal doors which are located at eight-foot intervals for the height of the structure. The silo is attached to the southeast corner of the dairy barn by a small concrete block hyphen terminating in a gable roof sheathed with corrugated metal.

Foundation Ruins of Bank Barn, Dairy Barn, & silo, view northeast

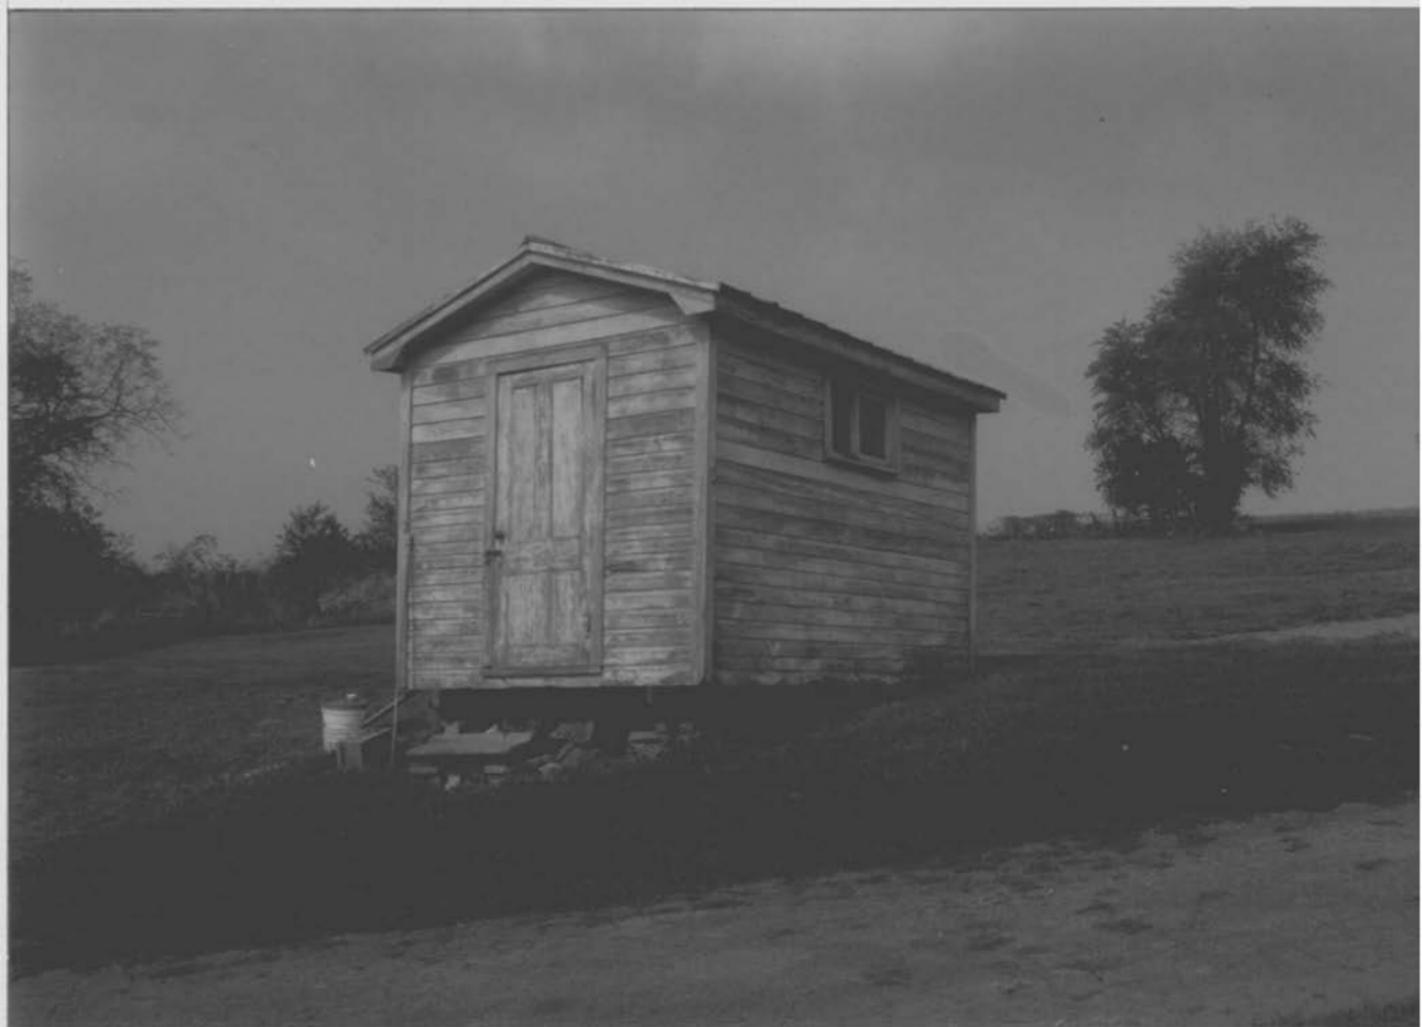
15 of 16

A one-story, rectangular wood-frame shed (ca. 1900) sheathed in horizontal lapped siding is located northeast of the principal dwelling and southwest of the bank-barn ruins. The shed rests on a dirt foundation supported by a wood sill. The gable roof is sheathed with standing seam metal. The primary (south) elevation of the building features a four-panel wooden door. The side elevations feature a one-by-one, wood-frame, sliding track window.

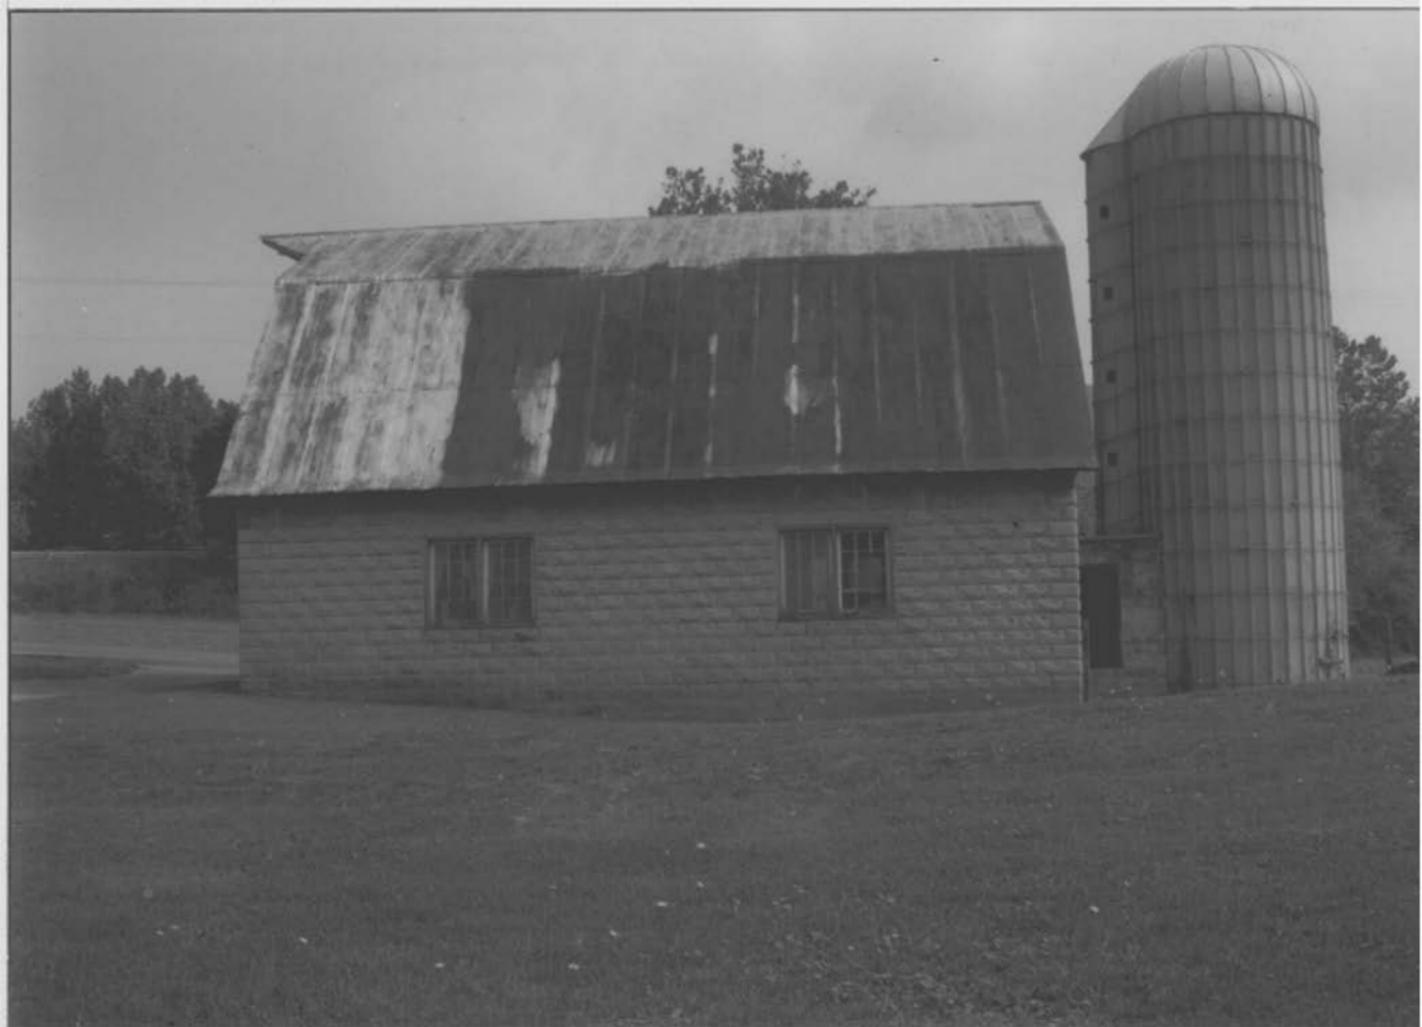
16. g. Dairy Barn and Silo, view east
