F-4-19

Vincent Sanner Farmstead
Middletown vicinity
Private

Ca. 1784-1940

State Historic Sites Inventory Form

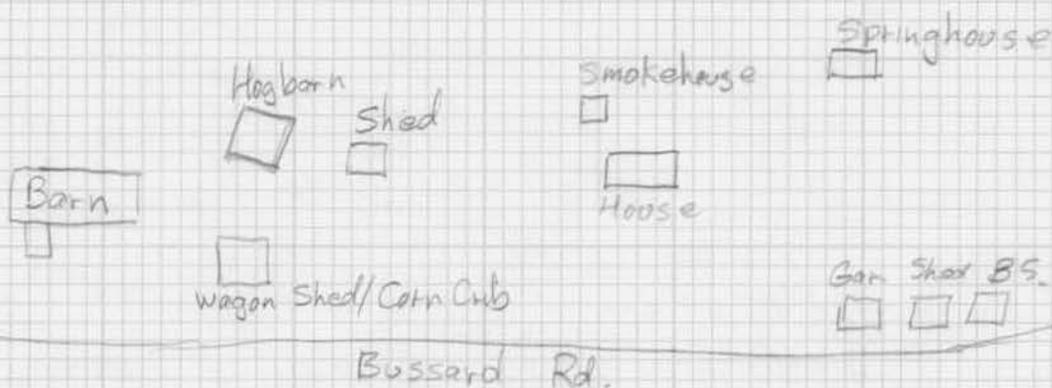
Not to Scale

The Vincent Sanner Farmstead is an agricultural group centered on a circa 1784 brick dwelling of two stories with an associated stone springhouse and a concrete block meathouse and an agricultural outbuilding group consisting of a frame bank barn, a frame wagon shed/corn crib, a frame hog barn, a frame hay barn, a frame blacksmith shop, a frame tool shed, all dated about 1875-1890, and a non-contributing concrete block garage. The farmstead is located on the south side of Bussard Road about 2/10 mile east of Old Middletown Road near Middletown, Frederick County, Maryland. The principal elevation of the house faces north and the agricultural outbuildings are located east of the dwelling. The blacksmith shop, garage, and tool shed are located northwest of the house at the edge of Bussard Road.

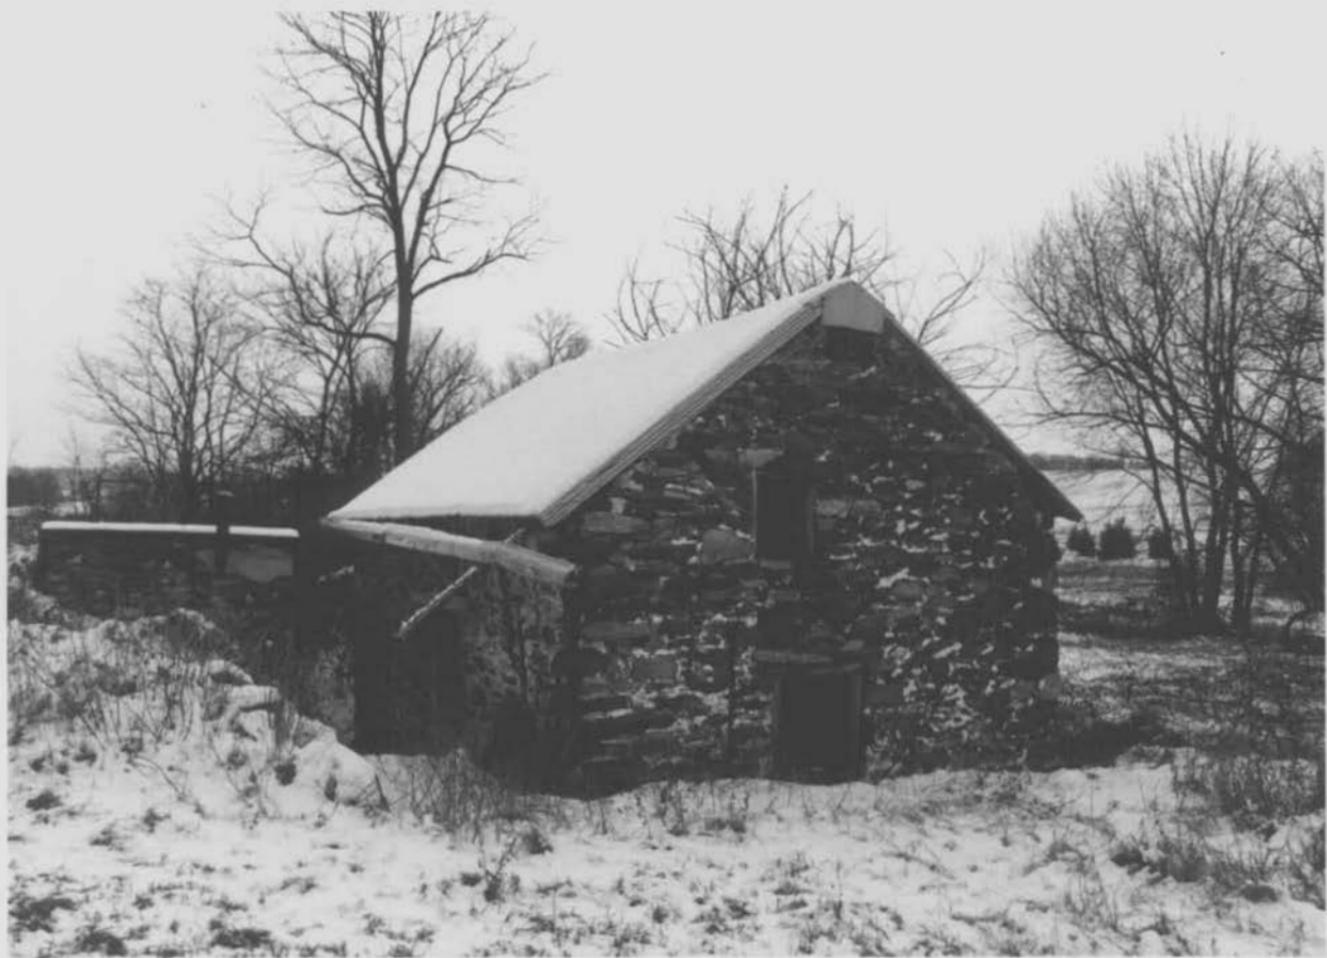
8/5

Springhouse: The stone springhouse is located southwest of the house near a creek which runs south of the building complex. It has a rectangular plan with two levels. A vertical board door is located on the north elevation and square window openings on both levels are in the west gable end. The sash is missing. A second doorway opening is in the upper level in the east gable end. The gable roof is covered with corrugated metal. The springhouse was probably built at the same time or within 20 years of the date of the house, approximately 1784-1800.

Springhouse, west elevation

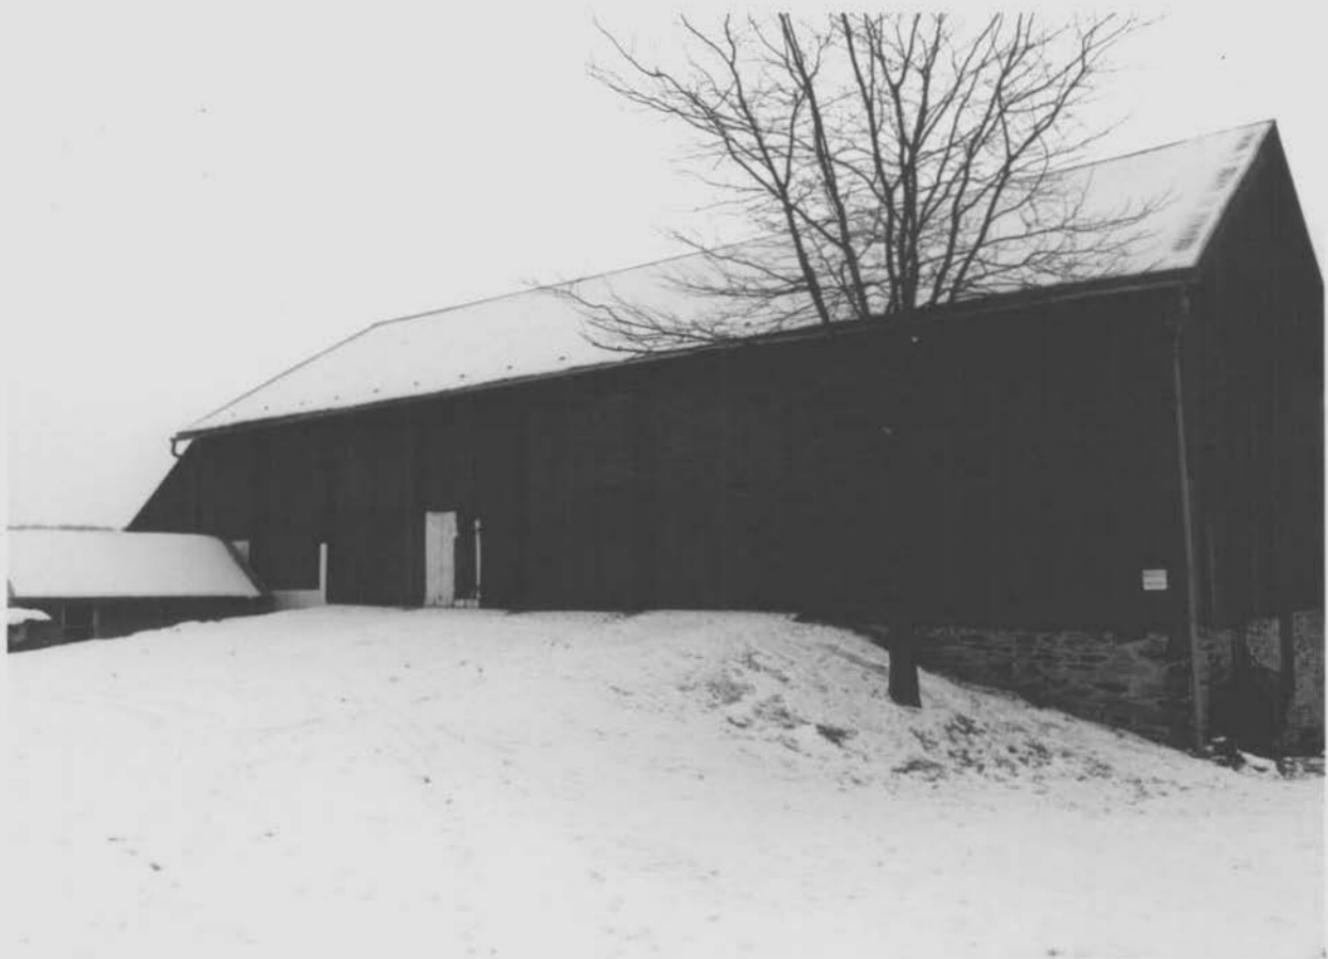
5/5

Bank barn: The frame bank barn is located east of the house with the ramp on the north elevation. It is a rectangular building with vertical siding, a corrugated metal roof, and vestiges of scalloped bargeboard trim on the west gable end. A shed roofed extension on the east gable end contains a granary. Built approximately 1850-1875, the barn was altered probably in the 1930's with the addition of an attached concrete block milk house on the north elevation and the lower level was sectioned off with concrete block to form a milking parlor. The rest of the lower level is faced with lattice, a feature common to the lower Middletown Valley.

Both north elevation
