F-4-33
Leatherman-Dutrow Farmstead
Middletown vicinity
Private

F-4-2233 *Leatherman-Dutton*
~~Peter Leatherman~~ Farmstead
Middletown
Frederick County

Maryland Historical Trust State Historic Sites Inventory Form

historic Leatherman-Dutrow Farmstead

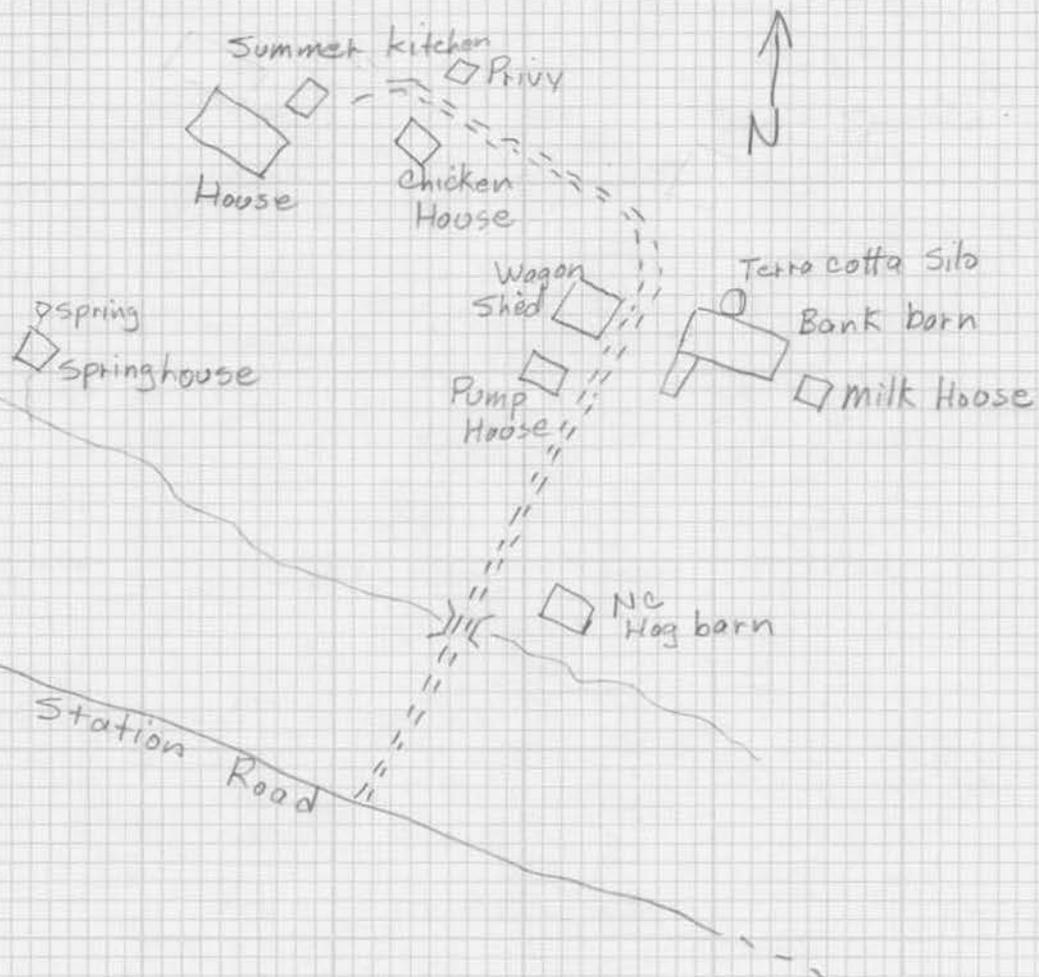
F-4-33
 Leatherman-Dutrow Farmstead
 Frederick County

The Leatherman-Dutrow Farmstead is an agricultural complex containing both domestic and agricultural building groups centered on a circa 1875-1880 frame two-story dwelling, with a frame summer kitchen, a two-level stone and frame springhouse, a frame privy, and a frame chicken house. The agricultural group contains a late 1930's frame bank barn with concrete block alterations for dairy operation, a concrete block milk house, a terra cotta silo, a concrete silo, and a frame pump house, all of the same period as the barn, and a frame wagon shed/corn crib of about 1875-1900. The farmstead is located on the north side of Station Road, about 1/4 mile from the intersection of Mount Tabor Road near Middletown, Frederick County, Maryland. The farmstead is reached by a farm lane from Station Road which crosses a small stream running northwest to southeast through the property.

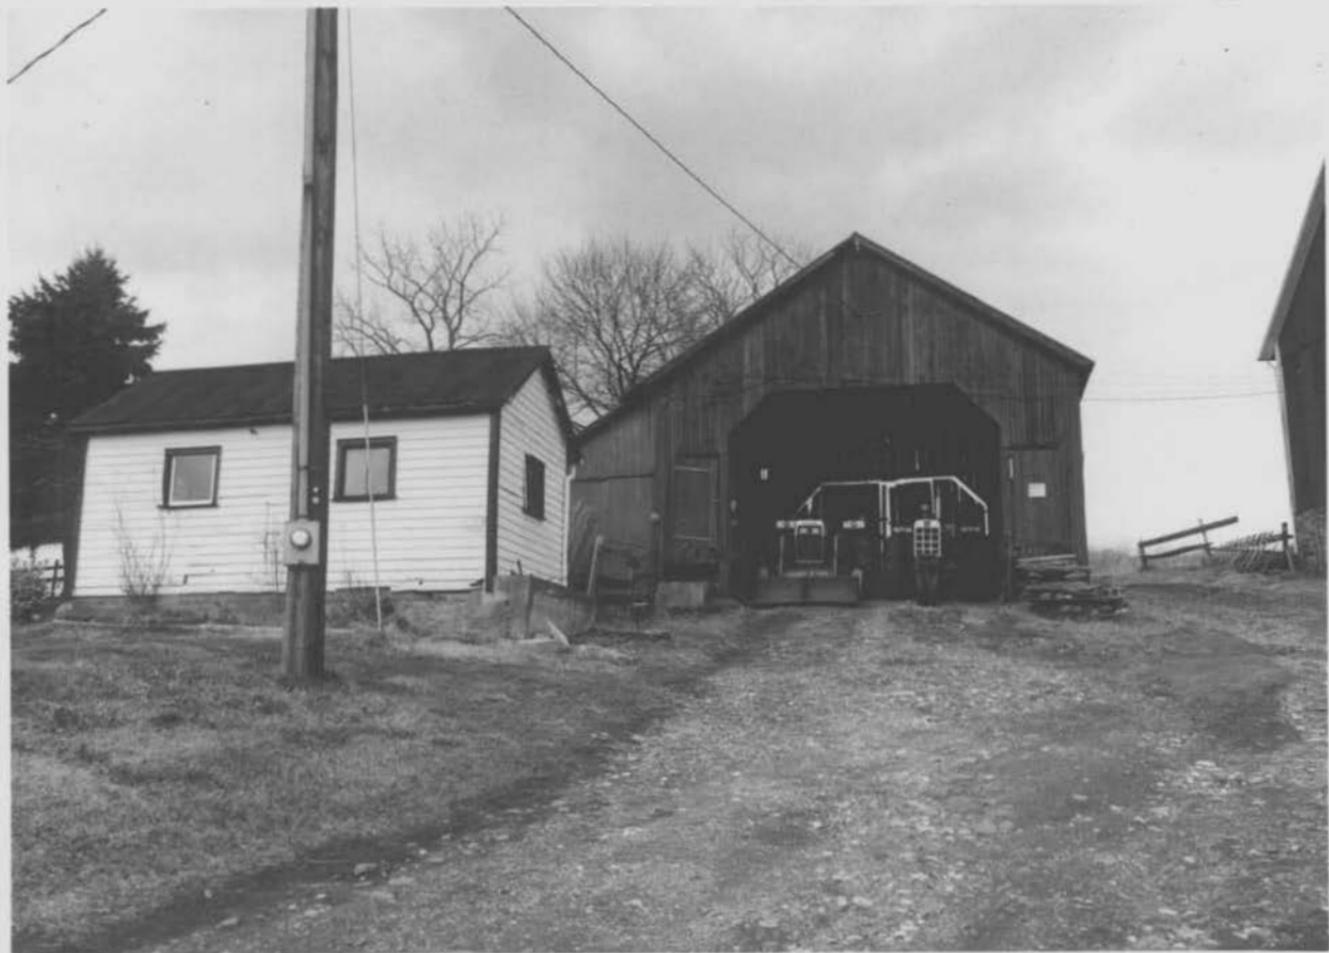
5/6

Pump house: The frame pump house, built approximately in the late 1930's to pump water to the milk processing operation in the barn, is located on the west side of the driveway south of the wagon shed. It is a rectangular structure with german siding and a corrugated metal gable roof. Two vertical tongue-and-groove doors are located in the north elevation.

Peep house near the shed/corn crib, south
elevation
