F-4-36

Daniel Kefauver Farmstead and Mill Site
Middletown vicinity
Private

Daniel Kefauver Farmstead and Mill Site
Middletown
Frederick County

Maryland Historical Trust State Historic Sites Inventory Form

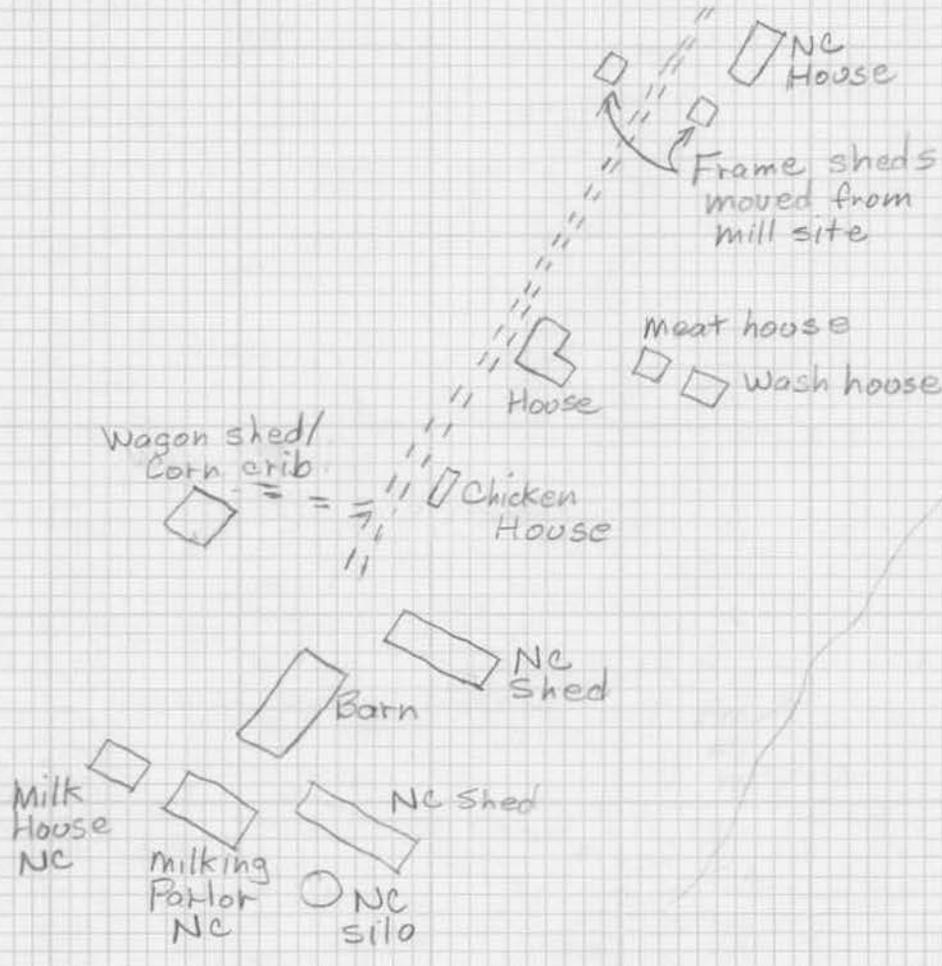
F-4-36
Daniel Kefauver
Farmstead & Mill
Site
Frederick County

Old National Pike (US 40A)

Approx. site of mill

Tobias Run

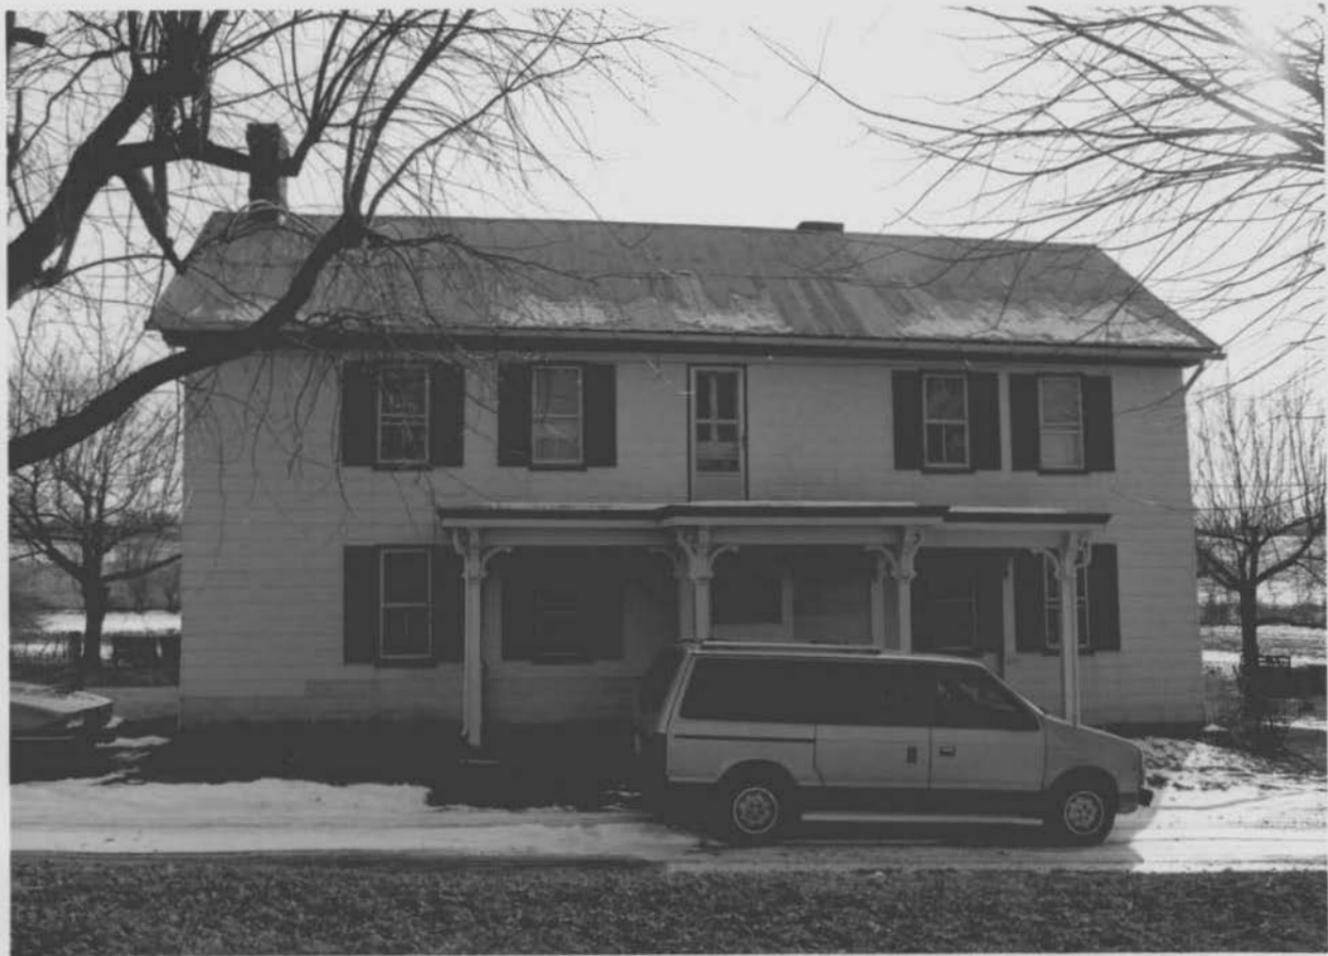
1/5

West elevation

The historic dwelling house, which currently is used as a tenant dwelling, has two sections, both covered with asbestos siding. The main section is a two-story log building with a five-bay west elevation. The proportions of the elevation suggest that the log part was itself built in two stages. The southern section has two bays closely spaced, suggesting it may have been the first part built. The center bay contains the current entrance and the two northern bays are more widely spaced. The first story's central three bays are sheltered by a bracketed porch probably added in the last quarter of the 19th century. The center of the porch projects, forming a simple entrance pavilion. The doorway has a built-out foyer partially screening the entrance. On the second story, the center bay has a paneled door with glazed upper panels, suggesting that the porch once had a roof railing for use as a sun porch. The windows have 2/2 sash and replacement louvered shutters. An interior end chimney is located on the north gable end, which has shuttered attic windows and two bays. Near the junction of the two probable log sections is a second chimney enclosed by the two sections. The cornice is boxed and there are returns on both gable ends. The two-story rear wing extends from the southeast corner of the log section. It appears to have frame structure, suggesting a mid to late 19th century construction, and it is also covered in asbestos siding. A doorway on the south elevation has a metal awning and on the north elevation of the wing is an integral two-story open porch with a scroll-sawn balustrade on the upper level and mesh screens on the lower level. The east gable end of the wing has an exposed section of the stone cellar with two 6/6 windows and a central door of vertical boards. The interior was not accessible for this survey.

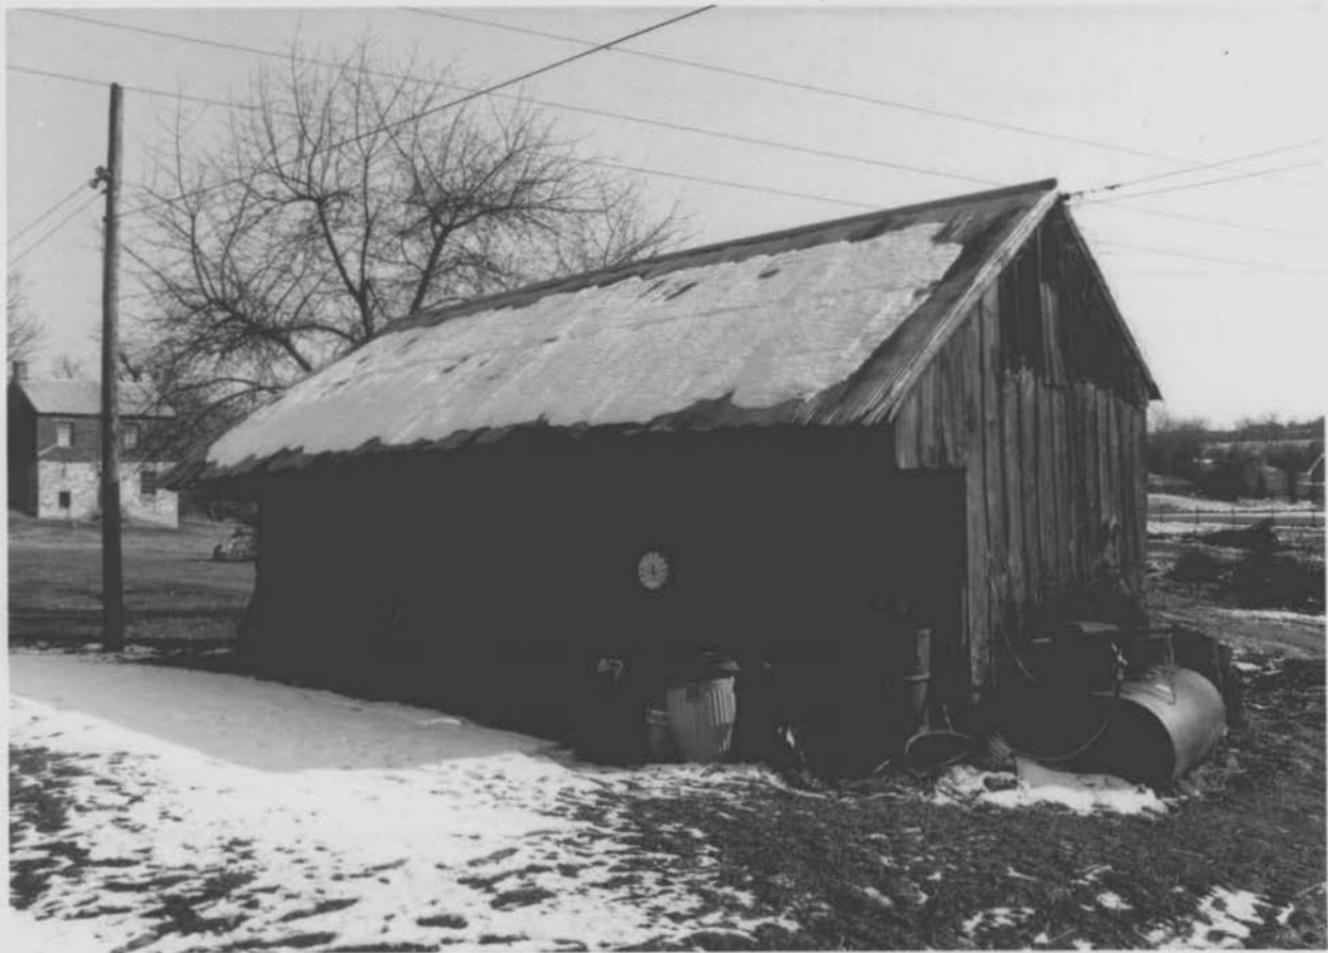
3/5

Chickens Jones, South west corner view

Chicken house: The log chicken house is located about 50 feet south of the house. It has a rectangular plan with two interior sections separated by roof beams, the lower logs having been cut to open the space probably when it was converted to use as a shop. The exterior is vertical board and battens with a cut-out opening on the east elevation. The gable roof is corrugated metal and extends over the west elevation, forming an overhang. The single door is in the southwest corner. The date of the structure is unknown, but its log material suggest that it was built about the middle of the 19th century, as frame chicken houses would have been more common in the late 19th century.

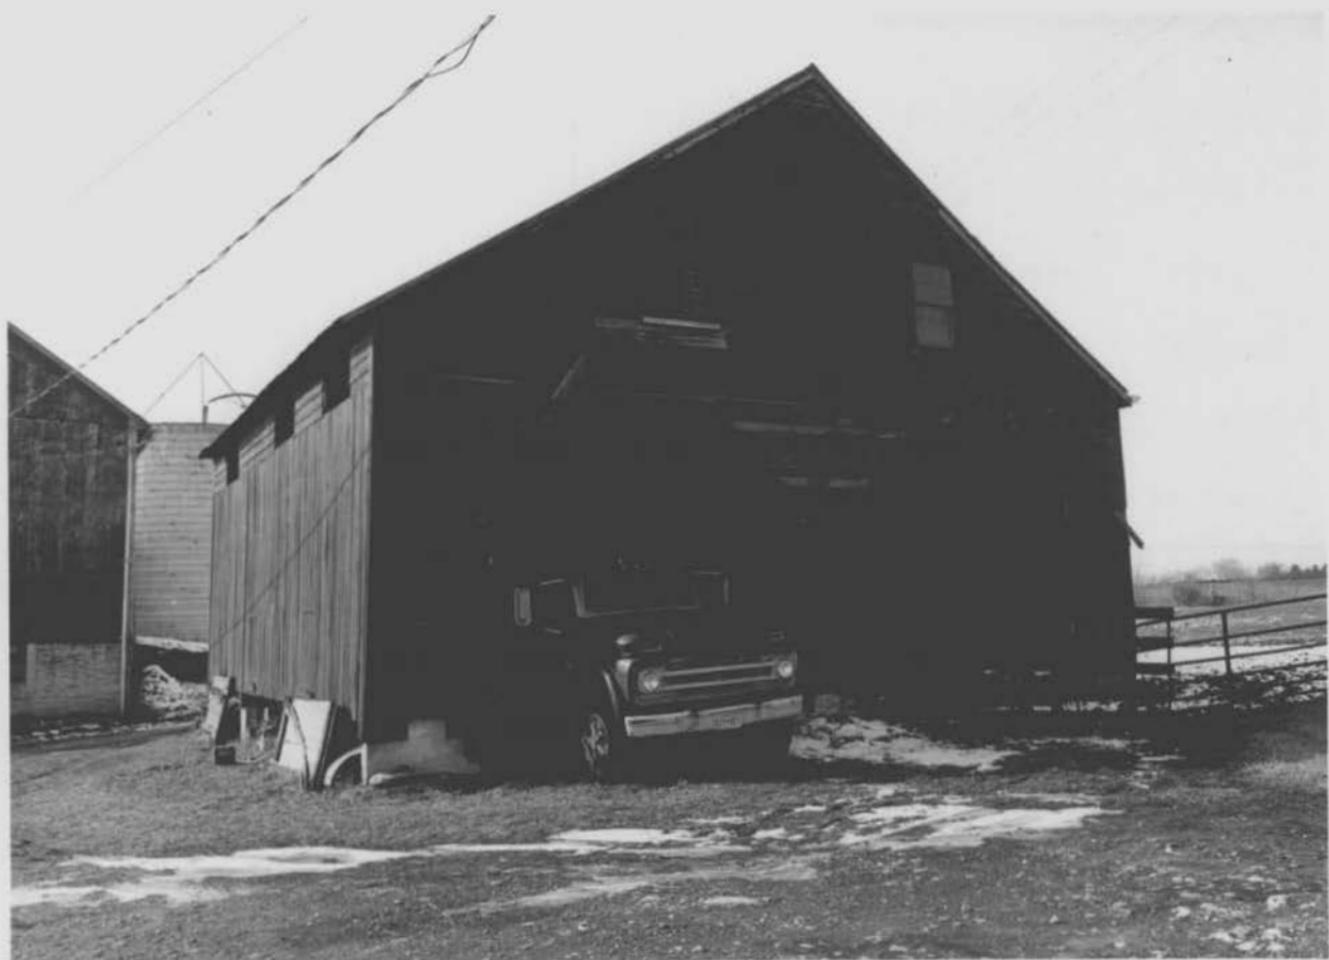
4/5

Wagon shed/corn crib, north elevation

Wagon shed/corn crib: The frame wagon shed/corn crib has two drive-through passages flanked by corn cribs. In the center pier is a staircase to the upper storage level, backed by a third corn crib bin. The exterior is german siding and in the north elevation are two window openings, both boarded. Along the east granary are three vent openings just below the eaves of the corrugated metal roof. The structure was probably built during the period 1875-1900.

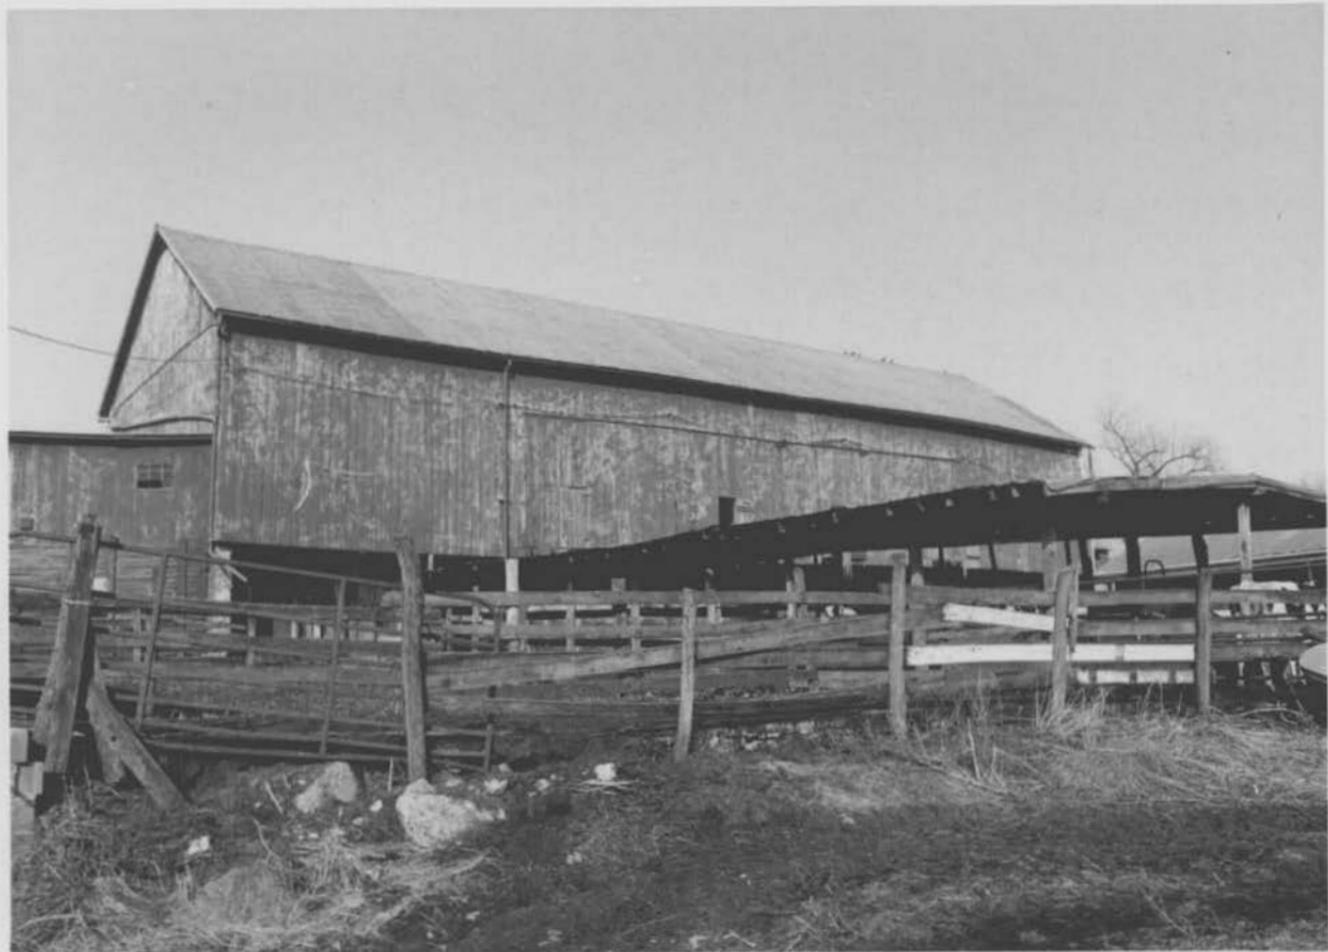
8/5

Bath east elevation

Bank barn: The frame bank barn is located south of the wagon shed. It has vertical siding and a standing seam metal roof. Its internal structural beams have circular saw marks, indicating that it was built about 1900-1920. A connecting frame catwalk on the south elevation links the barn with the non-contributing concrete block milking parlor.

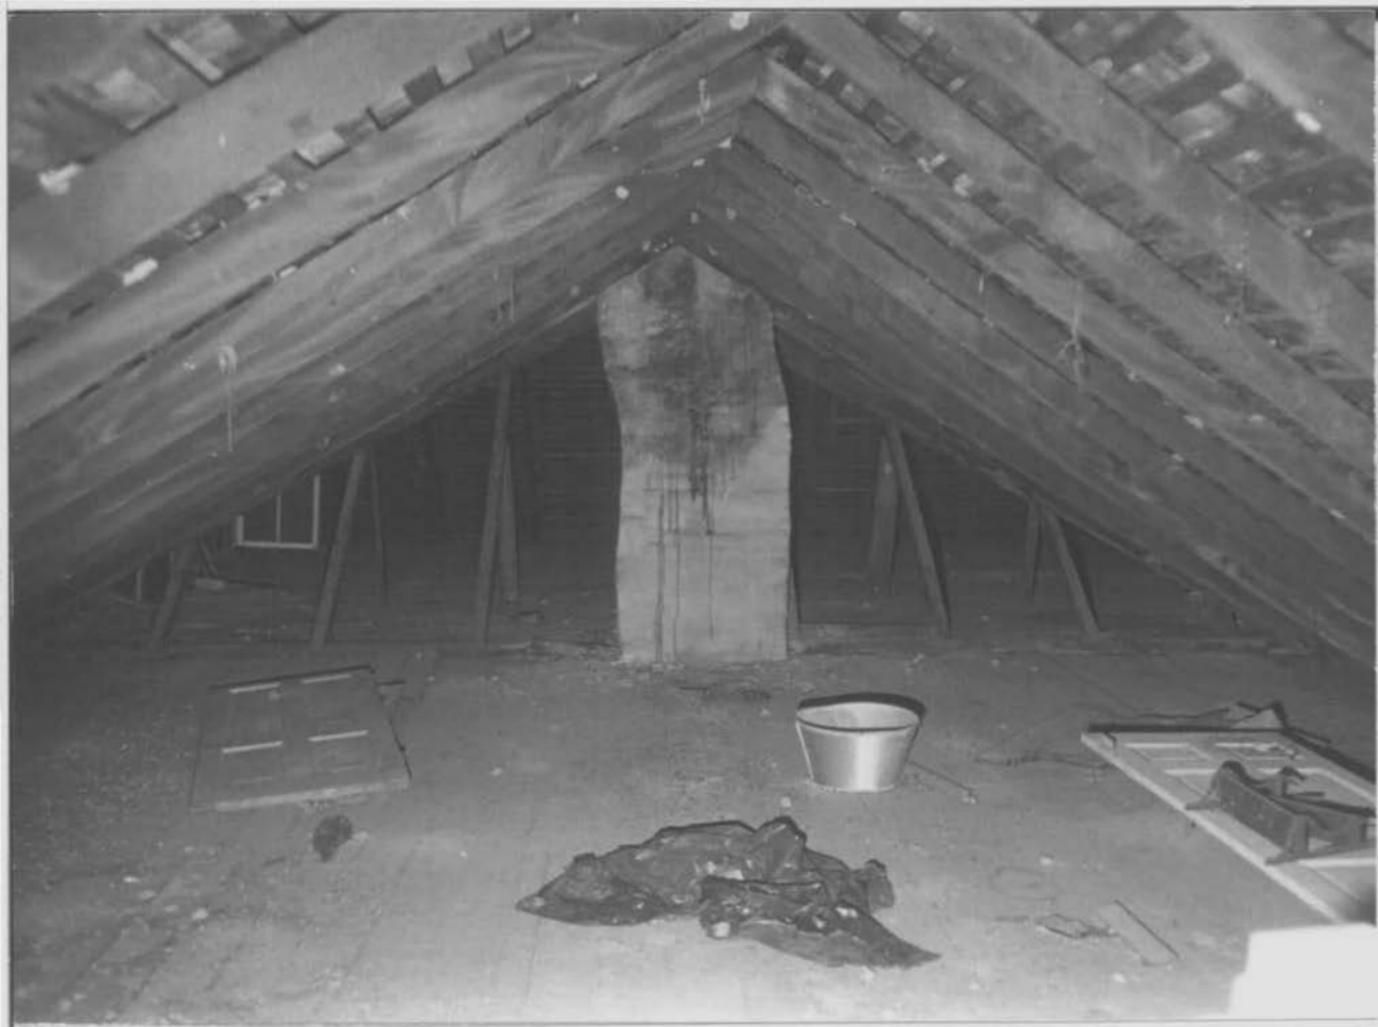
6 of 7

Main House, interior Attic of Addition, Facing West

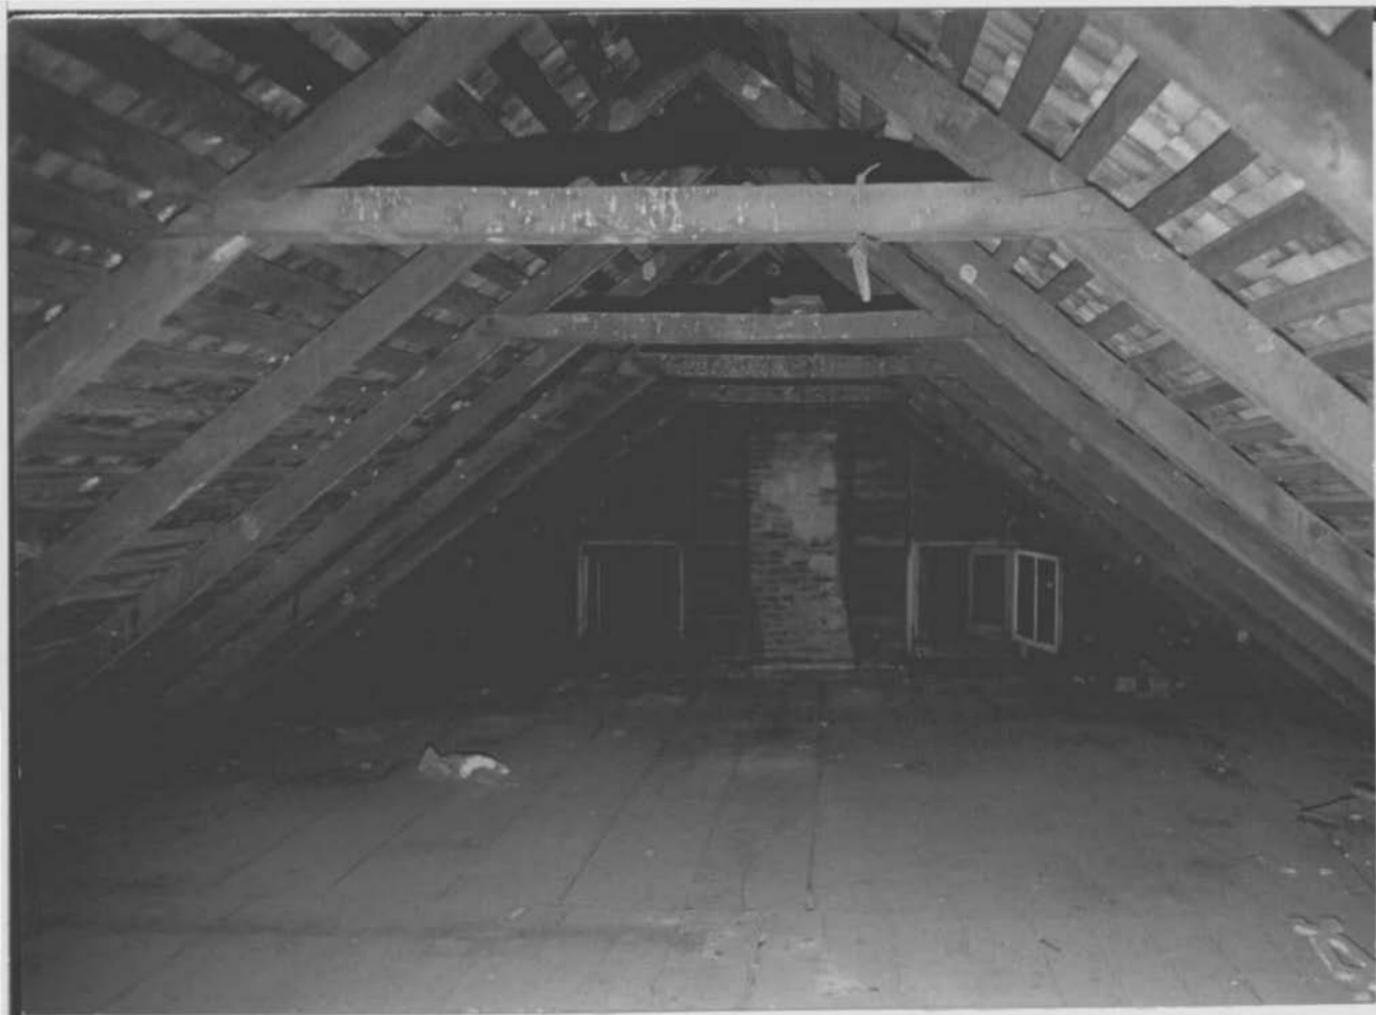
7 of 7

Main House, interior Attic of original section, Facing South
