F-4-44
Spoolsville Survey District
Middletown vicinity
Private

Spoolsville Survey District
Middletown
Frederick County

historic Spoolsville Survey District

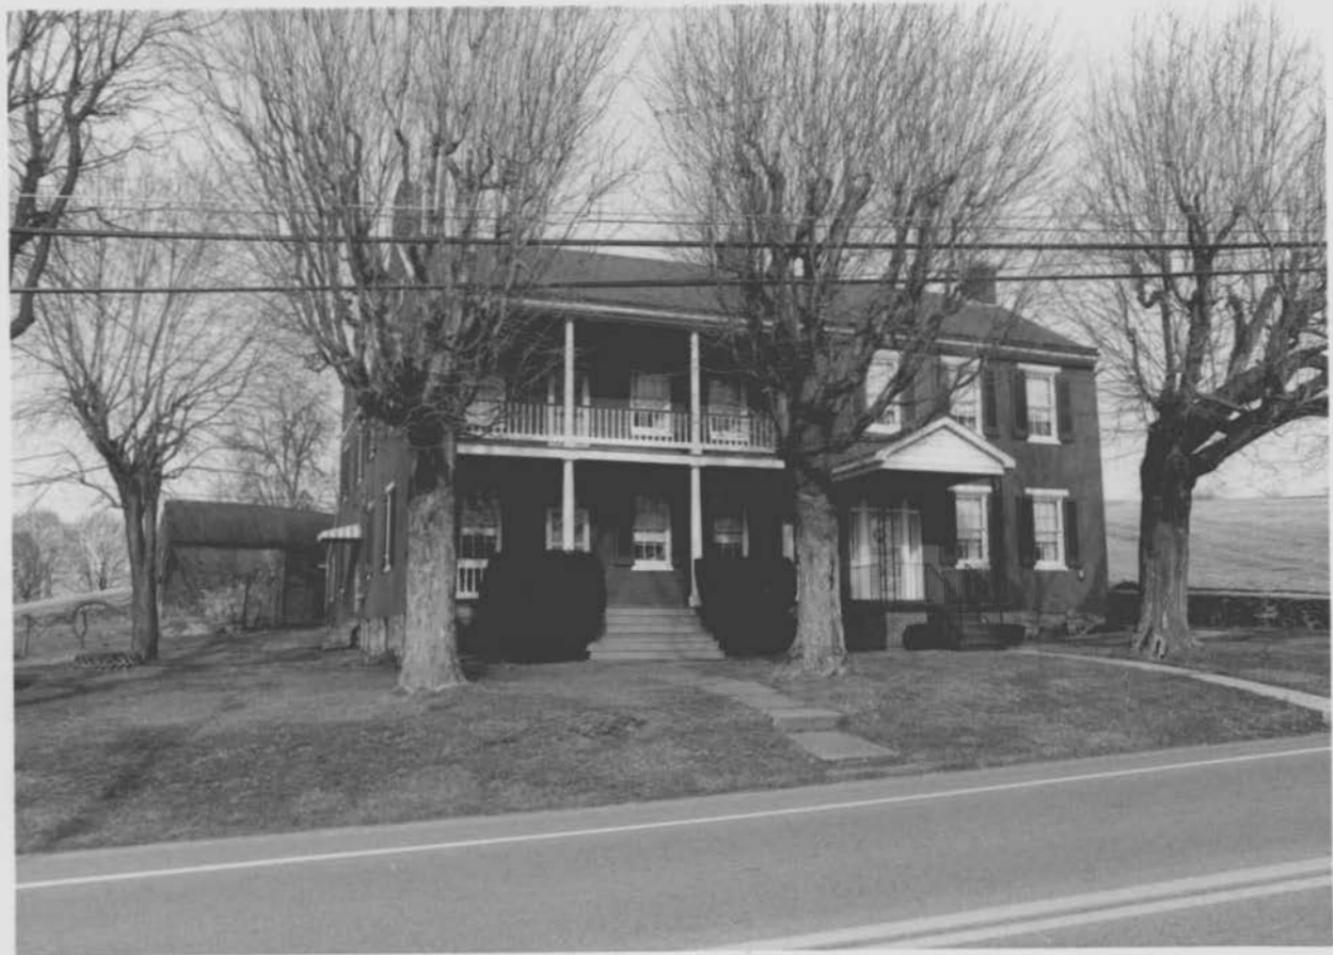
1/17

Koogle House, south elevation

Adam Koogle House, 3120 Old National Pike: The Koogle House is a two-story brick residence with a three-bay principal section facing south and a side wing with an integral two-story porch extending across the four bays of the wing. The main entrance in the three-bay part has an entry porch with replacement iron columns sheltering a doorway with transom and sidelights. The window openings have bull's eye corner blocks and 6/6 sash flanked by louvred shutters. The side wing porch has Tuscan columns. The house has interior end chimneys and a standing seam metal roof. A third chimney is located at the junction of the wing and main section. A two-story rear wing extends from the north elevation and has a shed addition, probably a mid-20th century alteration. Associated with the house are a frame chicken house and a brick and frame summer kitchen located near the northwest corner of the house. It has a corrugated metal roof and an exterior chimney. The Koogle House was probably built about 1830.

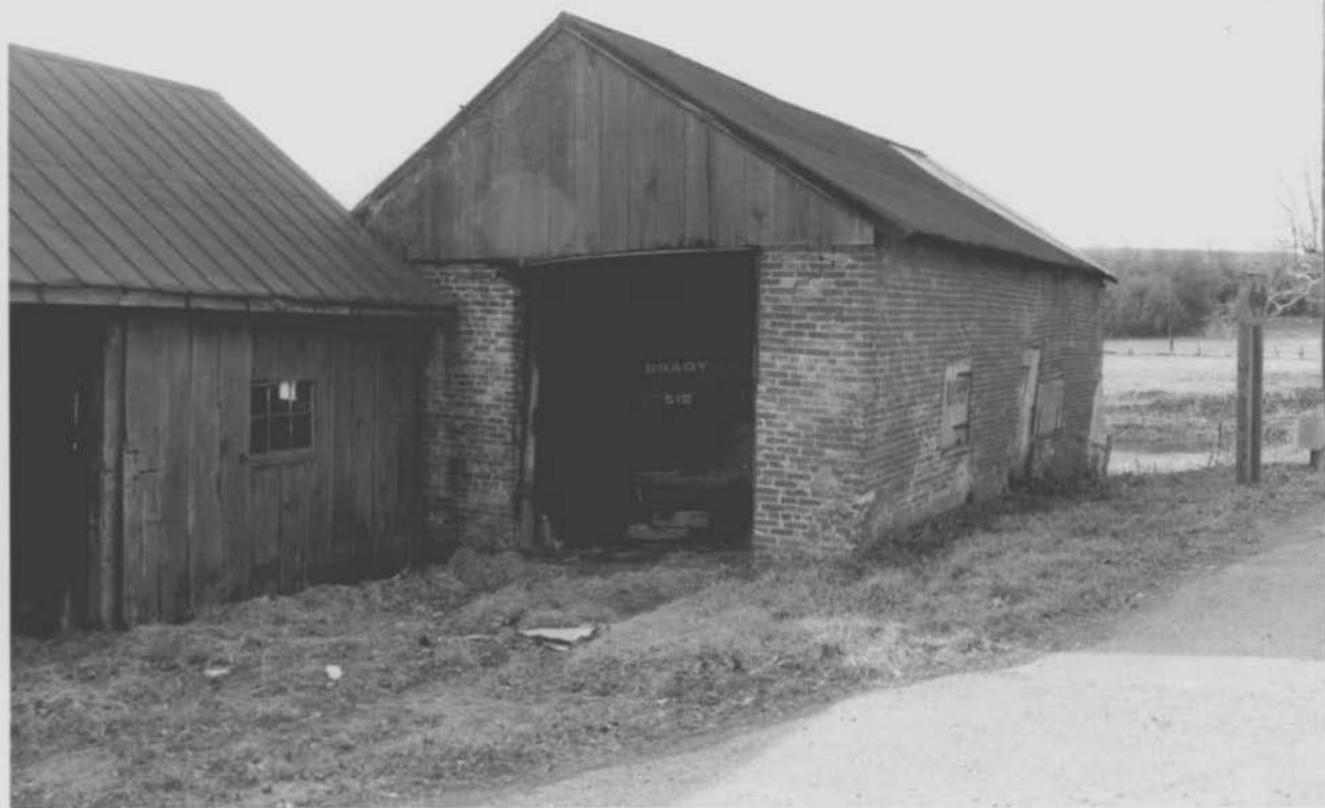
21-1

Blacksmith shop, east elevation

Blacksmith shop: The brick one-story blacksmith shop is located on the south side of Old National Pike near the west boundary of the survey district. It is rectangular in form and has 5:1 bond. The gable ends on the east and west are frame with vertical siding. In the east elevation is an enlarged doorway made when the building was converted to an agricultural equipment shed, probably in the early 20th century. An attached frame shed at the southeast corner has board and batten siding and a standing seam roof, as does the brick structure. On the north elevation of the brick shop is a solid shuttered window opening with strap hinges and vertical boards. A vertical board door is also located in the north elevation. According to one resident of the survey district, the shop was moved to its current location from the north side of the Pike and was only a part of the blacksmith shop. The early inventory form also refers to its being a remnant of a larger shop. It appears to date from about 1840-50 and the 1858 map does show a blacksmith shop on the north side of the Pike, and the 1873 map shows the shop on the south side.

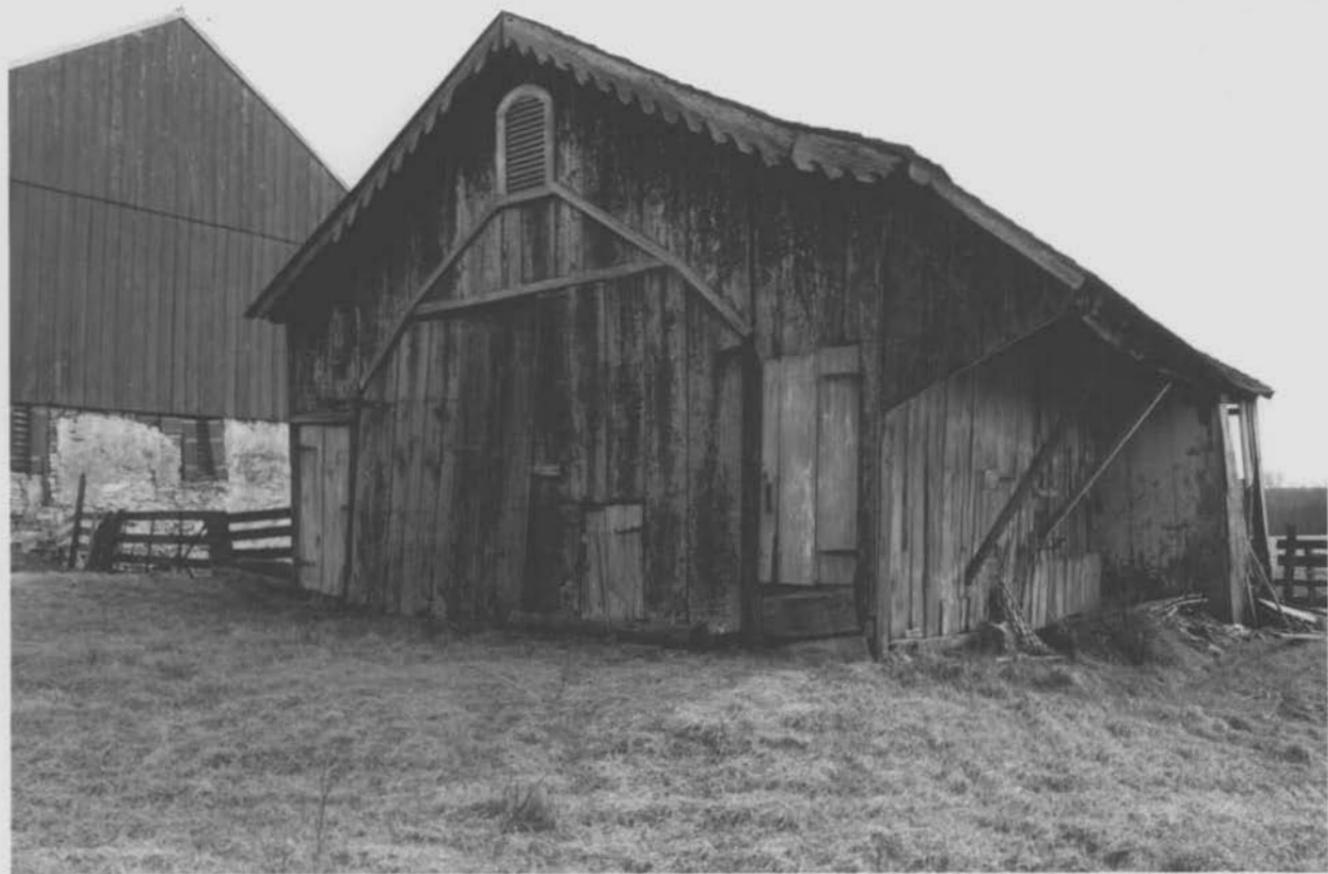
4/17

Wagon shed/corn crib, southeast corner view

Agricultural outbuildings: The agricultural outbuildings are associated with the Koogle House. They include a frame bank barn, a frame hog barn with an exterior stair to the upper granary level under an extended eave, a frame wagon shed/corn crib with a part of a decorative bargeboard remaining, and a small frame barn located south of the main group of outbuildings. All of the buildings have vertical siding and corrugated or standing seam metal roofs. They were built during the last quarter of the 19th century. A non-contributing concrete block dairy barn, a milk house, and a concrete silo built during the 1950's are located east of the frame outbuildings.

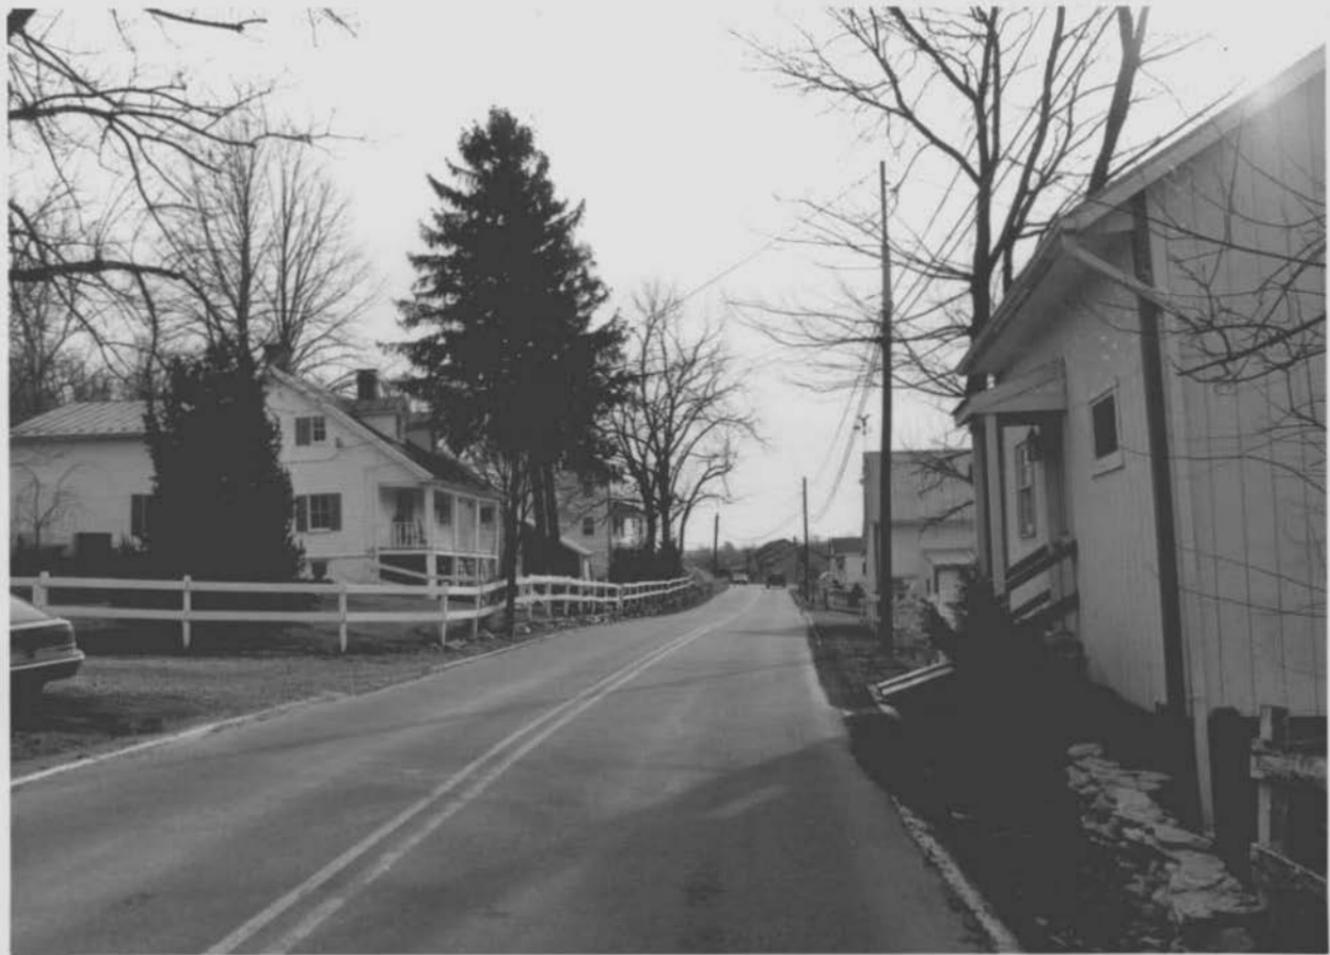
6/17

View south on Old Hagerstown Road

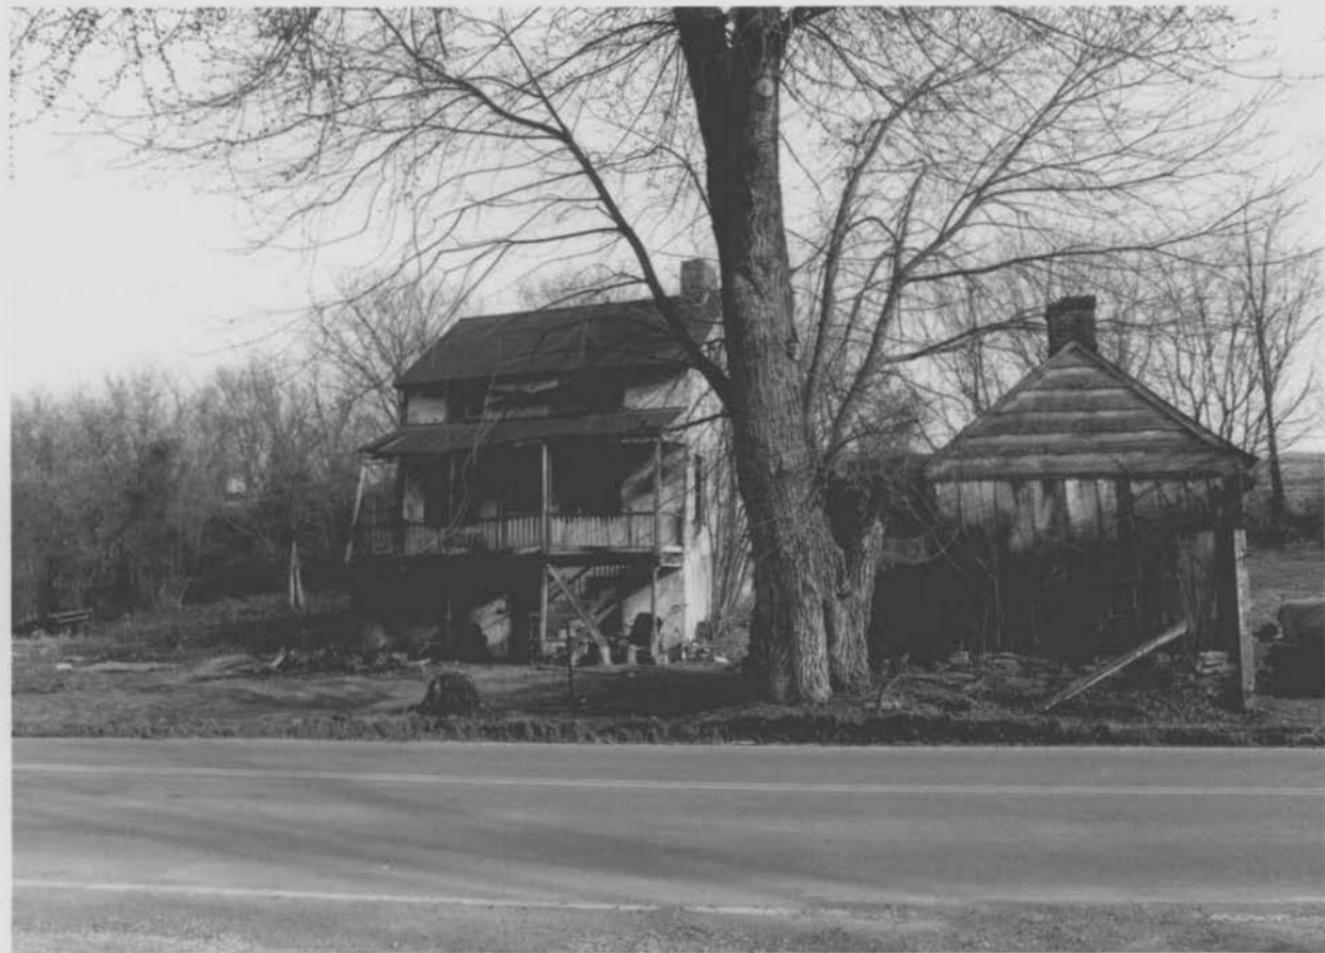
7/7

Abandoned house and summer kitchen, Old Hagers
Town Road, west side of main

Abandoned house: The 1-1/2 story abandoned log house is located on the east side of Old Hagerstown Road. It is in very deteriorated condition. The raised stone foundation is plastered and the remaining windows are 9/6. The roof is corrugated metal with a single interior end chimney. The three-bay west elevation has a two-level porch. Located at the edge of the road is a log summer kitchen with vertical siding and a corrugated metal roof. An interior chimney is located on the west gable end. A vertical board door is in the east elevation. The date of the two buildings is about 1830-40.

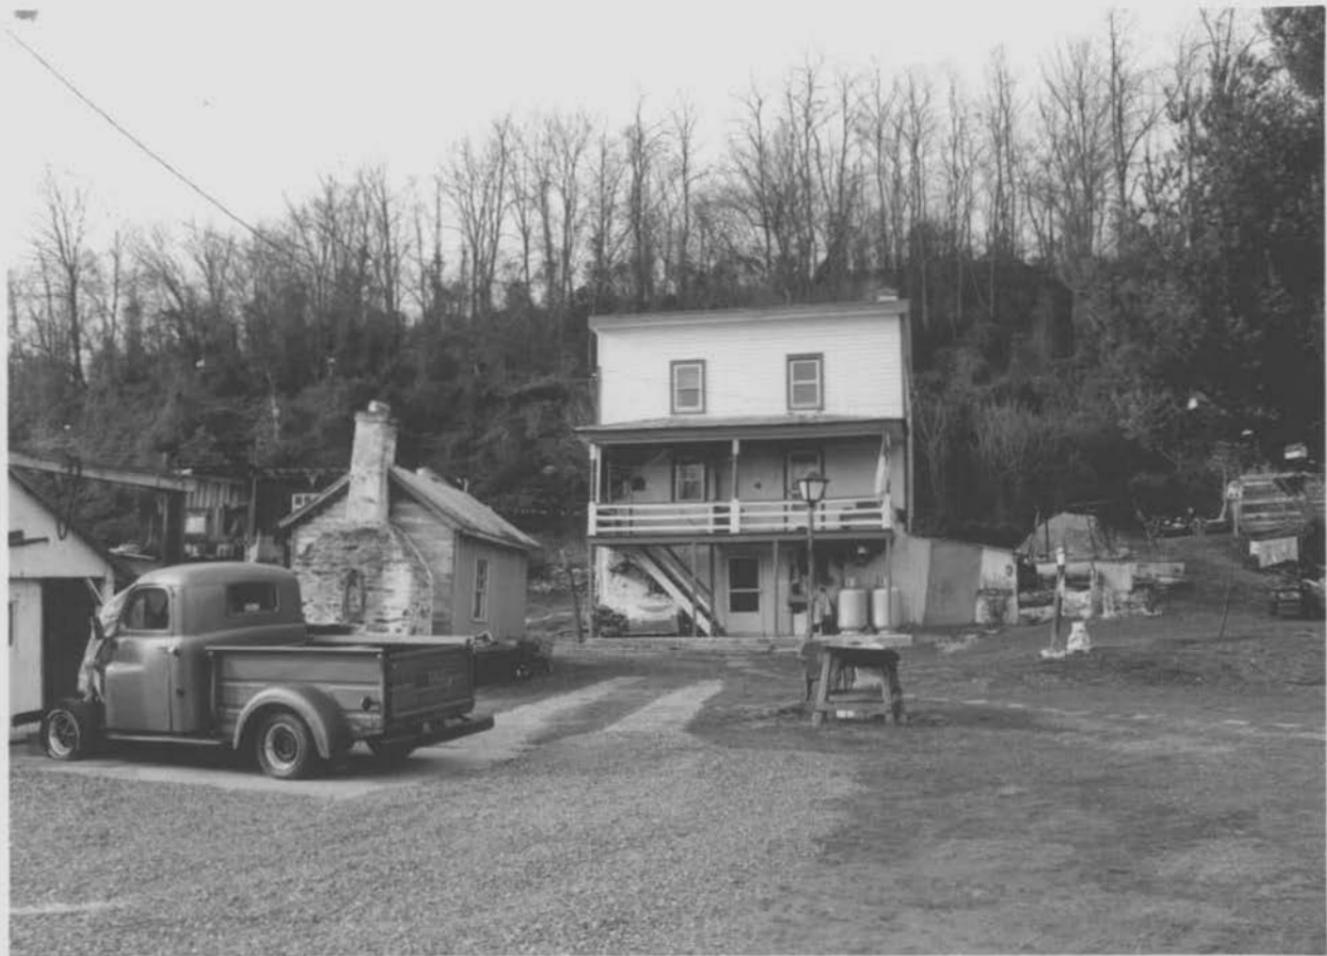
8/17

3022 A Old Rogerstown Road, southern location

8022A Old Hagerstown Road: This is a frame house built in about the last quarter of the 19th century on the west bank of Little Catocin Creek. The two stories are on an exposed stone foundation facing east. It has been much altered and the siding appears to be of several types, some asbestos shingles, some german or vinyl. The roof is corrugated metal. The replacement sash is 1/1 and the doors are also replacements. Several non-contributing outbuildings and sheds surround the house. The only contributing outbuilding is a log wash house with an exterior stone and brick chimney. The siding is german and the roof is corrugated metal.

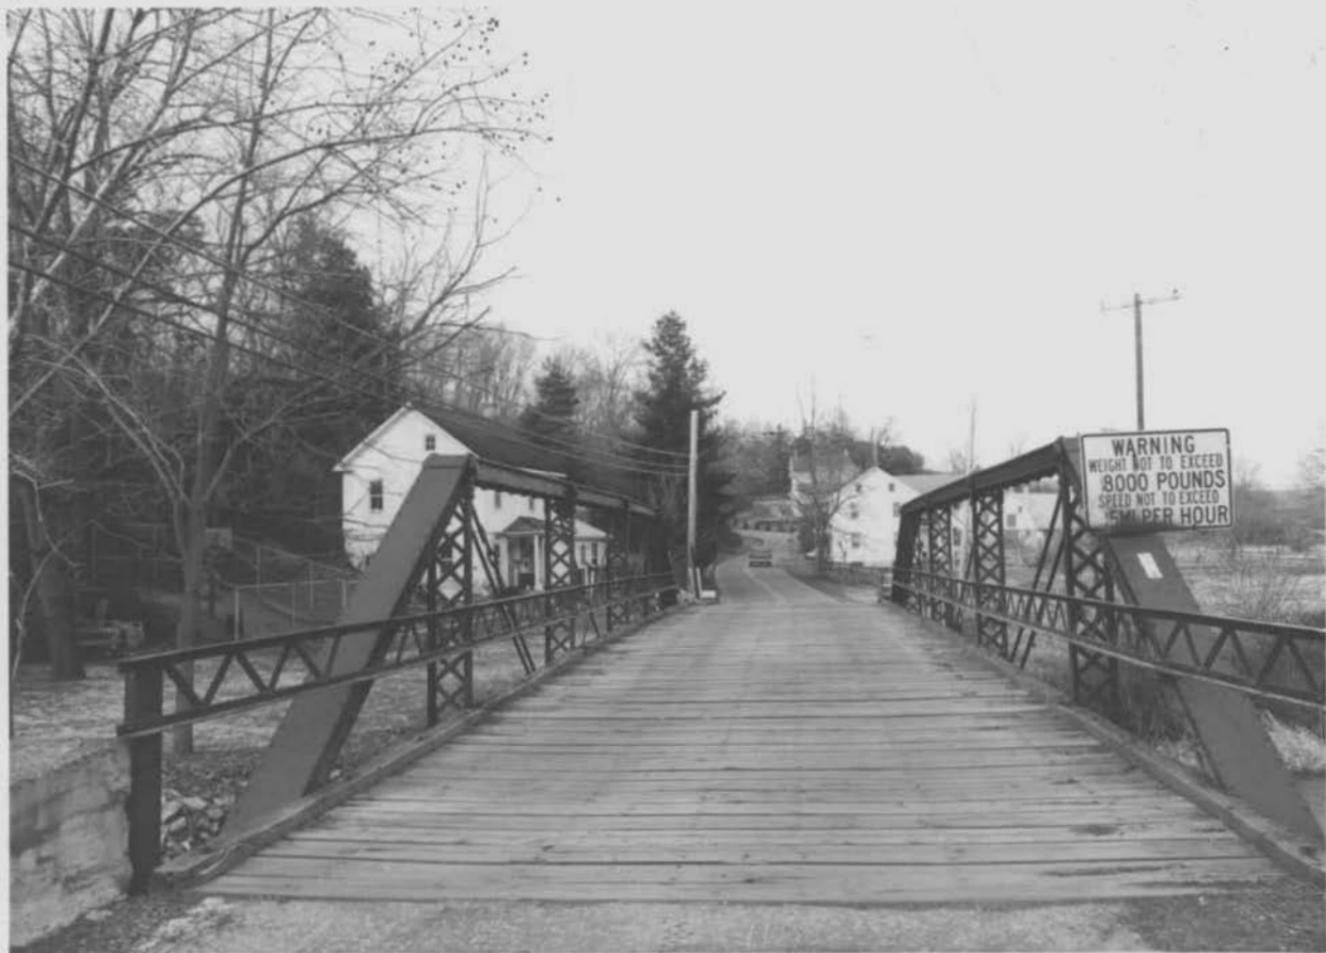
View north over Old Waterstown Road bridge
10/17

Old Hagerstown Road Bridge No.03-01 (F-4-2): The steel bridge is a single span pony Pratt truss built about 1920 over Little Catocin Creek. It is 66 feet long and about 27 feet wide. The connections are pinned and the deck is wood. The abutments are stone. No plaque is on the bridge, but the original inventory form estimates the date as 1920 based on State records (unidentified) and suggests the builder was probably the York Bridge Company of York, Pa.

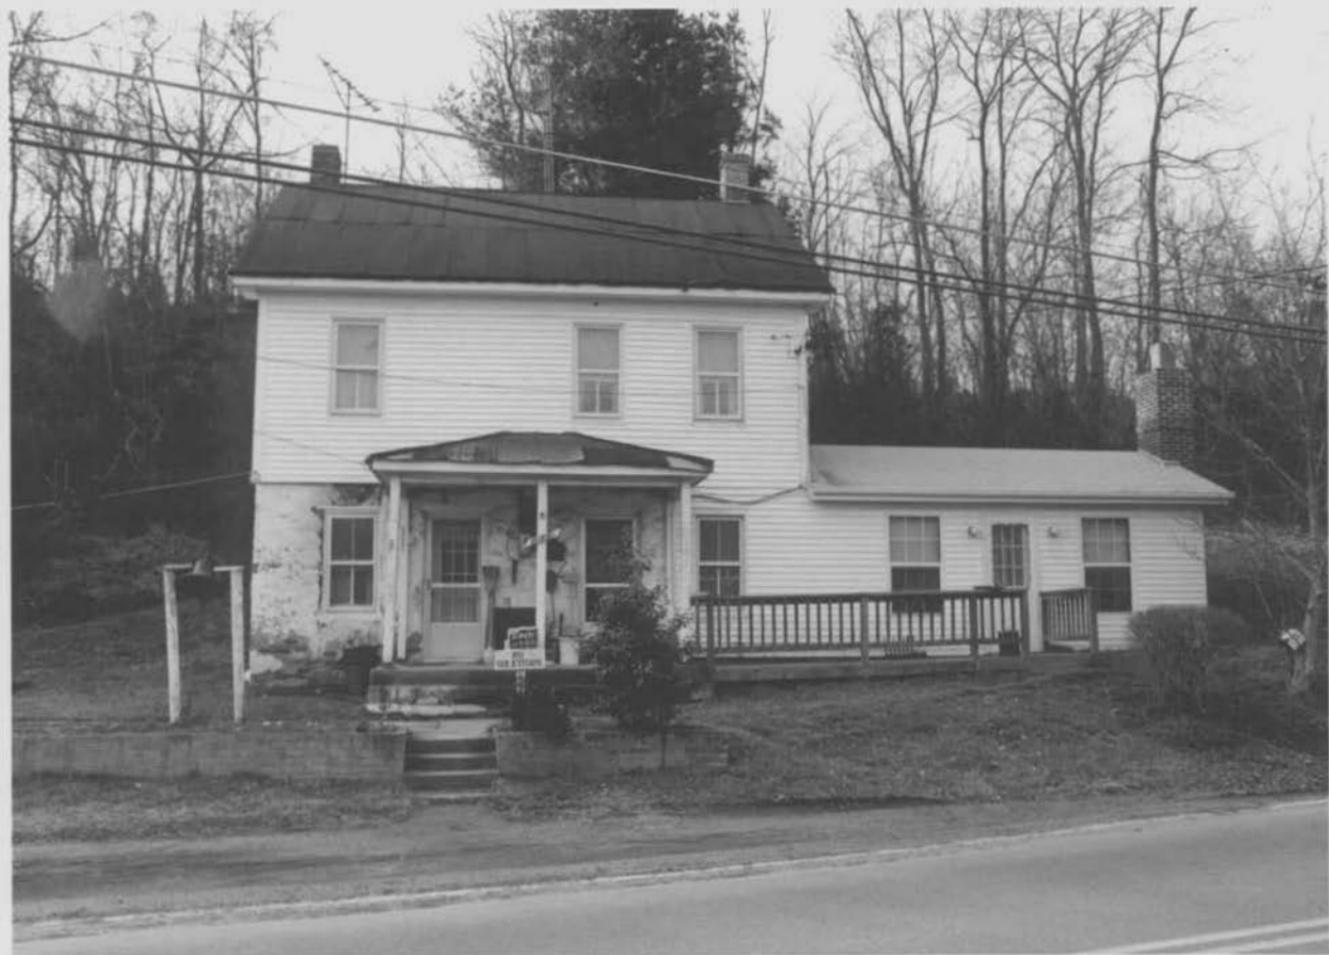
11/17

8100 Old Hagerstown Road, east elevation

8100 Old Hagerstown Road: This is a two-story frame or log house with three bays and a one-story porch on the east elevation. The house has two entrances, 2/2 sash, and replacement doors. The exterior is covered with vinyl siding. A one-story rear addition extends from the west elevation. The probable date of construction is about 1850.

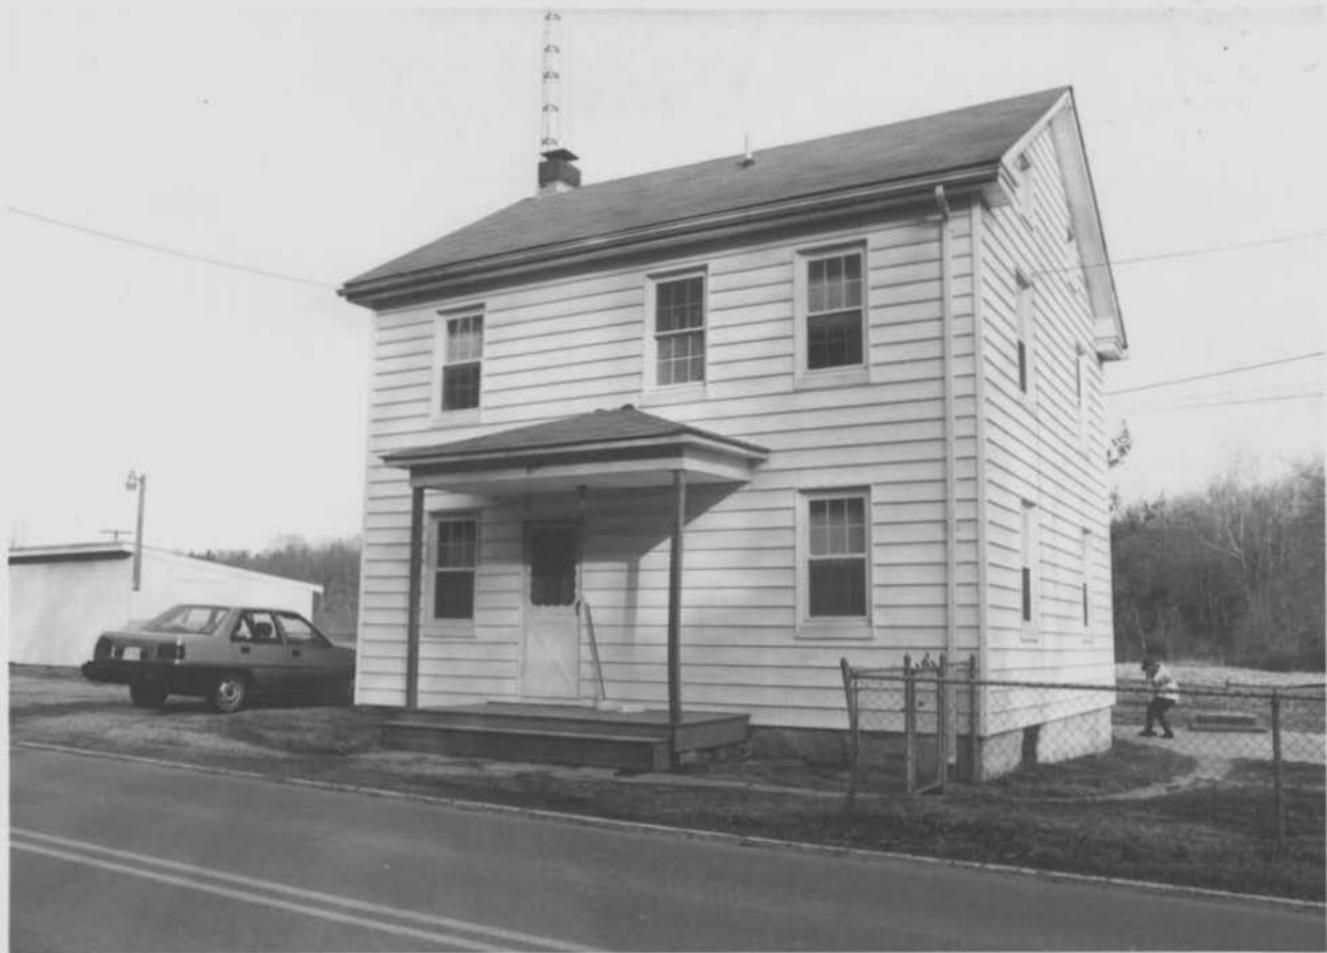
12/14

8107 S. Maryland Road, west elevation

8109 Old Hagerstown Road: The house is a three-bay, two-story log or frame house with asbestos shingle siding and a corrugated metal gable roof. Like 8100, the house has replacement doors and windows and a one-story porch. Located at the edge of Old Hagerstown Road, it was probably associated with the

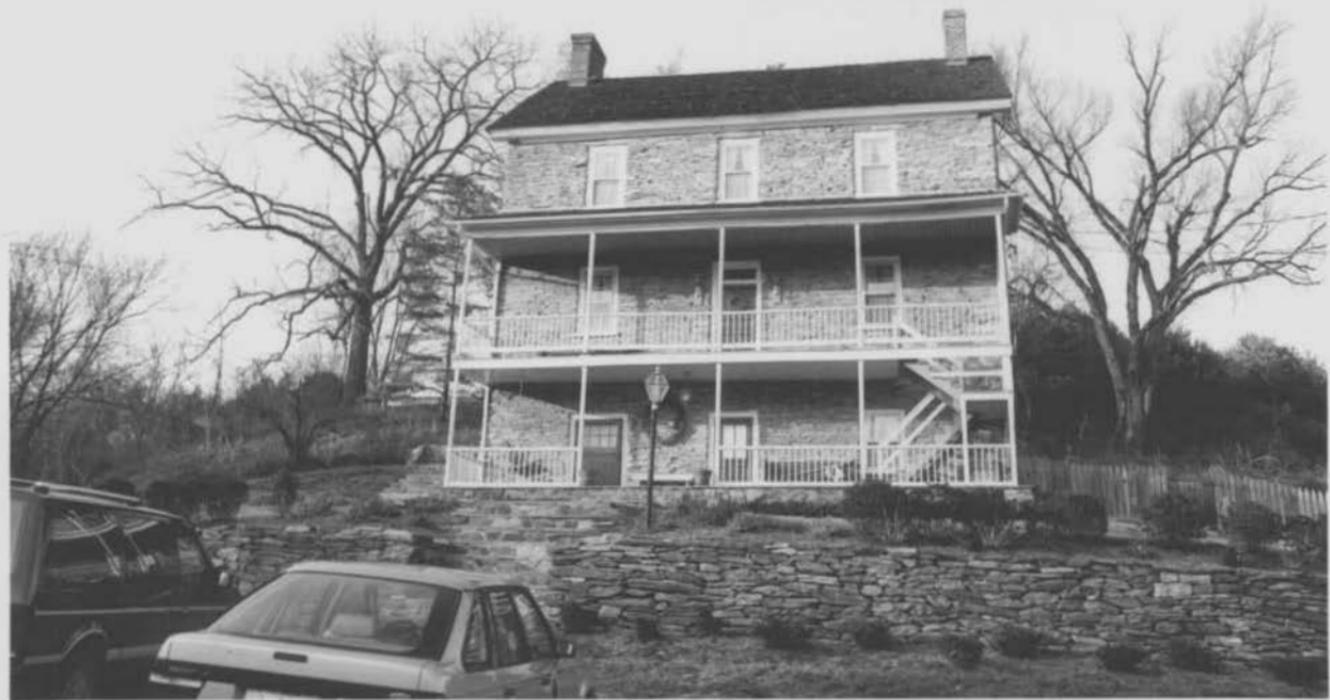
13/17

Bowling House, 5123 Old Hagerstown Road
South elevation

Bowlus Mill House, 8123 Old Hagerstown Road: The two-story stone house is located against a slope with an exposed foundation level on the south elevation. It has a two-story frame porch and a three bay elevation. The roof is standing seam metal. The sash is 6/6. The house has been recently restored and its interior features include original floors, plaster walls and plain door and window surrounds. The mantelpieces are particularly outstanding, being excellent examples of German carved decoration with edge designs of incised and raised floral motif and central medallions of flowers. An iron fireback with an illegible German proverb worked into the design was found outside the house and has been placed in one of the lower level fireplaces. The house was probably built about 1800. Associated with the Mill House are a frame bank barn of about 1850, a frame shed, and a wagon shed/corn crib located south of the house. A non-contributing concrete block dairy barn to the east stands on the site of the Bowlus Mill, later called the Keller Steam Mill or the National Steam Mill.

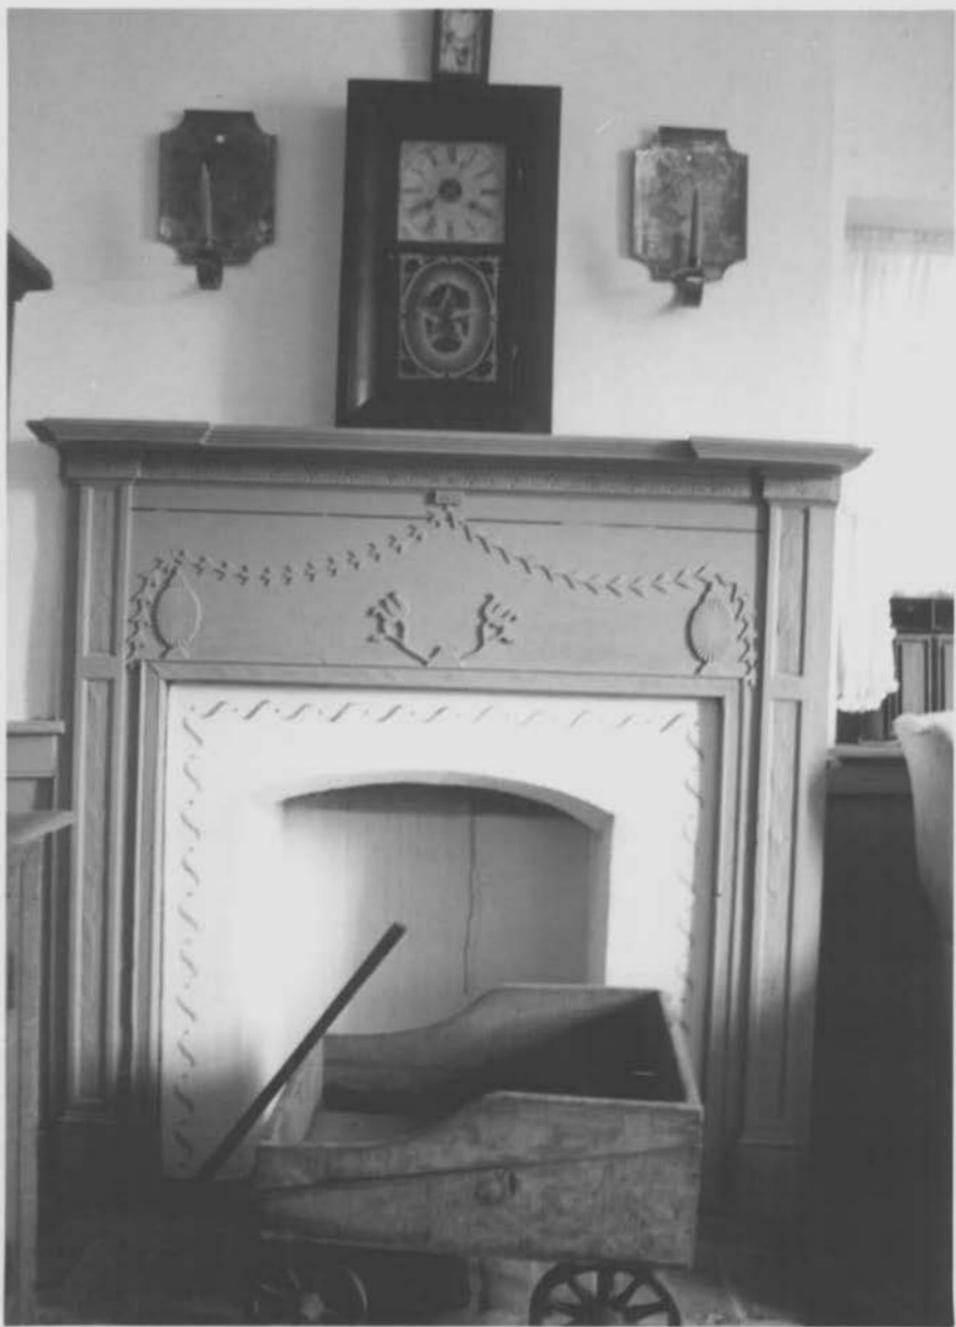
Bowling House 2nd floor window
12/79

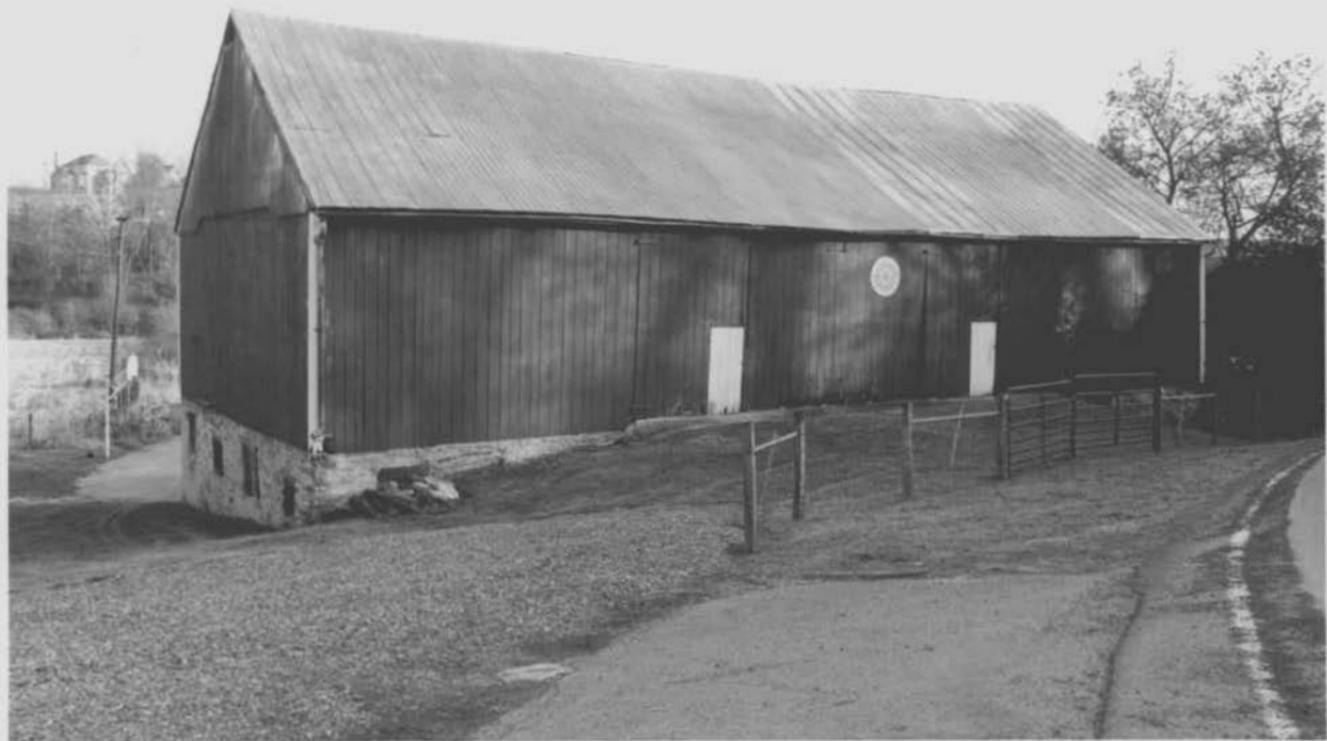
16/17

Bowling Green, So. 1/2/1917, north elevation
