F-4-50
Daniel Palmer Farmstead
Ellerton vicinity
Private

Maryland Historical Trust State Historic Sites Inventory Form

F-4-50
Daniel Palmer Farmstead
Ellerton
Frederick County

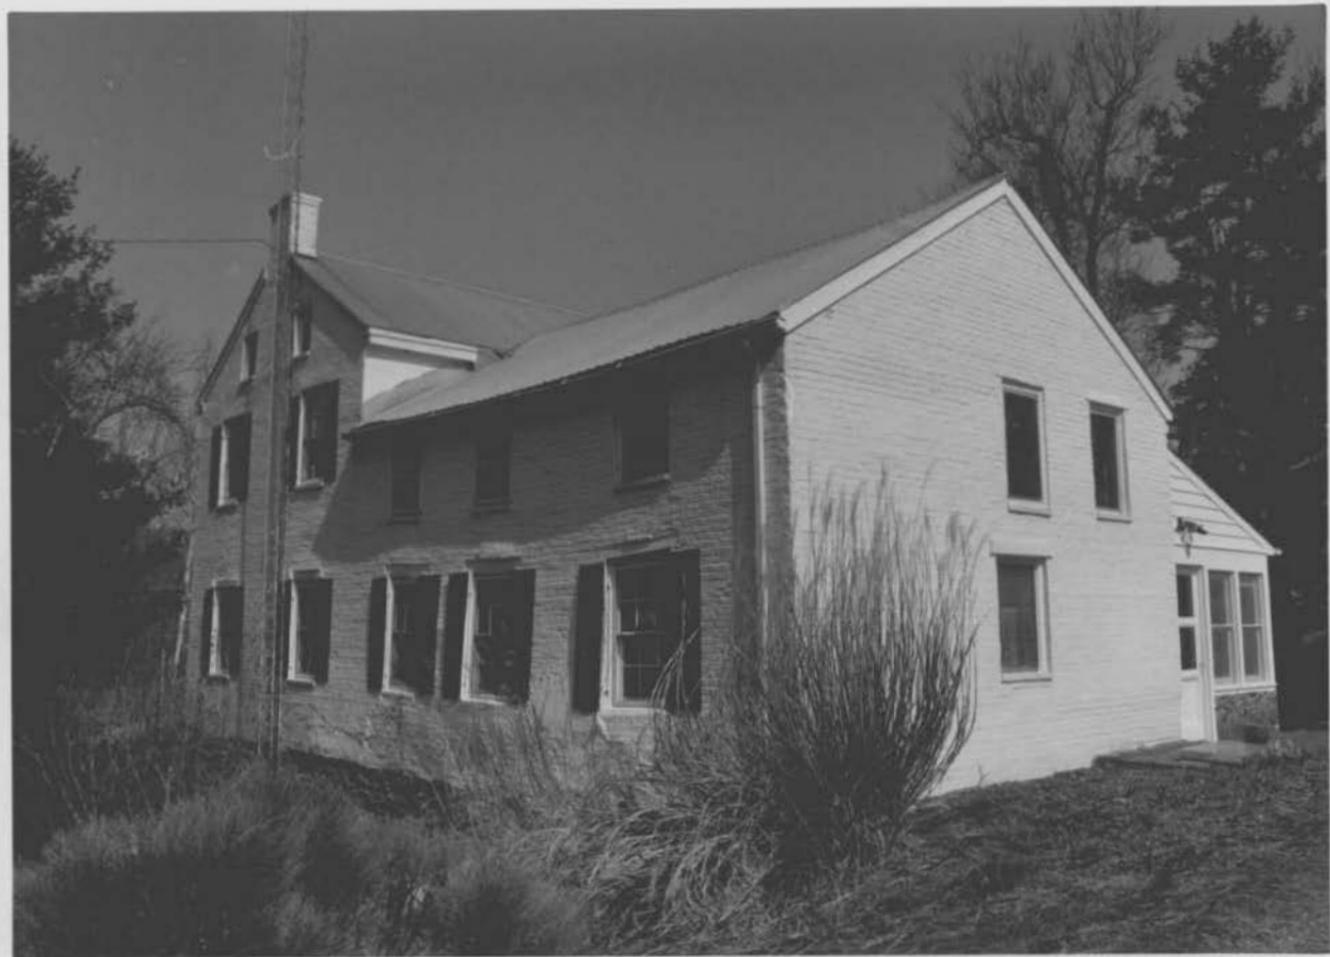
2/7

The dwelling is a two-story, three-bay brick structure with a 1-1/2 story brick rear wing. The bond pattern is unclear, with patches of 6 and 5 course American bond intermittently showing among predominantly stretcher bond and sections of new brick appearing in the vertical spandrels between the windows of each floor, near the gable end roof edges, and on the entire south elevation of the wing. The surface is painted white. The north elevation has an exposed stone foundation and a rebuilt frame entry porch rises to the center entrance. The square columns of the porch are salvaged members of the original porch. The stone foundation has raised grapevine type repointing, probably done in the early 20th century. The entrance has a transom and sidelights. The window arches are plain lintels with unadorned corner blocks. The sills are brick, indicating that they are replacements. The exposed foundation has window openings with wood sills, which are undoubtedly samples of the original material. The windows are 6/6 with replacement shutters. The cornice is boxed and the standing seam metal roof is also a recent replacement. The interior chimneys are located at the east and west gable ends. The gable ends have two bays each. On the east elevation is a cellar entrance with a four-panel door. Square attic level windows flank the chimney stacks and have ventilator fans on the east elevation and louvred covers on the west elevation.

Southeast view

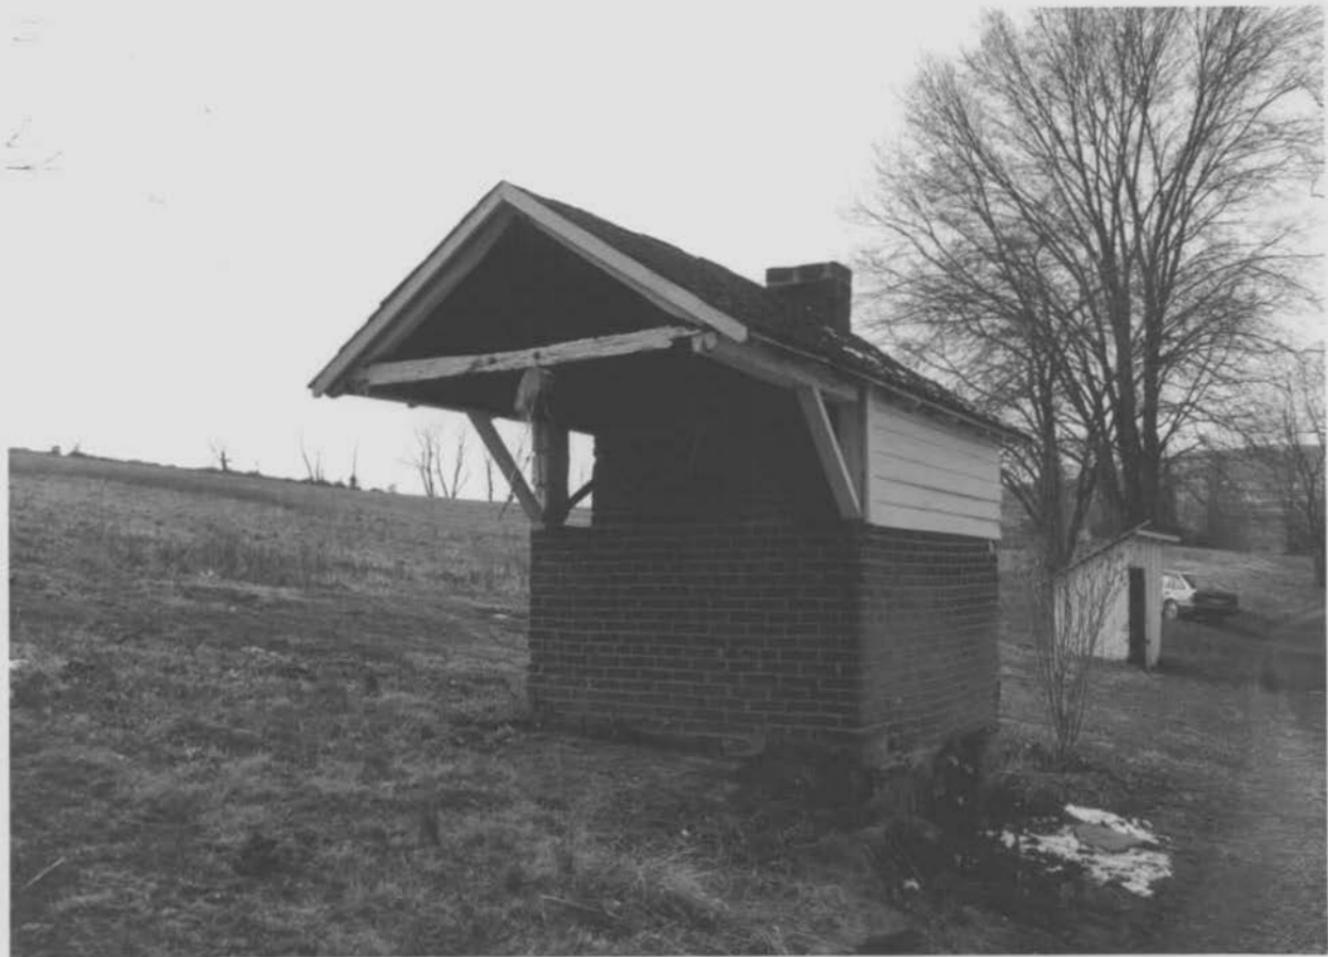
7/9

Bake oven: The bake oven is a roughly rectangular structure located just south of the rear wing. It has a stone foundation and a brick upper section. The domed top is plastered with concrete and the brick appears to have been repointed in recent years. Above the oven is a frame roof structure with shingles and german siding which extends over the east side above the oven door. The west part of the oven is a smoking chamber, with a firebox opening on the north side of the stone foundation and an access door on the west side. On the south elevation is the oven firebox opening. The oven opening itself is arched brick. The date of the bake oven is probably about 1850.

Bake oven, north-east corner view

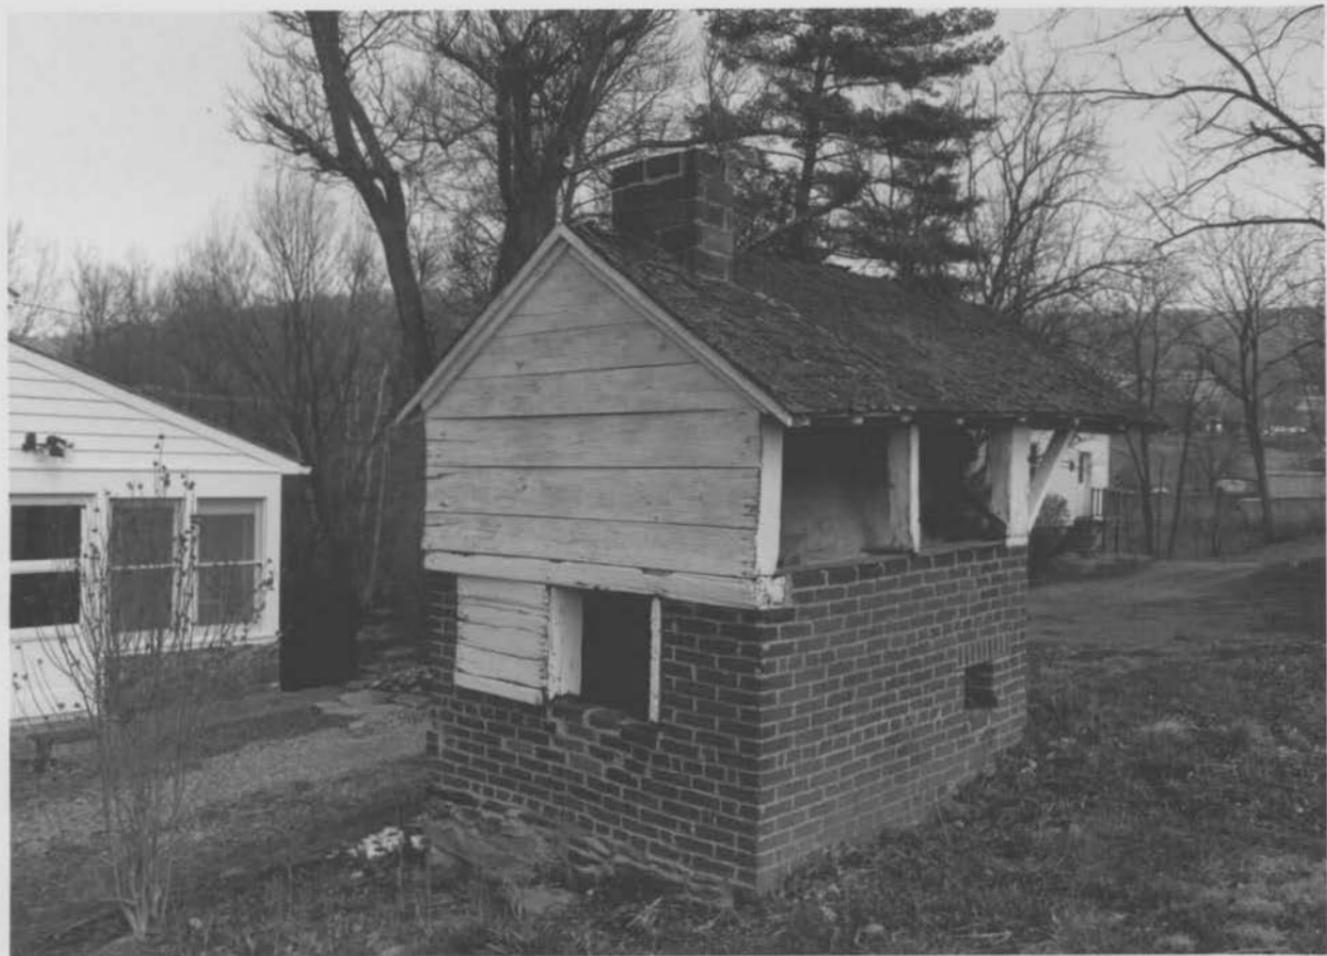
6/9

Boke own. Southeast & front view.

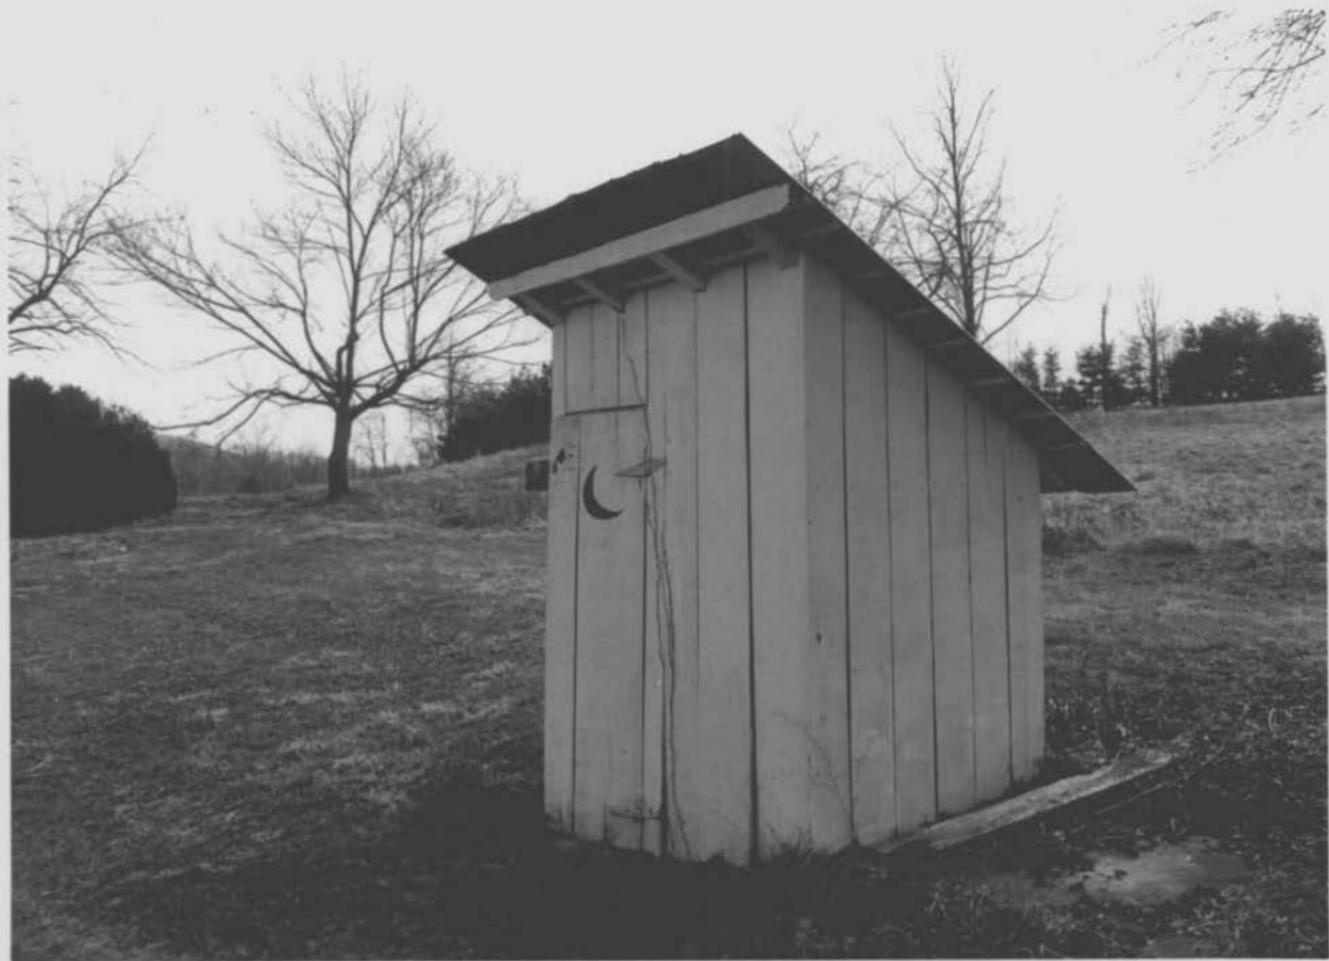
7/9

Privy: The frame privy dates from the last quarter of the 19th century. It is located southwest of the dwelling on the south side of the farm lane leading to the barn. It has vertical siding and a new metal roof. The privy had three seats and a single vertical board door in the north elevation.

Privy, northwest corner view

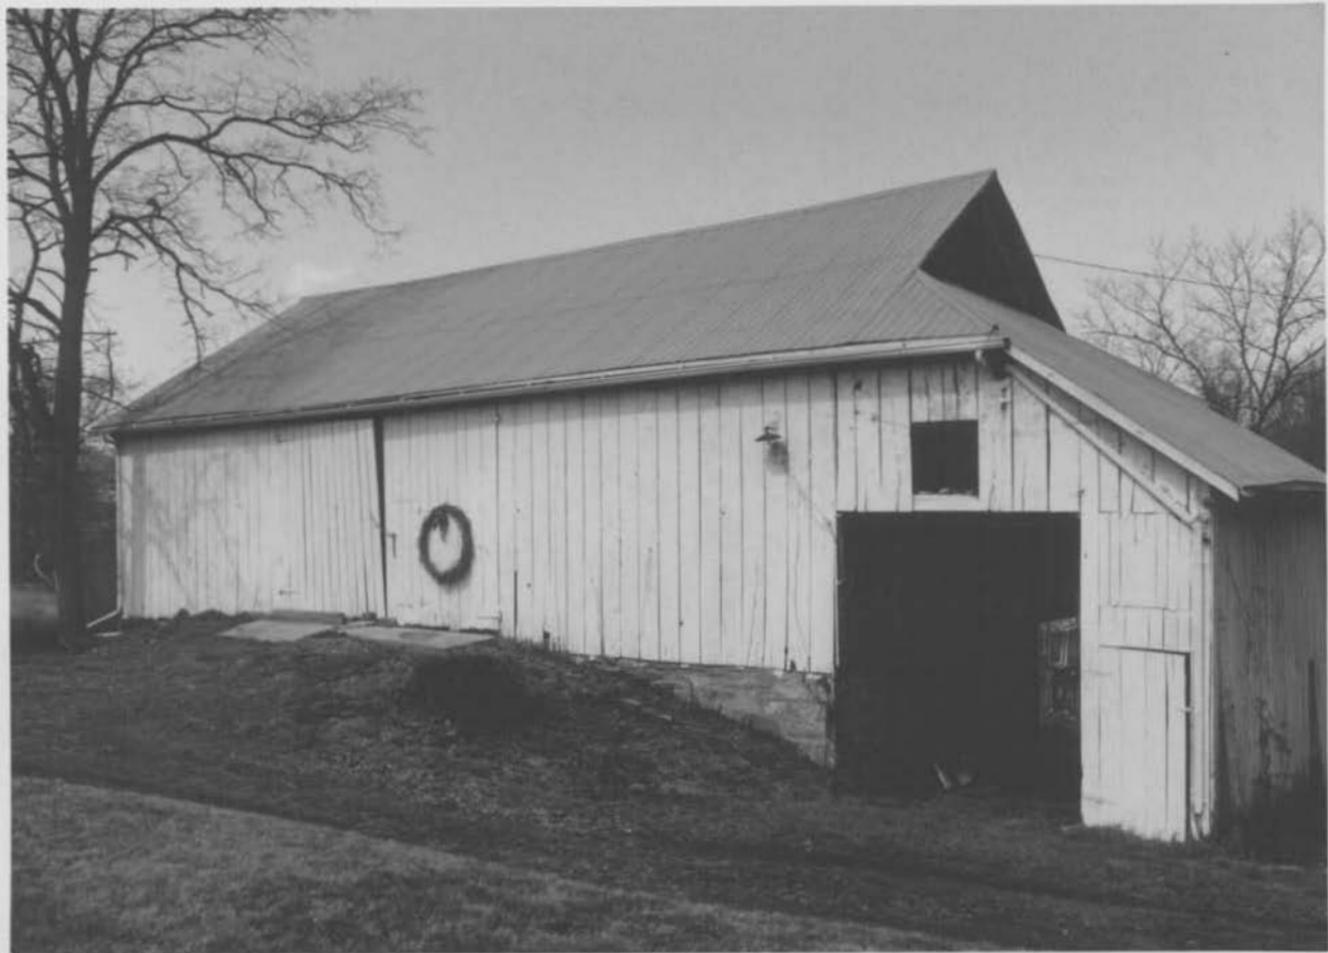
2/2

Barn: The frame bank barn is built on a stone foundation which may be earlier than the upper level. The framing timbers and exterior vertical siding have circular saw marks, indicating an early 20th century construction, perhaps to replace an earlier barn which burned or became deteriorated. The standing seam metal roof is also a recent replacement. The stall level on the north elevation has lattice and horizontal flush board enclosure. On the east gable end of the barn is a shed for wagons with a granary bin on the outside wall. The doorway at the ramp on the south elevation has double swinging doors.

Barren, south elevation.

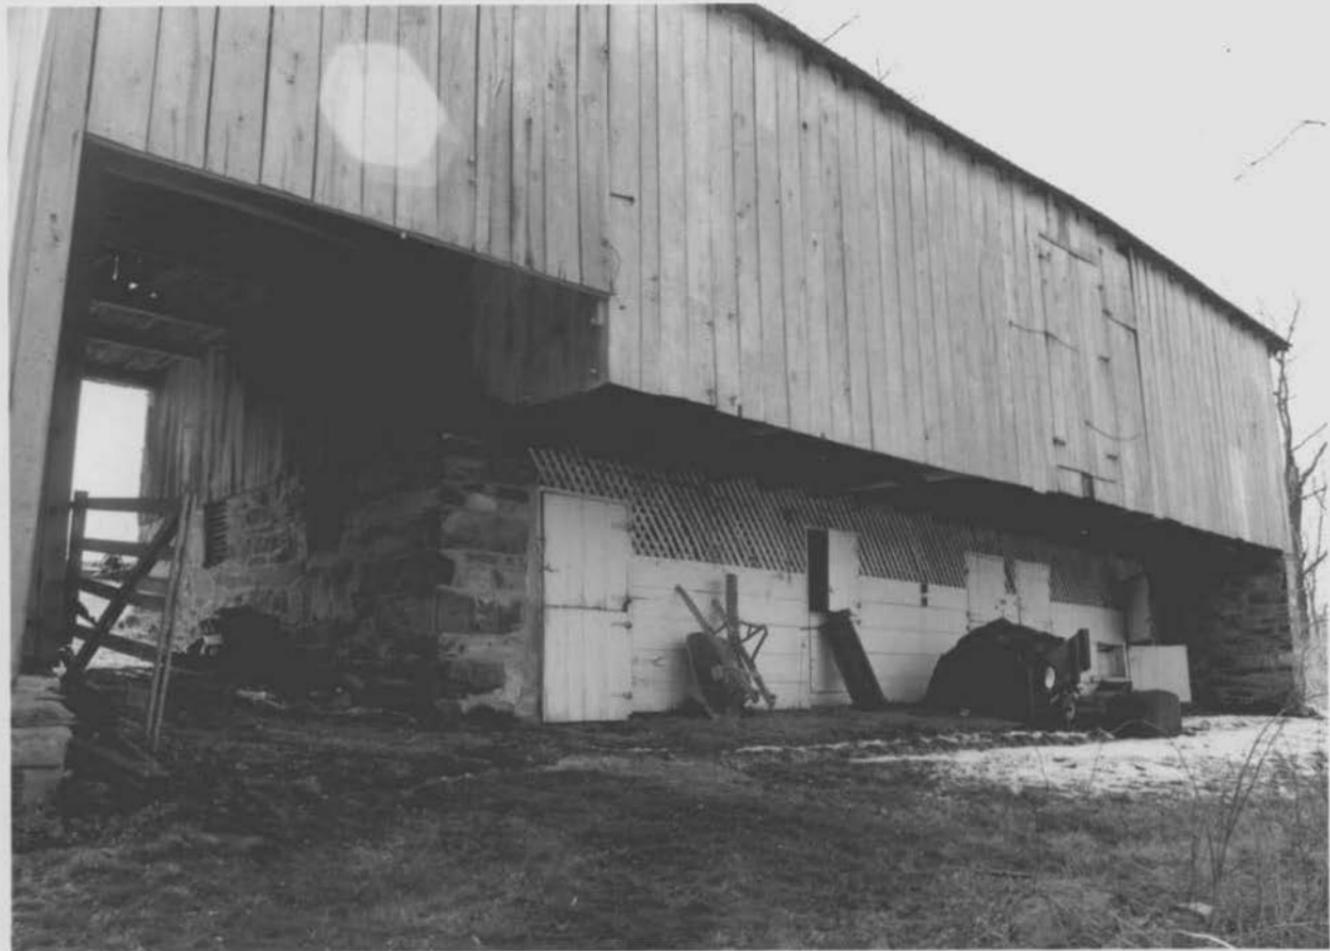
a/a

E. 1/4, north elevation
