F-4-52

Harmony Survey District  
Myersville vicinity  
Private

F-4-52  
Harmony Survey District  
Beallsville  
Frederick County

# Maryland Historical Trust State Historic Sites Inventory Form

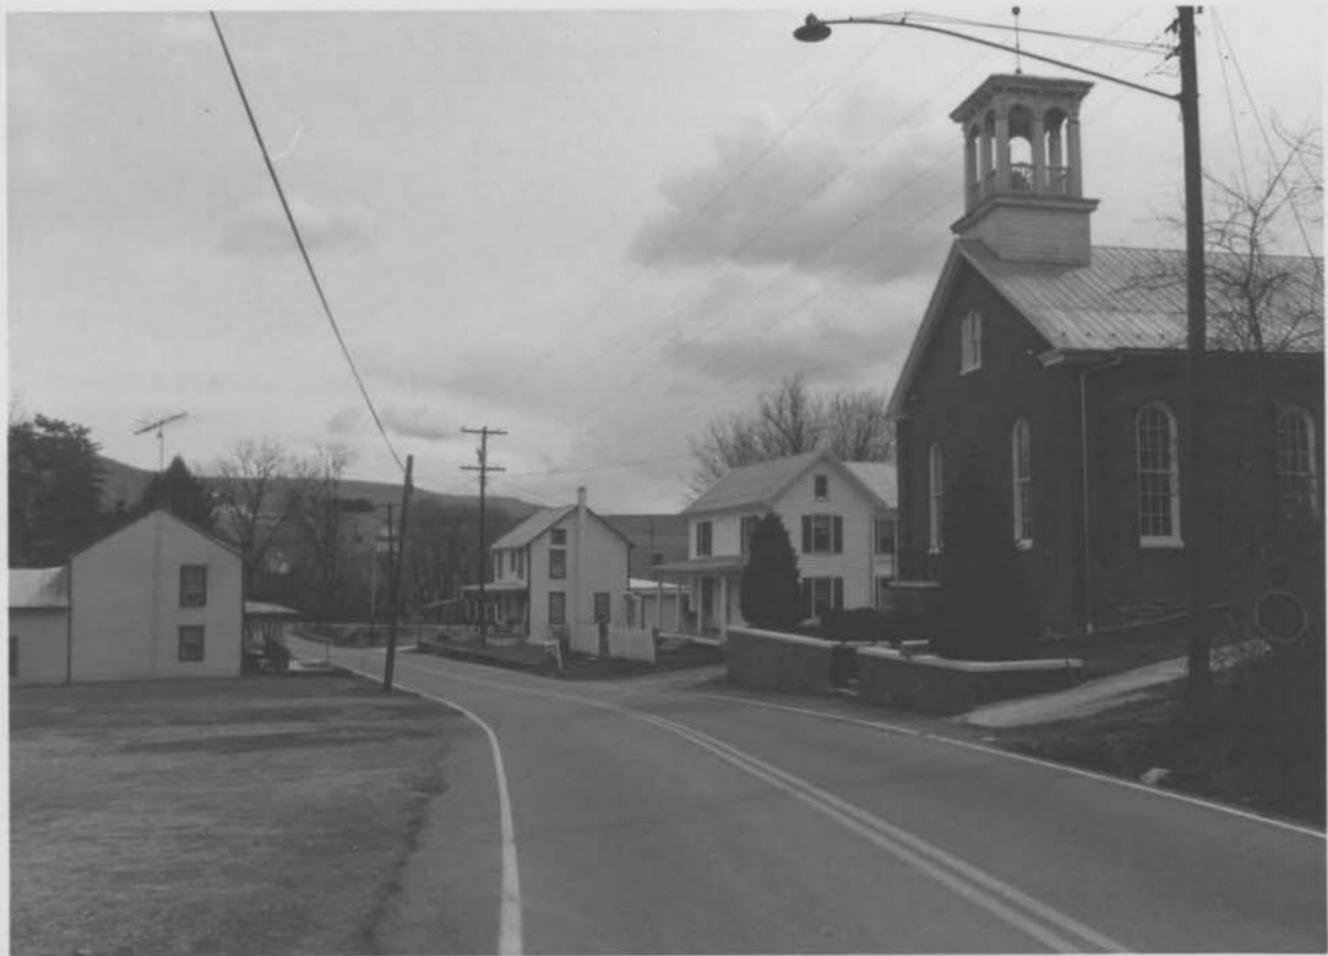
1/12

View east on Brothers Church Road

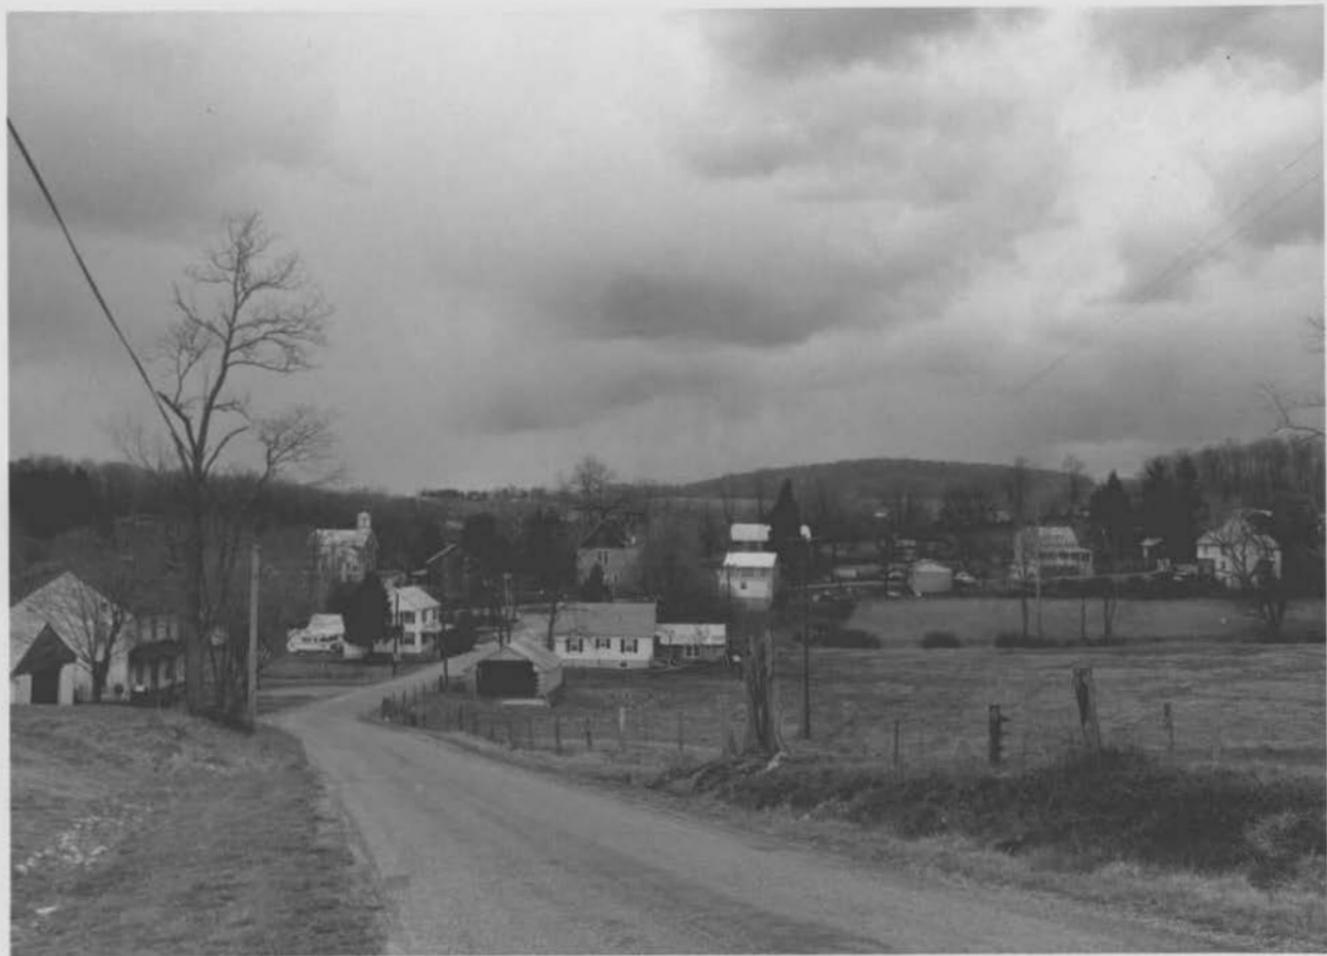
2/12

View west on Hoffer Road

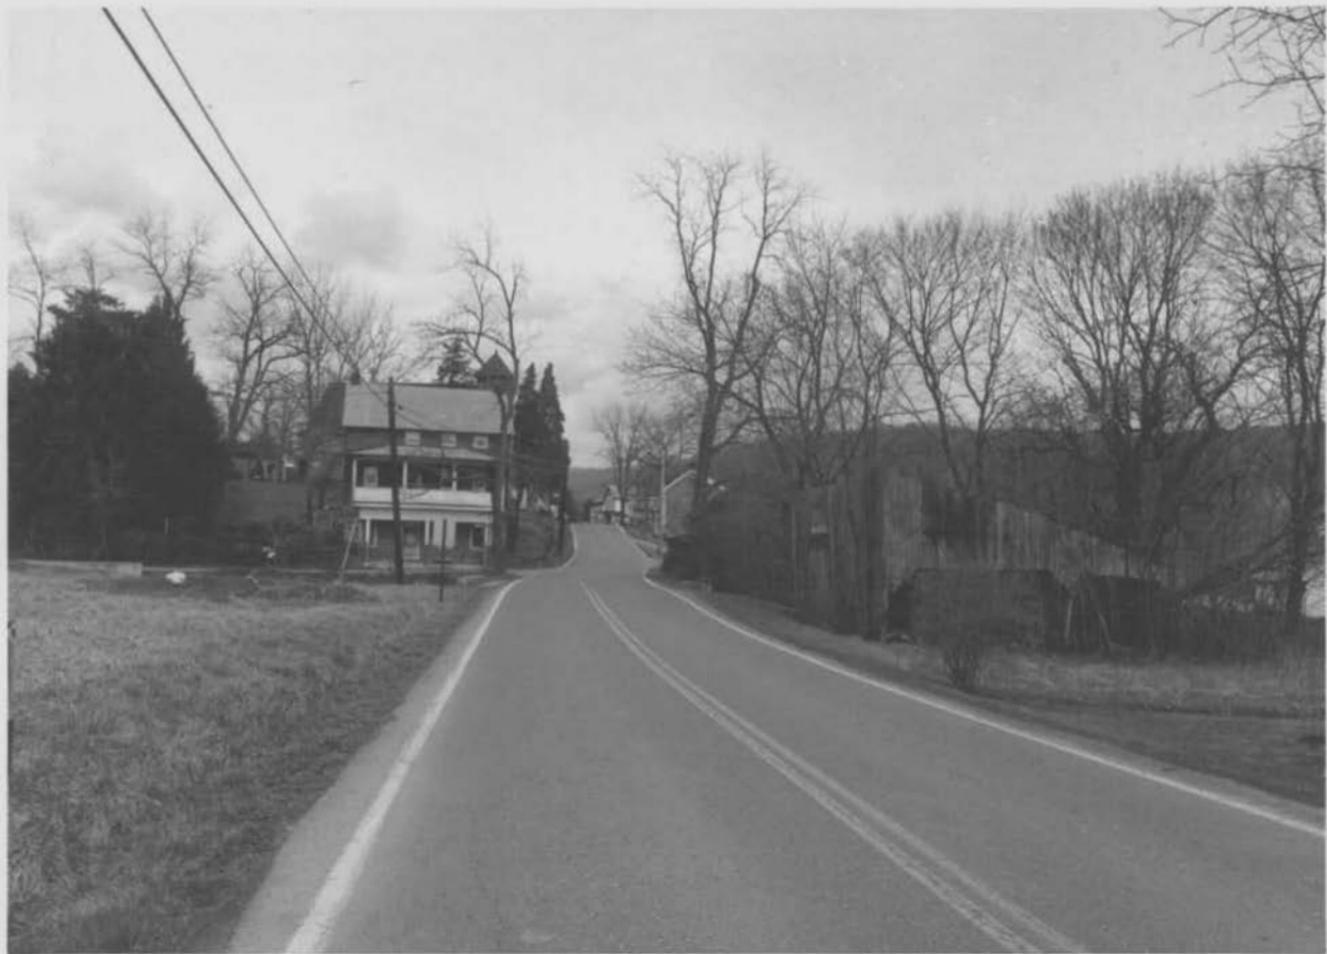
3/2

View N.E. - Harmony Road

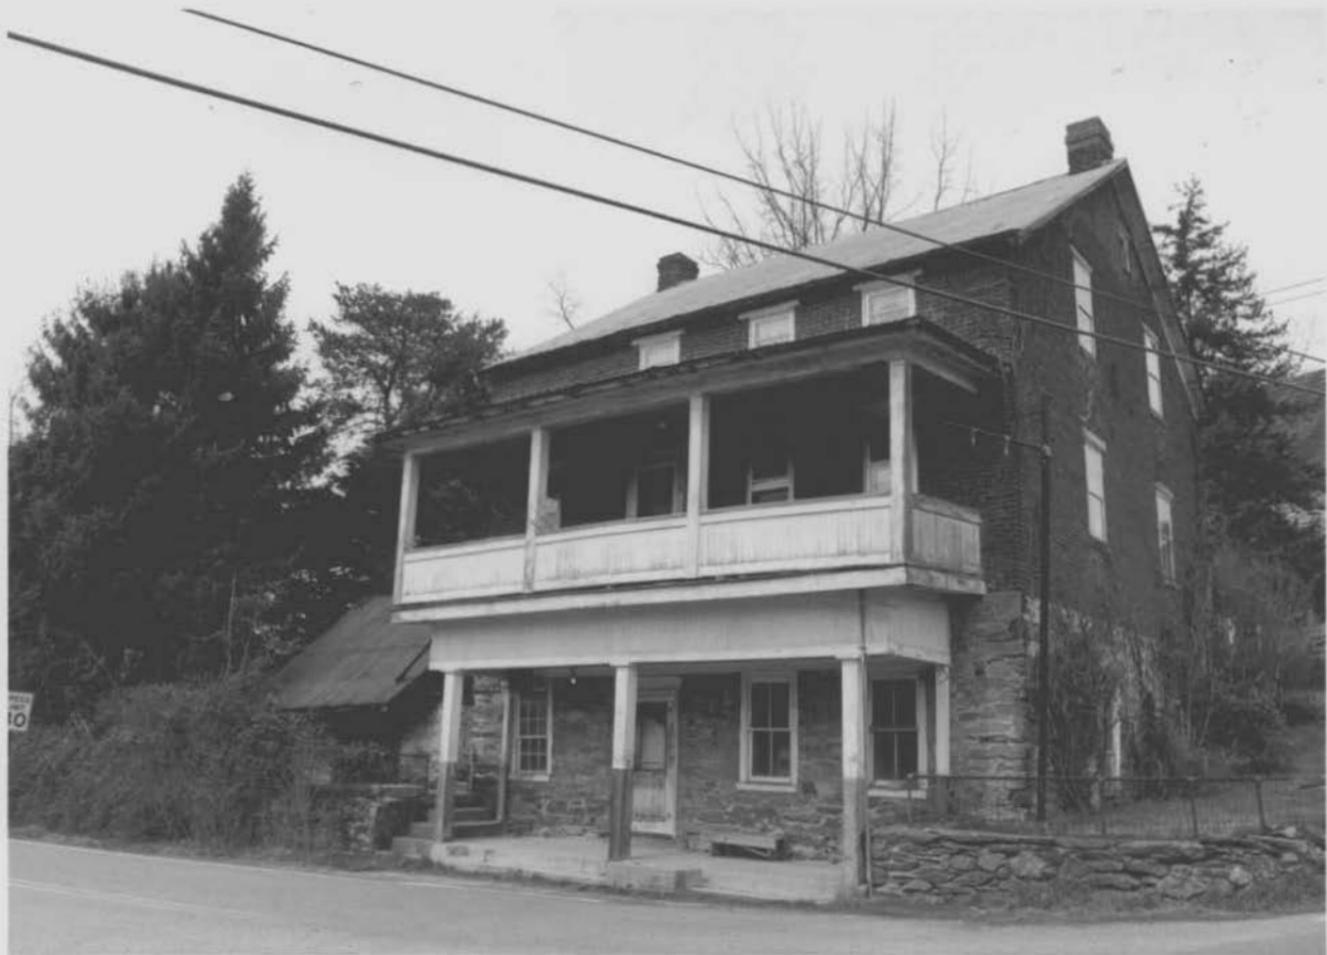
4/12

Branderberg Store and Residence, southeast  
corner view

Brandenburg House, 9510 Harmony Road: This is a two-story brick dwelling with two sections located on the west side of the road. The three-bay northern

section has a side hall entrance and entry porch. The southern section has two bays with an additional entrance. The roof of the entire structure is corrugated metal. Three chimneys are located at each gable end and at the junction of the two sections. The windows are 3/1 with plain lintels. A two-story rear wing extends from the northwest corner. Two non-contributing outbuildings are located west of the building. The house probably was built about 1840, possibly by Daniel Brandenburg, whose son John N. purchased the house in 1849. John N. Brandenburg was a blacksmith throughout the last half of the 19th century in Harmony. Both the 1858 and 1873 maps show the shop was located on the east side of Harmony Road approximately opposite the house, but it has been demolished.

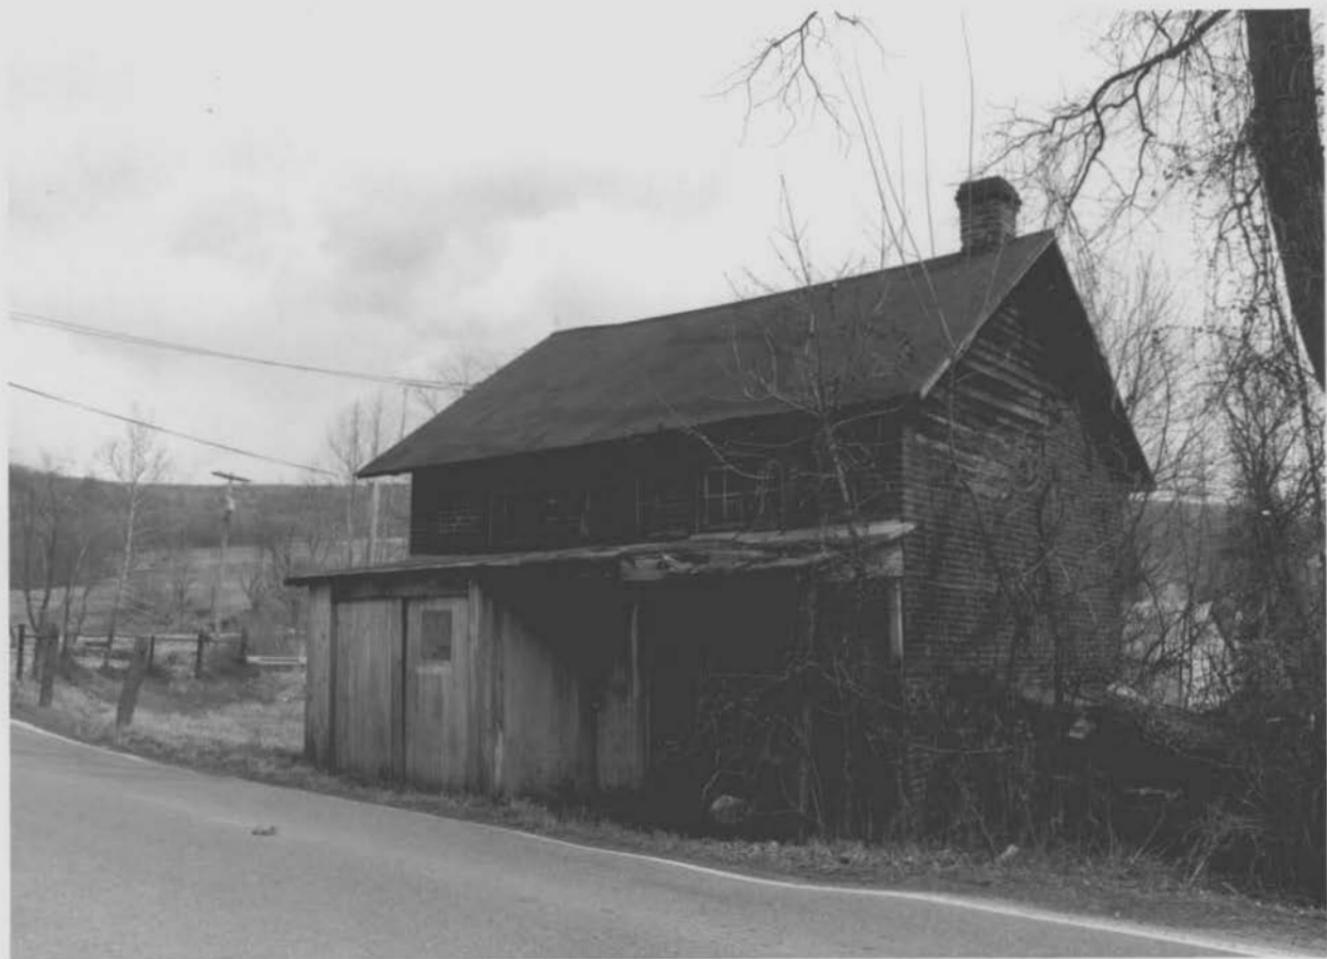
5/12

Loc. 4 light commercial buildings, southeast  
corner view

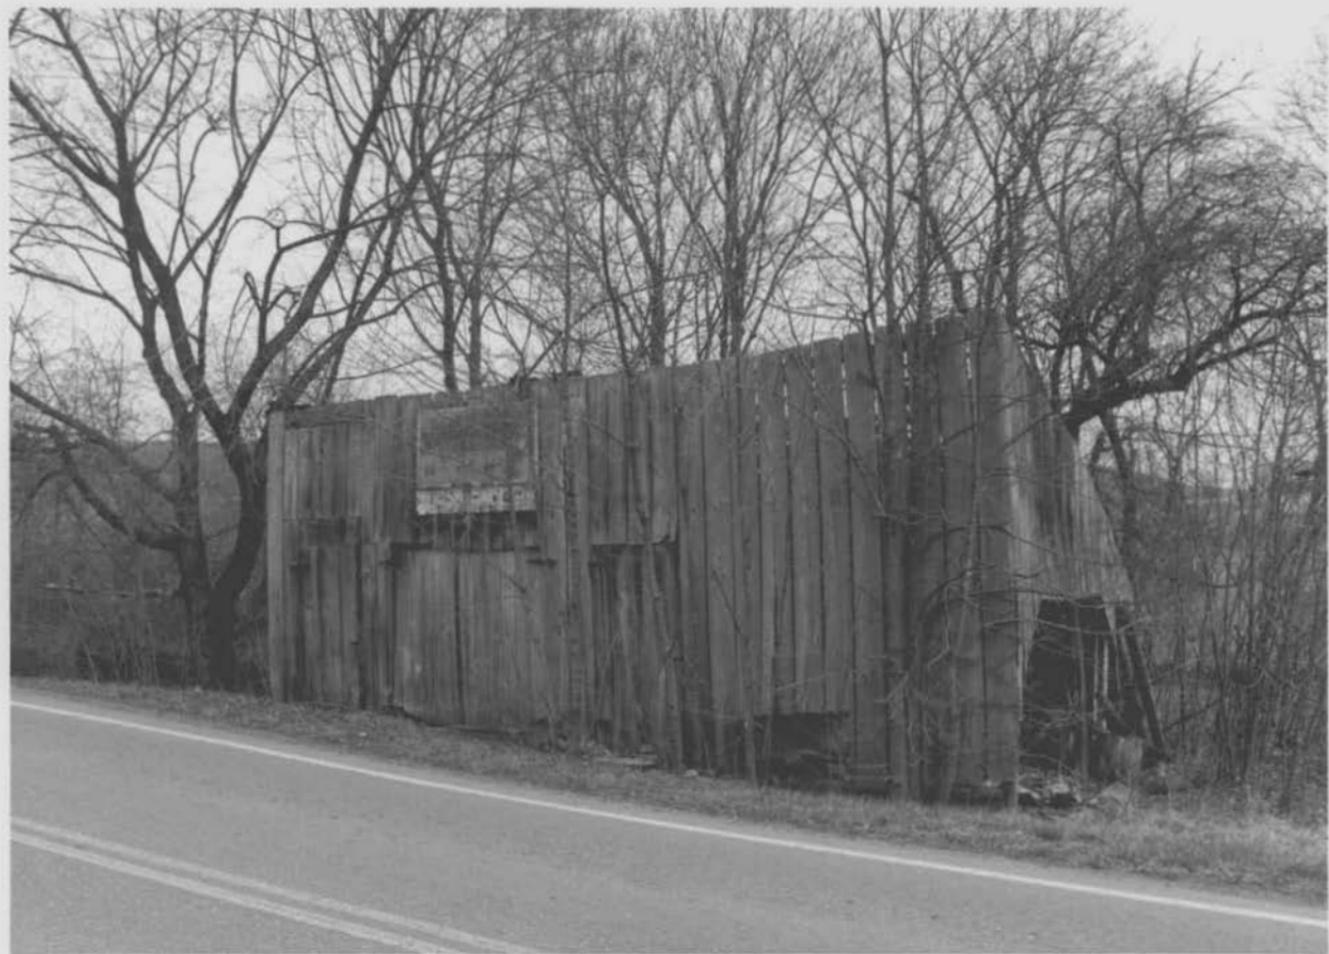
5/2

Ford's Grocery: This is a deteriorated, shed-roofed frame building located on the east side of Harmony Road just south of the bridge over the tributary stream. It has vertical siding and three bays with swing doors in the west elevation. Above the central door is a weathered metal sign advertising Royal Crown Cola over the name "Ford's Grocery". The southern end of the structure apparently had a machine shop of unknown purpose, although some machinery is still in place. The south wall is partially open for ventilation of the space. The rest of the interior was inaccessible. Since the Ford family has owned the property from 1925 to the present, it is assumed the structure dates from the mid-1920's, although county directories for that period do not list the store.

Toad's Greenery, west elevation

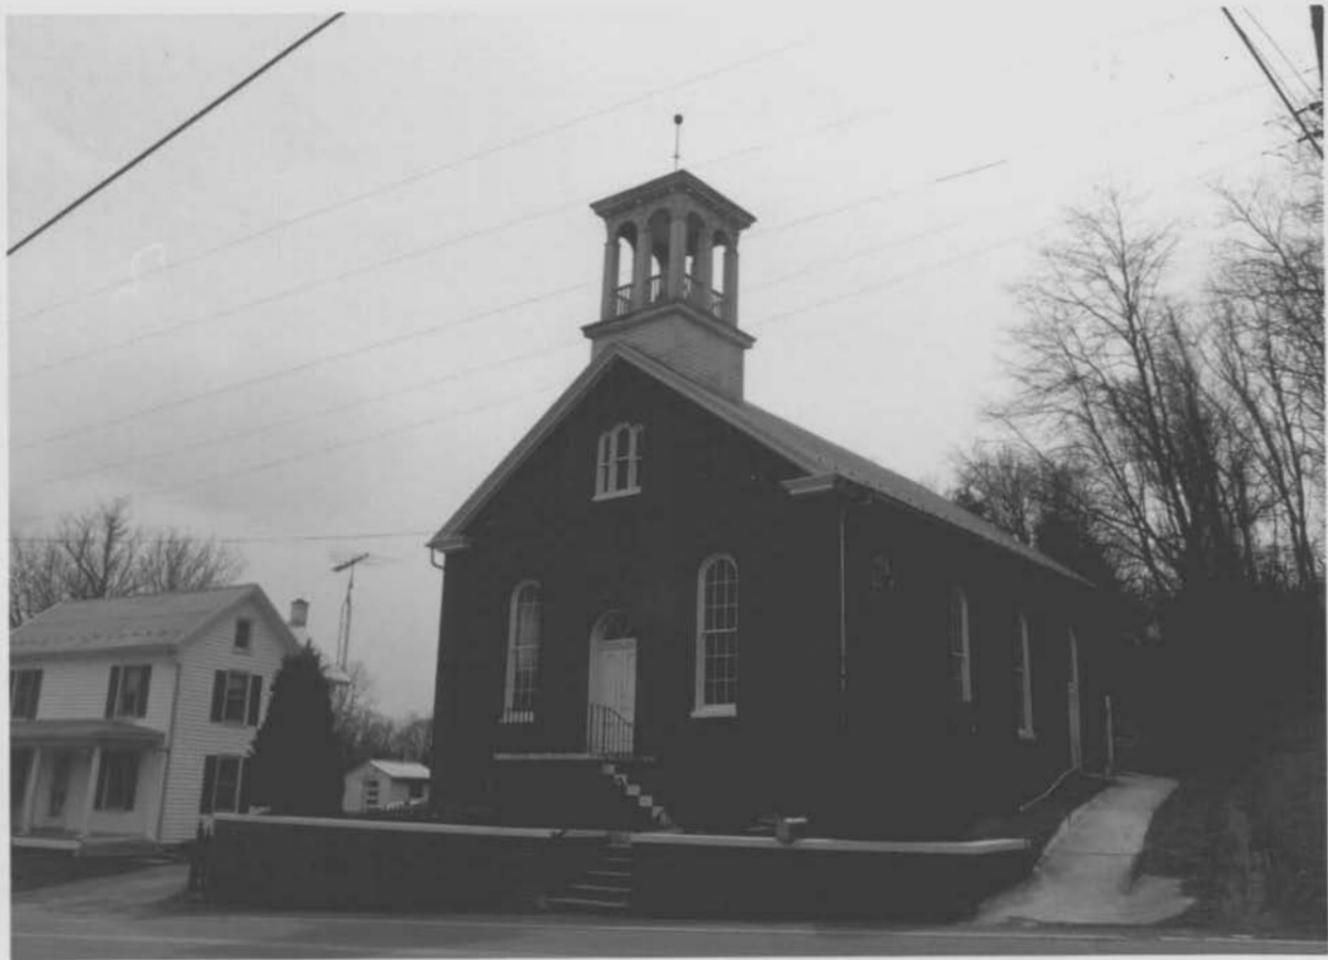
7/2

Harmony Evangelical Lutheran Church (Harmony Community Lutheran Church): The rectangular church is located on the south side of Brethren Church Road about 0.1 mile west of the Harmony Road intersection. Built in 1879 according to the datestone at the northwest corner, the brick Romanesque Revival church has three bays on the north elevation with round-arched windows and double doors in

the center with molding panels repeating the arch of the window openings. The transom above the doorway is semicircular. In front of the entrance is a modern brick porch platform topped with a concrete deck. The foundation is stone and the cornice is corbeled. The gable roof is covered with standing seam metal. The windows have 9/9 sash with textured glass. The east and west elevations have four bays in recessed panels.

Evangelical Lutheran Church post elevation

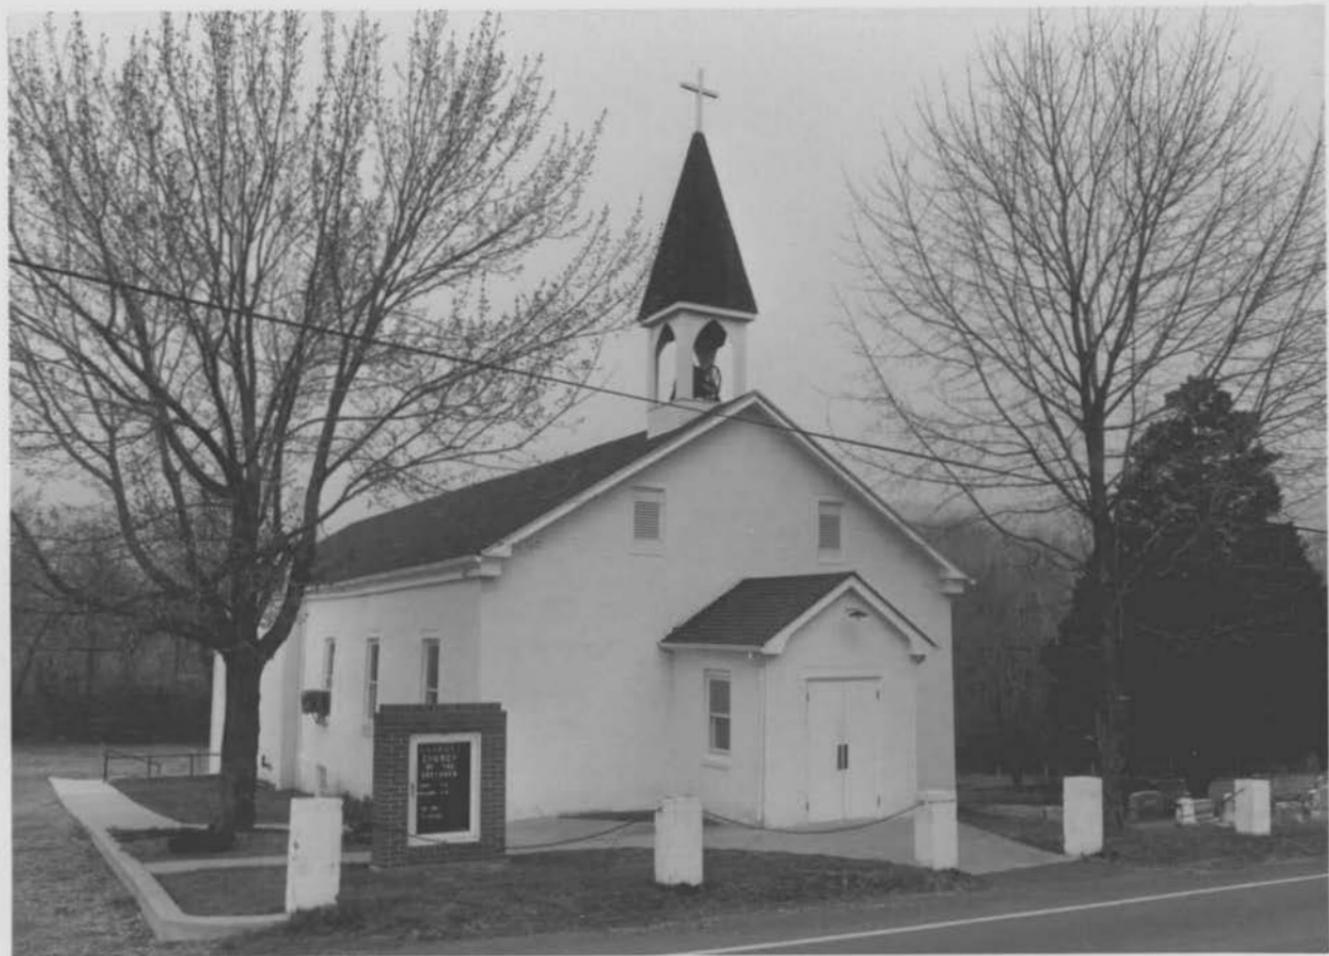
8/12

Harmony Church of the Brethren: The one-story stone church built about 1870 with additions of the early and middle 20th century is located on the north side of Brethren Church Road at the extreme western end of the survey district. The entire structure has been covered with stucco and is painted white, covering most identifying features of its construction. The stone foundation of the original structure is more uneven than the concrete block of the addition at the north end of the building, although painted white. The hall plan church has a gable roof currently covered with composition material. An open belfry probably added in the late 1890's or early 1900's is located at the south end of the ridge line. A projecting foyer on the south elevation is also a 20th century addition. The windows in the three bays of the east and west elevations of the original part are modern 1/1 replacements. East of the church and partially enclosed by a concrete block fence is the cemetery, with graves dating from about 1790, the approximate date of the congregation's formation.

United Brethren Church, south elevation

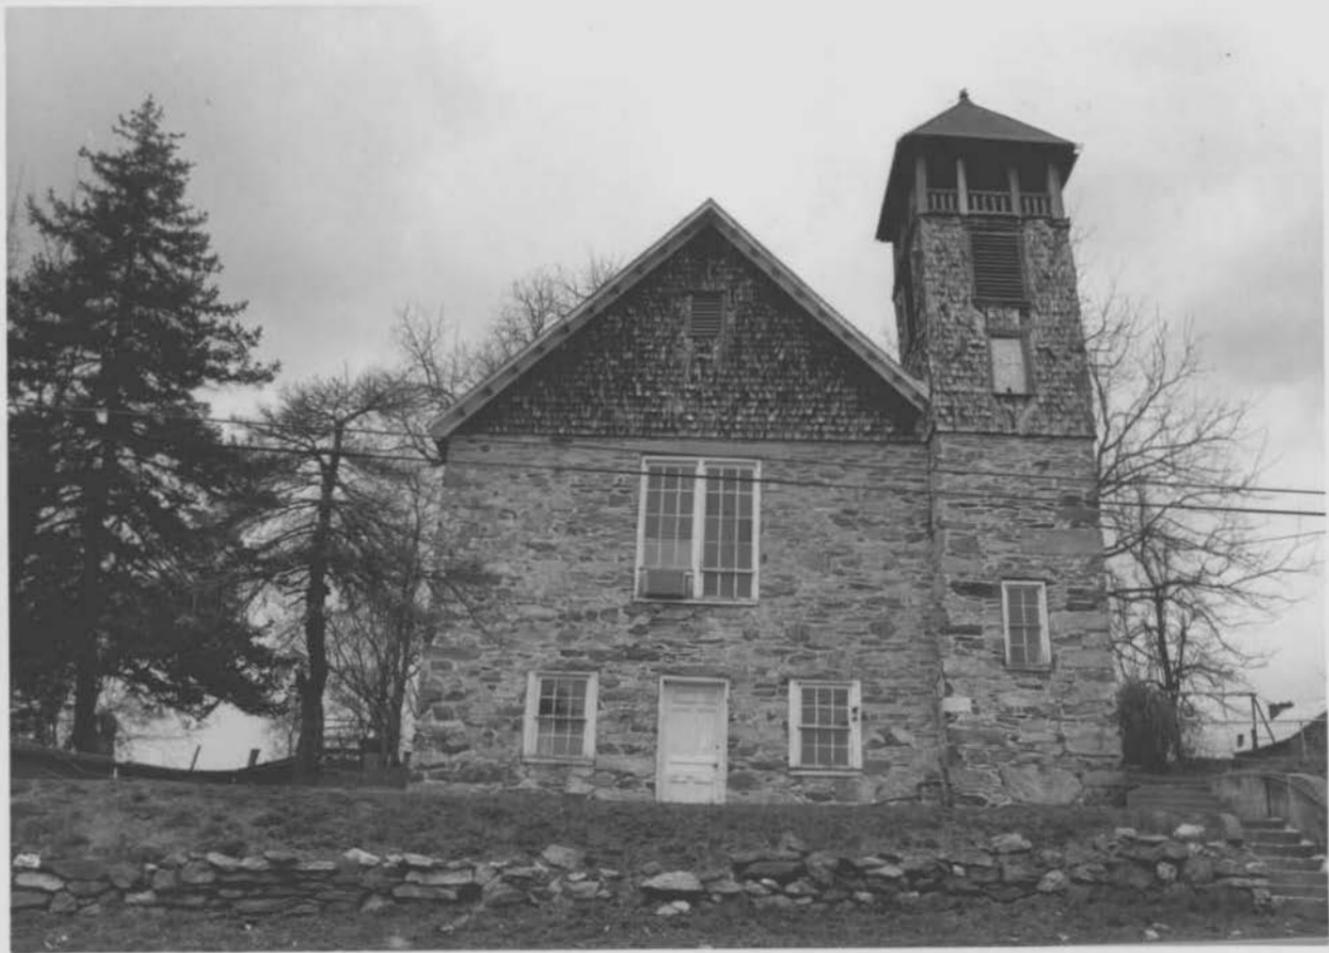
9/12

Reformed Church: Located on the west side of Harmony Road facing the intersection with Hollow Road, the 1909 stone church has two stories with a bell tower at the northeast corner. The gables and the upper level of the bell tower are covered with wood shingles, which are currently very weathered and somewhat deteriorated. The gable roof is covered with pressed metal. The east elevation has three bays with a center entry through a simple 6-panel door. The flanking windows are 6/6 on the first story. The upper story windows are 12/3 with stenciled stained glass. The tower contains another entrance with double paneled doors in the north side. The north and south elevations have three bays, with stenciled stained glass in the south elevation windows and clear glass on the north elevation. The west elevation projects from the main bulk of the church, probably containing the vestry. At the rear of the building are two deteriorated frame privies. The church building is currently used for community activities and is owned by a local civic band.

Returned Church, east elevation

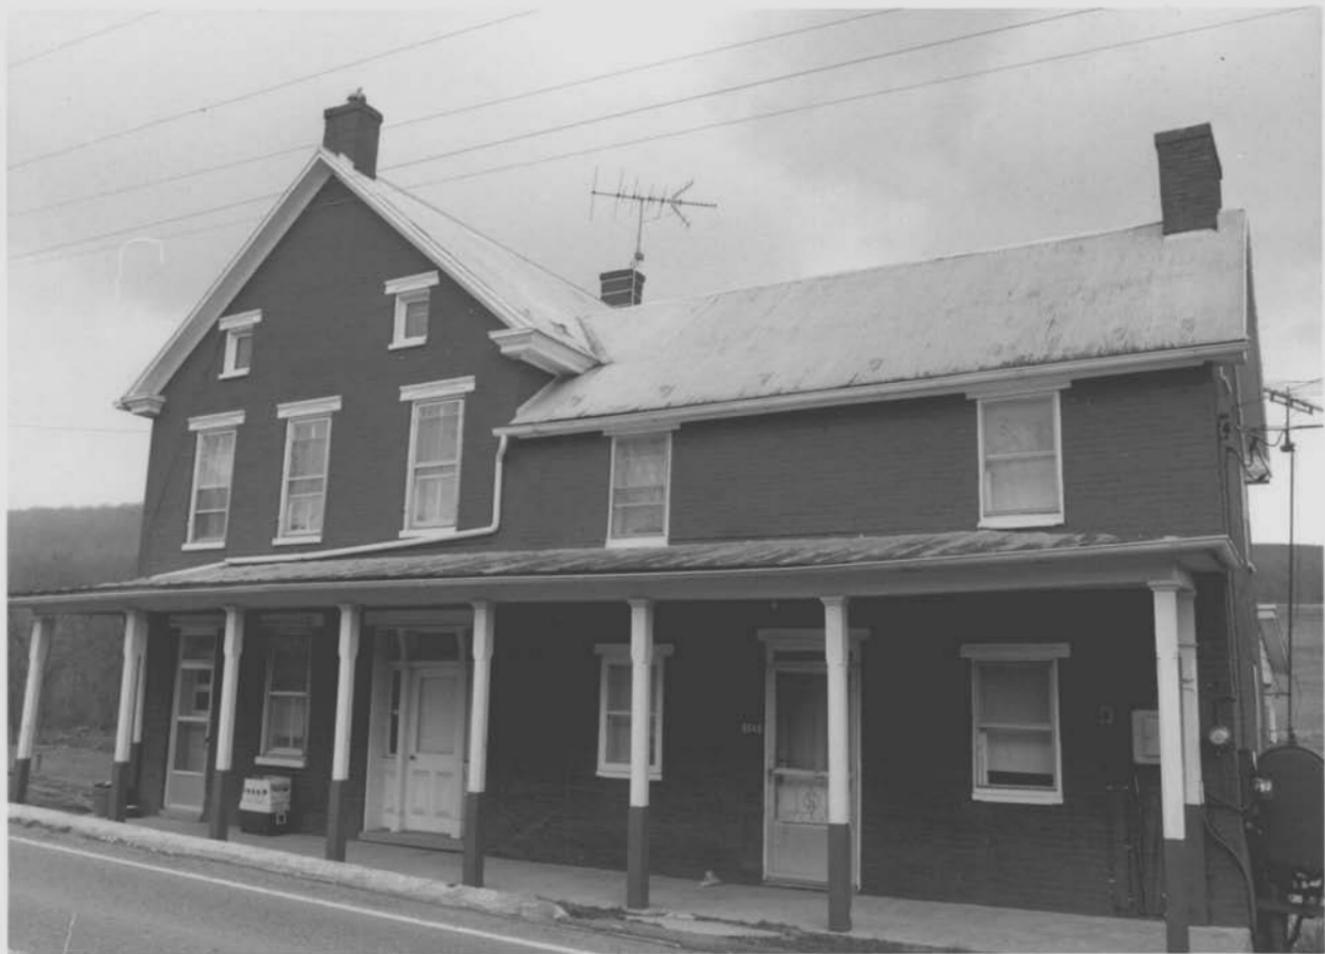
10/12

Smith-Unverzagt Residence and Shoemaking Shop, 9545 Harmony Road: The two-story brick L-plan building has two 3-bay sections facing west, the southern section having the longer facade and the northern having a gable facade. The southern part was presumably the residence and the gable-fronted section the shoemaking shop. The building had center entries in each section, with paneled doors with upper sections of glass. The window openings have plain lintels in the residence section and those in the shop section have molded lintels. The sash is 1/1 in the residence and 2/2 in the shop. The shop doorway has a transom and sidelights with molded soffits. In the gable is a semi-circular window. A one-story porch extends across both sections, supported on chamfered posts. The roof of the building is corrugated metal and the chimneys are located at the gable ends. Located northeast of the house is a frame chicken house with vertical siding and a corrugated metal shed roof, undoubtedly a building of the late 19th or early 20th century. The main structure possibly dates from about 1840. It is identified on the 1858 map as C. Smith, who is described in Williams and McKinsey's History of Frederick County as a shoemaker to whom Henry Unverzagt (born 1833, Hesse-Darmstadt, Germany) apprenticed himself in the 1850's. Unverzagt purchased the property and the business from Smith in 1860 and went on to become the owner of several buildings and farms in the vicinity of Harmony. The shoemaking business at its peak in the last quarter of the 19th century employed as many as 6 workers. In 1866, Unverzagt started a produce store, which he sold to Charles Coblentz about 1890, continuing the shoemaking business. Coblentz made the store a general merchandise operation. It is not clear whether both commercial activities took place in this structure.

Ortizant House, 9545 Hornum rd., west  
elevation

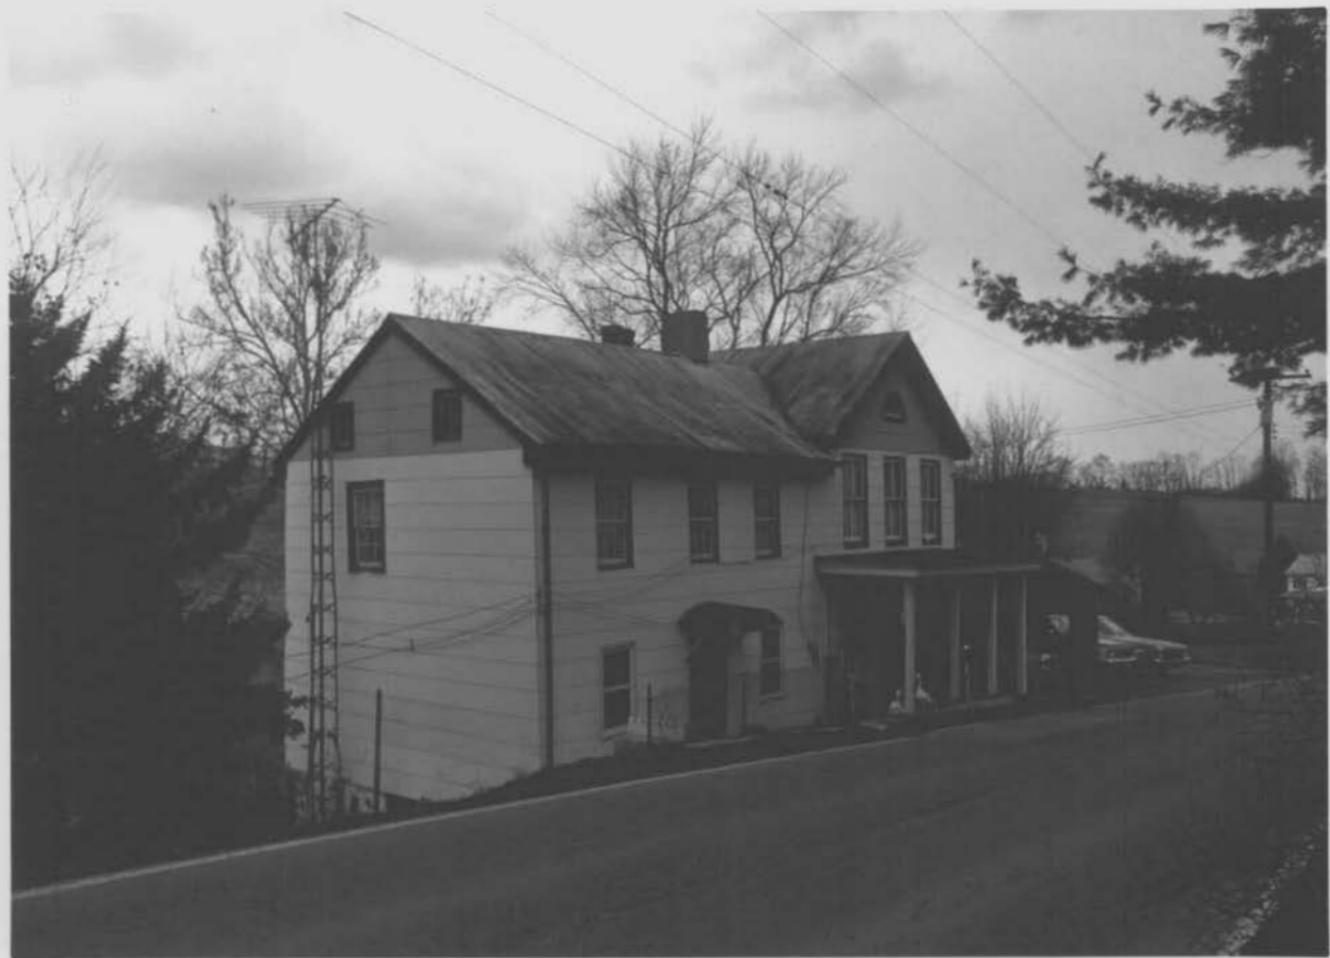
11/12

9521 Harmony Road: This building has a similar plan to the Smith-Unverzagt House at 9545 Harmony. It has two sections, one a residence with two stories and three bays adjoining a gable-fronted, three-bay section presumably once a store. It has the same center entrance in each section and the semi-circular window in the gable as in the Smith-Unverzagt building. The exterior here is asbestos shingles and the sash is varied: 1/1 on the first story of both sections, 2/2 on the second story of the gable section, and 6/6 on the second story of the residence. The roof is covered with corrugated metal. The entrance to the gable section has a 2-light transom and a glazed panel door. A one story porch extends across the entire facade and a modern carport is attached to the south elevation of the building. This property was also owned by John Brandenburg, the blacksmith, and later by Henry Unverzagt. Probably built about 1840-50, its possible use as a store is unconfirmed by title research or historical maps.

9521 Harmony Road northeast corner view

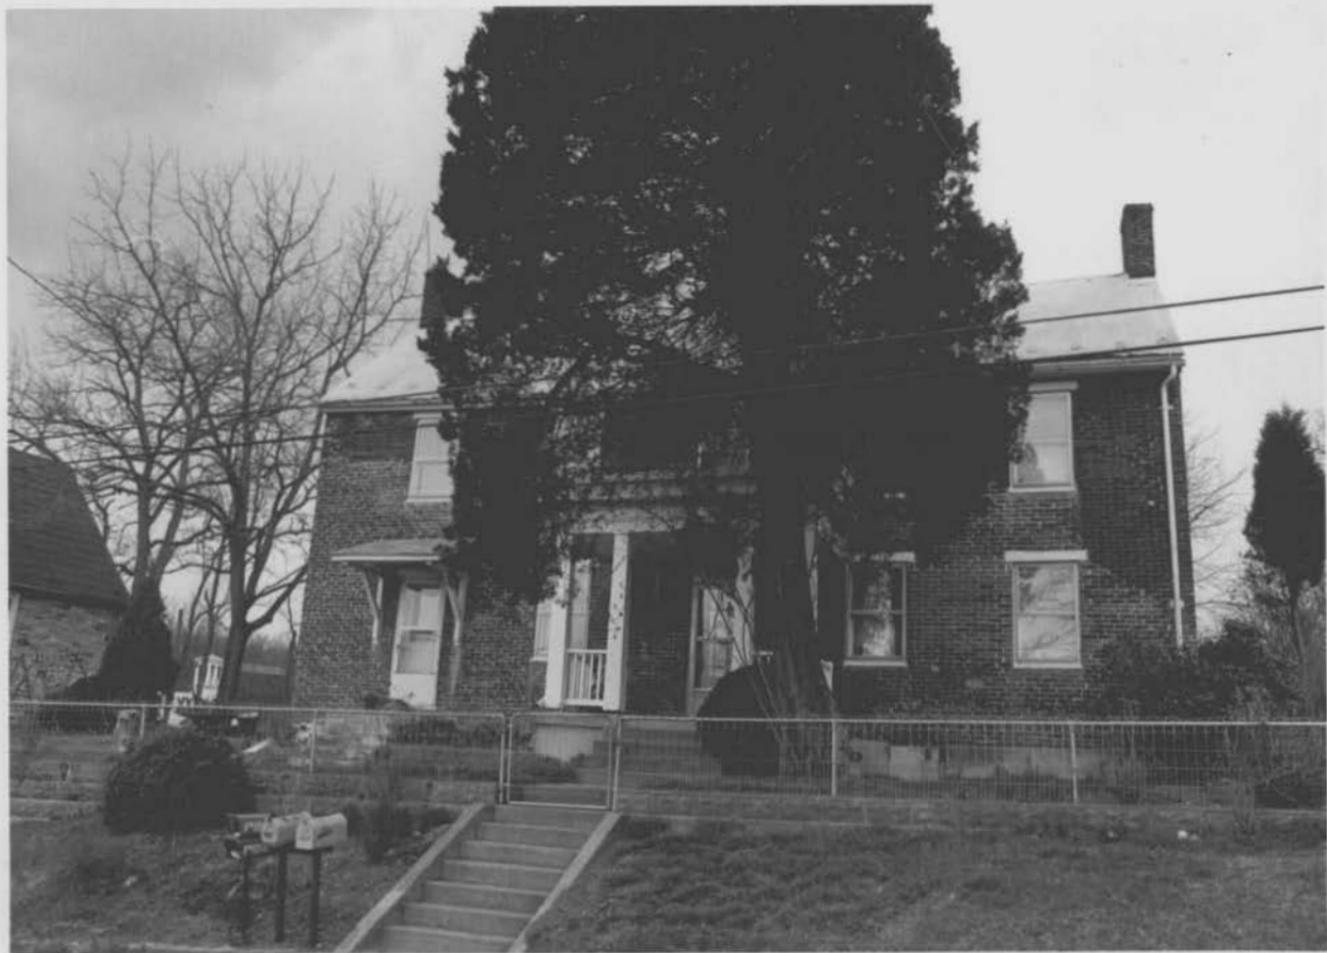
12/12

9512 Honolulu Road east elevation
