Harshman-Frushour Farmstead;
Hagerstown & Frederick Trolley Shelter
Wolfsville vicinity
Private

F-4-57
Harshman-Frushour Farmstead
Wolfsville
Frederick County

Maryland Historical Trust State Historic Sites Inventory Form

Survey No. F-4-57

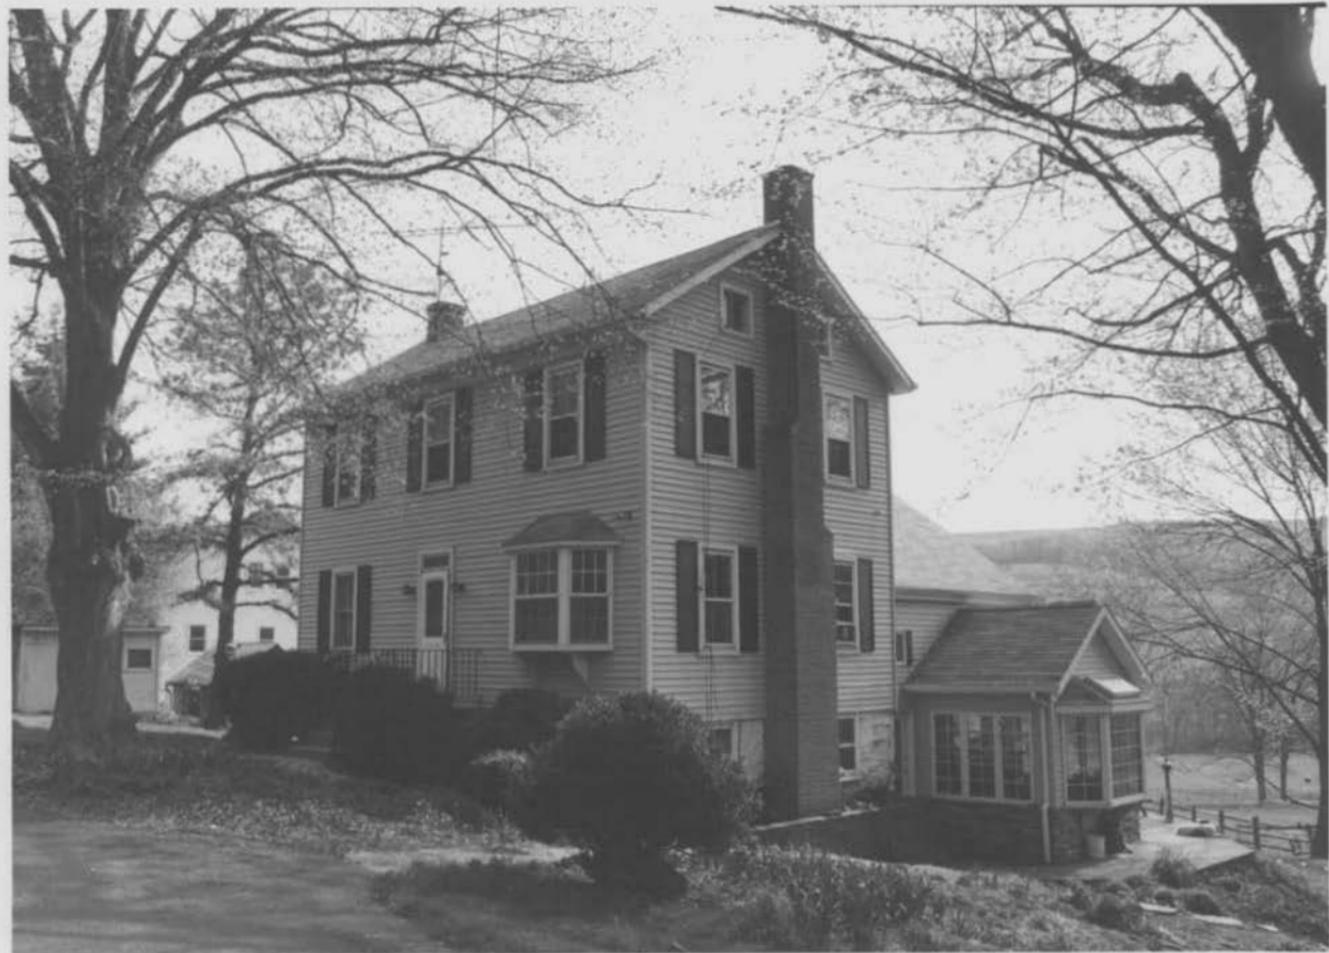
1/6

The circa 1880 dwelling is located on a slope with the principal elevation facing west and the rear part of the house following the slope downward to the east. The west elevation has three bays with a center entrance. A two-light transom tops the doorway and the door has four panels. The siding was probably originally german, but is now covered with vinyl. In the south bay is a modern bay window. The rest of the sash is 2/2 with replacement shutters. The roof is composition and the original chimneys were on the interior walls of the gable ends. One has been rebuilt on the exterior of the south gable end. The modern additic. extends from the original rear two-story wing and virtually engulfs the wing. The interior was inaccessible for this survey.

Southeast corner view

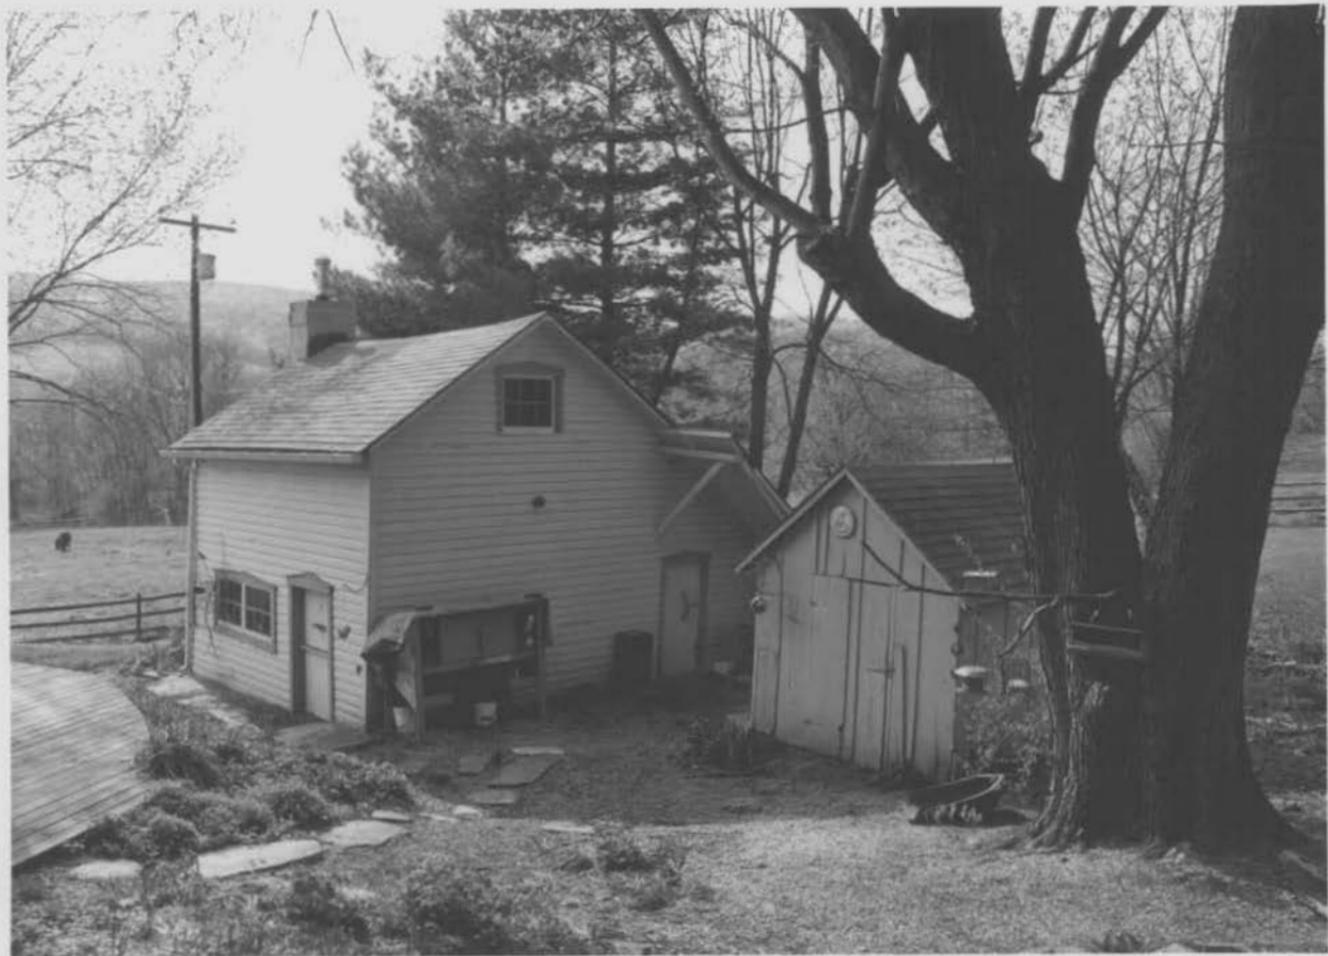
2/6

Summer kitchen: The summer kitchen is a 1-1/2 story frame structure with german siding and a vertical board dutch door in the north elevation. Also on the north elevation are 3/3 windows with peaked window frames which may have been rebuilt from the originals. The composition roof extends over a small shed addition on the south elevation. The exterior brick chimney is located on the east gable end. The building probably dates from about the same period as the dwelling, the 1880's.

Smokehouse: The frame smokehouse is now used as a garden shed. It has a rectangular plan with board and batten siding and a vertical board door in the north elevation. The gable roof is composition. Like the summer kitchen, the smokehouse is probably contemporary with the dwelling.

Former kitchen & smokehouse

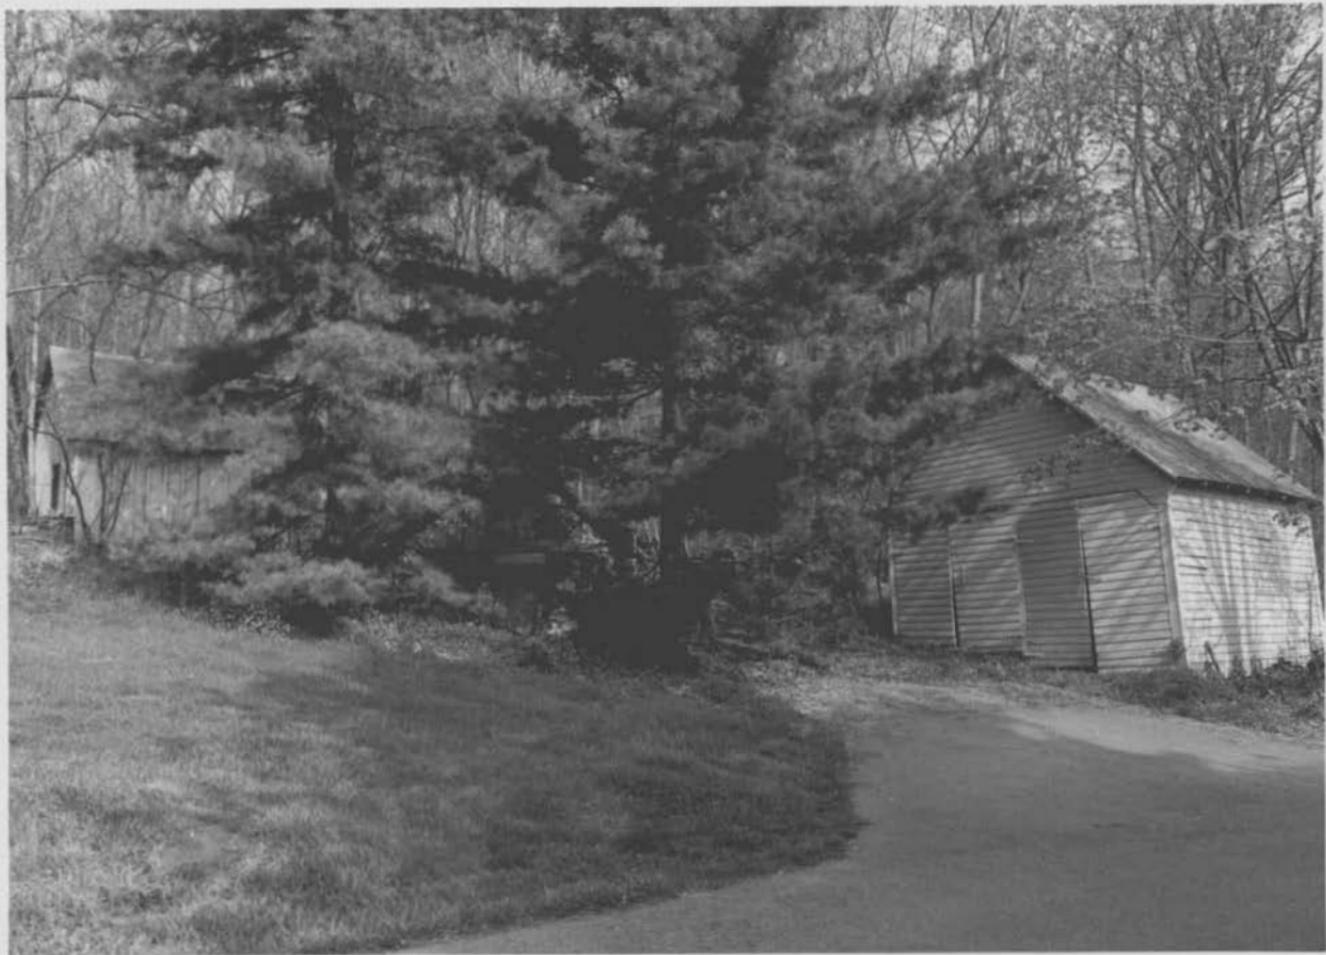
3/6

Root cellar/ice house: The stone root cellar may have been used as an ice house. It is built into the slope of the hill northwest of the house in a grove of pine

trees. A vertical board gable supports a corrugated metal roof. The single door in the east elevation is board and batten and a second boarded opening is located directly above it.

Wagon sheds: There are three frame wagon sheds west of the barn, clustered near the stone root cellar/ice house. The westernmost has board and batten siding, a corrugated metal roof, and double swing doors in the east elevation. The other two sheds are located north of the root cellar. One has double bays on the south elevation, german siding, and a corrugated metal roof. Each bay has double vertical board swing doors. The third shed has a single bay with an open doorway on the south. It has vertical siding and a standing seam metal roof. All three sheds appear to date from about 1900.

Icehouse and sheds, view from east

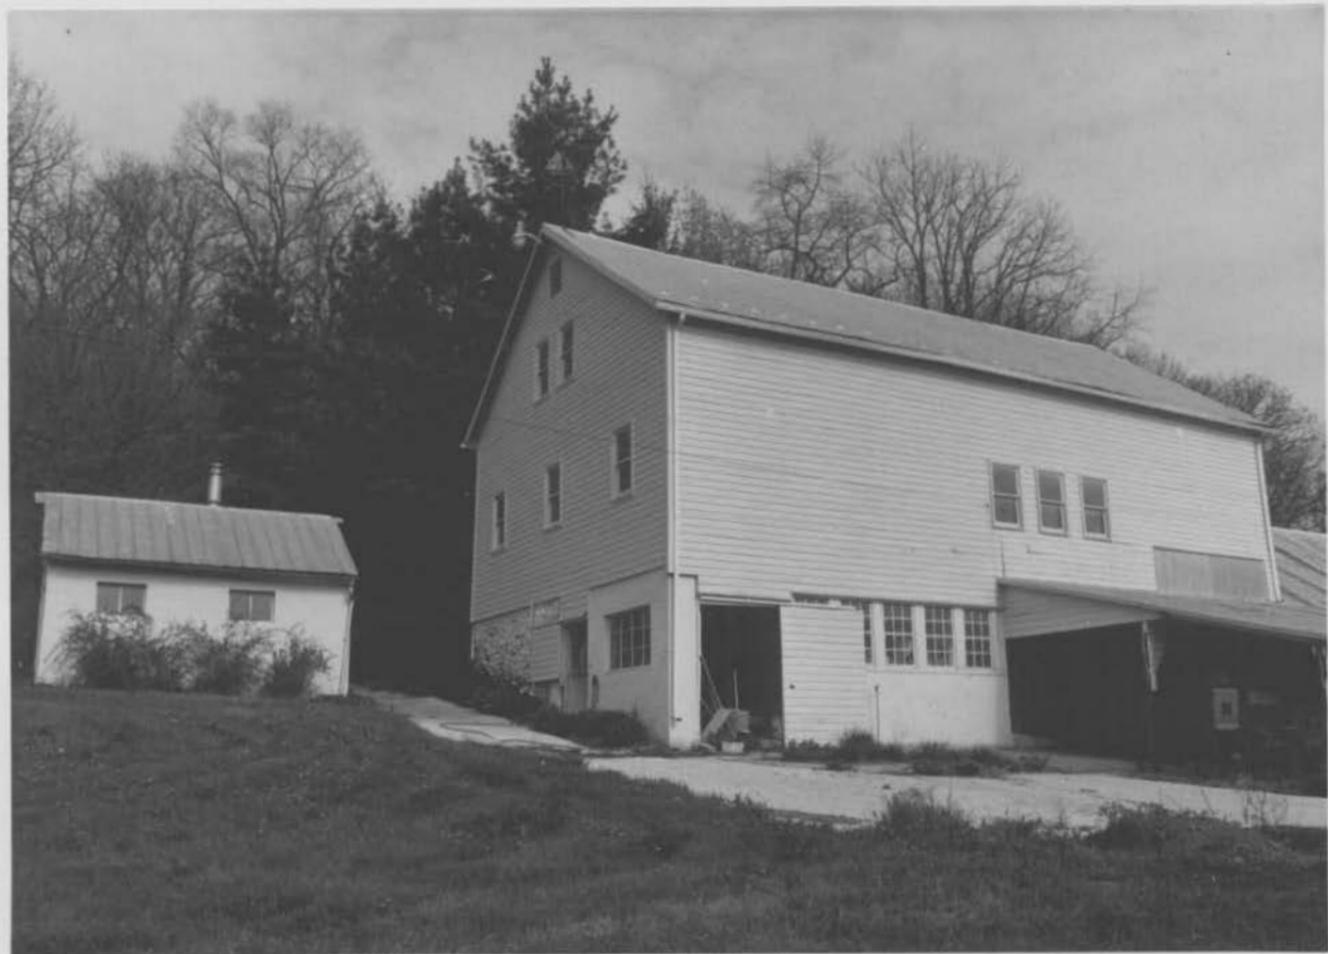
4/6

Barn: The frame bank barn appears to date from about 1900. It has a stone foundation and recently replaced vertical siding on the upper level. The stall level was partially enclosed with concrete block in the 1930's for use as a milking room. The rest of the stall level has been altered in the 1980's for use as a horse barn, with extensions on the east and the north. The ramp on the west elevation has been rebuilt. The interior main beams show almost straight saw marks, indicating that the structure may incorporate members of an earlier barn. The sliding doors are german siding.

Milk House: The concrete block milk house is located directly south of the barn near the milking room. It is a one-story structure with 2/2 metal sash and a standing seam metal roof. It was probably built in the mid-1930's.

Barn and milk house, view from east

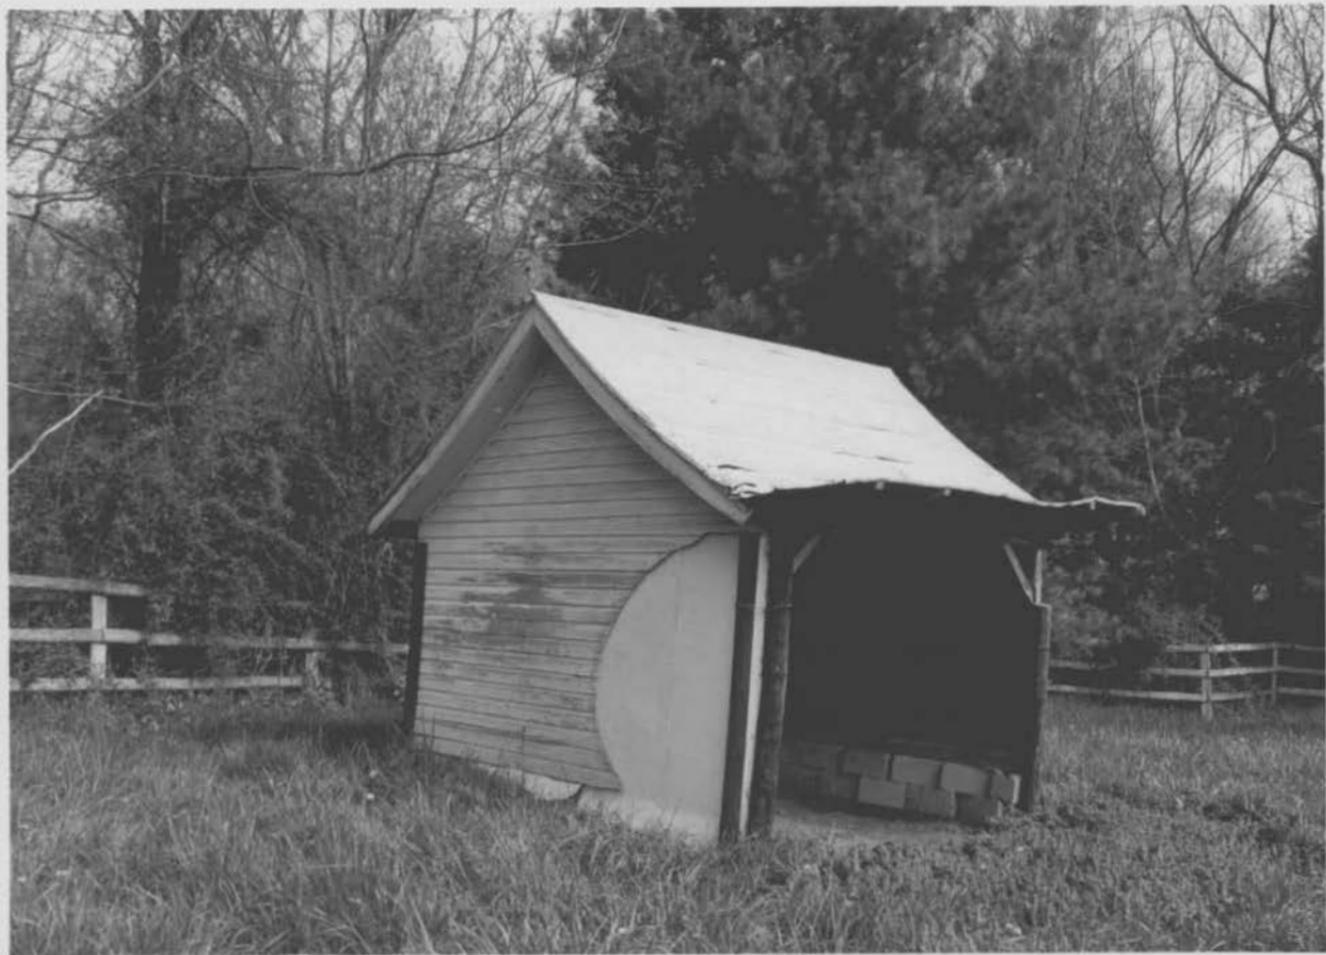
5/6

Trolley shelter/hay shed: The trolley shelter is located in a pasture southwest of the main complex and is visible from Meeting House Road. It is a small rectangular frame structure with german siding and a bellcast gable roof covered in original pressed metal. The west or back of the structure has been altered with a sliding door, giving access to the hay rack installed on the rear wall. A small metal extension of the roof projects from the east or open side of the shed. On the north and south sides of the structure were originally cut out in a C-curve; these have been filled with sheet metal. The shelter was built about 1900-1910 and probably moved from the electric railway line between Myersville and Middletown about 1945 when the line was discontinued. About 6 of these structures were scattered throughout the Hagerstown & Frederick system, but this is the only known remaining one. A photo of one of the shelters in use is in Harwood's Blue Ridge Trolley, p. 69.

Tidley shelter, view from south
