F-4-58

Josephus Palmer Farmstead
Wolfsville vicinity
Private

Ca. 1860; Ca. 1880

Maryland Historical Trust
State Historic Sites Inventory Form

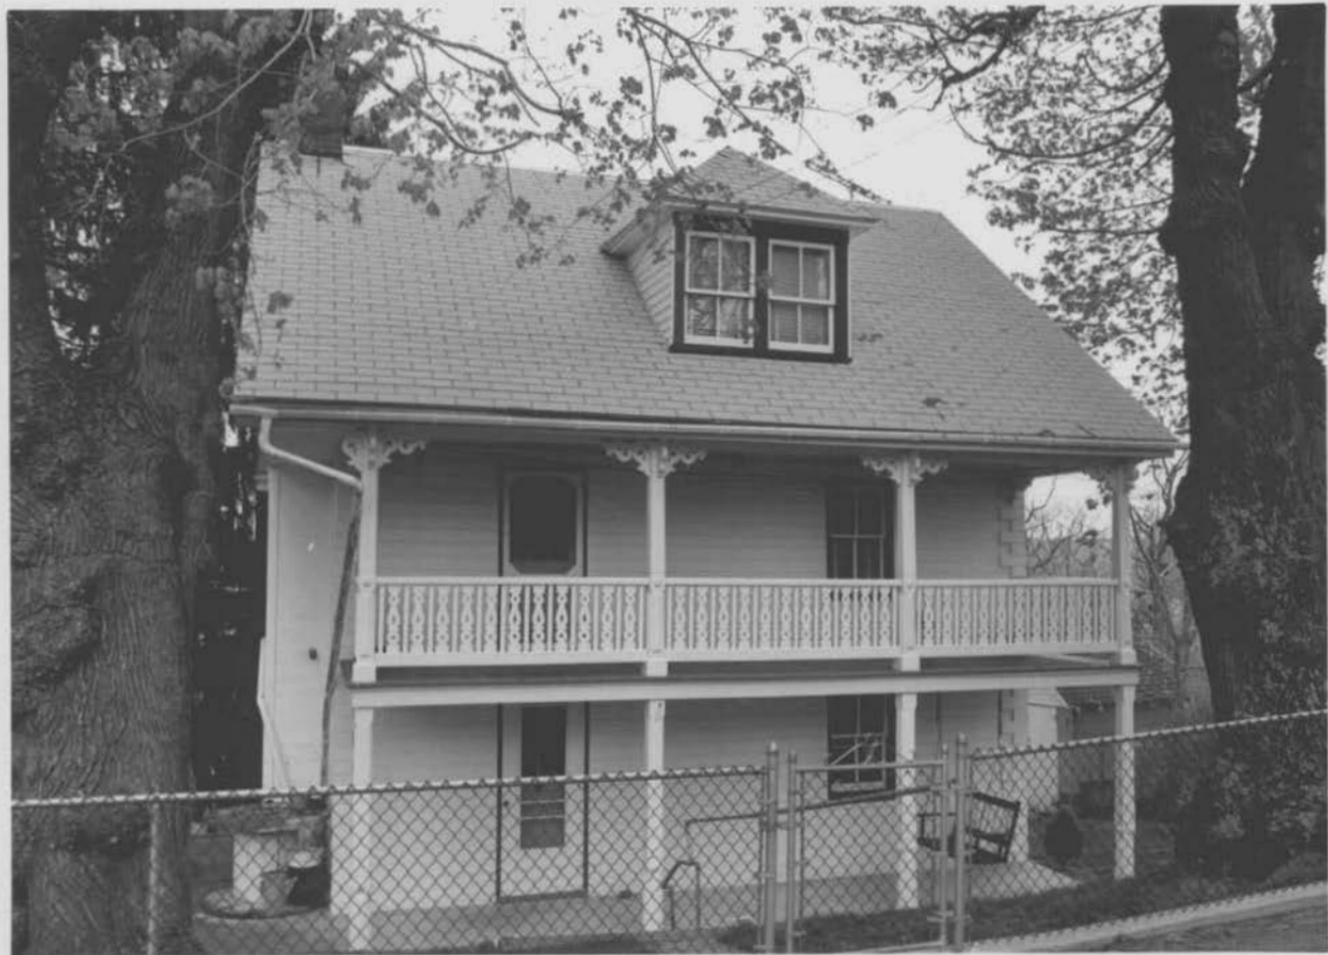
1/5

West elevation

The dwelling has two stories over a stone cellar exposed on the east elevation. The west elevation has two bays with a side hall entrance. A two-level open porch is attached to the west facade, with a concrete platform and a scroll-sawn balustrade and bracketed columns. The attic level and roof which extends over the porch were probably added in about 1880, along with the rusticated wood siding and shingled gable surfaces. A single dormer with a hipped roof and paired 2/2 windows is centered in the west slope of the composition roof. The east slope of the roof is pressed metal. Pressed metal also covers the soffit of the extended attic on the gable ends, the ceiling of the second level of the porch, and the interior ceiling on the second floor. A metal-covered projection on the north gable end apparently covered the chimney, which is no longer in use, but still rises from the roof. The east elevation of the house has a shed addition on a concrete block foundation added after 1940. An open porch is also attached to the east elevation. Above the porch, the second story wall is covered with aluminum siding. The sash is mainly 2/2 throughout the building. The interior has a side hall plan with double parlors. The stairway is in the northwest corner next to the chimney. The interior trim is plain, with 6-panel grained doors and hook moldings on the plaster walls.

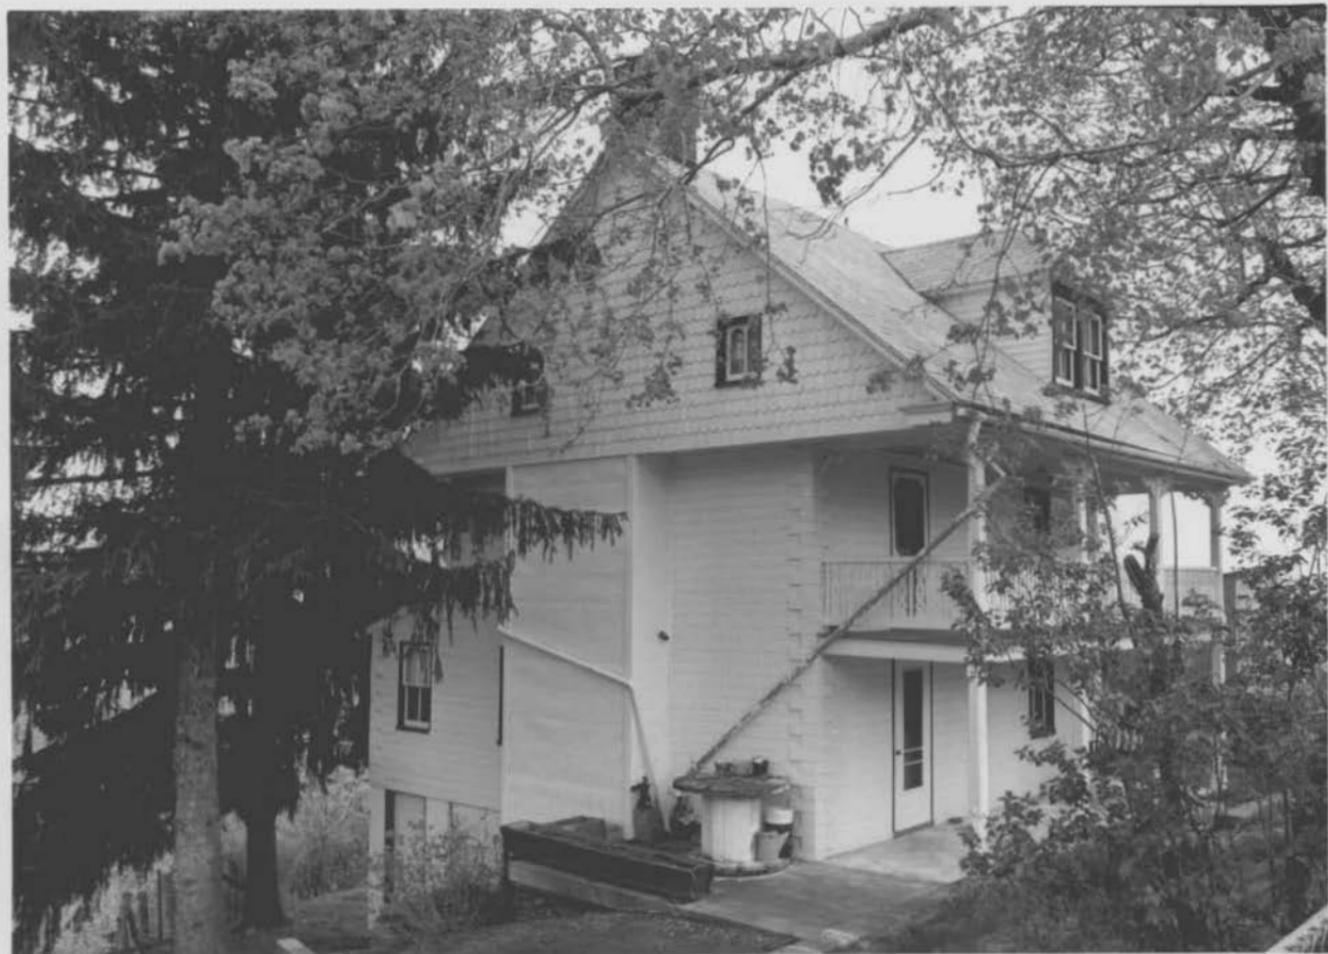
2/5

North elevation

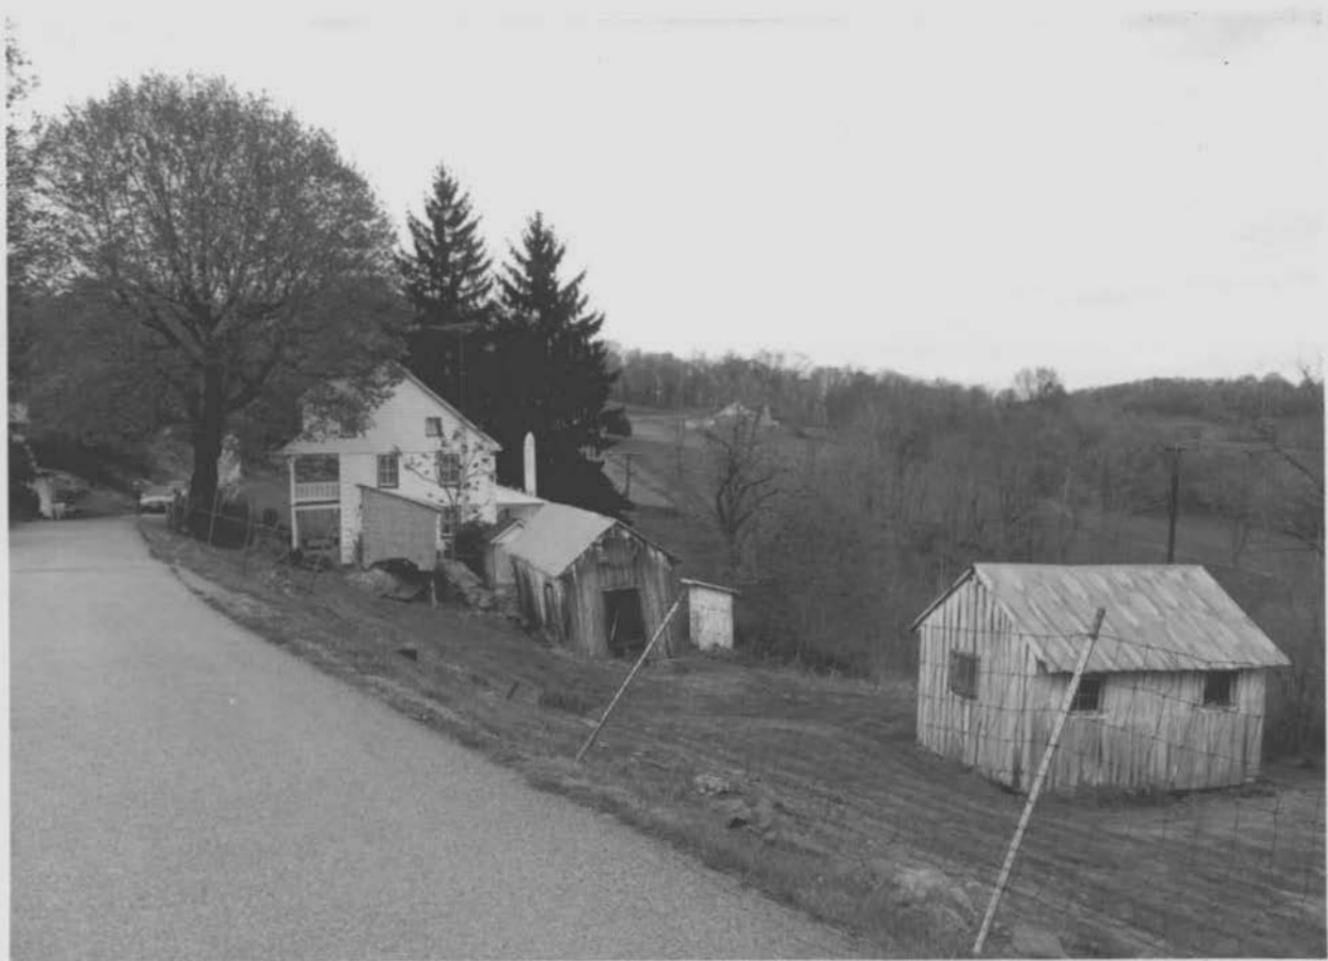
2/5

General view from south

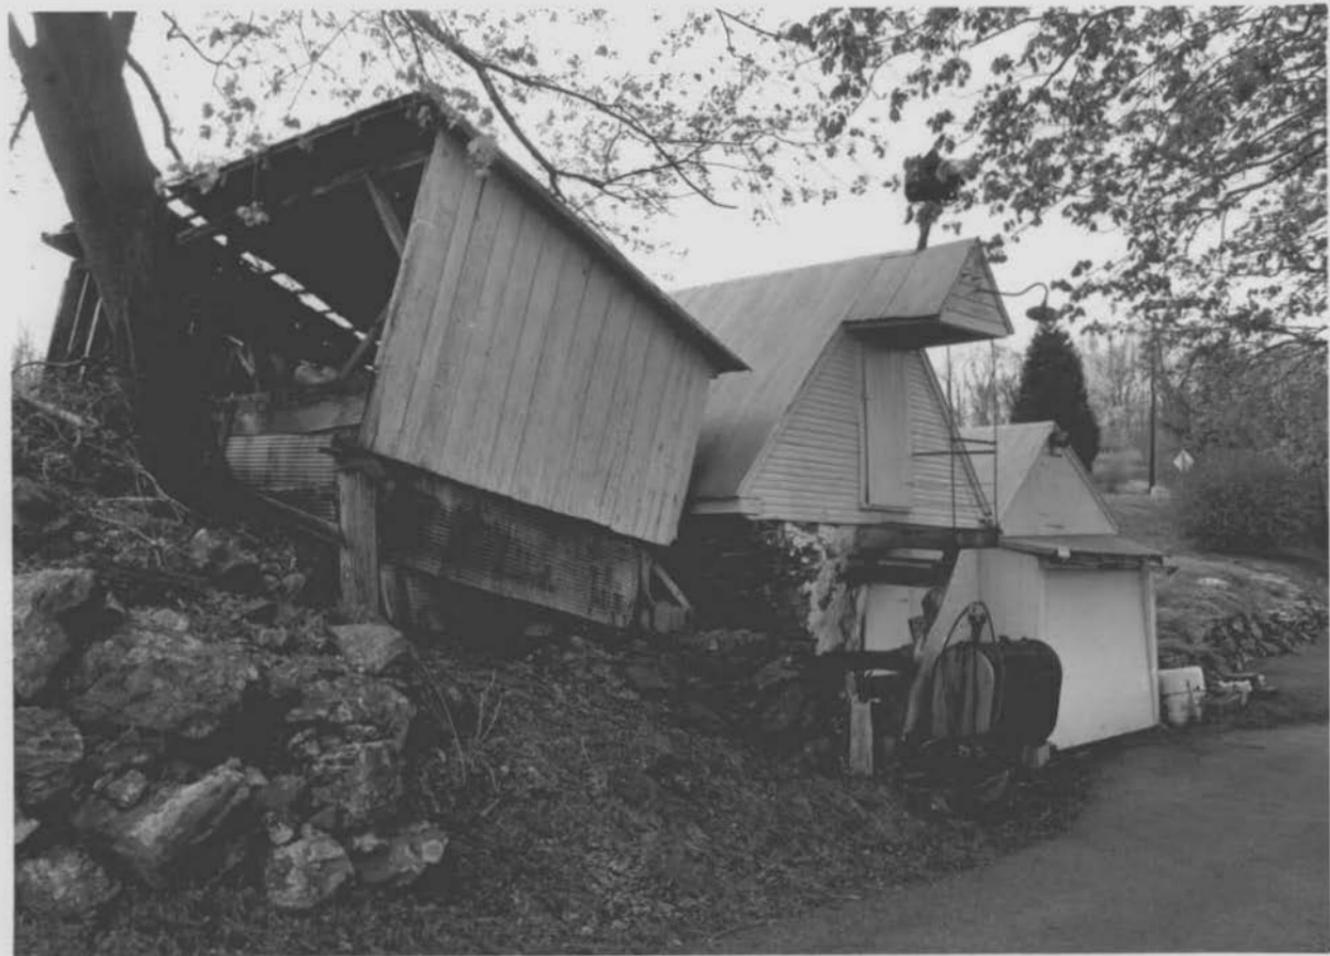
5/5

Domestic outbuildings, view from south east

Privy: The circa 1940 frame privy is located southeast of the house. It has vertical tongue-and-groove siding and a corrugated metal shed roof. The vertical board door is located in the west elevation.

Smokehouse: The concrete block smokehouse was built about 1940 and is located south of the house. It has a shingle gable roof and a vertical board door in the north elevation.

Wood shed: The frame wood shed stands on a rocky outcrop south of the house. It was moved to the farmstead after 1940 by the present owner. It currently has composition siding and a corrugated metal gable roof.

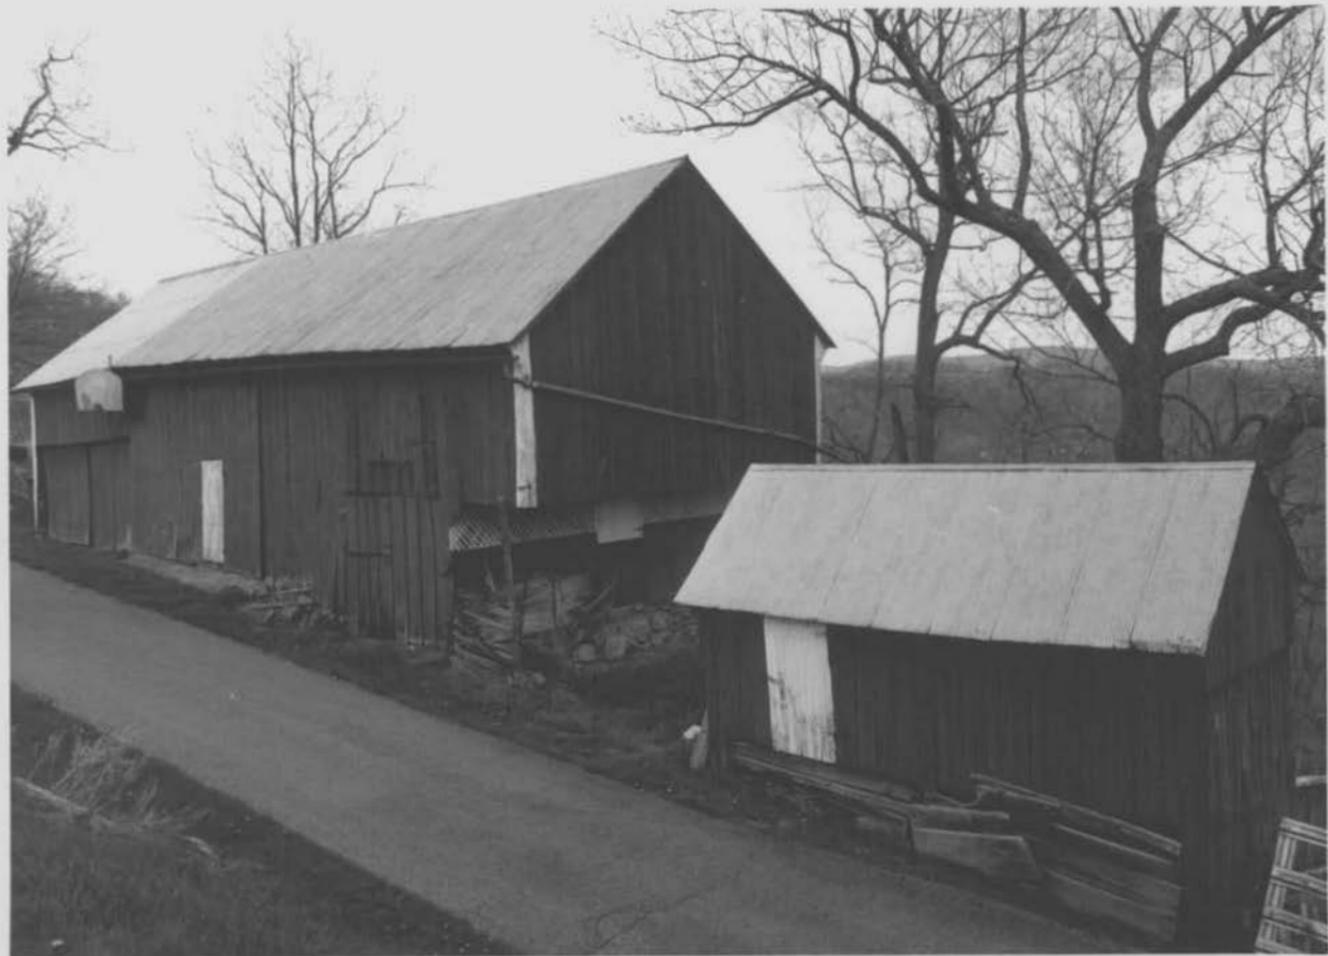
5/5

Hog barn and stable. View from southwest

Hog pen: The frame hog pen was built probably in the last quarter of the 19th century or the first decade of the 20th century. It is located with the stable north of the house near the junction of the driveway with Church Hill Road. It has vertical board siding and a standing seam metal roof. The west elevation has a single door near the northwest corner and the lower level pens are boarded.

Stable: The stable, probably built in the same period as the hog pen, is a small bank barn with the stall level on the south gable end. It has vertical siding and a standing seam metal roof. The stall level is enclosed with horizontal boards and lattice. On the west elevation is a vertical board door near the southwest corner and a single door off-center in the northern part of the barn, giving access to the storage level. An extension on the north gable end for tractor and wagon storage has double swing doors on the west elevation.
