Easterday-Summers Farmstead
Myersville vicinity
Private

F-4-64
Easterday-Summers Farmstead
Myersville
Frederick County

State Historic Sites Inventory Form

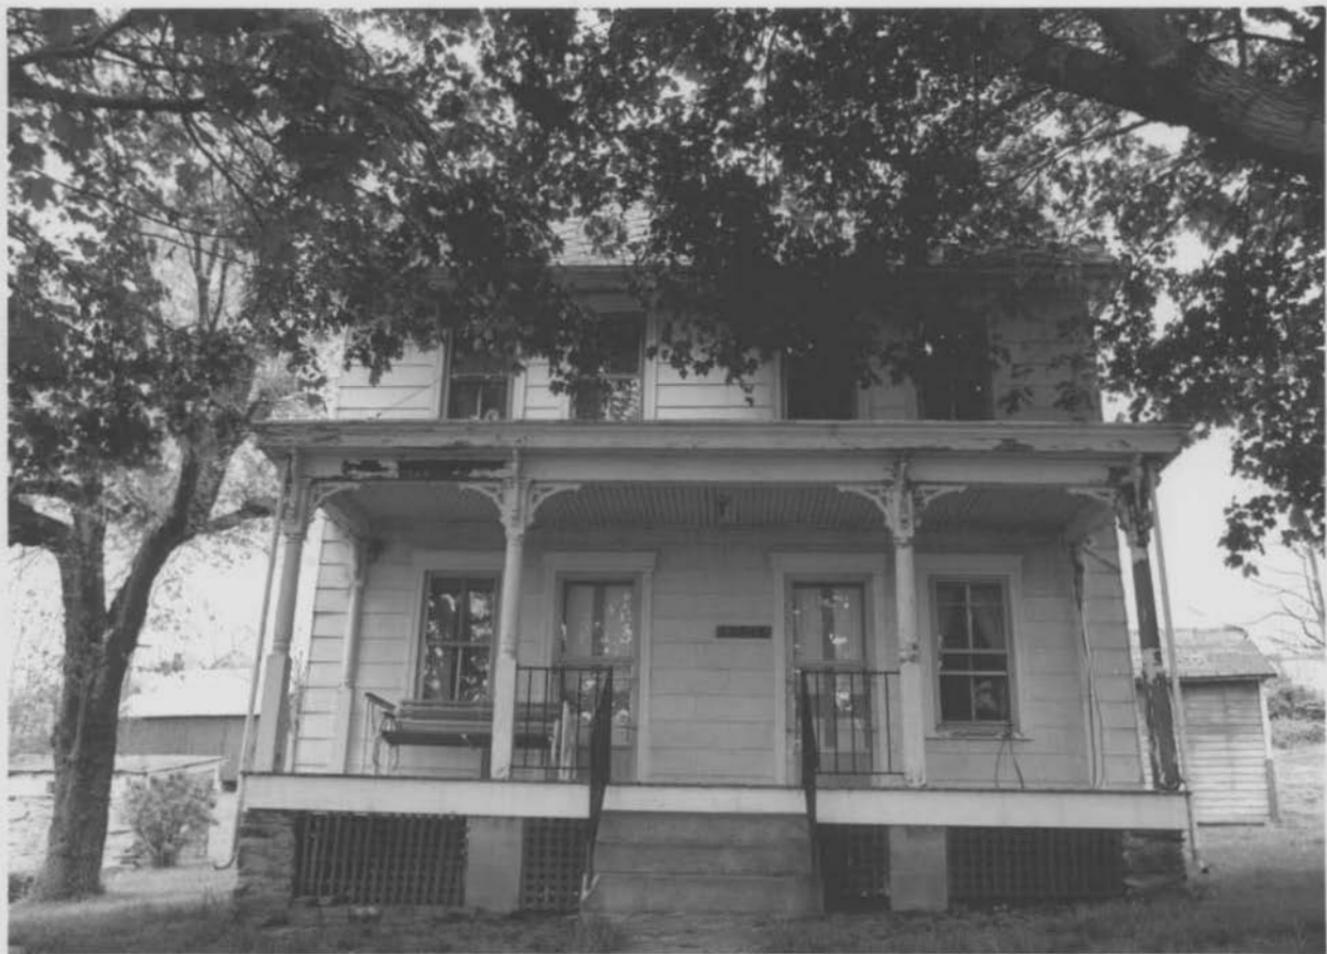
1/2

East elevation

The house has a four-bay east elevation with double entrances. The sash is 2/2 with molded frames and lintels. The doors are in the inner two bays and have four panels. The entrances have no transoms. The porch has turned columns and decorative brackets. Its roof is composition, as is the main roof. The cornice is boxed and returns on the north and south gable ends. The chimneys are interior on both gable ends. The north and south elevations each have two window bays. A two-story rear wing extends from the northwest corner of the main section. It originally had an open two-level porch on the south side, but this has been enclosed in the mid-20th century and sided with aluminum. The west end of the wing has a third interior chimney. The interior was not accessible for this survey.

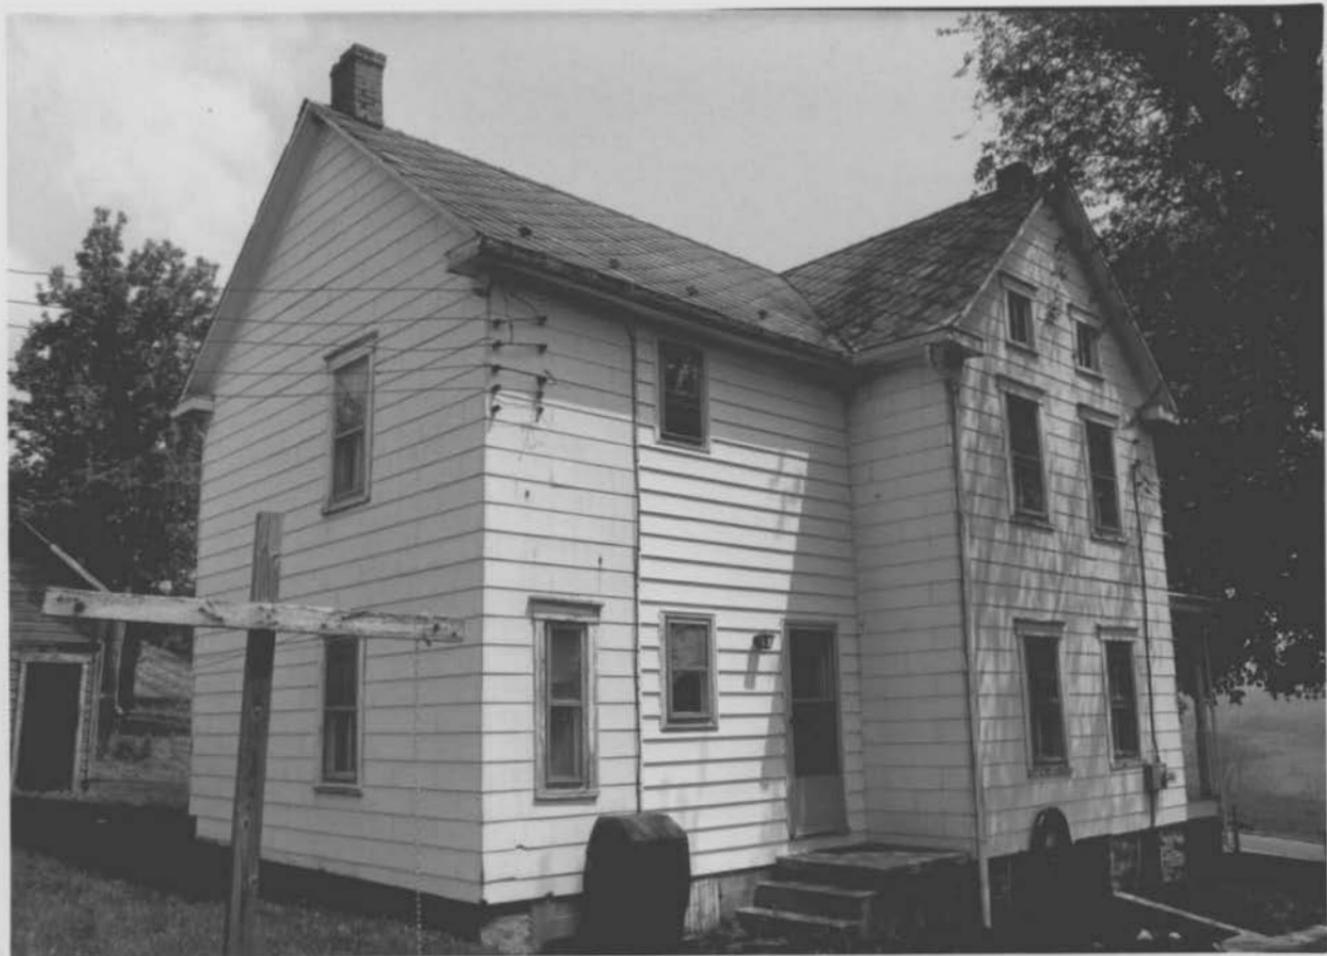
2/2

Neg. loc: Md. SWSO Cr. 1000-1000-111d
Southwest corner of lot

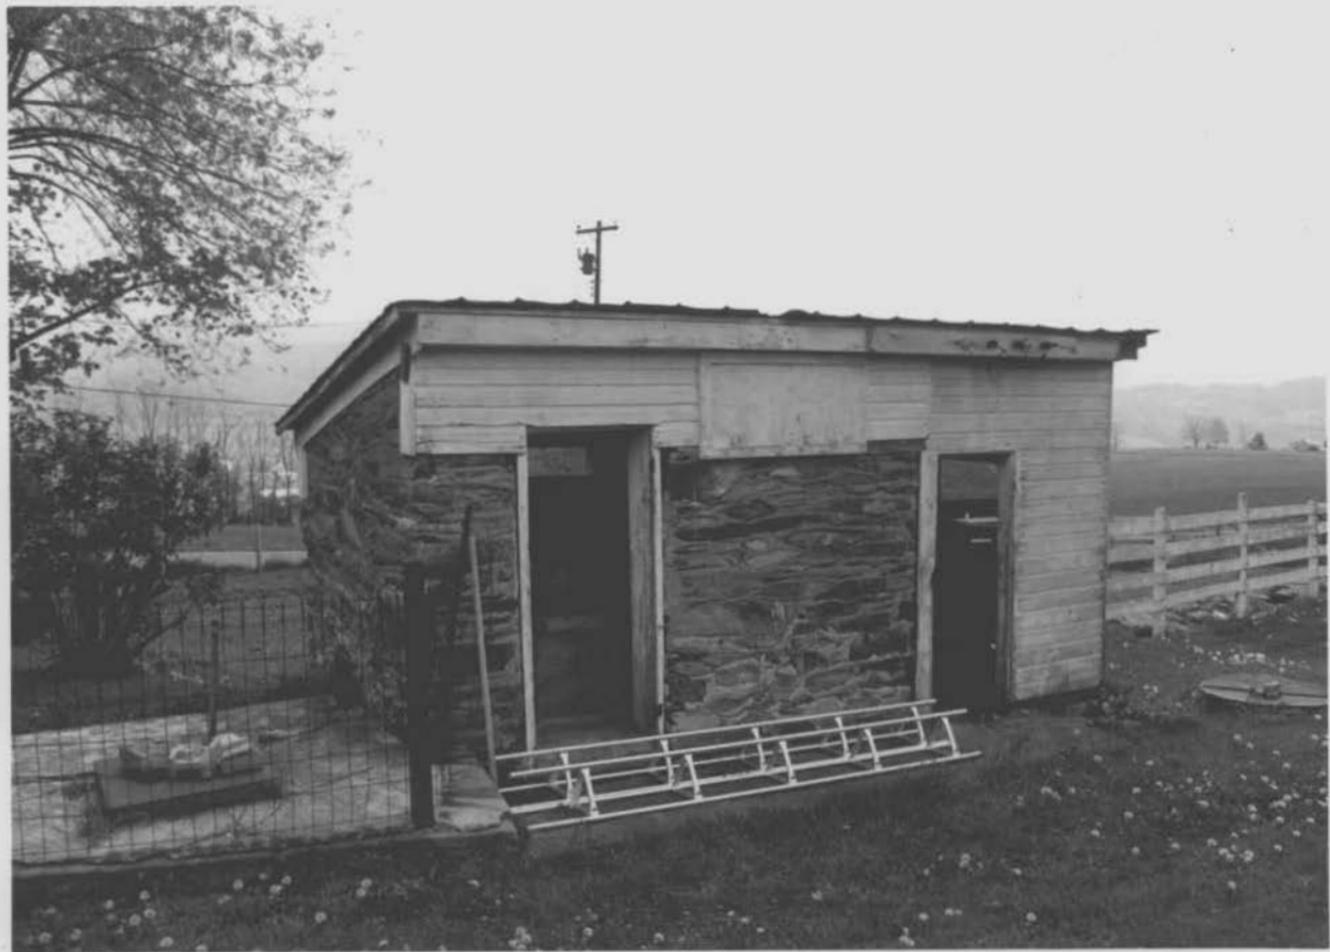
4/6

Dairy, west elevation.

Dairy: The stone dairy is located south of the house immediately south of the well. On the south end of the stone structure is a frame extension with german siding. The building has a standing seam metal roof and two vertical board doors in

the west elevation. Inside are concrete troughs for cooling milk and other containers. The dairy may date from the 1920's when dairy production throughout Frederick County expanded.

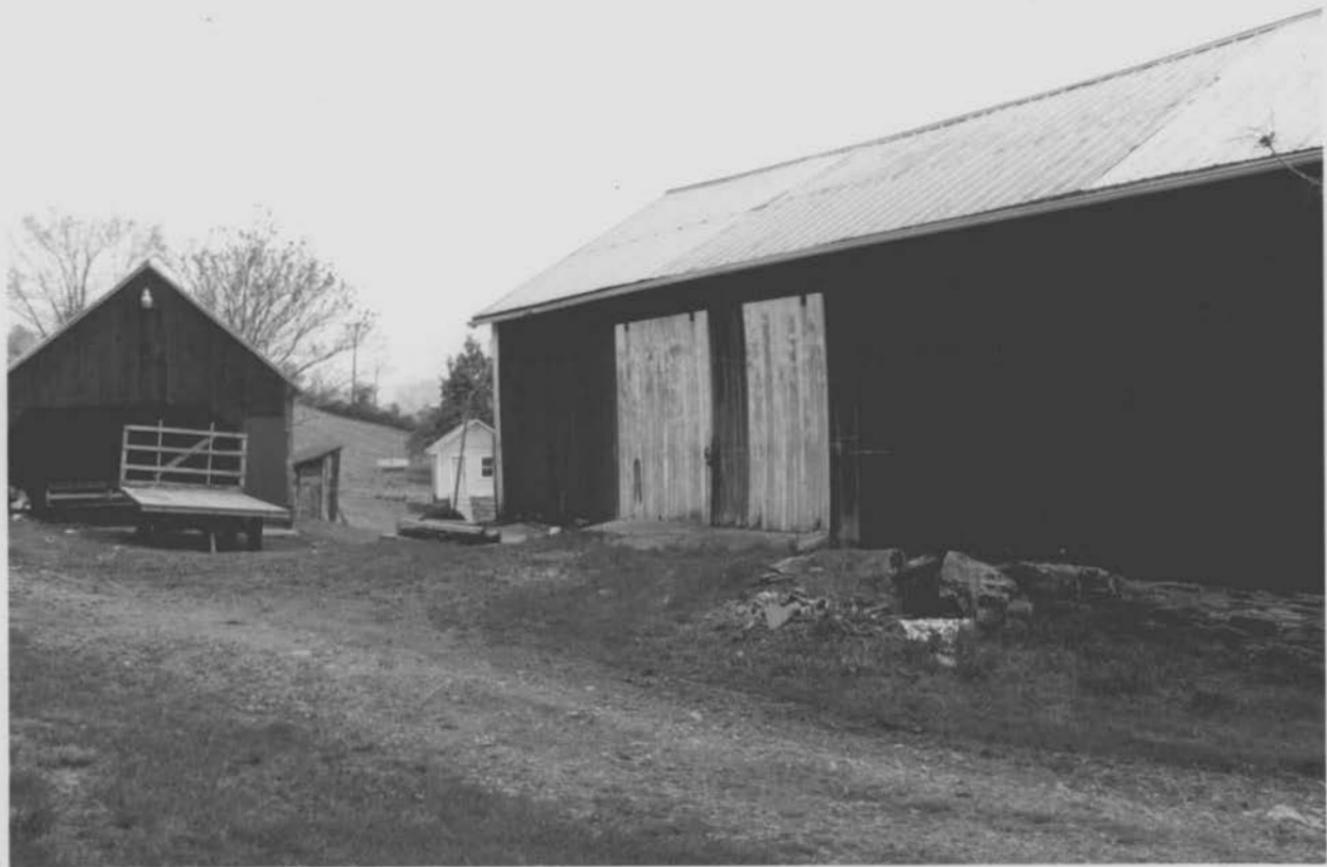
5/6

Wagon shed and well, view from southeast

Wagon shed/corn crib: The frame wagon shed/corn crib was built about 1875-1900 and has vertical siding and a corrugated metal roof. The single crib is on the east side of the shed.

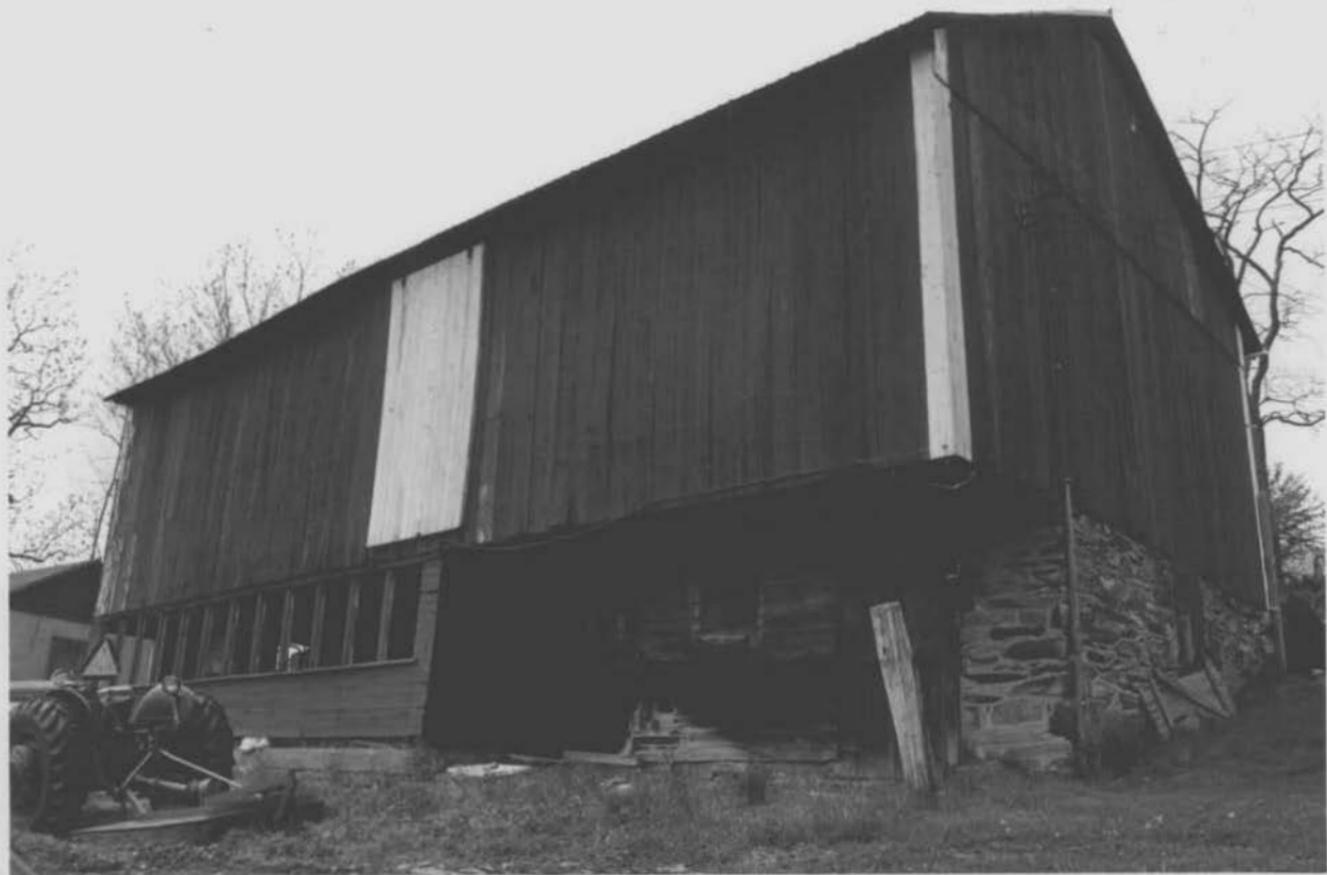
3/5

Born. northeast corner yard.

Bank barn: The circa 1900 frame bank barn has vertical siding and a standing seam metal roof. The stall level near the southeast corner has been partially enclosed with concreted block for use as a milking room. The rest of the stall level has horizontal wood siding with a tool niche. Near the ramp to the storage level on the west elevation is the base of a silo, which has been demolished. A concrete block milk house built about 1935 is located south of the barn. It has a composition roof and 2/2 metal sash. The door in the north elevation is vertical tongue-and-groove.
