Jacob Leatherman Farmstead
Wolfsville vicinity
Private

Ca. 1850-1925

Maryland Historical Trust State Historic Sites Inventory Form

Survey No. F-4-66

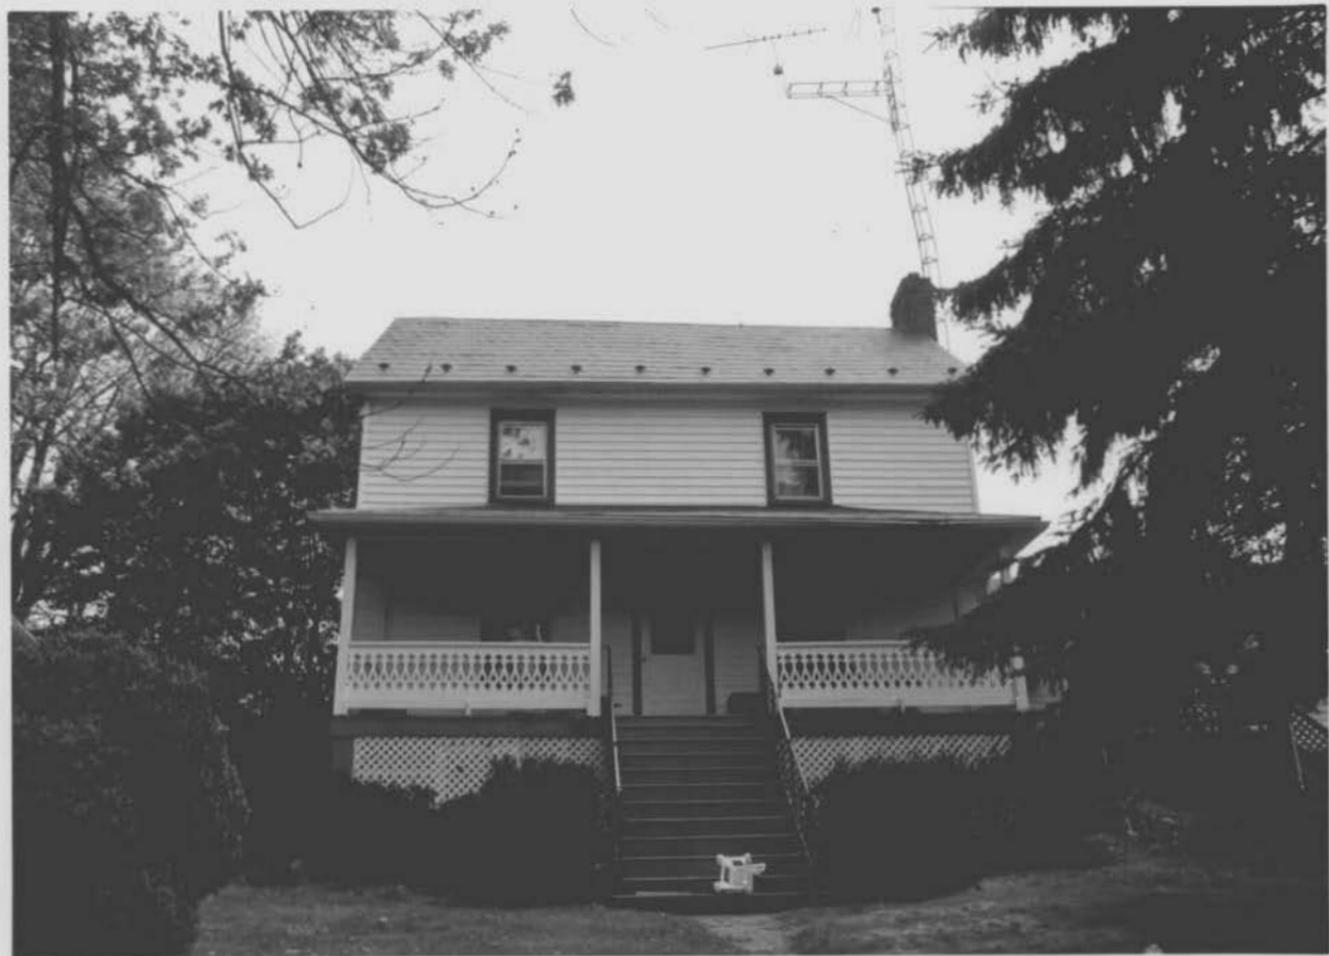
1/5

Acid elevation

The house has a north elevation with three bays on the first story and two on the second story, and a one-story porch with a scroll-sawn balustrade, probably added in the last quarter of the 19th century. The supporting posts are chamfered. The exterior of the building is covered with vinyl siding, concealing german siding. The current owner's father, Mr. Queen, interviewed on the site, stated he did not think there were logs in the structure of the house and that he understood that the house was a frame building erected about 1912. The interior was not accessible for this survey; however, examination of the interior plan and details, although altered according to Mr. Queen, may help determine a more accurate date for the house. Its general exterior plan is consistent with structures built from about 1850 to 1875 and the details such as the porch and the pressed metal roof are typical of the period 1875-1900. The windows are 3/1 with molded lintels, the sash apparently being replaced during the 1920's, as this type is very common during the 1920's and 1930's. The chimney is an exterior rebuilt type on the west gable end. At the rear of the house is a two-story wing with a late 1980's one-story addition on the west side. A second exterior brick chimney is located on the south gable end of the wing. A one-story enclosed porch is located on the east side of the wing. Vinyl siding covers both the wing and the addition.

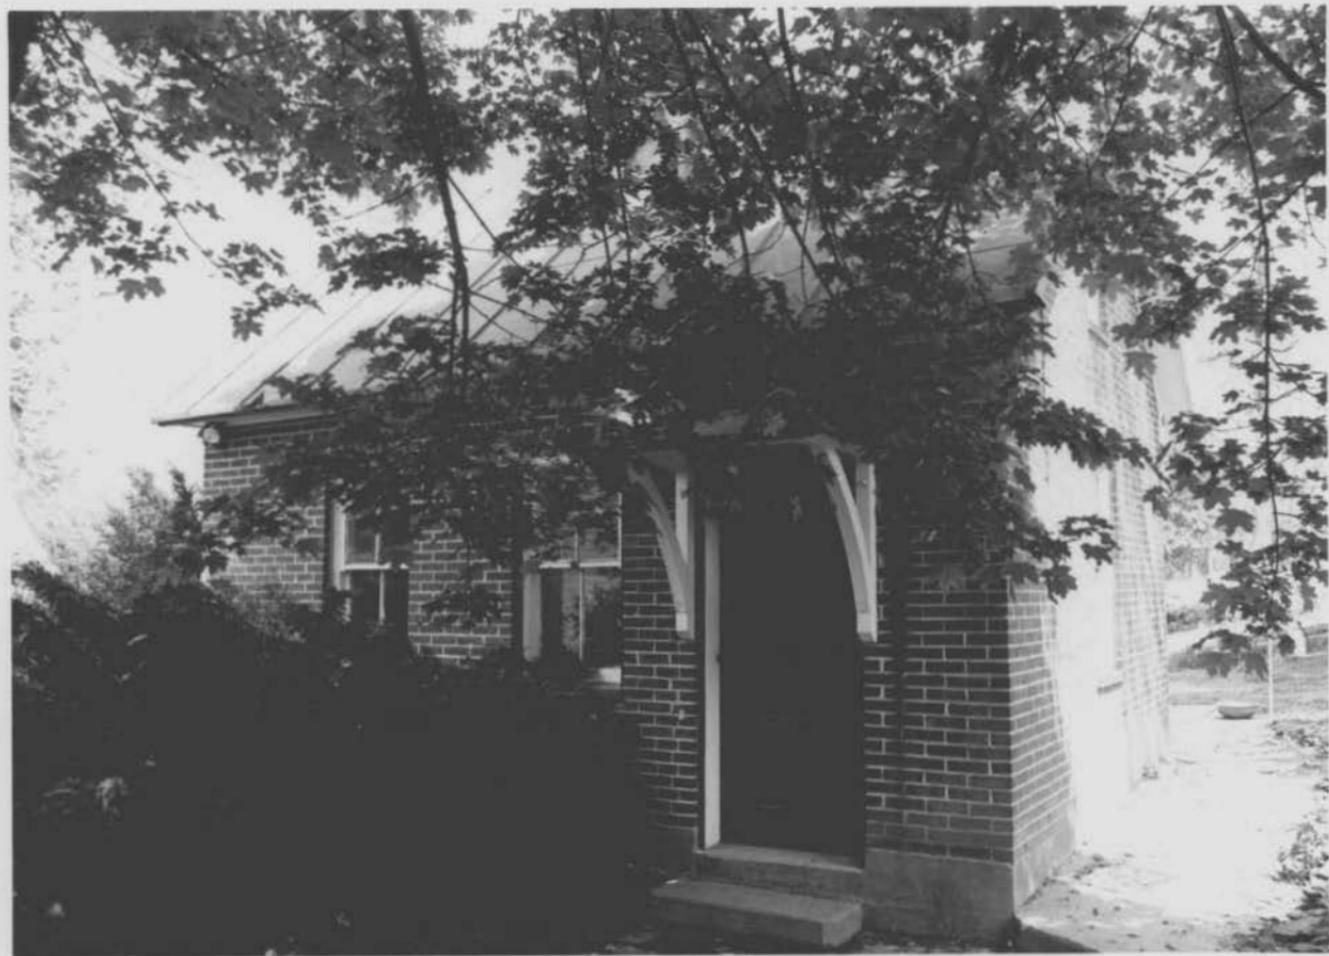
3/5

Now loc. Md. State, Crossville, Md.
Butcher's shed, southwest corner view

Butchering shed: The brick butchering shed is a one-story structure located east of the rear wing of the house. It has a rectangular plan with 2/2 windows and a standing seam metal gable roof. The door is a five-panel type located near the southwest corner under a bracketed hood. An exterior brick chimney is located on the north elevation. The butchering shed was also built during the 1920's.

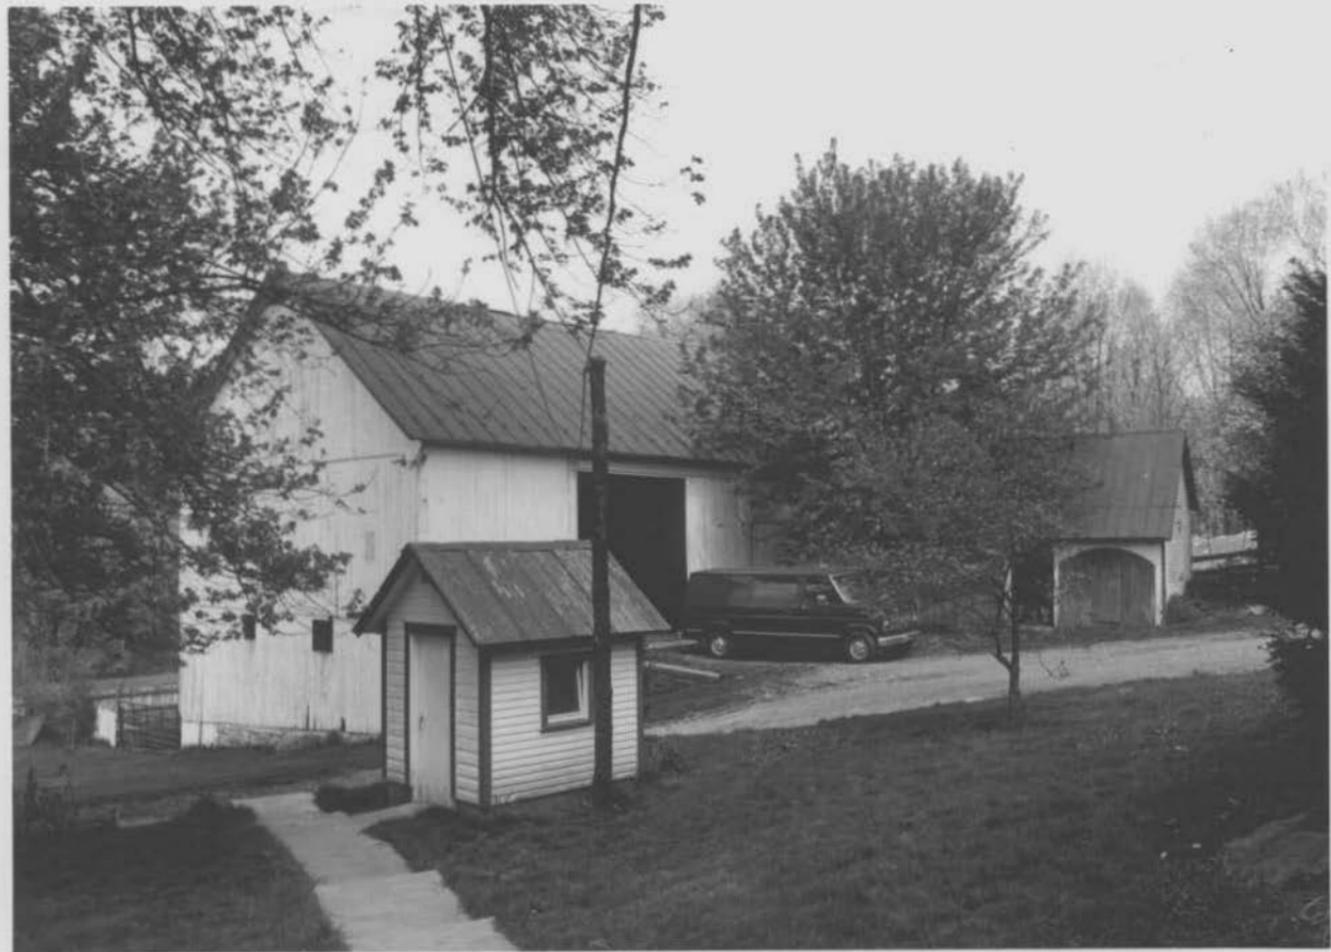
4/5

Agricultural outbuildings and barn view
from south-east

Bank barn: The frame bank barn is located at the northeast corner of the farmstead and appears to be an early 20th century replacement of an earlier structure. It has a stone foundation and the vertical siding of the upper part bears the marks of circular saws. The roof is standing seam metal.

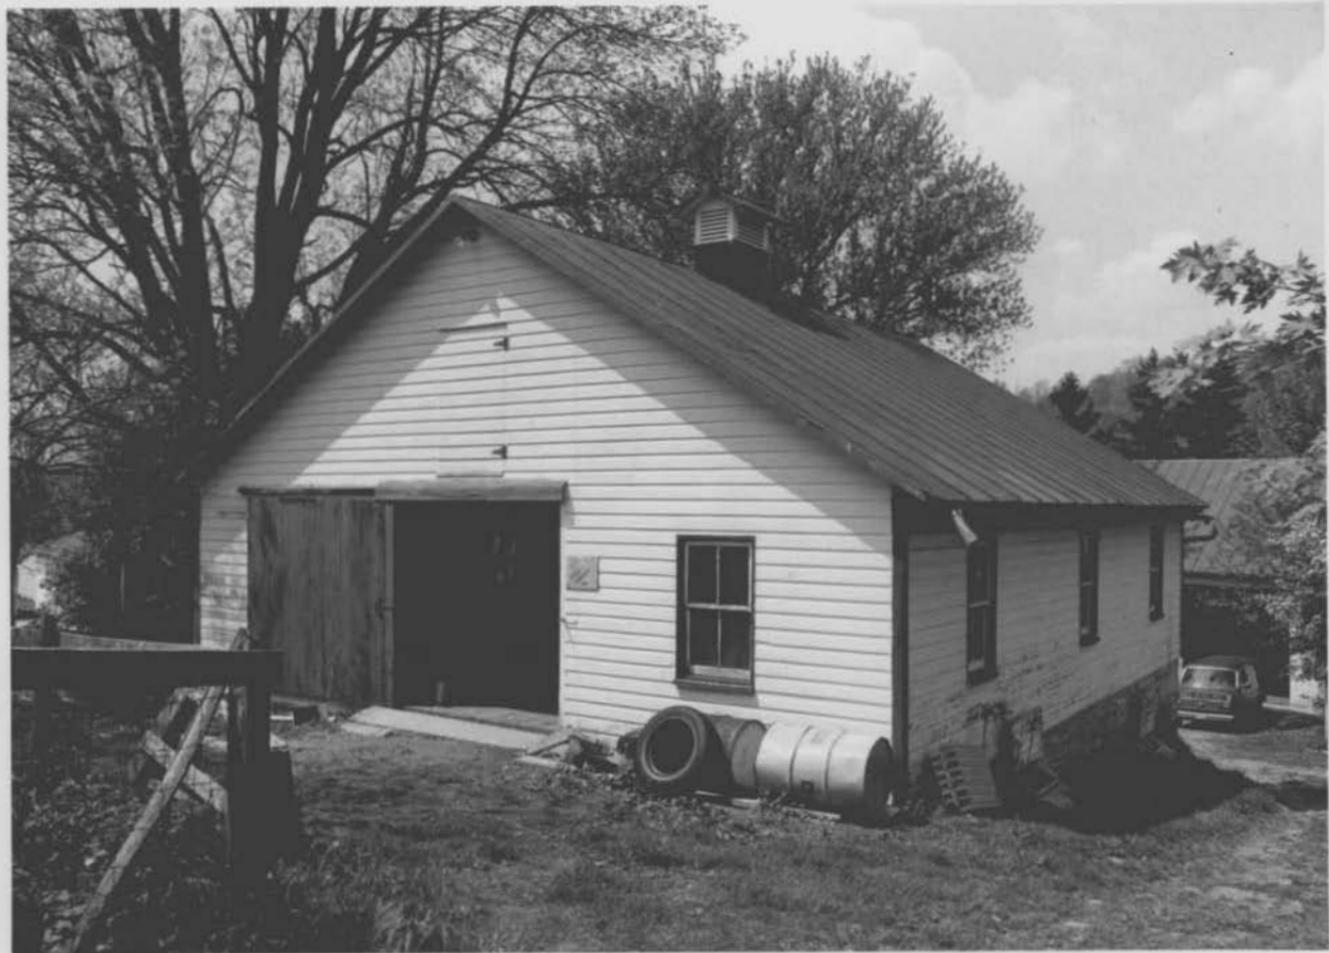
3/5

Shop/foot cellar - east elevation

Root cellar/shop: This is the most unusual building in the farmstead, having been built in the early 20th century for the combined purpose of cool storage and a workshop on the upper level. It is built into a slope south of the barn with a stone lower level and a large opening on the north elevation. Inside the lower level is an extensive storage area with a frame enclosure at the rear with sliding doors. The front section may have been for equipment storage. The upper level of the building is entered from the south elevation and contains a large shop space with 2/2 windows, german siding, and a standing seam metal gable roof. On the ridgeline is a cupola for venting the below-ground storage cellar, with the flue rising through the center of the workshop.
