F-4-69

Benjamin Shuff Farmstead  
Wolfsville vicinity  
Private

F-4-69  
Benjamin Shuff Farmstead  
Wolfsville  
Frederick County

# Maryland Historical Trust State Historic Sites Inventory Form

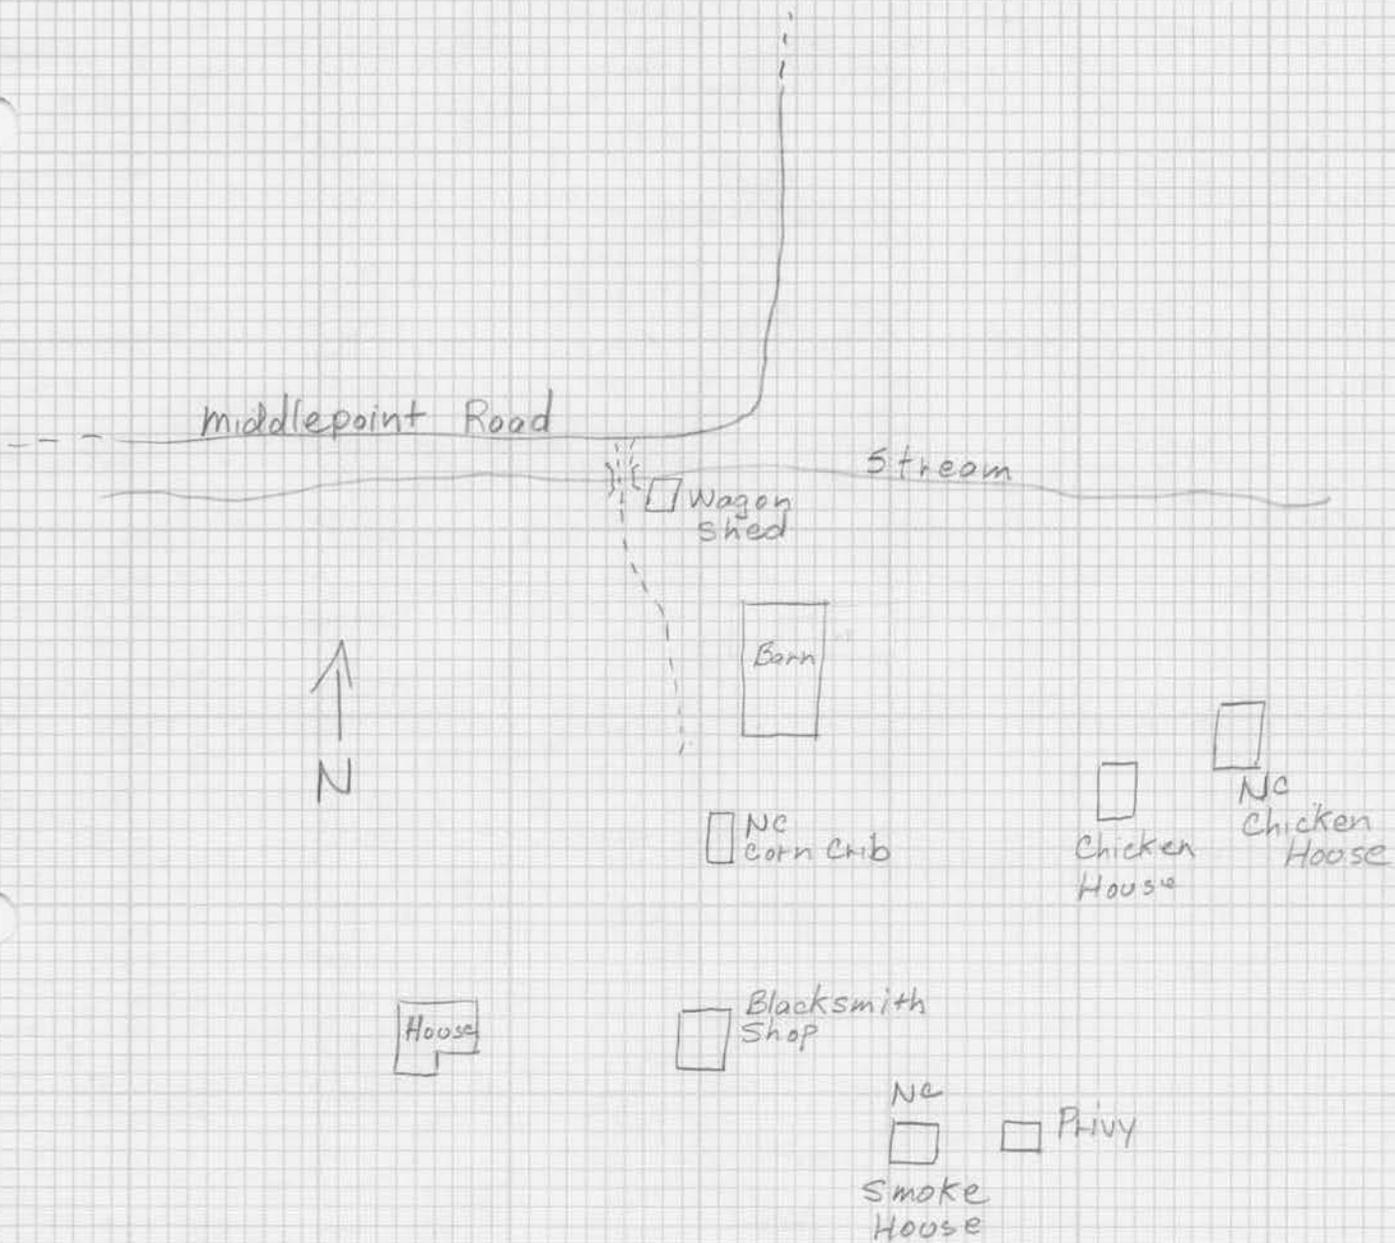
F-4-69  
 Benjamin Shuff Farmstead  
 Frederick County

Janet Davis  
 May 12, 1992  
 Not to Scale

The Benjamin Shuff Farmstead is an originally agricultural complex now used as a private residence, centered on a frame, two-story dwelling built during the period 1875-1900 to replace an earlier residence which burned, and a group of eight domestic and agricultural outbuildings, of which five are contributing resources, including a frame bank barn of about 1865, a wagon shed, a blacksmith shop now used as a tool shed, a chicken house, and a privy, all dating from about 1865-1900. The farmstead is located on the south side of Middlepoint Road about 1/4 mile east of Wolfsville Road, near Wolfsville, Frederick County, Maryland. The wagon shed and barn are nearest the road on the bank of a small stream which parallels and separates the farmstead from Middlepoint Road. The dwelling is set back about 50 yards and the outbuildings are arranged east and northeast of the house.

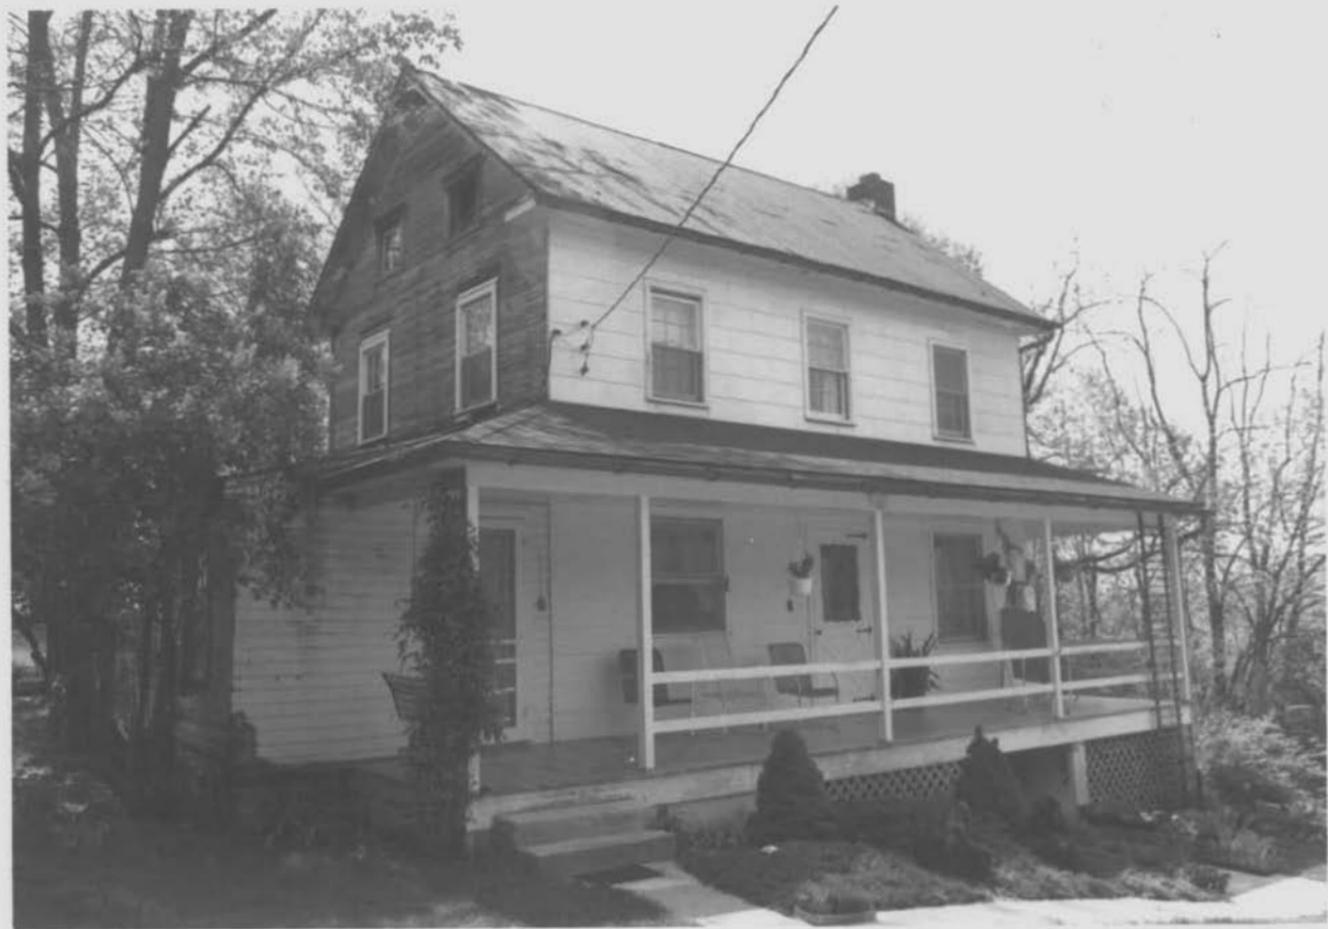
1/5

North elevation

The principal elevation of the house faces north and has three bays. The house has asbestos shingle siding on the second story and pressboard siding on the first story under a one-story porch across the north side. The original principal entrance was in the center bay with a small entry porch sheltering the doorway. During the 1950's, the entrance was relocated to a small shed addition on the east side of the house. The original siding was german and remains exposed on the east and south elevations above one-story additions made after 1950. The gable roof is covered with corrugated metal and an exterior brick chimney is located on the west gable end. The sash is 6/6 replacement on the second story and 8/8 replacement on the first story. Both the shed addition on the east and the one-story rear wing were built after 1950. The interior was not accessible for this survey; however, Mr. Shuff, the present owner, said the interior plan and finishes have been considerably altered and the stairway relocated.

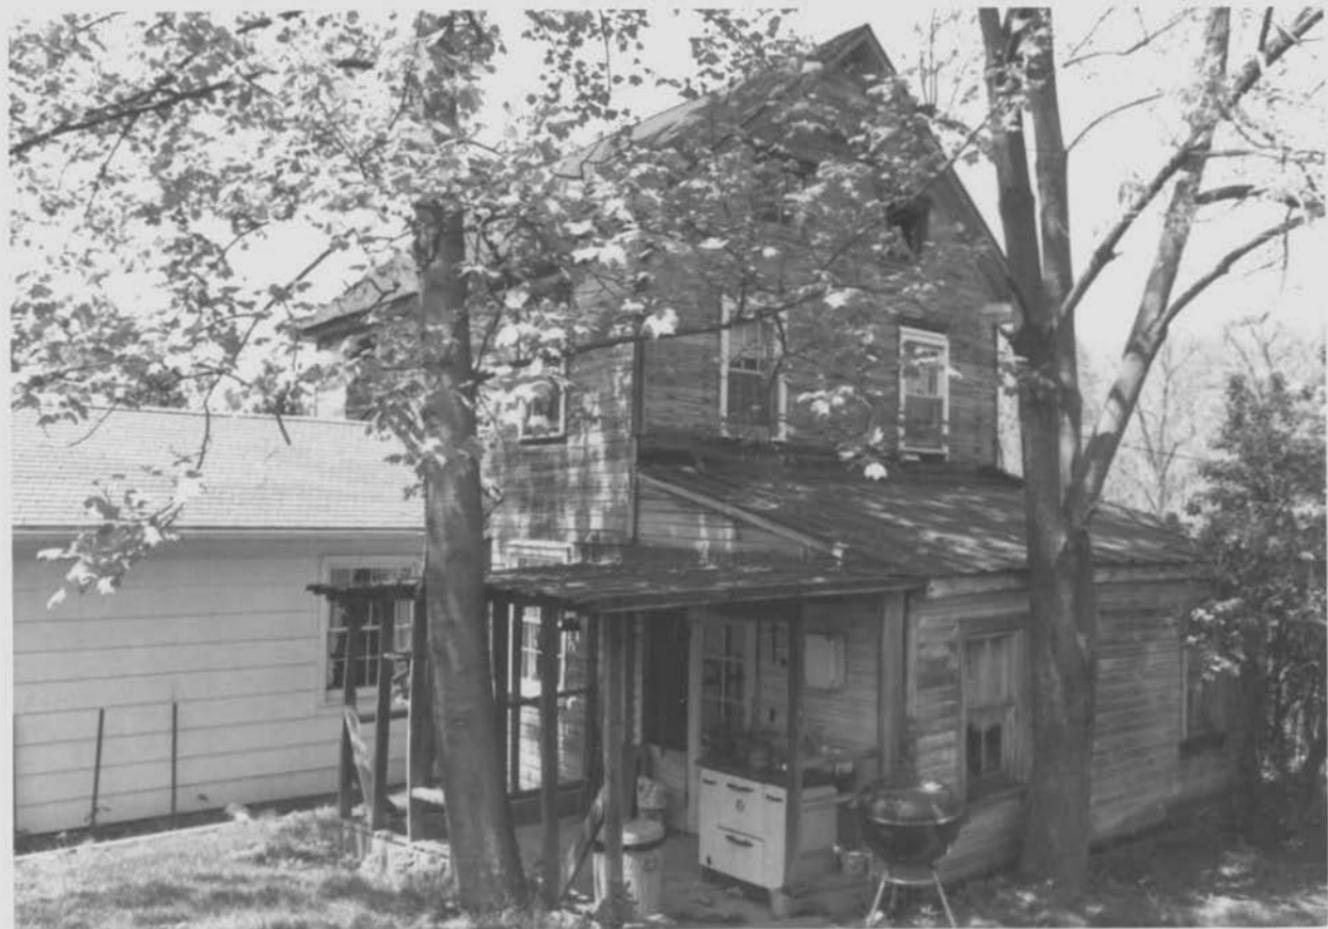
2/5

Southwest corner view

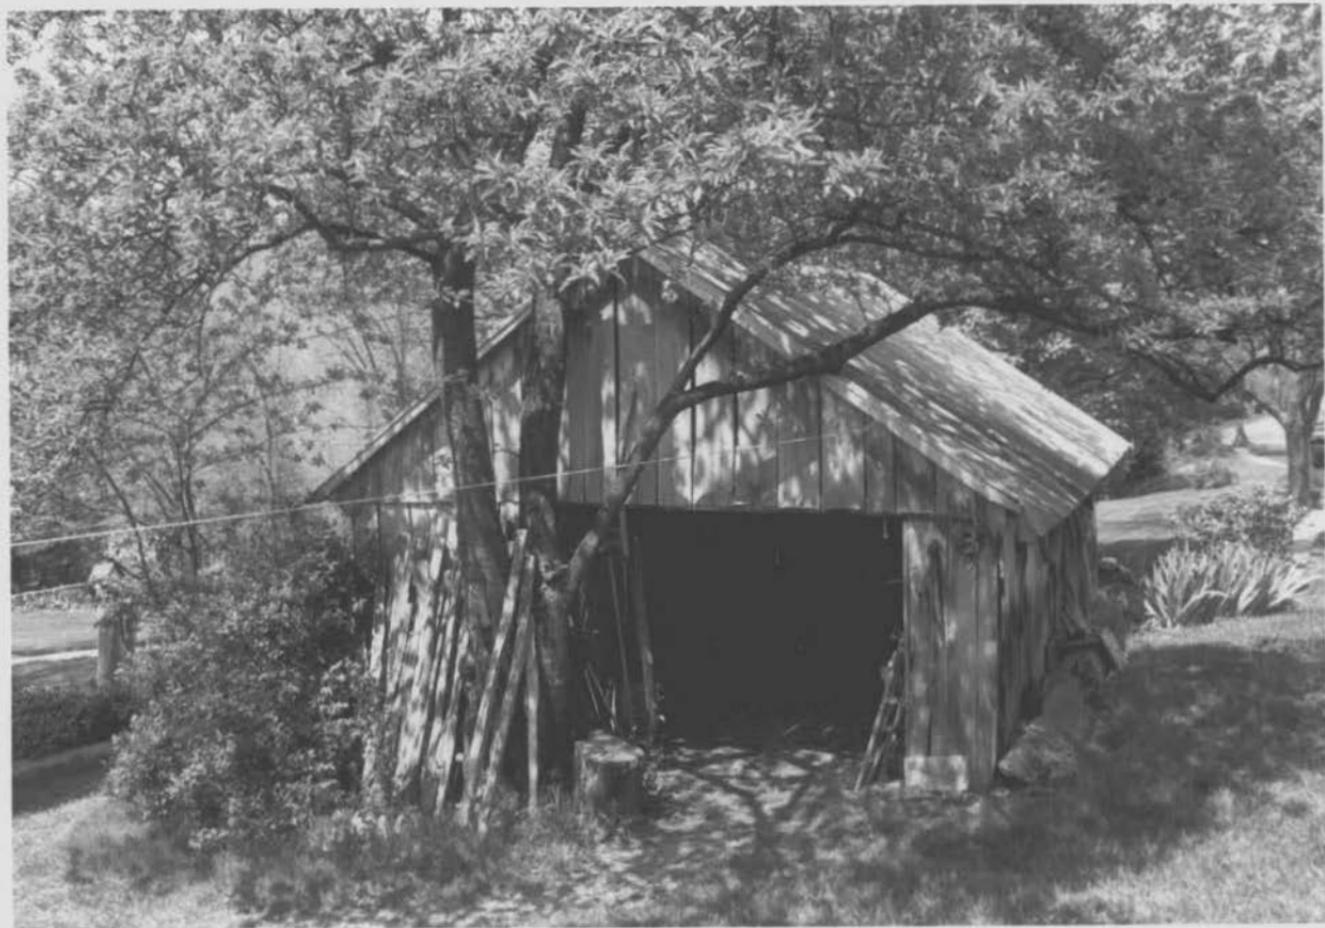
3/5

Blacksmith shop, south elevation

Blacksmith shop: The log blacksmith shop is a one-story structure located east of the house. It has vertical exterior siding and a corrugated metal roof. Currently used as a tool shop, it has a wide doorway in the south elevation. This building may date from about 1865.

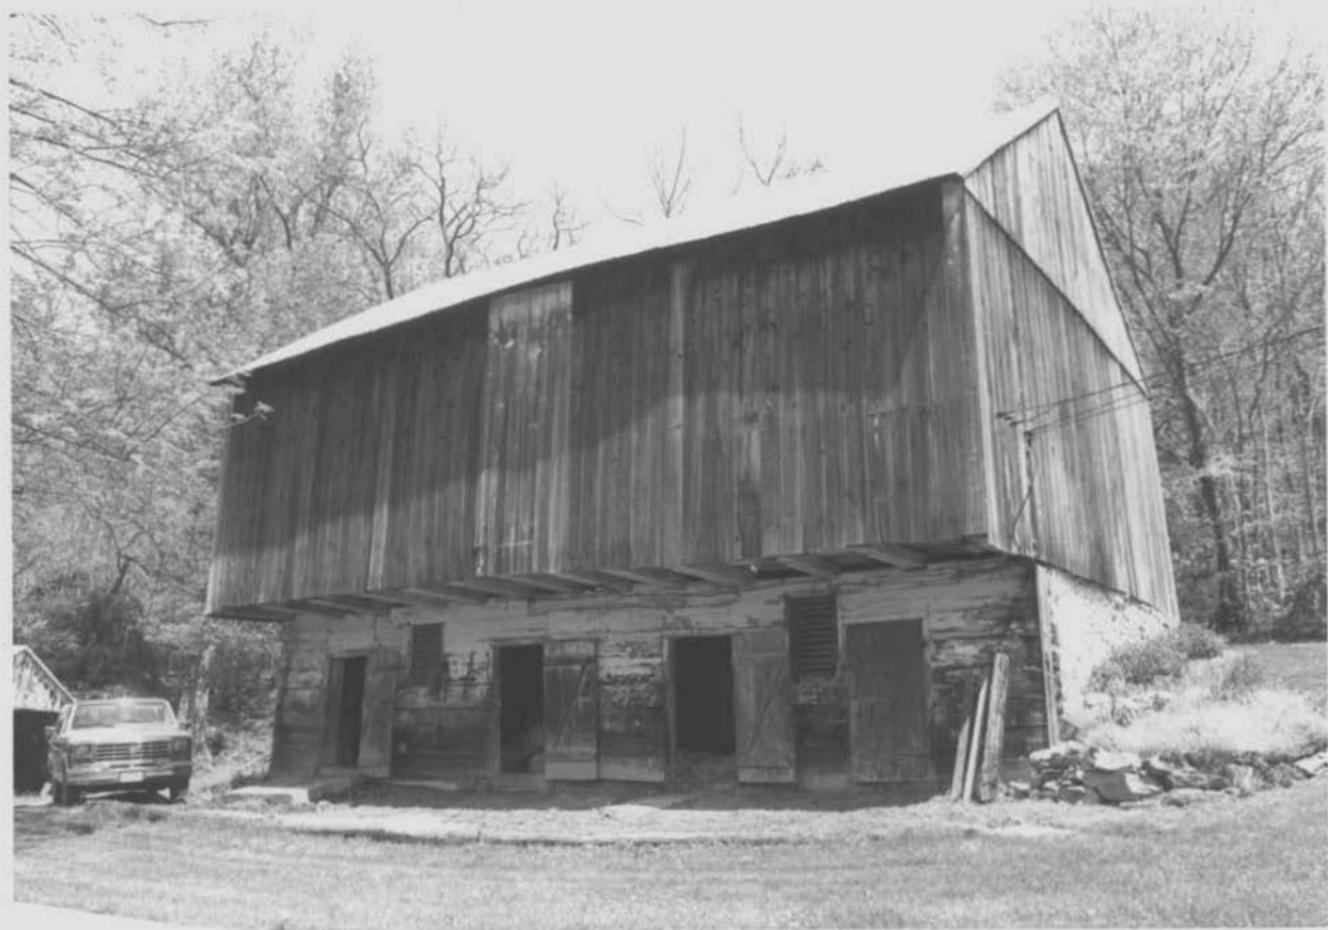
5.5

Barn, west elevation

Barn: The frame bank barn was probably also built about 1865, having up-and-down saw marks on the main structural beams of the interior. The exterior vertical siding also has some early boards among some replaced in the early 20th century. The stall level on the south elevation is enclosed with horizontal flush boards. The roof is standing seam metal.

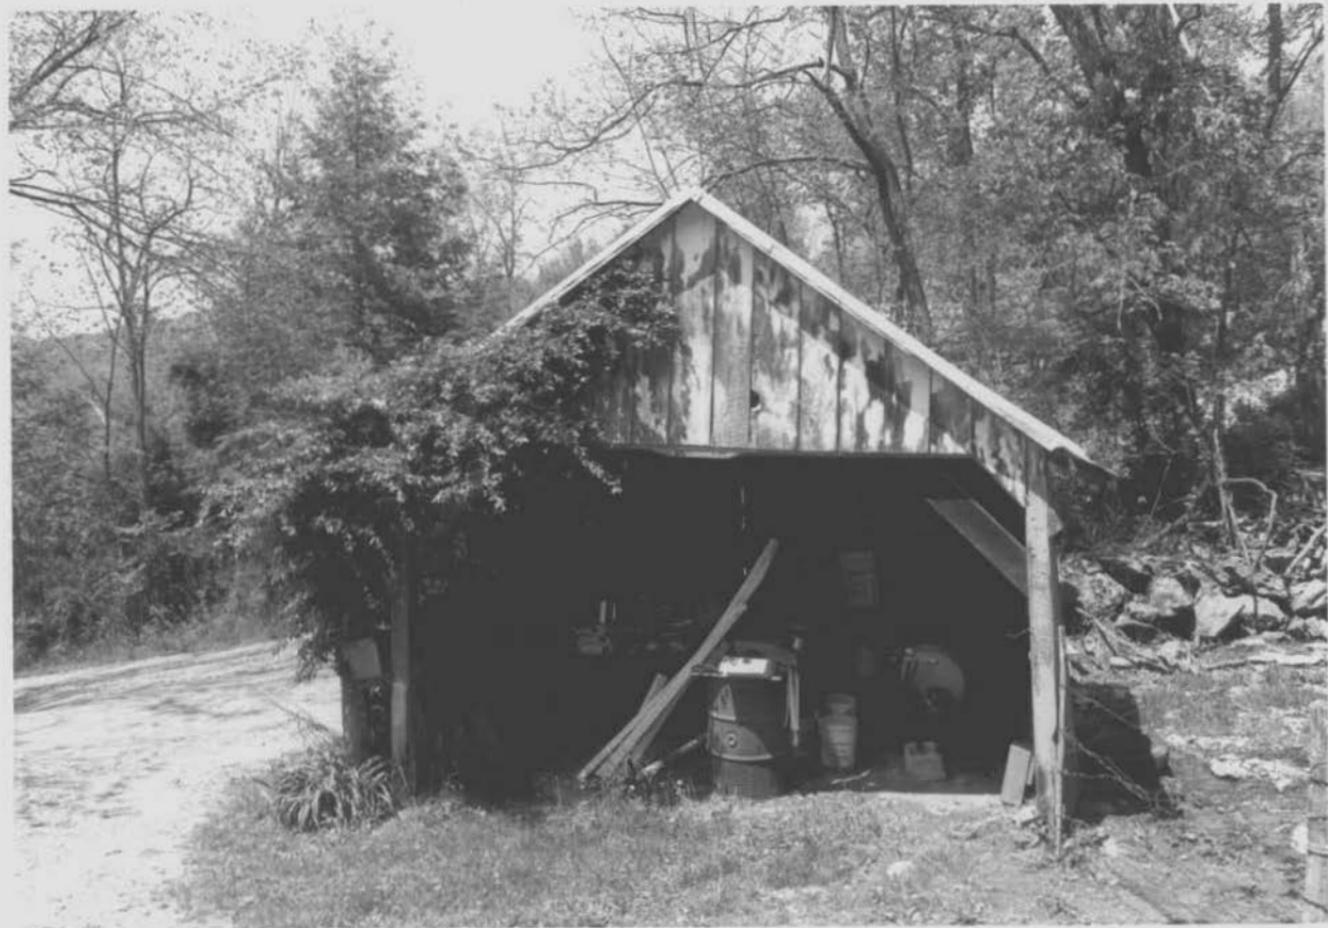
4/5

Slod, south elevation

Wagon shed: The frame wagon shed is located on the edge of the stream near Middlepoint Road. It has an open south elevation and vertical board siding on the other elevations. The gable roof is standing seam metal. This building was probably erected in the 1890's.
