F-4-70

Schlosser-Waters Farmstead  
Myersville vicinity  
Private

F-4-70  
Schlosser-Waters Farmstead  
Myersville  
Frederick County

**Maryland Historical Trust**  
**State Historic Sites Inventory Form**

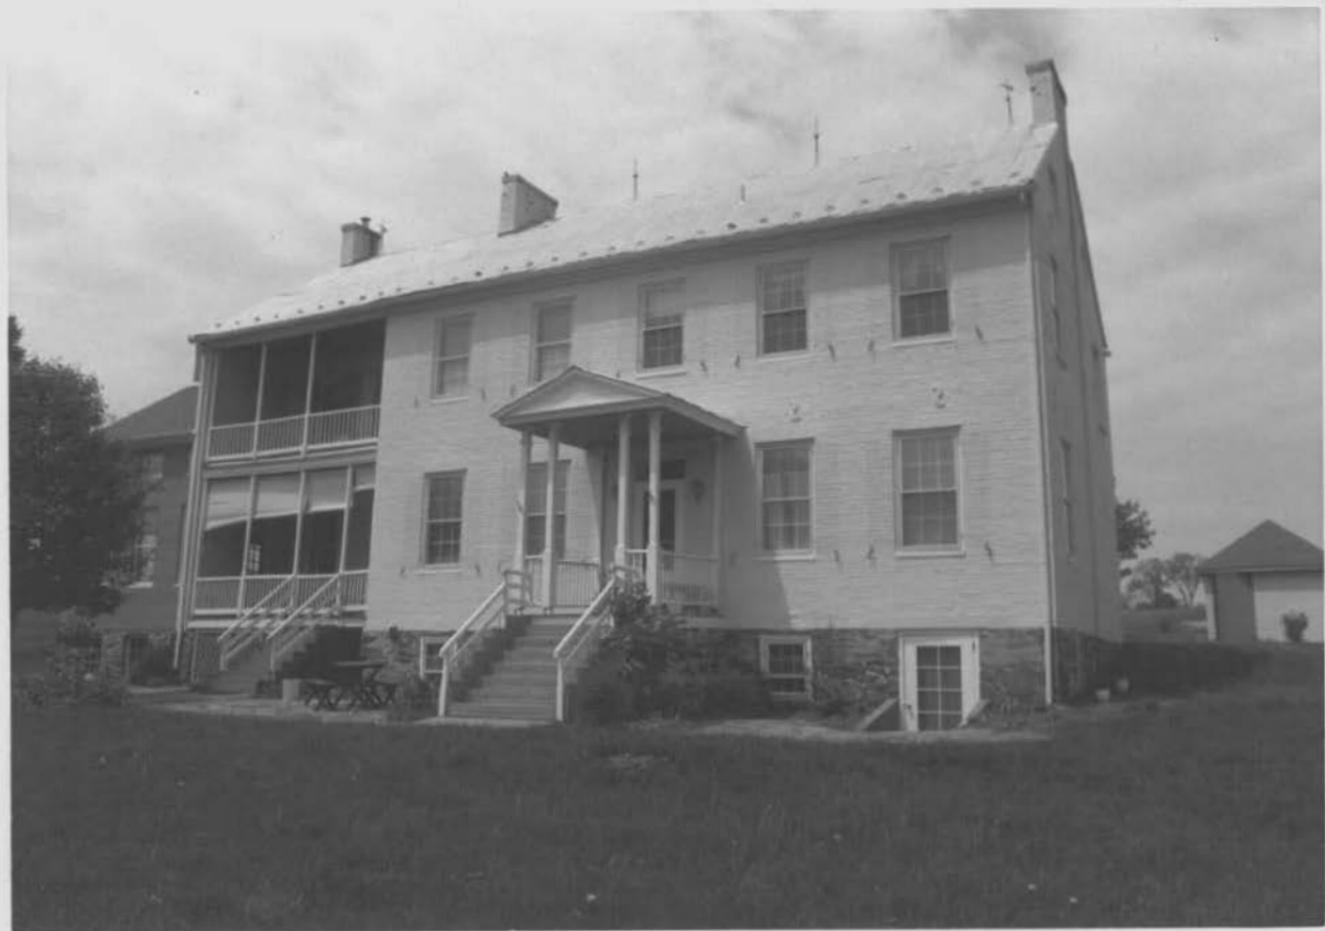
1/6

East elevation

The dwelling faces east toward a small pond on the edge of which are the summer kitchen and the springhouse. The house has a flemish bond exterior in the earlier section which is painted white. The north side and west elevations have 4:1 American bond. The east elevation has five bays with a center entrance. The entrance porch has been rebuilt on a stone foundation with new brick steps. The modern pedimented roof has paired square columns which appear to be about 1850 in date. The main entrance door has 10 panels, with raised profiles, under a three-light transom. The window openings have gauged arches and wood sills. The sash is 6/6 with original shutter hardware still in place, although the shutters have been removed. The cornice is corbeled and the gable roof is covered with corrugated metal. The interior chimneys are located at the gable ends. On the south side of the five-bay section is a two-story side wing with a two-level open porch. The porch posts are chamfered and the balustrade is plain. The wing has two bays with 6/6 sash and a three-light transom above the 10-panel door. A third chimney is located at the south end of the wing, enclosed by the two-story modern addition on the south. The addition is faced with natural brick. The west elevation has the same number of bays in each section of the original dwelling as in the east elevation. The facade is flush, with no porches or other projections. The 6/6 sash are replacements. The north elevation has two bays with replacement 6/6 windows in the west bay on the second floor. The first floor window has been filled in. The interior was inaccessible for this survey.

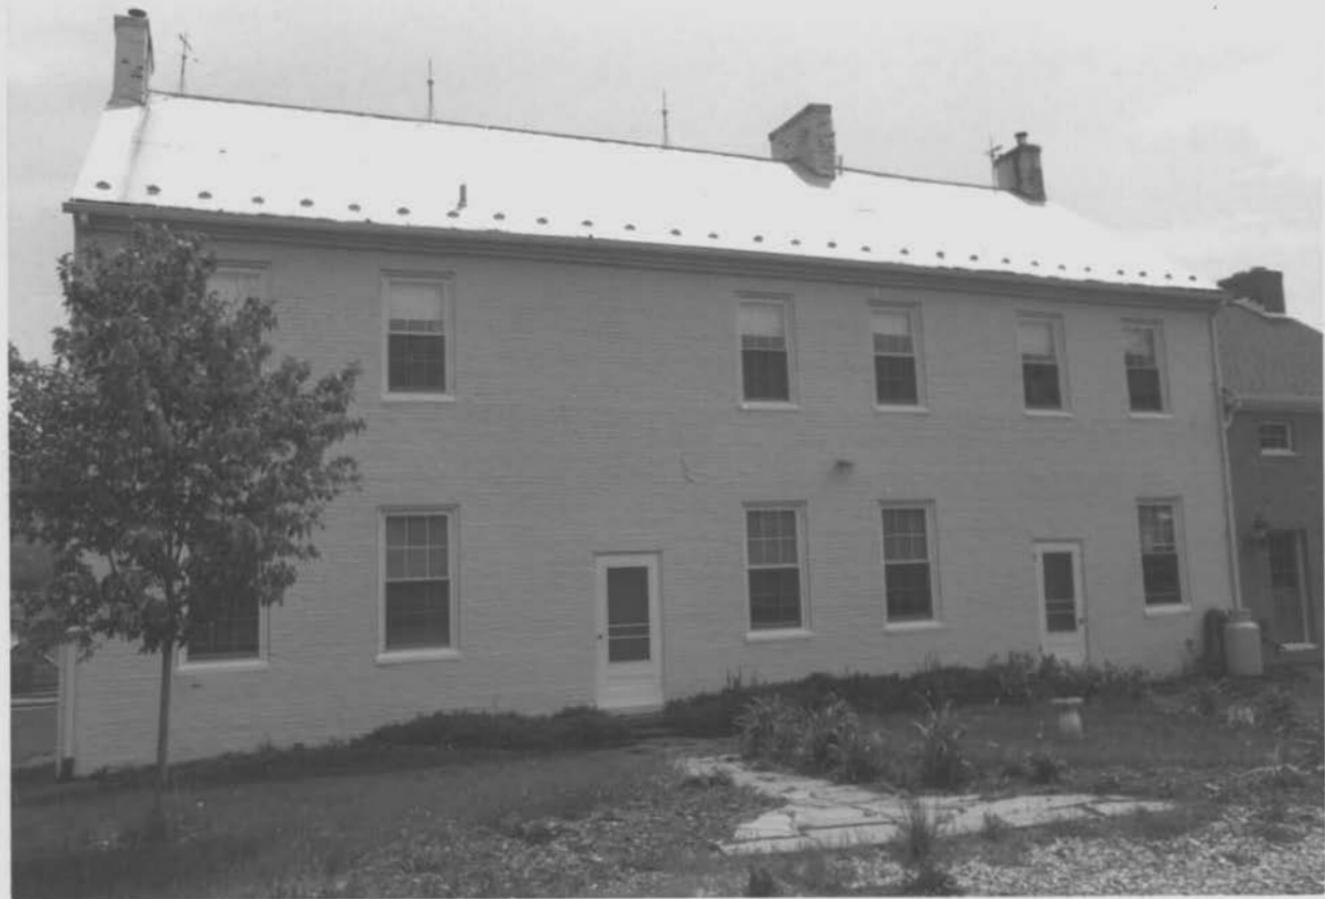
2/6

West elevation

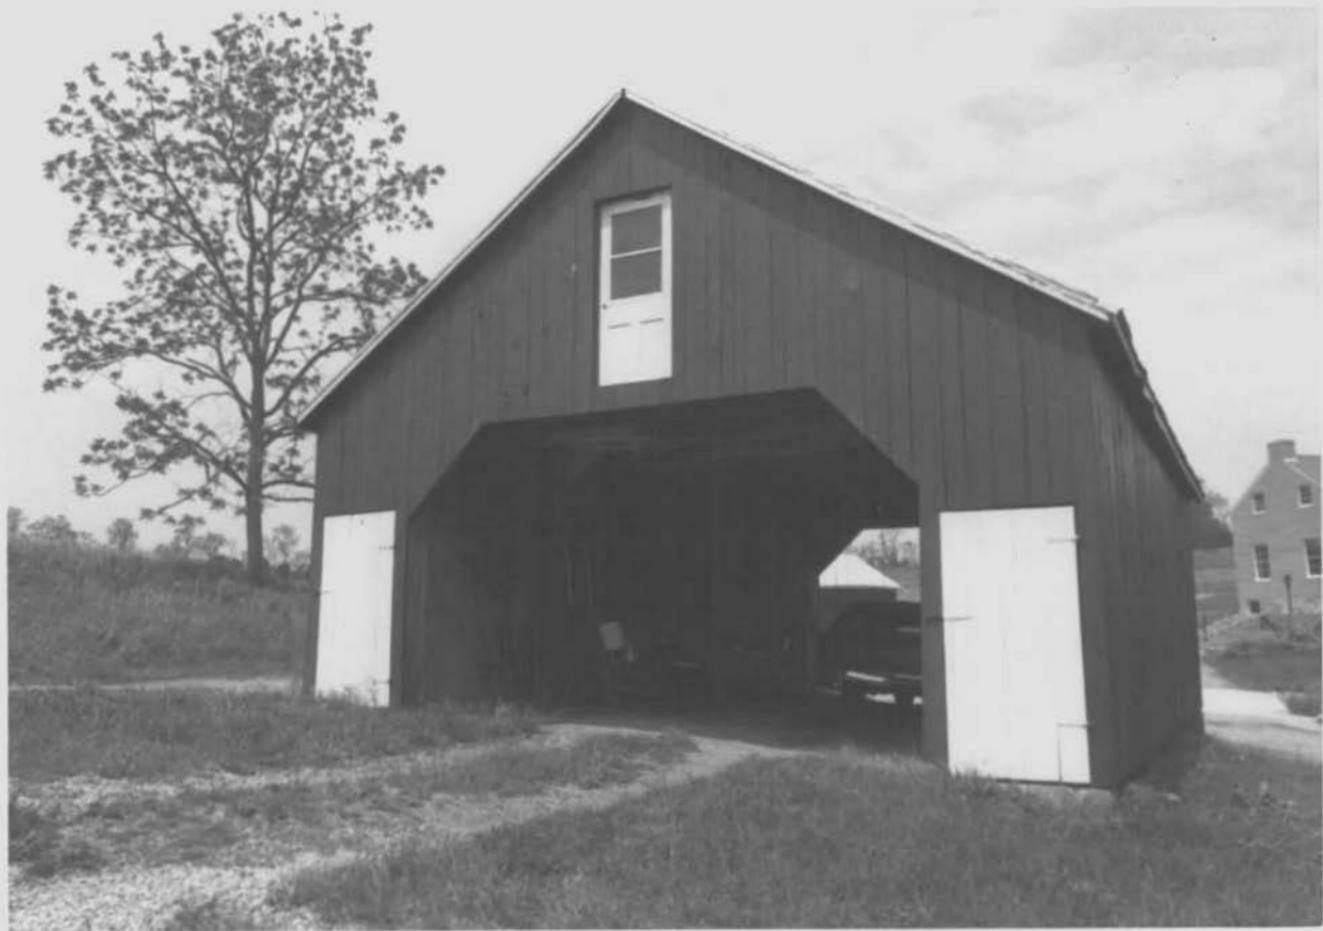
4/6

Wagon shed/corn crib, east elevation

Wagon shed/corn crib: Southwest of the bank barn is the frame wagon shed/corn crib, which dates from about 1875-1900. The double corn cribs are located on the north and south sides of the drive-through. The structure has a glazed and paneled door in the east elevation above the drive-through. The exterior is covered with vertical boards.

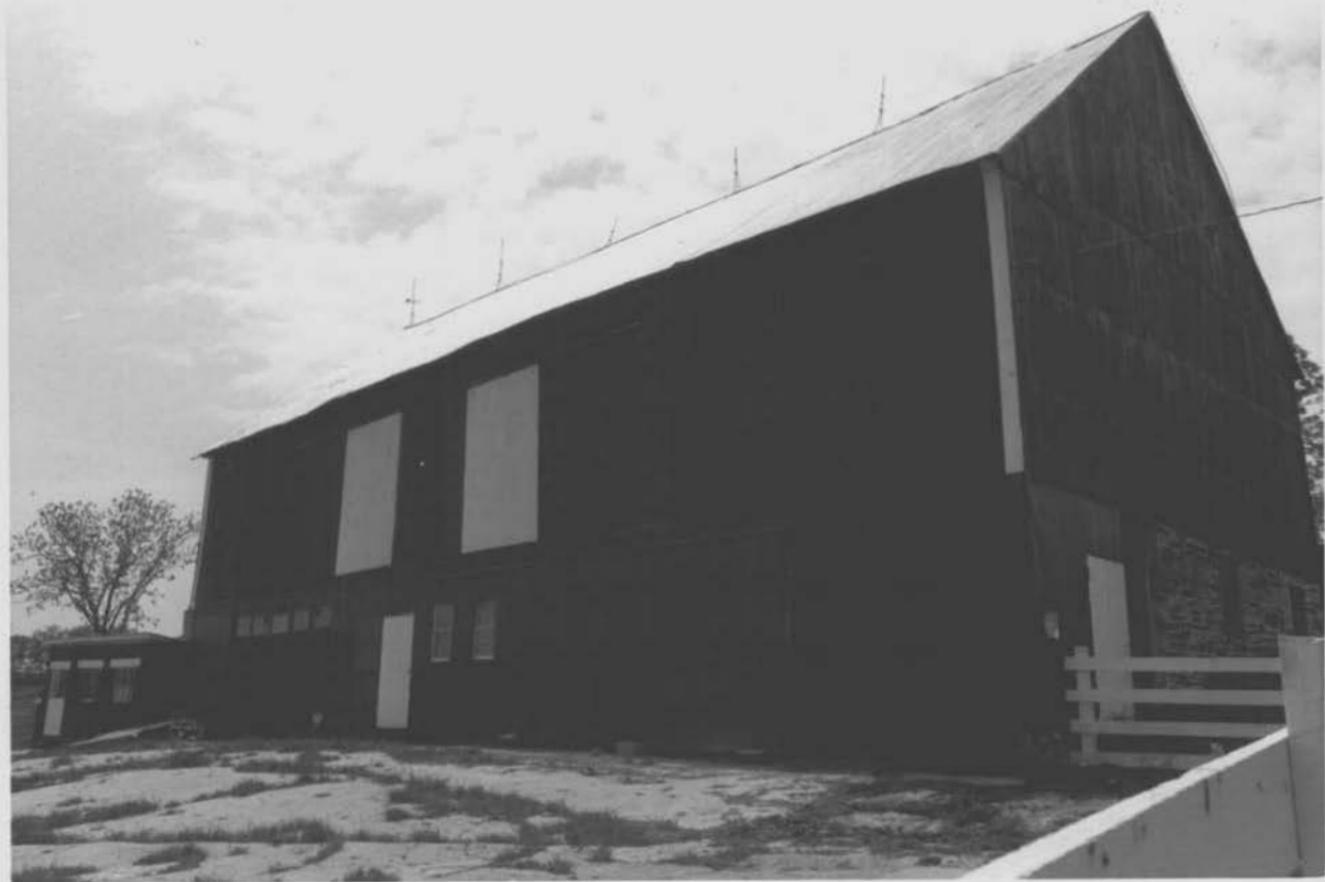
5/6

Bank barn, north elevation

Bank barn: The frame bank barn may have been built about 1875-1900. It has some replaced boards among the vertical siding of the upper level. The stall level on the north elevation has been partially enclosed with concrete block for dairy use, probably during the 1920's. A small section near the northeast end is faced with vertical boards. The doors on the upper level of the north elevation are sliding types, with vertical boards. The south elevation has two double doored entrances with sliding covers. Near the east side of the ramp is the debris of a demolished brick silo. The roof of the barn is corrugated metal. Attached to the east elevation is a small concrete block milk house with metal sash, probably added in the 1920's, which is now used as a chicken house.

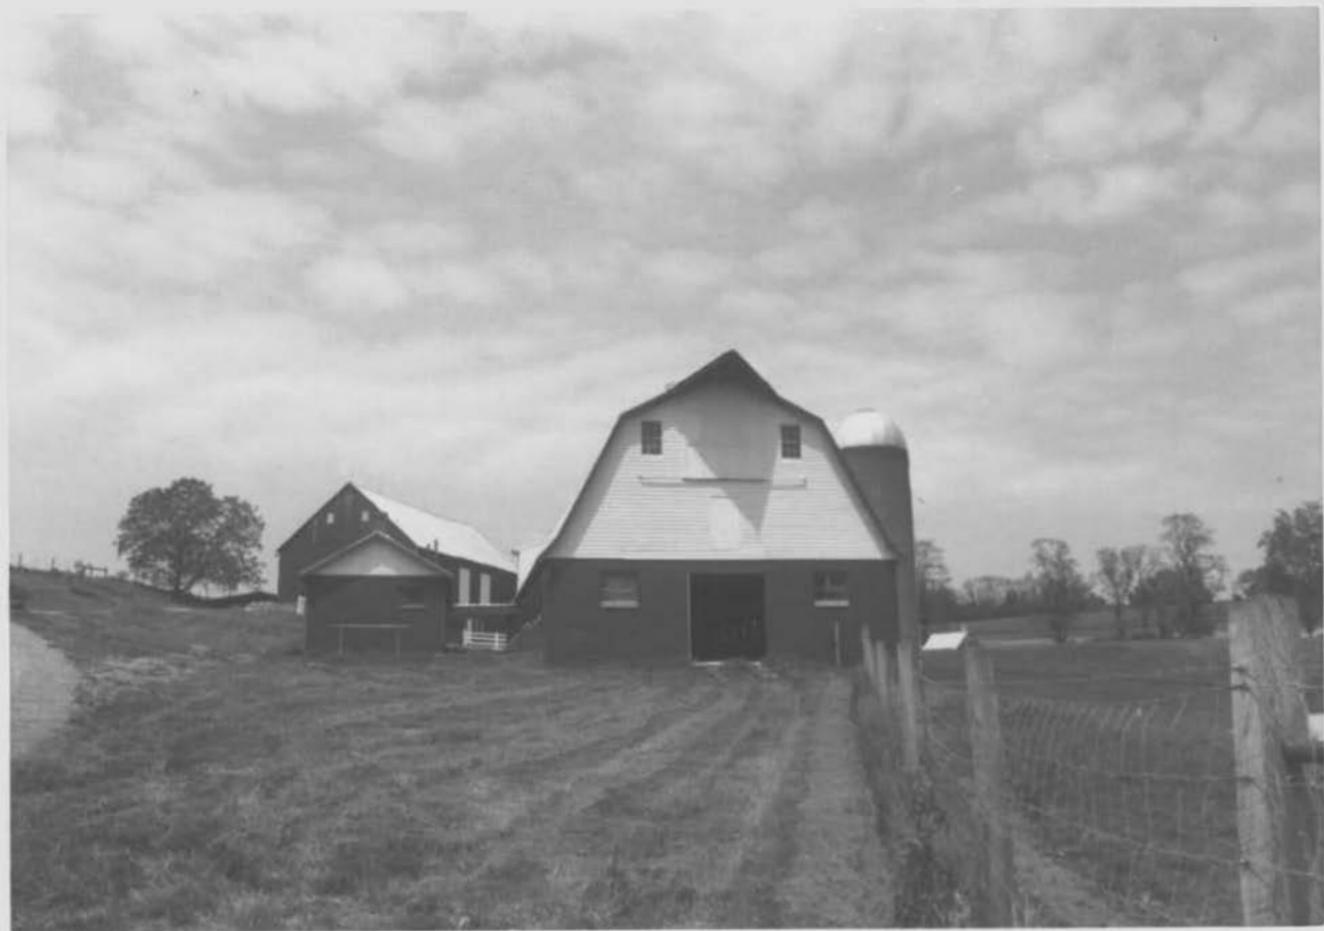
6/6

Dairy barn, milk house, and brick silo.  
view from east
