Doub-Routzahn Farmstead
Myersville vicinity
Private

Ca. 1840-1940

Maryland Historical Trust State Historic Sites Inventory Form

Survey No. F-4-79

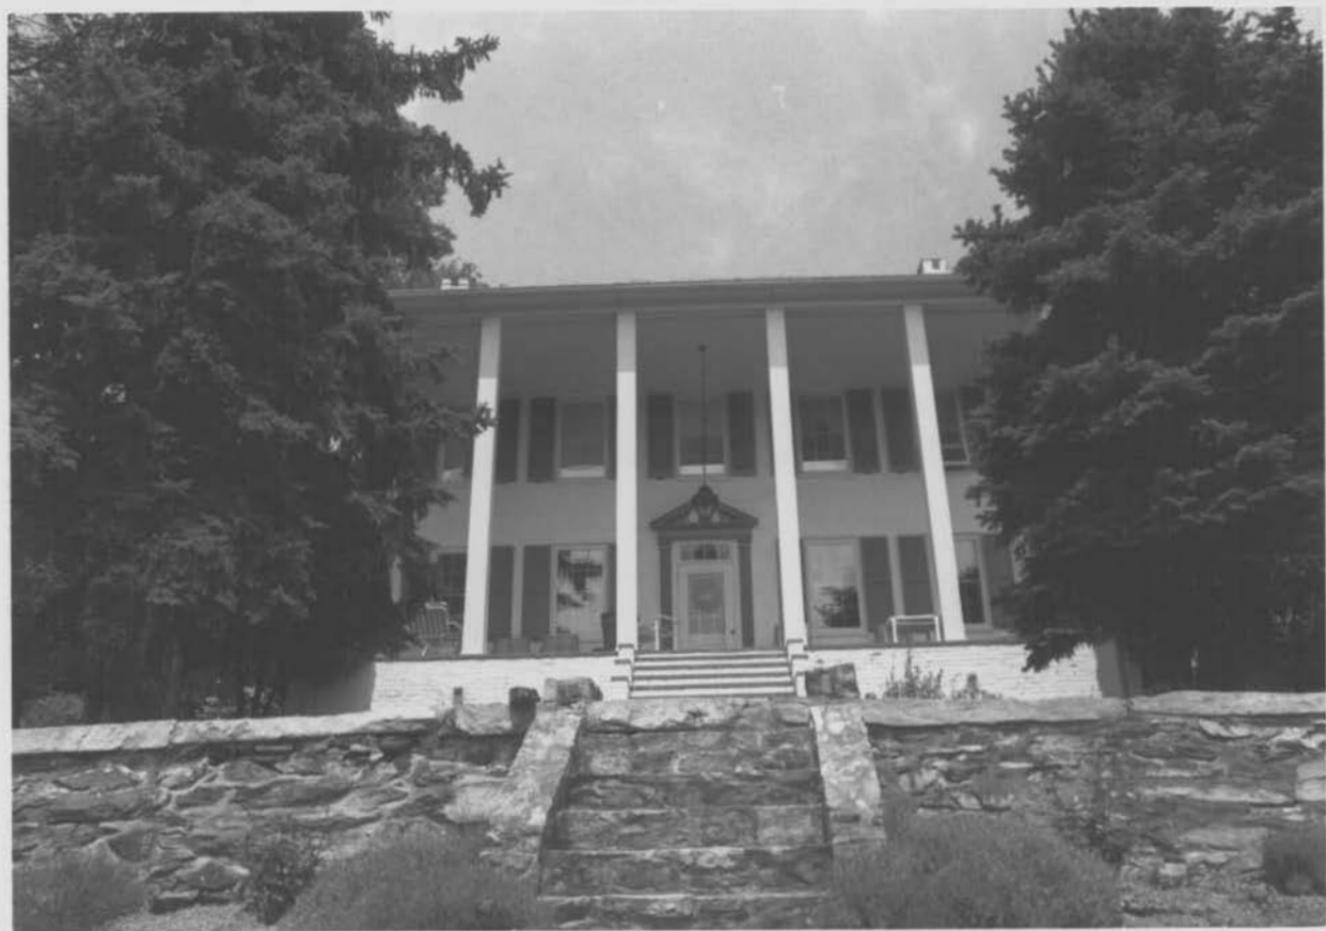
1/8

The dwelling's south elevation is laid in flemish bond and is painted white. The portico has square columns rising to the cornice line of the building. The porch platform is brick. The topography of the site slopes downward to the south with landscaped terraces on stone retaining walls. The principal elevation has five bays with a center entrance and a mid-20th century Georgian Revival style door surround featuring a broken pediment. The doorway has a four-light transom and a modern replacement door. The window openings have gauged brick arches and 6 sash. Replacement shutters flank the windows. The bond pattern on the east and west gable ends is 5:1 American and is repeated in the 1-1/2 story rear wing, with a corbeled cornice. The roof of the entire house is slate. Interior end chimneys rise at the east and west gables. The gable ends each have two bays of 6/6 windows on each floor level. The rear wing has a modern frame addition of one story on the west elevation with pressboard siding. An interior end chimney is located at the north end and the sash is 6/6 as on the main section. Replacement shutters are also present. A brick-paved patio is located on the east side of the wing. The interior was inaccessible for this survey.

South elevation

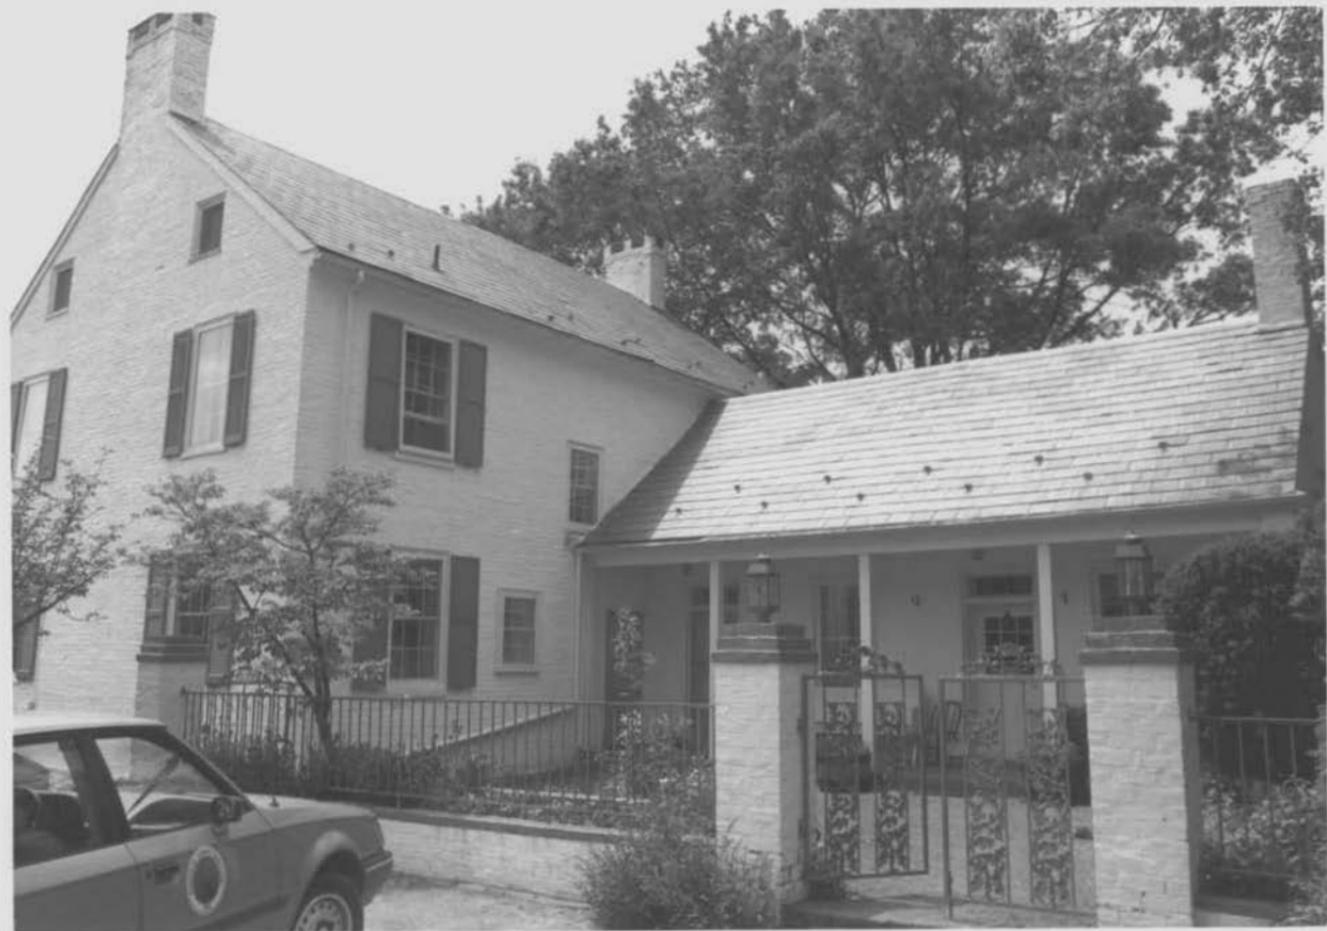
2/8

Northeast corner view

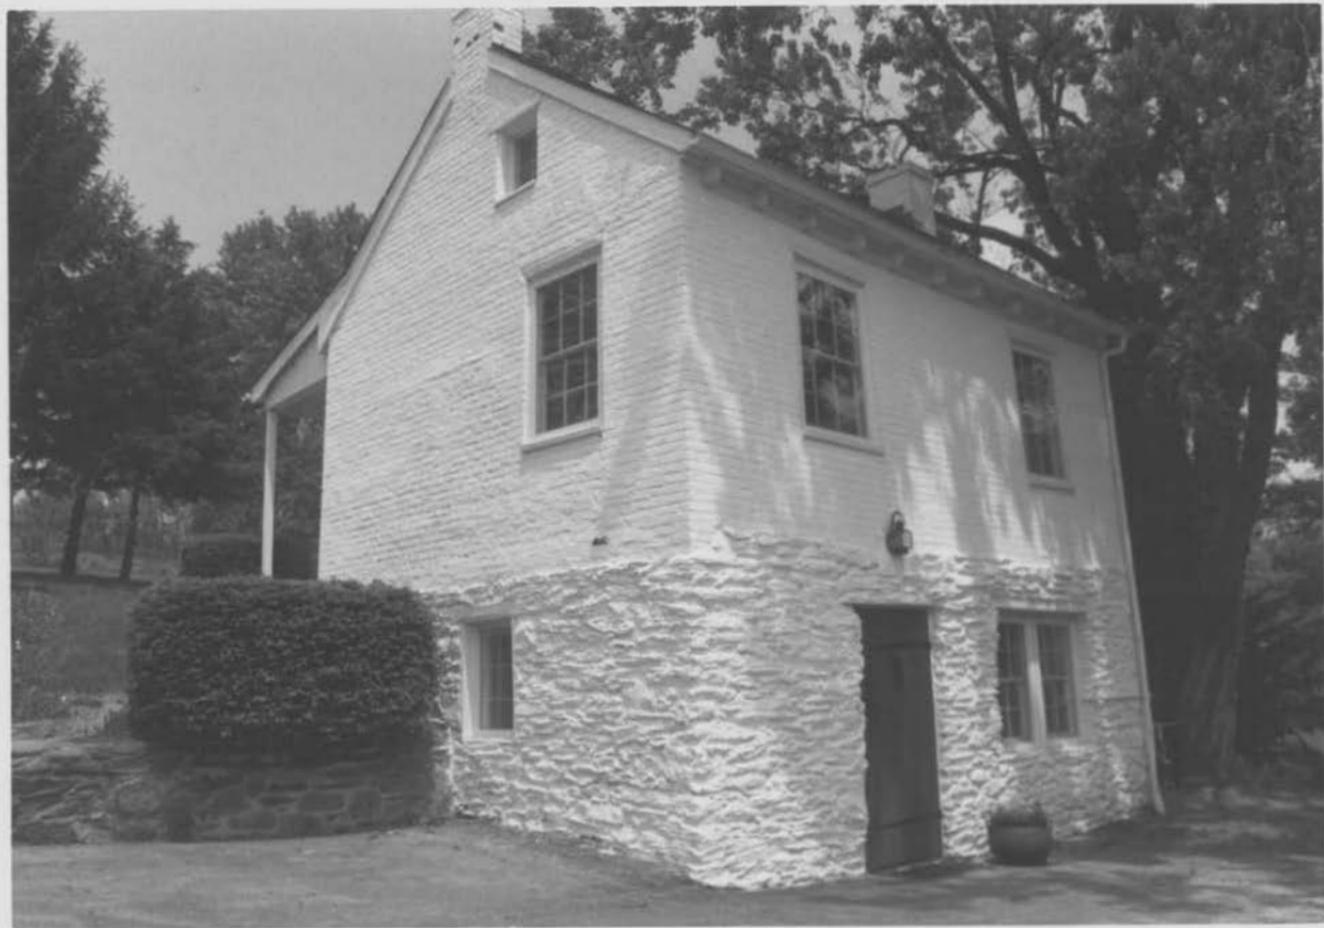
3/8

Summer kitchen/slave quarters: The two-story stone and brick building is located east of the house and a non-contributing concrete block garage. It has been considerably altered in the 20th century, particularly its interior finishes, and its exterior is painted white. It is sited at a slight angle from the house, with an exposed stone foundation on the southeast elevation, where a beaded vertical board door with mid-19th century hardware is located. A pair of 6/6 windows in this level are modern alterations. The upper story has 6/6 windows and an exterior stone and brick chimney are located on the east gable end. A second interior chimney is located at the west gable end. The roof is slate. On the north elevation is a modern one-story porch with square posts. A replacement door gives access to the upper level through the porch. The interior of the building was inaccessible, but its original use as a summer kitchen and possible slave or servant quarters is apparent from the exterior features and siting. The date is less certain, but may be contemporary with the house.

Slave quarters, south elevation

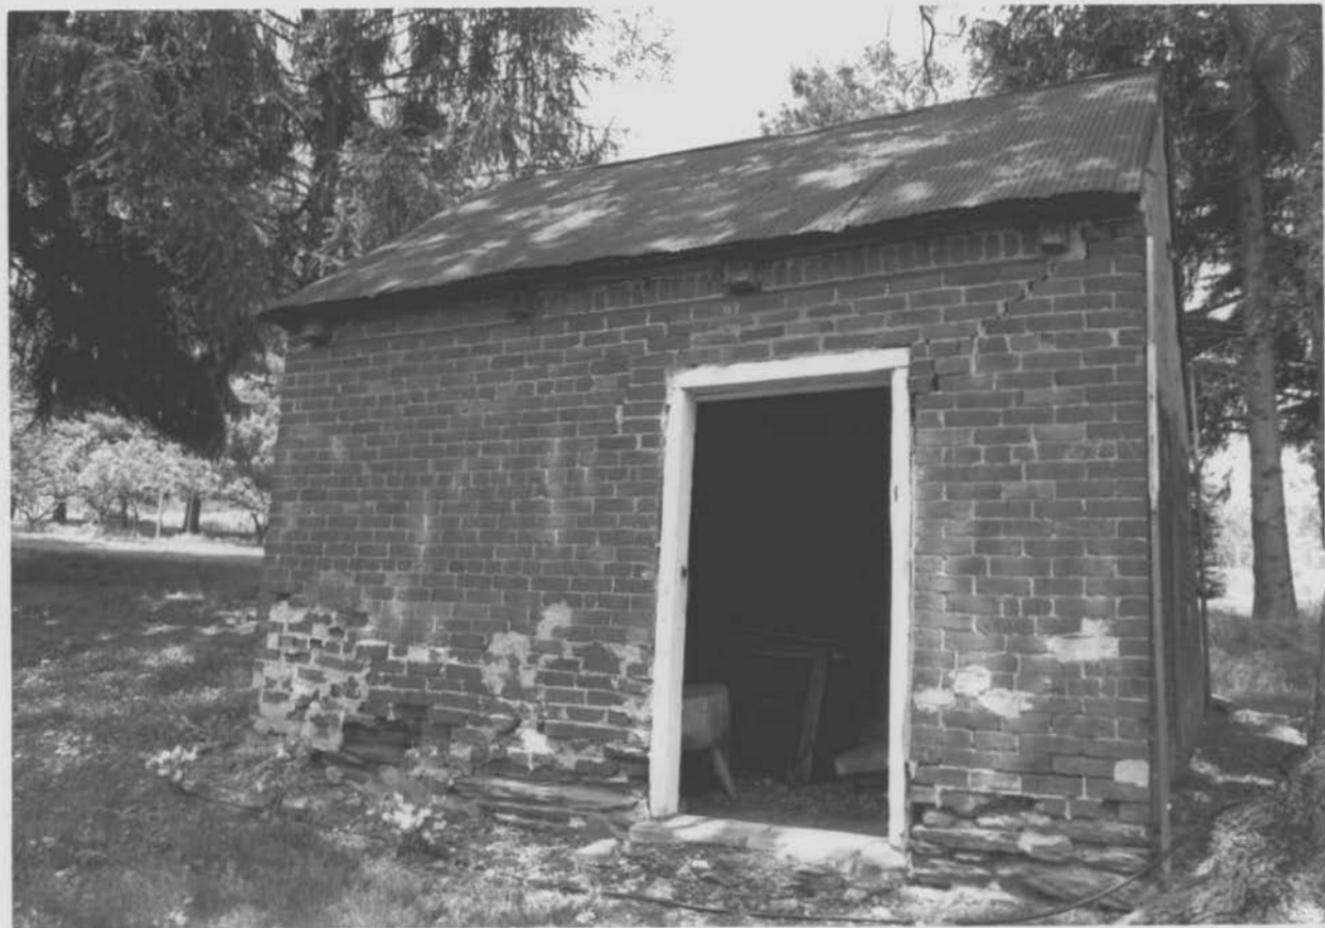
4/8

Smokehouse: The brick smokehouse is located north of the dwelling on the higher slope of the farmstead site. It is a rectangular one-story building in 5:1 American bond with a vertical board door in the south elevation. The gable in the east

elevation is plastered. The roof is covered with corrugated metal. The interior still has a "tree" with a wheel and hooks for hanging meats. The building is somewhat deteriorated and is currently partially filled with wood debris. Its date is probably 1840.

Neg. loc.: Md. SHPO, Crownsville, Md
Smokehouse. Tower elevation

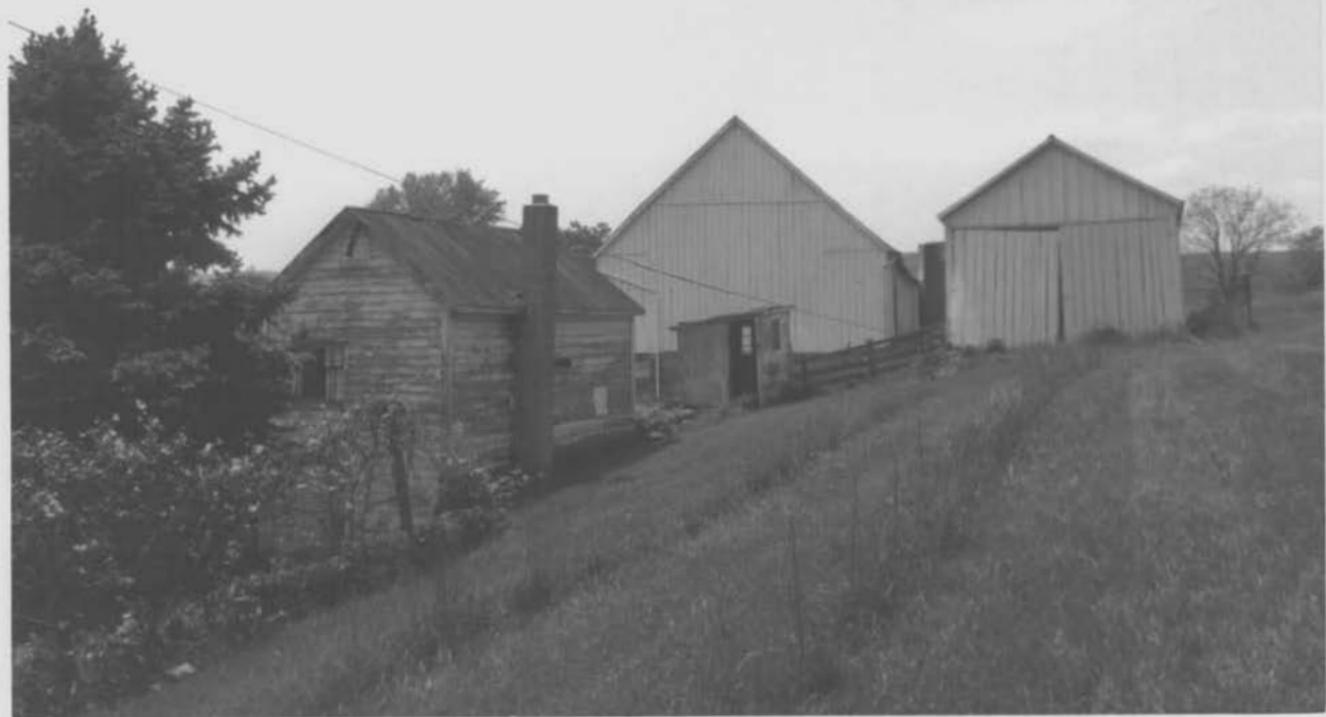
5/8

Agricultural outbuildings, view from east

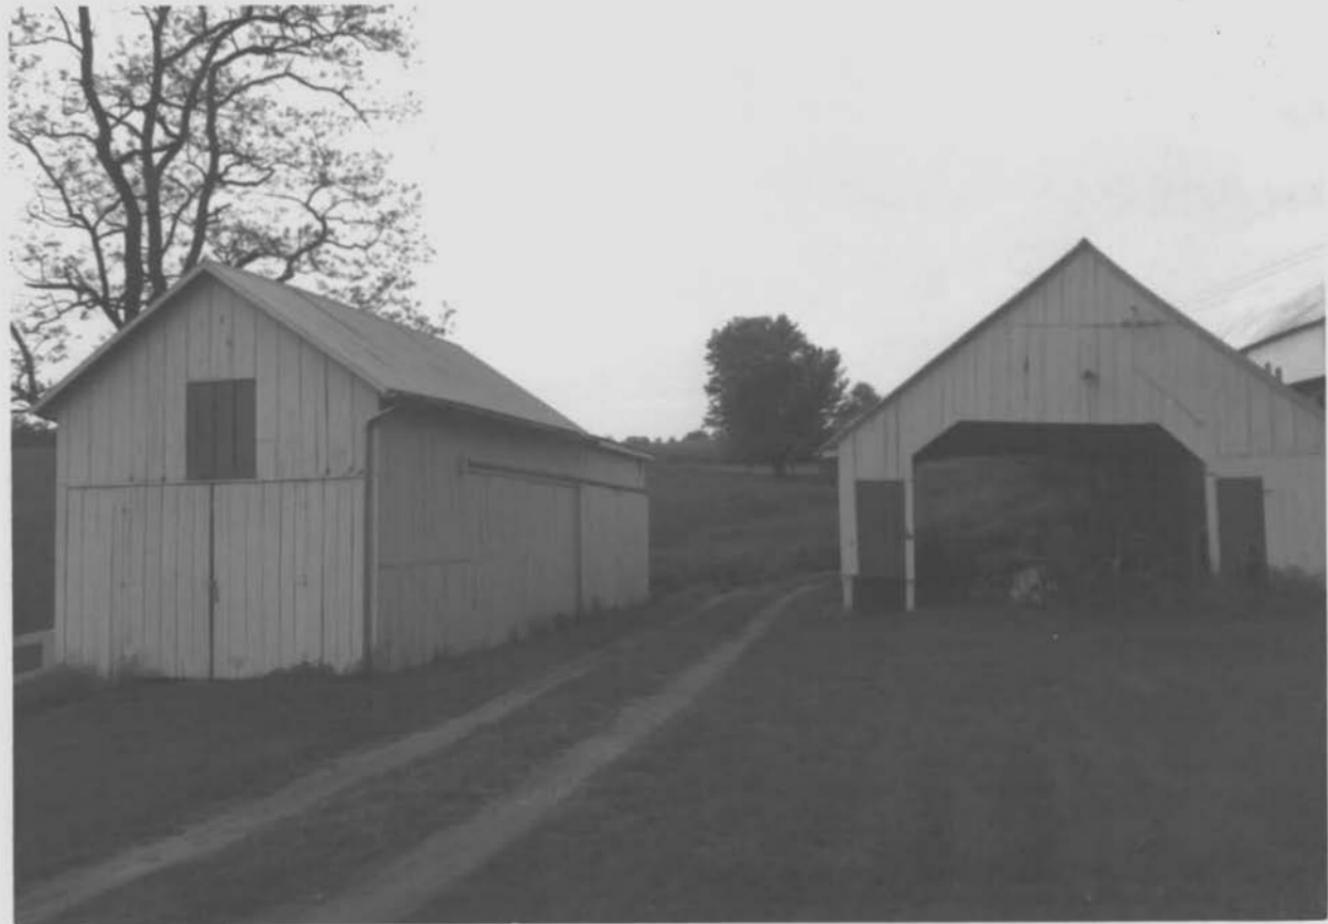
6/8

Wagon shed/corn crib, frame tool shed, and garage: These three buildings are located south of the dwelling on a farm lane leading off the main driveway toward the agricultural grouping west of the house. The wagon shed/corn crib, built probably in the period 1875-1900, has a single corn crib on the south side of the drive-through passage and a shed extension on the north side. The exterior is vertical board siding and the roof is standing seam metal. The frame tool shed is located near the junction of the farm lane and driveway and has a stone foundation exposed on the south elevation. The upper level is covered with vertical board siding and a vertical board door opens on the north elevation. Its original use is unknown, but its location and general form suggests a possible blacksmithy, although there is no evidence of an exterior chimney or vent. The roof is corrugated metal. The frame garage was probably built to shelter farm equipment during the period 1875-1900. It has a standing seam metal gable roof and vertical board siding. Double swing doors are located in the east gable elevation.

Shed and wagon shed/corncrib, view
from east

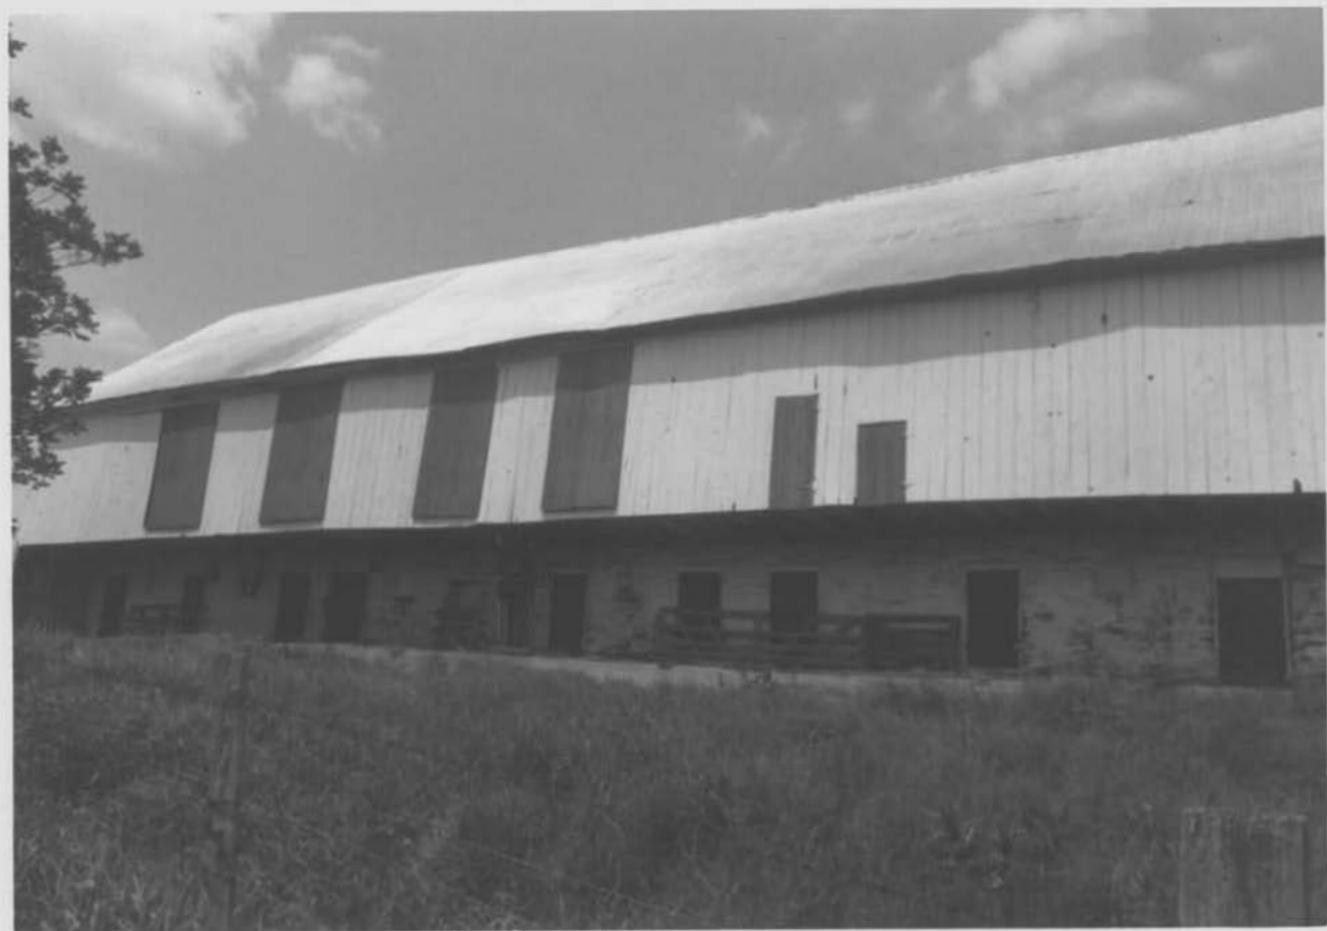
8/8

Bank barn, silo, and milk house: The large frame bank barn is located at the west side of the farmstead and has a stone foundation with the stall level on the south elevation. The upper siding is vertical tongue-and-groove and plain vertical boards. The roof is corrugated metal. The stall level is walled with stone and an extension on the west end is enclosed with horizontal wood siding to form a milking room. This extension was probably made in the late 1920's or early 1930's. A brick silo base is located near the northwest corner of the barn and a concrete block milk house, built at the same time as the milking room extension, stands next to the west end of the barn.

Bank Corn., south elevation
