F-4-80

Rout-Smith Farmstead

Maryland Historical Trust State Historic Sites Inventory Form

7. Description

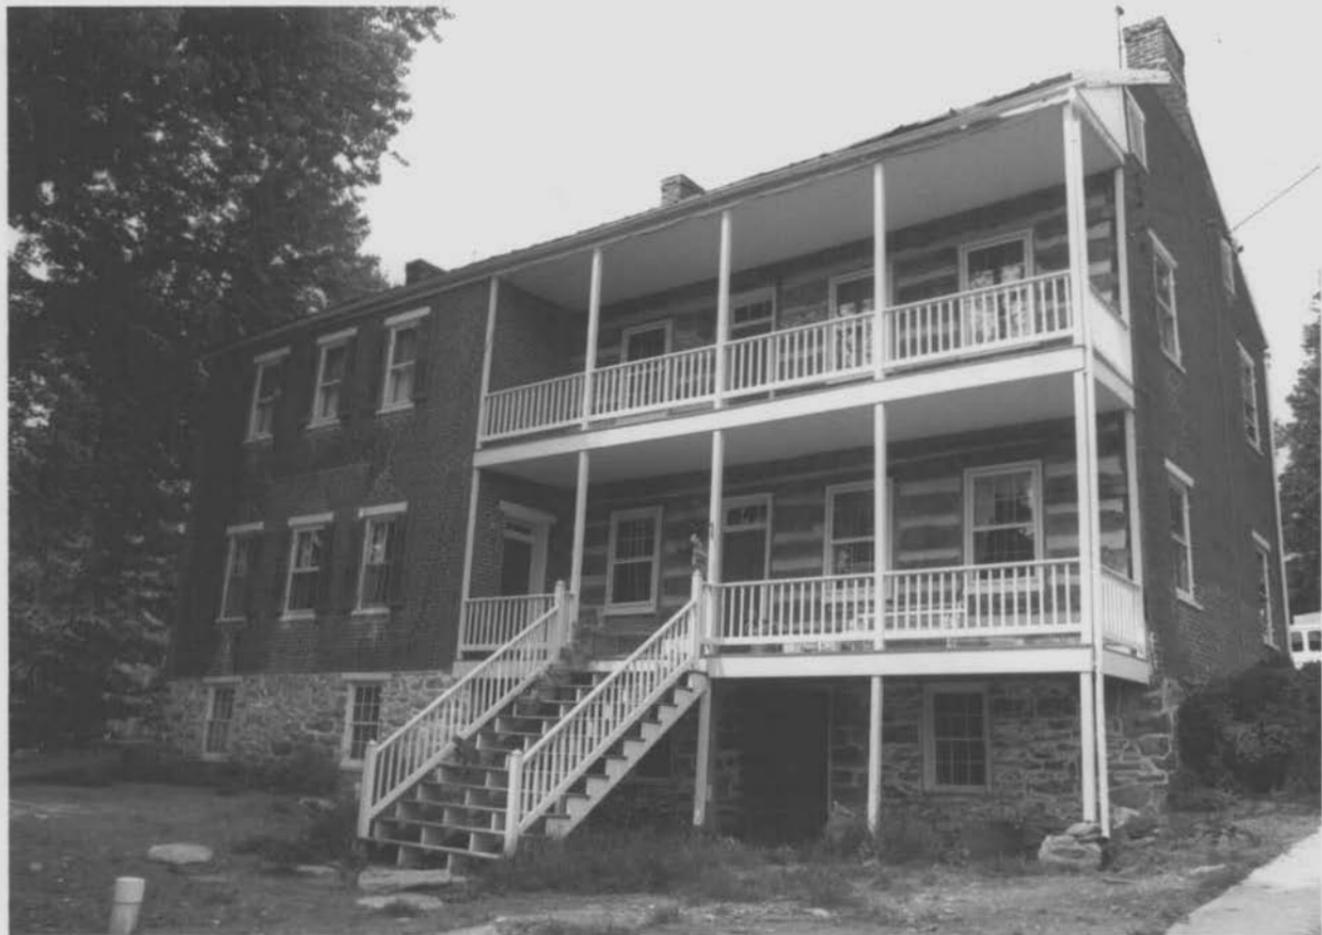
1/5

Southeast corner view

The two sections of the dwelling form a generally rectangular two-story structure with the log section on the east end and the brick on the west. The sections are offset in plan, forming recessed facades on the north and south elevations in reverse. Two-story porches occupy the spaces formed by the offset. The logs of the circa 1800-1810 part are exposed on the south elevation with brick veneer covering the north and east elevations. The south elevation has four bays with an entrance in the inner western bay. The windows have wood lintels and sills and 6/6 sash. The door is a 6-panel replacement. The brick section, built about 1880, has three bays with originally a center entrance on the south elevation under an entry porch. In the early 20th century, this door was changed to a window and the entry porch was removed. The brick pattern is 5:1 American bond. The windows have segmental arched sash in 2/2 configuration with louvred shutters. The north elevation has a two-story porch and a center entrance in the three-bay facade. The roof is covered with standing seam metal and the chimneys are at the interior gable ends. The interior of the house has been much altered, but portions of original or early materials and features remain. The log section apparently had two rooms in its original plan, with a chimney at each gable end and an enclosed staircase at the southwest corner. The staircase remains in place, but the chimney has been separated by the addition of a modern cross wall. The chimney opening has been closed off. Original floor boards are still visible, although the walls have been covered with wall board, which the current owners are planning to remove to expose the log surfaces. The eastern room has also been partitioned and an original mantel of simple design is located in the southeastern room. The brick section has two rooms, one of which is the modern kitchen, with a third chimney opening on the west wall.

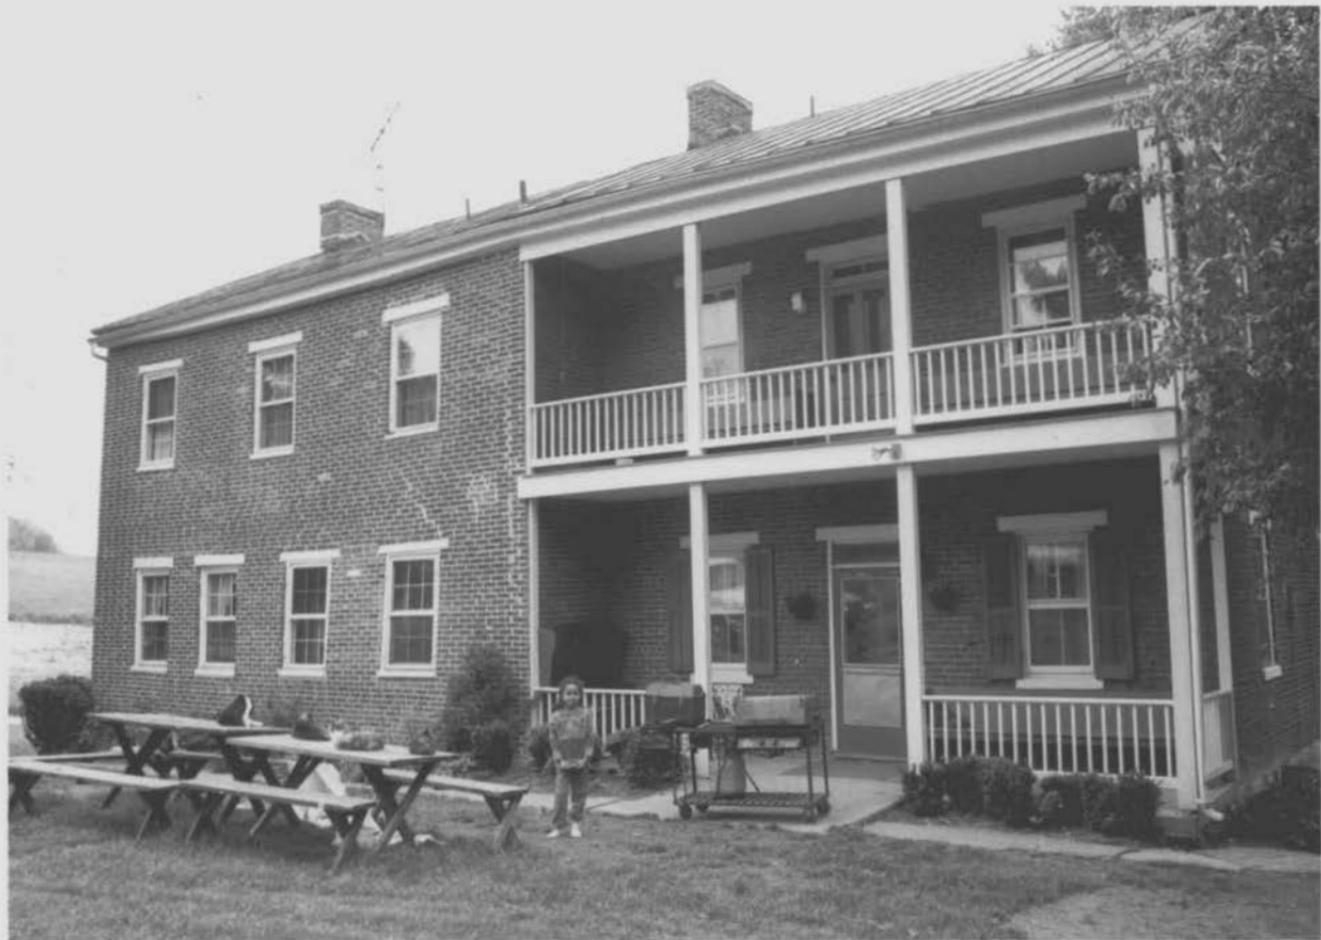
2/5

North elevation

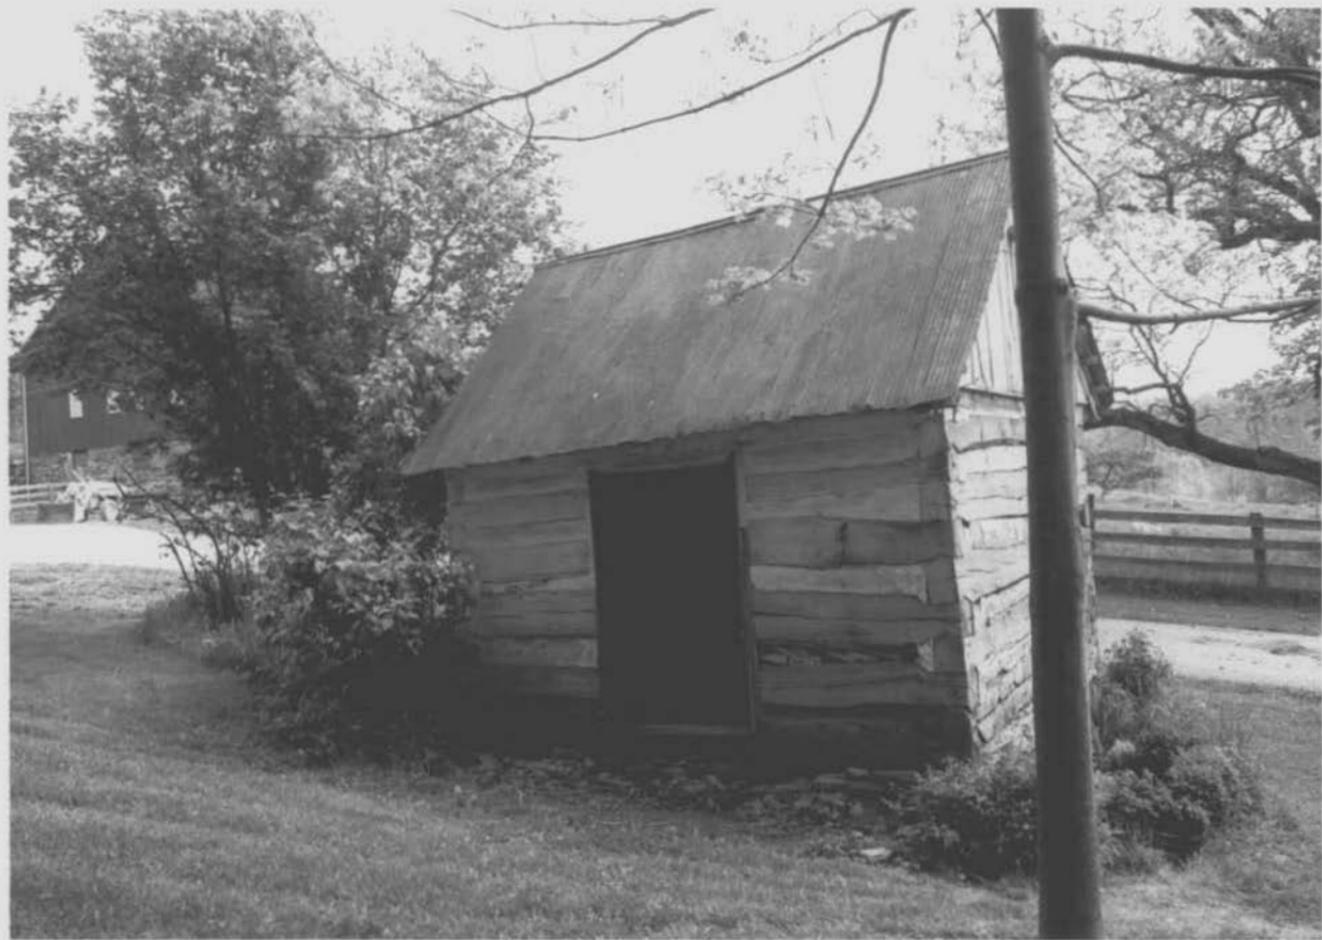
3/5

Smokehouse, north elevation

Smokehouse: The smokehouse is located east of the summer kitchen. It is also an exposed log structure with wood nogging and a corrugated metal gable roof. The gable end on the north is covered with board and batten siding. A vertical board door is also located on this elevation. The smokehouse may date from the same period as the main dwelling house.

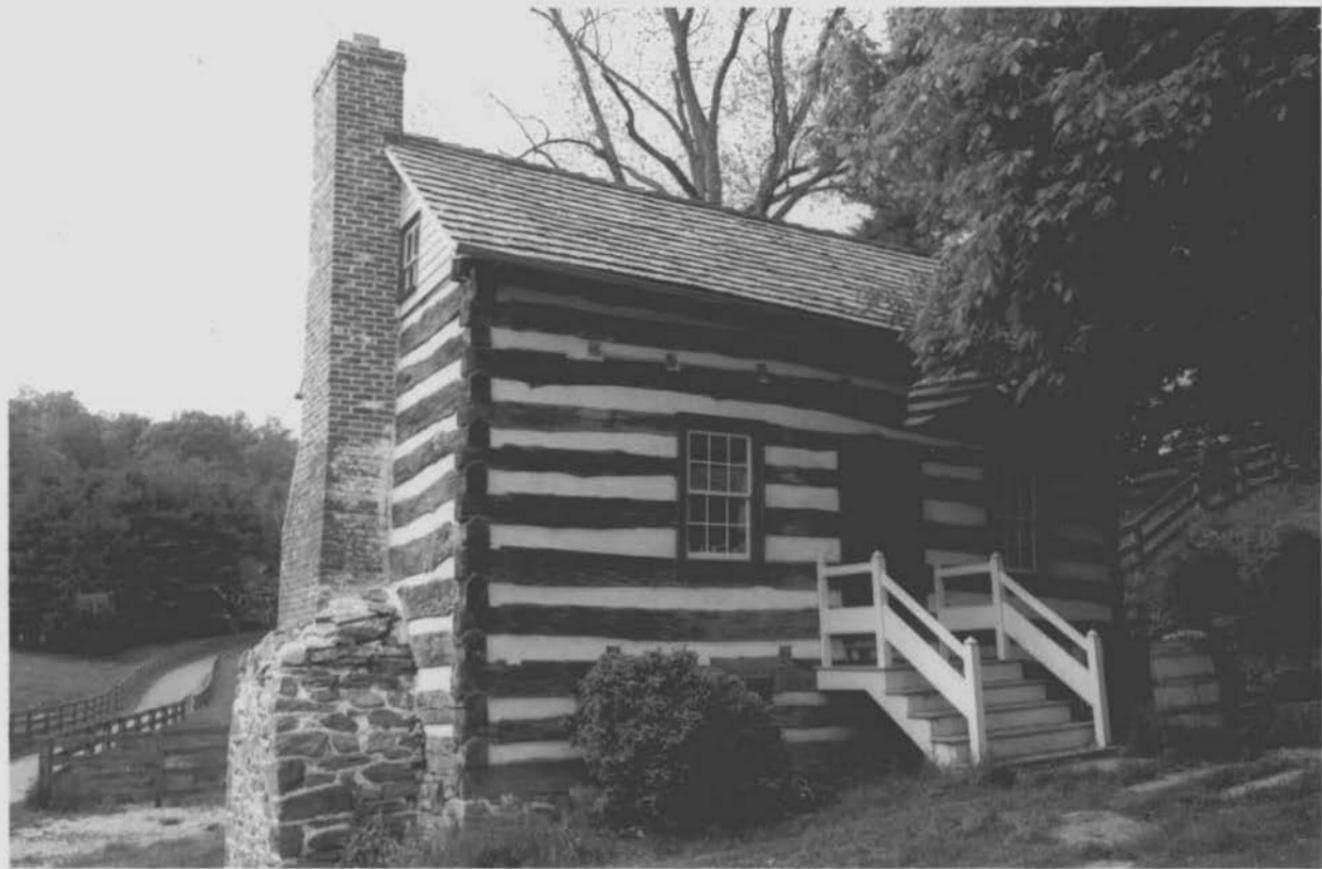
4/5

Summer Kitchen, east elevation

Summer kitchen: The log summer kitchen has a stone lower level which contains a springhouse. The stone is exposed on the south elevation. The east elevation has three bays with a vertical board door and replacement 6/6 windows. The repaired molded window frames appear to be of the first quarter of the 19th century. The wood shingle gable roof is also a modern replacement. The stone and brick exterior

chimney on the south elevation has been rebuilt. The west elevation has two bays with a vertical board door on the stone lower level. According to local residents in the area, the summer kitchen is thought to be the earliest dwelling in the farmstead, having been built prior to 1800 and used until the erection of the log section of the present dwelling. Although not observed in this survey, an interior inscription in the chinking between the logs gives a name and a possible date, according to Mrs. Christensen, the present owner. The summer kitchen is located south of the main building.

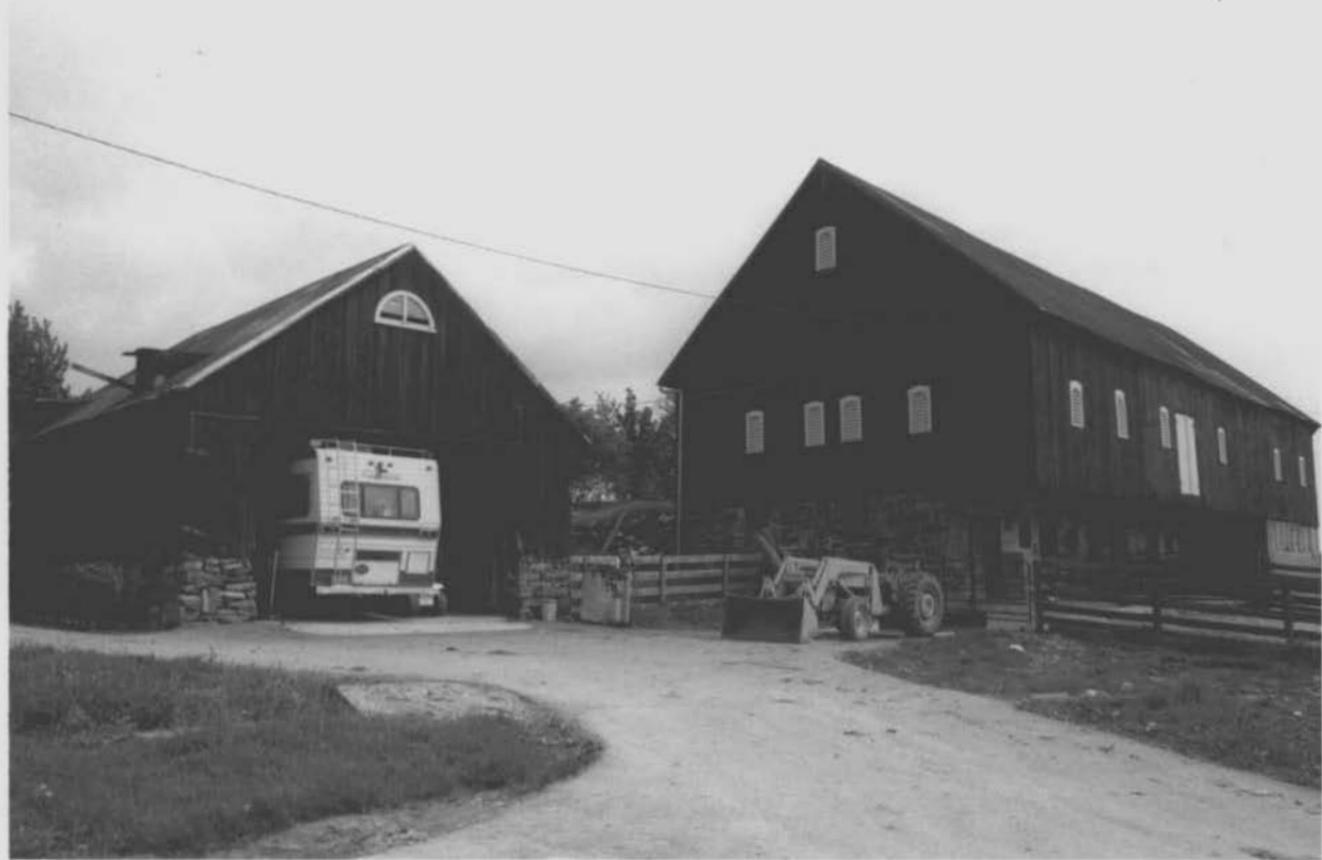
5/5

Wagon shed/corn crib and barn, view from west

Barn: The frame and stone bank barn is located southeast of the domestic buildings. It was probably built about 1830-1840, but has been enlarged and altered through the late 19th and early 20th centuries. The stall level on the west elevation is stone, with a concrete block partial enclosure on the south end for a milking room. The vertical-sided upper section has louvred vents with repaired arched frames. The gable roof is covered with corrugated metal.

Wagon shed/corn crib: The frame wagon shed/corn crib is located north of the barn. Built in the period 1875-1900, it has vertical siding and a corrugated metal roof. Double cribs flank the drive-through opening and the building is supported on a stone foundation.
