F-4-92

F-4-92  
Routzahn-Waters Farmstead  
Middletown  
Frederick County

# Maryland Historical Trust State Historic Sites Inventory Form

historic Routzahn-Waters Farmstead

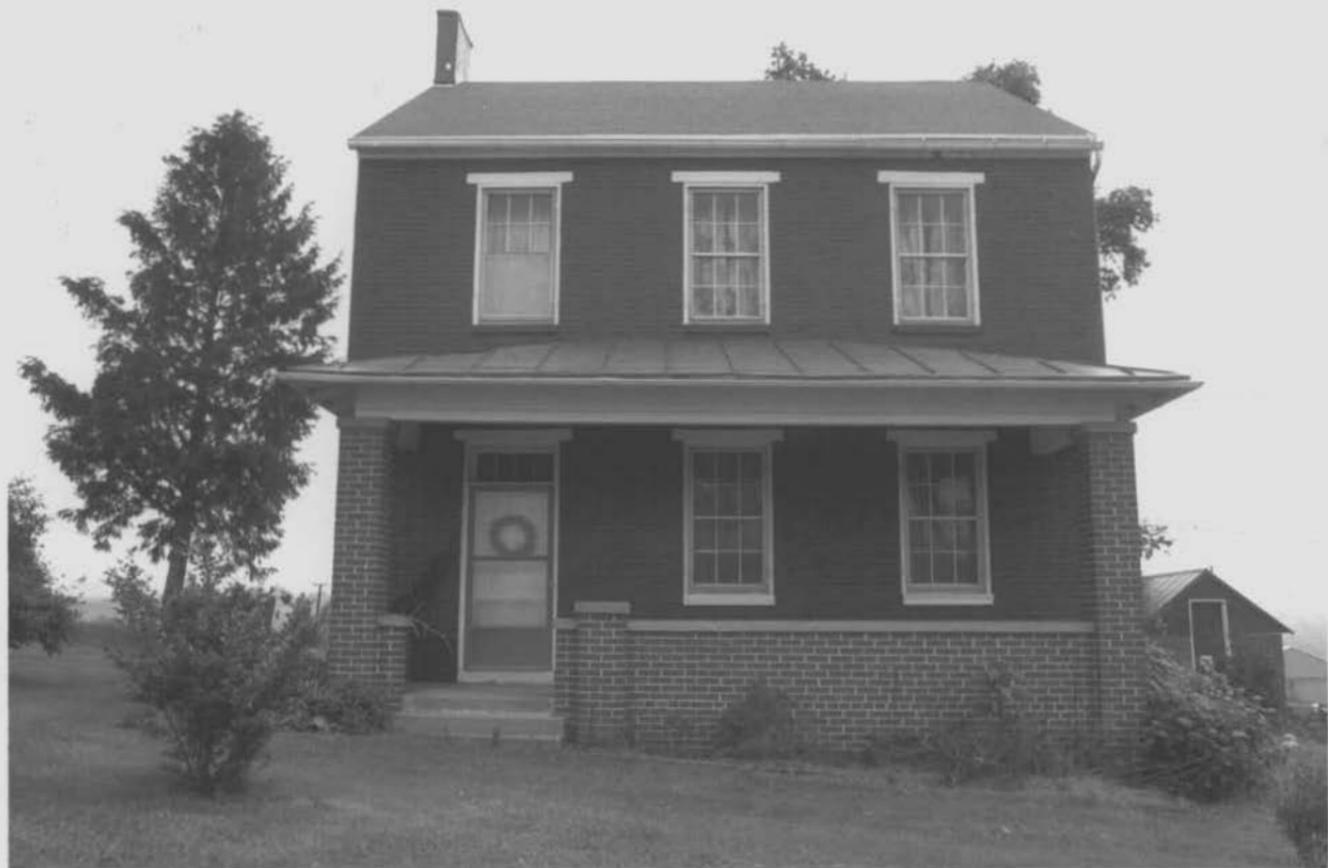
6

Neg. loc.: Md. SHPO, Crownsville, Md.  
West elevation

The dwelling faces west toward Old Hagerstown Road and has a three-bay west elevation with a one-story porch with brick platform and piers added during the mid-20th century. The brick pattern is 5:1 American bond painted red. The entrance is in the north bay, with a modern paneled door and a 4-light transom. The windows are 6/6 with plain lintels and brick rebuilt sills, flanked by shutter hinges and braces, although the shutters are missing. The roof is covered with composition material and a single interior chimney is located at the north gable end. The north elevation has a single bay near the northeast corner with 6/6 sash and two attic windows with 2/2 sash. The south elevation has two bays with similar sash and attic windows. Extending from the northeast corner of the main section is a two-story rear wing with a two-story open porch on the south side. The north side of the wing has an irregular bay arrangement with four on the first story and three on the second. A multi-paned door is located off-center with a three-light transom. The east end of the wing has only two attic windows and an interior end chimney. A patched section of brick indicates the probable location of a back oven projection which has been removed. The south side of the wing has two entrances on the first level and a frame enclosure of the east end of the porch on the first level. The stone basement of the wing is exposed below the porch deck. The porch has plain square posts and a simple balustrade. The interior was inaccessible for this survey.

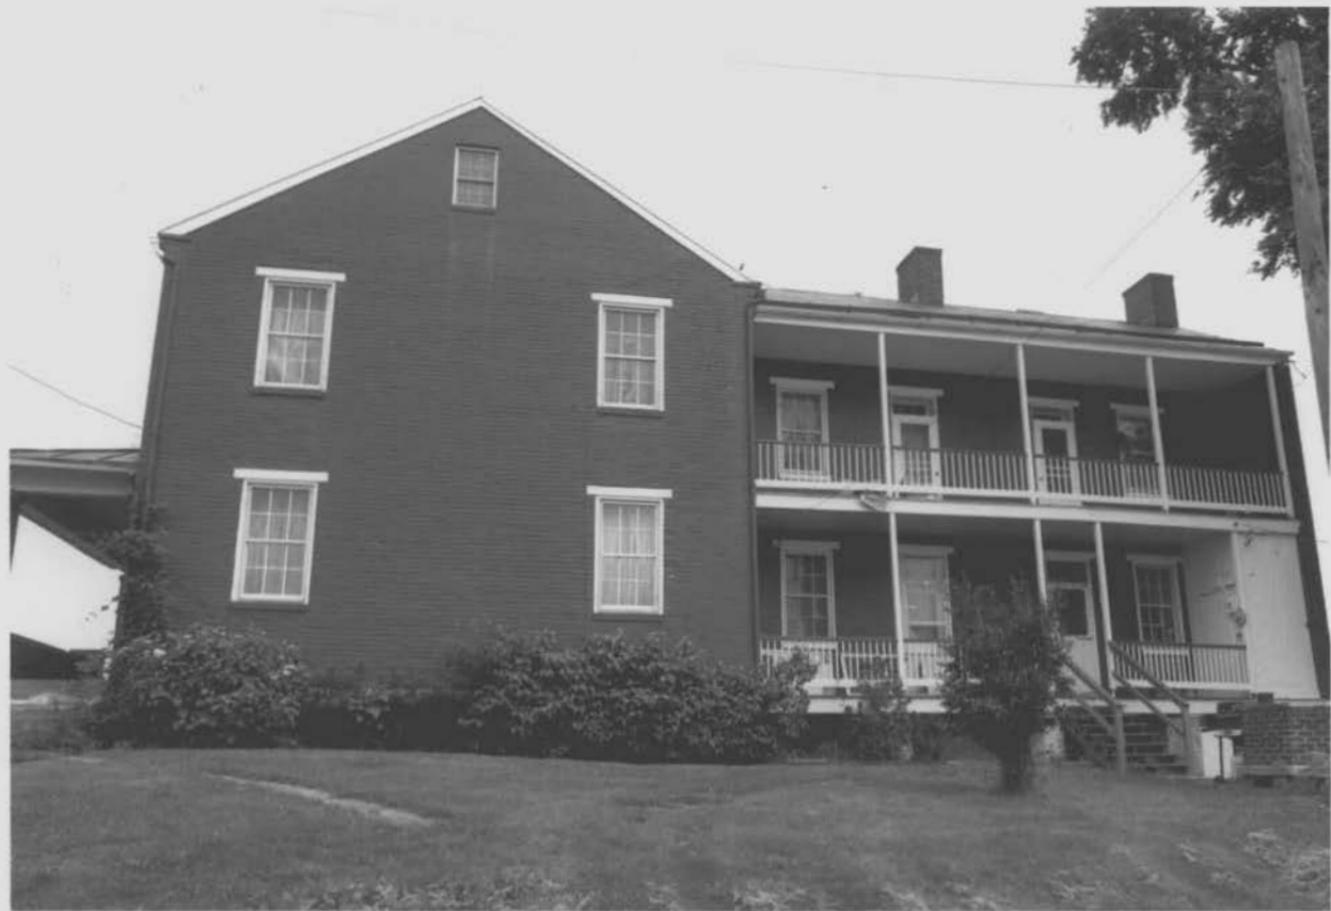
2/6

South elevation

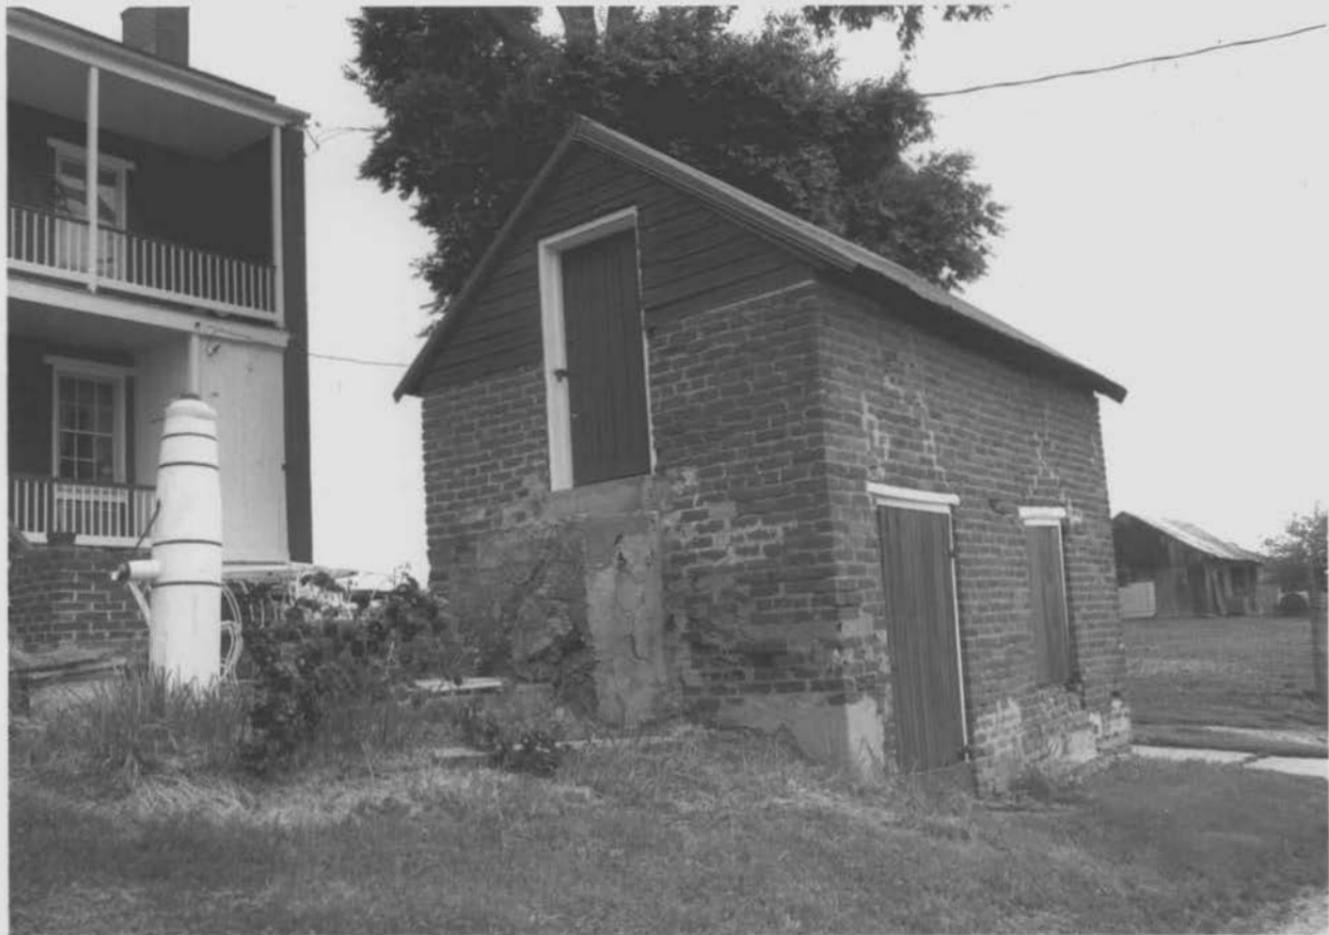
3/6

Neg. loc.: Md. SHPO. Crownsville Md  
Smokehouse, southwest corner view

**Smokehouse:** The brick smokehouse was probably built at the same time as the house. It is located south of the rear wing near the entrance drive which continues eastward into the agricultural group. The smokehouse is generally rectangular with a vertical board door in the east elevation and two vertical board doors in the south elevation. A door in the west elevation gives access to the upper level of the smokehouse. The north elevation has a 2/2 window and a horizontal sliding window. The gables are covered with german siding and the roof is standing seam metal.

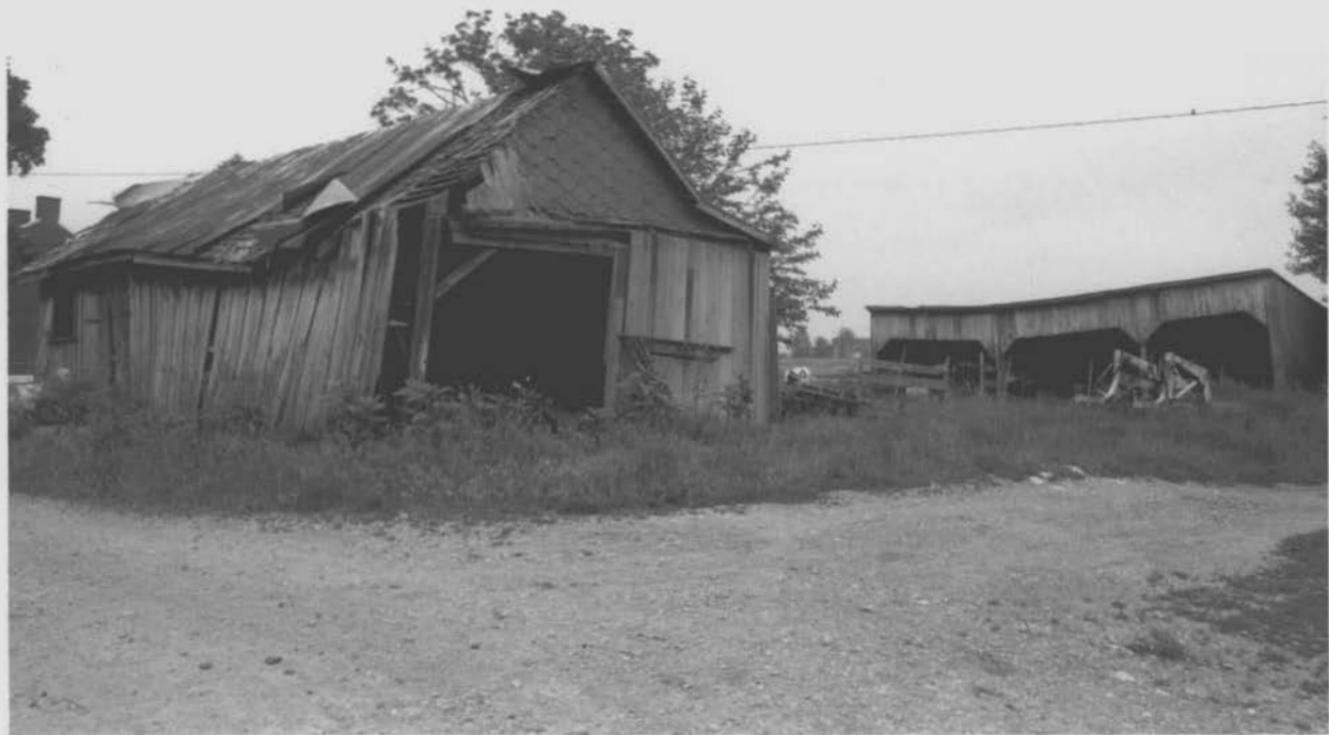
4/6

Deteriorated agricultural outbuildings,  
view from southeast

Frame shed: A deteriorated frame shed is located east of the blacksmith shop. Its use is undetermined, but it was probably built about 1875 as an equipment shed. It has vertical board siding with board and batten on the north and south elevations. Sliding tongue-and-groove doors are located on the east gable end. A wood shingle roof is visible under the deteriorated corrugated metal roof covering. The west elevation has a single vertical board door with a flanking 3/3 window.

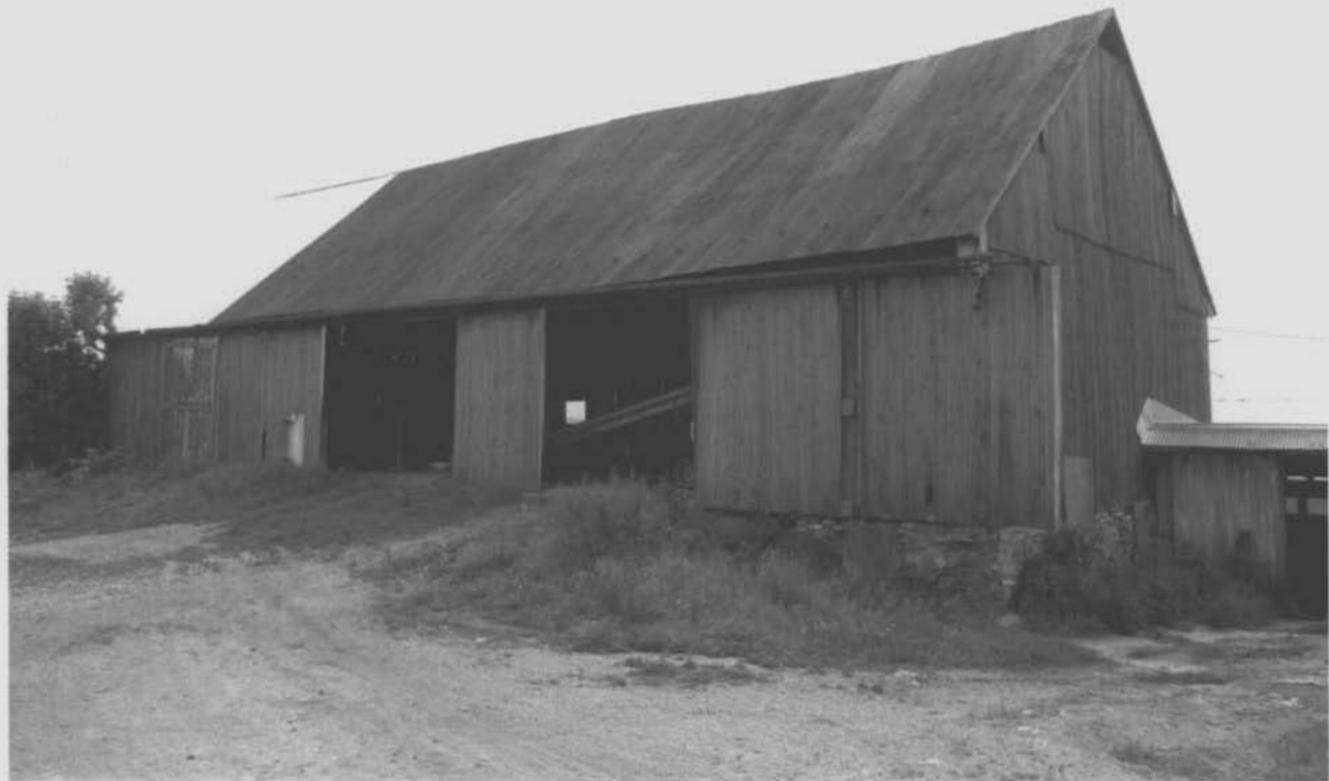
5/6

Neg. loc.: Md. ST170, Crownsville, Md.  
Bank barn, north elevation

Bank barn: The frame bank barn is located at the eastern edge of the agricultural group. It has a stone foundation and vertical siding on its upper structure. The roof is partly shingle under corrugated and standing seam metal. The north elevation has tongue-and-groove sliding doors which probably replace the original swing doors. At the southwest corner is a non-contributing loafing shed with metal siding. The barn was probably originally built about 1850.

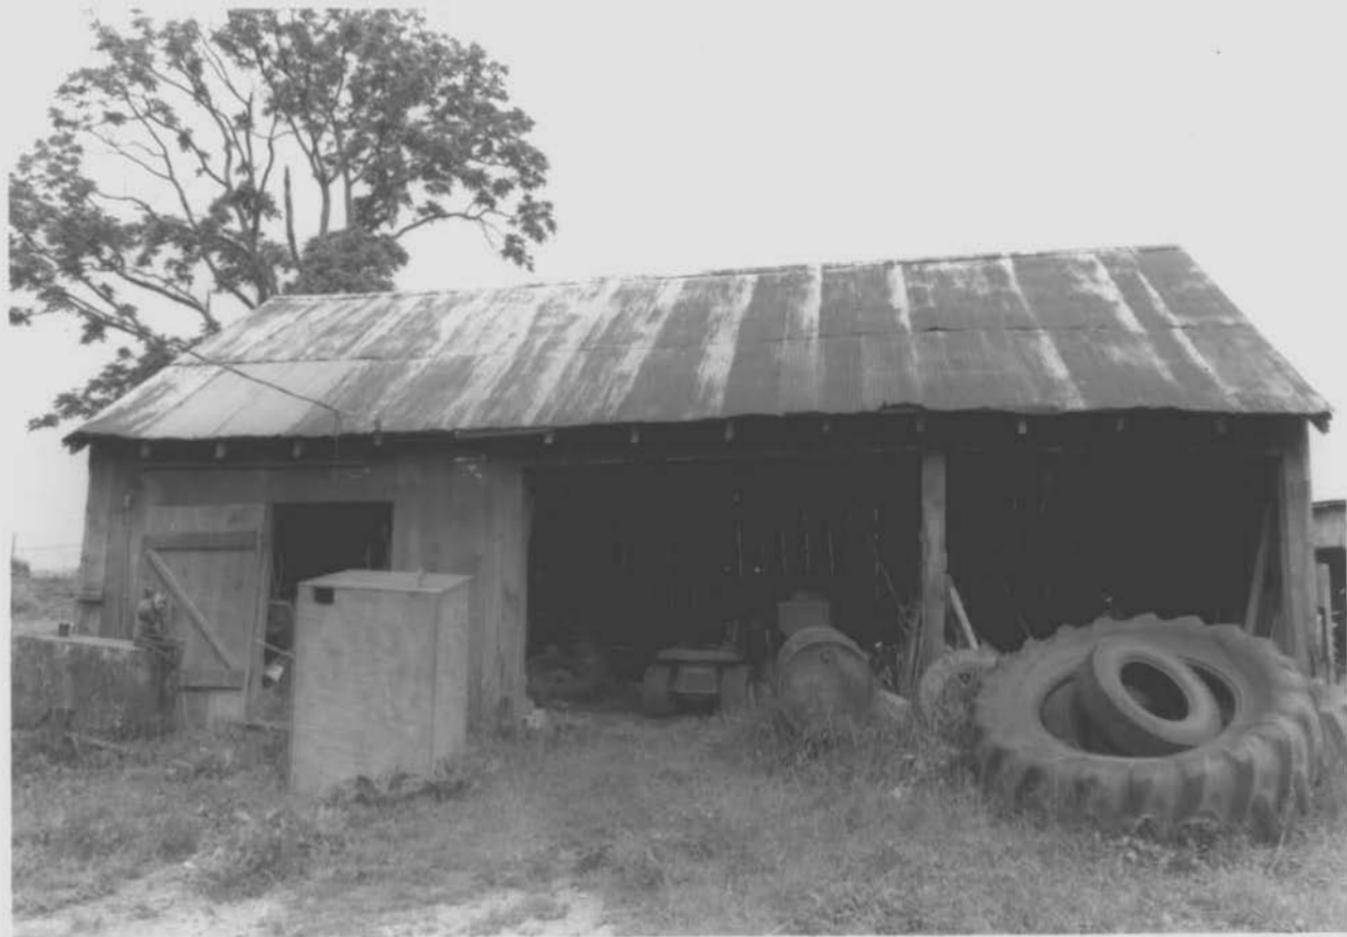
Blacksmith Shop north of water  
bldg

**Blacksmith shop:** The frame blacksmith shop may date from about 1875. It is located north of the farm lane and has a wagon shed adjoining on the east. The shop section has vertical board siding and a corrugated metal roof covers the entire structure.

A vertical board door in the south elevation opens to the shop area, where a stone and concrete forge is located at the west wall. The east and west wall exteriors are covered with corrugated metal. The wagon shed has two open bays.
