Daniel Shoemaker Farmstead  
Middletown vicinity  
Private

# Maryland Historical Trust State Historic Sites Inventory Form

historic Daniel Shoemaker Farmstead

street & number 9022 Mt. Tabor Road \_\_\_ not for publication

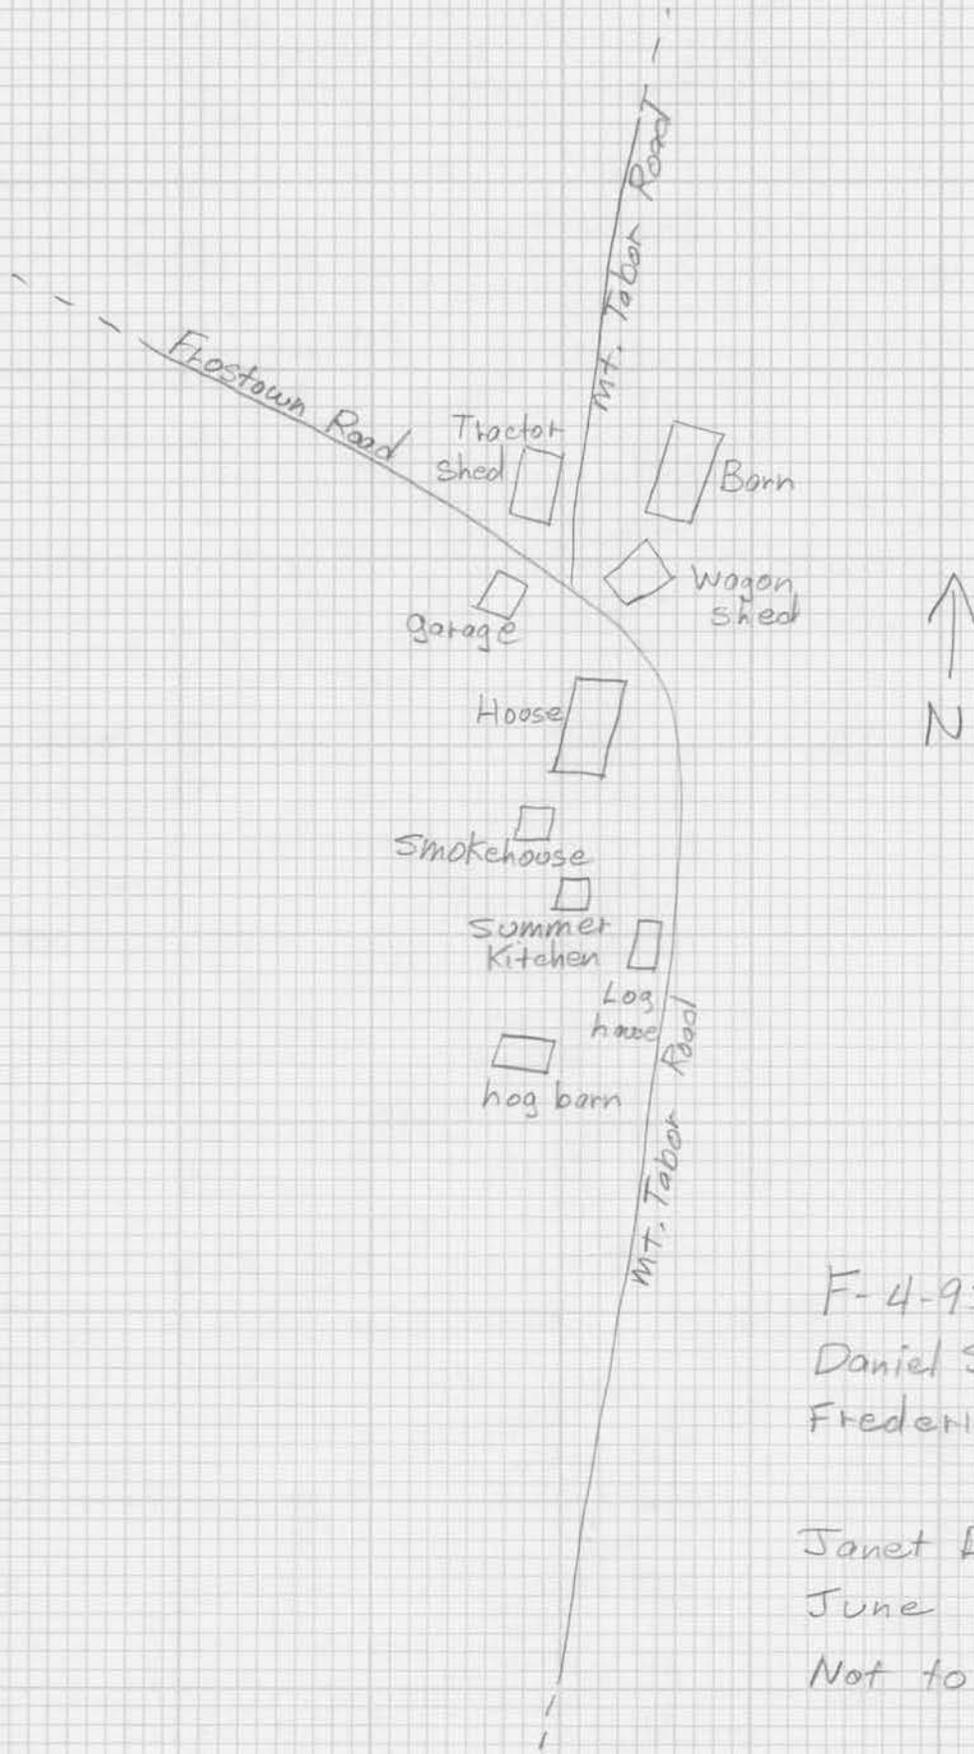
F-4-93  
Daniel Shoemaker Farmstead  
Frederick County

Janet Davis  
June 1992  
Not to Scale

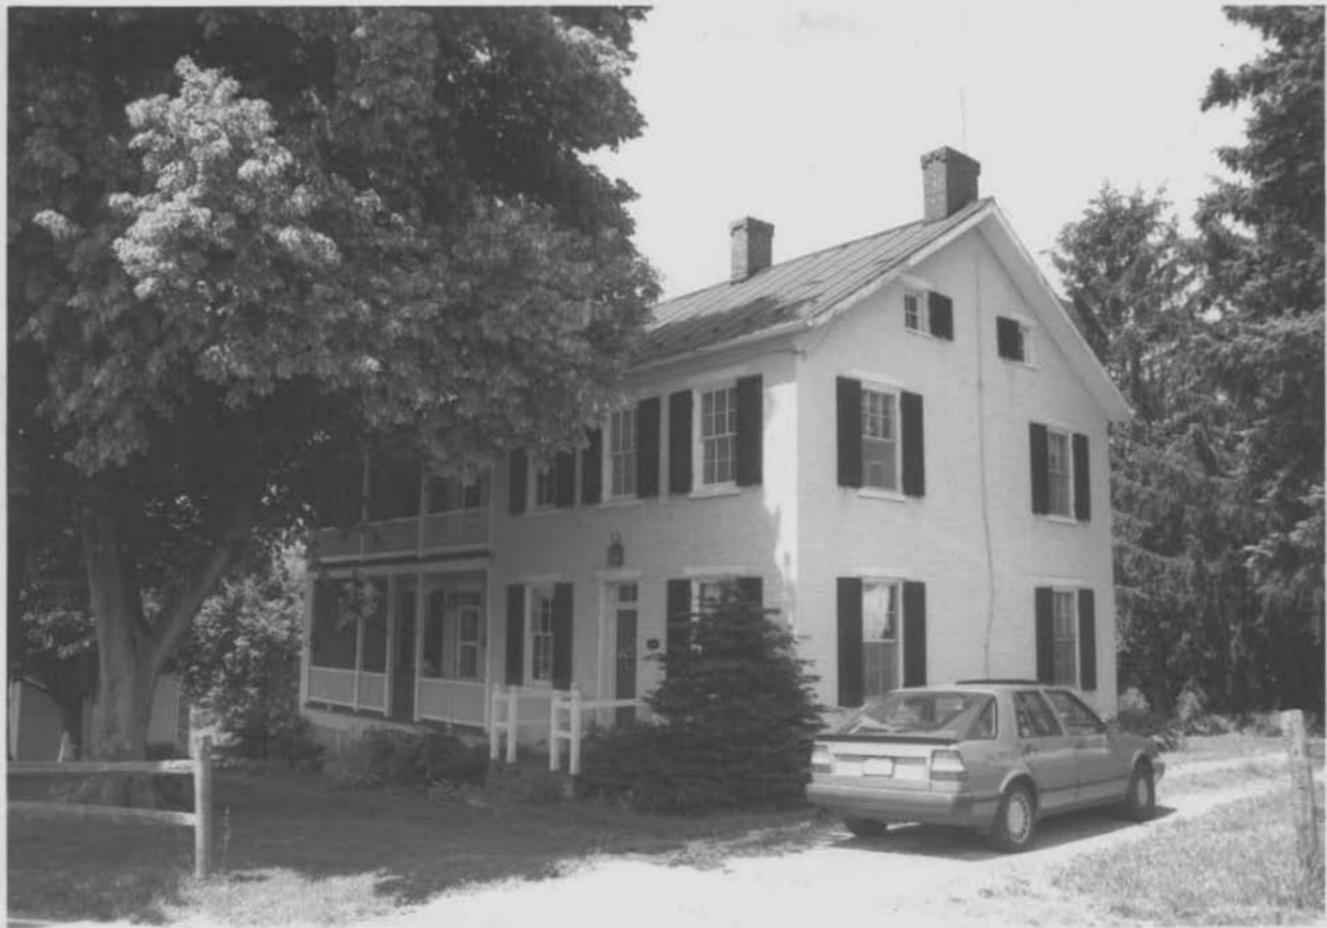
1/7

The dwelling is generally rectangular in shape and faces east with the main section at the north end of the rectangle and the wing on the south end. The main section has three bays on the east with a center entrance. A frame entry porch with a brick base is a recent replacement. The doorway has a four-panel door under a three-light transom and a paneled soffit. The brick exterior walls are laid in 6:1 American bond painted beige over brick red. A Frederick County Landmarks Foundation plaque, No. 270, is attached to the wall near the door. The cornice is corbeled and the gable roof, originally shingled, is now standing seam metal. The windows are 6/6 with plain lintels and sills flanked by louvred shutters. The wing has four bays on the east with an open two-story porch. Two entries containing four-panel doors alternate with 6/6 windows. The porch posts are chamfered and the railing is plain. The south elevation of the house has no openings except a vertical board door to the exposed stone basement and two 2/2 attic windows with louvred shutters. The west elevation has four irregular bays and a modern one-story frame porch projection on the rear of the wing. The projection has German siding. The north elevation has 5:1 bond and two bays of 6/6 windows, with attic windows as on the south elevation. The interior was inaccessible for this survey.

Northwest corner view

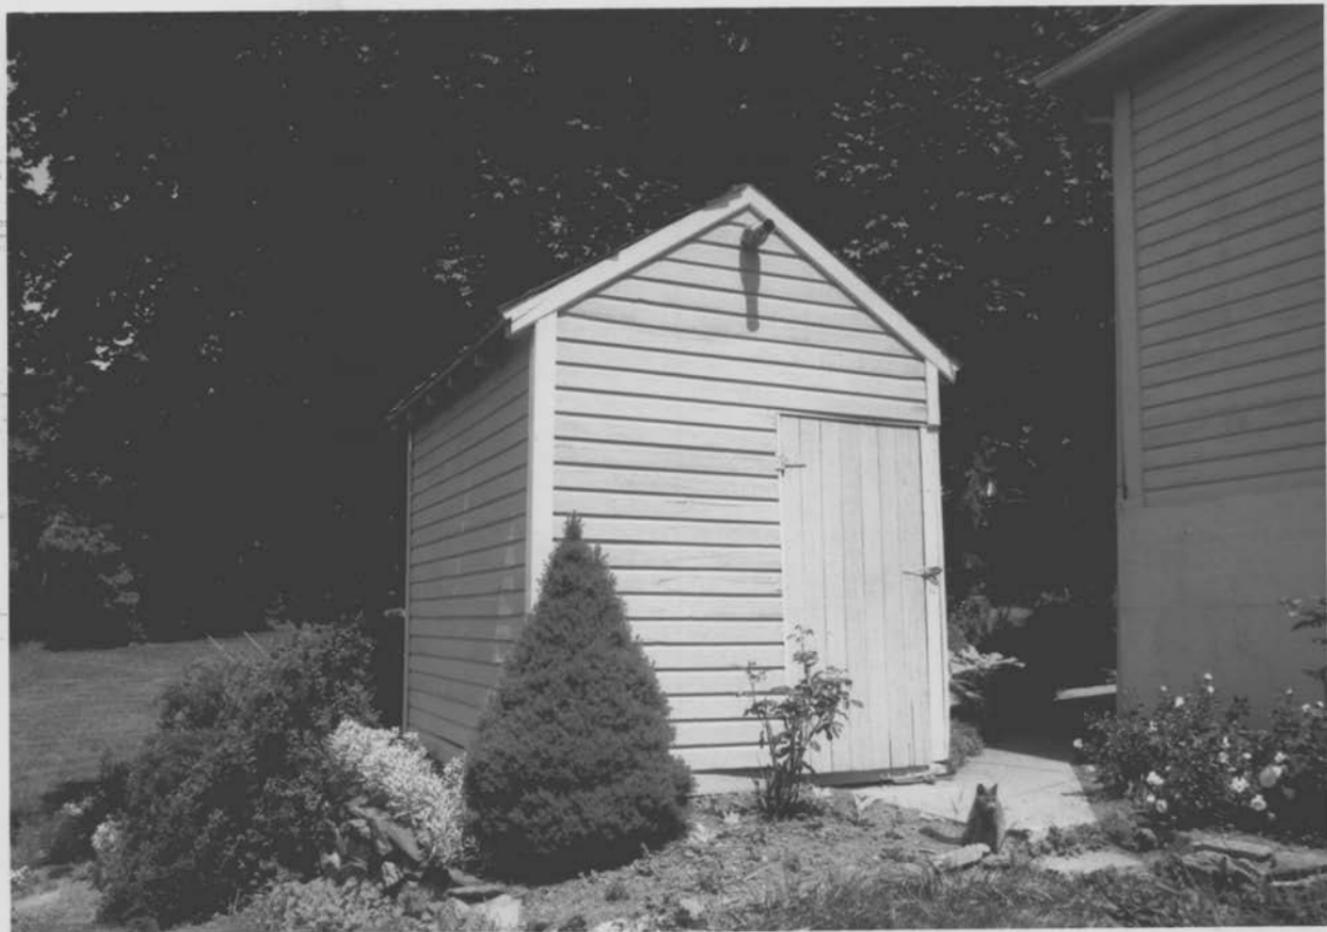
3/7

**Smokehouse:** The frame smokehouse may date from the period 1850-1890. It has a generally square plan with german siding, a vertical board door, and a wood shingle roof. It is located southwest of the dwelling.

Neg. loc.: Md. SH20, Townsville, Md  
Smokehouse, east of road on

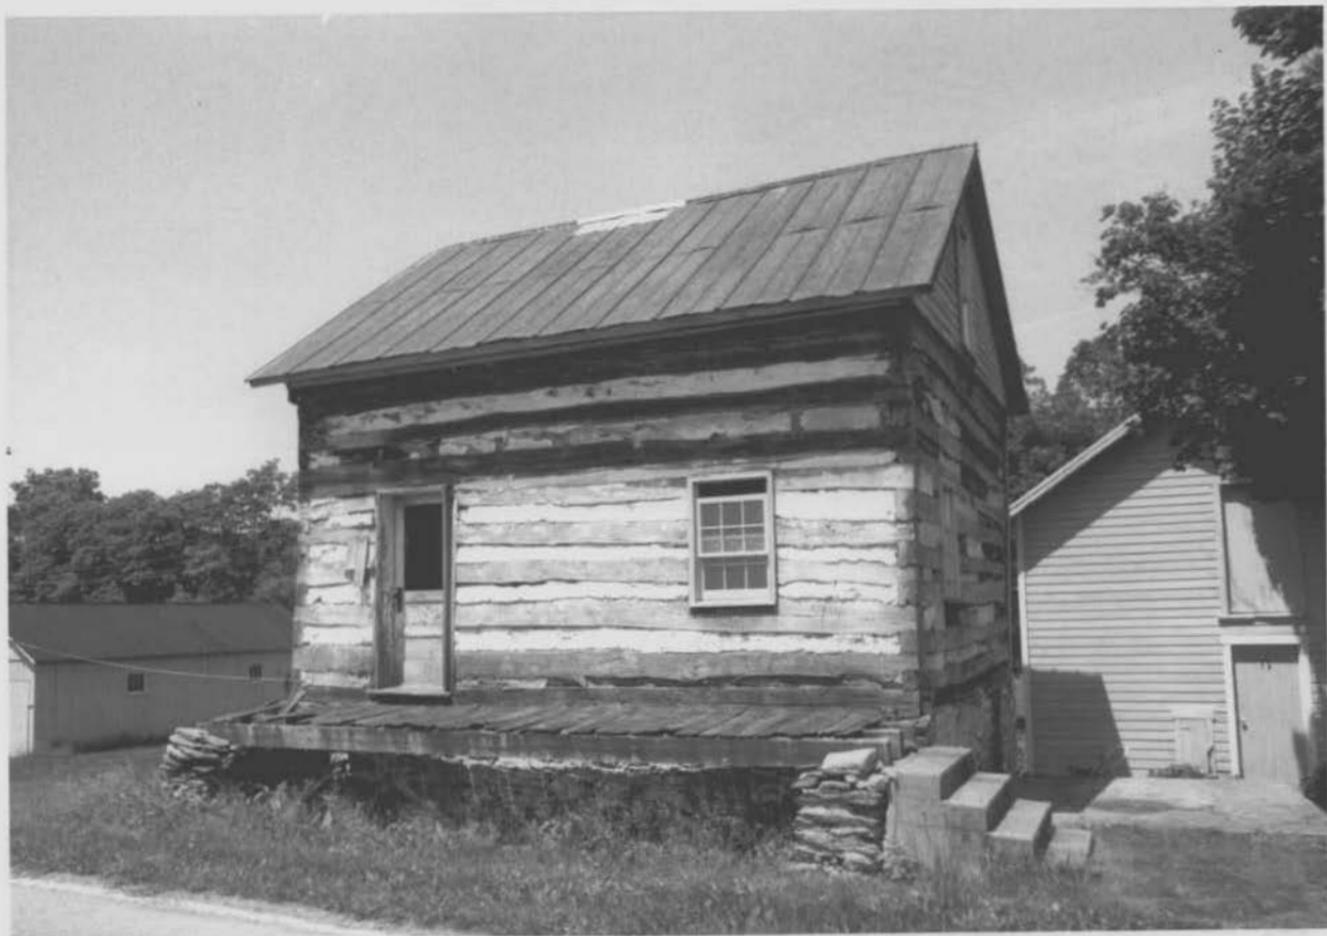
4/7

Log house: The one-story log structure is located southeast of the main dwelling at the edge of Mt. Tabor Road. It has an exposed stone foundation on the west and south. An exterior stone chimney base is located on the south elevation. The exposed log structure reveals wood nogging and interior lath. The north and south gables and the west elevation are covered with German siding. The east elevation has a single glazed panel door and a 6/6 window. Other window openings have missing sash. The roof is standing seam metal, with a patched section indicating the location of an originally center chimney. At the northeast corner, a painted sign reading "+J. Shank+" is visible. Jacob Shank owned the farmstead from 1872 to 1905 and his descendants held the property until the mid-1970's. The current owner, Mrs. Dorr, stated that a late 1700's date was found in the interior chinking of the building. Its interior was not accessible for recording; however, the date of the building could be as early as the last quarter of the 18th century.

Log house, east elevation

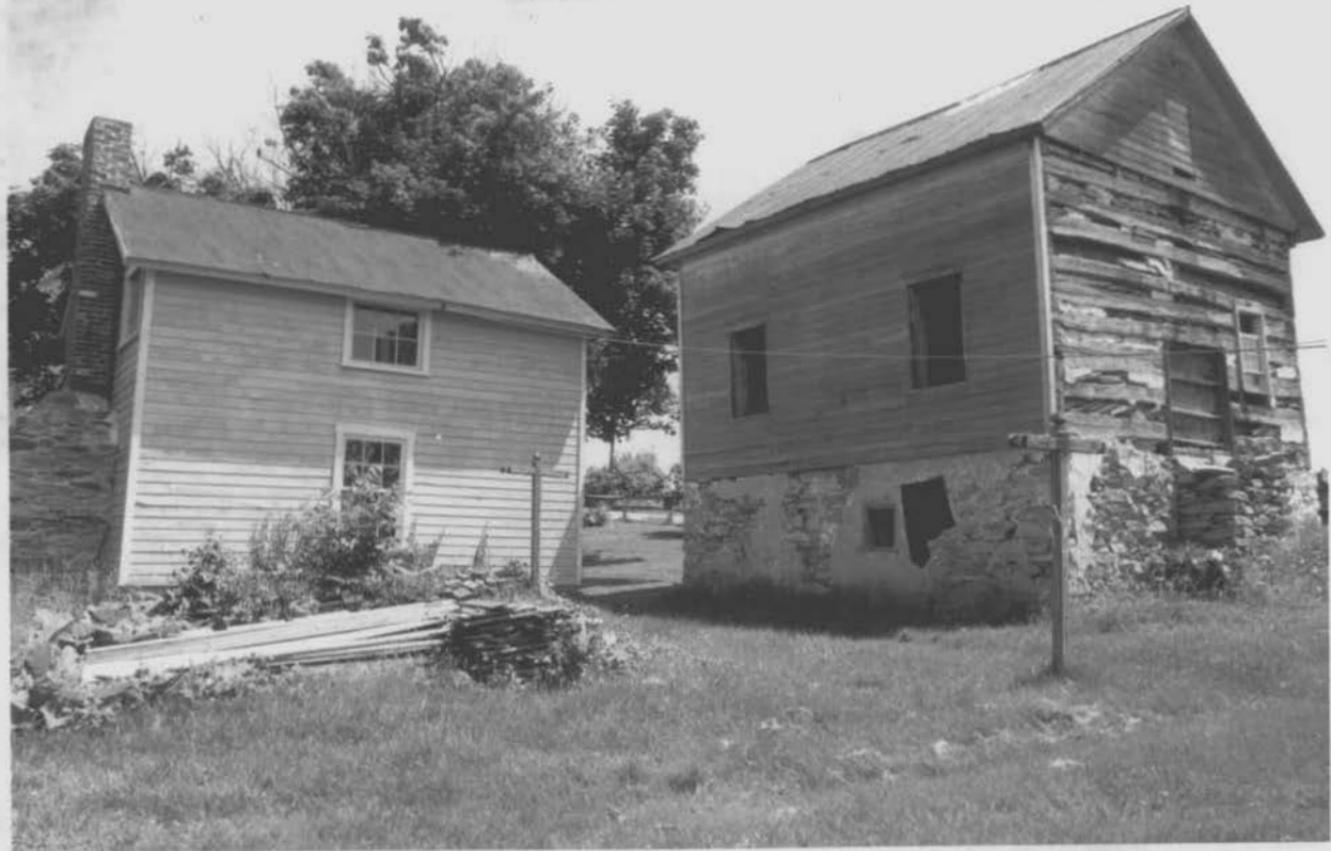
5/7

**Summer kitchen:** The frame summer kitchen was built about 1910, according to Mrs. Dorr. It is located near the log house south of the dwelling. It has a rectangular plan with two levels, the lower being the exposed stone basement. The upper section is covered with german siding. At the northeast corner are vertical tongue and groove doors on both levels. The windows are 6/6 except for a 3/3 window on the south elevation of the upper level. An exterior stone and brick chimney is located on the south elevation and the gable roof is covered with corrugated metal.

Summit kitchen and log house, view from south

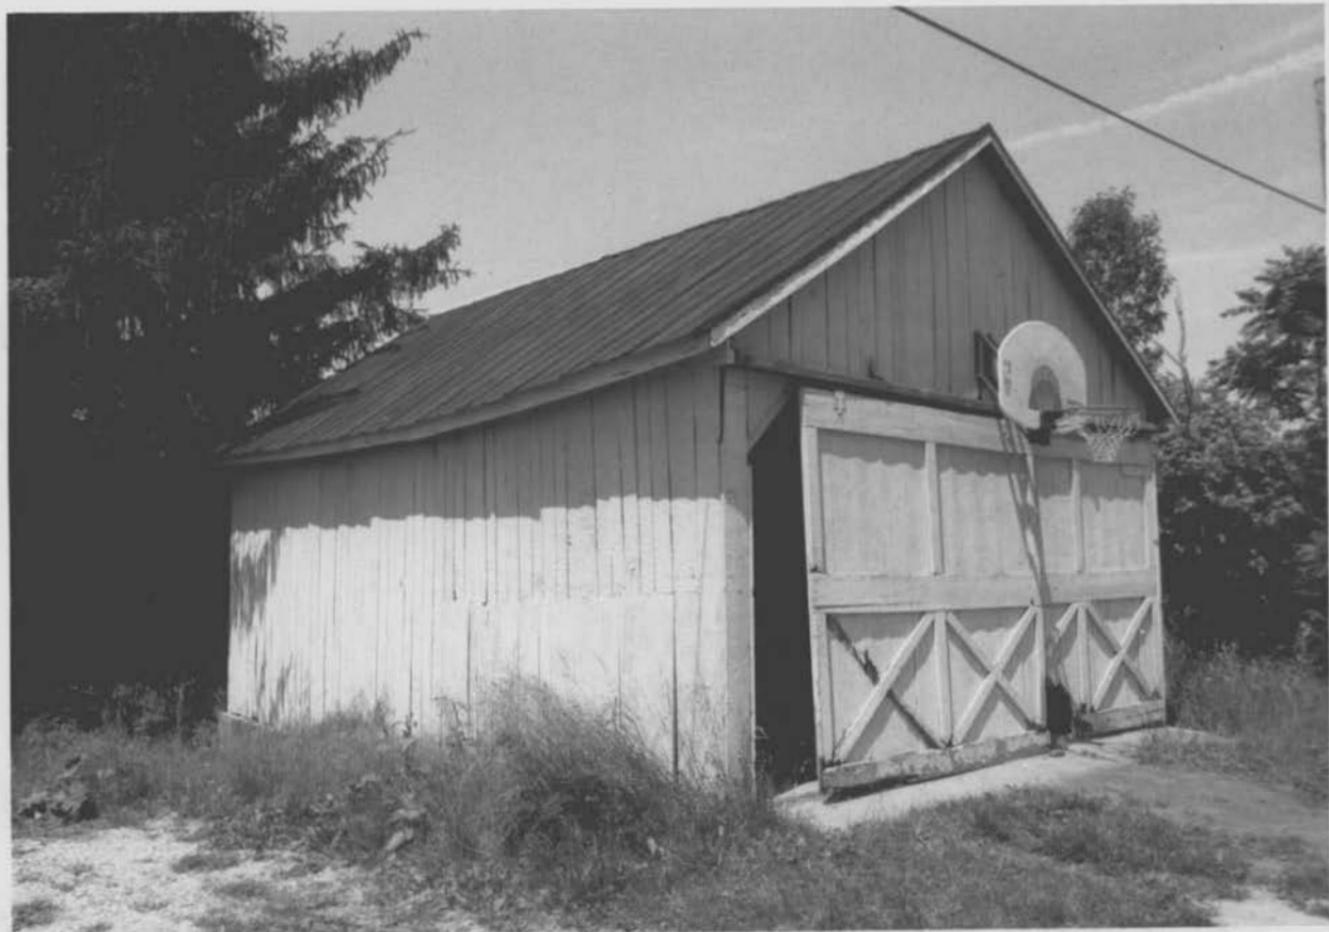
6/7

**Garage:** The frame garage was probably built about 1920. It stands northwest of the dwelling at the edge of Frostown Road facing the continuation of Mt. Tabor Road to the north of the complex. It appears to have been built over an earlier stone structure, perhaps an ice house, with an exposed south elevation. The upper structure has vertical board siding and sliding doors on the north elevation. The roof is standing seam metal.

Garage, north elevation

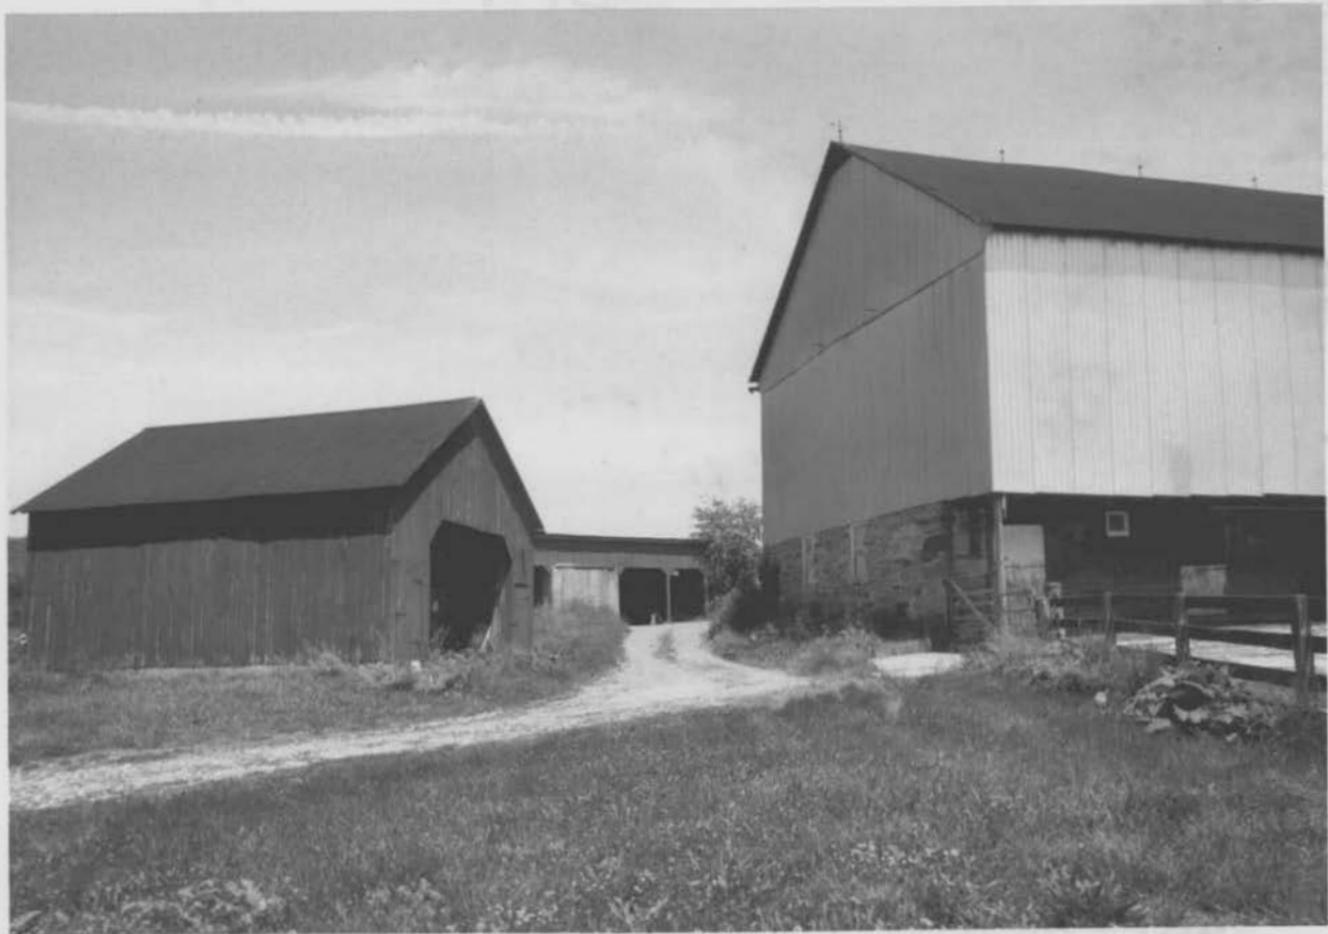
7/7

**Bank barn and wagon shed/corn crib:** The bank barn is located on the northeast side of Mt. Tabor Road. It was built about 1910, according to Mrs. Dorr, as a replacement for an earlier barn. It has metal siding probably concealing vertical boards. The lower level on the east elevation is enclosed with horizontal siding. The west elevation has sliding doors and the roof is covered with corrugated metal. The wagon shed/corn crib is located just southeast of the barn. Built about 1875-1900, it has vertical siding and a concrete foundation, which may replace an original stone foundation. The roof is standing seam metal. Both the barn and the wagon shed are located on Parcel 119, owned by Charles O. Myers and Betty A. Myers, 2717 Milt Summers Rd., Middletown, MD 21769.

**Tractor shed:** The frame tractor shed is located on the west side of Mt. Tabor Road directly west of the barn barn. It has five open bays on the east elevation, with vertical siding on the other elevations and a standing seam metal roof. It was probably built as a wagon shed in the period 1875-1900. The shed is located on Parcel 85, owned by Edgar E. and Gladys I. Poffenberger, 9109 Frostown Rd., Middletown, MD 21769.

Wagon sheds, and bank barn, partial view  
from southeast
