F-4-99

Routzahn-Summers Farmstead
Myersville vicinity
Private

F-4-99
Routzahn-Summers Farmstead
Myersville
Frederick County

Maryland Historical Trust State Historic Sites Inventory Form

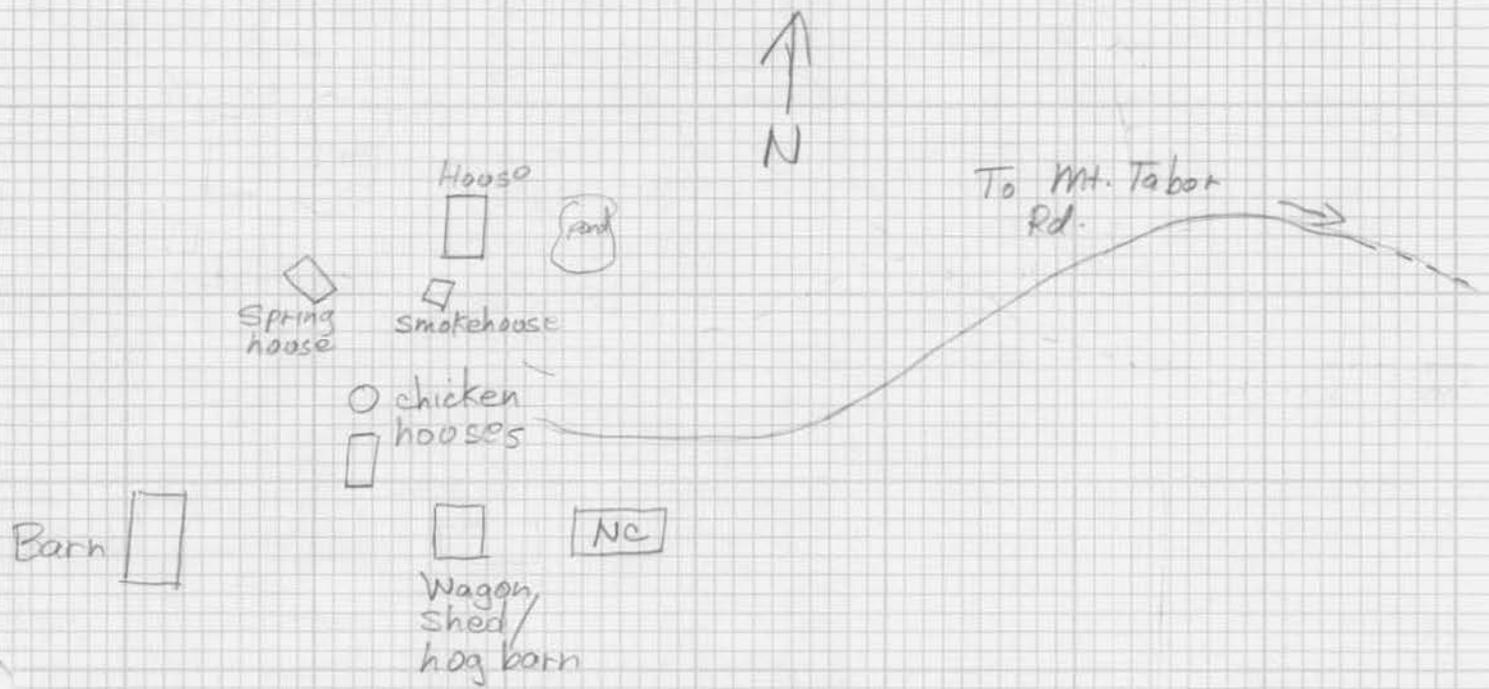
F-4-99
Rootzahn-Summers Farmstead
Frederick County

Not to Scale

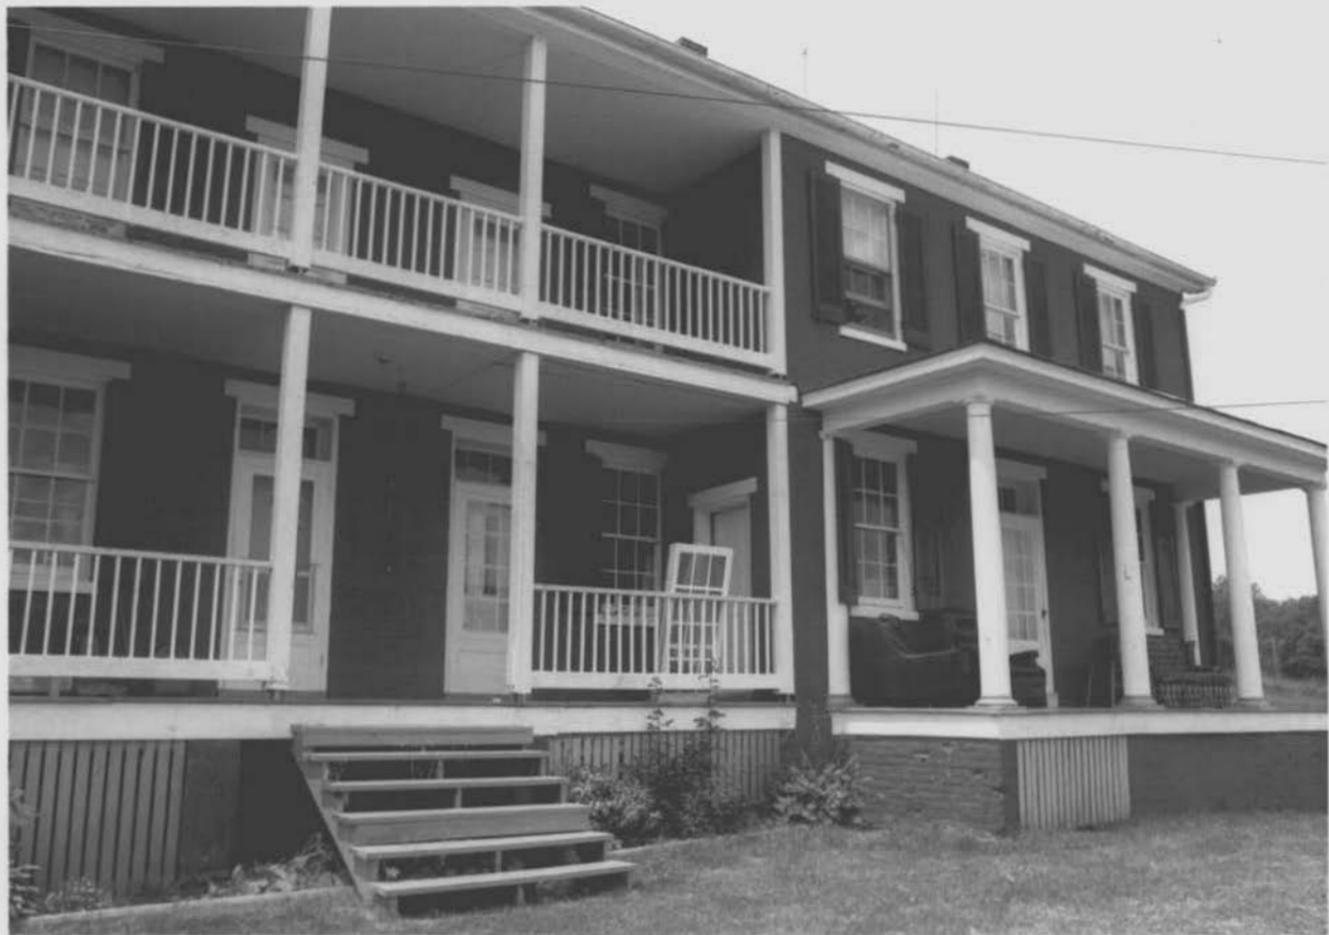
1/6

East elevation

The dwelling has two sections, a three-bay main section on the north and a four-bay wing on the south with an integral two-story porch. Both sections face east. The walls are laid in 5:1 American bond and are painted brick red. The three-bay section has a center entrance and a one-story porch with Tuscan columns, which was probably added in the period 1905-1910. The window and door openings have plain lintels and sills and the doorway has a three-light transom. The door has 6 panels. The sash is 6/6 with louvred shutters. The cornice is boxed and the roof is covered with corrugated metal. The chimneys are at each gable end and at the joining wall between the main section and wing. The wing has a plain balustrade and square posts on each level. The four bays have two entries in the inner bays. One of the doors has glazed upper panels, while the other has four solid panels. The bases of the porches on both the main section and the wing have brick pedestals, perhaps indicating that these were built in the early 20th century to replace earlier porch foundations. The north elevation has two bays with 6/6 sash and two attic windows with 2/2 sash. The west elevation has an irregular bay arrangement, with three bays in the center flanked by incomplete bays at each end of the house. The northernmost bay has a door to the rear of the main section under a small shed roof. The southernmost bay in the wing section has a similar entrance sheltered under a small entry porch, which was probably added in the early 20th century. The interior of the house was inaccessible for this survey.

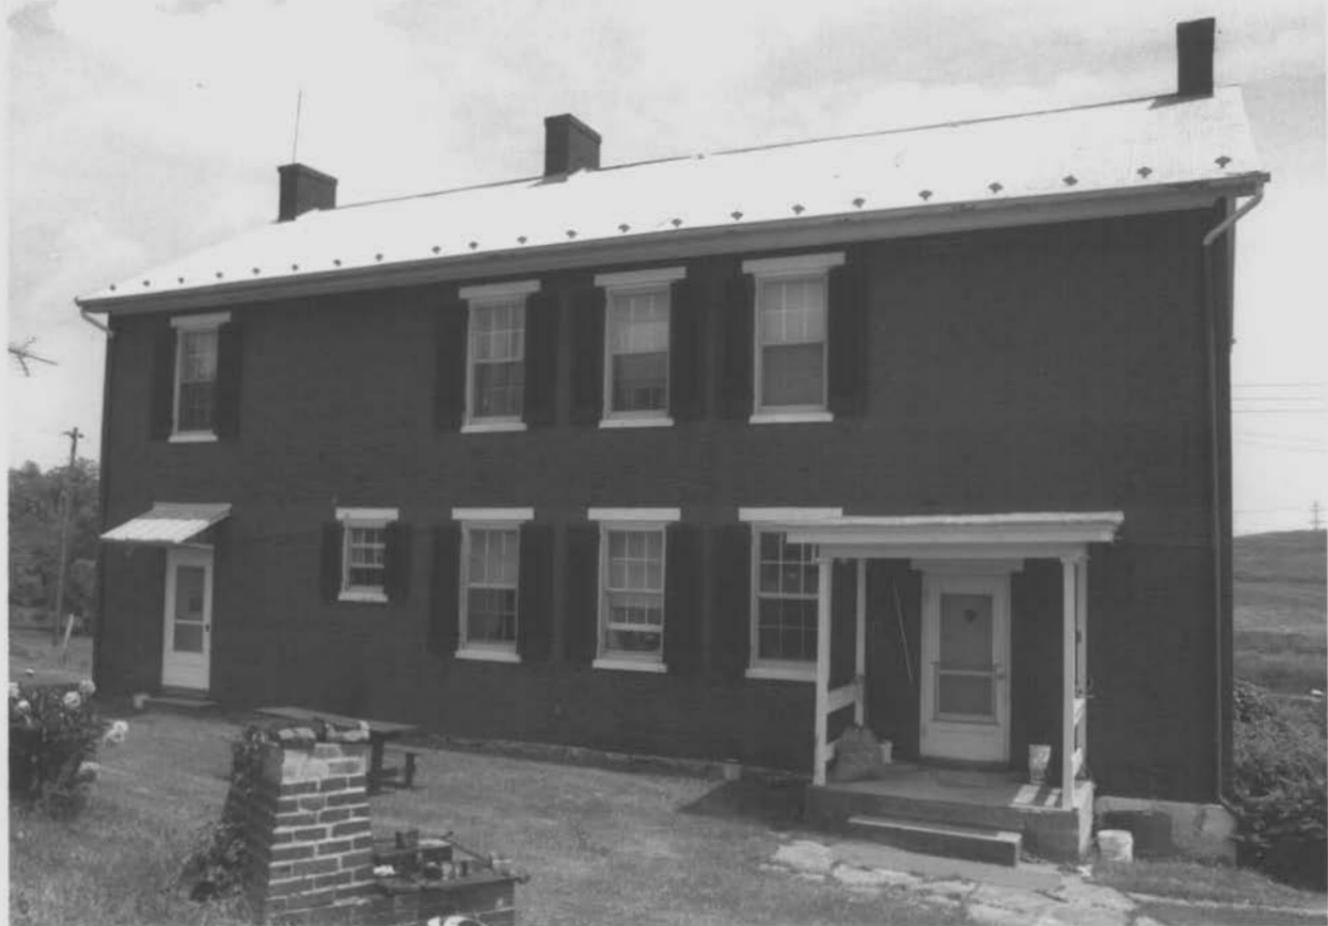
2/6

West elevation

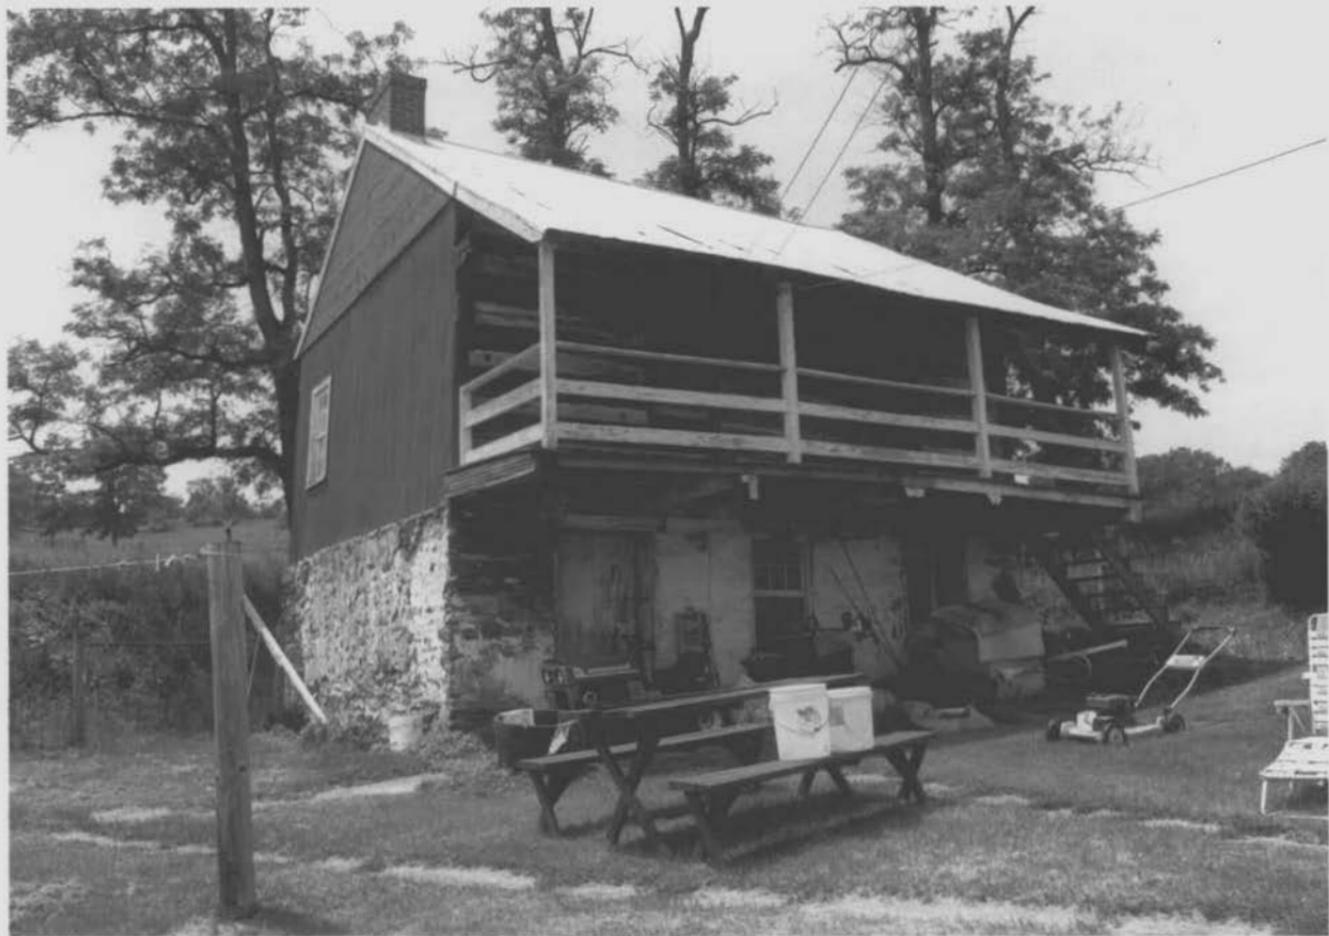
3/6

Springhouse, northeast elevation

Springhouse: The stone and log springhouse is a two-story building located southwest of the house and placed diagonally to the plane of the house. The stone first level has three openings on the northeast elevation with doors in the outer bays. One of these at the southeast corner is a vertical board door, while the other has a an open or glazed panel. The center bay has a 6/6 window. The fieldstone walls were once whitewashed and some of this survives on the northeast elevation. The second story of the springhouse is exposed log on the northeast side, but the log structure is covered with corrugated metal siding on the other elevations. The second story has a cantilevered porch with a side access stair and a plain horizontal railing with square posts. The second story has two bays with a vertical board door and a 6/6 window. The roof is covered with corrugated metal and

an interior end chimney rises at the south gable end. The springhouse interior was inaccessible, so the determination of the use of the upper level is incomplete. It may have been a summer kitchen, slave quarters, or a wash house. Its date appears to be contemporary with the house; however, it is possible that the building could pre-date the brick house by 20-25 years, and may have been the first residence on the farm.

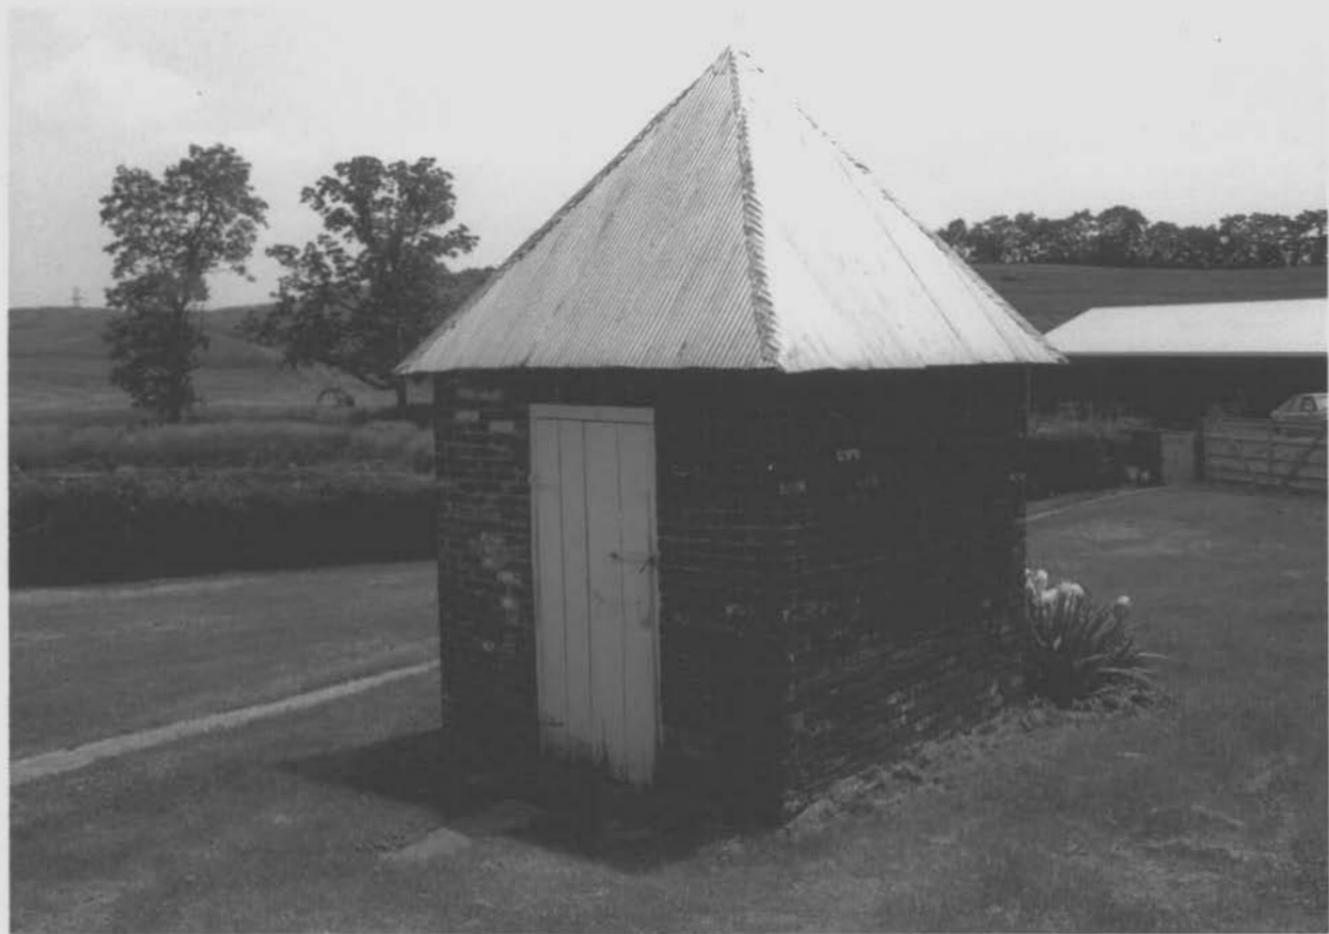
4/6

Neg. loc.: Md. SHPO, Crownsville Md
Smokehouse, west elevation

Smokehouse: The square plan brick smokehouse is located south of the house. It has a hipped or pyramidal roof covered with corrugated metal. A single vertical board door is in the north elevation. This building also appears to have been built during the same period as the brick dwelling.

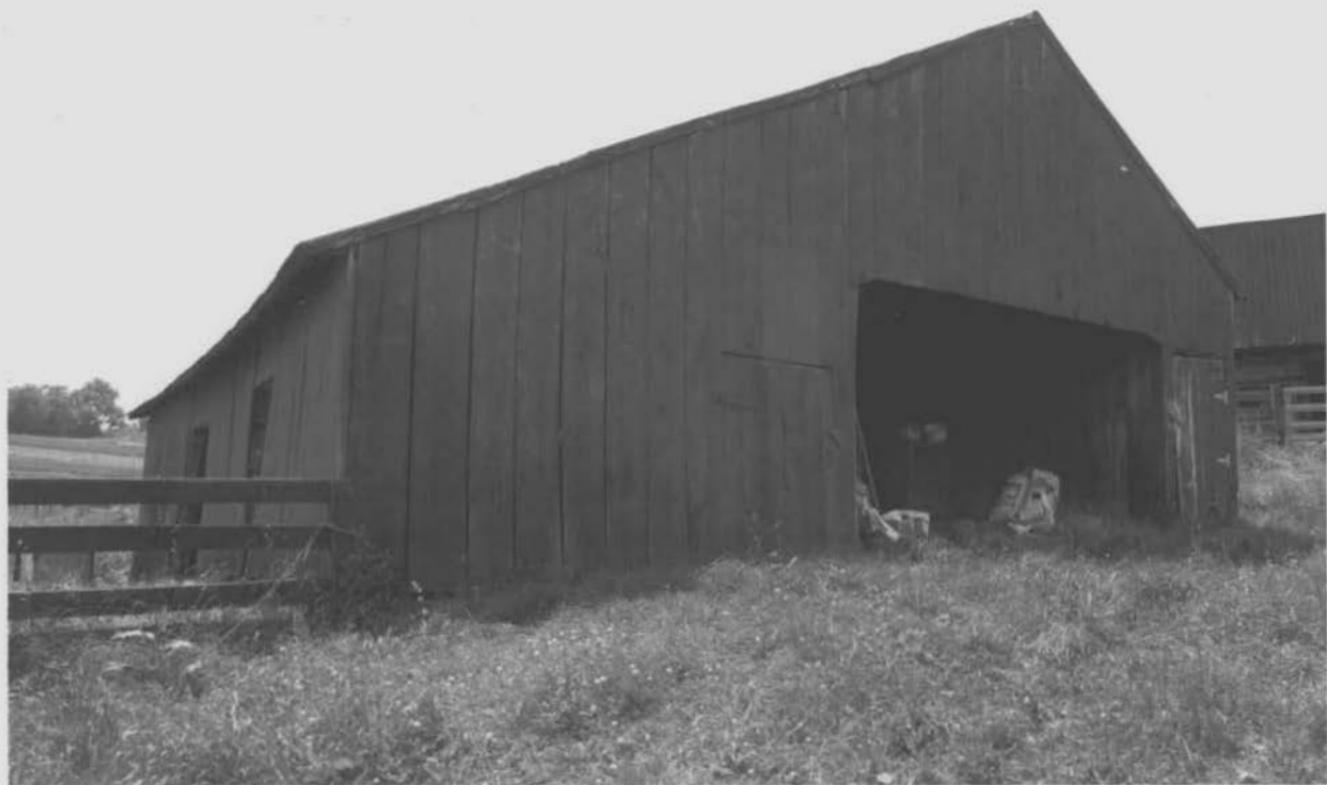
5/6

Wagon shed / hog barn, north elevation

Wagon shed/hog barn: The frame wagon shed with its attached hog barn was built in the first decade of the 20th century. Located east of the barn, the wagon shed has a single bay on the north elevation with vertical siding and a corrugated metal roof which extends to the east to cover the hog barn. The barn section has two open doorways on the east elevation. The entire shed is now used as storage space.

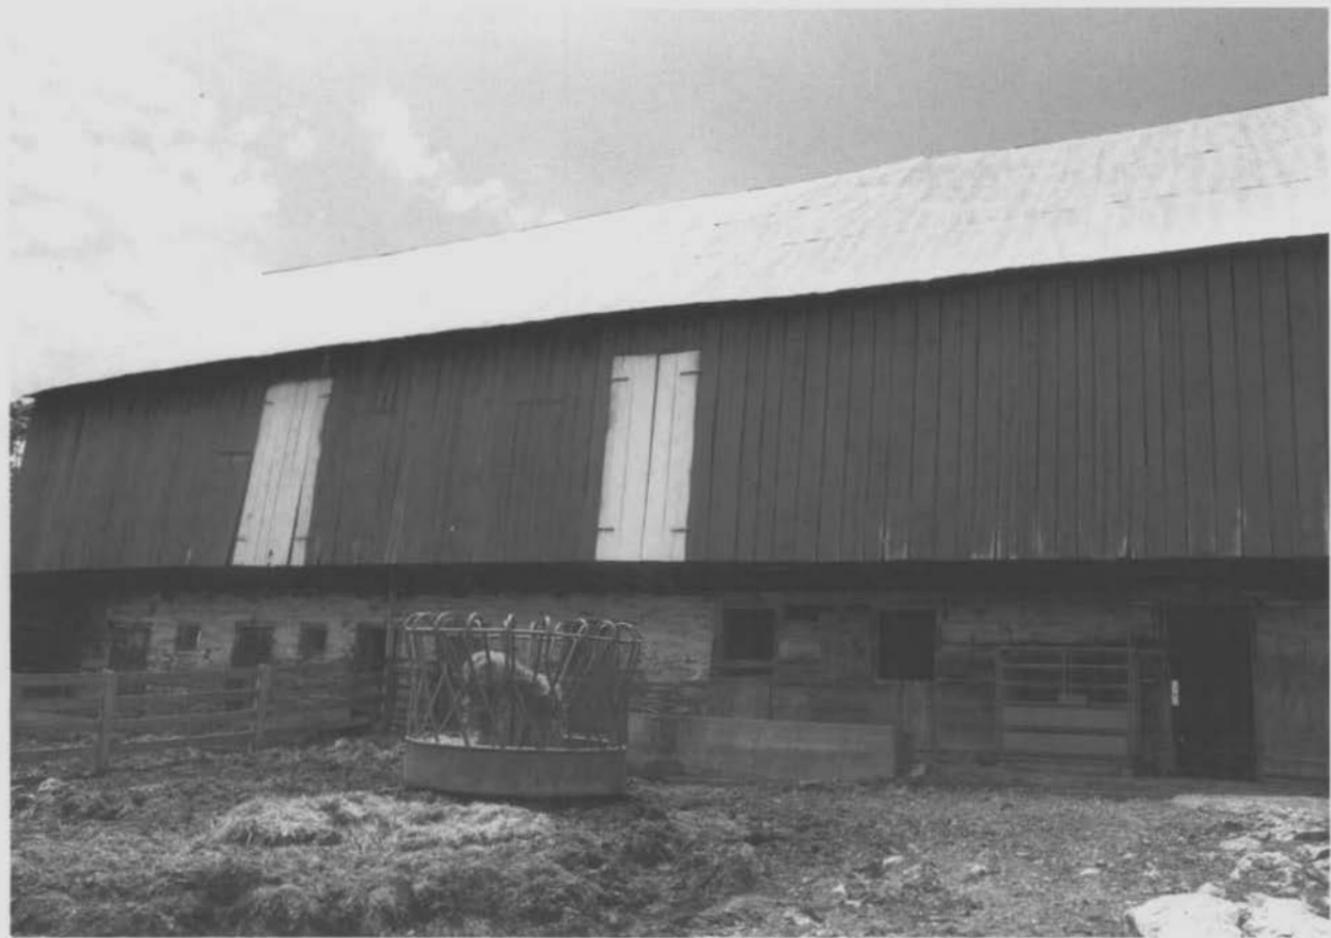
6/6

Barn, east elevation

Bank barn: The large frame and stone back barn is located southwest of the house. Originally built in the first or second quarter of the 19th century, it was probably enlarged during the first decade of the 20th century. The foundation and stall level on the east are fieldstone which has been whitewashed in the past and still survives on the older section of the barn in the souther portion of the building. The northern section, which is indicated by the stalls section enclosed by flush horizontal boards, is the early 20th century part. The upper section of the barn has vertical siding and two swing doors painted white on the east elevation. The roof is covered with corrugated metal. The barn is still in use as a cow barn.
