Kolb Property
MIHP # F-5-167
West Side of Linganore Road
Frederick
Ca. late nineteenth/early twentieth centuries
Private

Maryland Inventory of Historic Properties Form

Inventory No. F-5-167

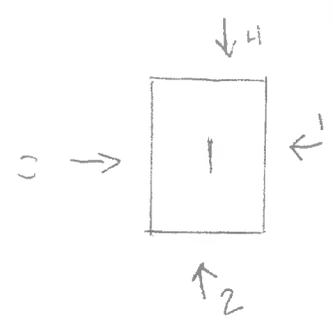
1. PRINCIPAL DWELLING
2. CONCRETE-BLOCK DWELLING 1
3. CONCRETE-BLOCK DWELLING 2
4. COLLAPSED BUILDING 1
5. COLLAPSED BUILDING 2

MHP # F 5-167
 KOLB PROPERTY
 WEST SIDE OF
 LINGASTORE ROAD
 FREDERICK
 FREDERICK COUNTY, MD
 APRIL 2015
 DRAWN BY: V. PEELEY
 NOT TO SCALE

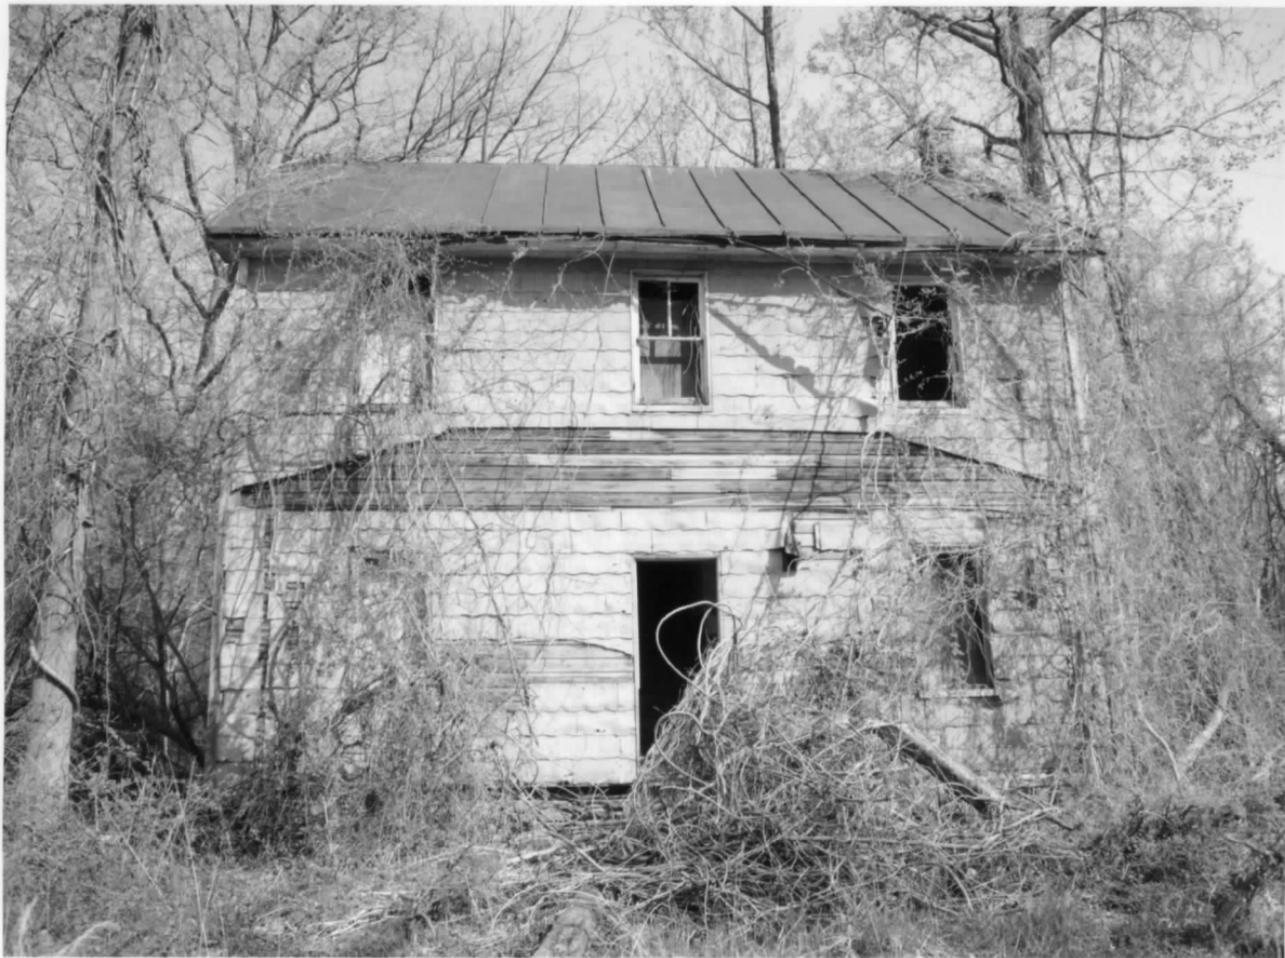
1 OF 14

The east elevation is three bays. The remnants of the full-width porch are visible. The primary entrance is centered on the elevation; the door no longer is extant. Two windows flank the primary entrance. Both window openings are covered in plywood. At the second floor, the remains of the two-over-two-light, double-hung sash are visible in the central window. The south window opening is covered in plywood while the north opening is uncovered.

MD SHPO
PRINCIPAL DWELLING, EAST ELEVATION

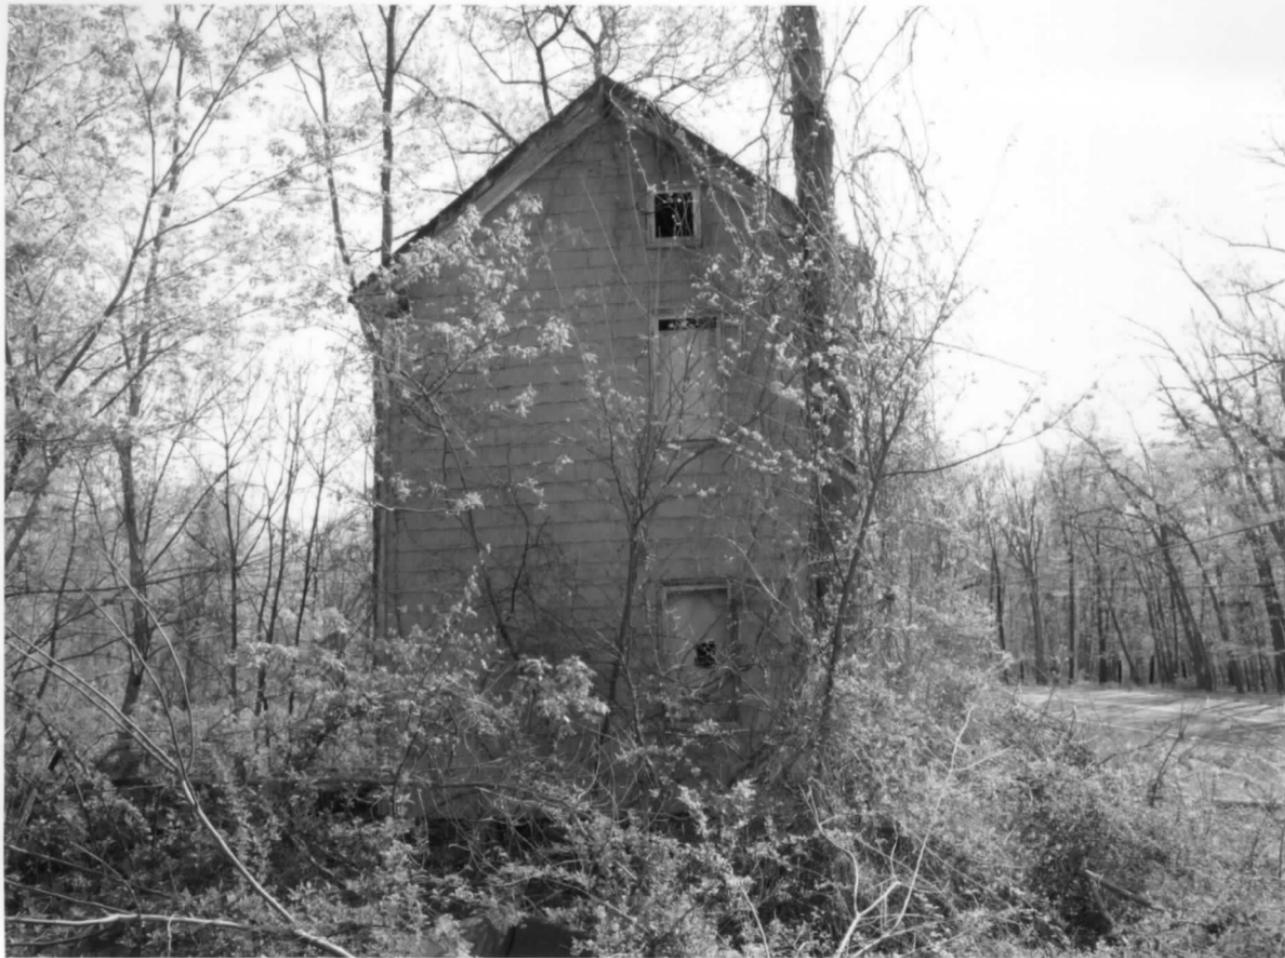
PRINCIPAL DWELLING, SOUTH ELEVATION
2 of 14

The one-bay north and south elevations are similar. On the south elevation, one window is found on each the first and second floors of the east end of the elevation. A wood window opening is located in the gable end. The wood sash remain at the first floor and in the gable window on the north elevation. Plywood covers the second-floor window opening.

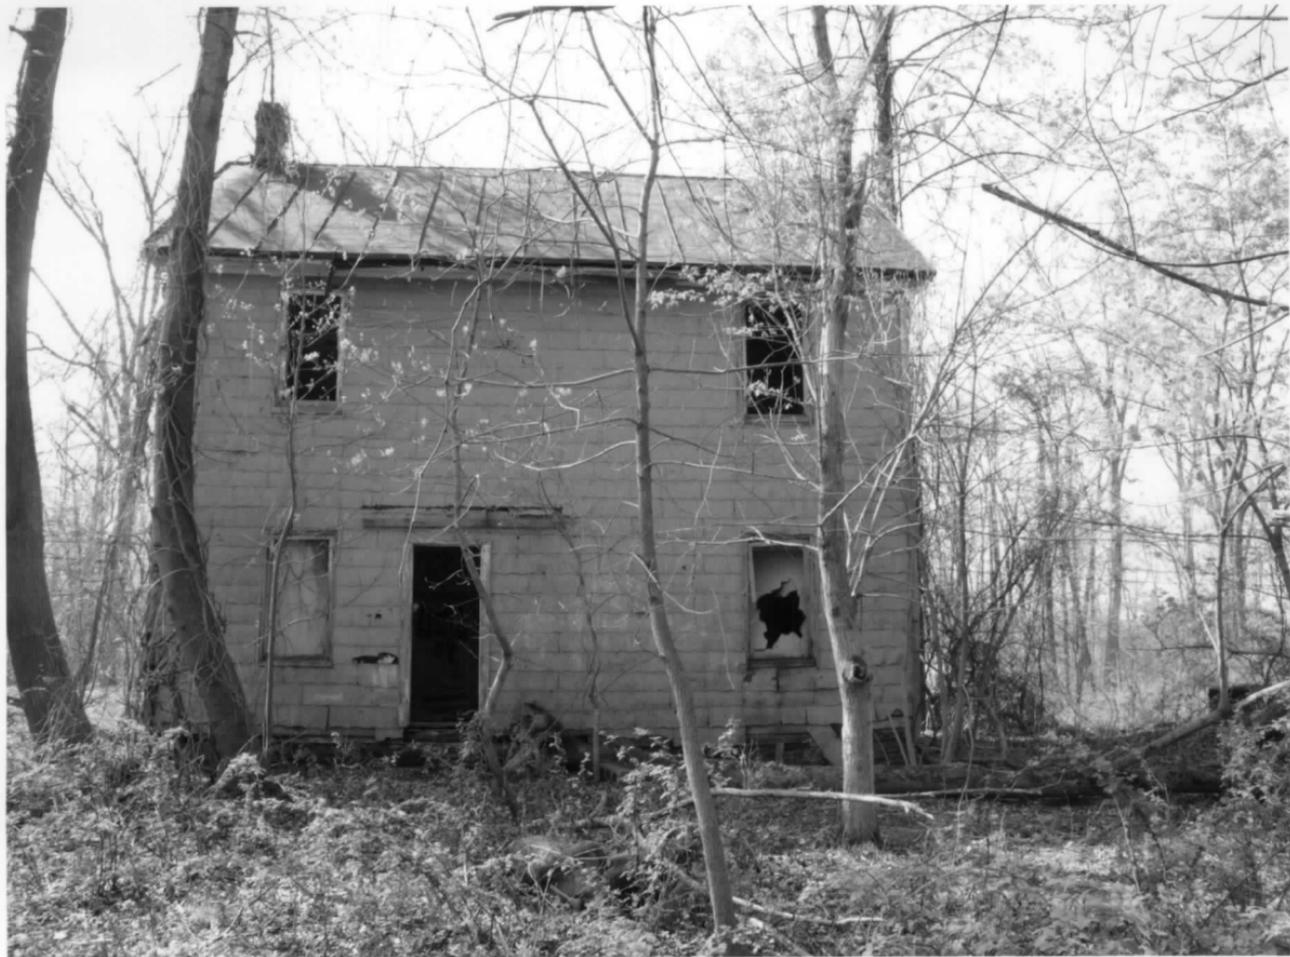
3 OF 14

The asymmetrical west elevation (rear) features an off-center door. Visual observation suggests a stoop or porch defined the entrance. The door no longer is extant. The two first-floor windows, which flank the entrance, are covered in plywood. The two second-floor window openings are uncovered.

PRINCIPAL DWELLING, WEST ELEVATION

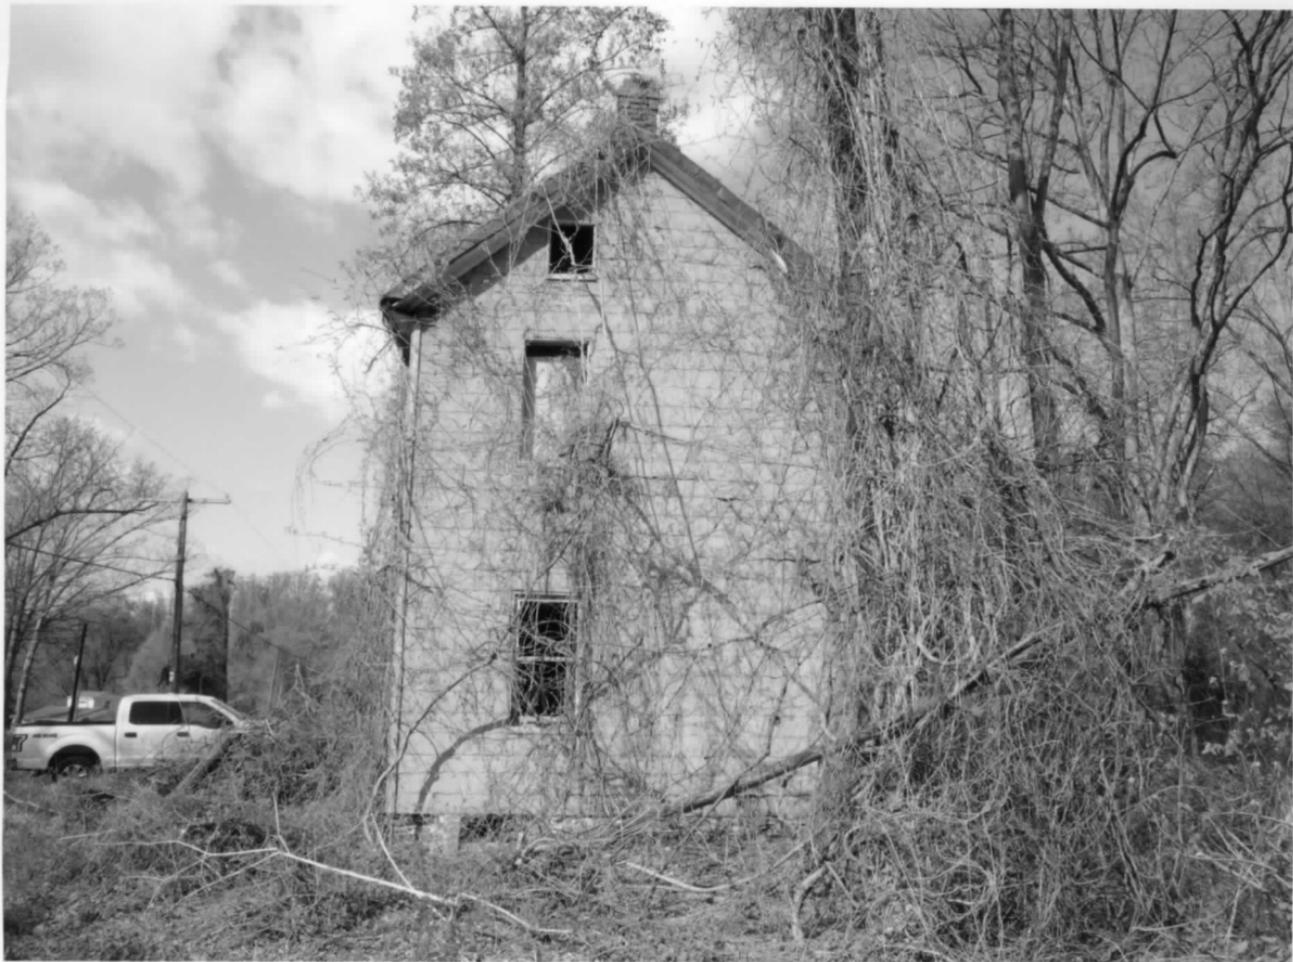
4 of 14

MHP # F-5-167
KOLB PROPERTY
FREDERICK COUNTY, MD
PLANS
APRIL 2015
MD SHD
DWELLING, NORTH ELEVATION

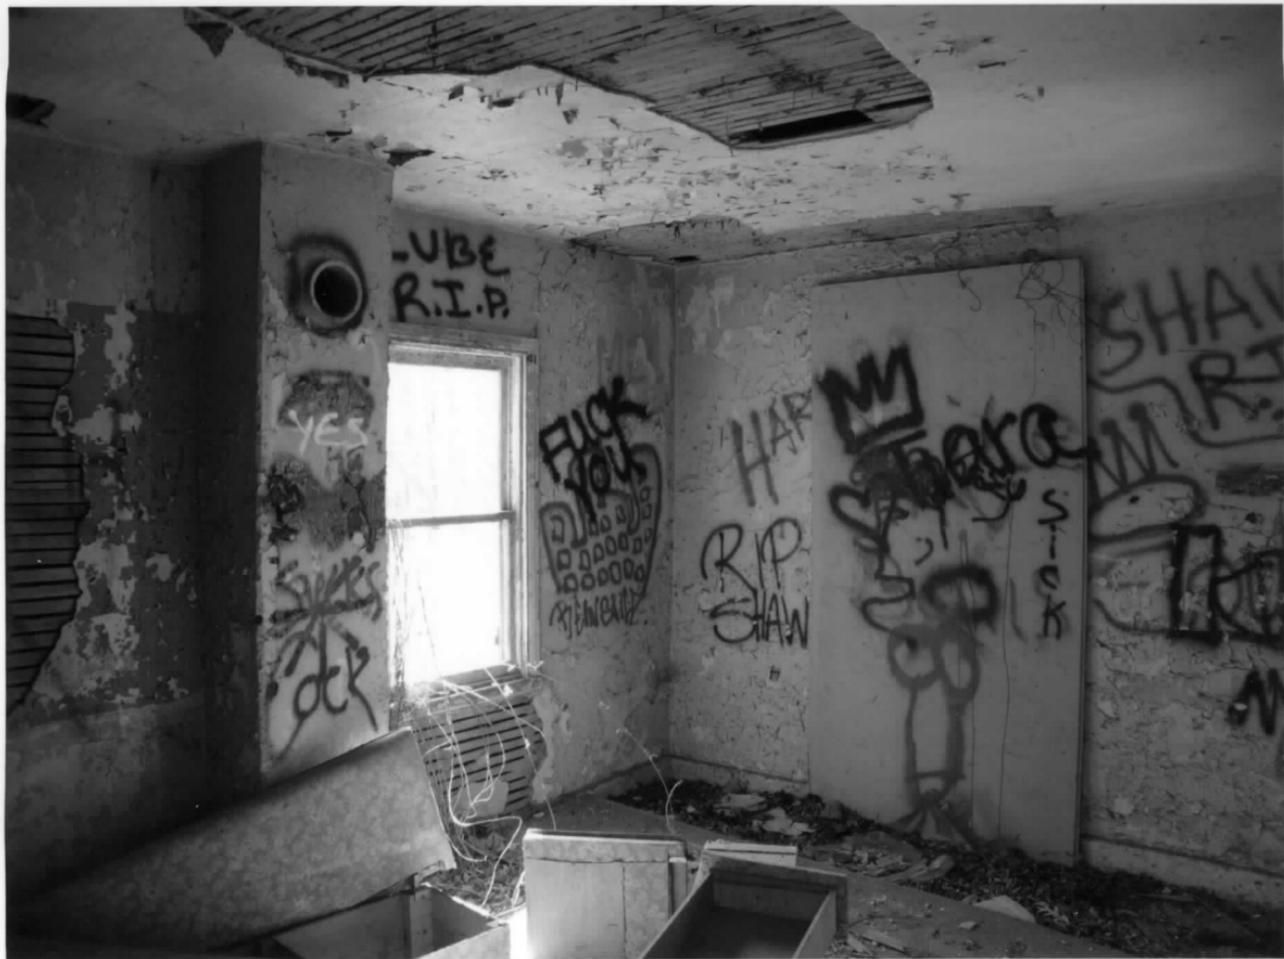
5 OF 14

In plan, the dwelling is two rooms deep with an enclosed, straight-run, central stair. The second floor was not accessible.

PRINCIPAL DWELLING, INTERIOR, NORTH PARLOR

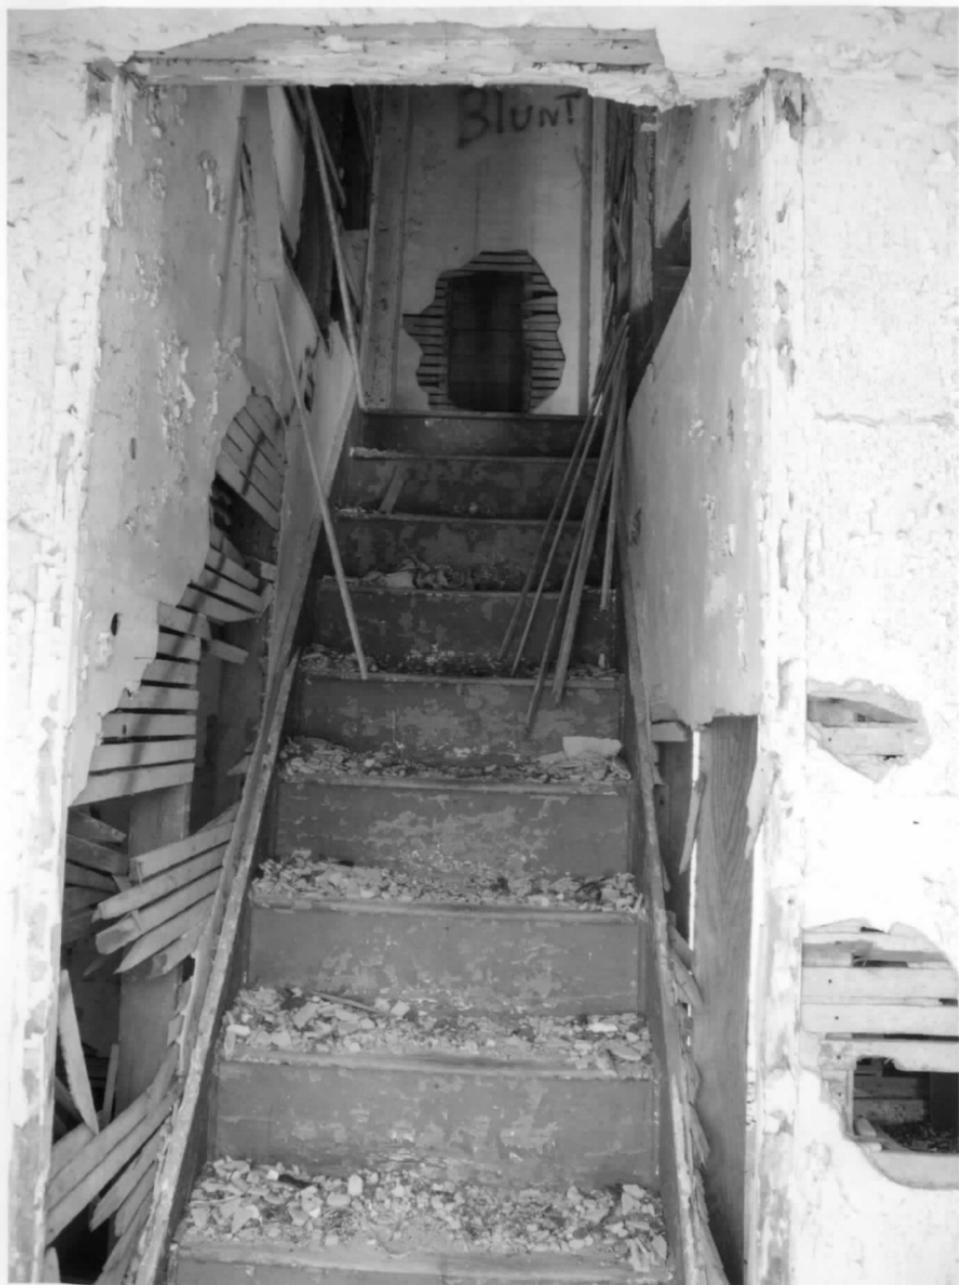
7 05 14

PRINCIPAL DWELLING, STAIR

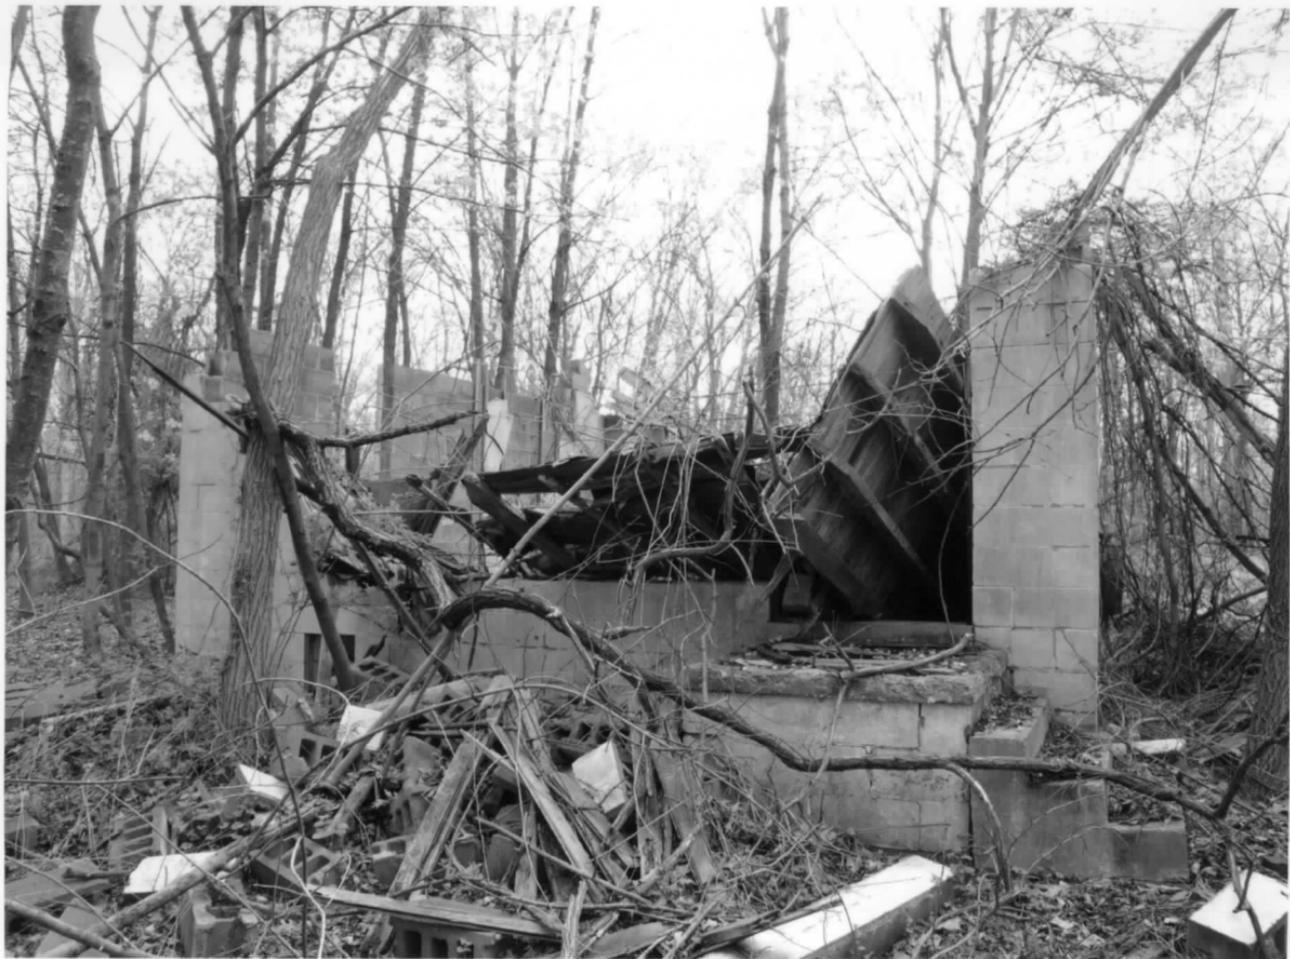
9 OF 14

A single-story, concrete-block building is located north of the principal dwelling. The building occupies a square footprint and rests on a concrete-block crawl space. The roof has collapsed into the building interior. The dwelling faces east; the principal entrance is centered on the east elevation. Two window openings flank the entrance; the sash no longer are extant. One window opening is located on each the north and south elevations; the sash no longer are extant. Most of the west (rear) elevation no longer is extant. An entrance, defined by a concrete-block stoop, is located at the south end of the elevation.

CONCRETE-BLOCK DWELLING 1
WEST ELEVATION

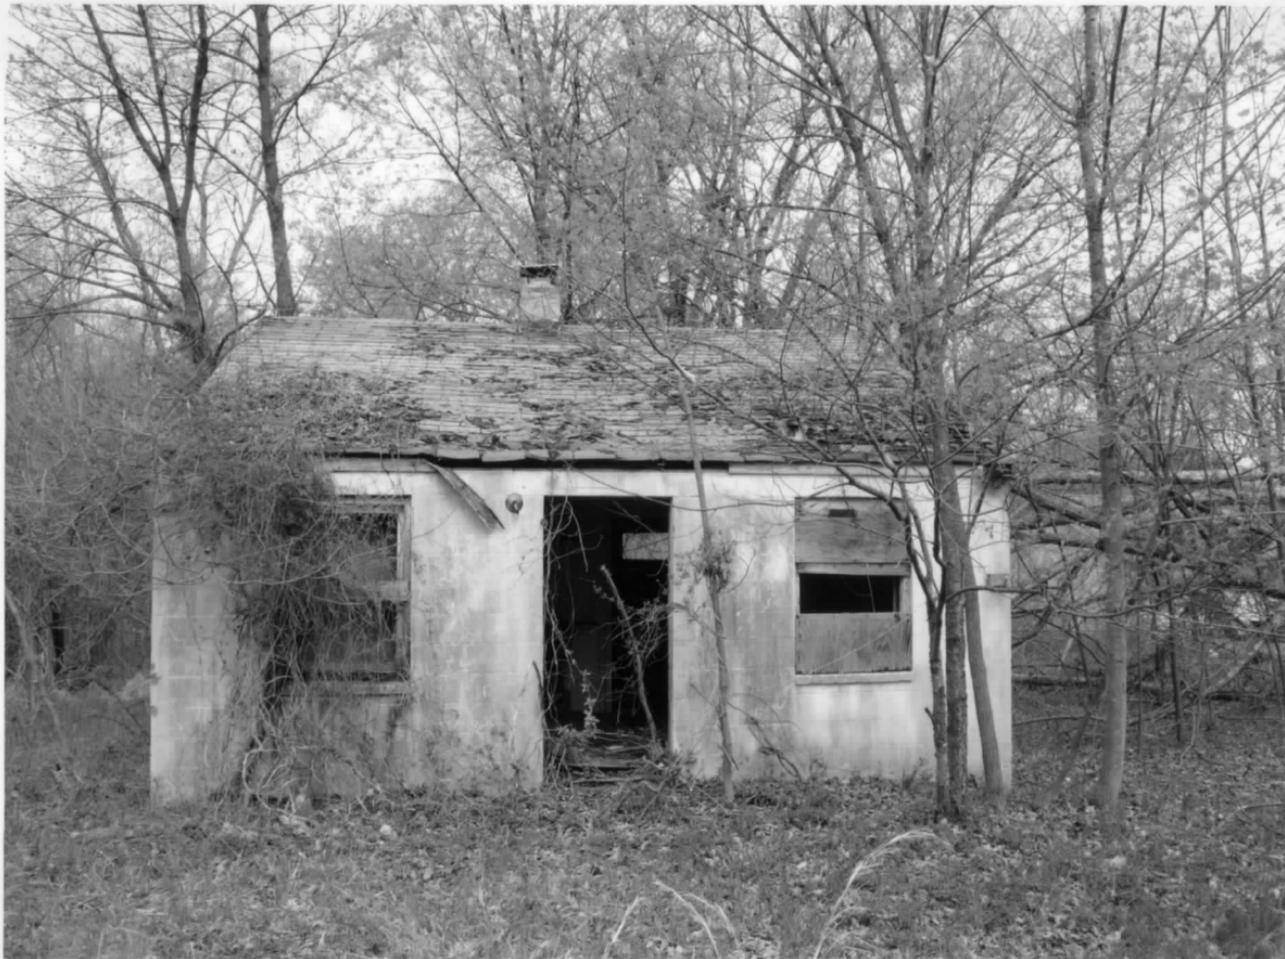
EAST ELEVATION
10 OF 14

A single-story, concrete-block dwelling is located north of concrete-block dwelling 1. The dwelling is a three-bay, single-story building that occupies a square footprint. The building terminates in a side-gable roof sheathed in asphalt shingles. A chimney is centered in the roof's ridge. The main entrance is centered on the east elevation and is flanked by two window openings; the sash are no longer extant. The north and south elevations are each one bay. The window opening on the

CONCRETE-BLOCK DWELLING 2

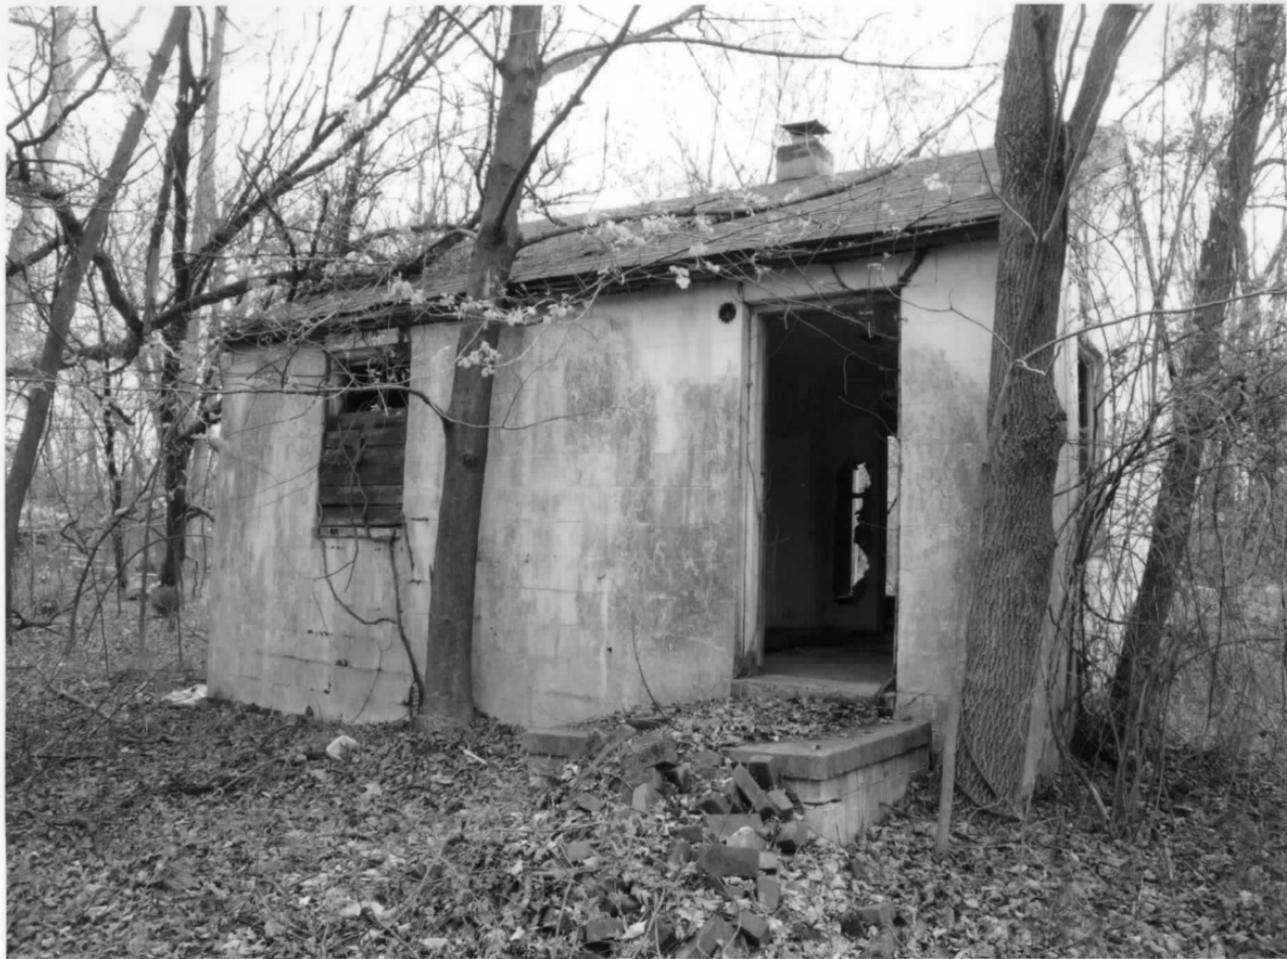
11 OF 14 WEST ELEVATION

north elevation is covered in plywood; the opening on the south elevation is uncovered. The two-bay west elevation features a covered window opening and an entrance. A poured-concrete and concrete-block stoop provides access to the entrance.

CONCRETE-Block DWELLING 2

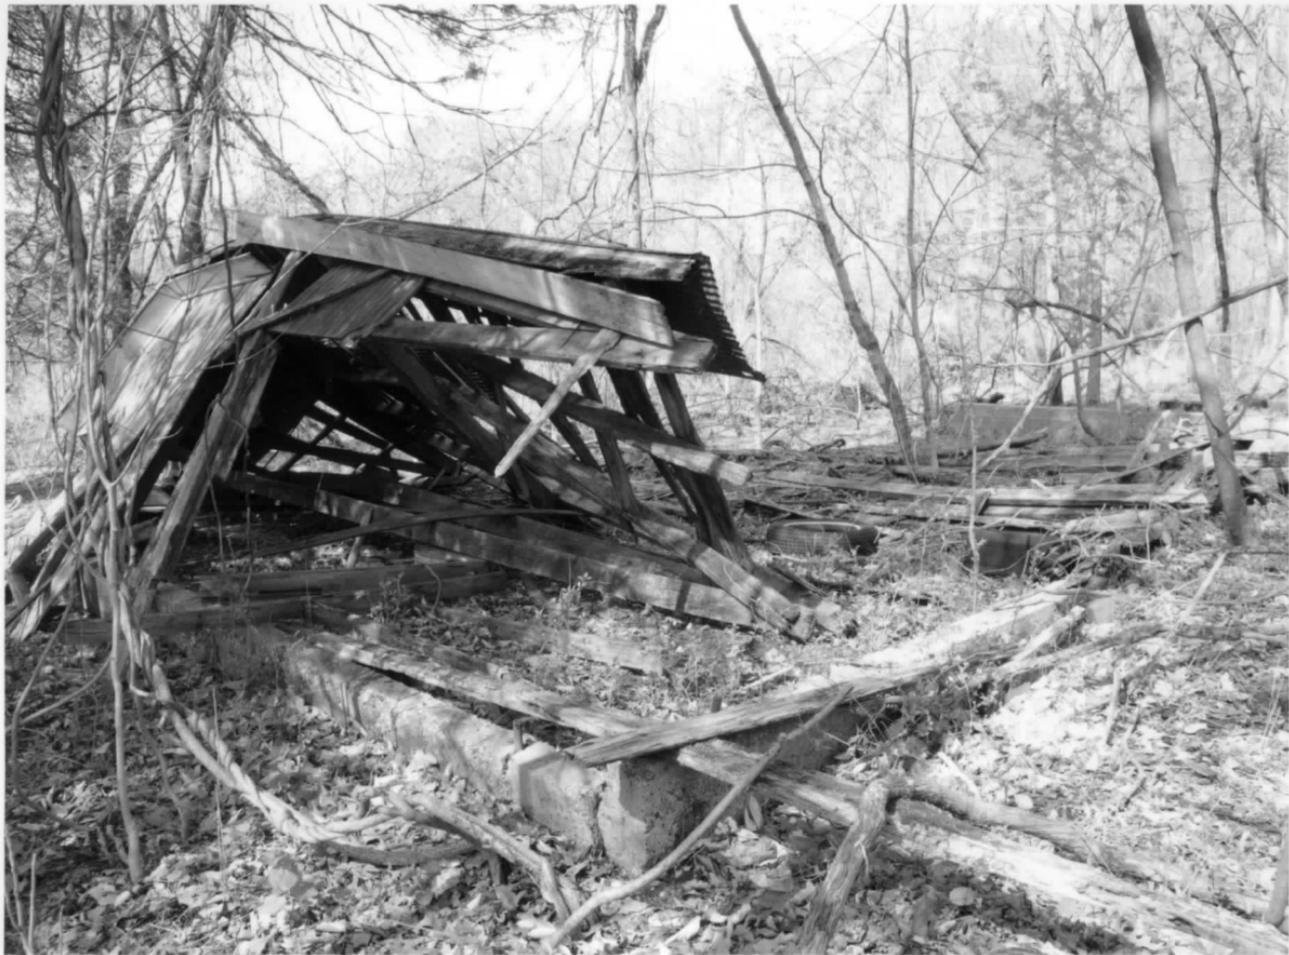
12 of 14

A partially collapsed building is located south of the principal dwelling. The wood-frame building features a poured-concrete retaining wall and foundation. The roof is sheathed in corrugated-metal panels; roof type is indiscernible. Use and type of building could not be determined.

COLLAPSED BUILDING 1, LOOKING SW

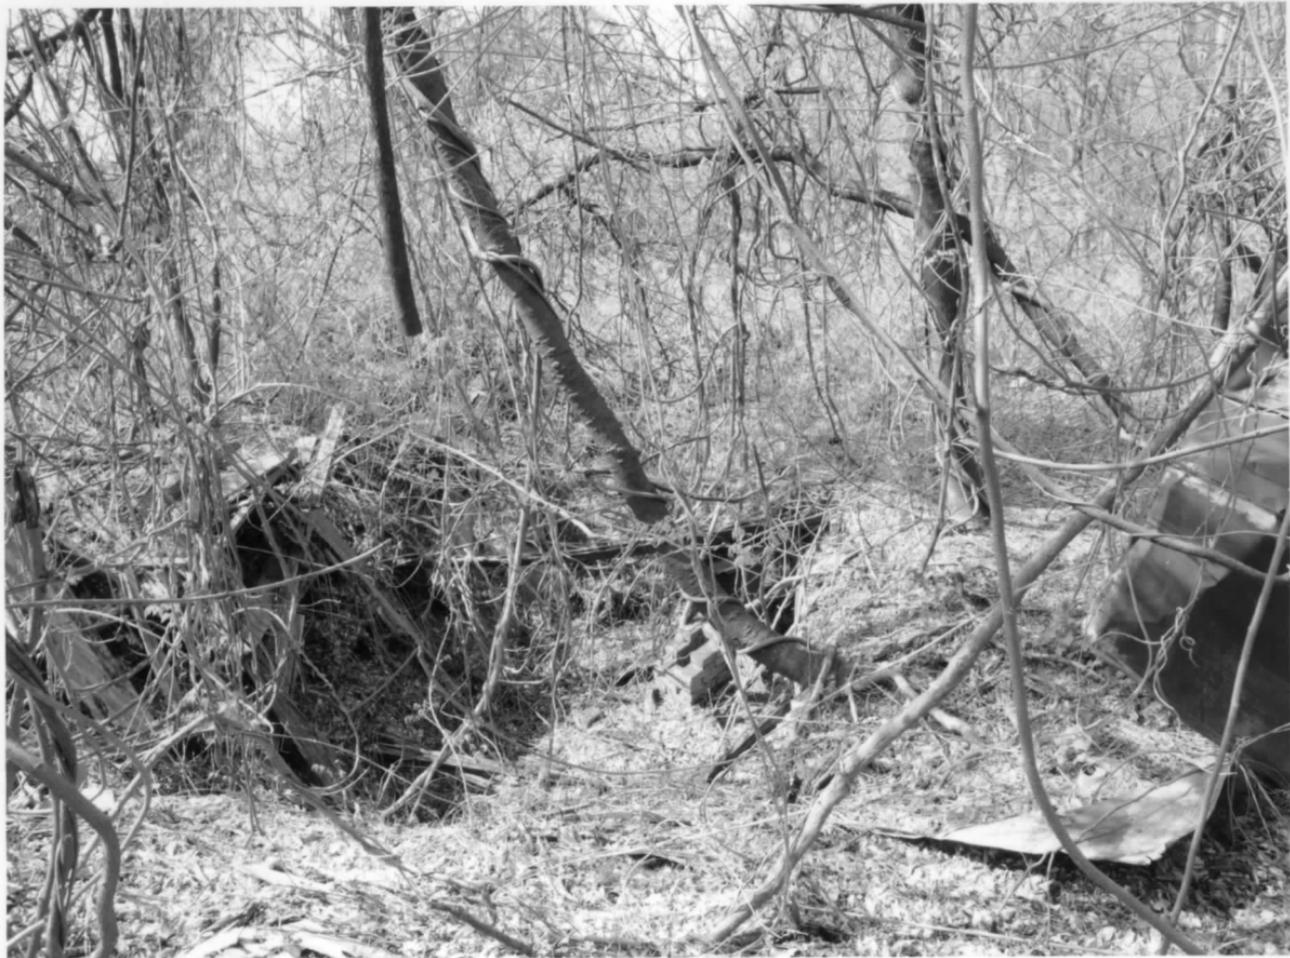
13 OF 14

A wood-frame building is located south of Building 1. Wood-framing is visible. Other visible materials include poured-concrete, brick, piping to suggest the building might have had plumbing, and corrugated metal. The original type and use of the building is indiscernible.

COLLAPSED BUILDING 2, LOOKING S

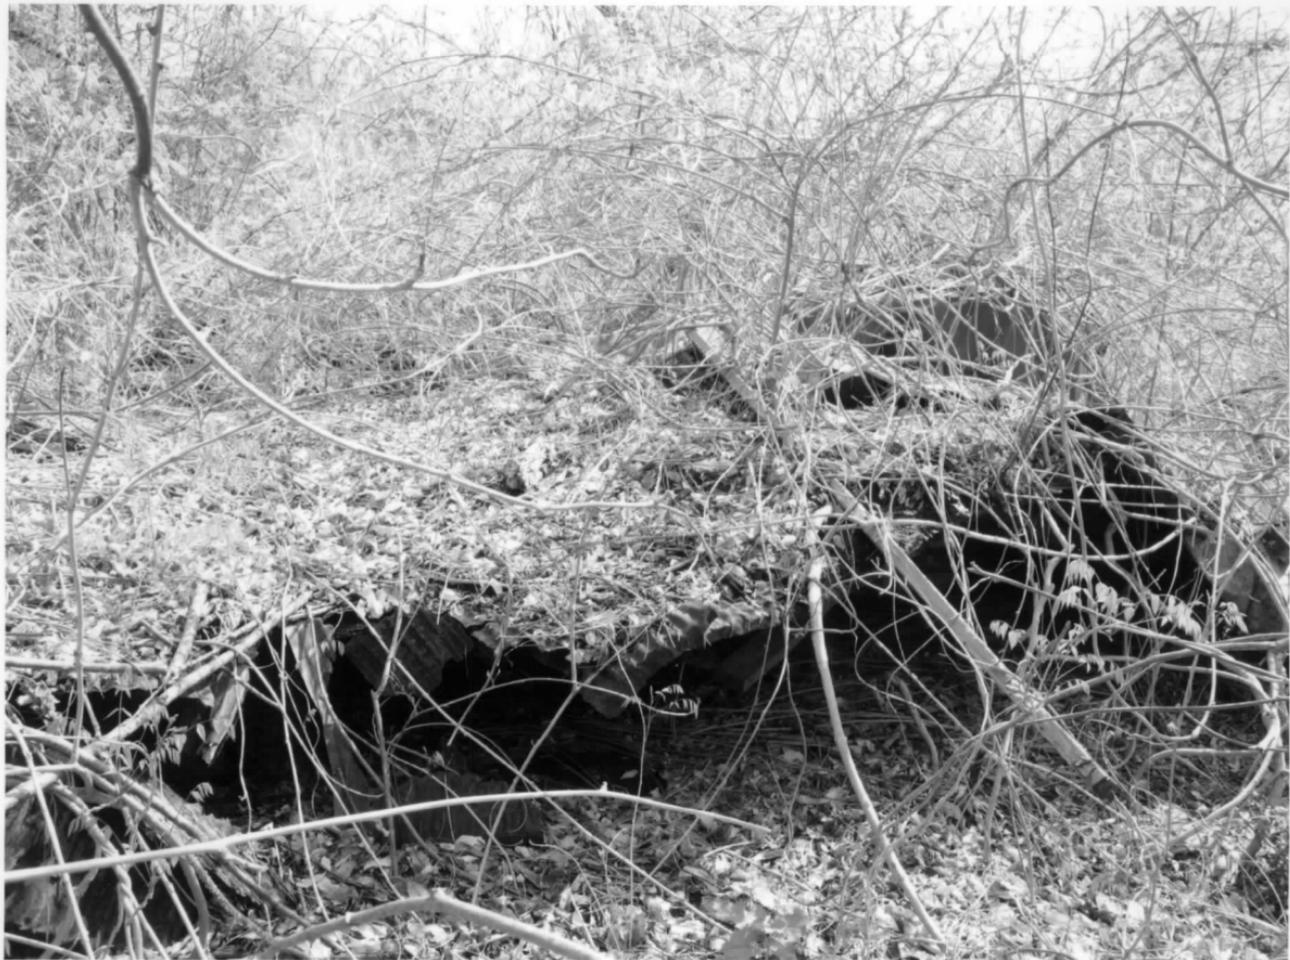
14 OF 14

COLLAPSED BUILDING 2, WORKING 14
