Rippin Property

MIHP # F-5-169

West Side of Linganore Road at Gas House Pike

## Maryland Inventory of Historic Properties Form

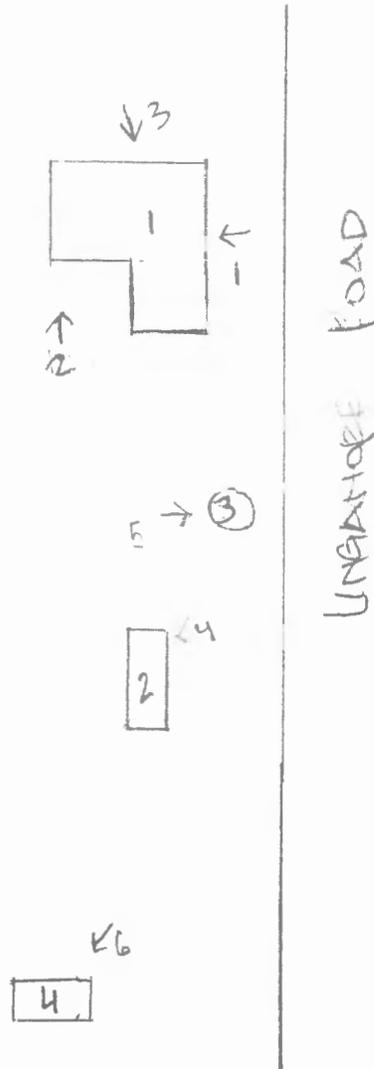
1. DWELLING
2. CHICKEN COOP
3. RUIN
4. COLLAPSED OUTBUILDING

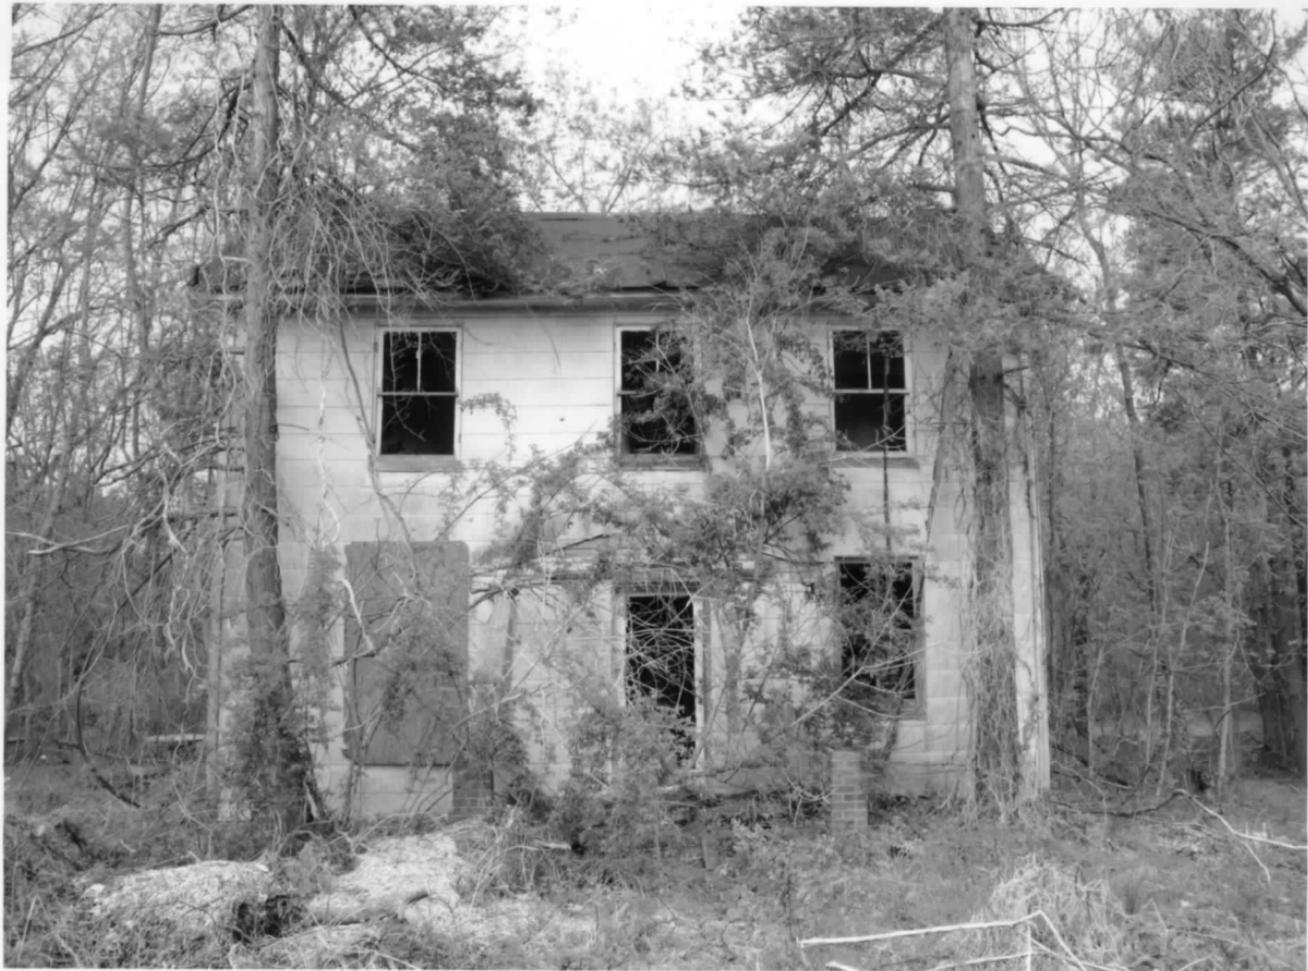
1 of 8

The two-story, wood-frame dwelling with integral ell faces east. The building rests on a stone foundation and terminates in a side-gable roof sheathed in corrugated-metal panels. Three chimneys pierce the roof. One chimney is located at the north and south gable ends of the principal block and one chimney is located at the gable end of the ell's west elevation. Cladding materials are asbestos shingles over lap siding. Windows are two-over-two-light, double-hung, wood-sash units; most windows are missing the bottom sash. In some cases, both the top and bottom sash are missing altogether. The remains of a porch are visible on the east (front) elevation.

The main entrance is centered on the east elevation. The door is no longer extant. Brick piers and wood flooring remain on the porch. Visual observation suggests the piers were constructed during the late twentieth century. Window openings flank the entrance; the south opening is covered in plywood, the north opening is uncovered. The three second-floor windows retain their upper sash. The one bay south elevation features one window at each the first and second floors. The first floor window retains its sash; however, the sash at the second floor no longer is extant. A window also is located in the gable end; the sash is not extant. The north elevation of the principal block is similar to the south elevation; however, all windows retain their sash. The west elevation is blind. Poured-concrete steps located on the west elevation provide access to the basement. A well with a poured-concrete cap is located at the southwest corner of the dwelling's principal block.

DWELLING, EAST ELEVATION

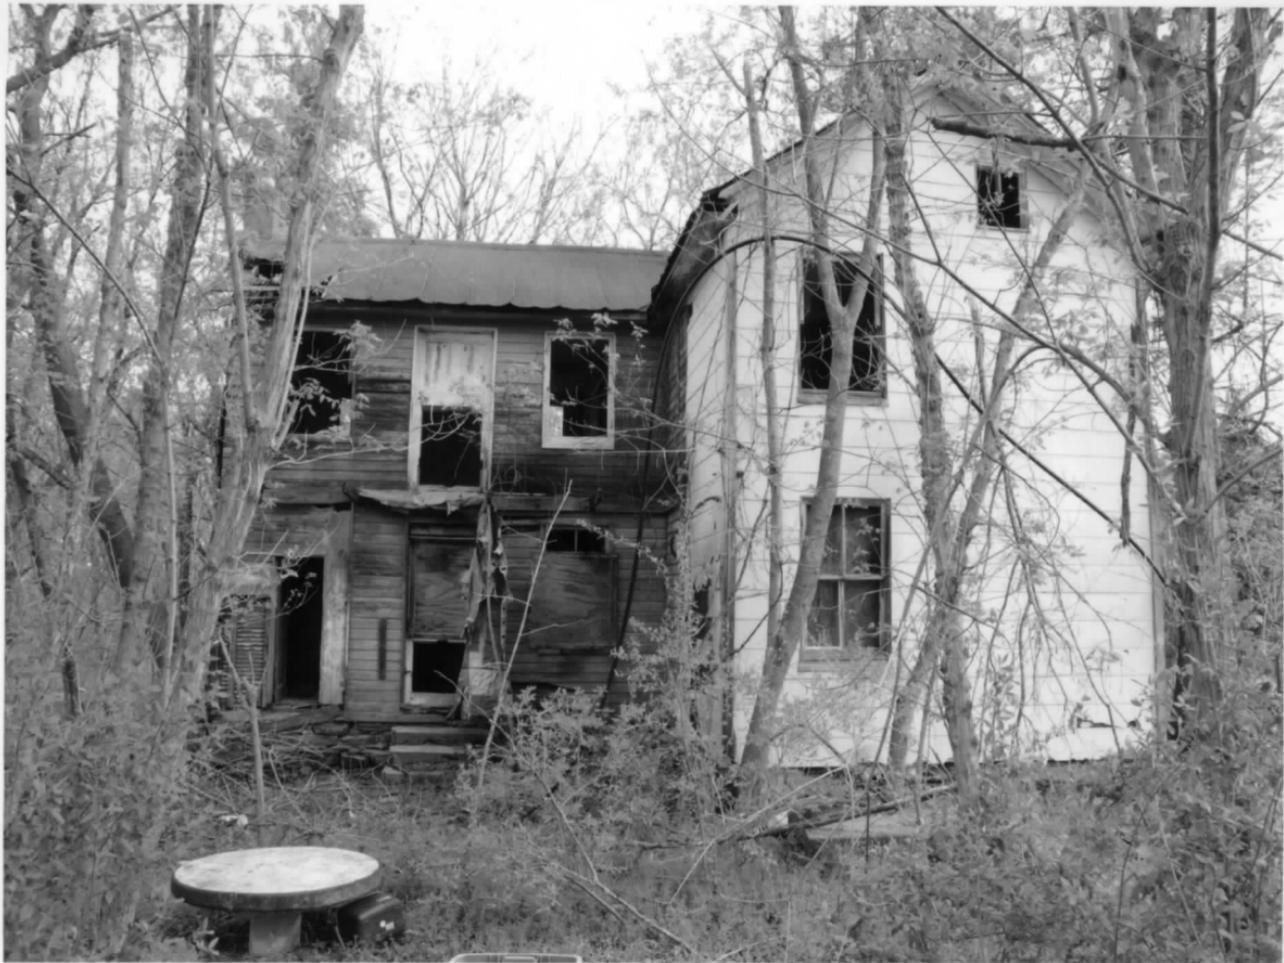
2 of 8

All windows on the integral ell are similar to those found on the principal block. The ell's north elevation is two bays whereas the south elevation is three. Door openings are centered on the south elevation at the first and second floors. None of the second floor window sash remain intact. The remains of a two-story porch are evident on the ell's south elevation. An exterior concrete-block chimney and a window in the gable-end define the west elevation of the ell.

DWELLING, SOUTH ELEVATION

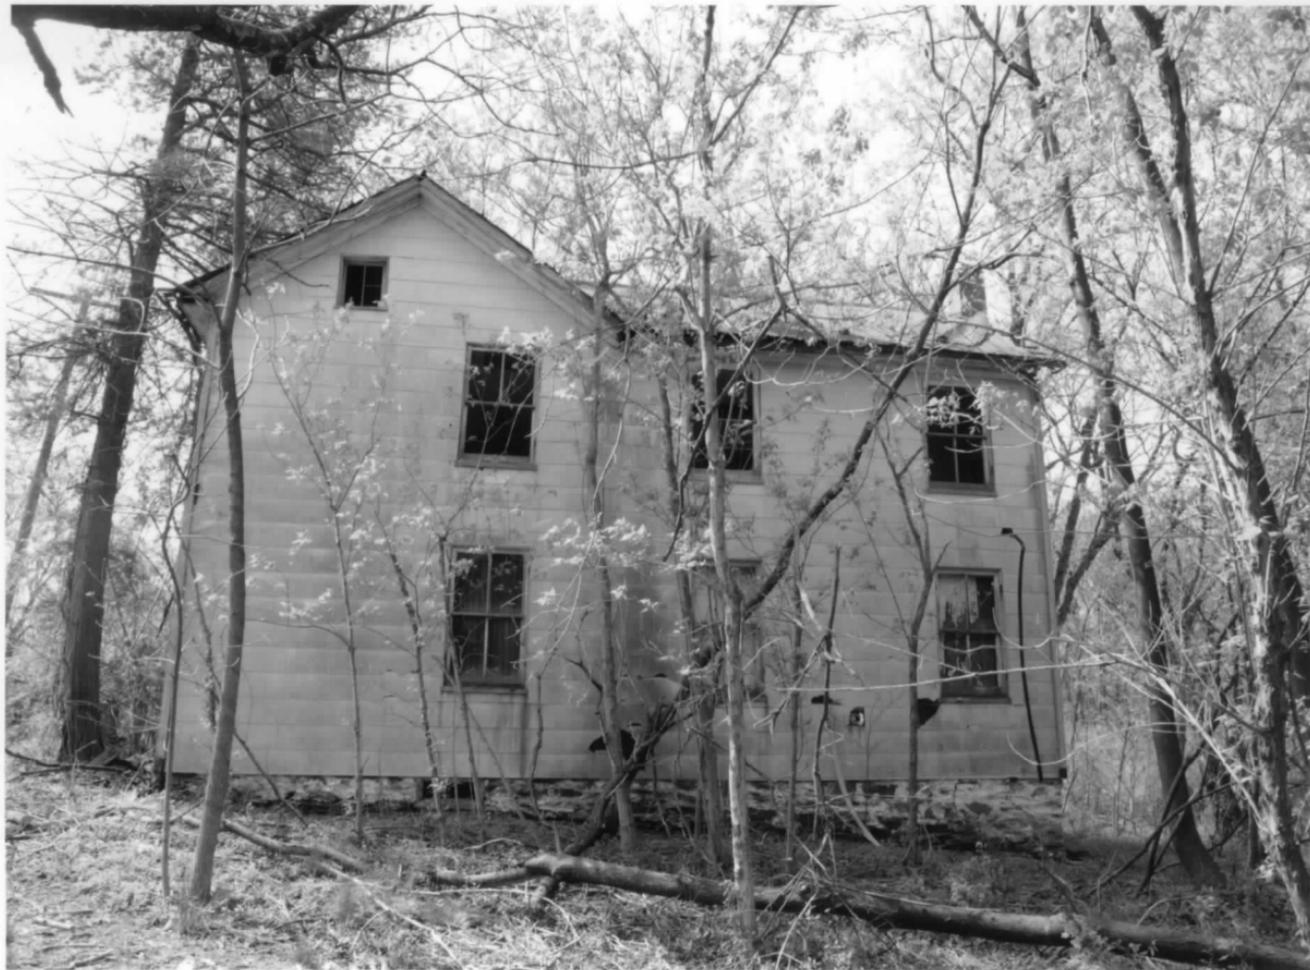
3 of 8

DWELLING, NORTH ELEVATION

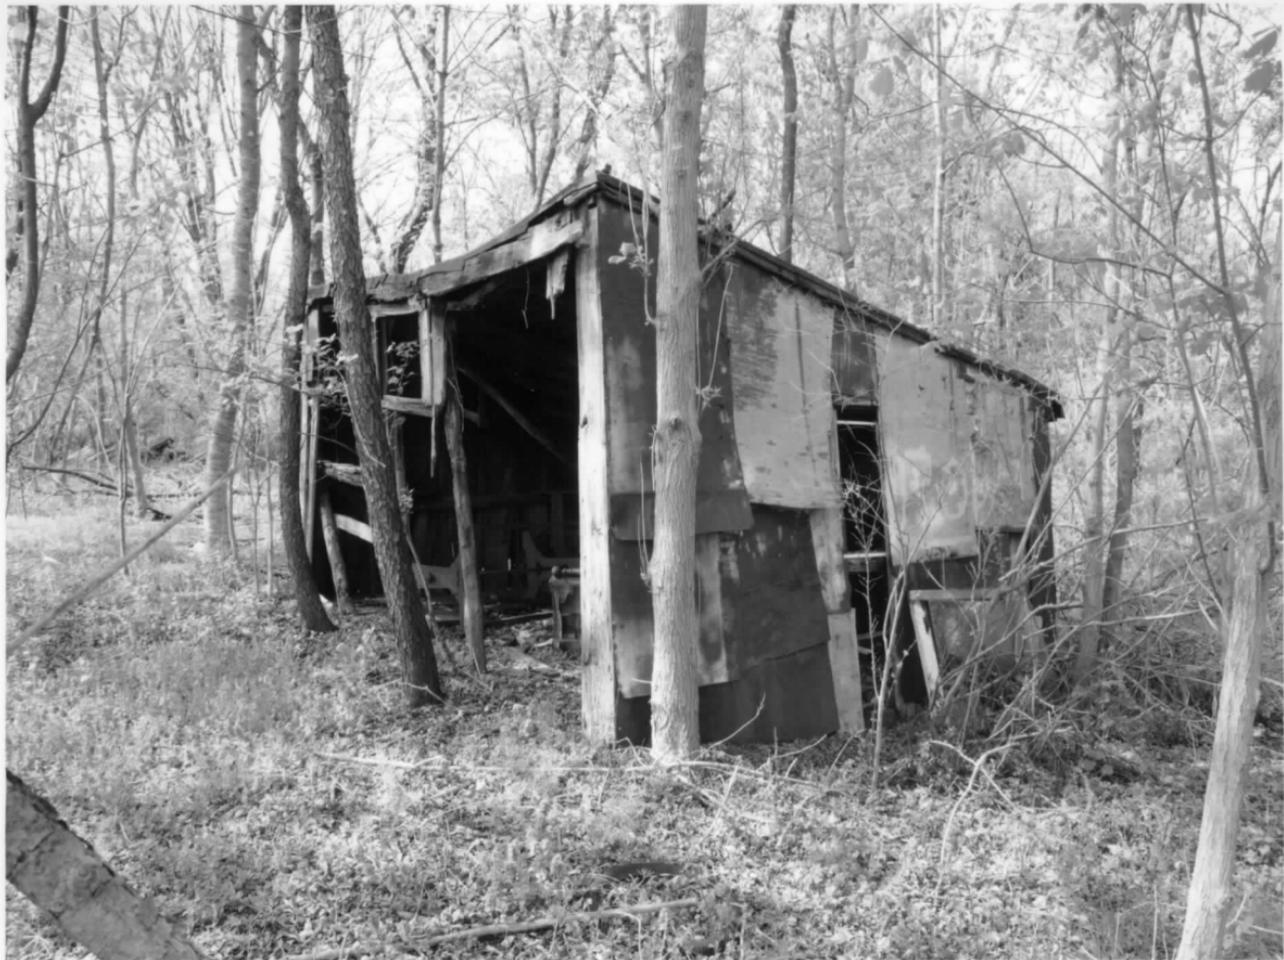
4 of 8

A wood-frame chicken coop, which is located south of the dwelling, is clad in corrugated-metal and metal panels. The building faces east, occupies a rectangular footprint, and terminates in a shed roof sheathed in corrugated metal.

CHUCKEN COOP, LOCKING SOUTHWEST

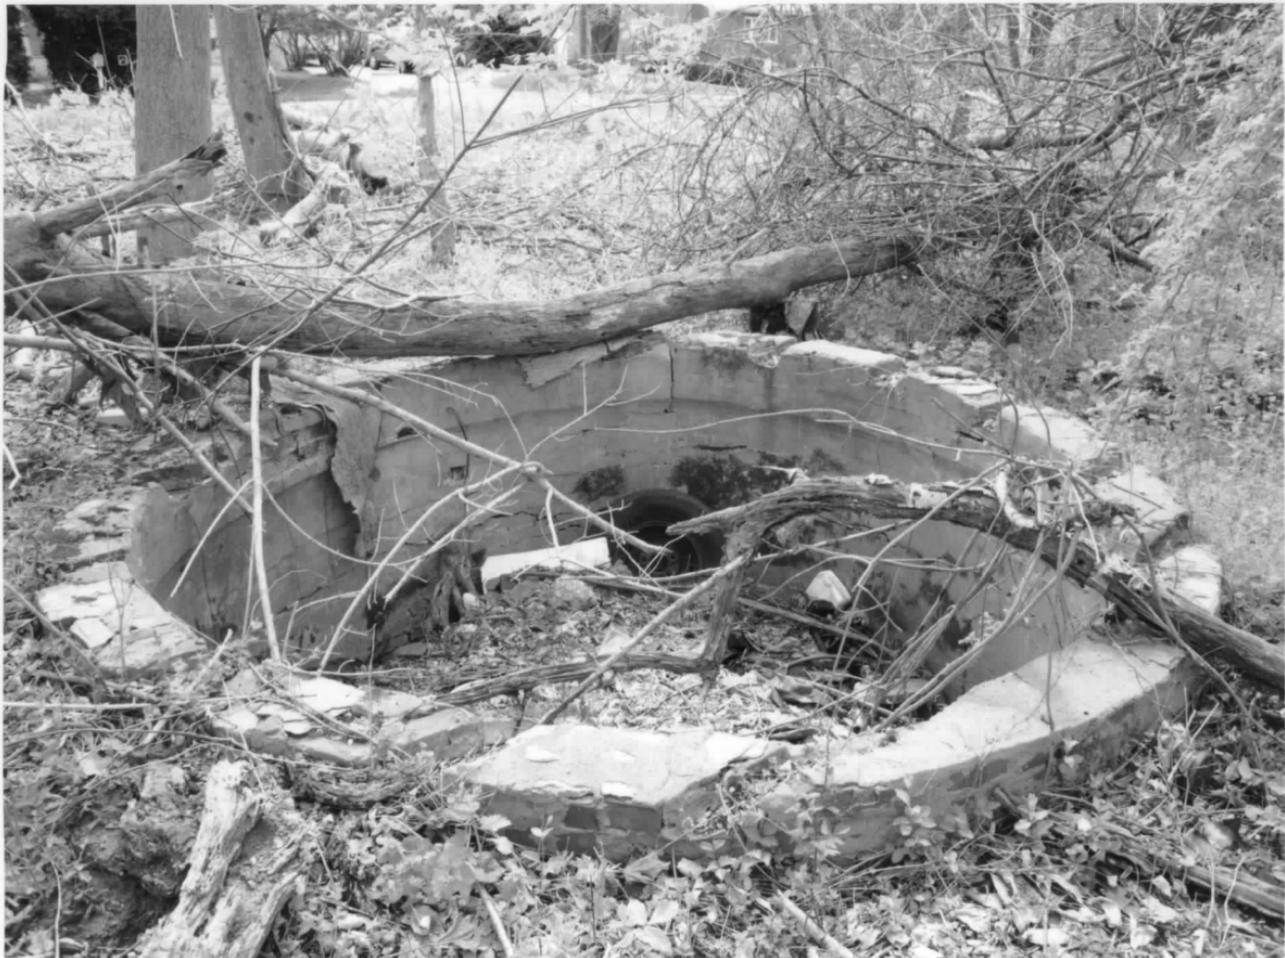
5 of 8

The remains of a brick and concrete built resource are located south of the chicken coop and adjacent to Linganore Road. The resource occupies a circular footprint. The original use of the resource is unknown.

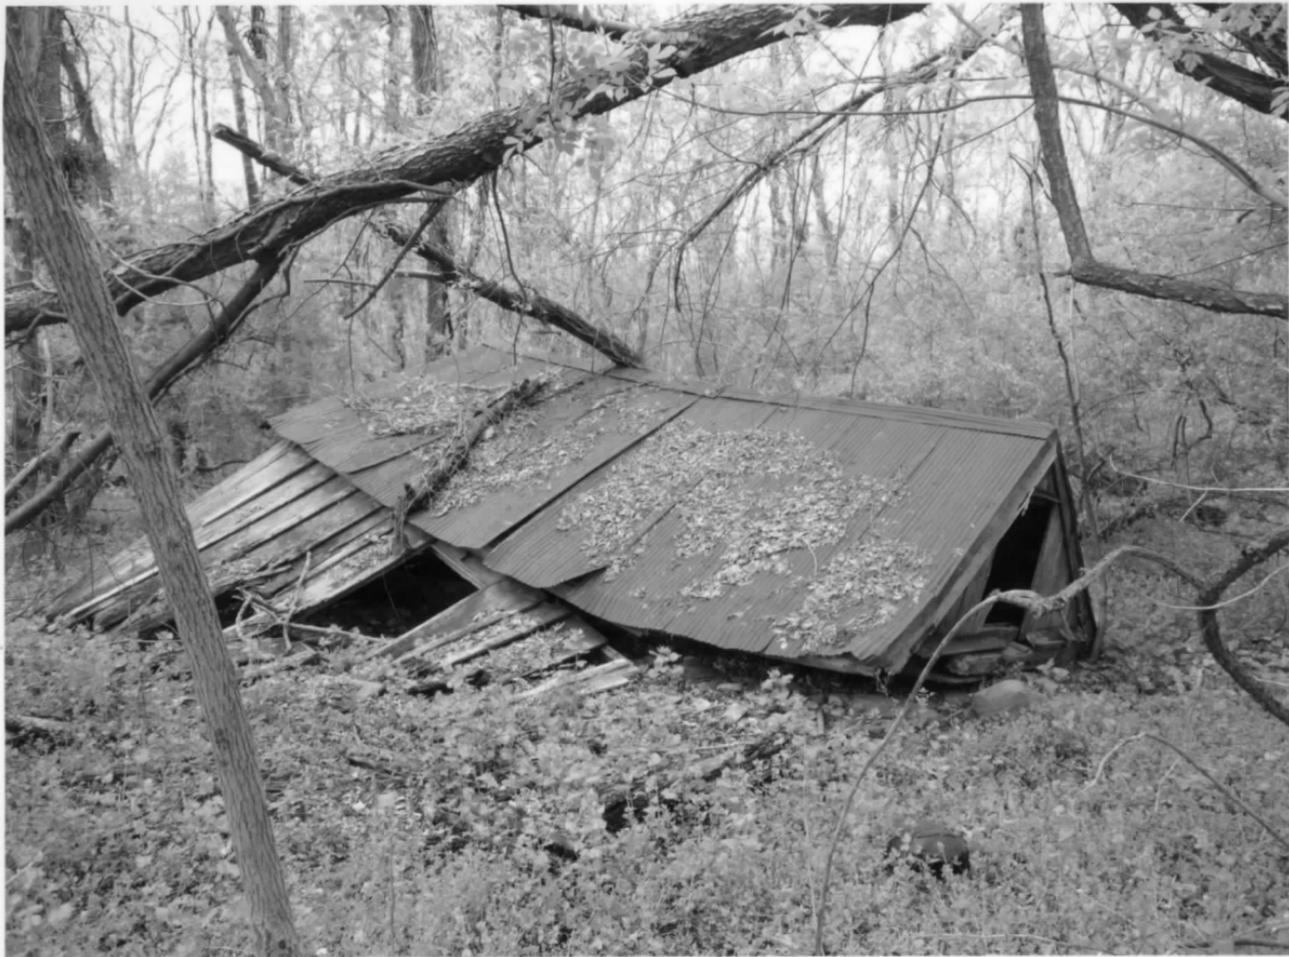
A collapsed building is located south of the chicken coop. The wood-frame building is clad in board-and-batten siding. The building occupies a rectangular footprint and terminates in a front-gable roof sheathed in corrugated metal. One opening is located on each the north and east elevations. The building type and use is unknown.

HU STAD  
UNAPPROVED BANDS, LOOKING SOUTHWEST  
6 of 8

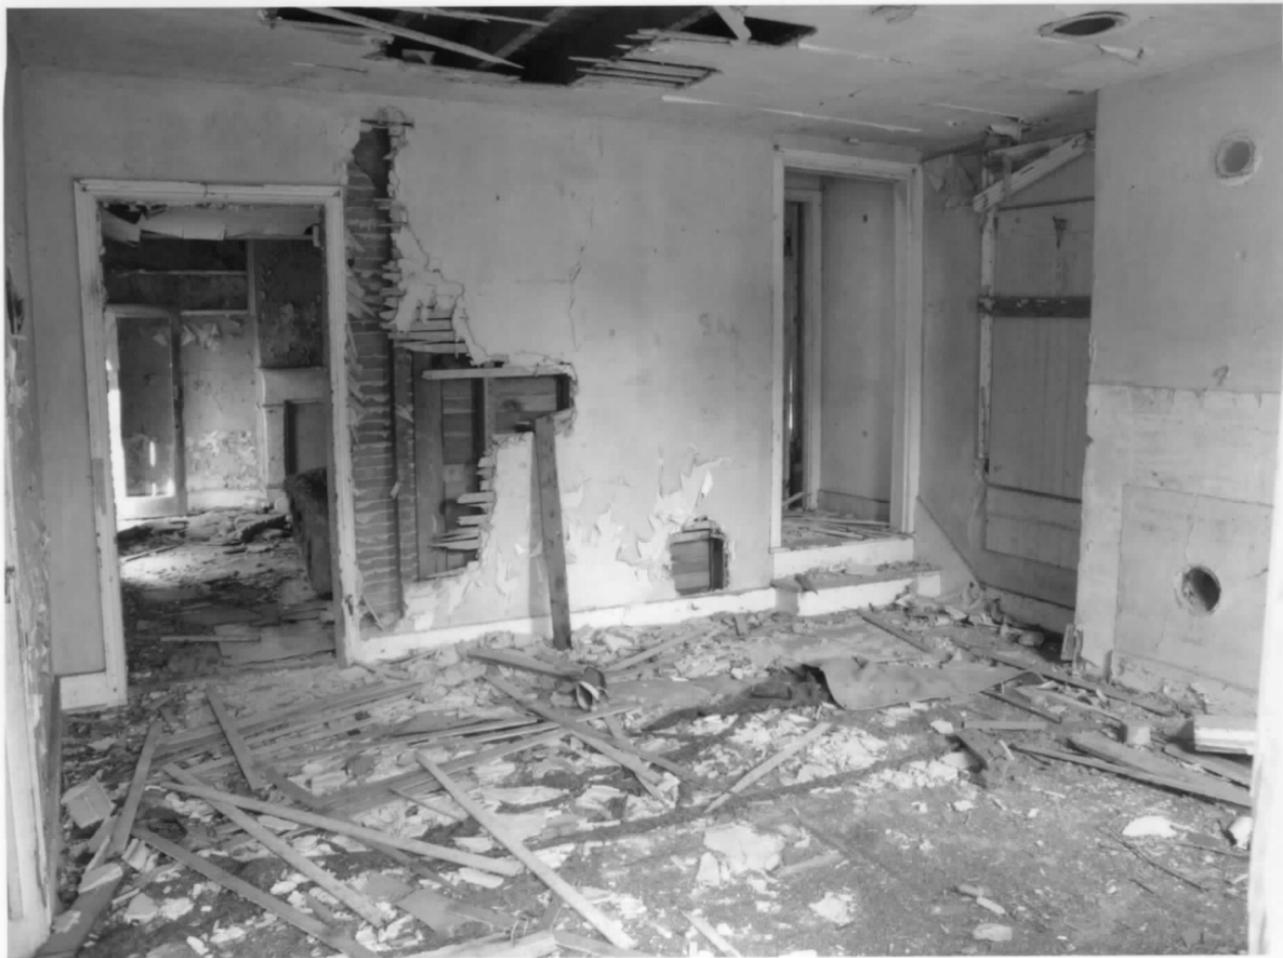
The dwelling has three rooms on the first and second floors. A mantel is present on the wall breast for the fireplace located in the ell. A straight-run, enclosed stair provides access to the second floor.

MUD # F-5-169  
RIPPIN PROPERTY  
FREDERICK COUNTY MD  
RCA  
APRIL 2015  
MD SHPO  
SWELLING INTERIOR FRONT PORCH  
7 of 8

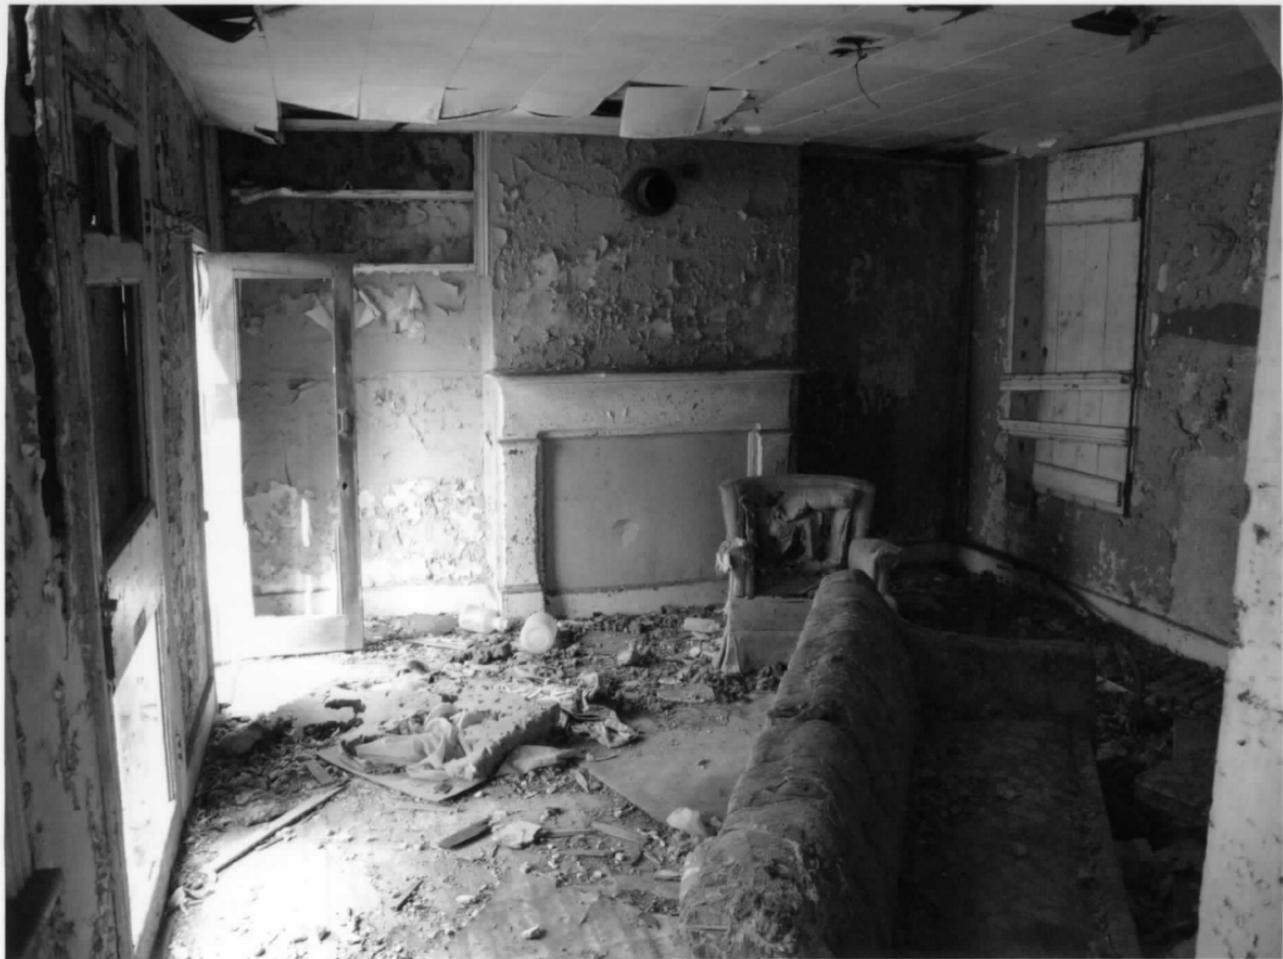
8 of 8

DWELLING INTERIOR, DINING ROOM
