Storms-Rippon Farm Dwelling
MIHP # F-5-170
10801 Gas House Pike
Mount Airy
Ca. 1871
Private

Maryland Inventory of Historic Properties Form

Inventory No. F-5-170

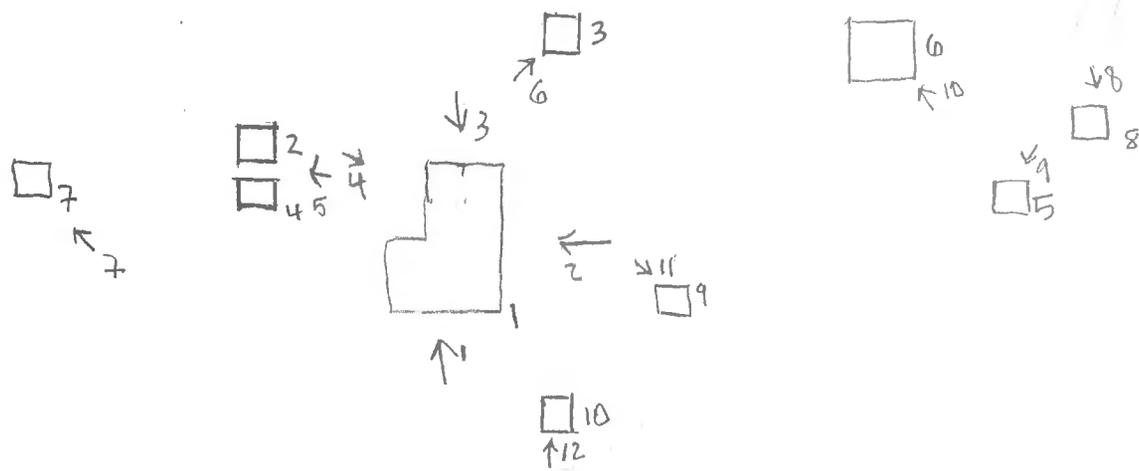
MHP # F-5-170
STORMS- RIPPON FARM
10801 GAS HOUSE PIKE
MOUNT AIRY
FREDERICK COUNTY, MD

- 1. DWELLING
- 2. PRIVY
- 3. CHICKEN COOP
- 4. OUT BUILDING
- 5. WOOD-FRAME BUILDING
- 6. WOOD-FRAME ANIMAL SHELTER
- 7. COLLAPSED BUILDING 1
- 8. COLLAPSED BUILDING 2
- 9. COLLAPSED BUILDING 3
- 10. COLLAPSED BUILDING 4

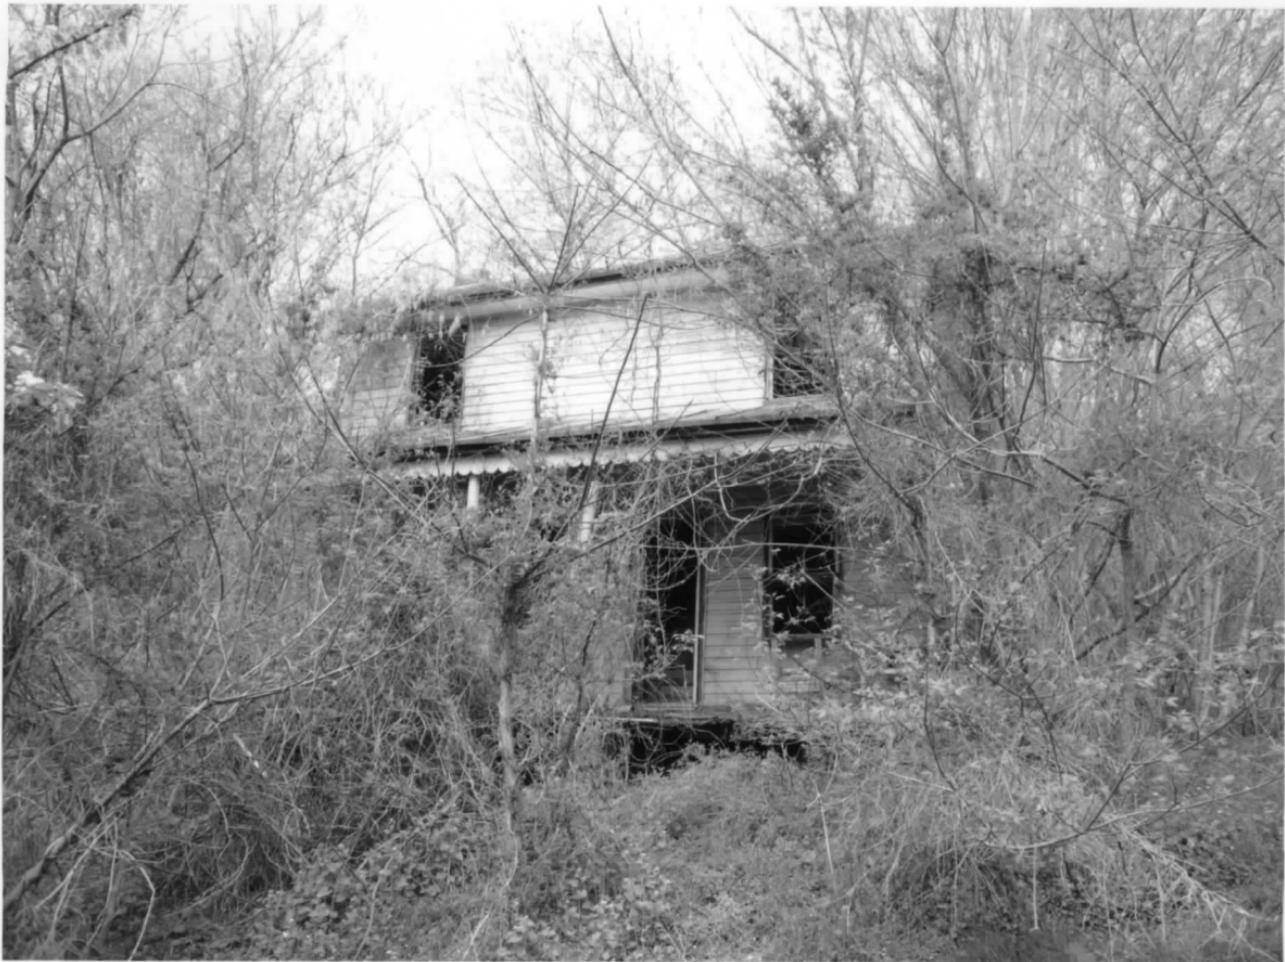
1 OF 14

The south elevation of the principal block houses the primary entrance centered in the elevation.. Overgrown vegetation obscures most of the first floor. Second-floor sash no longer are extant.

DWELLING, SOUTH ELEVATION

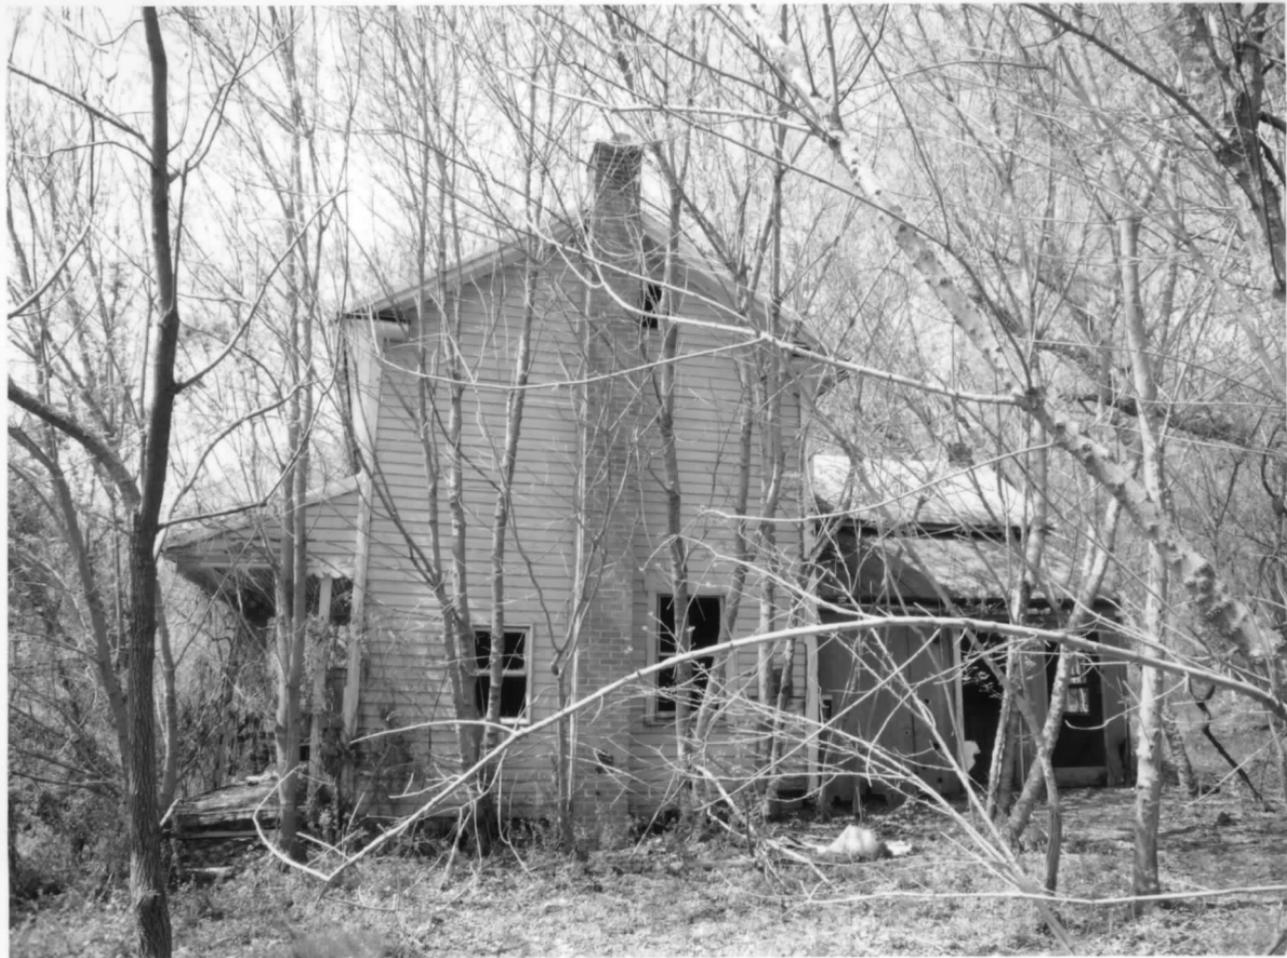
2 OF 14

MD SHAD
DWELLING, EAST ELEVATION

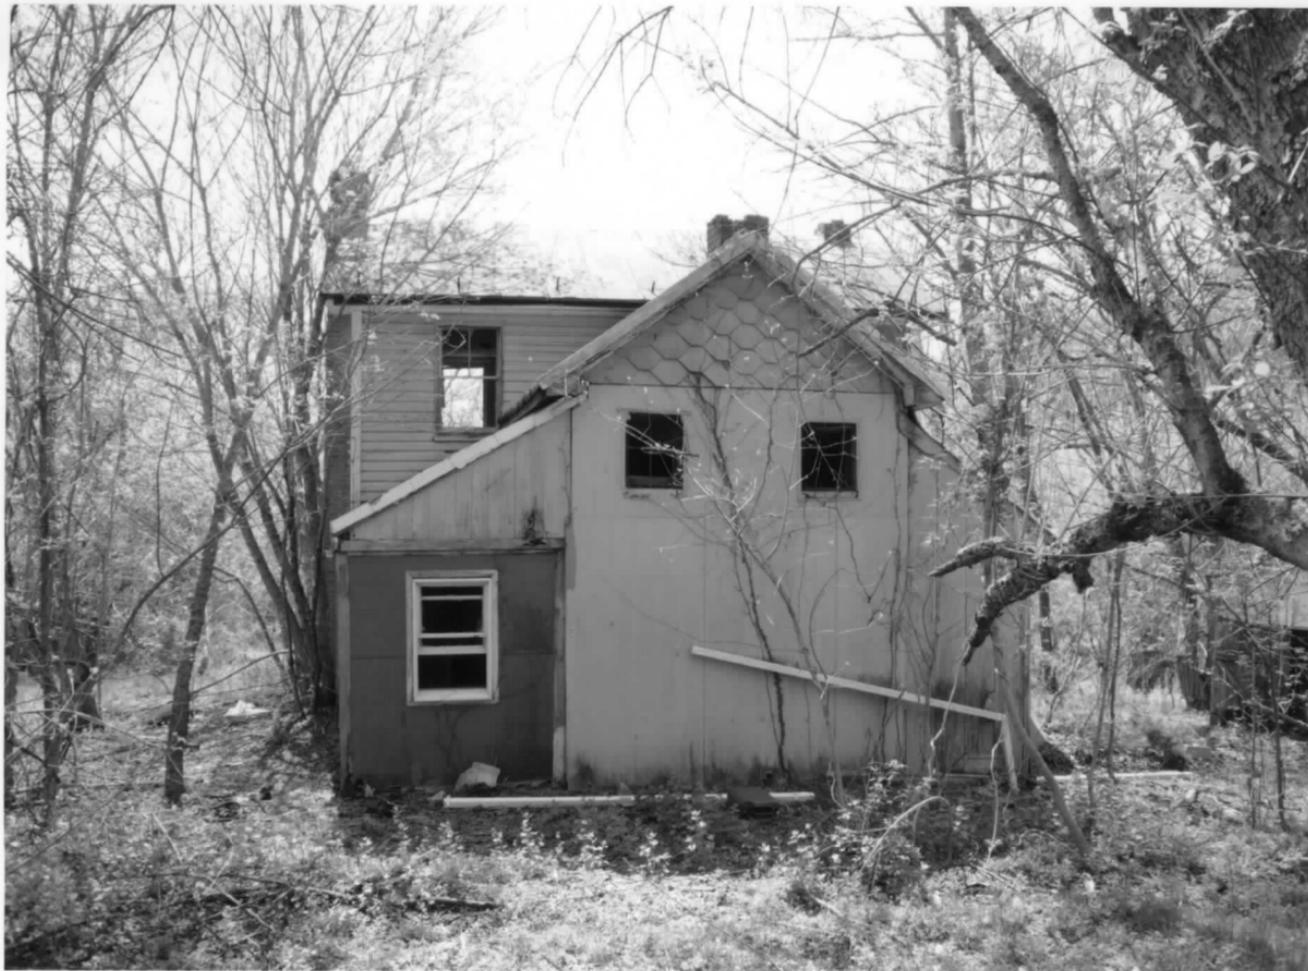
3 of 14

A lower-scale, two-story frame kitchen addition was appended to the rear, north elevation of the principal block. Both the principal block and ell are supported by stone foundations. The kitchen addition was expanded through east and west shed additions.

DWELLING, NORTH ELEVATION

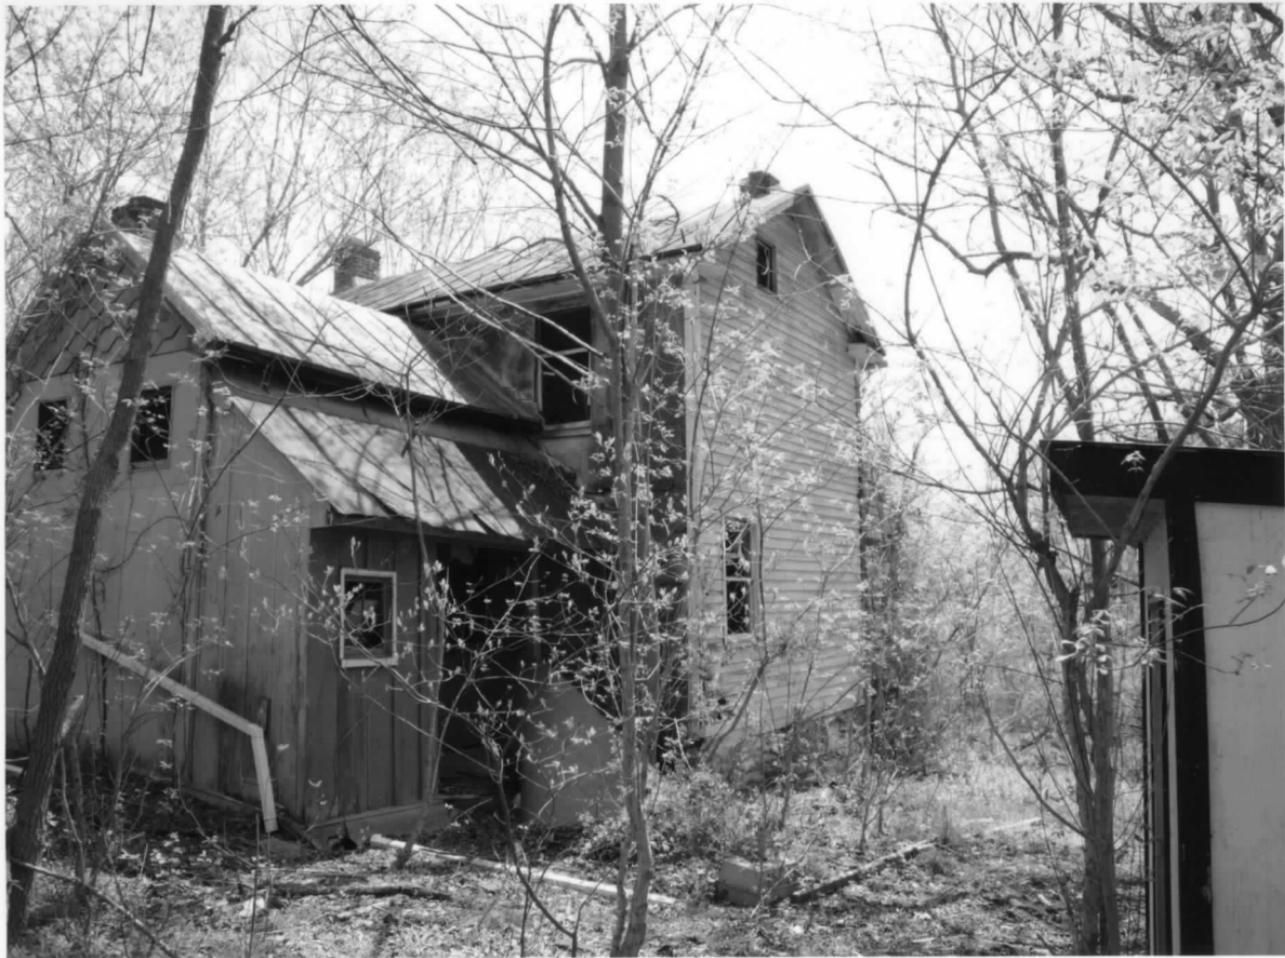
MHP # F-5-170
STORMS RIFTON FARM
FREDERICK COUNTY, MD
RCA
APRIL 2015
MD SHPO
DWELLING, WEST ELEVATION
4 of 14

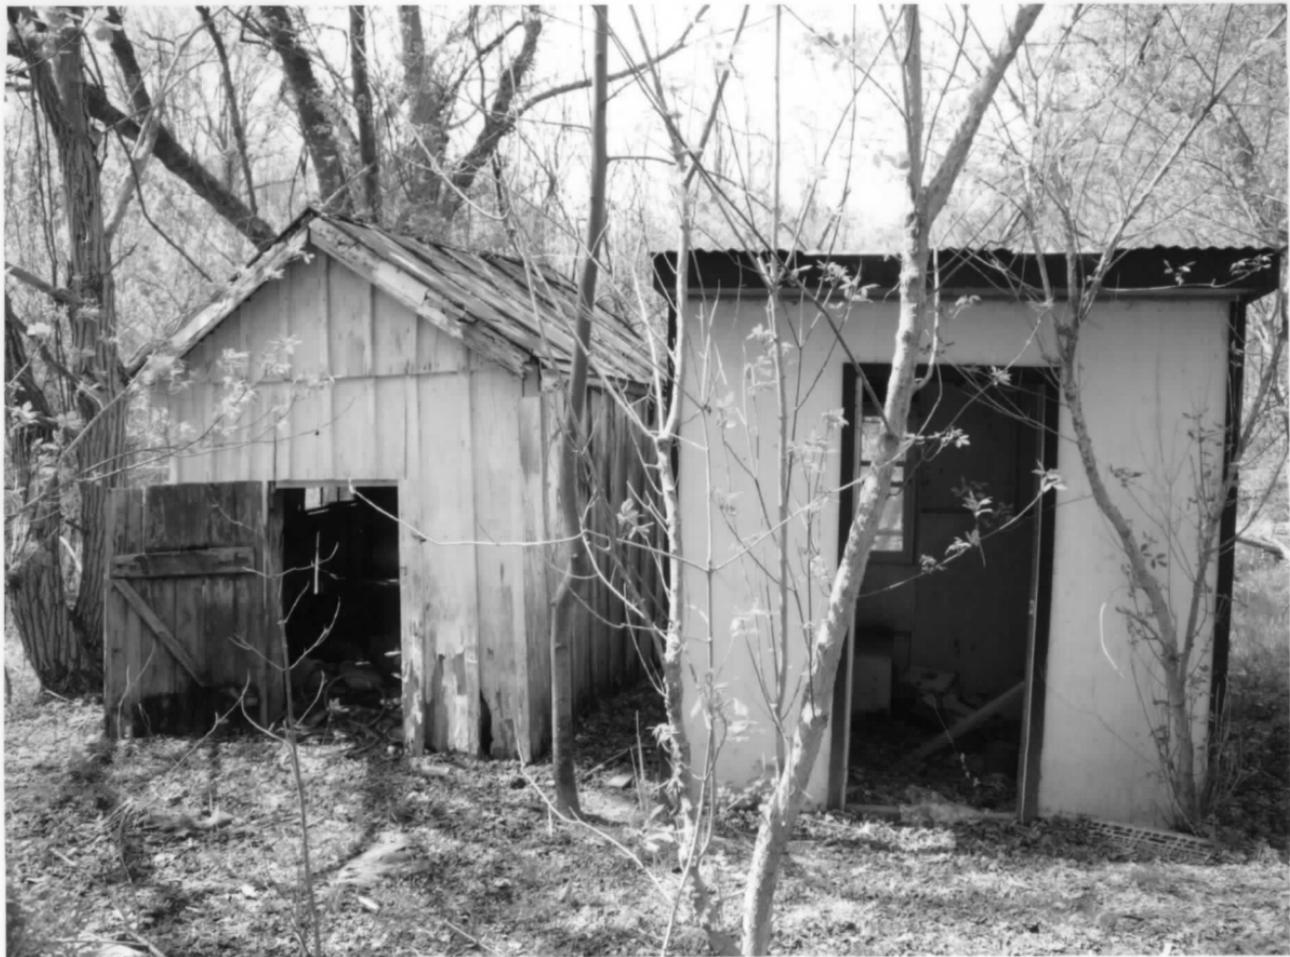
5 8 14

A wood-frame, single-story privy clad in T1-11 wood siding is located west of the dwelling. The building terminates in a shed roof sheathed in corrugated plastic. The east elevation features the building's entrance; the door no longer is extant. A one-over-one-light vinyl-sash window is found on the west elevation. The north and south elevations are blind.

A single-story, wood-frame outbuilding clad in board-and-batten siding is sited adjacent to the privy. The building terminates in a front-gable roof sheathed in standing-seam metal. Openings consist of a hinged, wood door on the east elevation and a six-light, fixed-sash window on the south elevation. The north elevation is blind.

PENY + OUTBUILDING, EAST ELEVATION

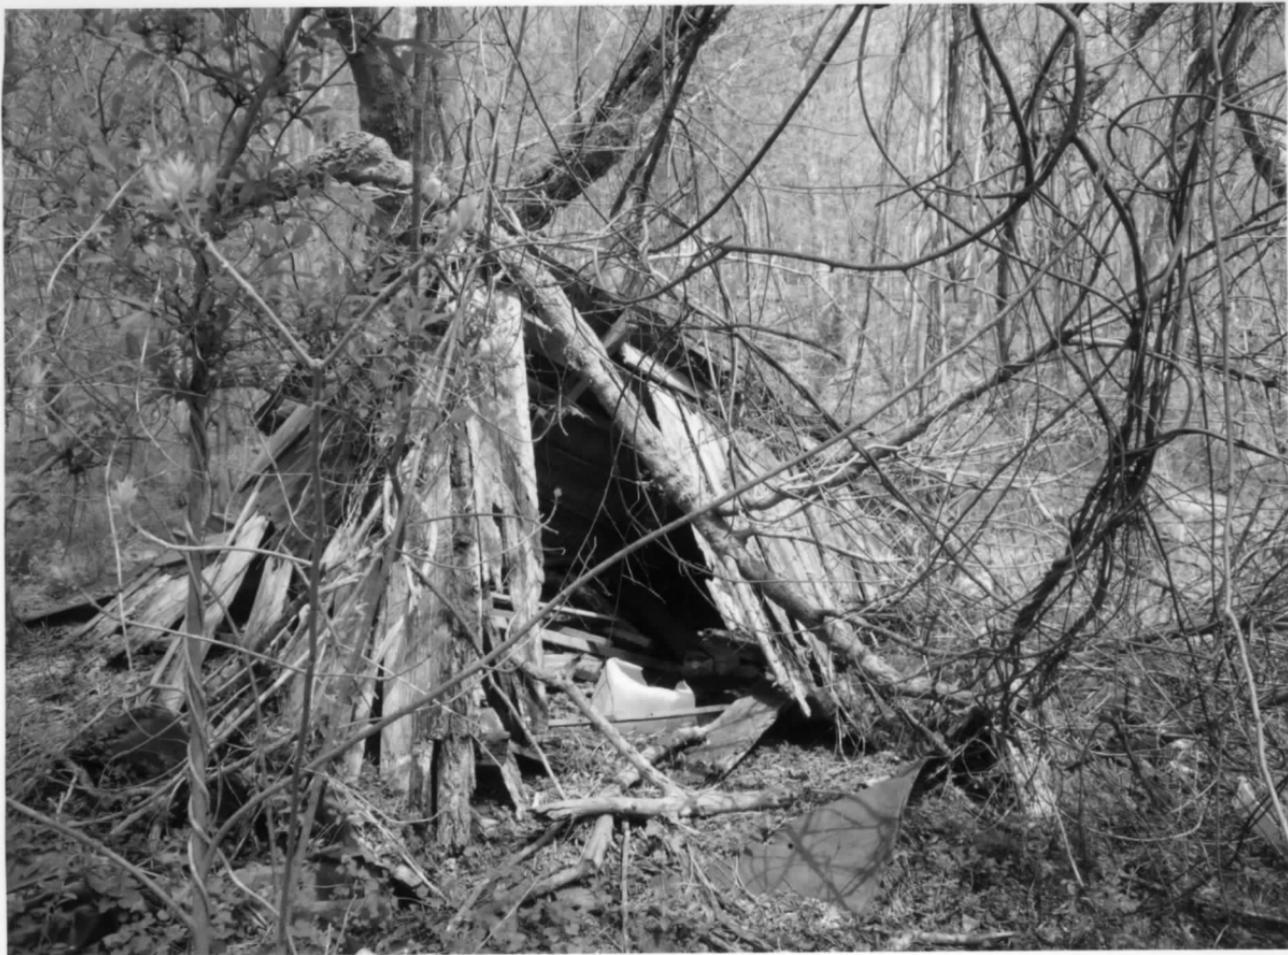
6 of 14

A partially collapsed chicken coop is found northwest of the dwelling. The one-story, wood-frame building is clad in wood planks. Roofing materials are corrugated metal.

MWP # F-5-1A0
STORMY RIFTON FARM
FREDERICK COUNTY, MD
PCSA
APRIL 2015
MD SUPD
CHICKEN COOP, LOOKING NE

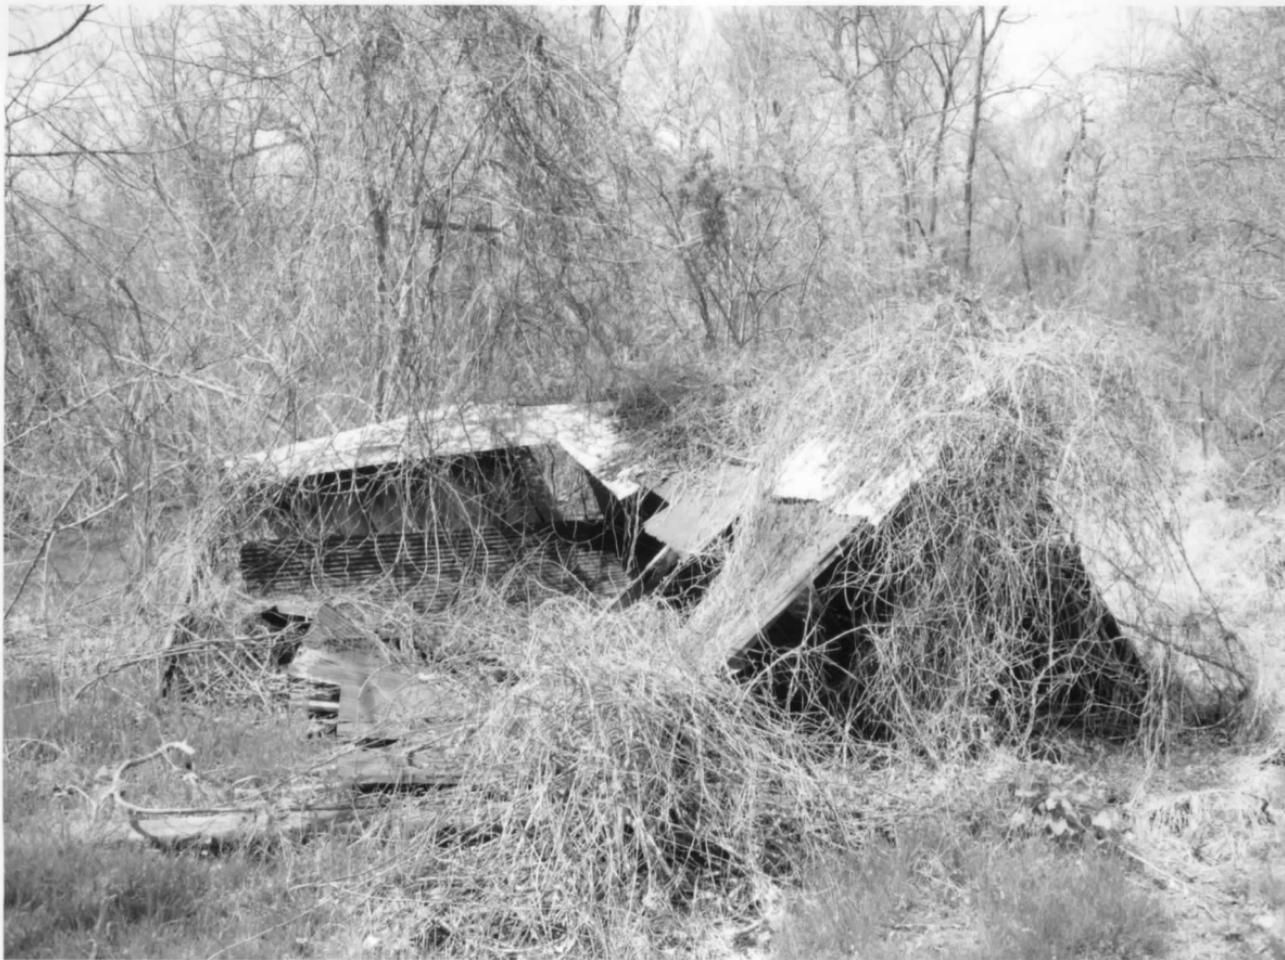
7 of 14

A corrugated-metal roof and plywood remain of a collapsed building located west of the dwelling.

MD SHPO
COLLAPSED BUILDING, LOOKING NW

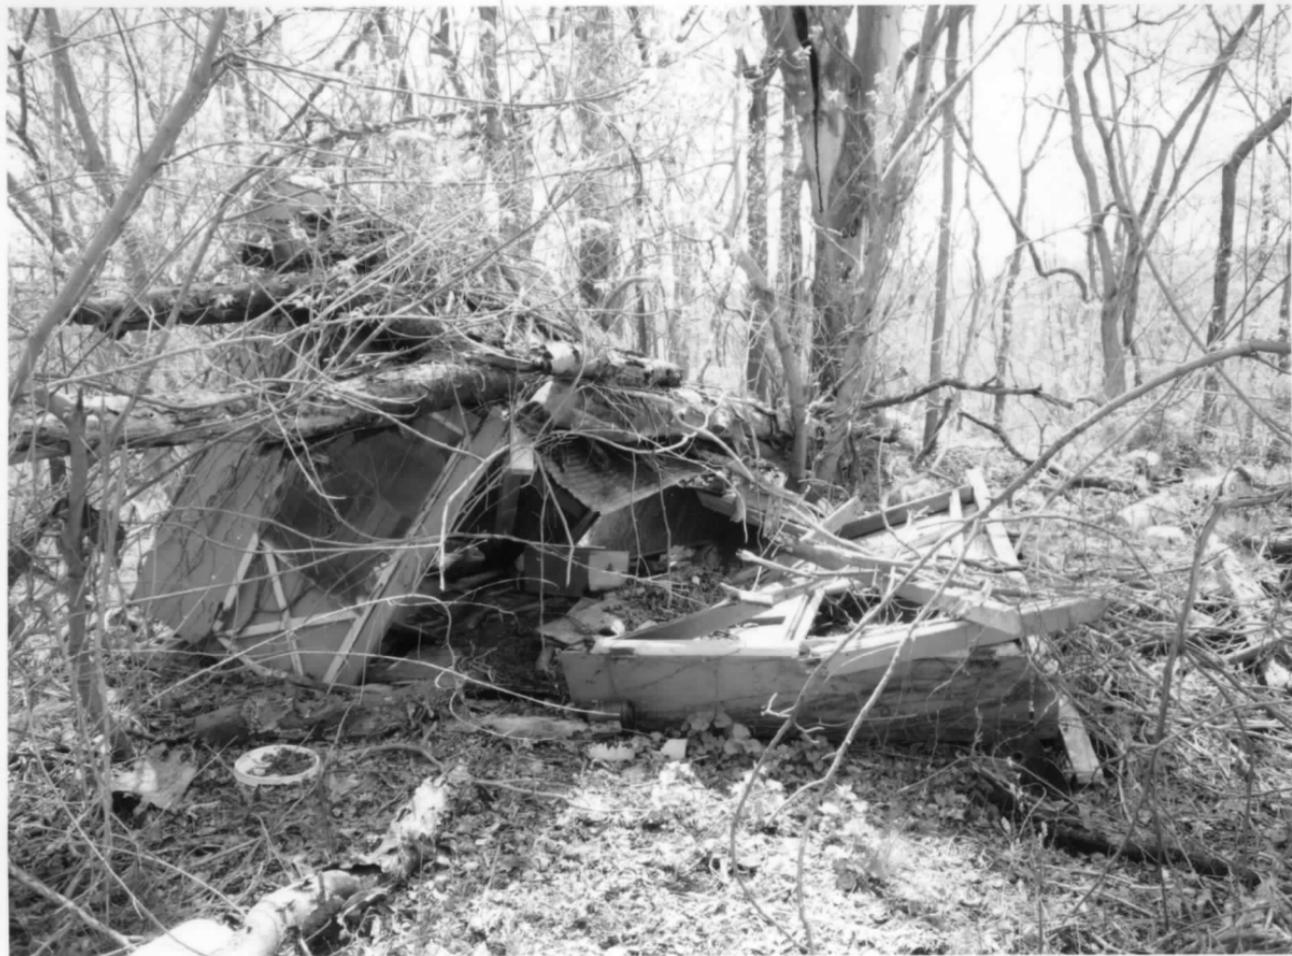
808 14

A wood-frame collapsed building is located on the east side of the access drive, northeast of the dwelling. Additional materials include corrugated metal panels. Visual observation suggests the building might have been a prefabricated shed.

APRIL 2015
COLLAPSED BUILDING 2, Looking SOUTH

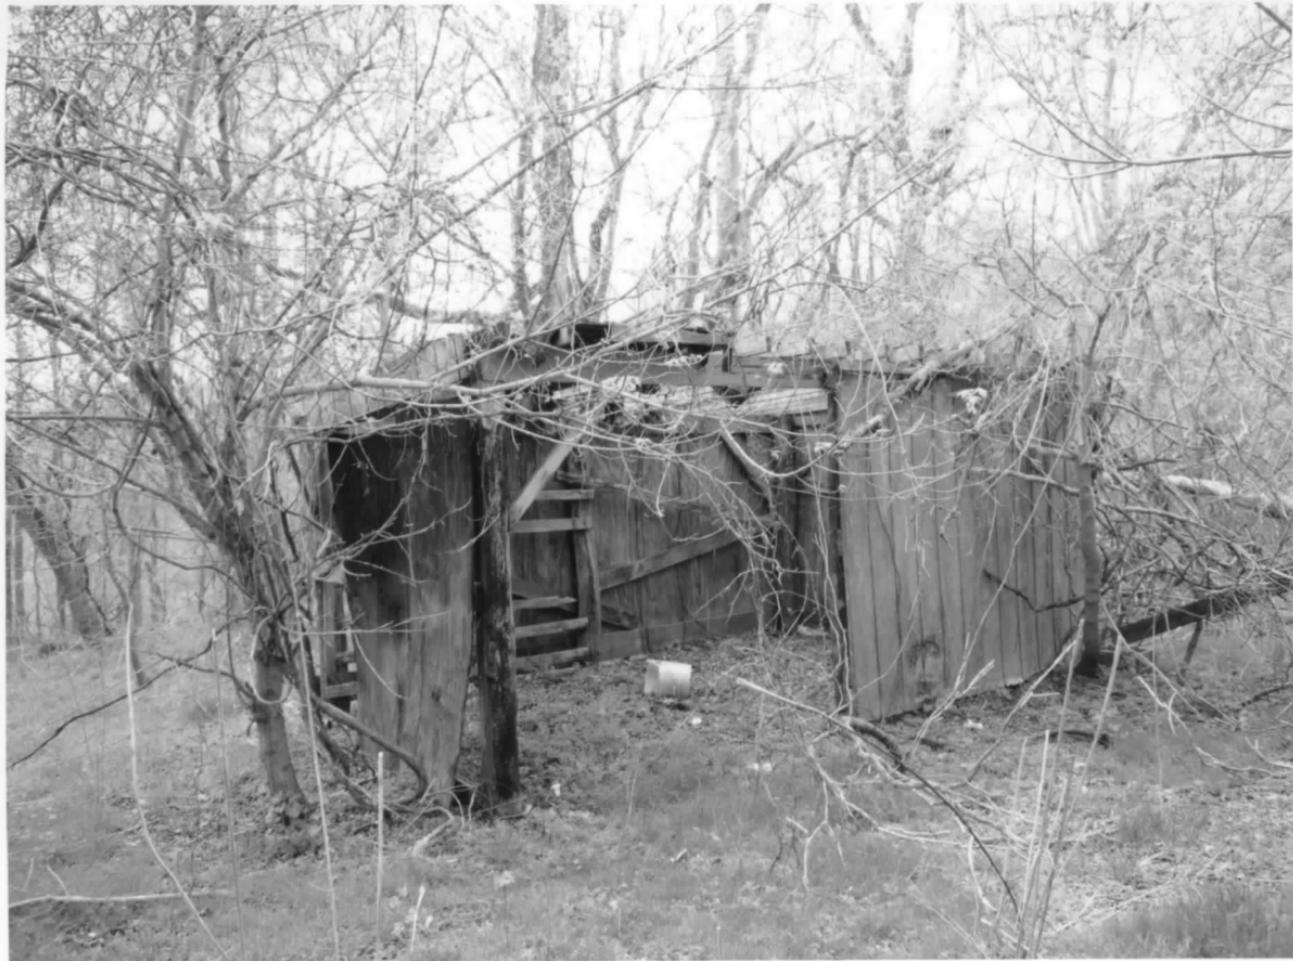
9 of 14

A single-story, semi-enclosed, wood-frame building clad in T1-11 wood siding is located south of the collapsed building. Plywood sheathing partially covers the roof. Visual observation suggests the building might have been used to shelter small animals.

WOOD FRAME BUILDING, LOOKING SW

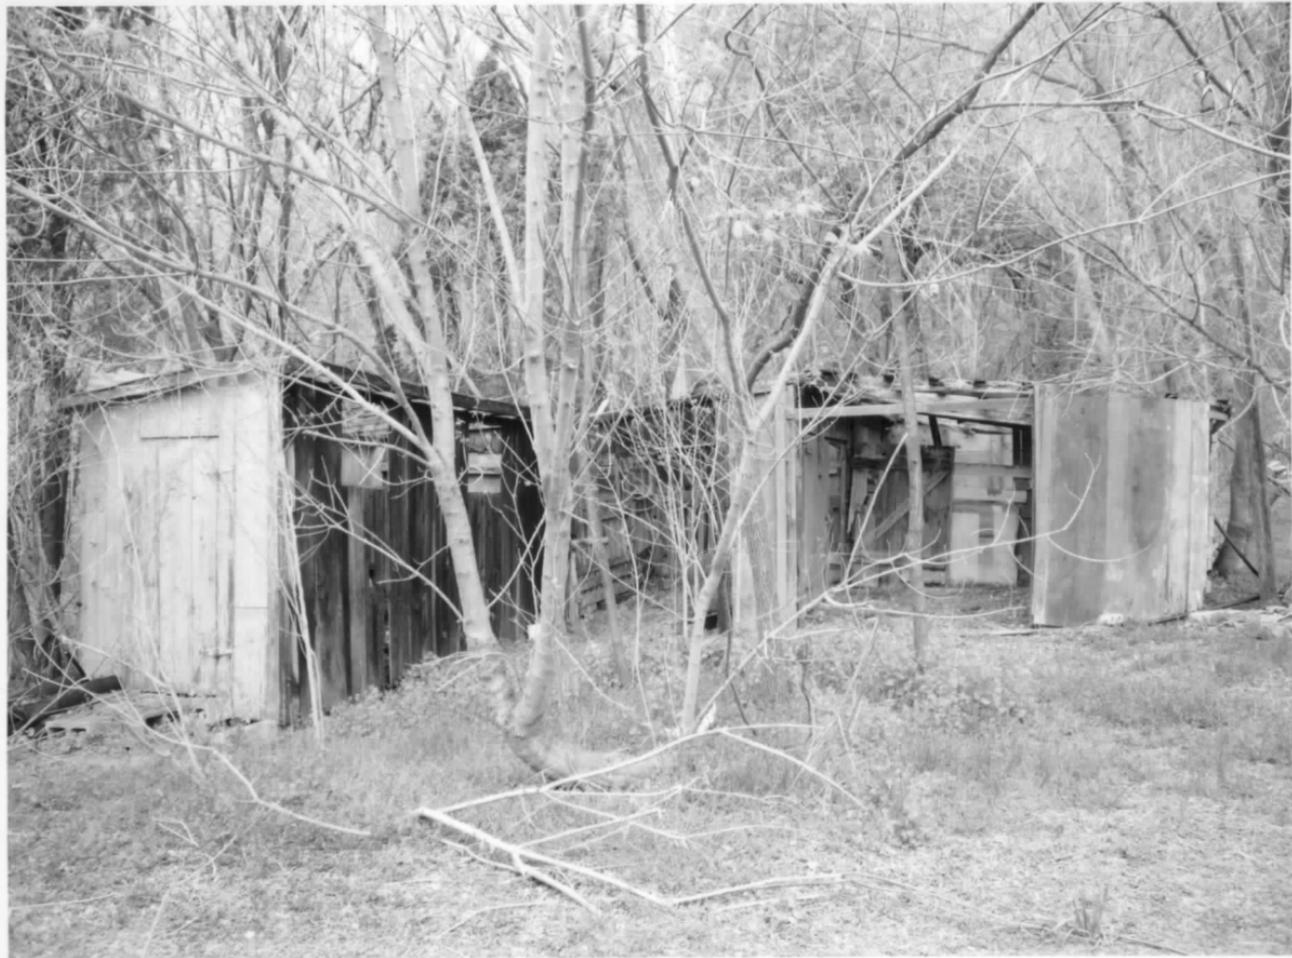
A single-story, wood-frame chicken coop is attached to a wood-frame stable. The building complex is located on the west side of the access drive, south of the collapsed building. The chicken coop is clad in wood planks and terminates in a shed roof sheathed in corrugated metal. The northeast corner of the building attaches to a wood-frame animal pen with stalls. Cladding materials are wood planks and corrugated metal and metal panels. The roof no longer is extant.

WOOD-FRAME ANIMAL SHELTERS, LOOKING W
10 of 14

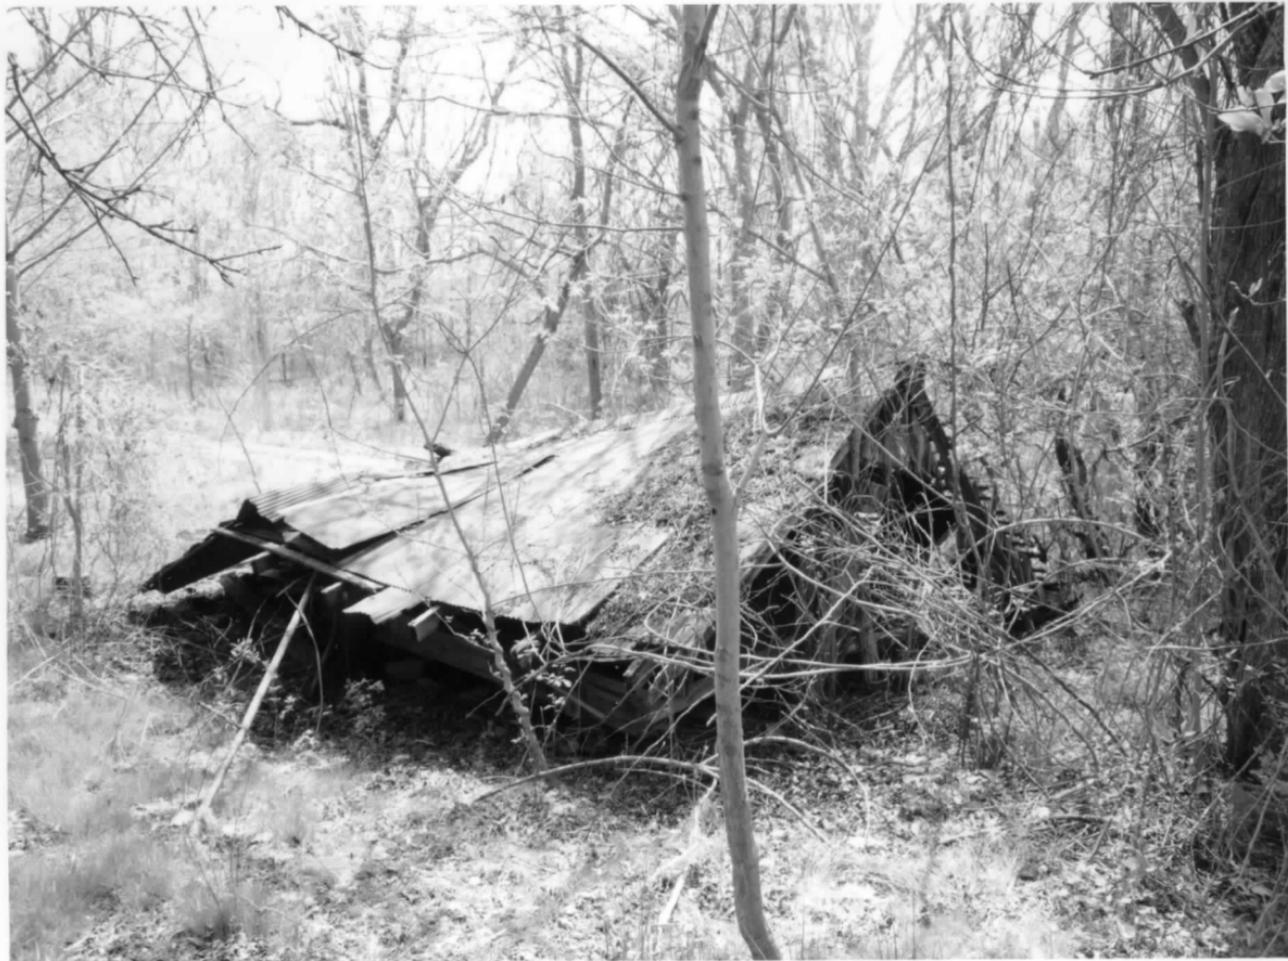
11 OF 14

A wood-frame, collapsed building with gable roof sheathed in corrugated metal is located south of the animal shelters. Type and use of building could not be determined.

COLLAPSED BUILDING 3, LOOKING SE

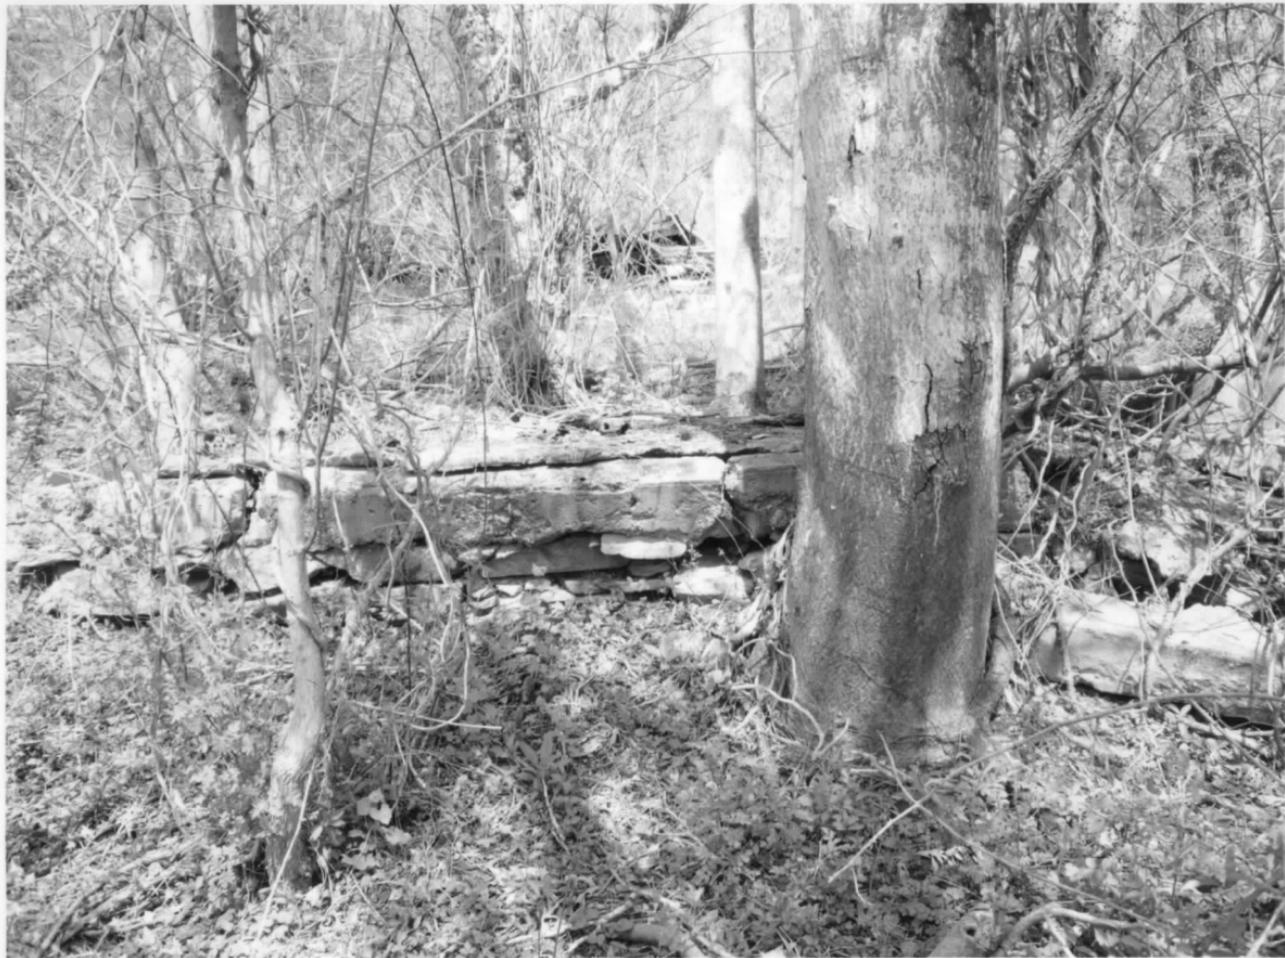
12 OF 14

The remains of a building are found southeast of the dwelling near the access road. Remains include a poured-concrete and stone foundation. Original building use could not be determined.

COLLAPSED BUILDING 4, LOOKING N

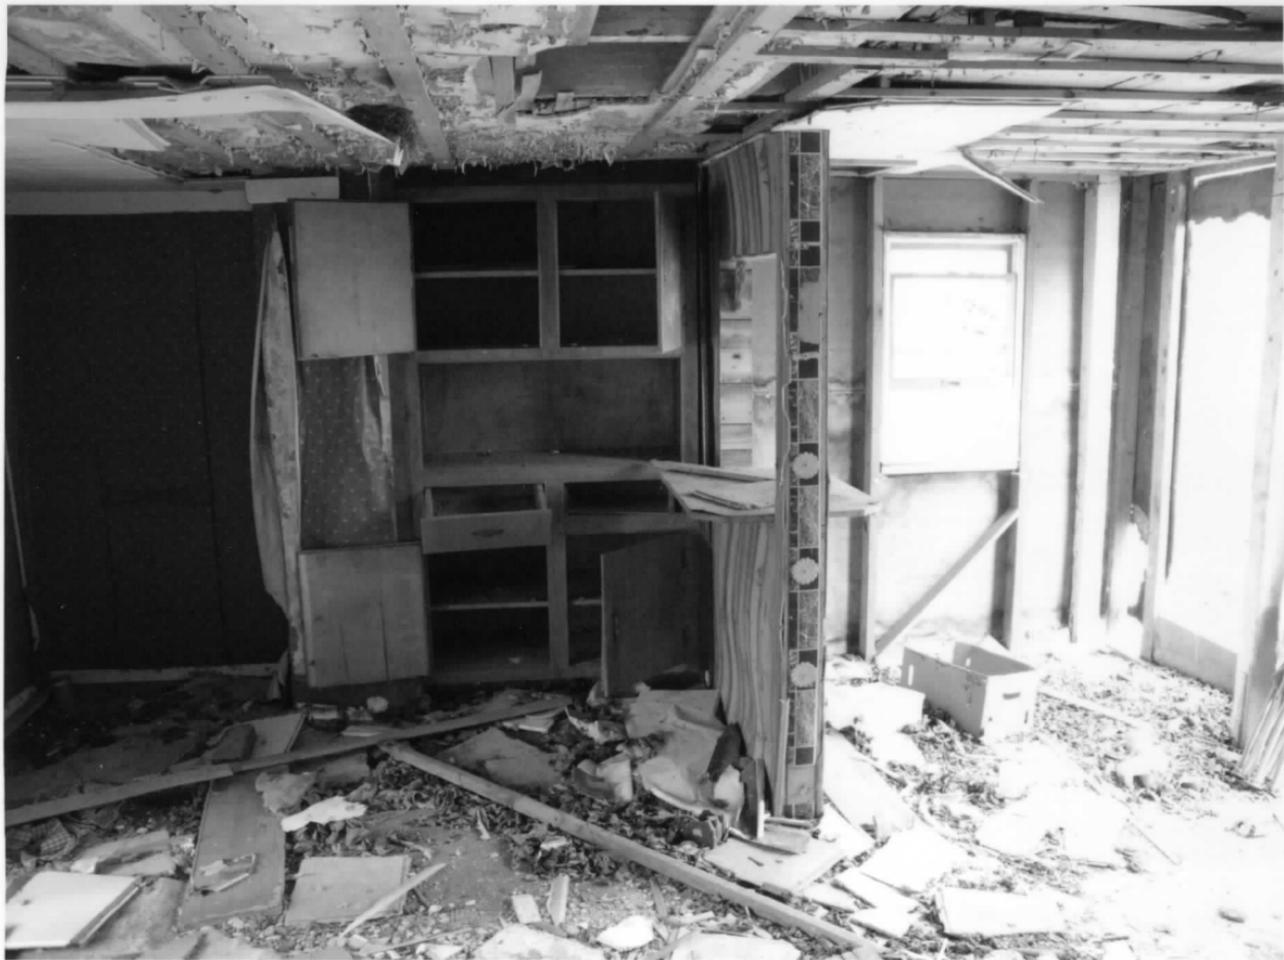
An enclosed, straight-run stair divides the first floor of the principal block into two rooms. The kitchen is located in the ell addition. The poor condition of the building prohibited investigation of the second floor.

MAP # F-5-170
STORNS - RIPPON FARM
FREDERICK COUNTY, MD
RCGA
APRIL 2015
MD SAPO
DWELLING INTERIOR, KITCHEN
13 OF 14

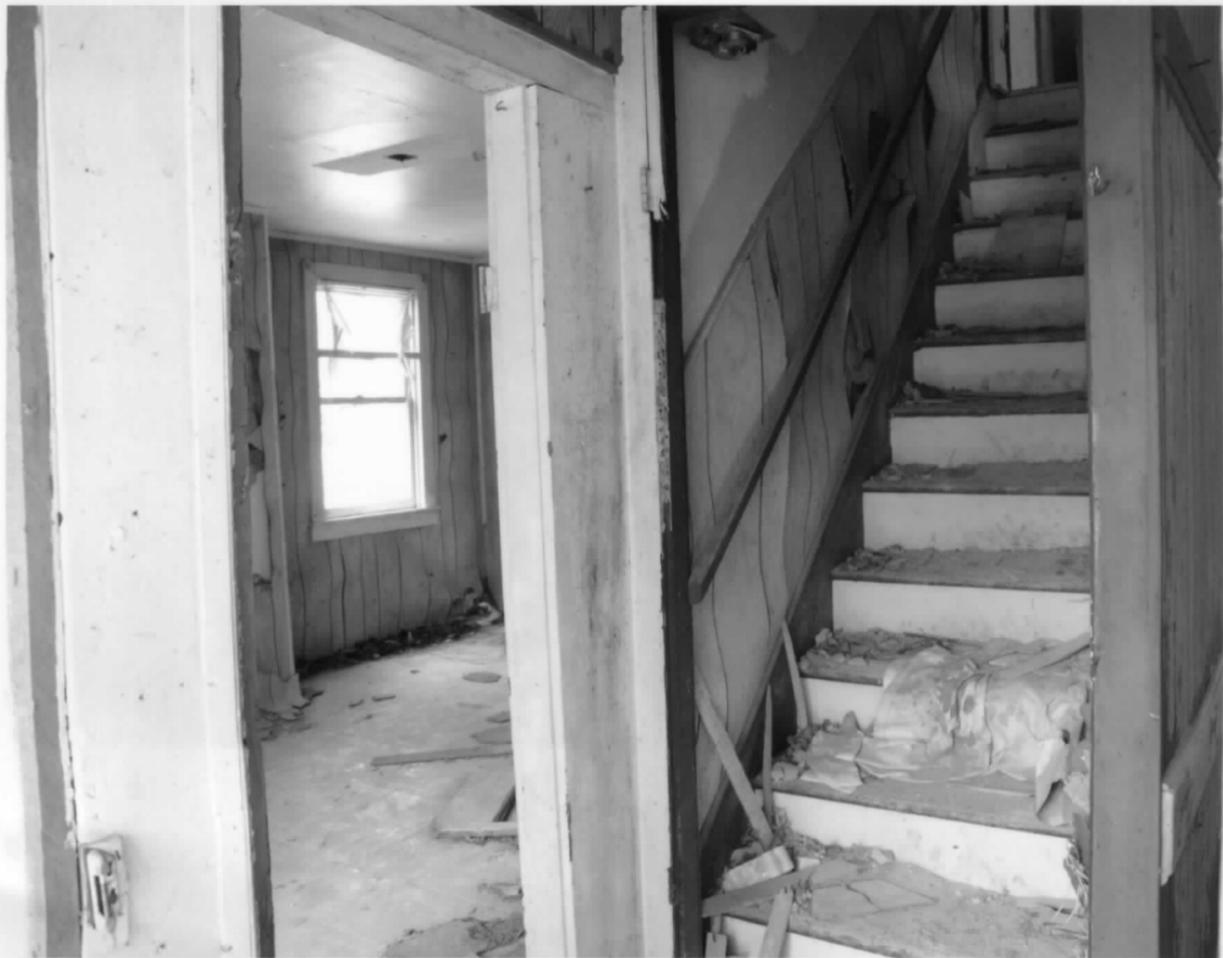
14 of 14

MHP # F-5-170
STORMS - RIPPON FARM
FREDERICK COUNTY, MD
RCGAS
APRIL 2015
DWELLING INTERIOR, STAMP
