F-5-63

William Walker House

Survey No. F-5-63
William Walker House
Bartonsville, Maryland vicinity
Frederick County, Maryland

**Maryland Historical Trust
State Historic Sites Inventory Form**

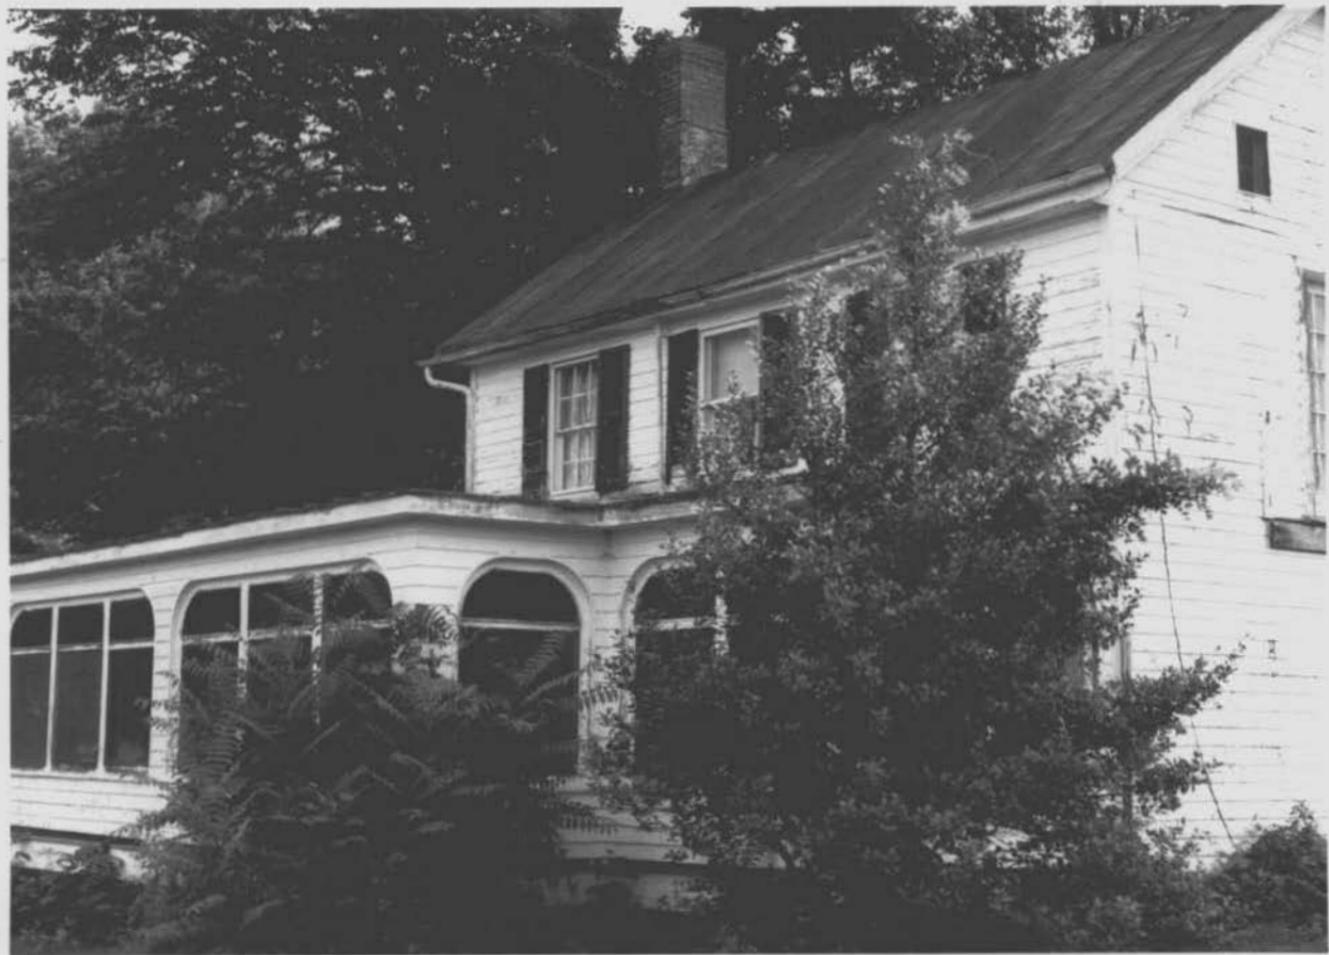
1/5

West elevation

The house has a stone foundation and german siding, a gable standing seam roof with a box cornice, and interior end chimneys. The west elevation has three original bays which are largely obscured by the screen-enclosed porch, which has an extended deck at the northwest corner of the house. The porch structure is covered with clapboard siding. The main entry is in the center bay of the house. Both the door and the north window bay on the first floor have been replaced with french doors, which are probably part of the early 20th century alteration period. The second story windows are 2/2 and are flanked by louvered shutters, some of which are deteriorated. The south elevation of the main section has a single bay on the second story where french doors apparently were installed in the early 20th century to give access to a small balcony built at the same time. The balcony is missing, but its outline is visible on the siding below the french doors. The north gable end has two window bays on each floor with 2/2 sash. Both gables have two square windows at the attic level.

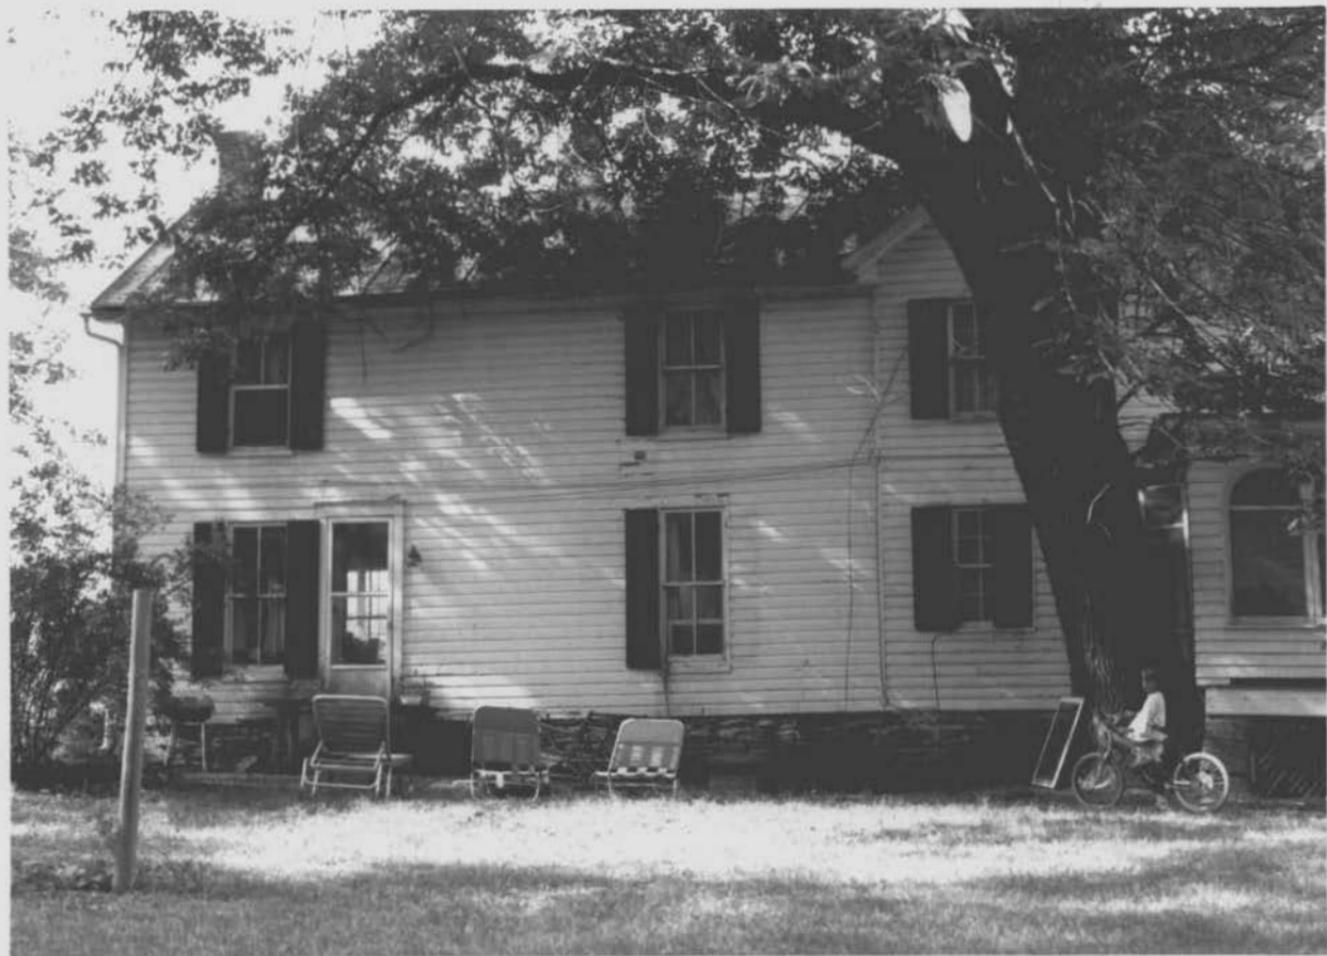
2/5

North elevation

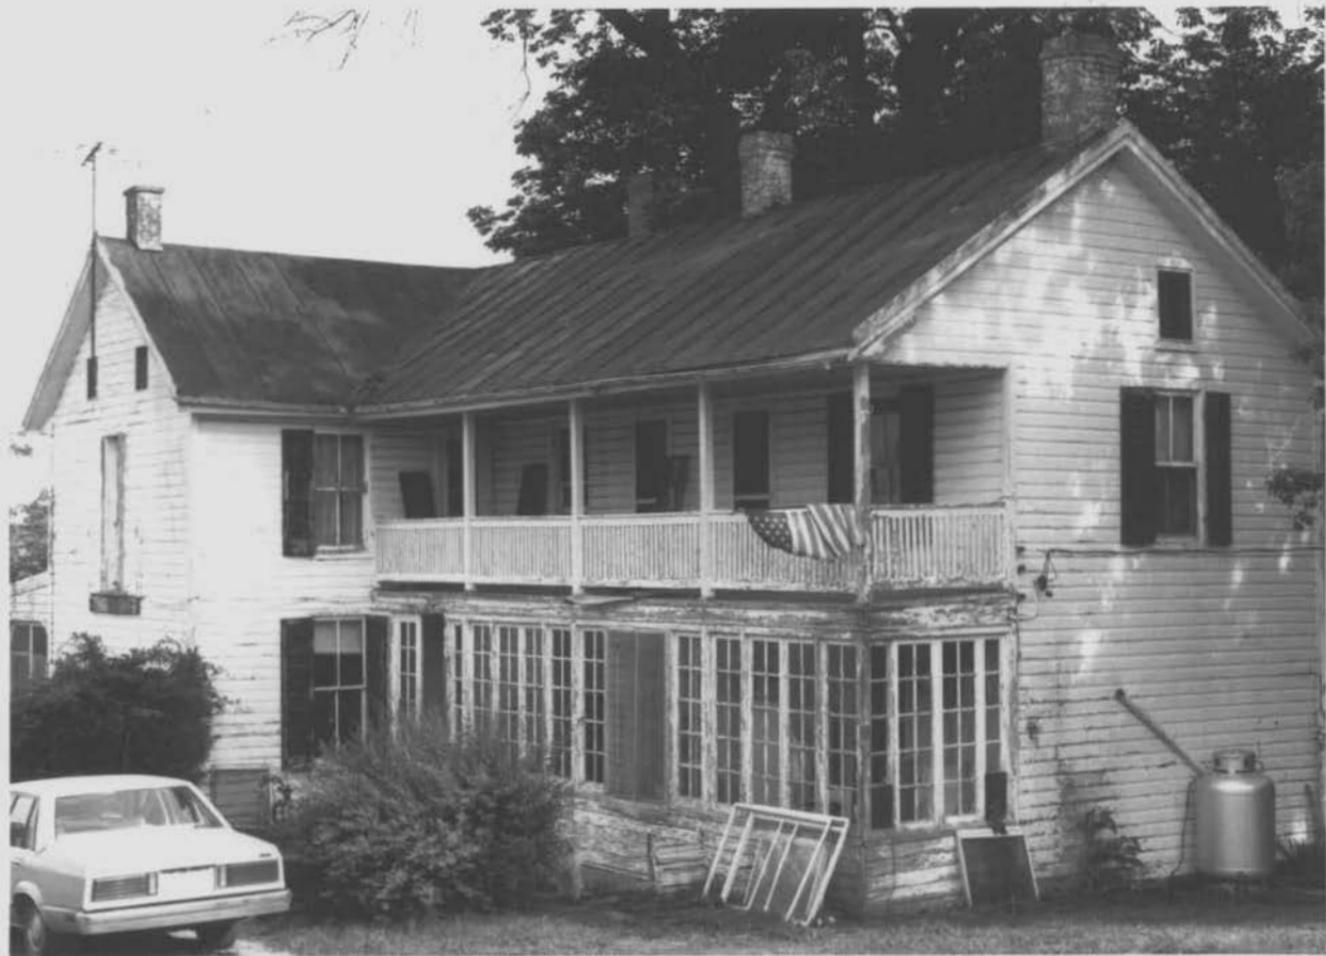
3/5

East elevation

The rear ell extends from the northeast corner of the house. An integral two story porch faces south on the south side of the ell. The first level of the porch is enclosed with a continuous wall of casement windows with a set of french doors at the end near the main section of the house. The upper level of the porch is open with a plain balustrade. The ell has two chimneys, one located near the center of the roof and the other inside the east gable end. There is a visible dividing joint between the stone foundations of the main and ell sections on the north elevation. A common sequence of building in the mid-19th century was the rear section being the first erected with the cooking fireplace where the residence was maintained until the main section was built. No other evidence to suggest this sequence at the Walker House has been identified; however, the possibility can not be excluded.

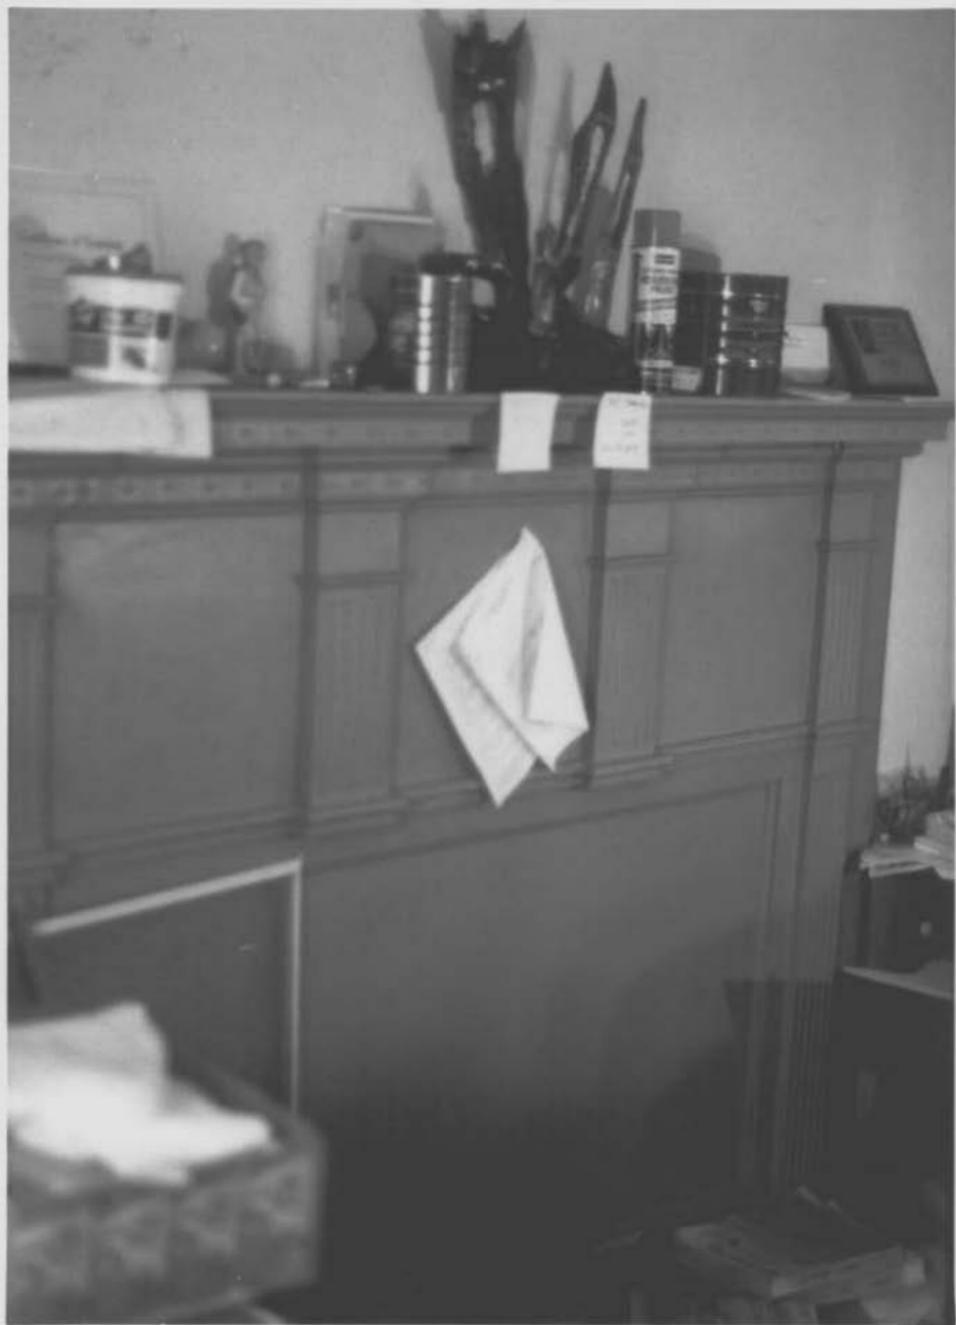
4/5

South parlor mantel (poor focus)

The interior plan of the house seems to have been originally a two-room type with a stair near the center of the house, or possibly a center hall-type. A cross partition wall to the left of the stairs, possibly part of the early 20th century alterations, enclosed the stairs completely from the two parlors. The south parlor has a Federal style mantel with fluted pilasters which appears to be older than the house itself. The west window in the south parlor is 6/6. The architraves are plain flat boards. The north parlor has a painted brick fireplace dating from the second quarter of the 20th century. The dining room in the west part of the ell has a crown molding which may date from the early 20th century.

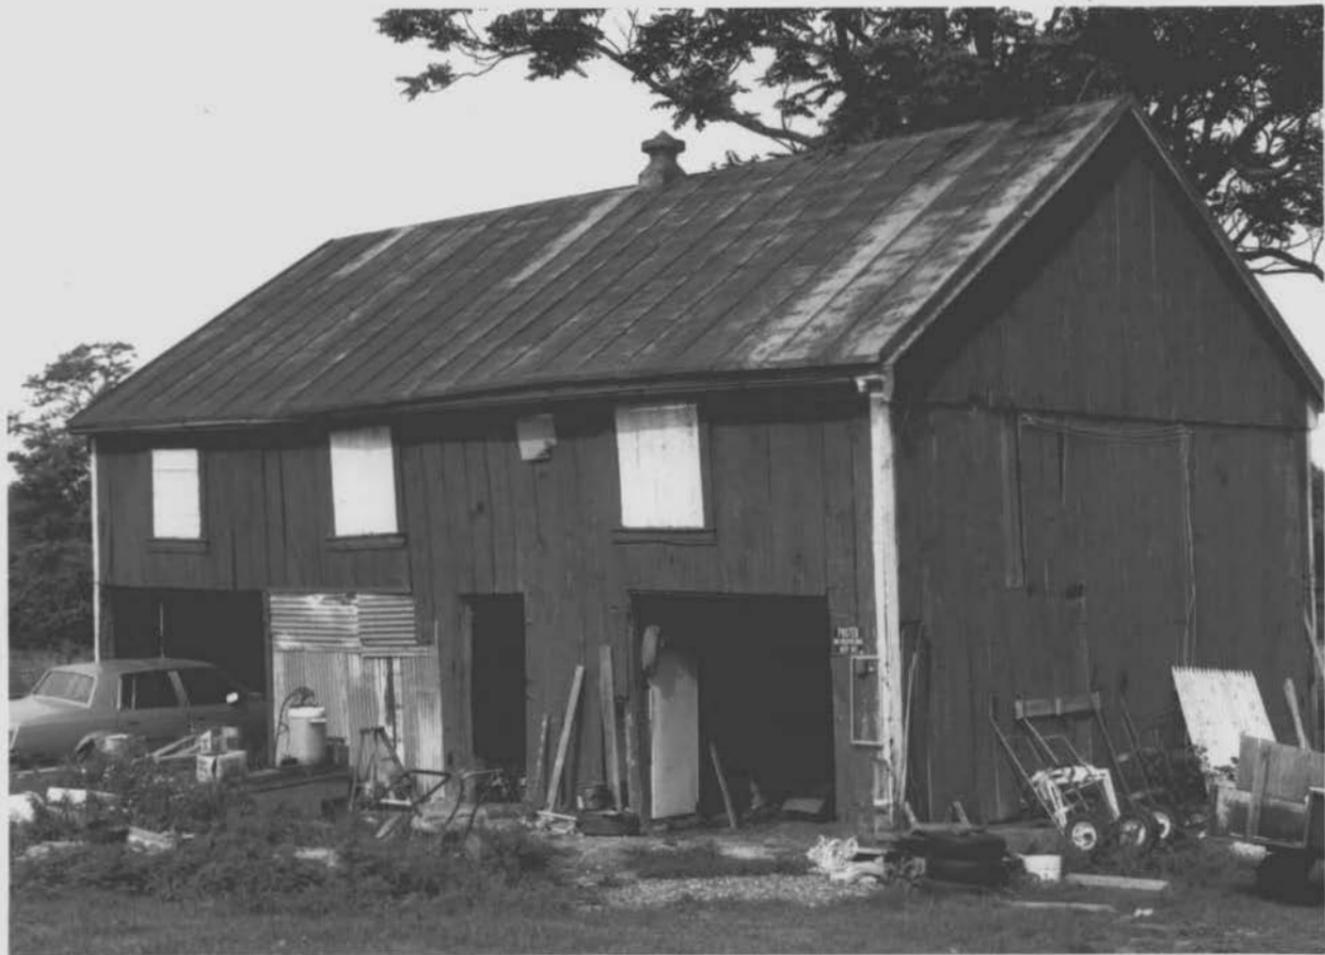
5/5

Born, east elevation

The barn is located south of the house. It is a rectangular plan structure with vertical siding and a standing seam metal roof. It appears to have had a center feeding aisle flanked by two stall ranks. The openings on the east elevation have been widened and the stall structures mostly removed. Three square loft doors are located on the east elevation above the doors. The interior frame of the barn has some hand-hewn timbers. The vertical siding is circular sawn, indicating that the date of the barn is probably in the last quarter of the 19th century. It is now used as a machine and repair shop. The doors are corrugated metal.
