Maryland Historical Trust State Historic Sites Inventory Form

historic Log House north of Creagerstown

Survey No. F-6-40

Measured Sketch Plan

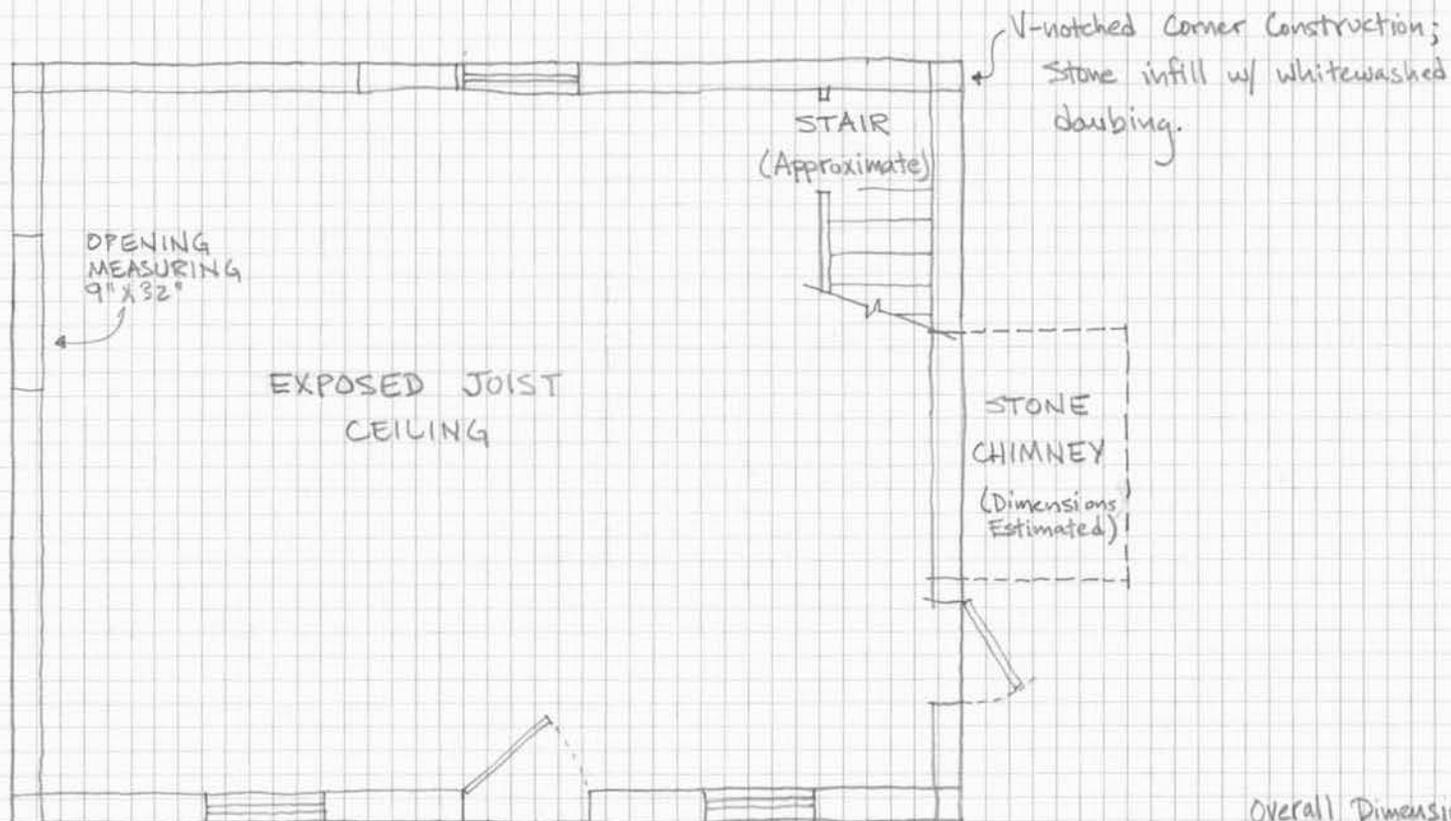
The building is a true story-and-one half log structure measuring 16 feet wide and twenty feet long. It is oriented to face south, with a pitched gable roof on an east-west axis. There are three openings in the principal facade; an exterior stone chimney on the east gable wall has collapsed. The logs are hewn on the interior and exterior face but are left unhewn on the top and bottom faces. They average 7½ - 8½" deep, 9 - 12" high, and are V-notched with stone infill. The daubing was originally whitewashed, but the exterior walls were later covered with narrow weatherboard siding nailed to vertical spacer strips with machine-made nails.

The interior of the building was not accessible but a limited view of the building was possible through various openings. The interior consists of a single room on the first floor and a floored loft above. A steep enclosed stair is located in the northeast corner of the building and rises against the east gable wall. This stair is enclosed with beaded boards. The first floor room has an exposed hewn joist ceiling. The loft is unfinished other than the flooring. The moderately pitched roof is of common rafter construction with rough wind-braces let into the tops of the gable end rafter pairs. The eaves are not fully boxed in and the early roofing has been covered with corrugated metal.

Overall Dimensions:
16'-1" X 20'-1"
