**INDIVIDUAL PROPERTY/DISTRICT
MARYLAND HISTORICAL TRUST
INTERNAL NR-ELIGIBILITY REVIEW FORM**

Property/District Name: Charles Hendry Farm Survey Number: F-7-137

Project: Villages of Urbana Agency: F/COE

F-7-137
Charles Hendry Farm
ca. 1850
Urbana Vicinity, Frederick County
Private

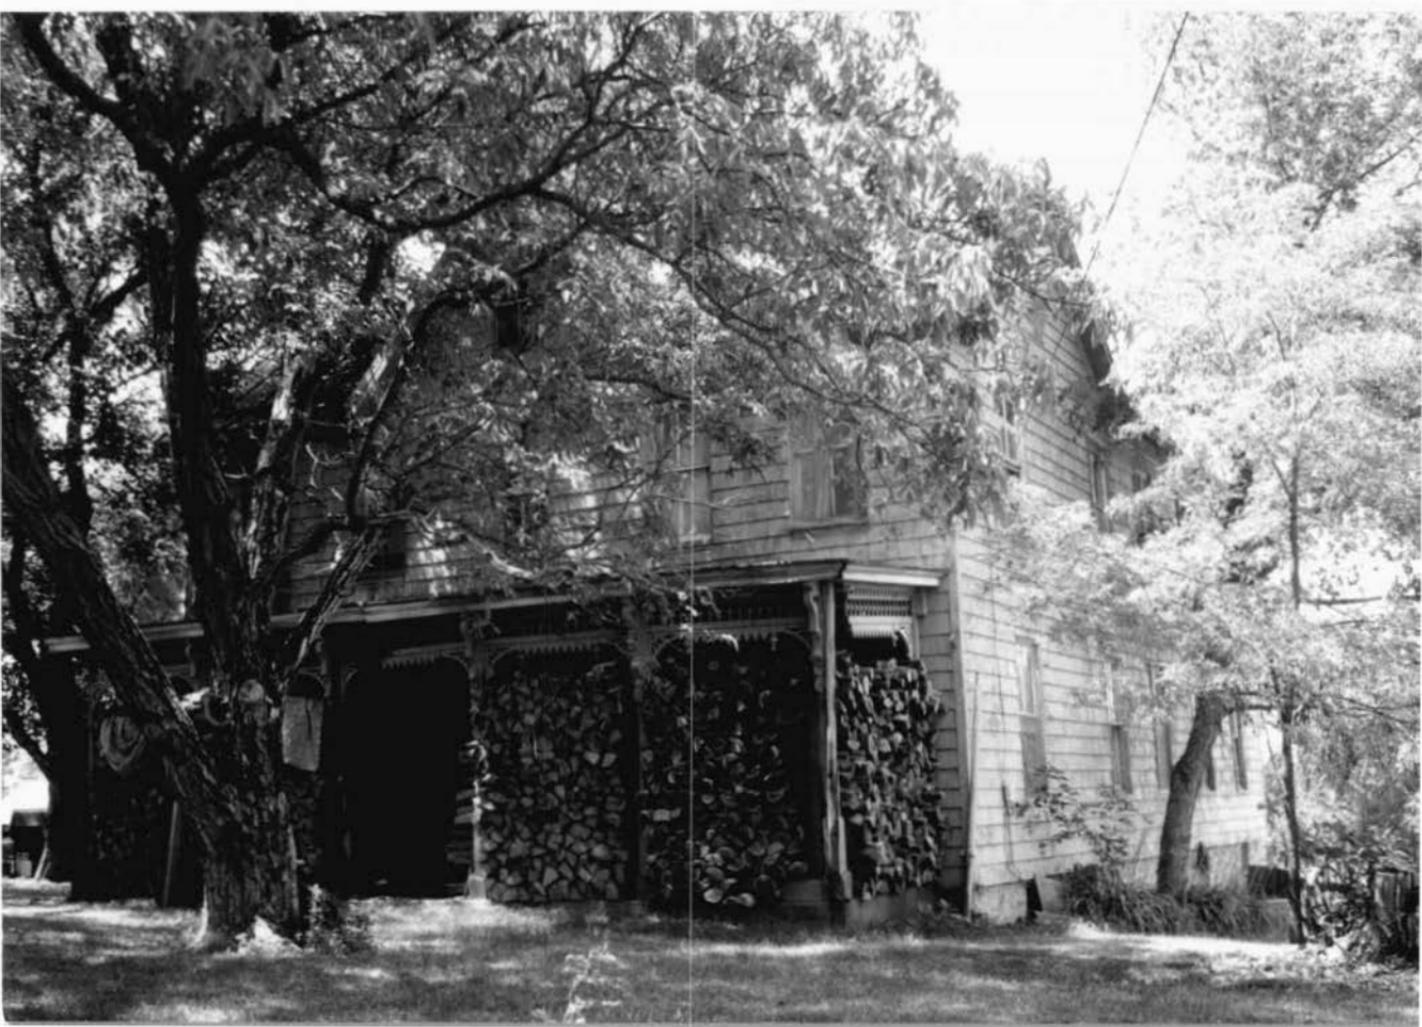
PHOTO 1 OF 8

VIEW NORTH PRINCIPAL AND SIDE ELEVATIONS

The Charles Hendry Farmhouse is a large, two-story, wood-frame dwelling built on a fieldstone foundation. The principal core, constructed ca. 1850, is five bays wide and four bays deep and adopts a T-shape plan. Late nineteenth century alterations to the dwelling, including architectural details and the porch, are evident. The main block of the house is oriented to the south. The rear ell is connected to the north wall of the main block and extends north. The rear ell is four bays wide and one room deep. The building incorporates a gable roof over the main block with an intersecting gable roof over the rear ell.

The principal entrance includes a four paneled door enframed by a simple beaded surround and multi-light transom. The eave line of the front and rear elevations of the main block is marked by a simple wood cornice. The two-light-over-two-light, double-hung, wood-sash windows are original to the structure and are aligned symmetrically. Paired brick chimneys with corbelled caps rise from the interior of the main block on both the north and south roof planes. Small attic windows are located at the gable end near the roof peak.

A one-story porch spans the primary elevation of the main block. This porch is not original to the building. The hipped roof of the porch is clad in standing-seam metal and is supported by six decorative turned columns. The columns sit on a poured concrete foundation.

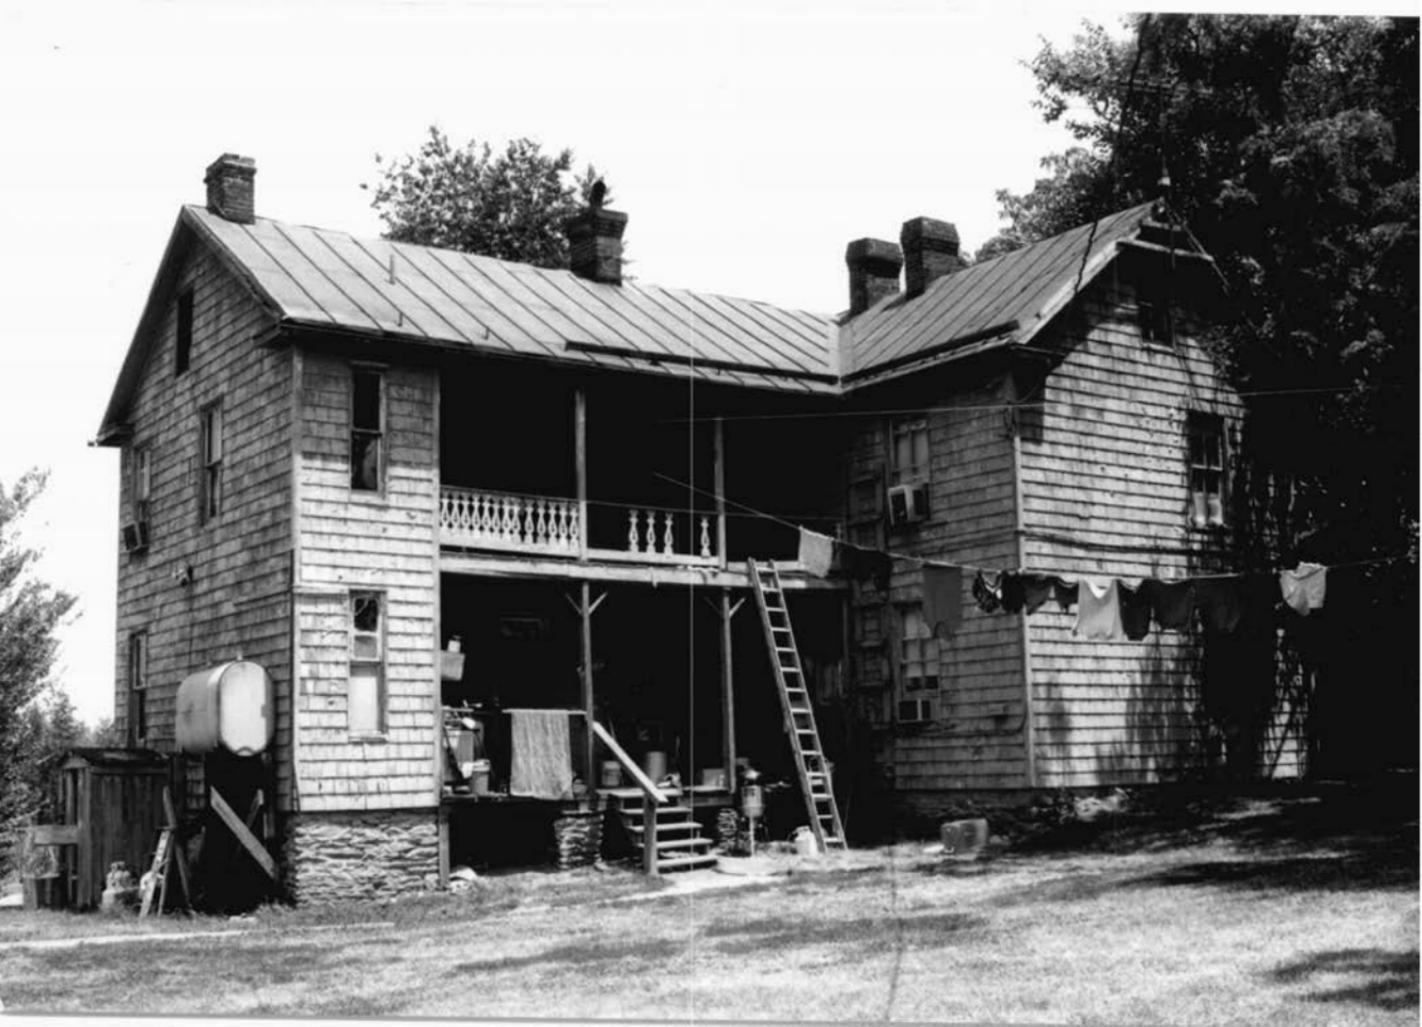
PLATE 2 OF 8

VIEW SOUTHWEST BEAR AND SIDE ELEVATION

The two-story, four bay rear ell extends from the north wall of the main block. This addition is wood-frame construction sheathed in wood clapboards. An interior-end chimney rises from the north elevation. A two-story porch spans the west elevation of the rear ell; this is a characteristic feature of nineteenth-century farmhouses in the Maryland Piedmont. The porch is incorporated under the principal roof of the rear ell and is supported by plain boxed columns on the first and second floors.

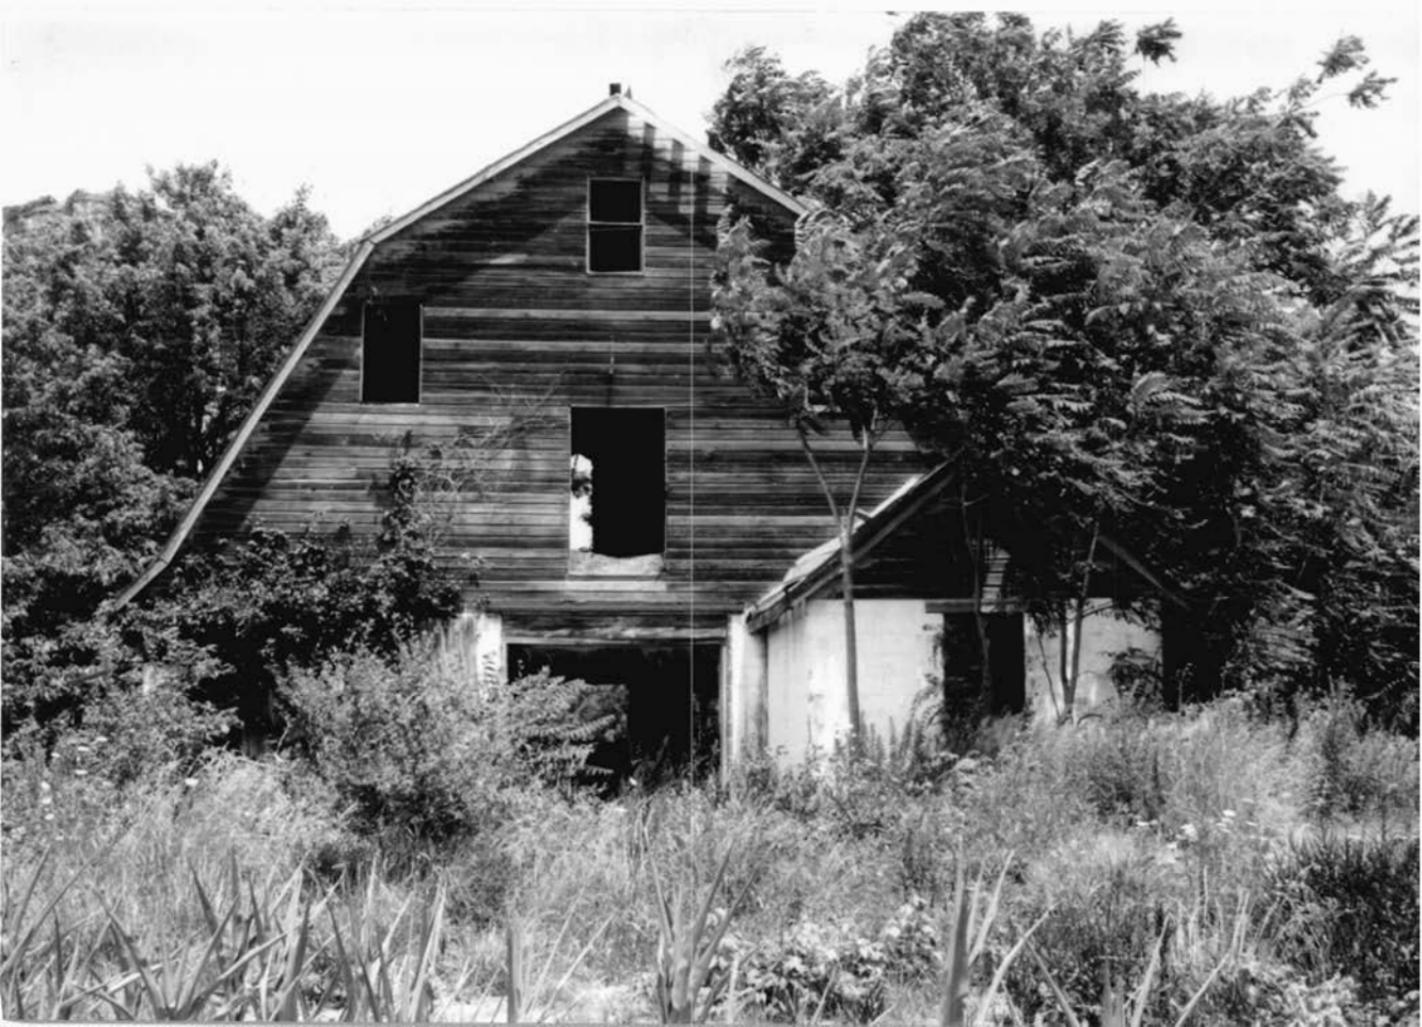
PHOTO 3 OF 8

VIEW EAST OF DAIRY BARN (H-2)

The dairy barn is located in the northwest portion of the building complex. It is a two-story, three-by-thirteen-bay building occupying a rectangular plan. The front elevation is symmetrical and divided into three bays; the side elevation include six bays of two-over-two, metal sash window units flanking a single wooden door. Concrete-block walls rise from a poured

concrete slab foundation to terminate in a gambrel roof. The gambrel roof is sheathed with standing seam metal panels; the gambrel ends are clad with horizontal boards.

Primary entry is gained through the east gambrel-end elevation. The primary entrance incorporates double wooden track doors. An aisle extends down the center axis of the barn. Metal milking stalls are situated on either side of the aisle down the length of the building. Mechanical milking units were not present during the survey. The structure is in fair condition.

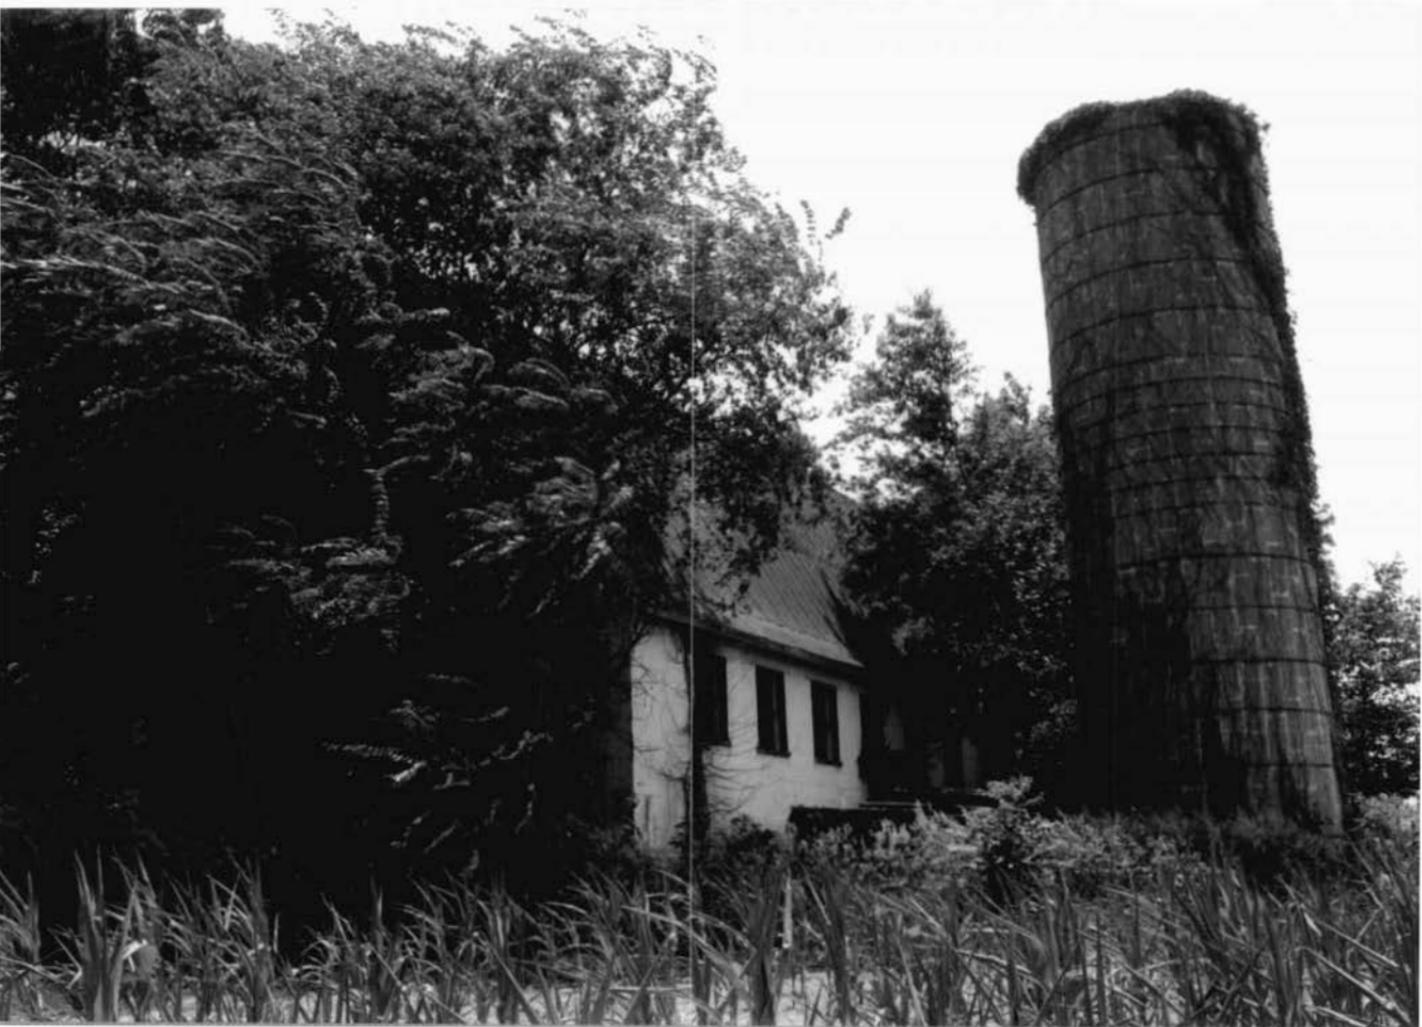
PHOTO 4 OF 8

VIEW SOUTHWEST OF DAIRY BARN AND SILO

A circular silo (H-5) is located at the north elevation of the barn. This structural clay tile silo lacks a roof and is in fair condition. A second circular silo (H-6) also is located southwest of the dairy barn; this structure is in deteriorated condition.

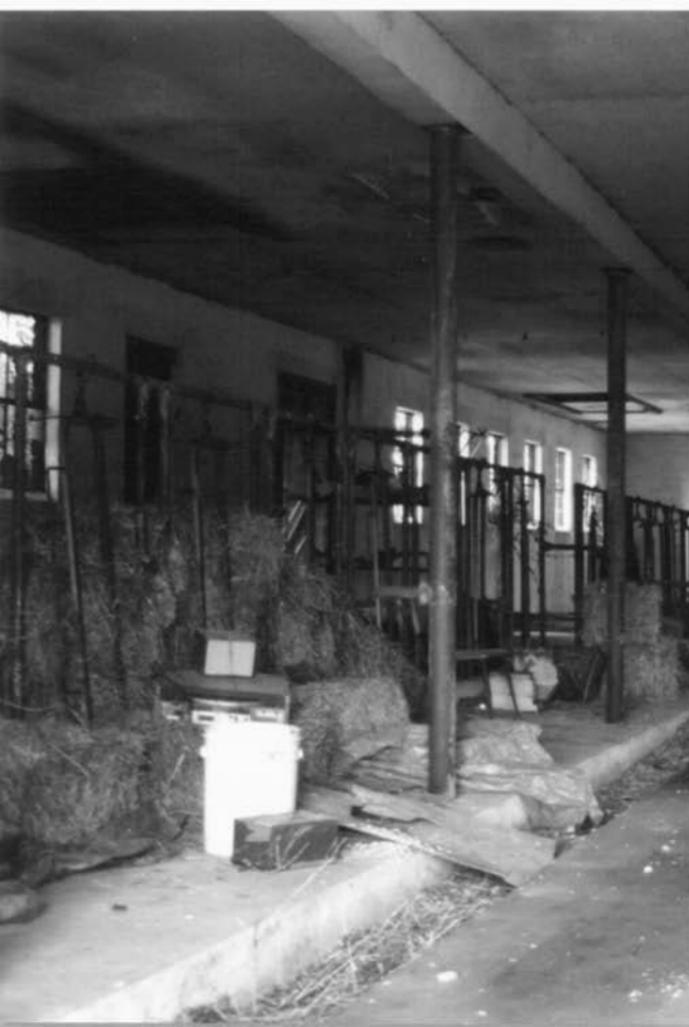
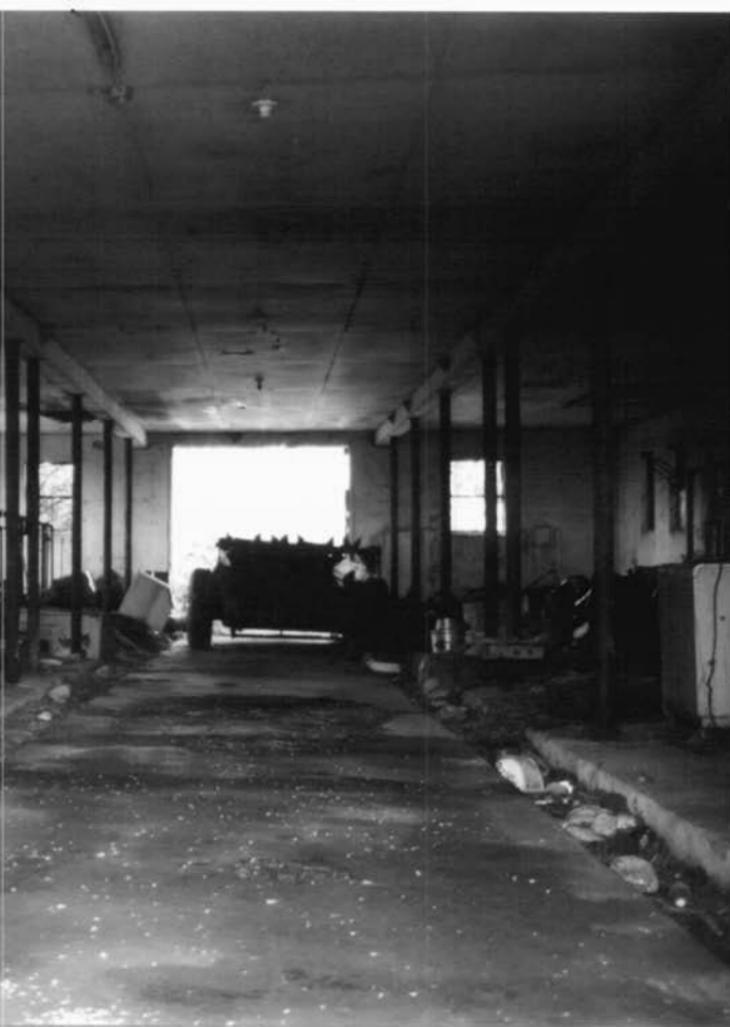
PHOTO 5 OF 8

VIEW WEST, INTERIOR OF DAIRY BARN (4-2)

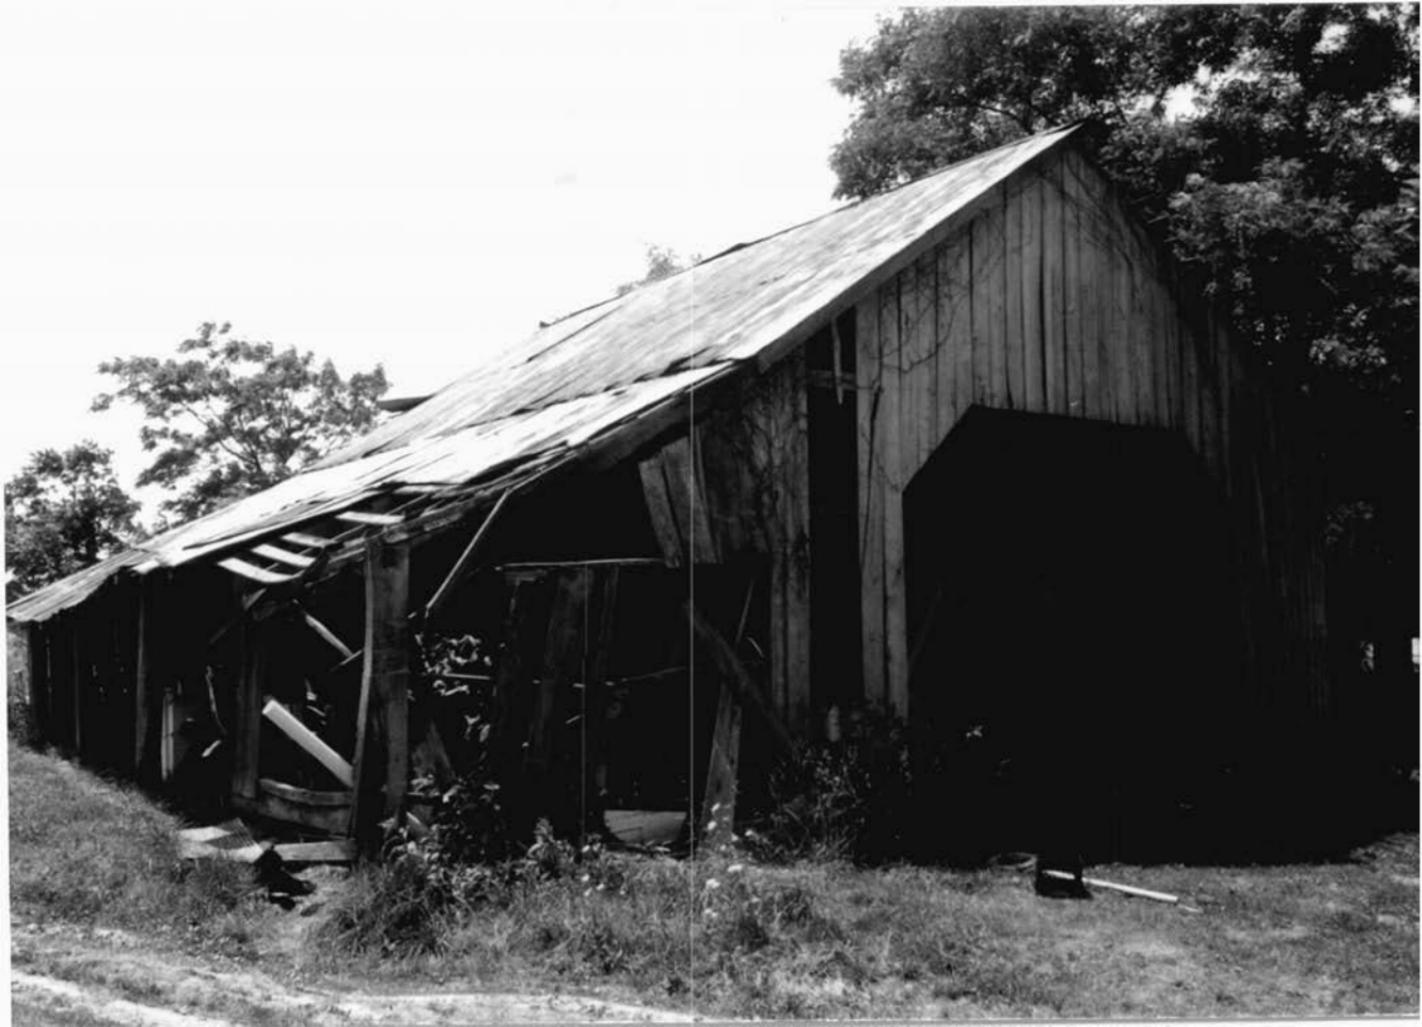
PHOTO 6 OF 8

VIEW NORTH WOOD FRAME CORN CRIB (H-3)

A wood-frame corncrib is located west of the dwelling. This one-story three bay structure terminates in a side gable roof sheathed with metal standing seam. The exterior of the corncrib is sheathed with vertical wood siding. A one-story, four bay by one bay shed roof addition is located on the south elevation. The building fabric of this structure is deteriorating, much of the west elevation is no longer extant and erosion is undermining the roof supports in both cribs.

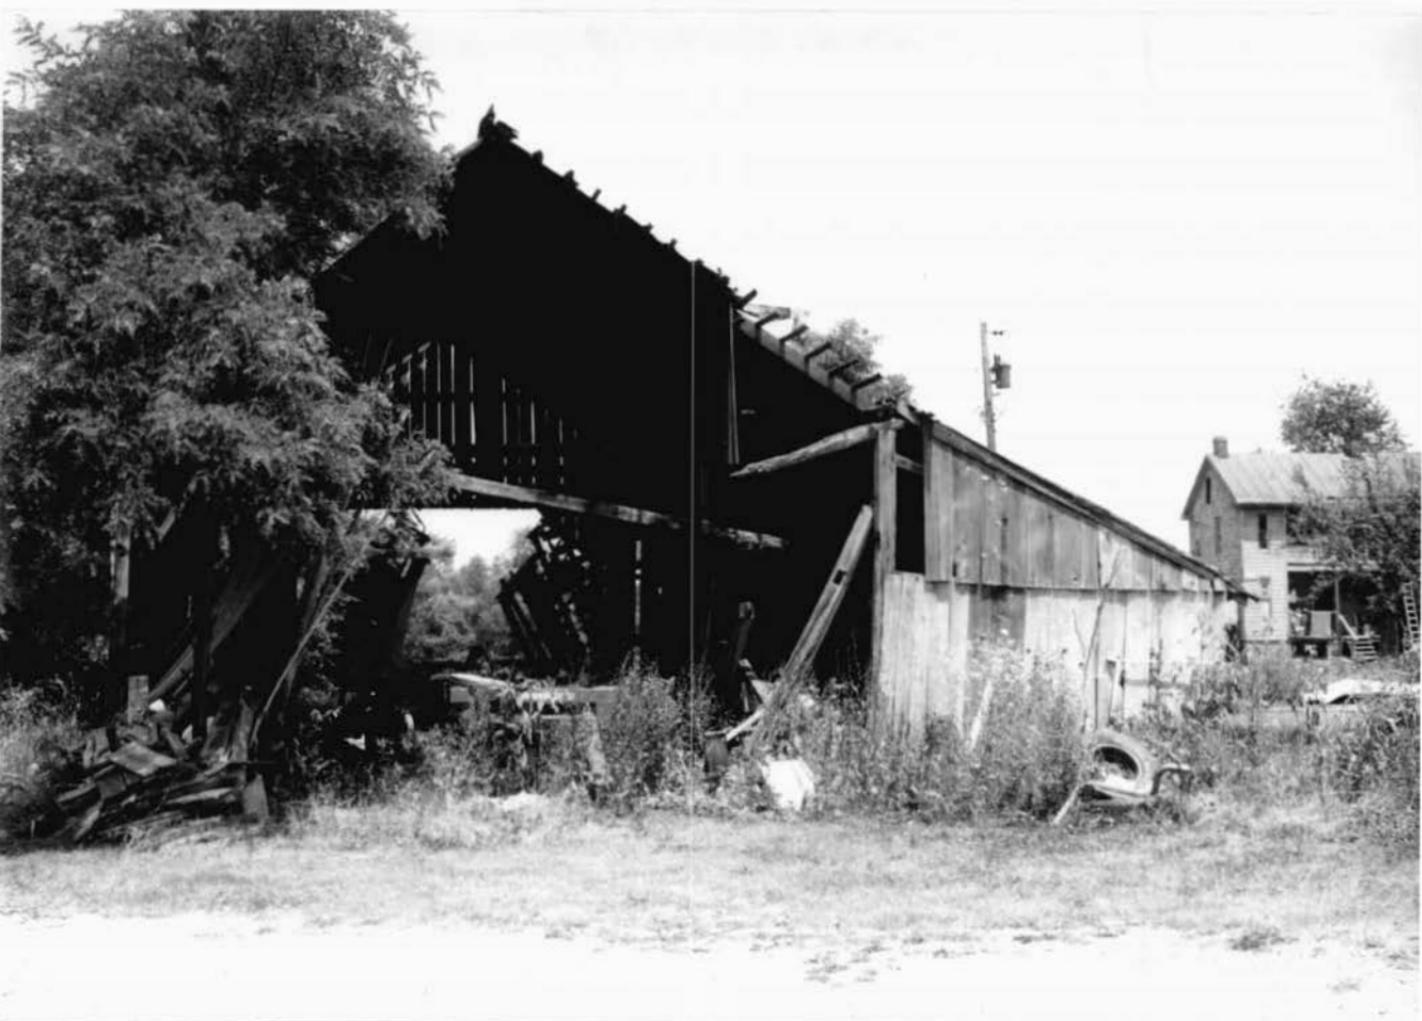
PHOTO 7 OF 8

VIEW SOUTHEAST, WOOD-FRAME CORN CRIB (4-3)

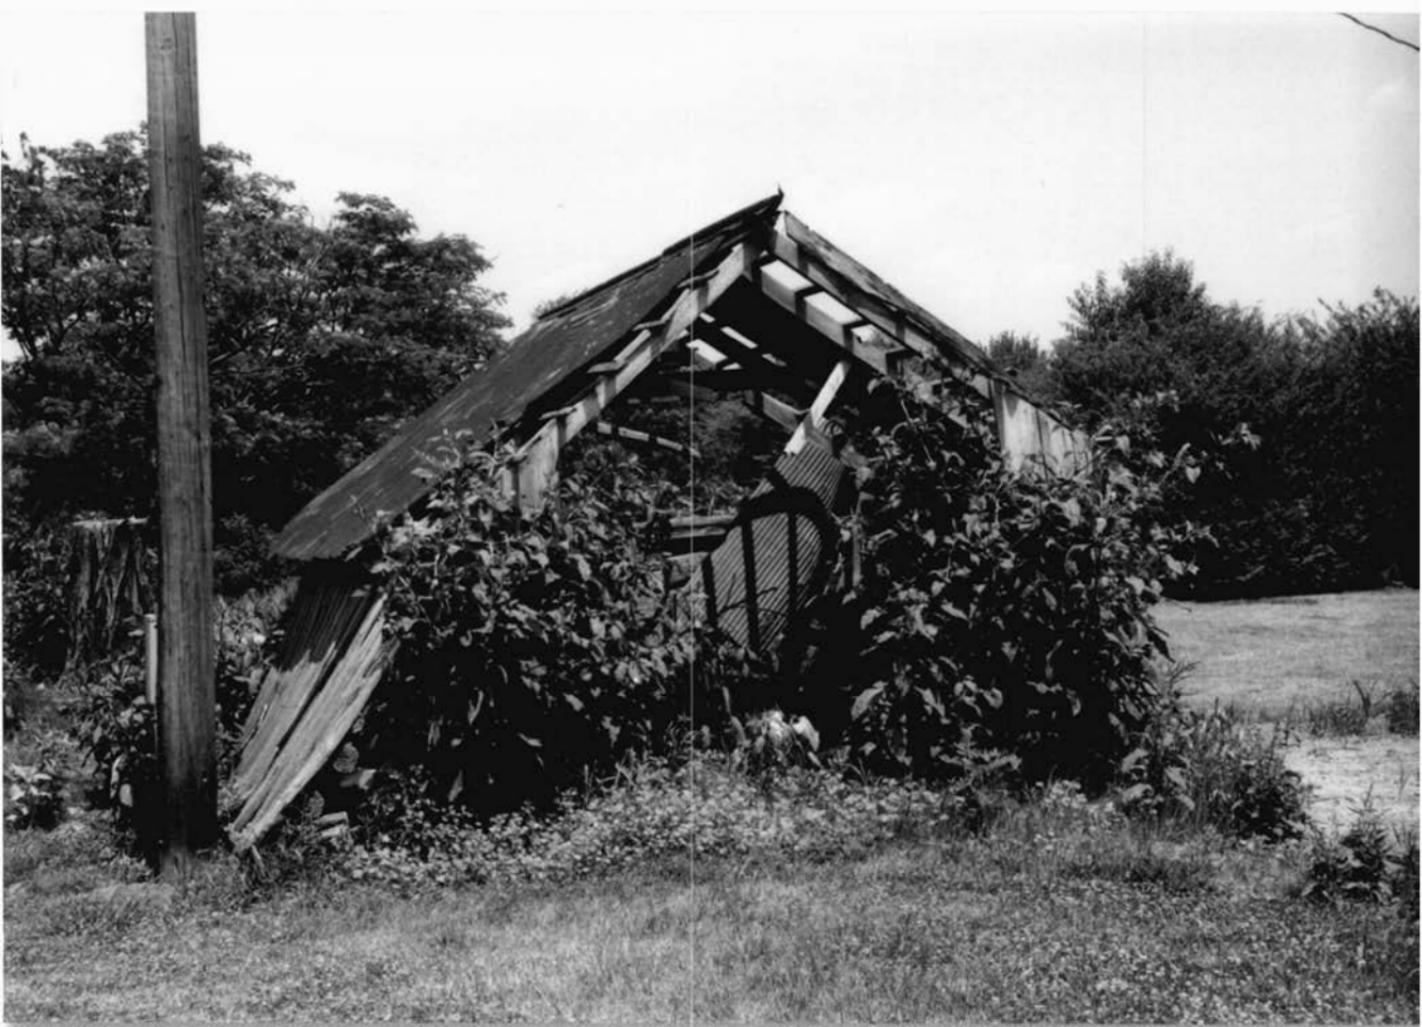
A wood-frame shed is located south northwest of the principal dwelling. This shed is a rectangular plan, one-story, one-bay structure that terminates in a front gable roof sheathed with corrugated metal panels. Vertical board siding clad the buildings's frame. The building fabric of this structure is deteriorating; wall cladding is shearing from the building frame, and holes are developing within the shed's metal roof.
