Survey No. F-8-115

J. Pfoutz Farmstead

Johnsville, Maryland

Maryland Historical Trust State Historic Sites Inventory Form

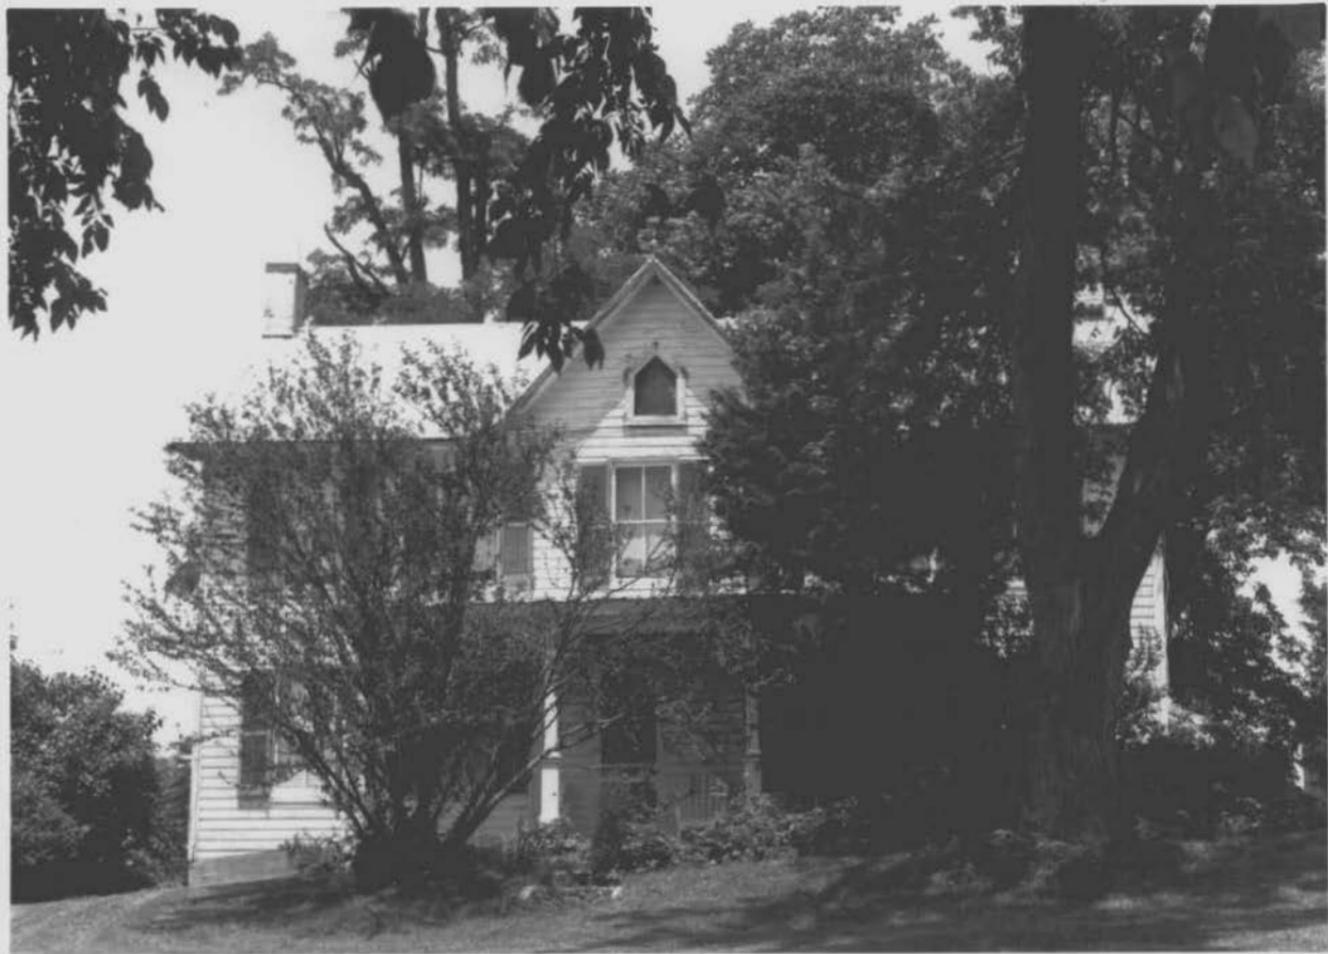
1/8

South elevation

The dwelling house is a two-story, five-bay building with a rear ell extending from the northeast corner. The south elevation has a central cross gable with a Gothic arched gable window. A one-story entry porch shelters the center three bays. The 1850-1875 date of the house is based on the basic form of the house, its main elevation porch and cross gable features which are known to be common in Frederick County and other Maryland counties during the third quarter of the 19th century. The log structure is not visible from the exterior, but was confirmed by Mr. Leatherman, the current owner. No details of its size and configuration were available at the time of survey. Log main sections or rear ells are also common features on vernacular dwellings of the middle third of the 19th century.

The foundation is stone and the exterior siding is german, the gable roof is corrugated sheet metal. The door and window surrounds have plain architraves. The center entrance has a three-panel door with a glazed upper panel and a single light transom. The windows are 2/2 with louvered shutters. The porch columns are chamfered square posts with scroll-sawn brackets. The side elevations on the east and west have interior end chimneys. The rear ell is two stories and has an enclosed two story-porch on the west elevation. A 1 1/2 story shed addition is attached to the north end of the ell and a one-story screen-enclosed shed porch is located on the east elevation. Windows in the ell are 6/6. The interior of the house was inaccessible for this survey.

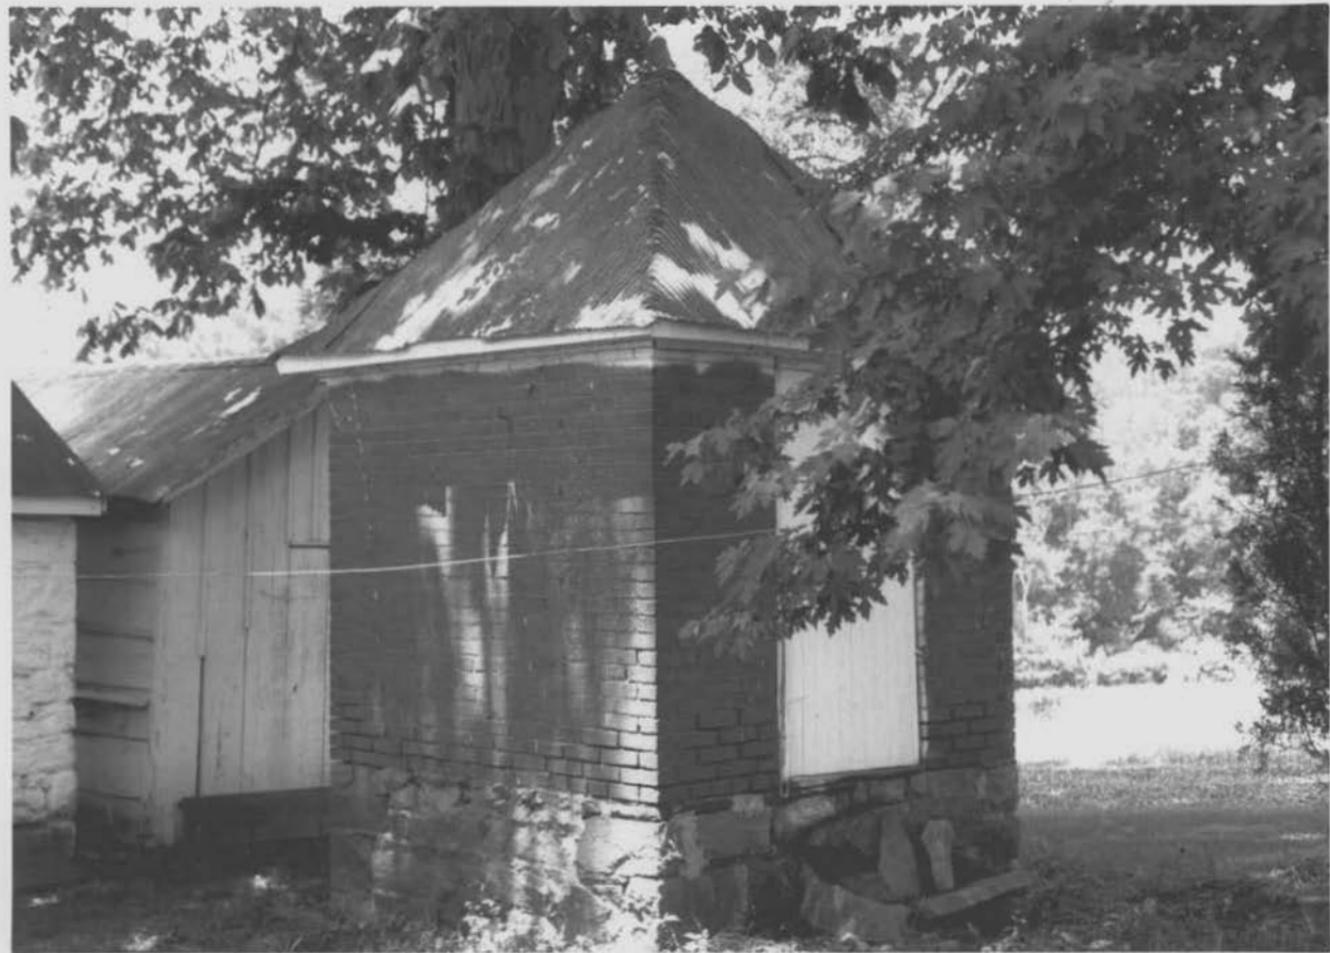
2/8

Smokehouse, southeast corner view

Smokehouse: This is a square plan brick structure with a pyramidal corrugated metal roof possibly covering original roofing materials. It appears to date from about 1850. The single door is on the east elevation. A section of railroad track extends from the north elevation, possibly a support for a center hanging rack.

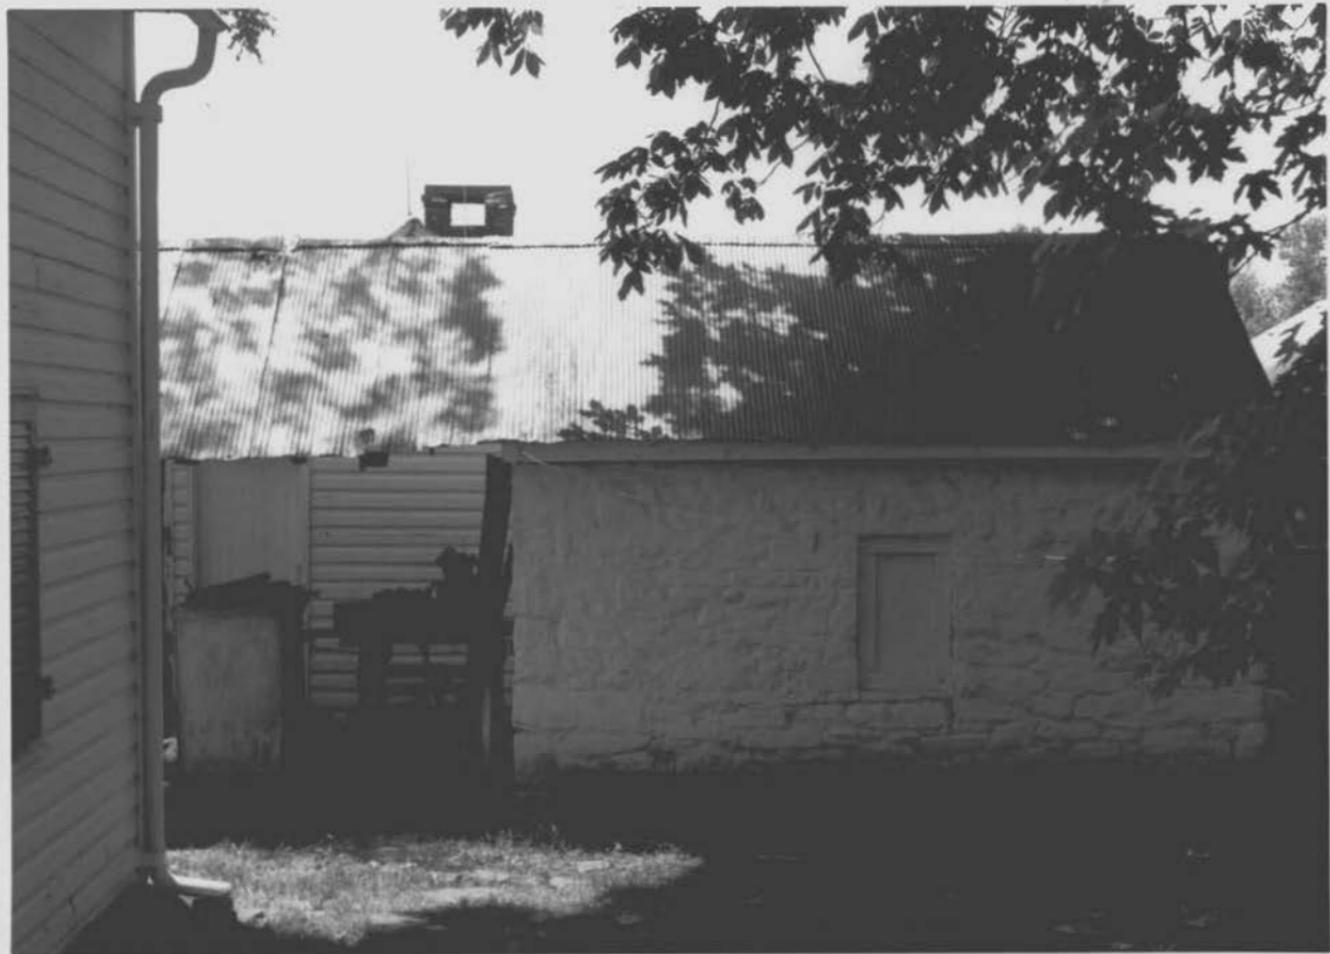
3/8

Neg. loc.: Md. SHPO, Crownsville, Md.
Springhouse, east elevation

Springhouse: The rubble stone springhouse is possibly contemporary with the log section of the house, about 1825-1850. It is a one-story building with a corrugated metal gable roof extended from the south to shelter a wellhead immediately south of the springhouse door. The springhouse is basically rectangular in plan with plastered interior walls and a cooling trough along the east wall. Mr. Leatherman states that milk cans were sterilized in the springhouse in the 1940's.

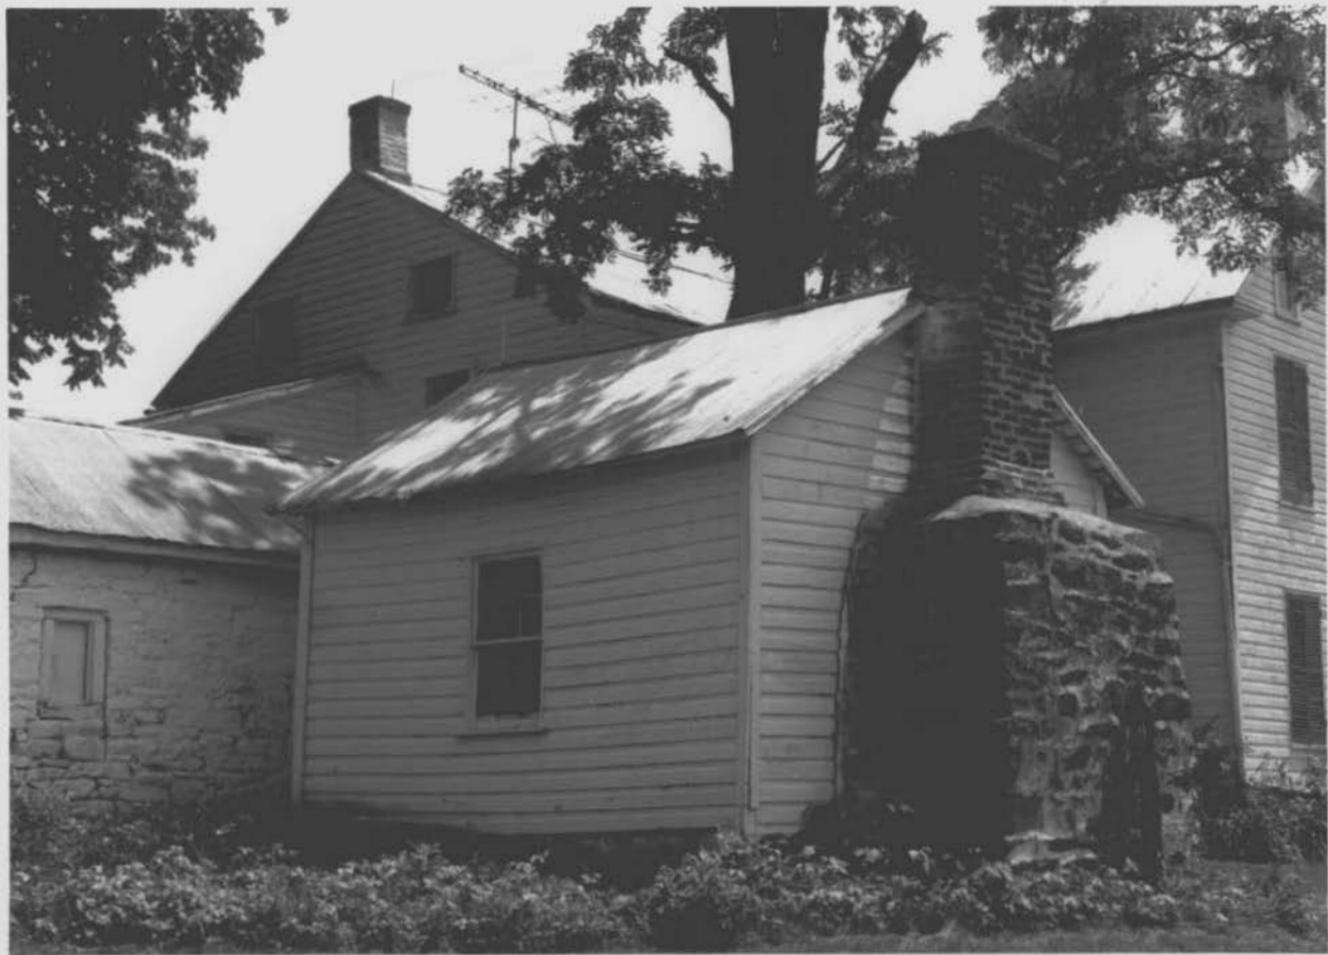
4/8

Wash House, west elevation

Wash house/butchering shed: This one-story frame building is rectangular with a single door in the east elevation and an exterior stone and brick chimney on the west elevation. The siding is german and the single windows in the north and south elevations are 6/6. The gable roof is corrugated sheet metal. The wash house may date from the 1850-1875 period of the house, given its siding material. Butchered hogs were processed in the wash house in the 1940's and 1950's.

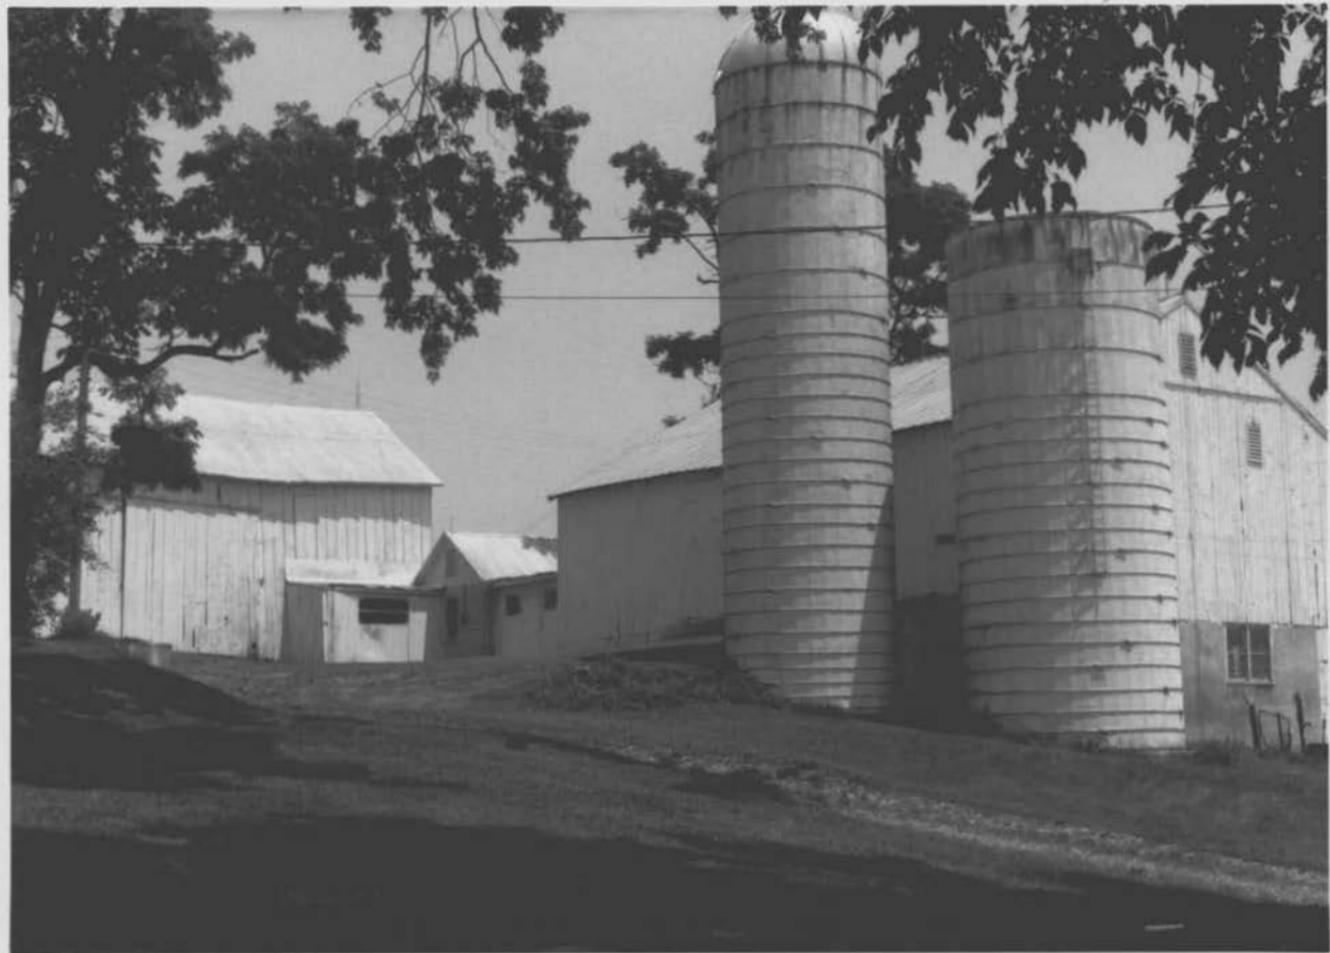
5/8

Hay barn, bank barn, and silos, view from
southwest

Hay barn: This is a frame vertical-sided building with a rectangular plan and sliding doors opening on the south elevation. An implement shed or tractor shed with an open side on the south is attached to the hay barn on the west. A second shed for tools is attached to the north elevation of the hay barn, with an opening on the east. It has metal siding and appears to be a recent addition. The hay barn itself dates from the first quarter of the 19th century.

Bank barn: This is a stone based, frame bank barn located at right angle to the hay barn with its ramp to the hay storage level on the west elevation. The forebay is on the east elevation and is partially enclosed by concrete block and frame to form a milking parlor, an alteration which took place in the 1940's. A date of 1874 was obscured on an interior beam by the alteration. The barn's hand-hewn structure and vertical siding appear to support 1874 as the date of construction. A concrete block milk house built in the 1940's connects the bank barn and the hay barn at the northwest corner of the bank barn. The bank barn has a standing seam and corrugated metal roof.

Silos: Two concrete paneled silos dated 1949 according to the current owner are located near the southwest corner of the bank barn.

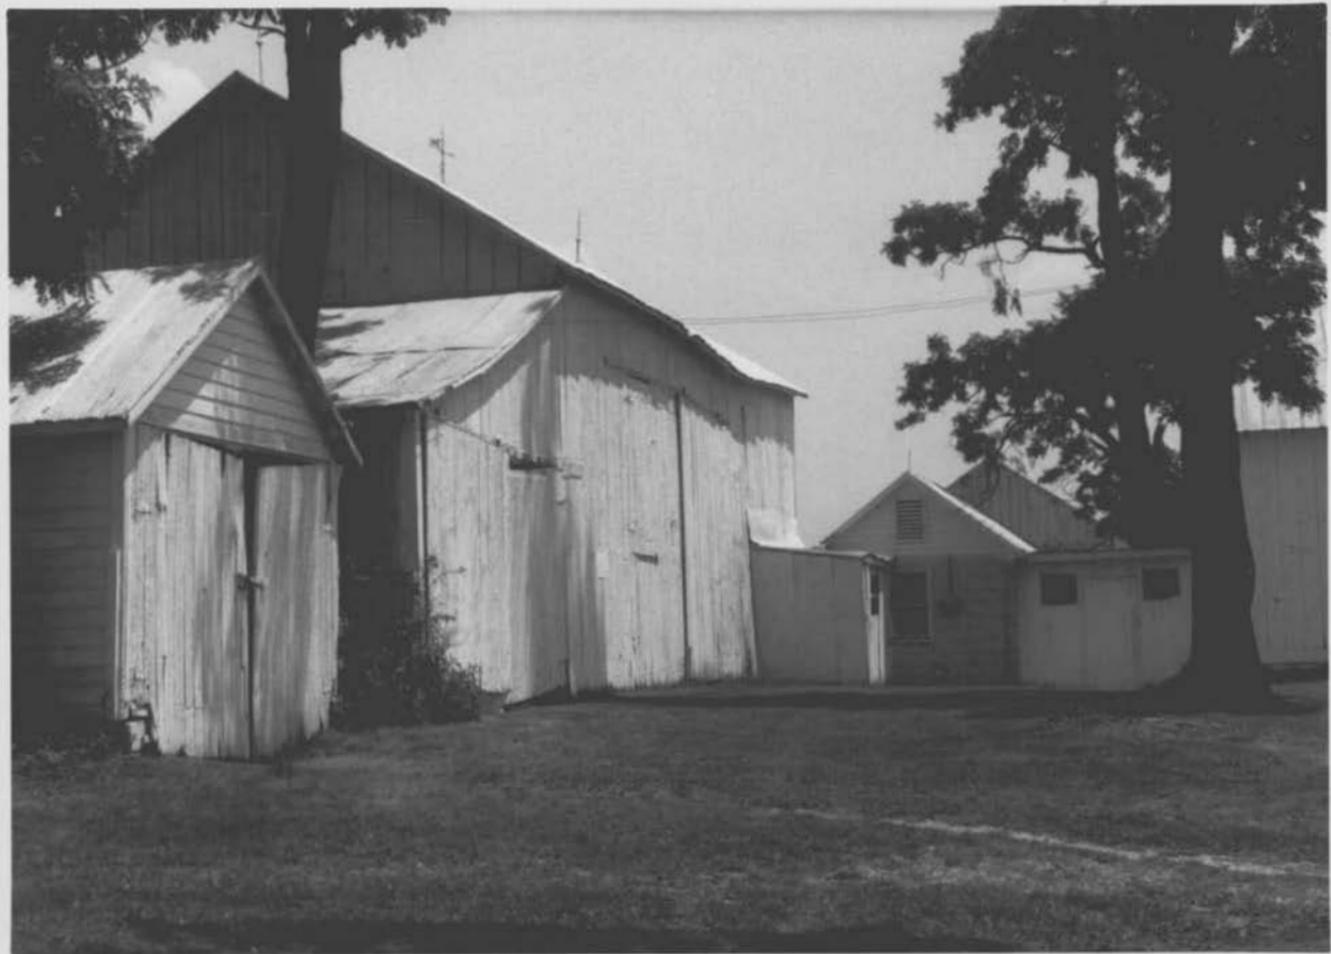
6/8

Garage, hay barn, milk house, view from
west

Garage: The second garage is a frame, german sided rectangular building located west of the hay barn, suggesting it also may have had agricultural as well as domestic uses. It has a corrugated metal roof and appears to be dated from the last quarter of the 19th century.

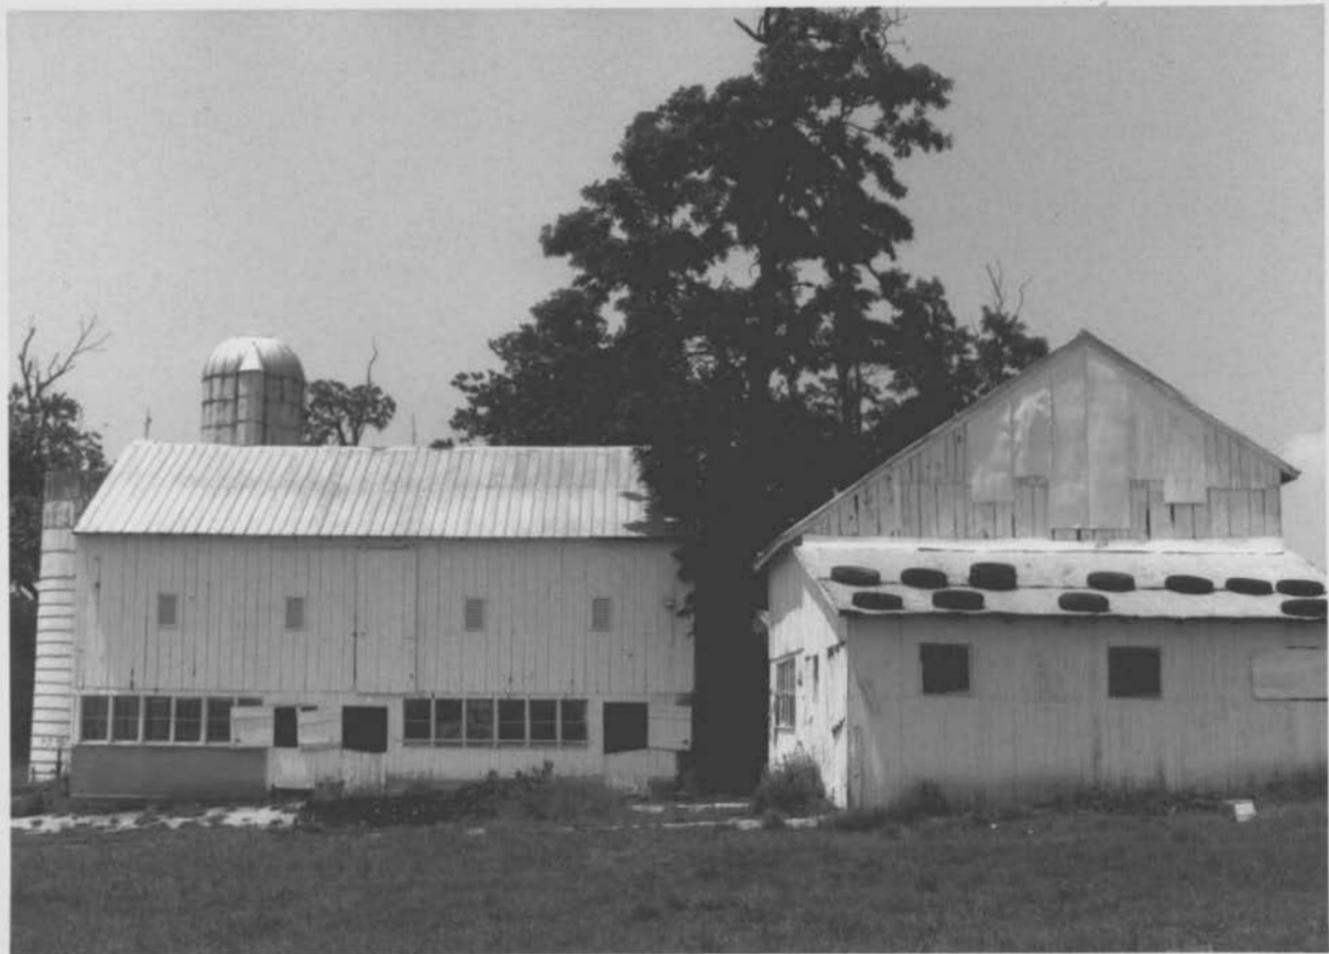
7/8

Bank barn and cow shed, east elevation

Cow and calf barn: This is a frame rectangular structure located east of the bank barn. It has vertical siding and a corrugated metal roof. Consisting of sections for new cows, calves, and dry cows, the structure has feeding aisles and access doors on the south elevation.

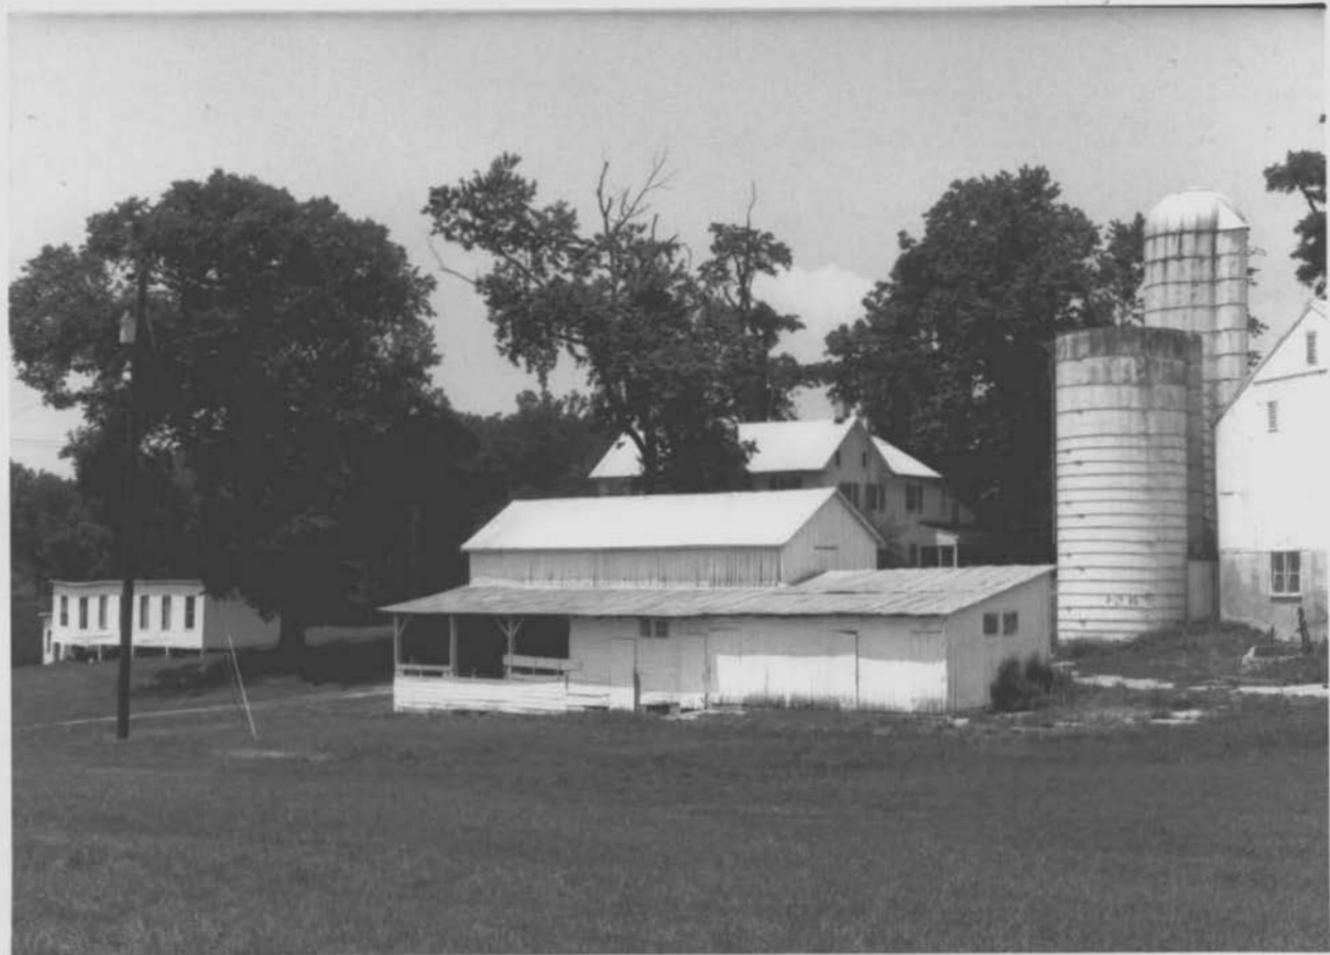
8/8

General view from south
