Survey No. F-8-116
John Garber Farmstead
Johnsville, Maryland
Private.

Ca. 1810-Ca. 1940

Survey No. F-8-116
John Garber Farmstead
Johnsville, Maryland
Frederick County

7.1 Description

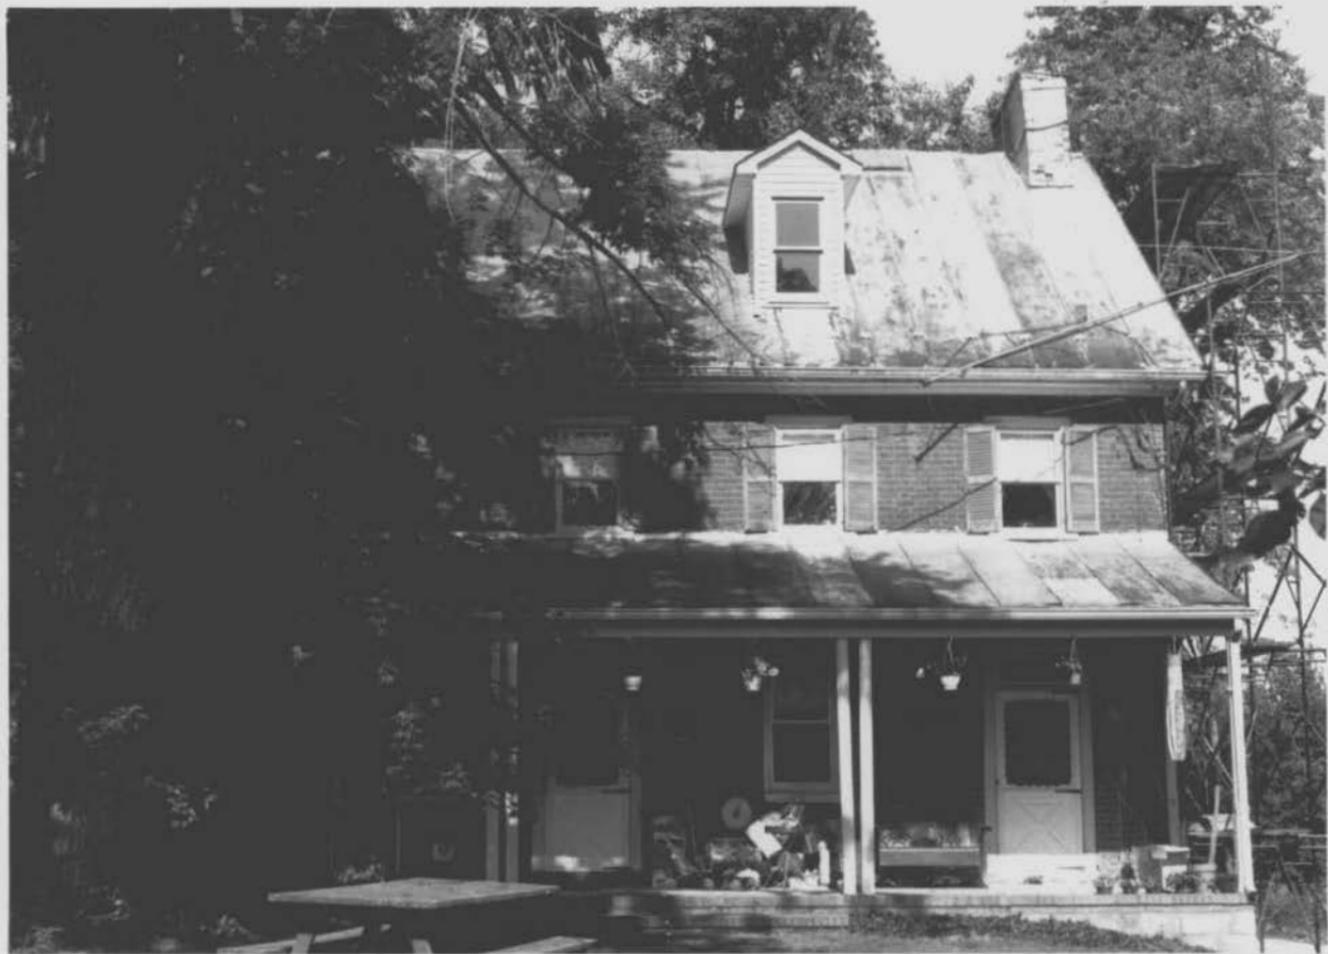
1/6

The dwelling house has two stories and a gable roof with its ridge at right angle to the road. Its principal elevation faces east. It has four bays in a flemish bond wall. The other elevations are in 5-course American bond. The bays on the east elevation are irregular, with four complete bays and an extra window opening on the first story. Two doorways are present, one in the north bay and one in the approximate center of the house. This may indicate two building periods, but no other evidence to support this has been documented. A shed porch extends across the elevation on the first story, with chamfered double posts; it appears to be an alteration of the mid 19th century. The doorways and windows have plain architrave trim with header jack arches. The doors are 6 panels with modern storm doors, 4-light transoms and plain lintels. The windows are 1/1 and louvered shutters flank the windows on the second story. The roof is standing seam tin with a modern dormer in the east side, just north of center. The side elevations have two bays and interior end chimneys. On the north elevation, the stone foundation is exposed and rehabilitation work is underway. A sliding glass door has been installed in the northeast corner of the basement level. At the time of survey, scaffolding is in place and repointing appears to be in progress. In each gable end elevation, there are two small square attic level windows with four lights each. The west elevation is dominated by a one story enclosed porch across the entire first level. It has eight 6/6 windows and is covered with brick-patterend composition siding. This addition appears to date from the early 20th century. On the second story are two windows with 1/1 sash and louvered shutters.

East elevation

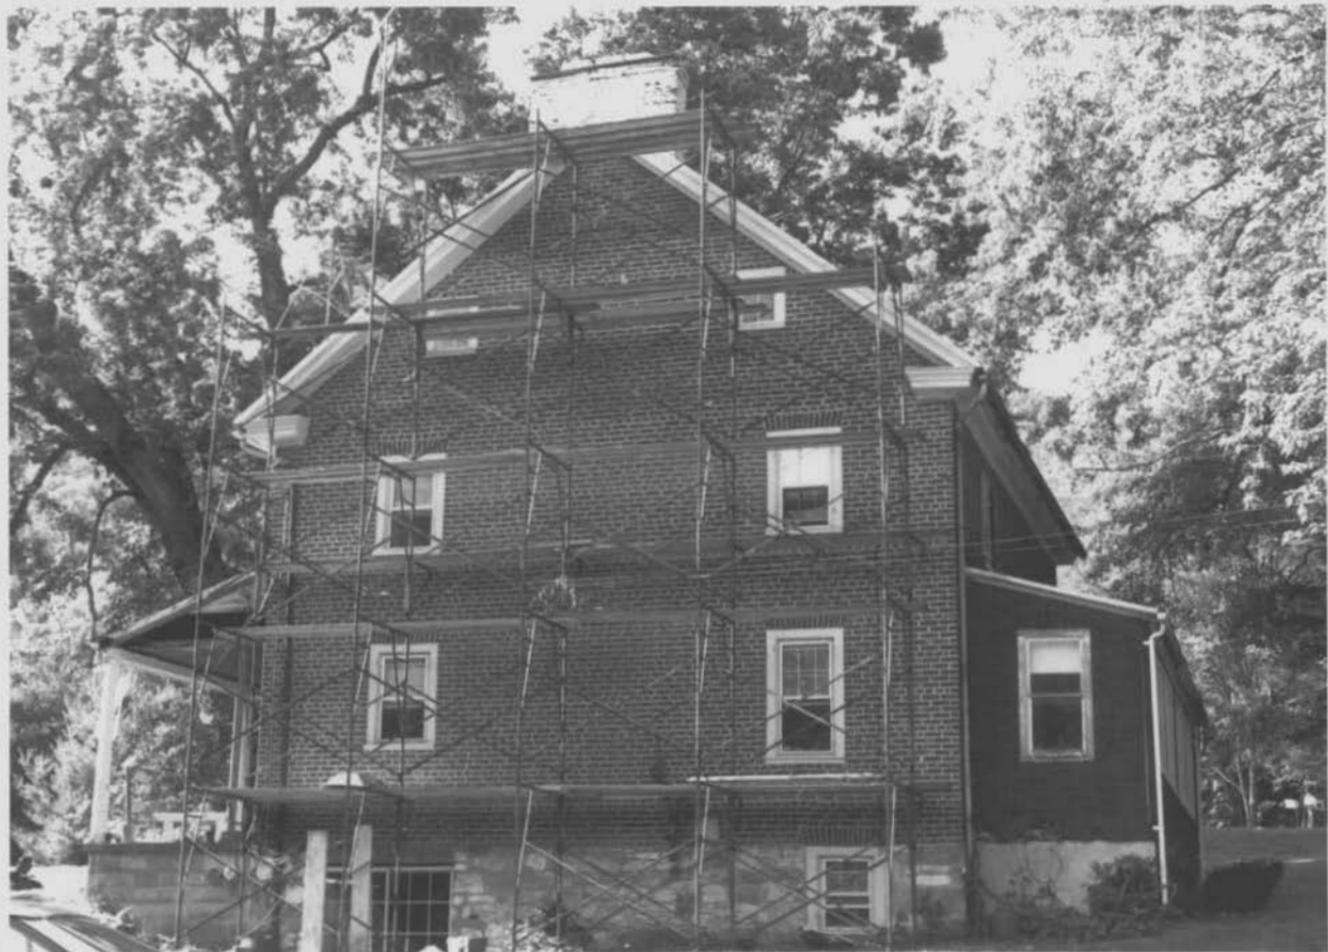
2/6

North elevation

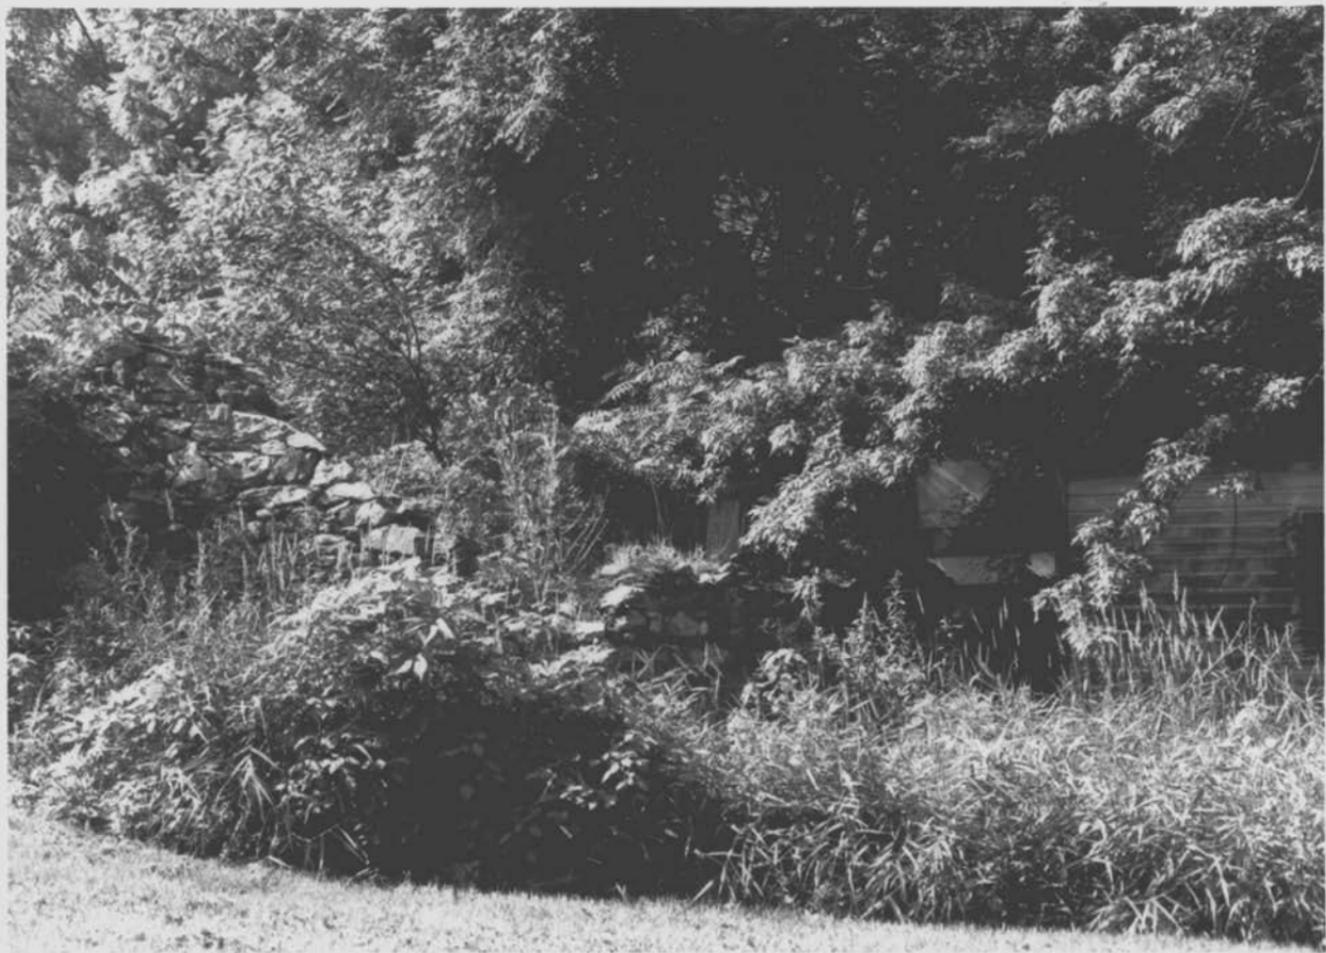
3/6

Summer kitchen: This is a frame, german sided rectangular building located about 20 yards north of the house. It was probably built in the last quarter of the 19th century. The interior is deteriorated, with the brick ruin of the fireplace on the west end of the building. The standing seam tin roof has evidence of a chimney opening which is now covered over. The single door is in the center of the south elevation. Two window openings without complete sash are located on the north elevation.

Springhouse ruin: The stone walls of a springhouse are located immediately north east of the summer kitchen. The spring has saturated the ground around both structures. The walls of the springhouse are partially deteriorated, but the structure had a gable roof and a three-bay south elevation with a center entry flanked by windows.

Springhouse ruin and partial view of summit
Kitchen, from north

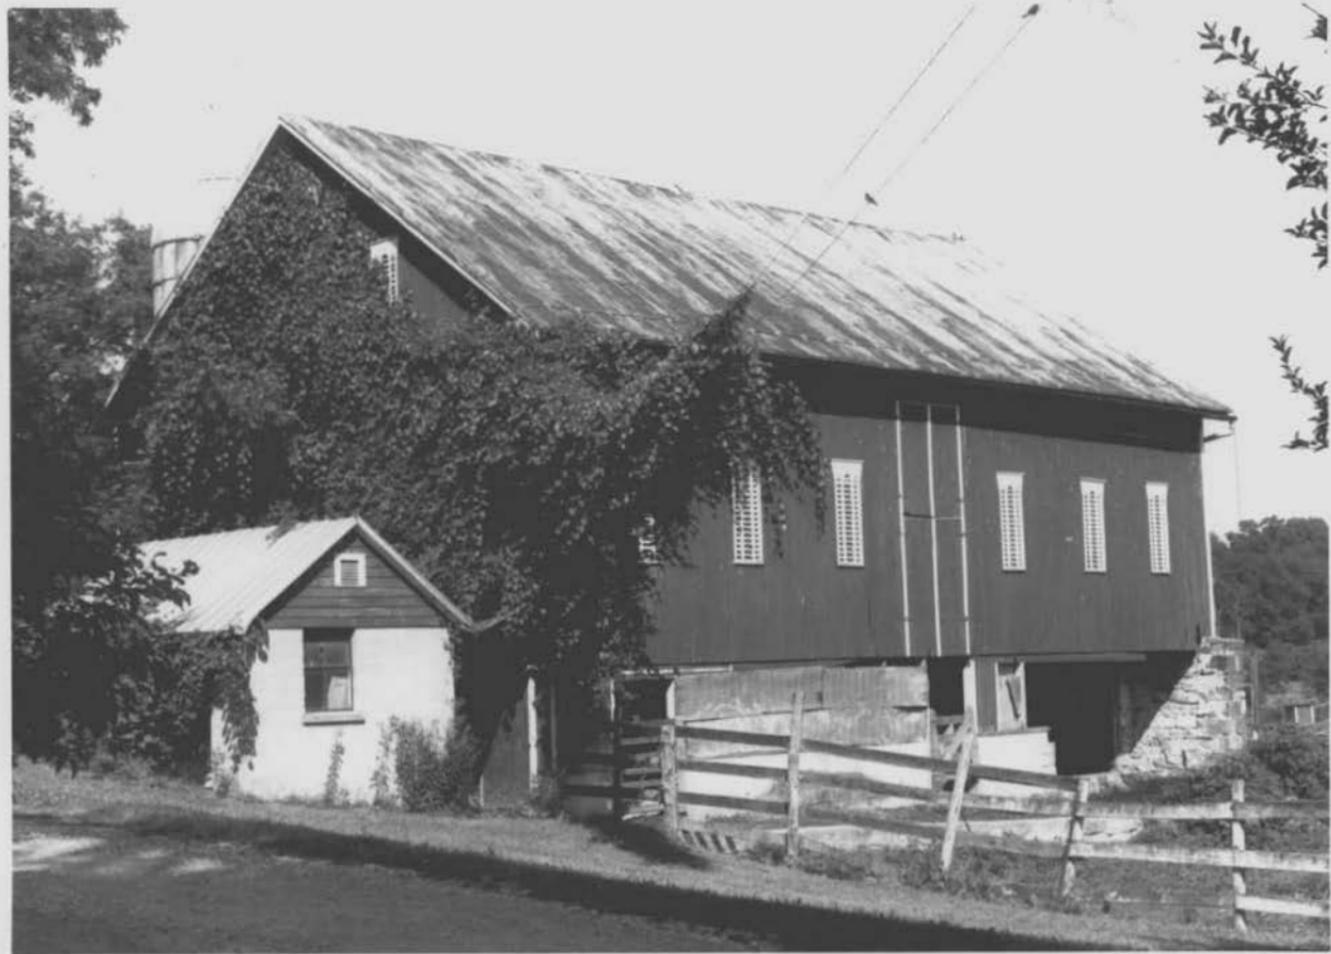
4/6

Bank barn: The barn has a stone base and a vertical sided frame upper structure. It is sited at a diagonal to the road with the ramp on the southwest elevation. The forebay on the northeast elevation is partially enclosed, undoubtedly for a milking parlor. This is a typical alteration of the 1930's due to government regulation of the dairy industry. The frame section has decorative vent panel surrounds on all elevations. The roof is both standing seam tin and corrugated metal.

Bank barn, east elevation

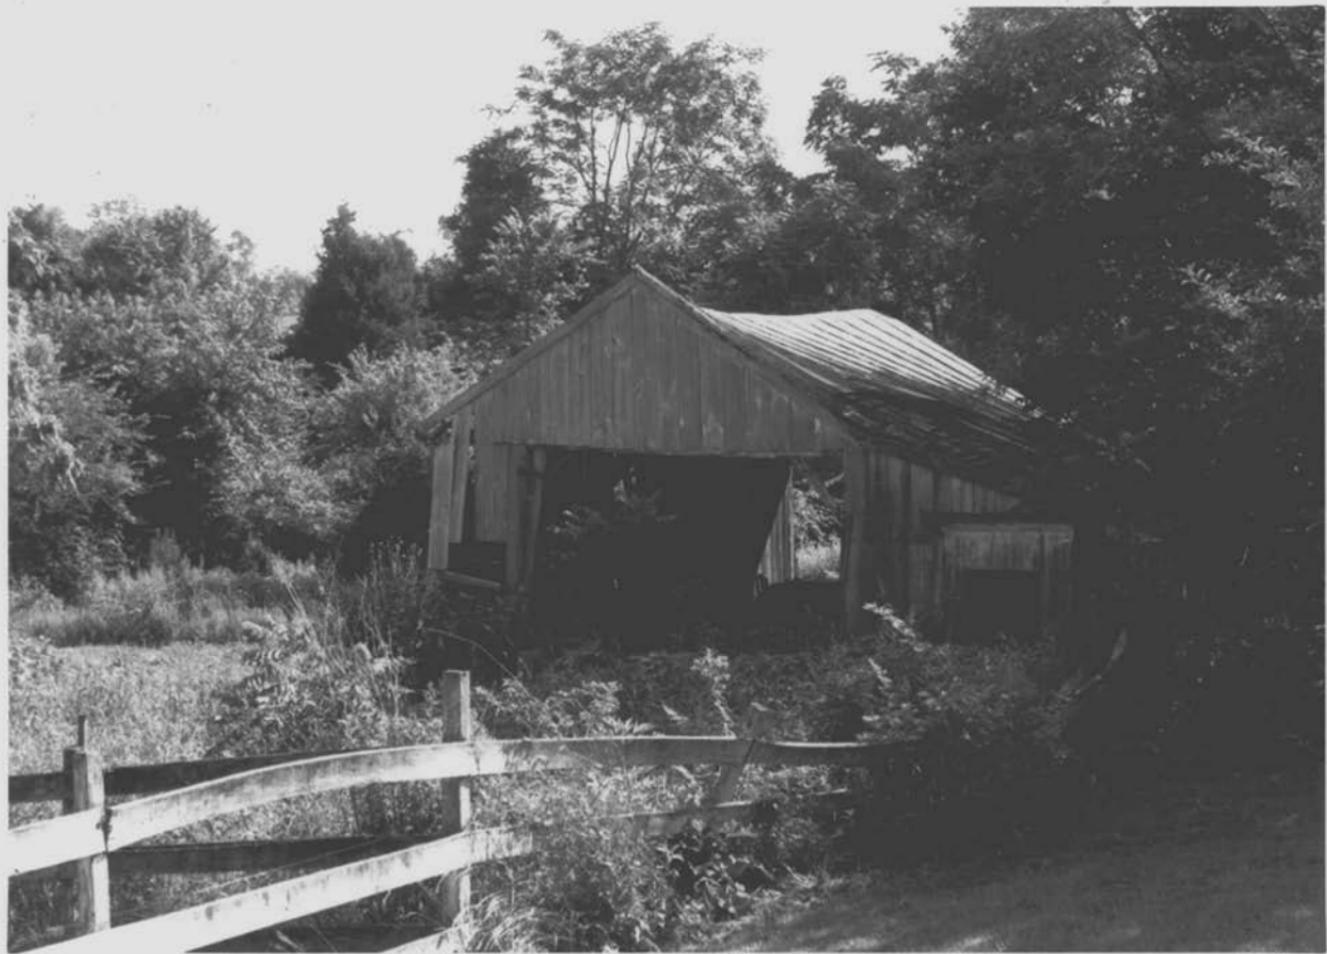
5/6

Privy: This is a square frame building with a corrugated metal shed roof and tongue and groove siding. The door is missing. Located near a corn crib in the agricultural outbuilding group, the privy, built in the last quarter of the 19th century, was probably moved from its original location nearer the house at an unknown date.

Pull-through corn crib: This is a double-sided corn crib built about the last quarter of the 19th century. It has vertical siding and a shed for equipment on the north elevation. The standing seam roof is deteriorated and original shingles are visible. The corn crib is now used for storage.

Corn crib and privy, west elevation

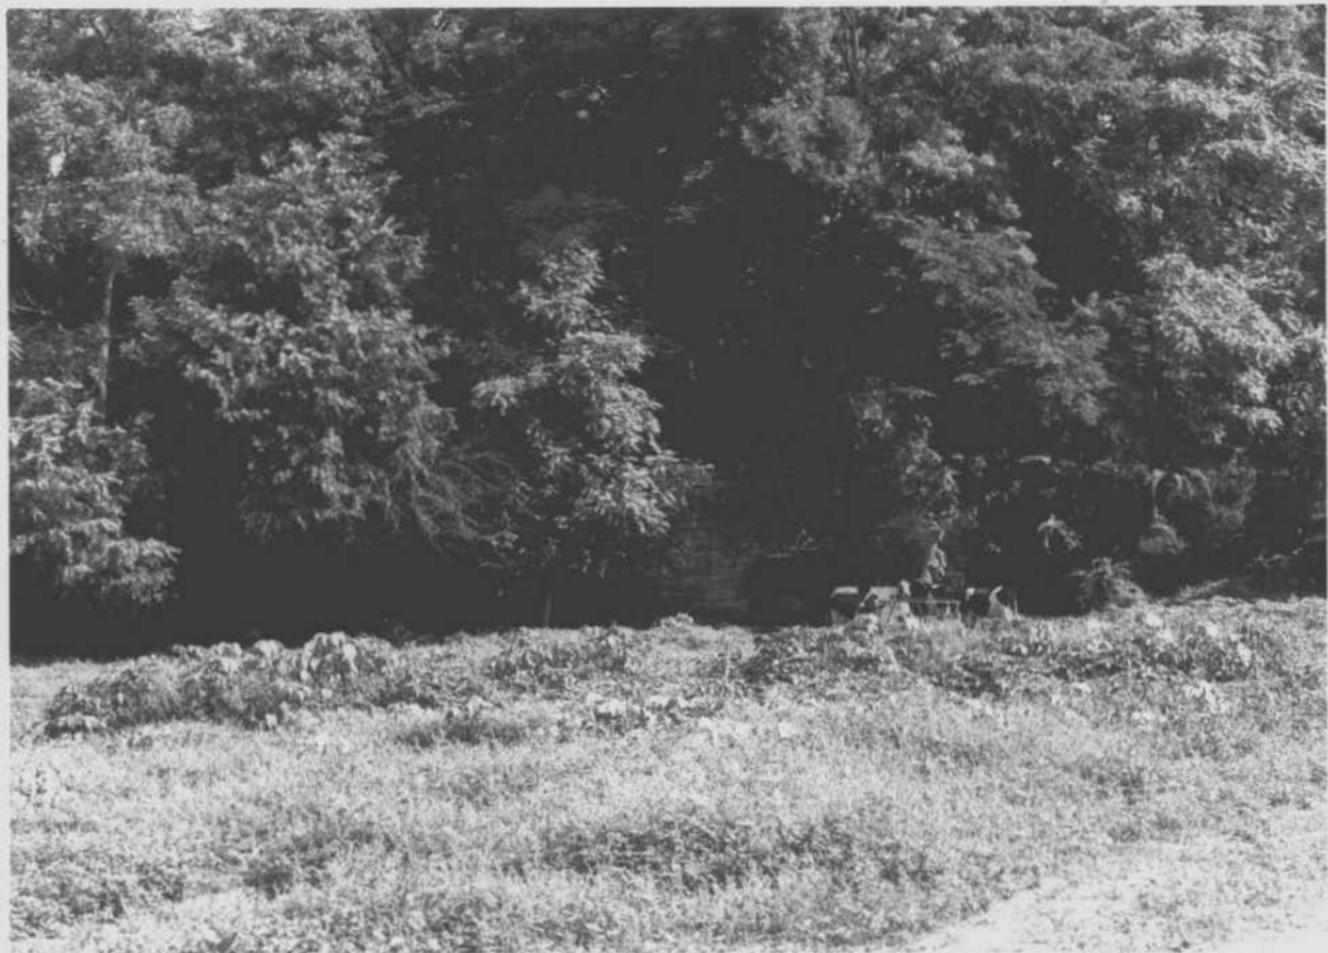
6/6

Lime kiln: The kiln is barely visible under heavy vegetation on the cliffside north of the farmstead, but is more easily seen during the winter. It has two arched openings at the base of a rubble stone stack built into the south side of the rock outcrop. The arches are outlined with three courses of header brick. The kiln may have been built in the middle third of the 19th century.

Lime Kiln, south elevation
