Herring Farmstead

Johnsville, Maryland

Survey No. F-8-117
Herring Farmstead
Johnsville, Maryland
Frederick County

**Maryland Historical Trust
State Historic Sites Inventory Form**

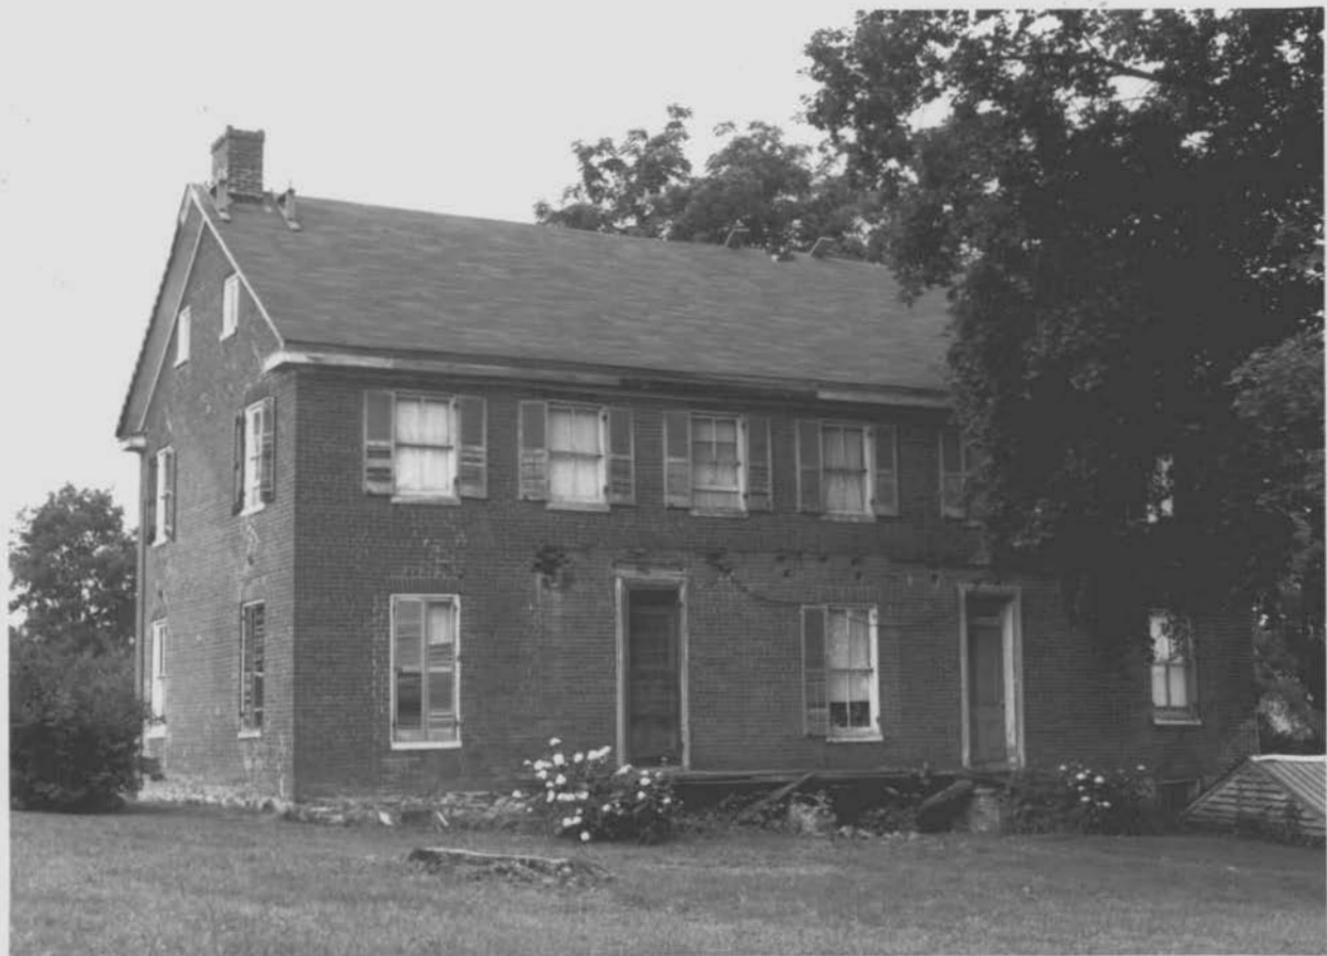
1/7

The dwelling house is a two-story rectangular brick building with a gable roof running east-west. The principal elevation is the north side, which is 5-course American bond, as are all the elevations. The north elevation has an irregular bay arrangement, indicating possibly two or more periods of buildings, but little exterior evidence confirms this other than a possible removed center chimney. The first story has five bays and the second story has six. Two entrances with bolection molding surrounds, commonly used in 18th century buildings, alternate with windows with 2/2 sash. The upper story windows have some louvered shutters which are deteriorated. The window openings on the first story have gauged brick arches and the second story has flat header arches. The doors are four panel types with round arches formed by moldings in the upper section, a typical pattern of the middle third of the 19th century and later. The openings have plain wood lintels and single-light transoms. Evidence on the brick surface indicates a shed one-story porch has been recently removed. The deck is greatly deteriorated. The stone foundation is exposed on the north and west elevations. The roof is composition and has a box cornice. The side elevations on the east and west have interior brick chimneys flanked by two window bays. The south elevation is even more complex than the north elevation. It has three entrances and six bays with an extra window inserted between the three-bay halves of the elevation. A cellar entrance is located below the first floor southwest corner bay. A one-story porch was also removed from this elevation and the wood deck appears to be new. At the time of survey, a scaffold for roof repair was in place in the center of the elevation. A slight variation in the roofline suggests an interior chimney was removed, a possible indication of the original form being a three-bay house later expanded. The first story openings have gauged arches and the second story has header flat arches. The doors have glazed upper panels ~~on both the first and second stories~~ above two base panels. Two window openings on both the first and second stories have been filled in with brick.

North elevation

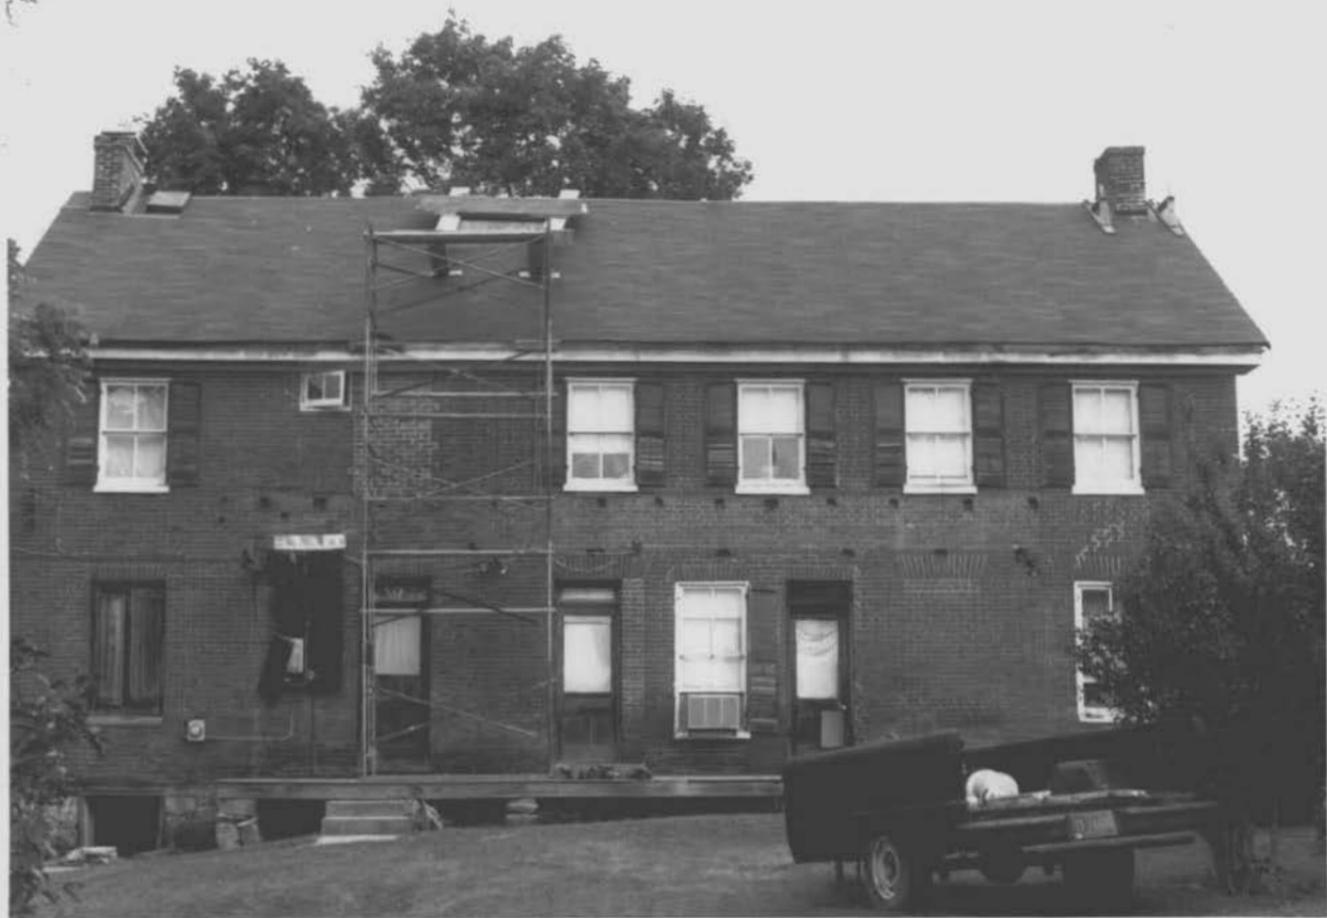
2/7

South elevation

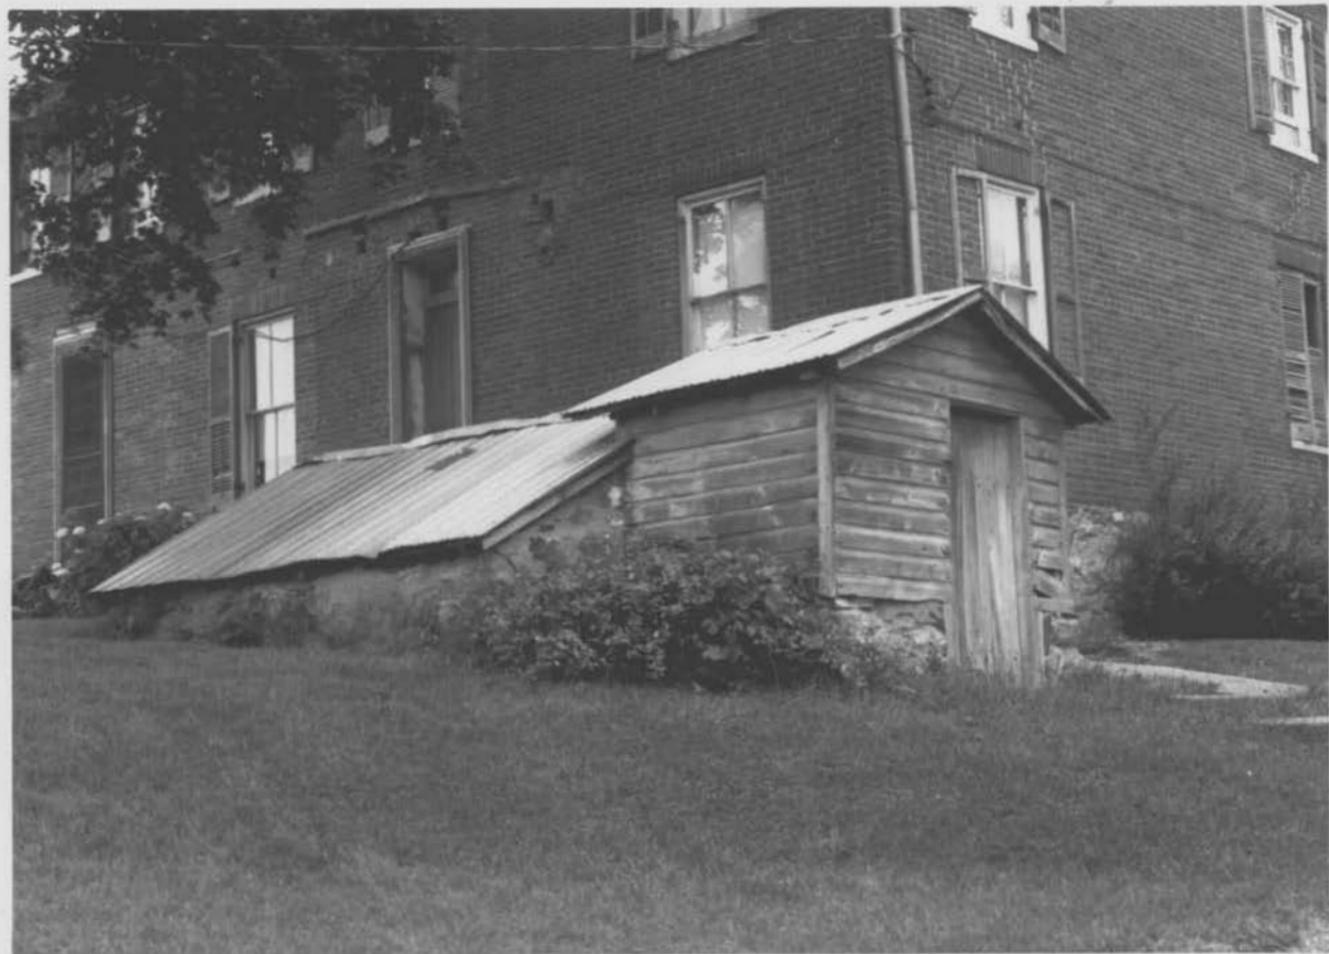
3/7

Springhouse: This is a stone structure set into the ground immediately north of the northwest corner of the house. It has a projecting doorway with a gable roof on the exposed west elevation. This section has clapboard siding and a vertical board door. Both sections have replacement standing seam metal roofs. The form of the springhouse is more typical of an icehouse. Confirmation of its original use may be made by access to the interior, which was not available at the time of survey. The springhouse is possibly dated in the second quarter of the 19th century due to its form and materials.

Icehouse/springhouse, northwest corner
view

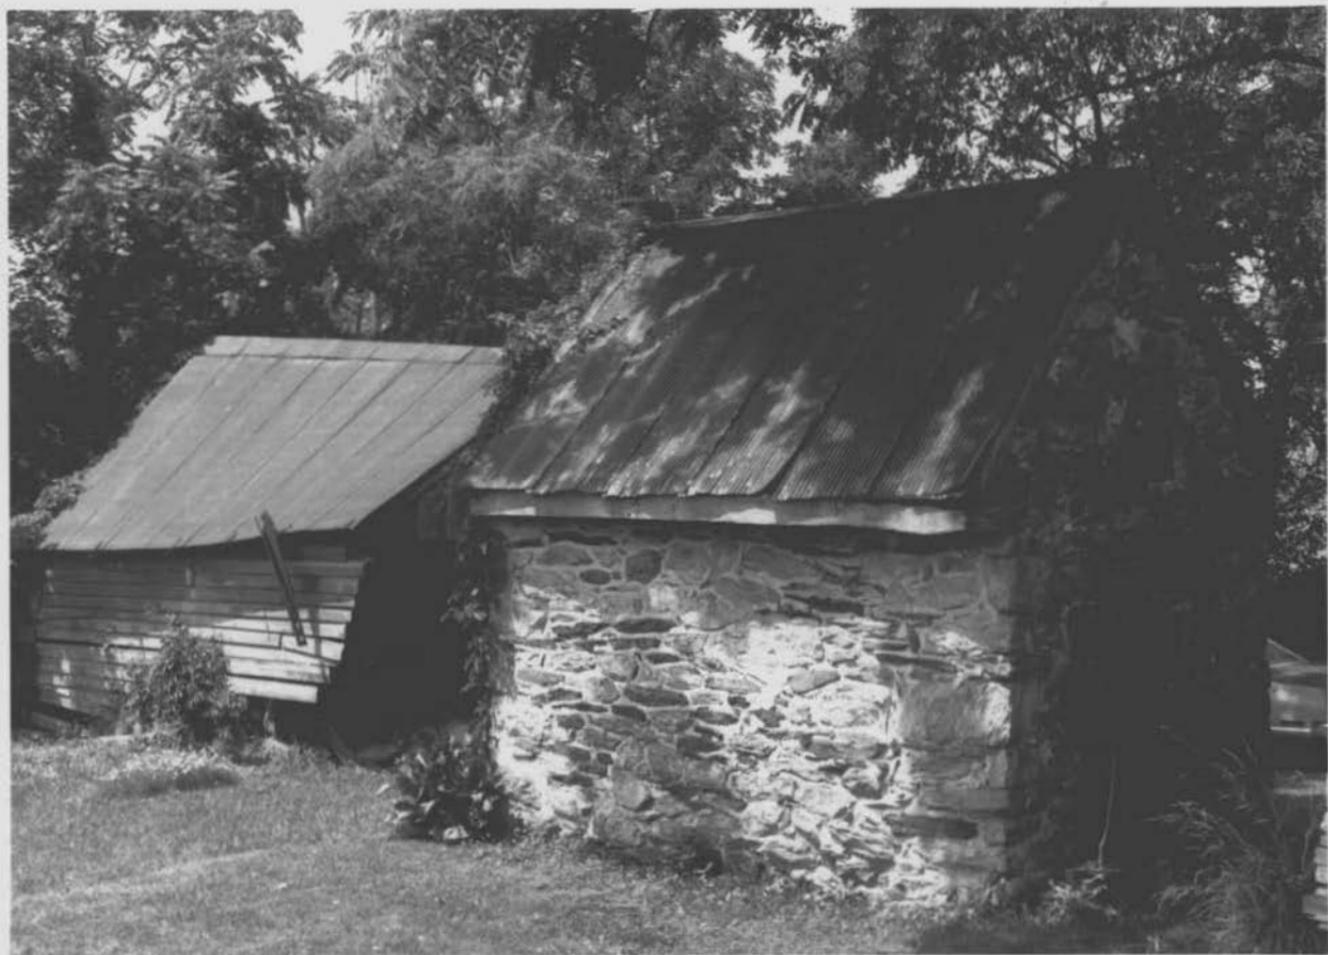
4/7

Deteriorated shed: The shed is located about 10 yards south of the southwest corner of the house. It has a shed roof of corrugated metal and its rear wall is partially collapsed. The shed configuration suggests a chicken house, but it may have had other domestic uses. It is located immediately in front of the door to the smokehouse, suggesting it was a late 19th century addition to the domestic group.

Smokehouse: This is a stone one-story rectangular building with a single door on the north. The door has been cut down to half-size and the building is now used for storage. The rubble stone exterior has been repaired with concrete at the southwest corner. The gable roof is corrugated metal and a vertical vent is located just below the south gable peak. The smokehouse may be contemporary with the springhouse, from the second quarter of the 19th century.

Smokehouse and shed, east elevation

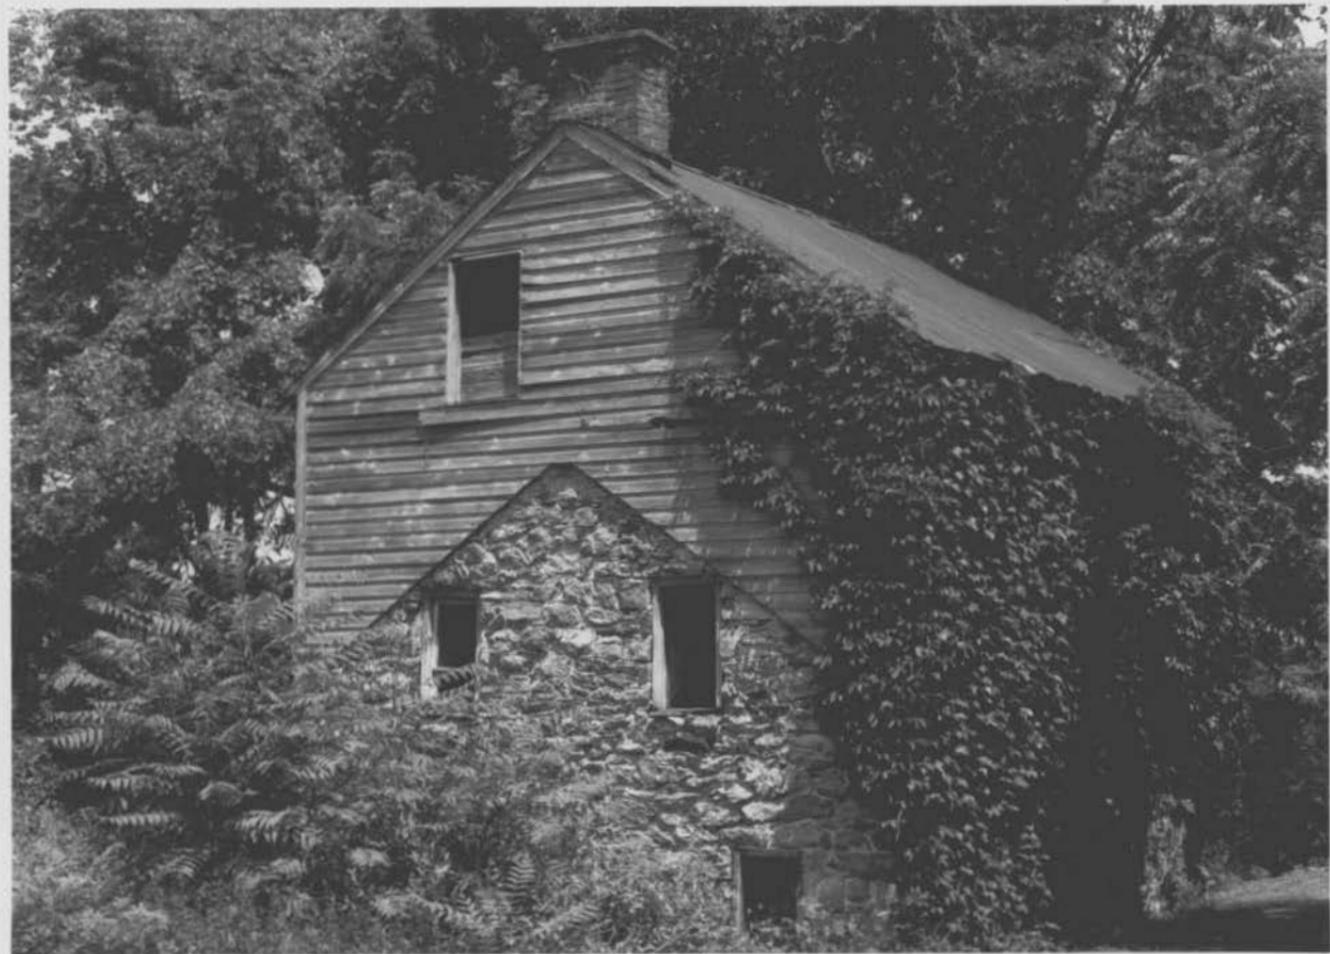
5/7

Summer kitchen: This is a two-story rectangular building with a stone lower level exposed on the west elevation and a frame upper level with a gable roof of corrugated metal. A ghost of a lower gable-roofed extension or other section is visible on the south elevation. A corrugated metal shed canopy is attached to the west elevation over the lower level. On this elevation, the stone section has two doorways and three alternating window openings. The sash is deteriorated, but is mostly 6/6. The doors are vertical flush boards. The interior is filled with debris, but a brick interior chimney is visible on the south wall. A chimney rises above the roof at the south gable end. The upper section is deteriorated, revealing under the clapboard siding a plaster and lath interior wall. A single four-panel door is located in the center of the north elevation, but the access stairway or porch is missing. The dating of the summer kitchen is difficult, but the stone section may be older than the frame upper portion, possibly built about 1830. The plaster and lath wall indicates the second quarter of the 19th century also, but further research on the building and its interior must be done to pinpoint a time of construction. Its use as possible slave quarters may also be confirmed by interior documentation and further research on the historical owners of the property. A second theory on its function may relate to the nearby saw and grist mill sites on the creek to the west of the farmstead. No sites have been confirmed in the area, but their proximity as shown on the 1873 Titus Atlas Map must be considered as having some possible connection with the Herring Farmstead, although no mention of these buildings is found in the land records regarding the property.

Summer kitchen / "slave quarters", south
elevation

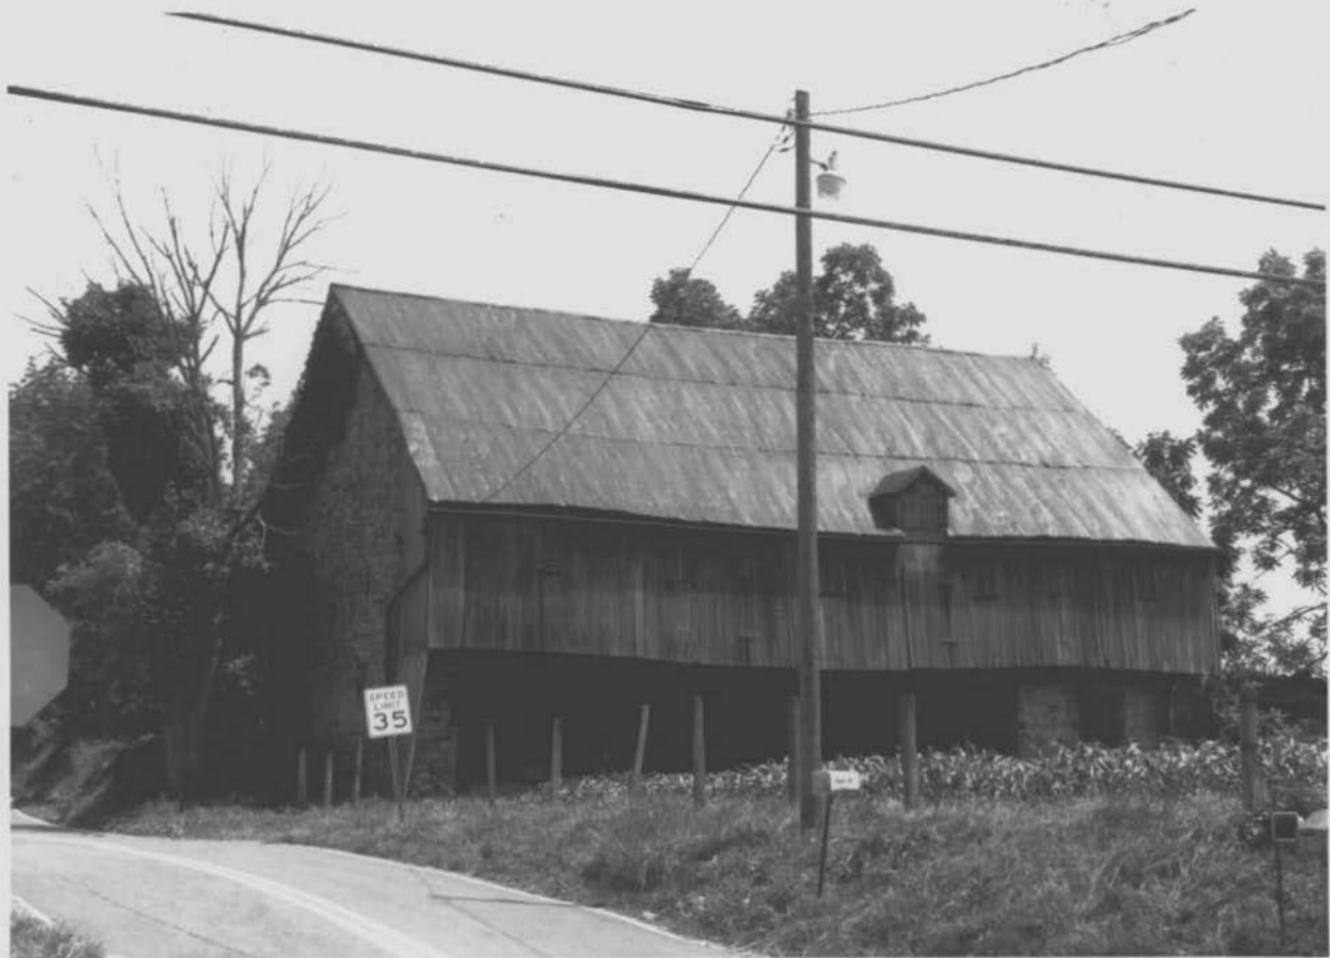
6/7

Stone barn: This building was possibly erected in the first quarter of the 19th century and has a rubble stone structure with a frame forebay on the south elevation. A loading door in a single dormer is located off-center in the standing seam tin roof on the south elevation. The frame section has beaded vertical siding. The lower level of the barn has not been enclosed and reveals the remnants of at least two feeding aisles, several mangers and other wood elements. Some of the supporting beams and timbers of the barn structure appear to have been replaced or added to give further strength. On the east and west elevations of the stone section are vertical vent slit openings. The doors to the barn floor are tongue and groove sliding doors, apparently replacements of the last quarter of the 19th century.

Bank barn, south elevation

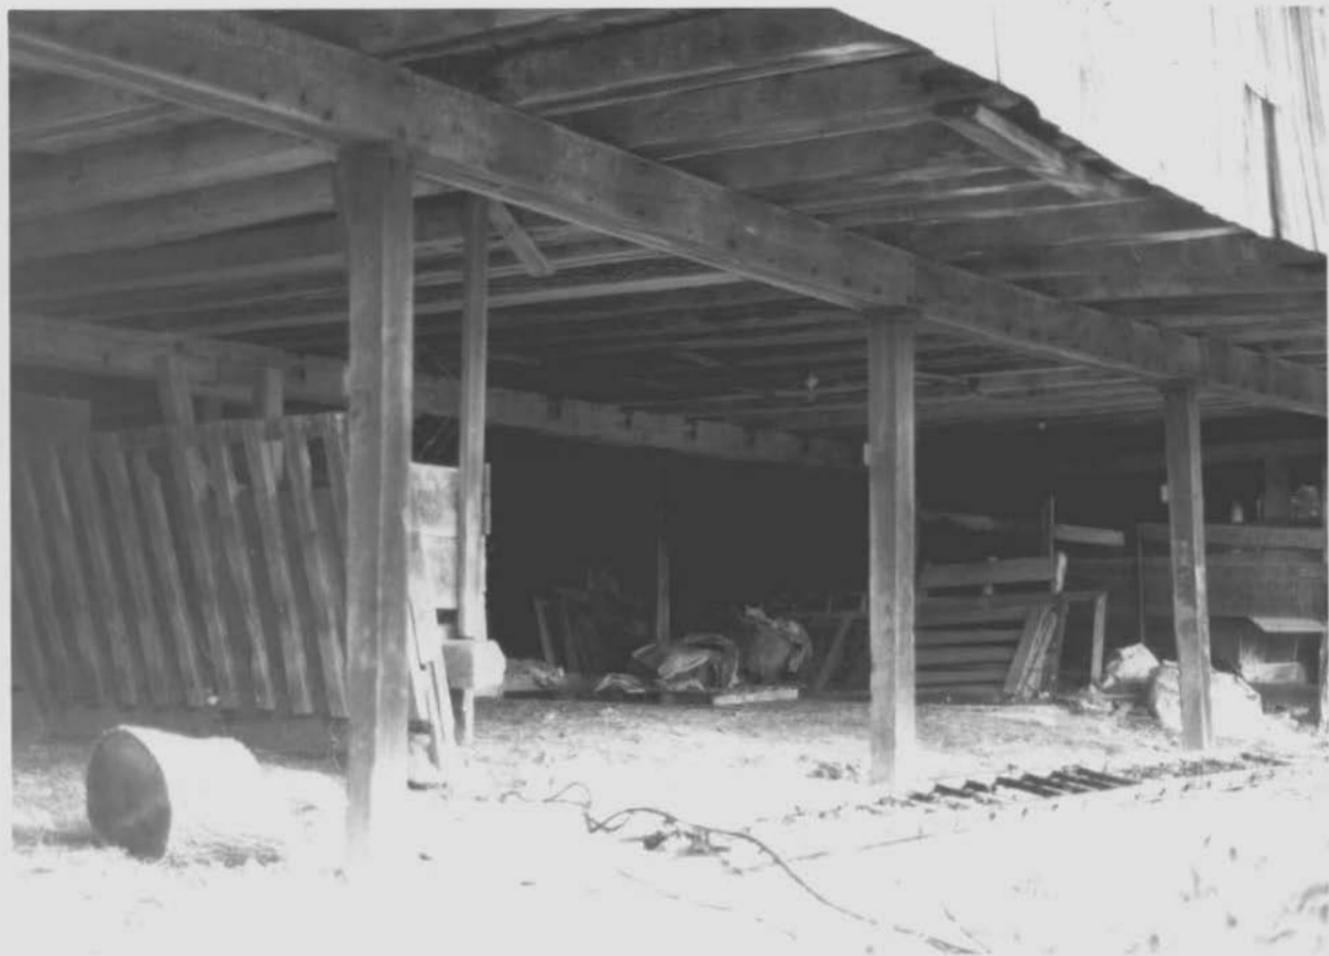
7/7

Bank born, forebay detail
