F-8-118
Pearre-Ensor Farm

Survey No. F-8-118
Pearre-Ensor Farm
Unionville, Maryland vicinity
Frederick County, Maryland

Maryland Historical Trust State Historic Sites Inventory Form

7.1 Description

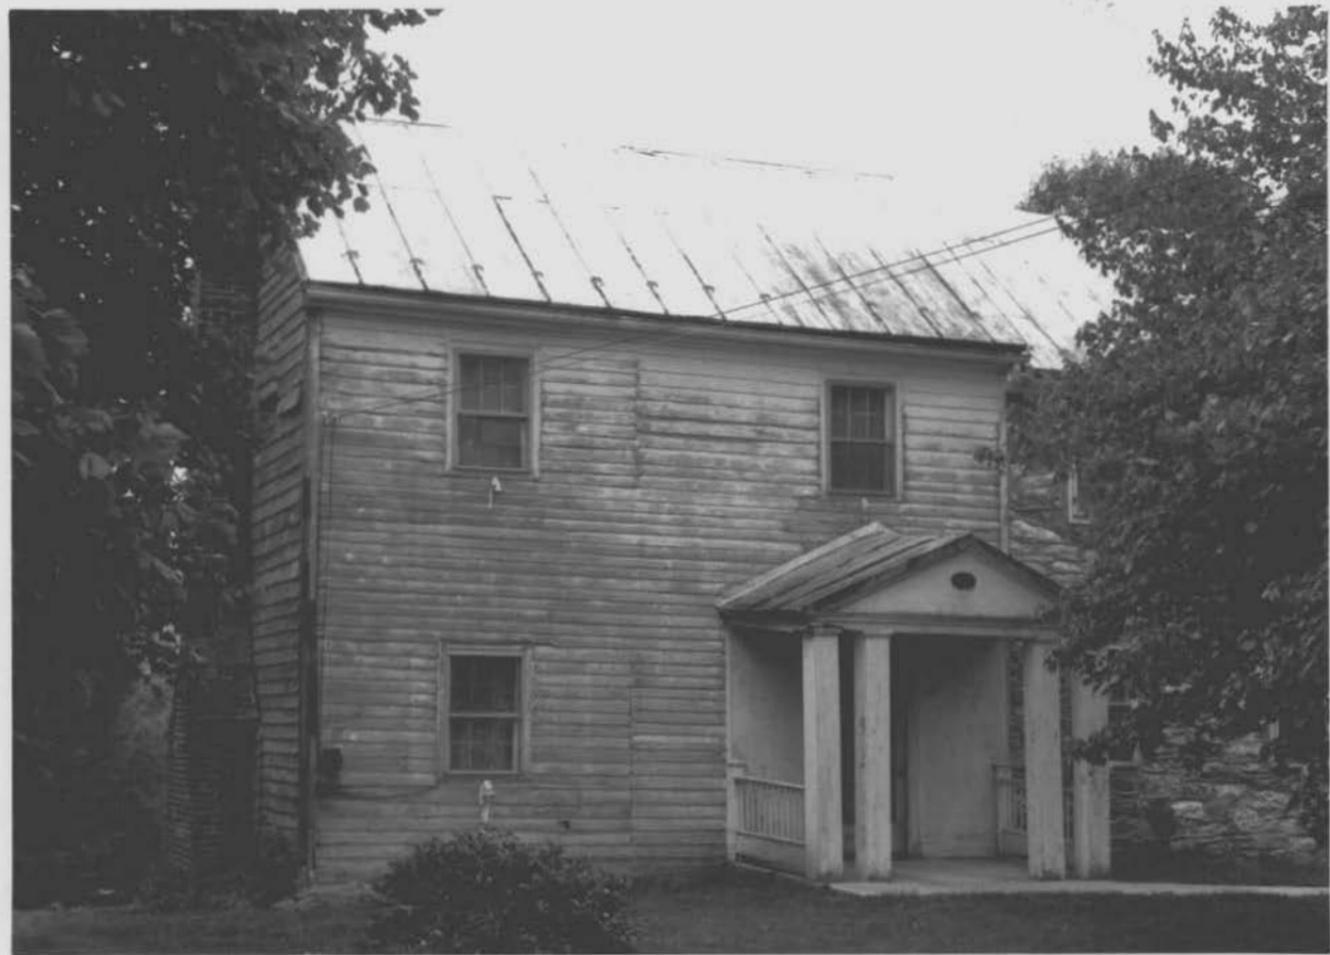
1/6

The house has two distinct sections clearly articulated by different structures and roof heights. The log section is two stories in height, with a probable three-bay original west elevation. The center opening of this elevation has been covered as breaks in the siding indicate, and the present doorway is located in the southernmost bay of the log section. The log part is covered with beaded clapboards. The window openings appear to have early 20th century architraves with 6/6 sash of the same period. The standing seam tin roof has a box cornice. An exterior brick chimney, probably a replacement since 1965 of the original, is located on the north elevation. The entrance is sheltered by a gable-roofed, pedimented entry porch with pairs of square columns at each corner. Centered in the pediment is a Frederick County Landmarks Foundation plaque, No. 94. The side balustrades of plain square balusters connect with the house wall and the columns. The door is a 6-panel type under a mid-20th century 12-light outer door. A 6-light transom completes the doorway. The stone section has a two-bay elevation adjoining the log section and extends eastward from the southeast corner of the house to form a two-story ell. The rubble stone has been repointed probably in the early 20th century in "gravevine" style. The windows in this section are 6/6 and have plain architraves. The cornice is boxed, as in the log section. On the south elevation of the main section is an exterior stone chimney with a brick top. It has been repaired and may be largely a reconstruction of the mid-20th century. The south elevation of the ell part has a two-story porch with a screened-enclosed upper level and a concrete deck. The stone foundation is exposed under the deck where the grade slopes away to the east. On the east elevation of the ell is an entrance to the cellar level with a modern entry porch with a gable roof and pediment. Above it is a recent 6/6 window and at the attic level are two small square windows. On the east elevation of the log section are three bays with a center entrance. A two-level porch enclosed by screens extends across the long section and the north elevation of the ell. A concrete patio is located at the cellar entrance of the ell. The ell windows on the north elevation have plain corner blocks and lintels. The interior of the house was inaccessible for this survey.

West elevation, log section

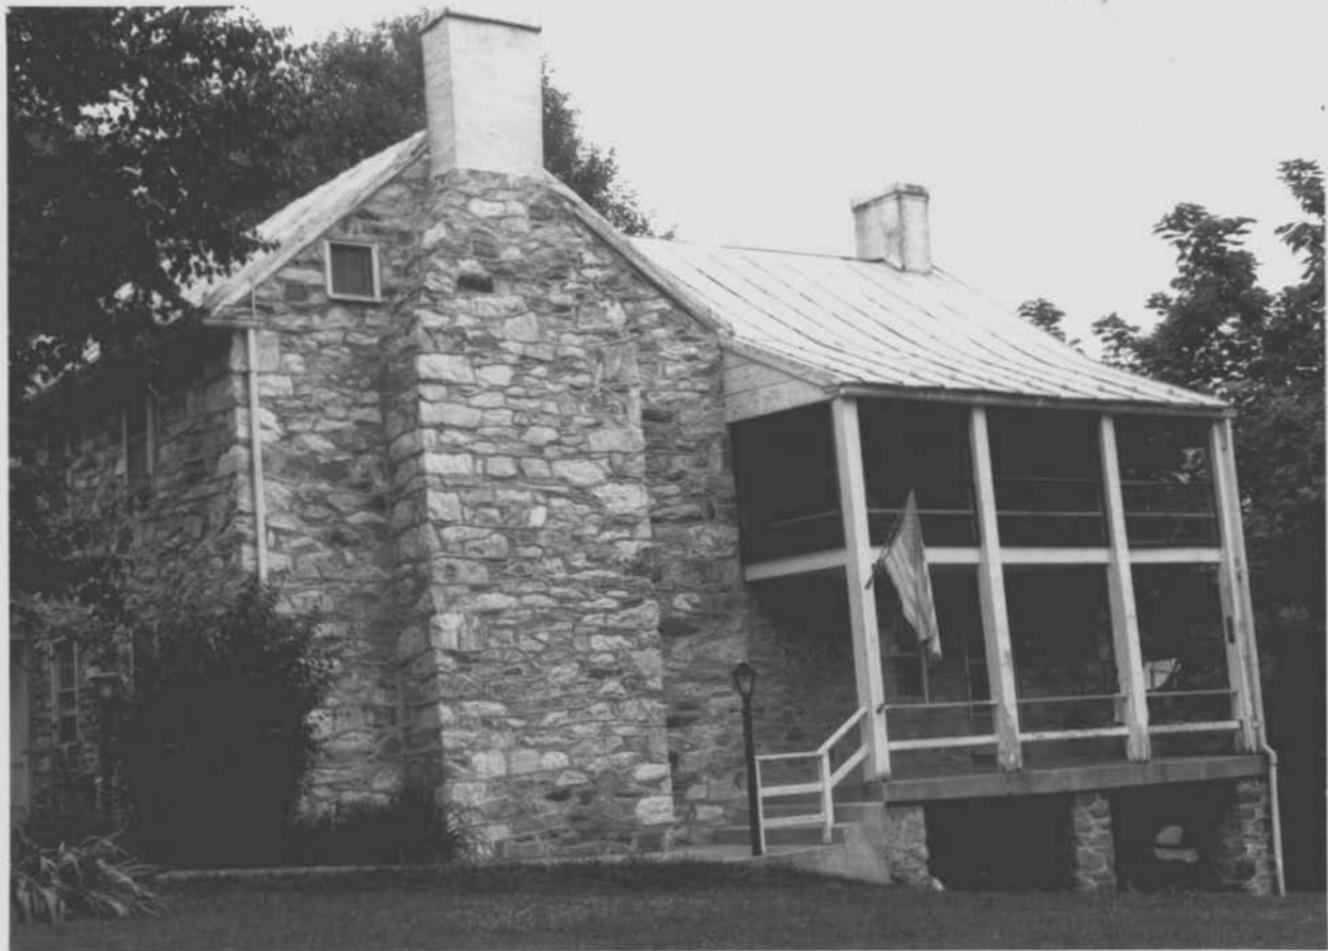
2/6

South elevation, stone section

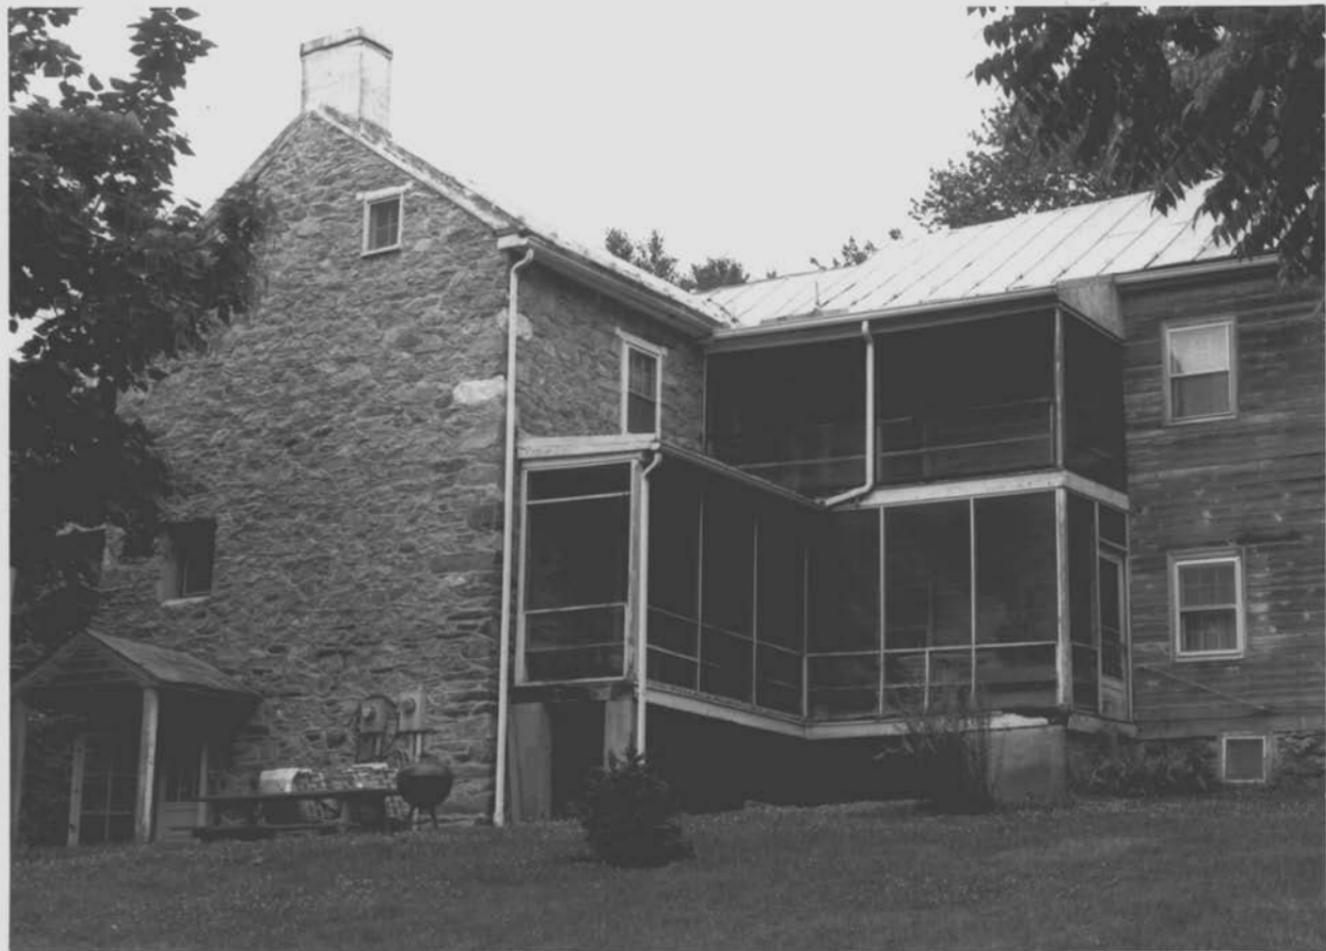
3/6

East elevation

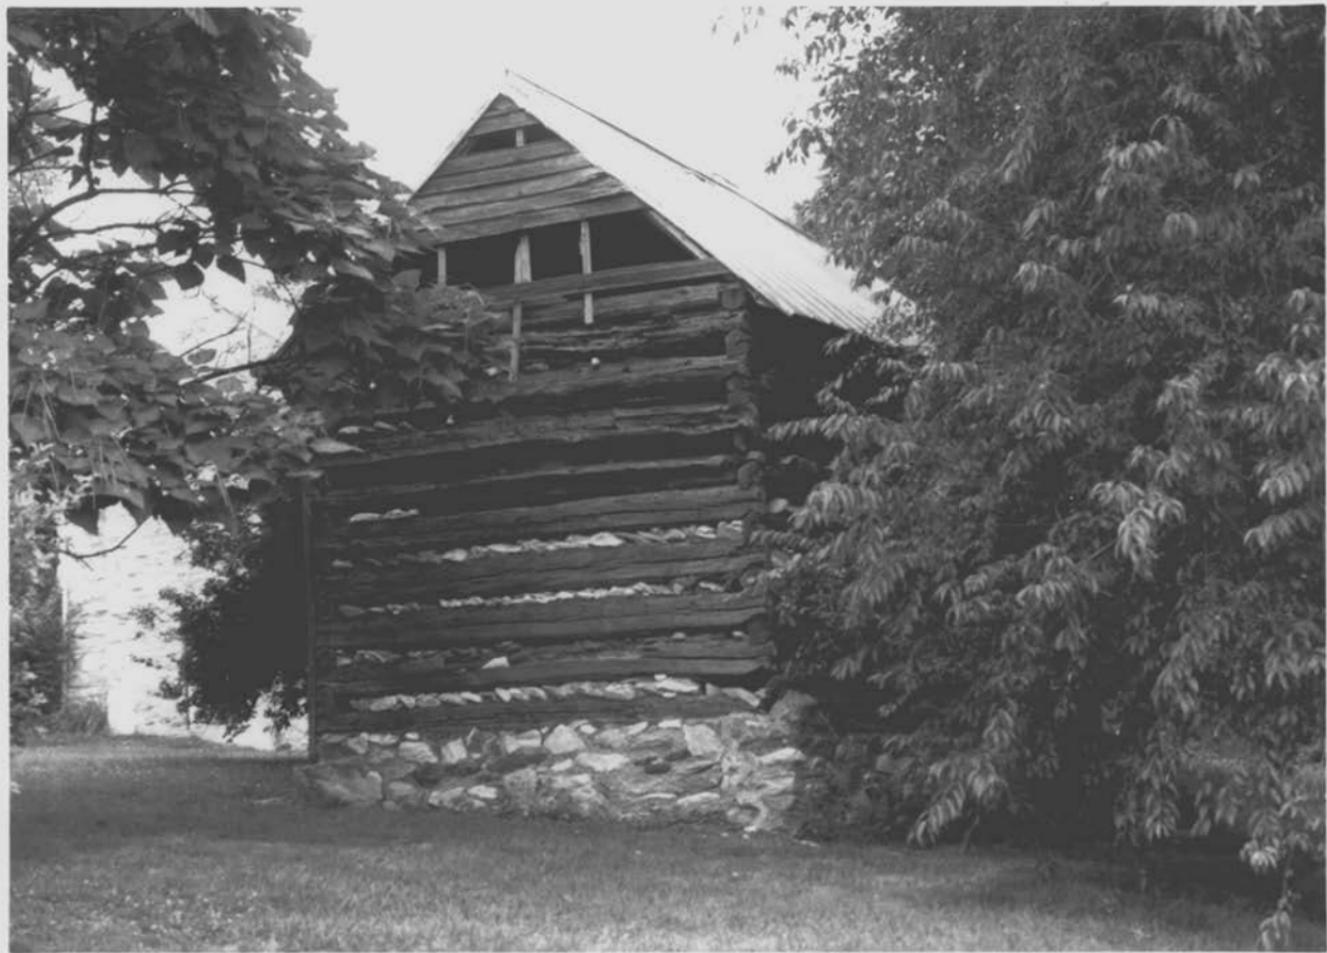
4/6

Log smokehouse and frame summer kitchen: This is a two-section single story building with the log section on the south end. The log structure has stone nogging. A single door is located on the west elevation. The upper walls of the log section are deteriorated and open to weather. The frame section is in better condition, with clapboard siding over plaster and lath walls. A standing seam tin roof covers both sections.

Smokehouse, south elevation

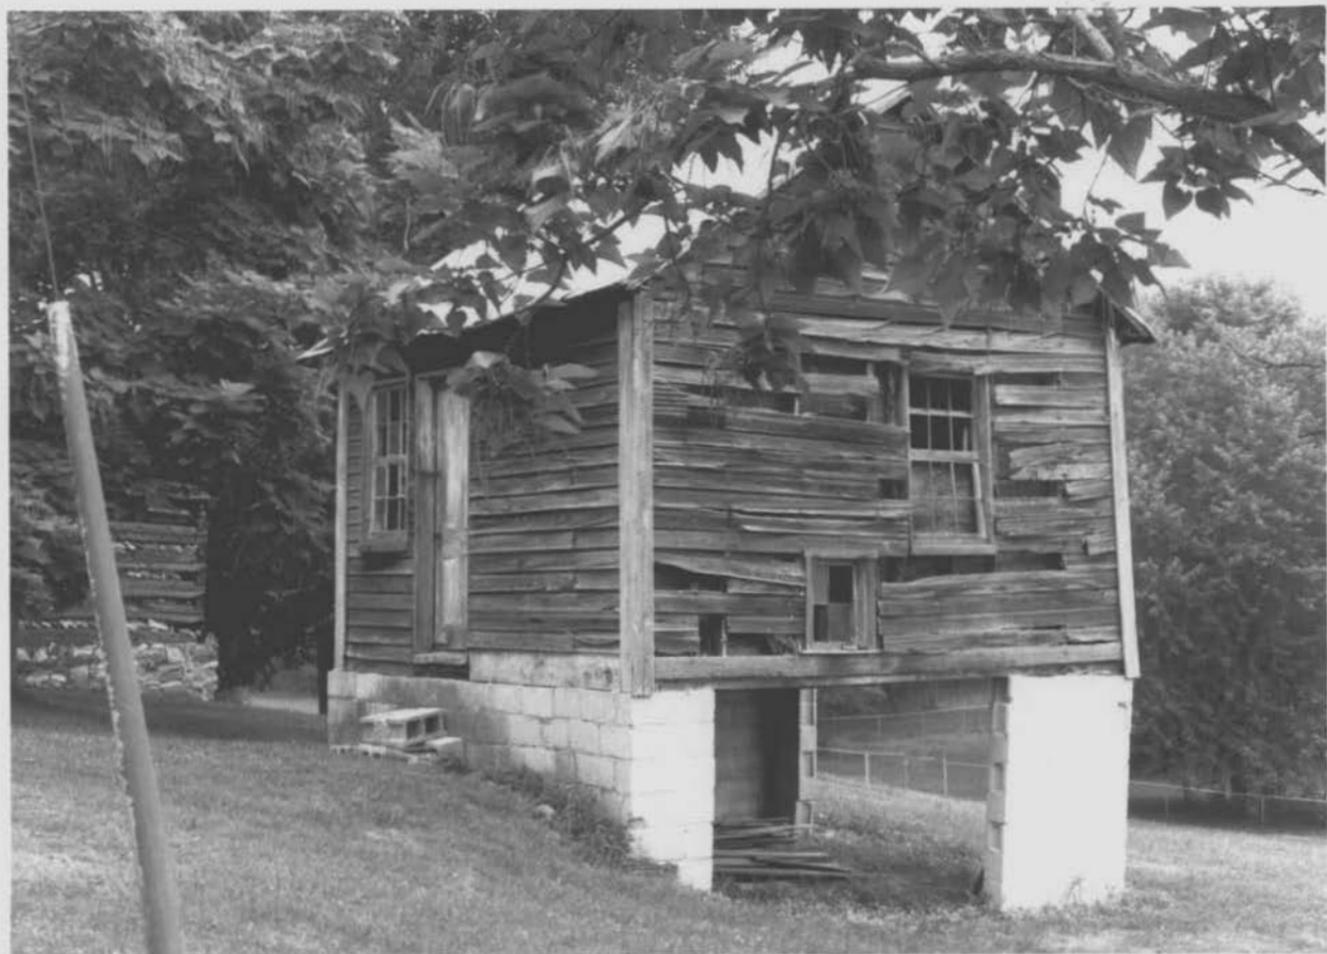
5/6

Frame building: This is a single story frame structure with a rectangular plan on a concrete block foundation, apparently a recent replacement of the probable original stone foundation. The slope of the site reveals the concrete block on the east where a storage area is formed under the building. The upper structure is covered with german siding and has a single four-panel doorway on the west elevation flanked by a 6/6 window. The gable roof is corrugated metal. Its function is unknown.

Frame out building, southwest elevation

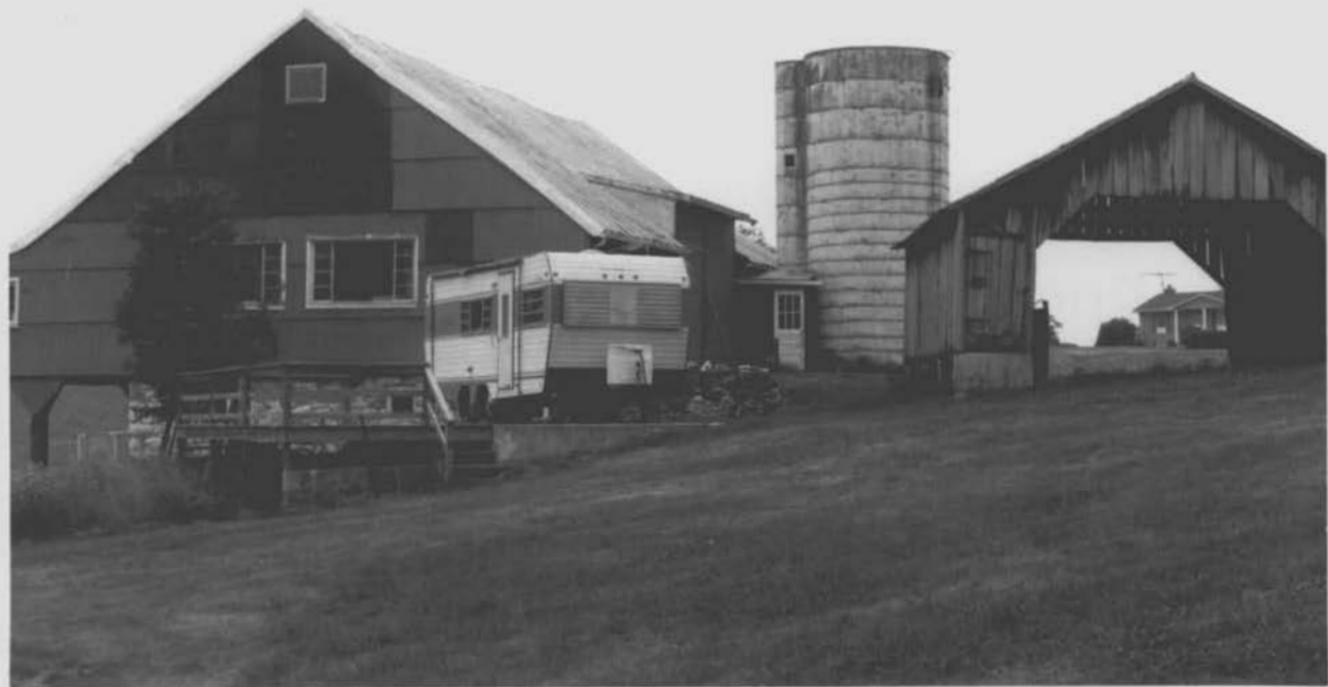
6/6

Corncrib/wagon shed: The ca. 1875 pull-through corn crib has double granaries on each side and is covered with vertical board siding and a corrugated metal gable roof. The foundation is concrete block, undoubtedly a replacement of the original stone.

Bank barn: The ca. 1875 bank barn has been considerably altered with the addition of plate glass windows and the enclosure of the forebay on the southeast elevation. The building has horizontal siding and replacement doors on the west elevation.

A 1960's or 1970's shed addition is attached to the southwest elevation and a concrete block milk house of the 1940's is located near the southwest corner. Concrete block was also used to enclose part of the forebay for a milking parlor in about the same time period. This now has a band of windows running across the entire enclosed forebay. A dormer projects from the southeast roof which is covered with standing seam metal.

Barn and corn crib/wagon shed, view from
north east
