F-8-119
Henry Baker Farmstead

Ca. 1825-1940

Unionville, Maryland vicinity

Frederick County, Maryland

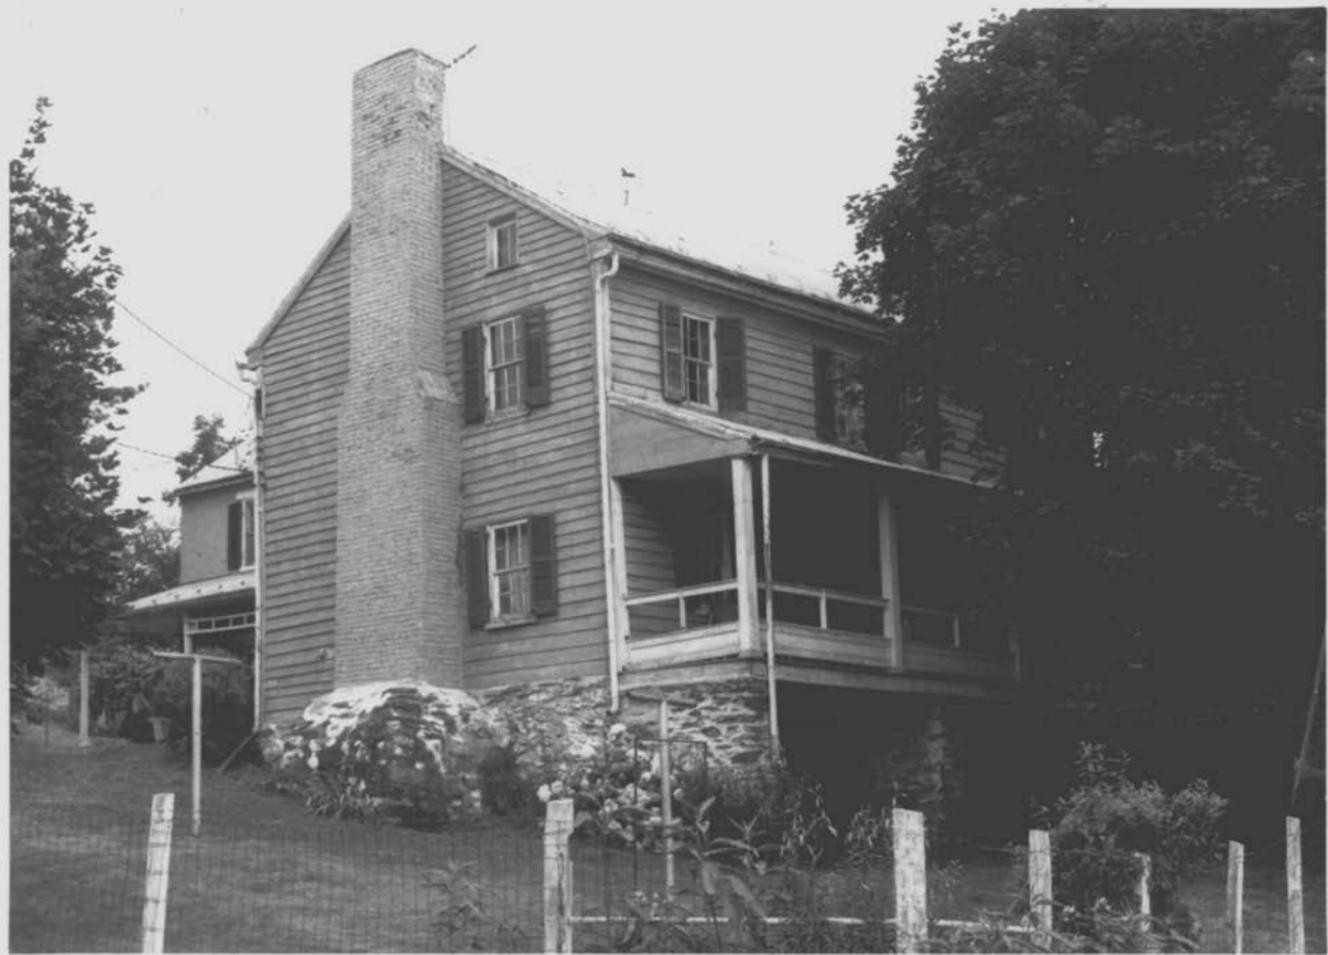
1/11

East elevation

The dwelling house has two sections, one a two-story log building with four bays facing east and a two-story brick ell extending west from the northwest corner of the log section. The log section is covered with clapboard siding and has a one-story porch extending across the width of the elevation. The topography on the east side of the house slopes away, exposing the stone foundation of the house and the porch and leaving storage niches under the porch. The access door to the cellar is under the porch in the southernmost niche. The porch has square columns and a balustrade with paneled bases. The log section has exterior end chimneys with a partially exposed stone base on the south chimney. The facade has two doorways in the center bays, one with a bullnose surround and the other with plain architraves. The windows are 6/6 and have louvered shutters. Square attic windows with 2/2 sash flank the chimneys. An extra bay appears to have been added on the south end, with a corresponding relocation of the chimney. The date of this addition has not been determined, but probably took place in the second quarter of the 19th century. The standing seam metal roof has a box cornice in the log section.

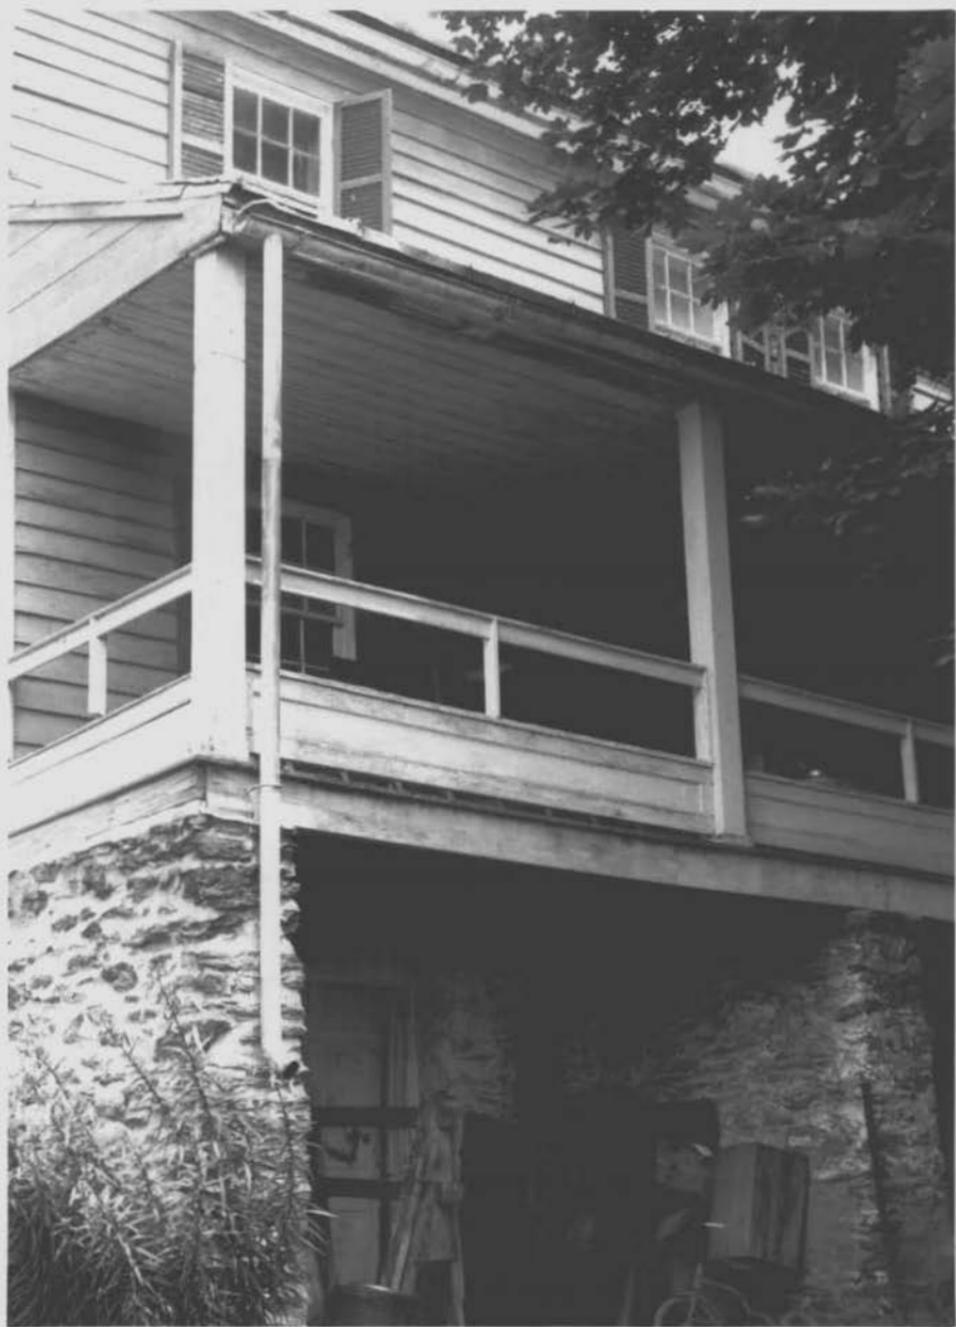
2/11

East elevation detail

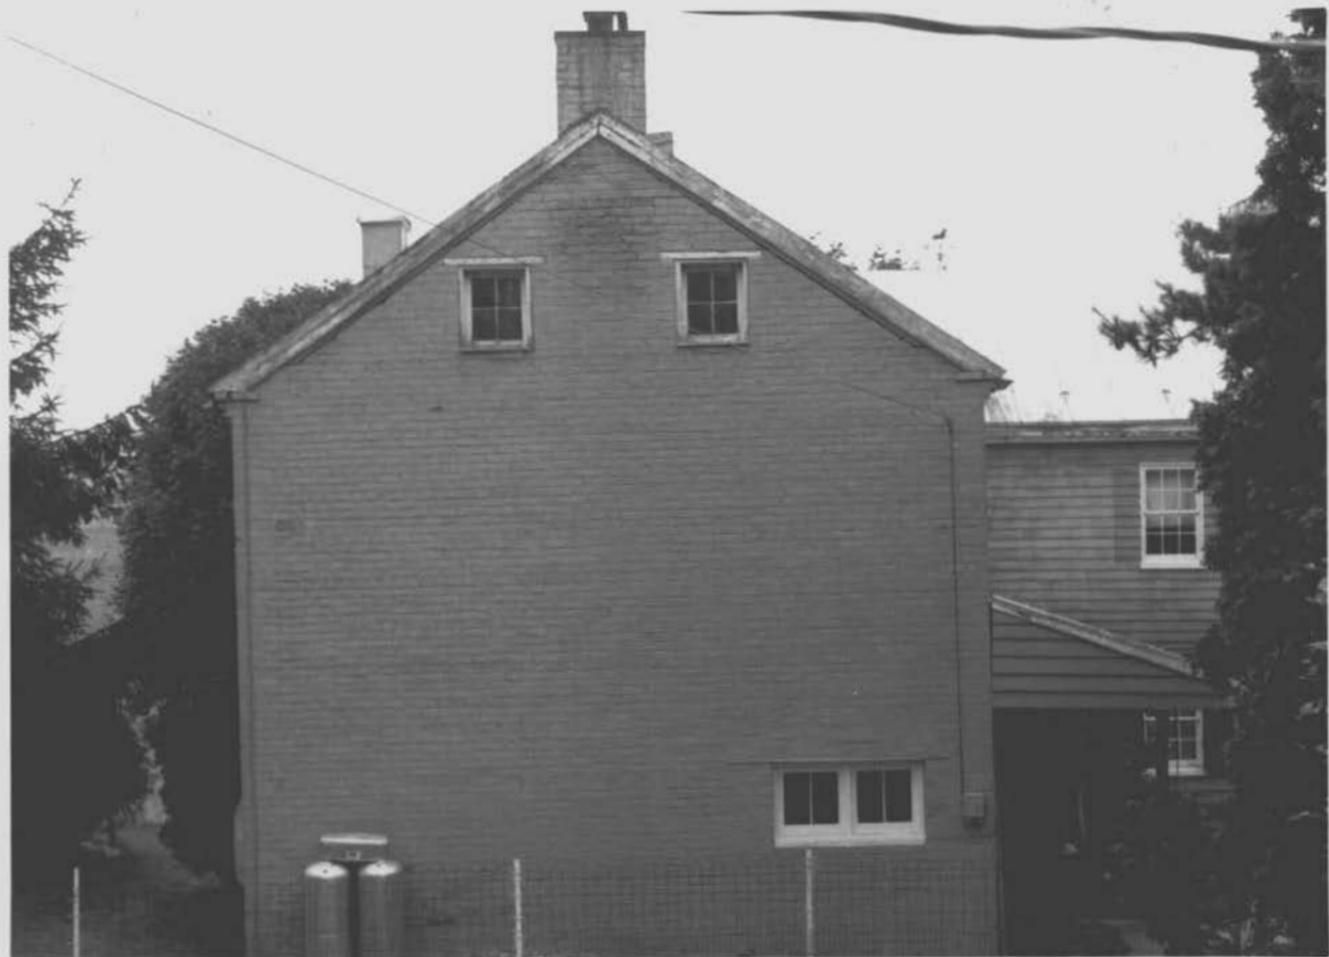
3/11

West elevation

The brick ell is laid in 6-course American bond and contains two rooms on both levels. The window and door openings have plain wood lintels and corner blocks. The sash is 6/6. The cornice is corbelled and the roof is an extension of the standing seam metal roof of the log section. A one-story open porch is located on the south side of the ell.

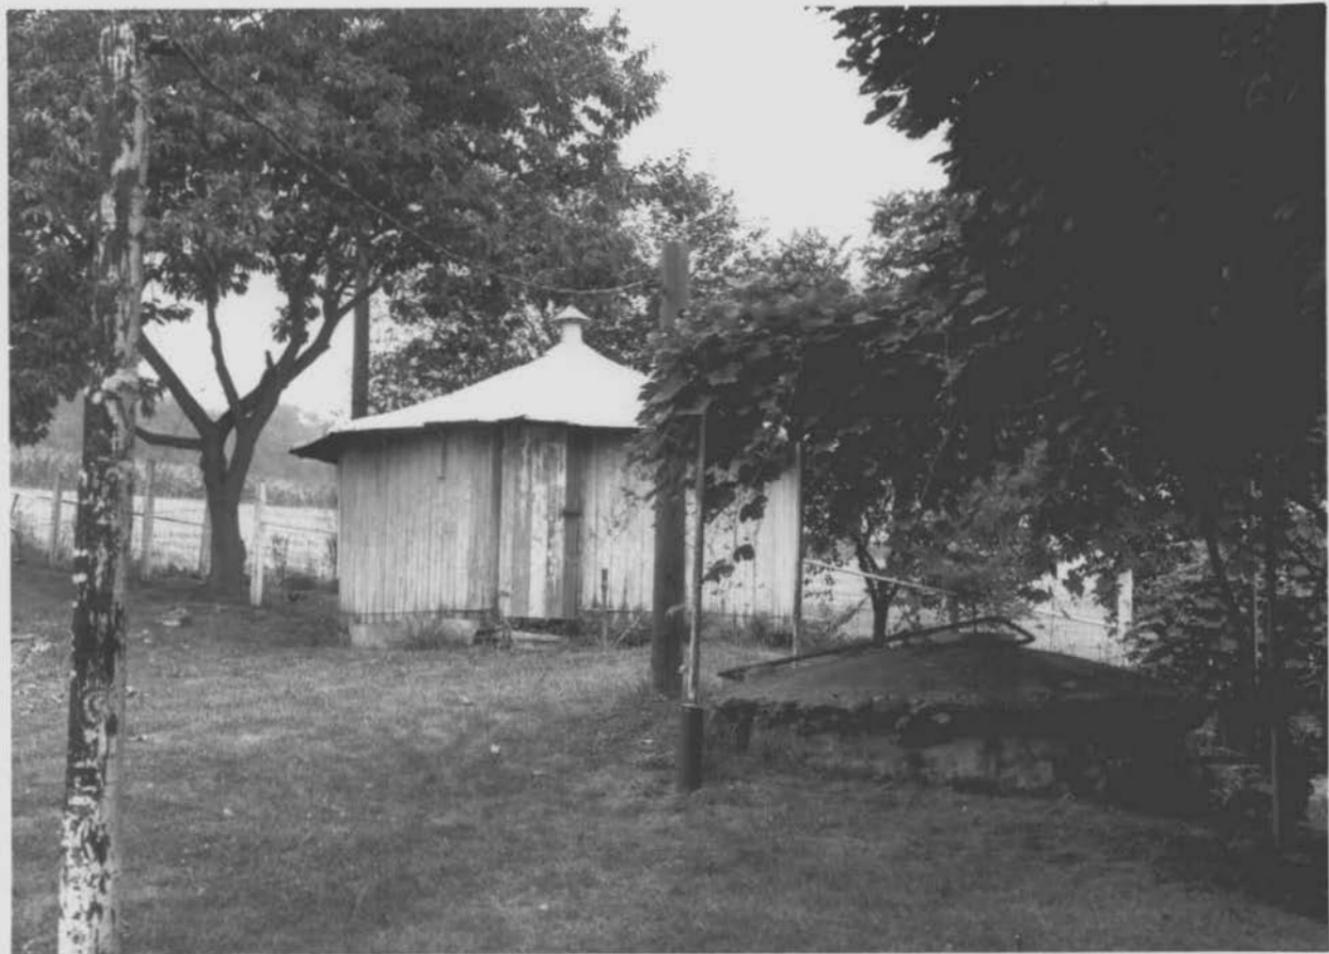
4/11

Chicken House #1, view from east; Cistern
in right foreground

Cistern: The cistern is located south of the Brooder House #1. It is a low brick-based, circular structure capped with concrete. A grape arbor stands above the cistern. The windmill described later pumped water from the spring east of the house to the cistern.

Chicken house #1: A small, wood "dog house" size structure located east of Brooder #2. The structure was acquired from another property but has never been used in the Baker Farmstead. Its date is unknown.

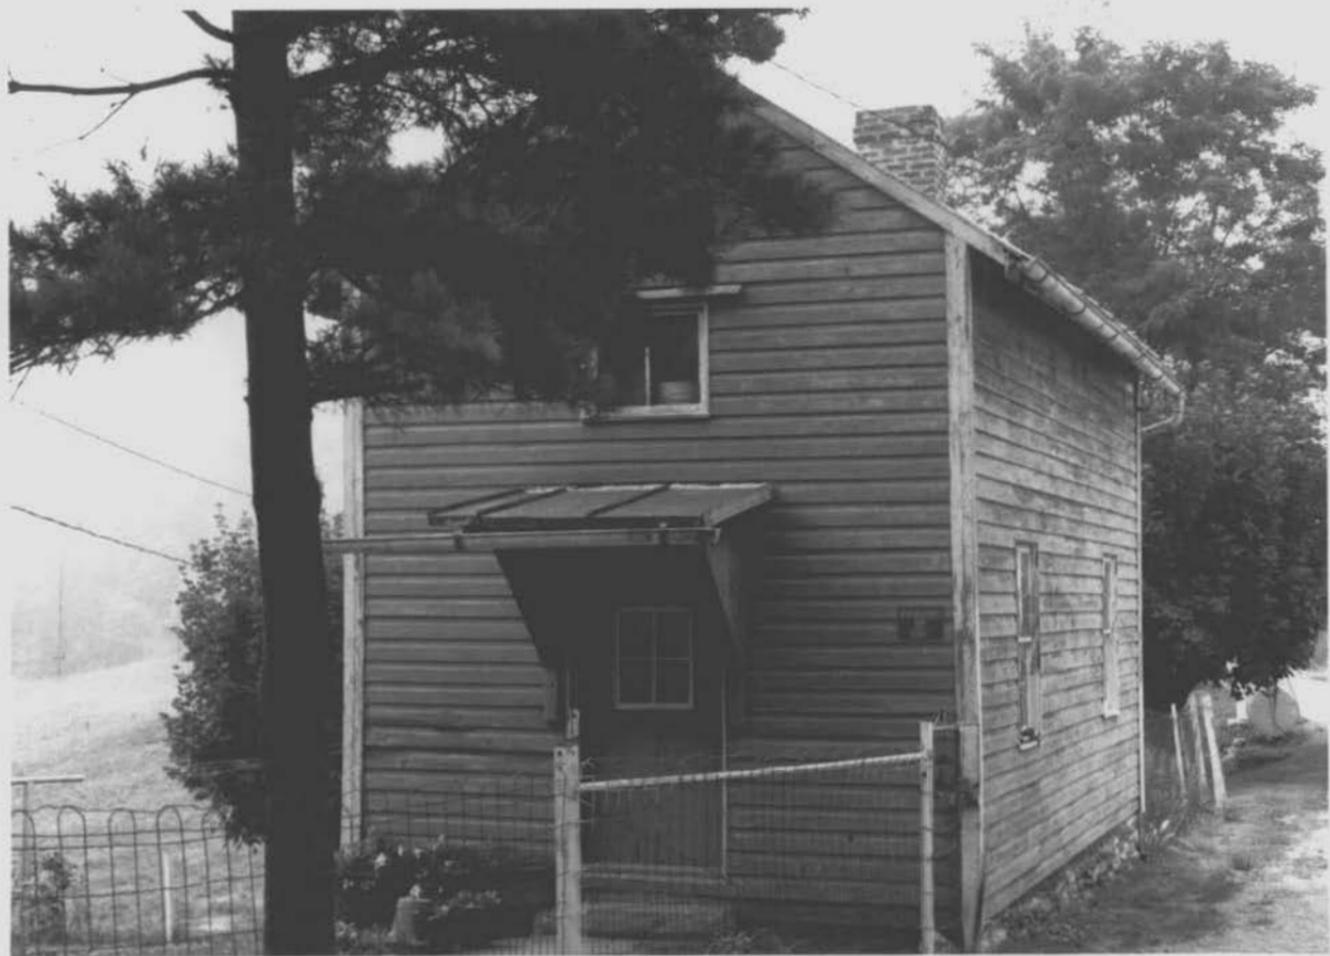
5/11

Summer kitchen, north elevation

Summer kitchen: A frame, two-story rectangular building of about 1875, the summer kitchen has German siding and an interior end brick chimney on the south end gable. A single door opens in the north gable end. The east and west elevations have two window bays each with 6/6 sash. The foundation is stone and the roof is standing seam metal. The door is vertical flush boards with a 2/2 glazed upper panel. A shed canopy extends over the door. A bell is attached to the north gable peak.

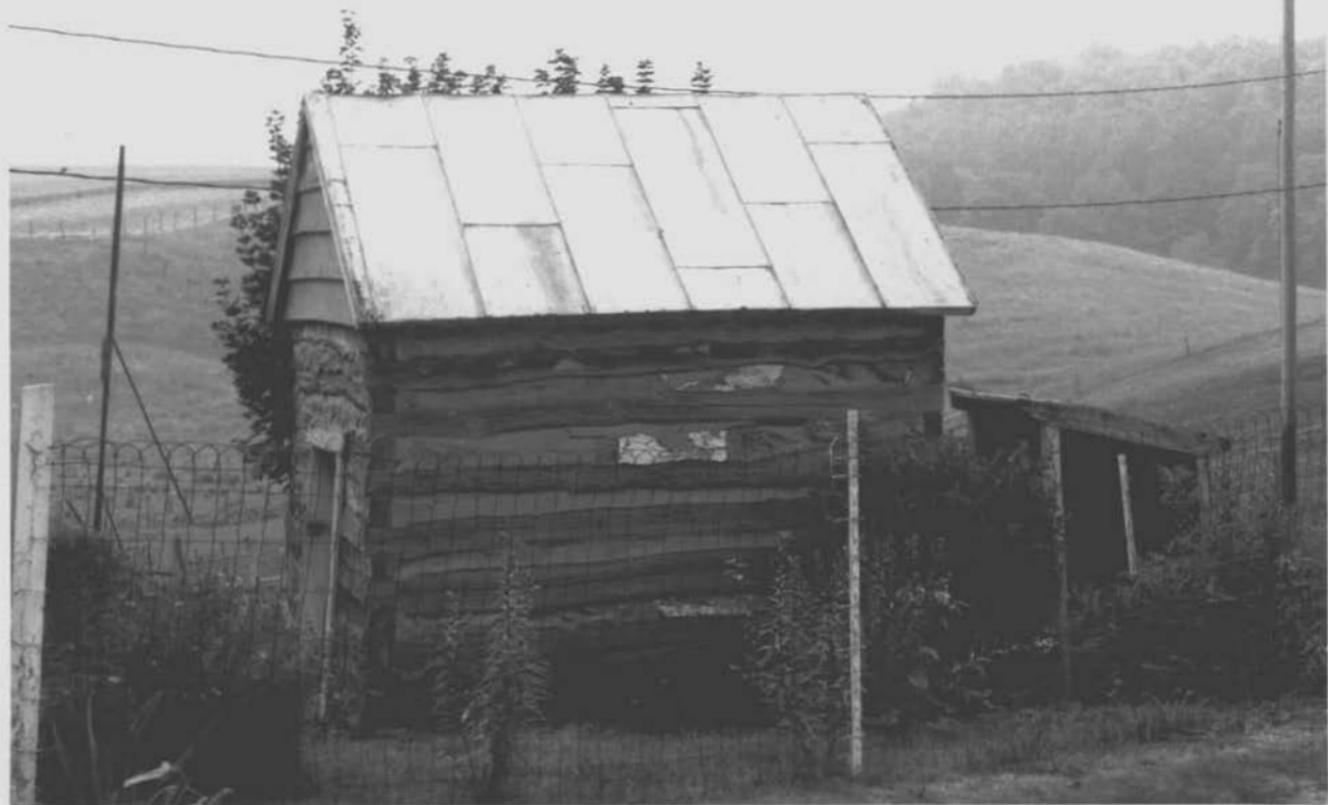
6/11

Smokehouse and privy, west elevations

Smokehouse: The log smokehouse may have been built in the second quarter of the 19th century based on the condition of the logs. It has a rectangular form with a gable roof covered with standing seam metal and frame gables with clapboard siding. The door is on the north gable end and is made with vertical flush boards.

Privy: The privy is located south of the smokehouse and is basically square in plan. It has vertical board siding and a shed standing seam metal roof. The single door is on the north elevation.

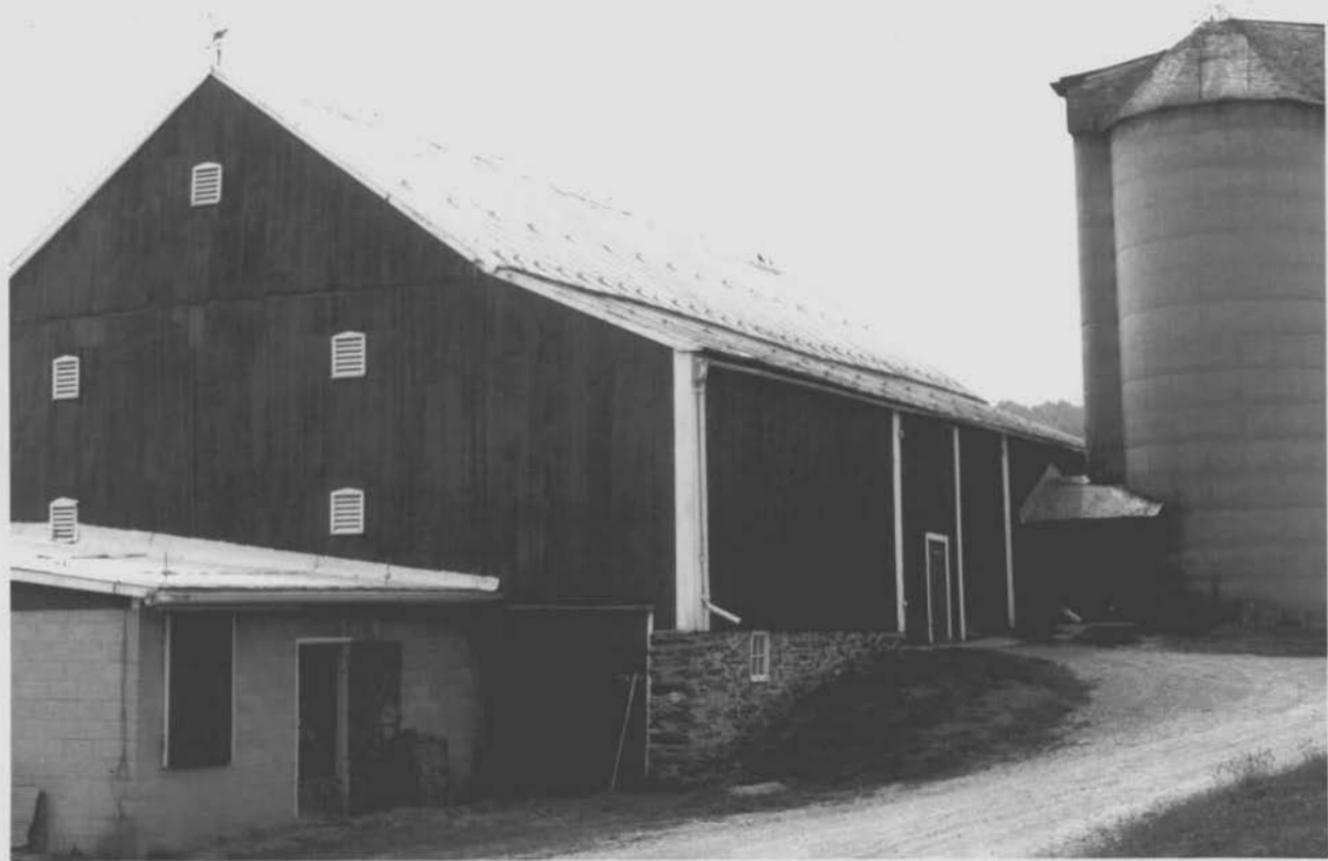
9/11

Neg. loc.: Md. SHPO, Crownsville, Md.
Bank born, northwest corner view

Bank barn: The barn appears to date from the third or fourth quarter of the 19th century. It has a stone foundation and hand-hewn frame upper structure. The vertical siding is machine-milled and probably dates from nearer 1900. The roof is both corrugated metal and standing seam metal. The standing seam portion on the west slope of the gable roof covers wood shingles. The plan is a typical single drive floor upper level with flanking hay mows over a two-aisle feeding level. A concrete block milking parlor built about 1945 encloses the south end of the forebay. Adjacent to the milking parlor is a separate concrete block milk house of about the same date. The forebay remains mostly intact. Two metal and concrete block loafing sheds and a heifer shed of the 1950's are located adjoining and east of the barn; these do not contribute to the complex. A concrete silo located at the southwest corner of the barn is also non-contributing due to recent construction.

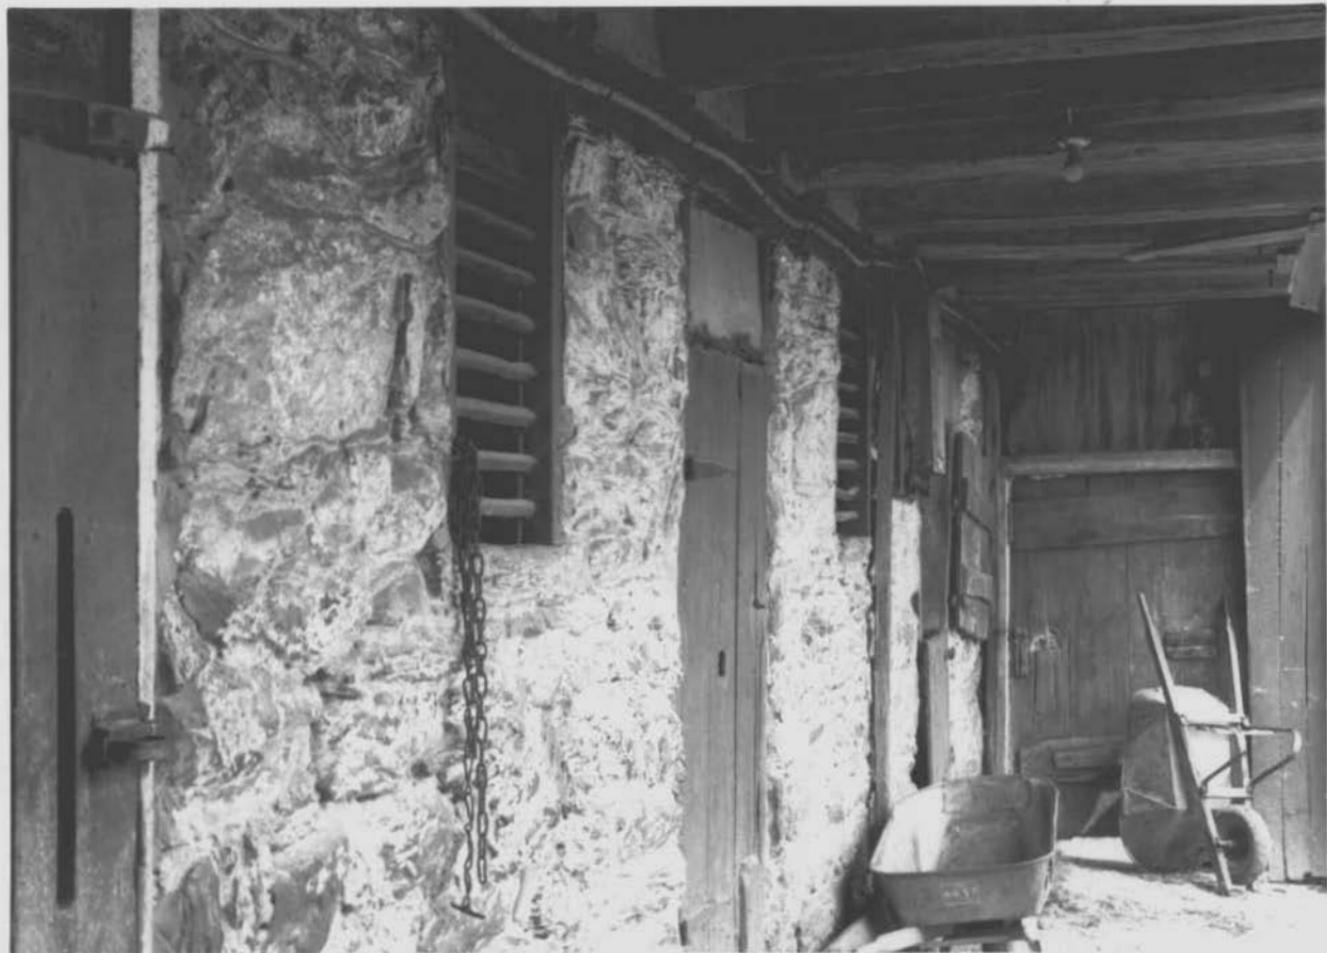
10/11

Bank barn, fore bay detail, east elevation

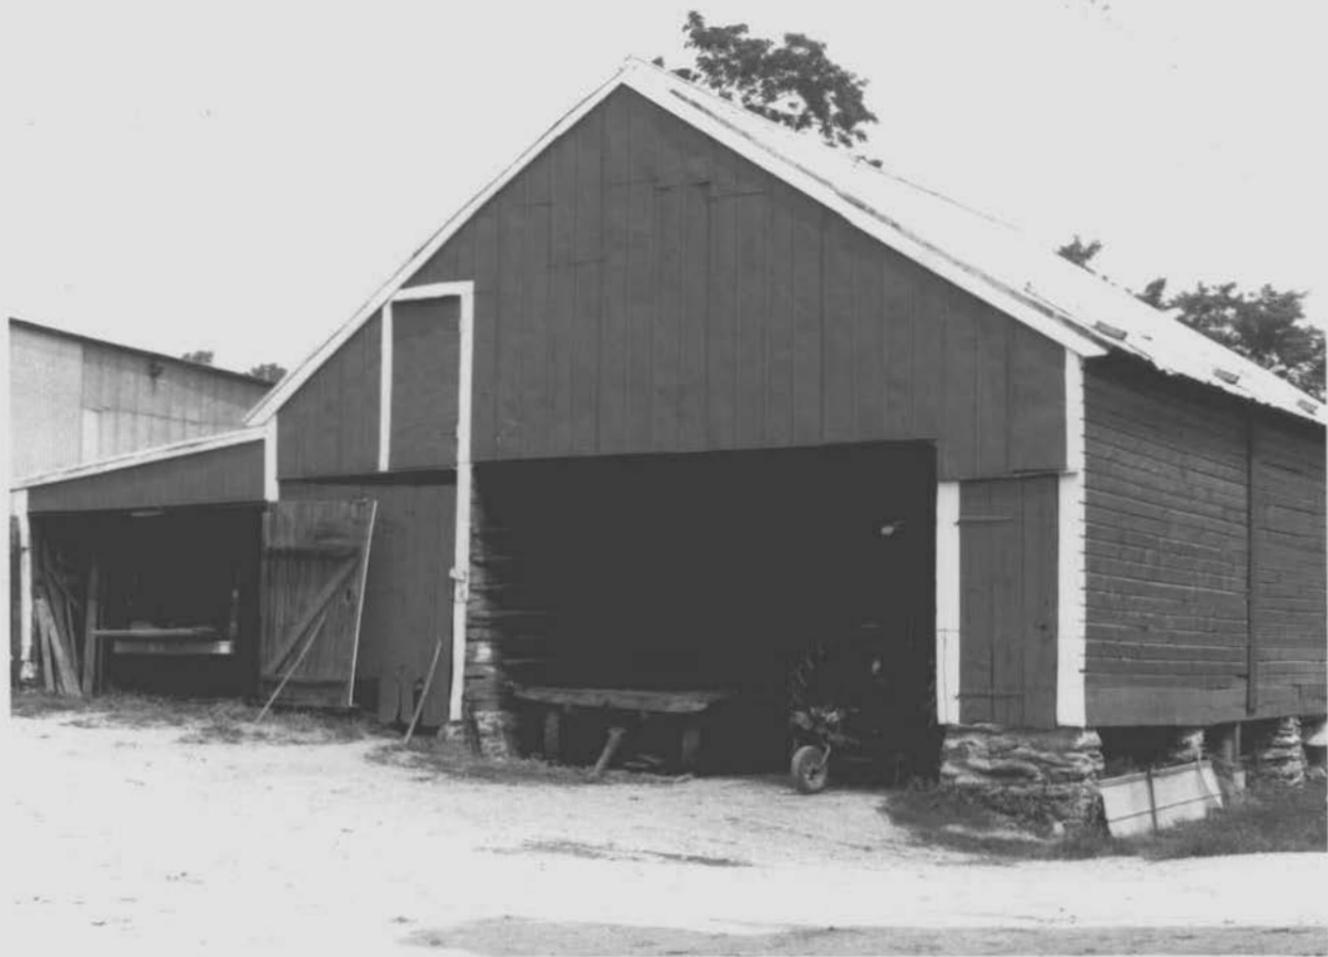
11/11

Corn crib/wagon shed, south elevation

Pull-through corncrib/wagon shed: The double-sided granary is located northwest of the barn and has a stone foundation, vertical and horizontal siding and a corrugated metal roof. An attached shed on the west side houses equipment. Metal siding covers the north and south gable ends of the corncrib. It probably dates from the last quarter of the 19th century.
