F-8-120
Reisler Farmstead

Survey No. F-8-120
Reisler Farmstead
Libertytown, Maryland vicinity
Frederick County

Maryland Historical Trust State Historic Sites Inventory Form

Survey No. F-8-120

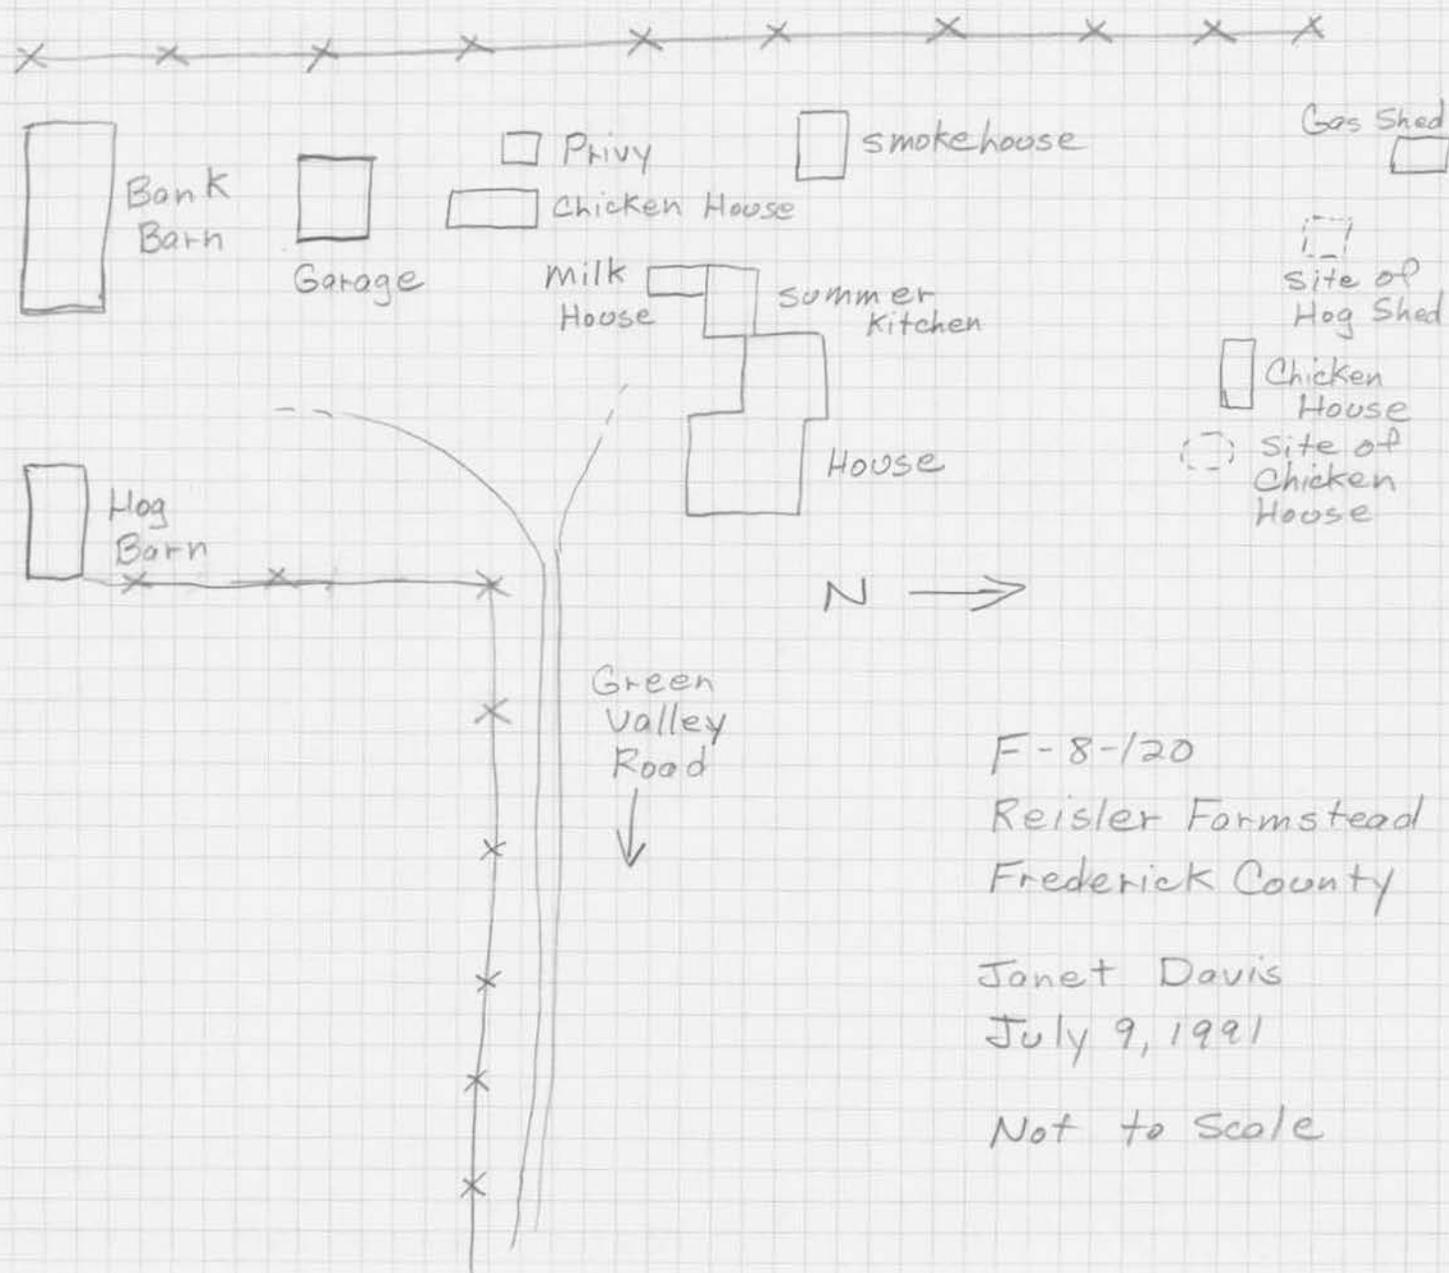
F-8-120
 Reisler Farmstead
 Frederick County

The Reisler Farmstead is an originally agricultural complex, now a private residence and separately leased farm, consisting of a circa 1855, 2 1/2 story brick dwelling house with 7 domestic outbuildings and three agricultural outbuildings ranging in date from contemporary with the house to the second quarter of the 20th century. The farmstead is located on the west side of Green Valley Road (MD Rt. 75), about 1500 ft. south of Coppermine Road, near Libertytown, Maryland. The house and outbuildings are about 50 yards off the main road in full view. The outbuildings include a frame summer kitchen adjoining the house's rear wing, a circa 1855 stone smokehouse, two chicken houses, a privy, a hog barn, a bank barn approximately contemporary with the house, a garage, and a gas shed.

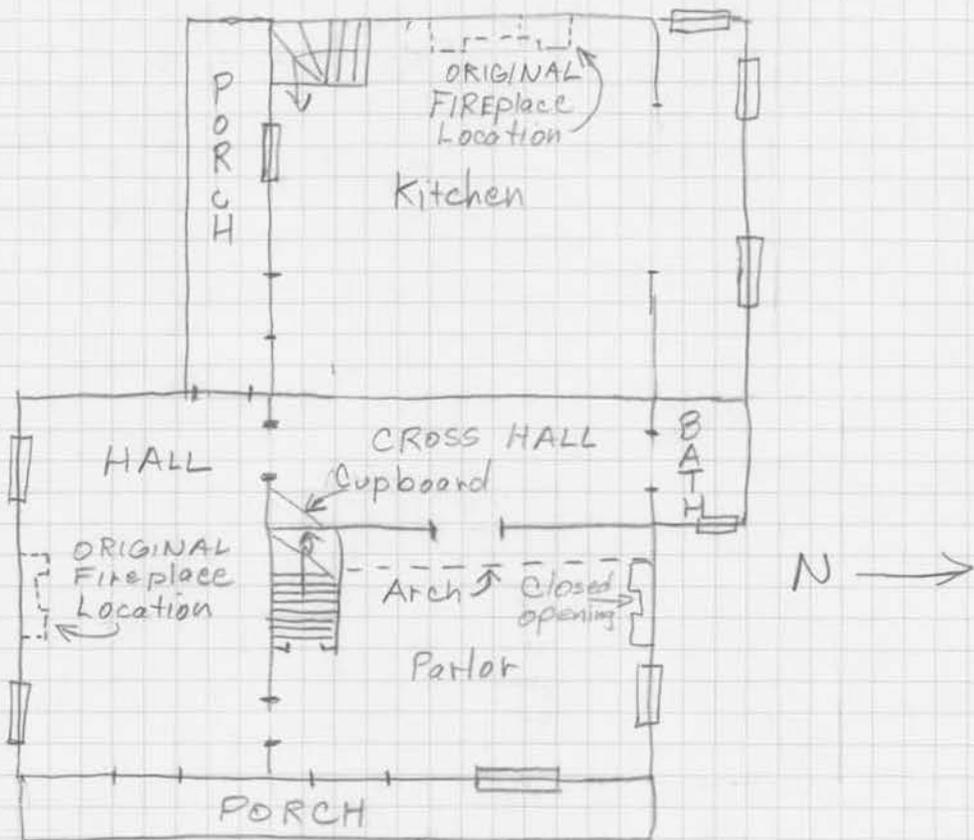
F-8-120
 Reister House
 Frederick County

The plan of the house is basically a side hall type, with the variation of the two entrances in the east elevation. The staircase is on the interior wall of the parlor rather than in the hall. At the rear of the parlor is a cross hall connecting the side hall and the entrance to the ell. An extension of the single space in the ell is located on the north side of the ell. A corner stairway is located on the southwest corner of the ell. The main hall has grained wood four-panel doors and grained plain architraves on the window and door surrounds. The walls are plaster under mid-20th century wallpaper. On the south wall of the hall is the outline of a stovepipe opening in the location of the original chimney and fireplace opening. No other evidence of the fireplace is visible. The parlor has grained wood trim and a simple paneled mantel on the north wall. The fireplace opening is closed. A plaster elliptical arch drops from the ceiling at the rear of the room and the outline of a stovepipe is visible in the northwest corner. This may indicate a possible altered double parlor floor plan, but further research is needed to clarify the plan. The staircase is enclosed and accessible through a door at the foot of the stairs. The cross hall at the rear of the main section has plaster walls and a wide board floor. Similar floors in the side hall and parlor are covered with carpeting. A corner cupboard with plain paneled doors is located on the southeast corner of the cross hall, backed by the stairs in the parlor.

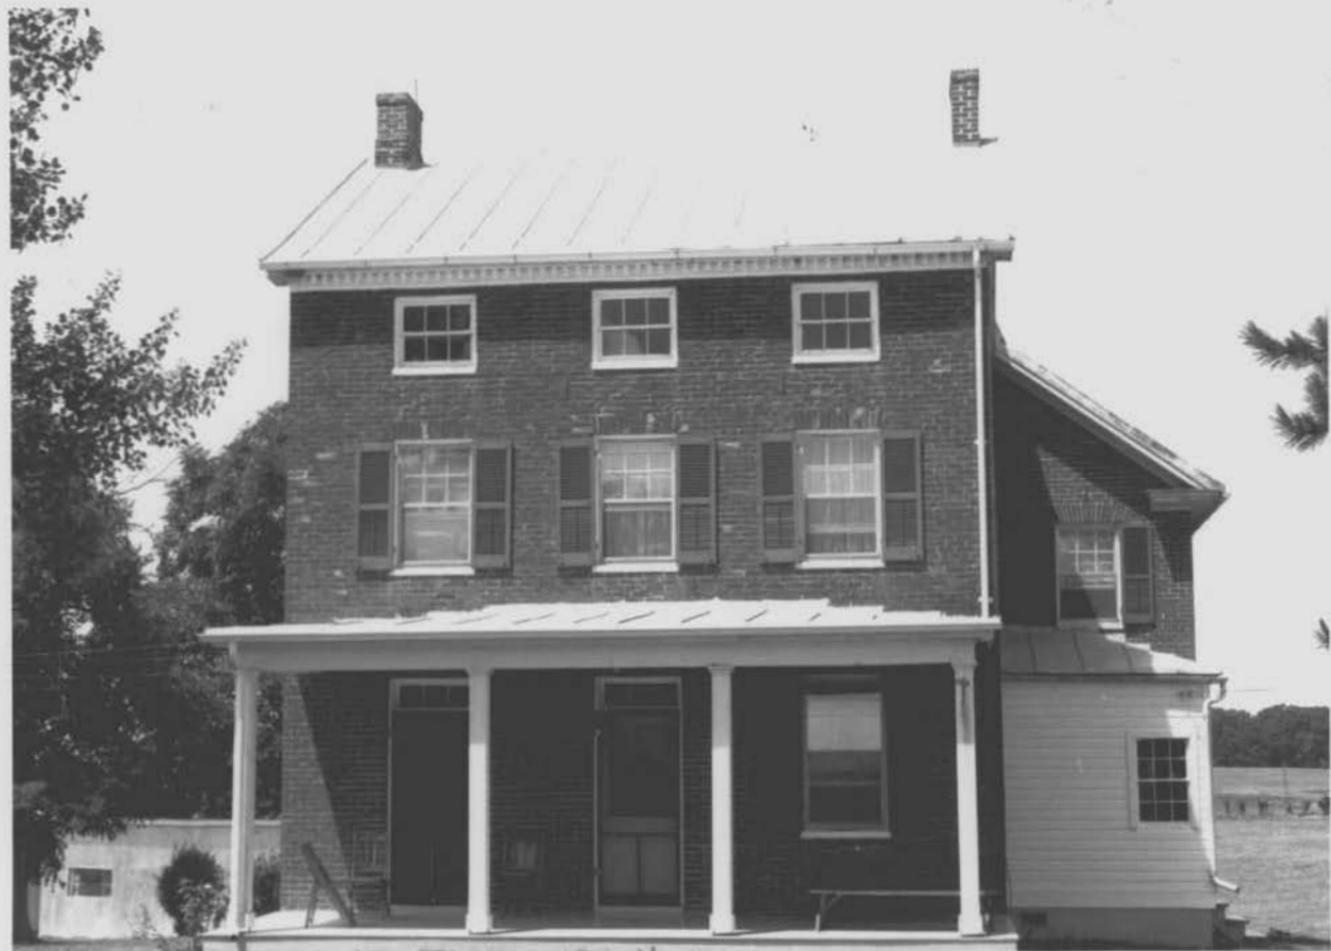
1/10

The dwelling house is a 3-bay brick building in 7-course American bond with interior end chimneys, a standing seam metal gable roof and a stone foundation. It has a one-story porch on the east elevation and a two-story porch on the south elevation of the rear wing or ell which extends from the northwest corner of the main section. The windows are 6/6 on the first and second stories and 3/3 on the top half-story which is the attic. There are two doorways in the east elevation in the middle and south bays, each having a three-panel door with a glazed upper panel and a three-light transom. The porch has four square columns and a concrete platform, a replacement of the original wood deck. The cornice is corbelled brick. The north and south elevations each have two window bays flanking the chimney. On the north elevation, the west bay has been enclosed by a frame, horizontal wood-sized structure, which is a bathroom added in the mid-20th century. The rear wing or ell is two stories in height. The south elevation of the ell has an open two-level porch with a plain balustrade on the second floor. At the west elevation of the ell is a central projection rising the height of the house which encloses the chimney of the kitchen fireplace. The wood cornice of the ell's roof extends around the chimney stack with returns on the west face.

East elevation

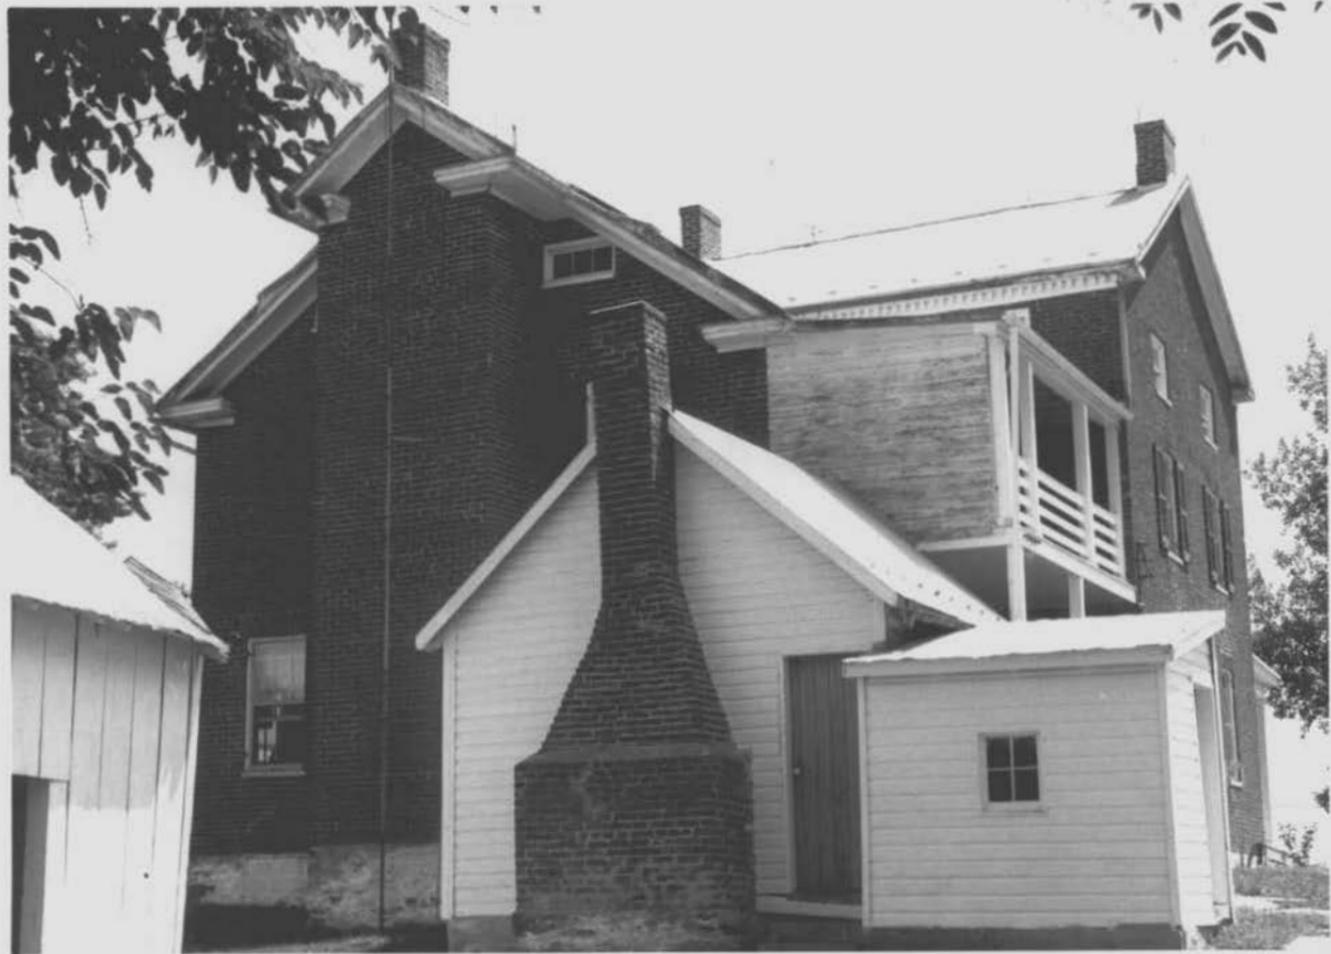
3/10

Summer kitchen: The frame summer kitchen is a one-story structure adjoining the west end of the porch on the house ell. It has german siding, a corrugated metal roof, and an exterior brick and stone chimney on the west gable end. The interior has a tongue-and-groove horizontal paneled wainscot, vertical flush board doors in each gable end, and a plain wood mantel over the fireplace opening. The building appears to date from the 1850's.

Milk house: Adjoining the summer kitchen on the south elevation is a small roughly rectangular frame shed, with a corrugated metal roof and german siding. Small square 2/2 windows are located in the east and west elevations. A vertical flush board door opens in the south elevation. The milk house was used to store sterilized milk cans and was possibly built in the 1920's or 1930's.

West elevation and summer kitchen and
- milk house

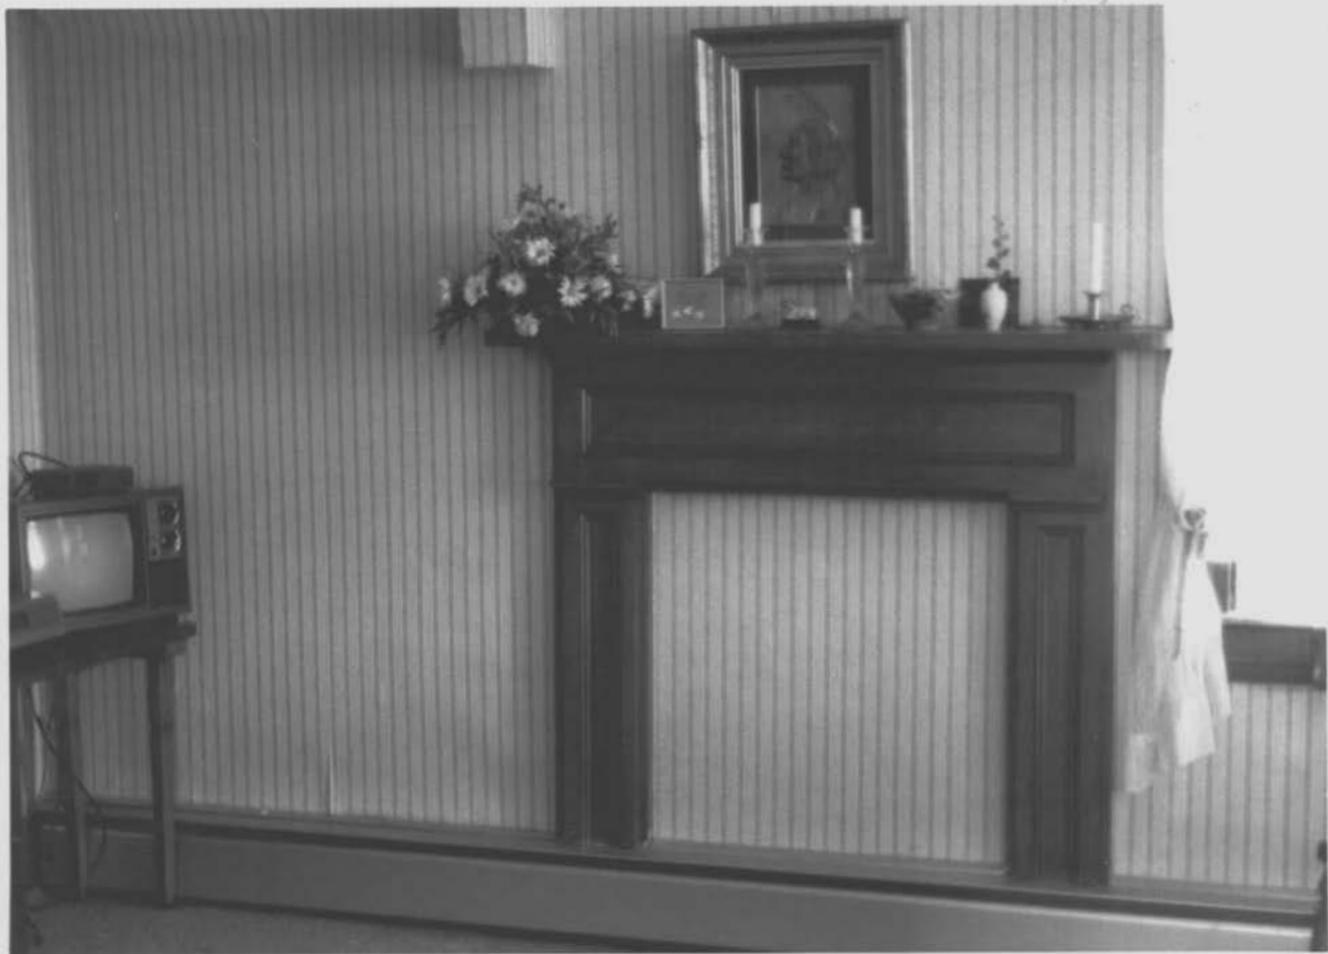
4/10

North parlor mantel piece

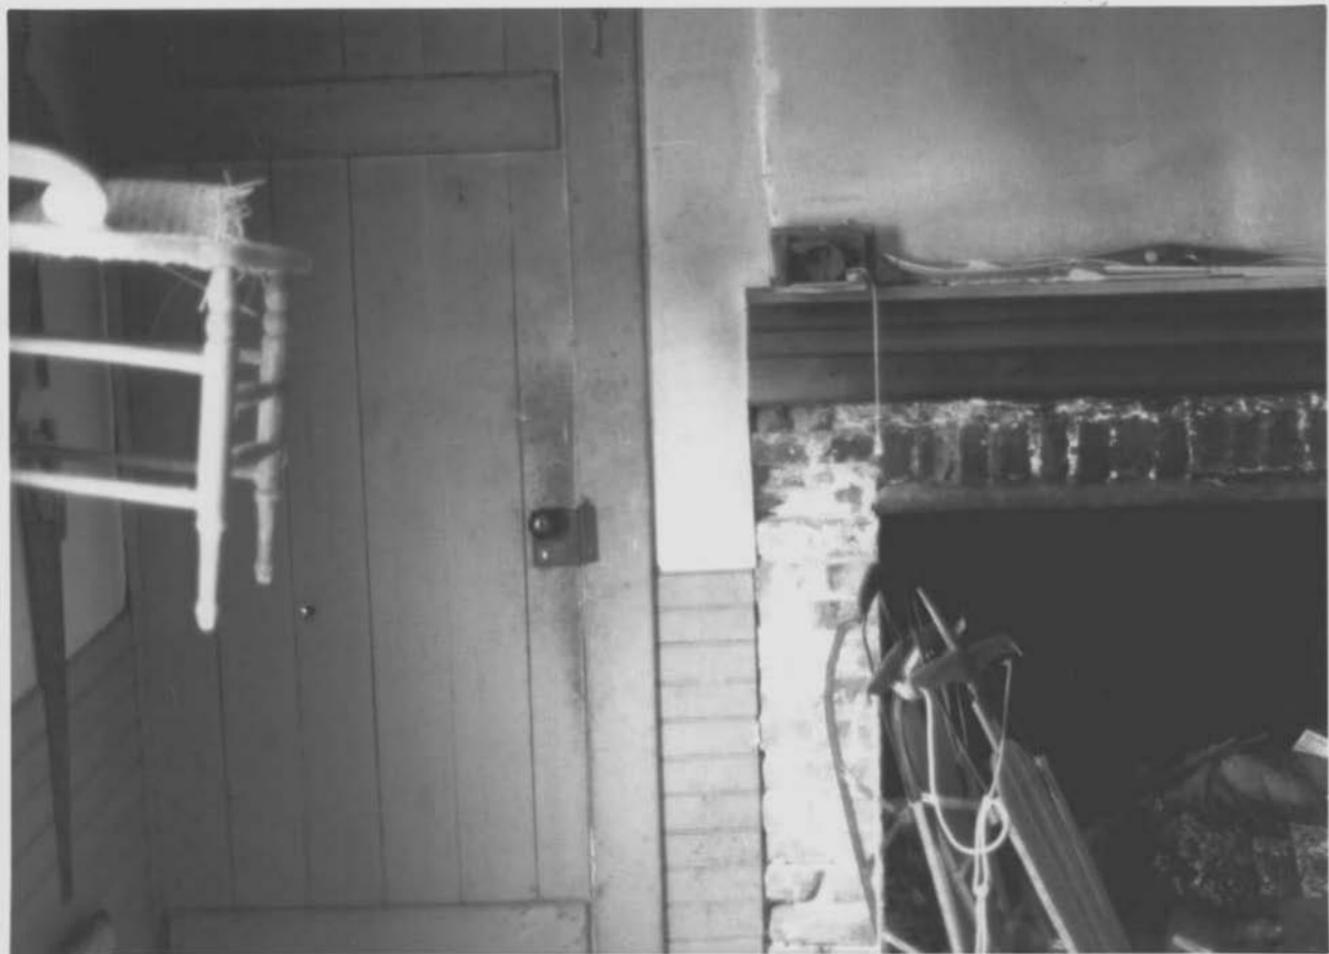
6/10

Neg. loc.: Md. SHPO, Crownsville, Md.
Summer kitchen interior detail

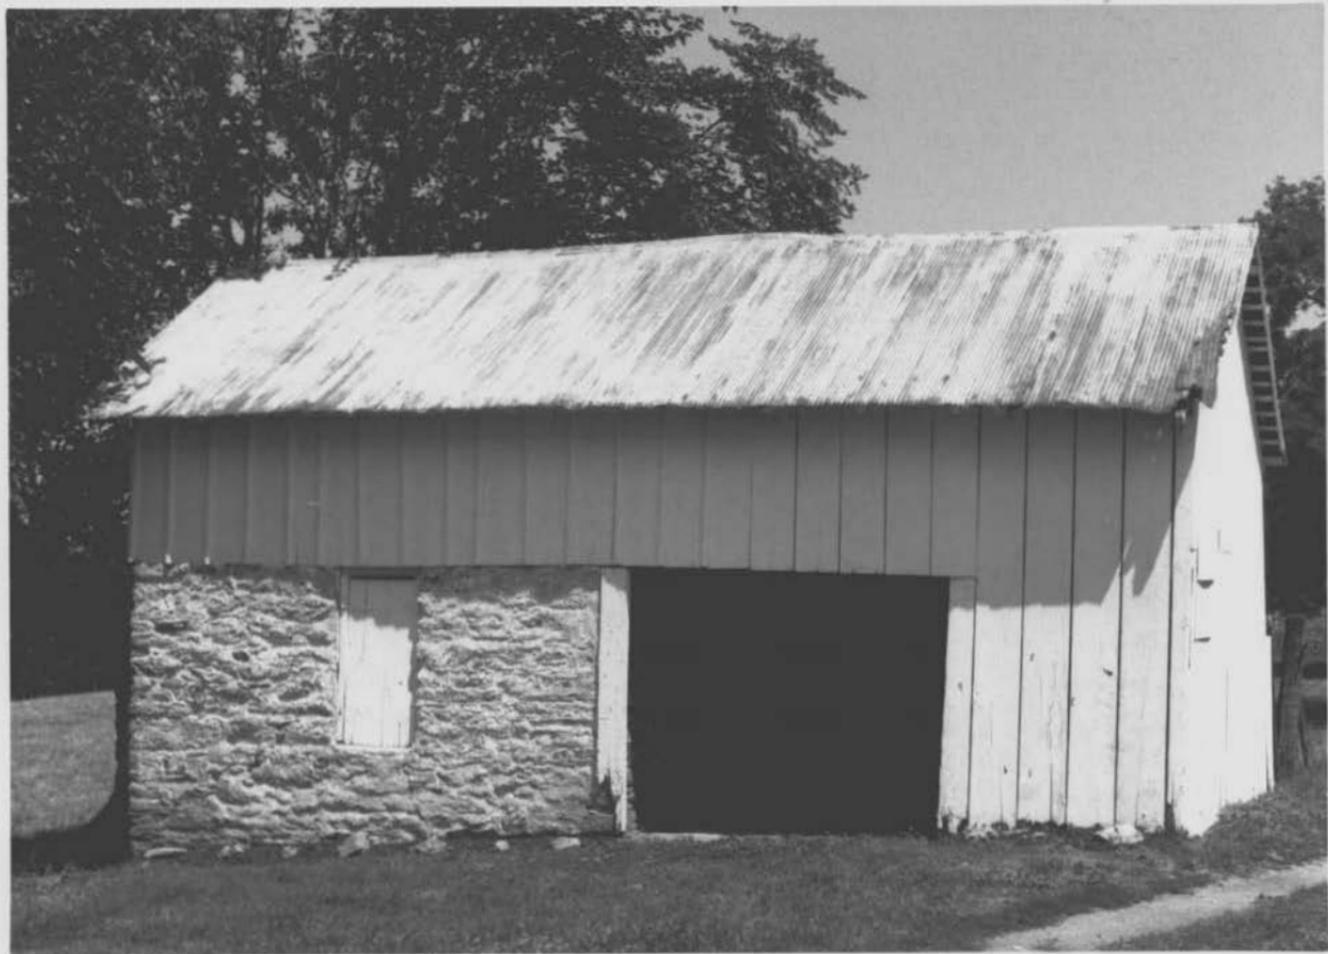
7/10

Smokehouse: The smokehouse is a square stone building northwest of the house. It probably dates from the 1850's. The stone section is topped by a frame upper section which extends eastward from the stone base to form a partially enclosed equipment shed. The frame structure is covered with board and batten siding. The gable roof covering the entire structure is corrugated metal. The interior fireplace in the smokehouse has a massive wood beam over the fireplace opening.

Smokehouse, south elevation

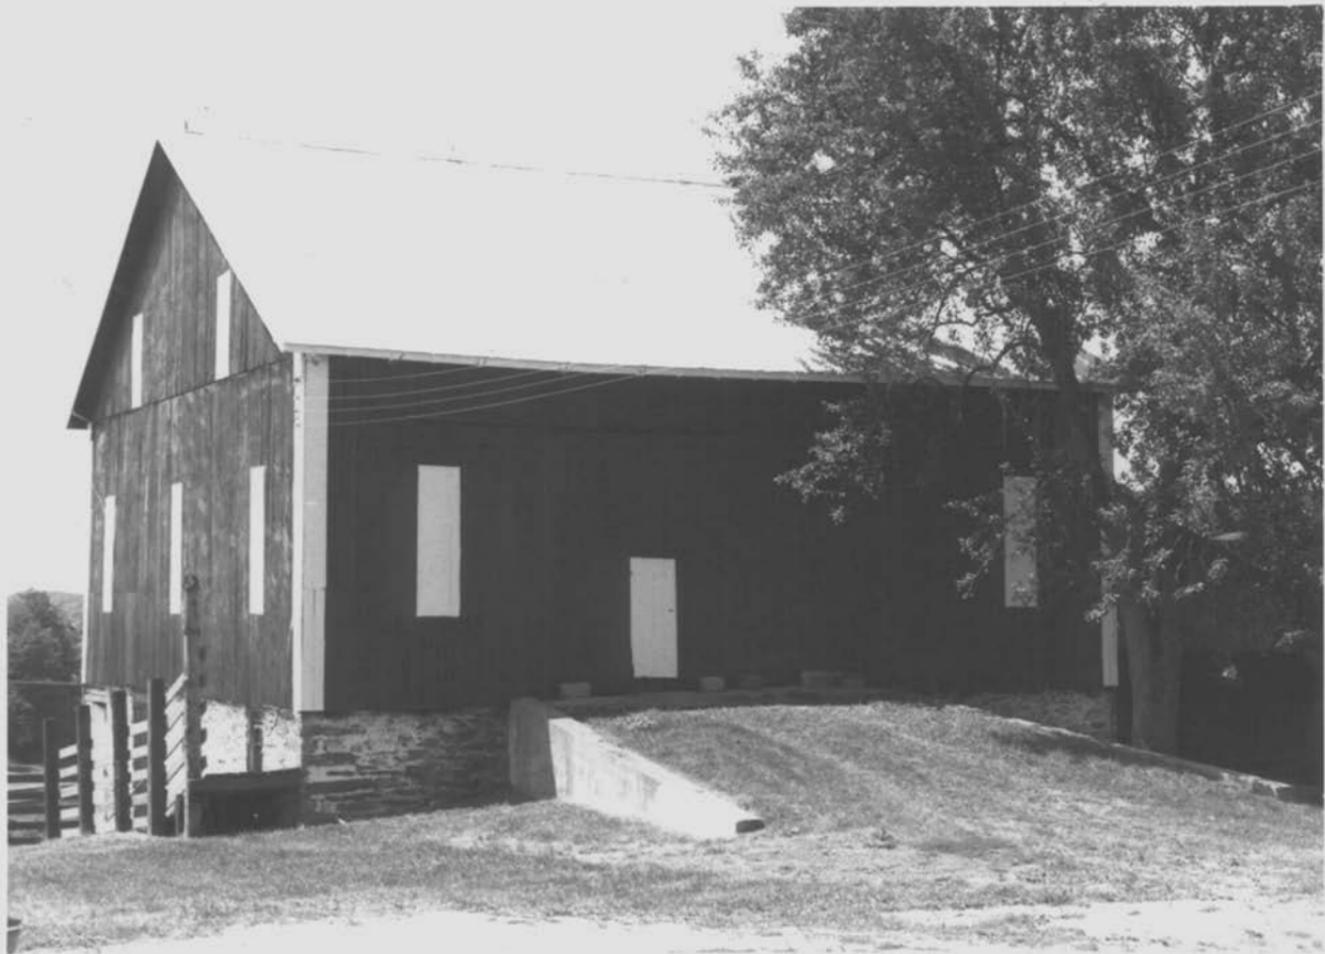
8/10

Bank barn: The bank barn was probably built in the third quarter of the 19th century, with vertical siding and some interior structure possibly dating from the last quarter of the 19th century. Metal siding has been applied over the wood siding on the north, east, and west elevations. The forebay on the south elevation and the feeding floor are undivided, retaining double feeding aisles, granaries, and mangers. Niches in the stone end walls for veterinary supplies are visible. The barn has a corn crib and wagon shed on the west elevation.

Bank born, north elevation

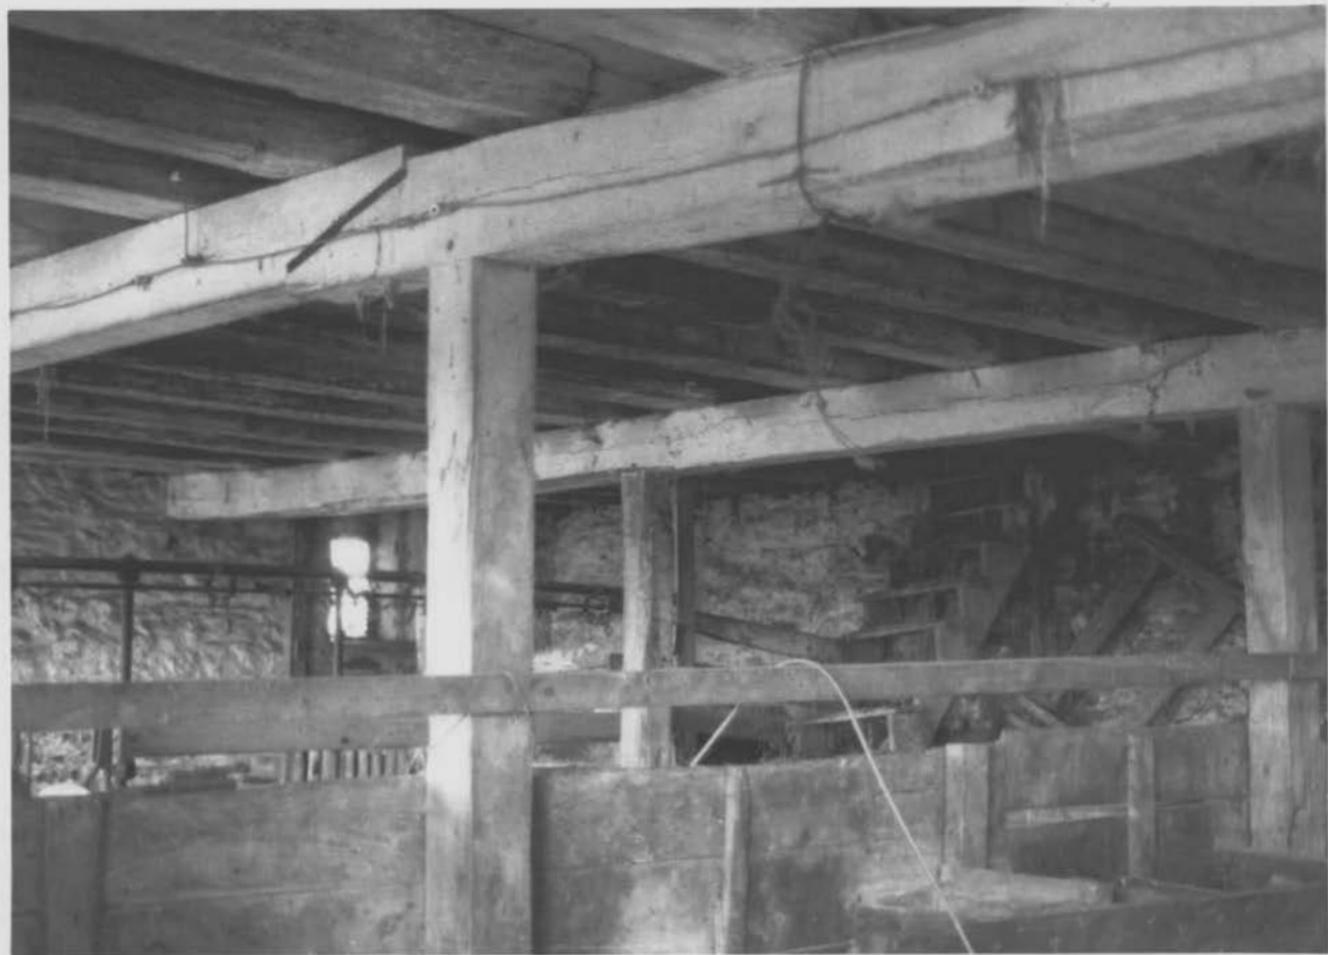
9/10

Bank barn, forebay detail

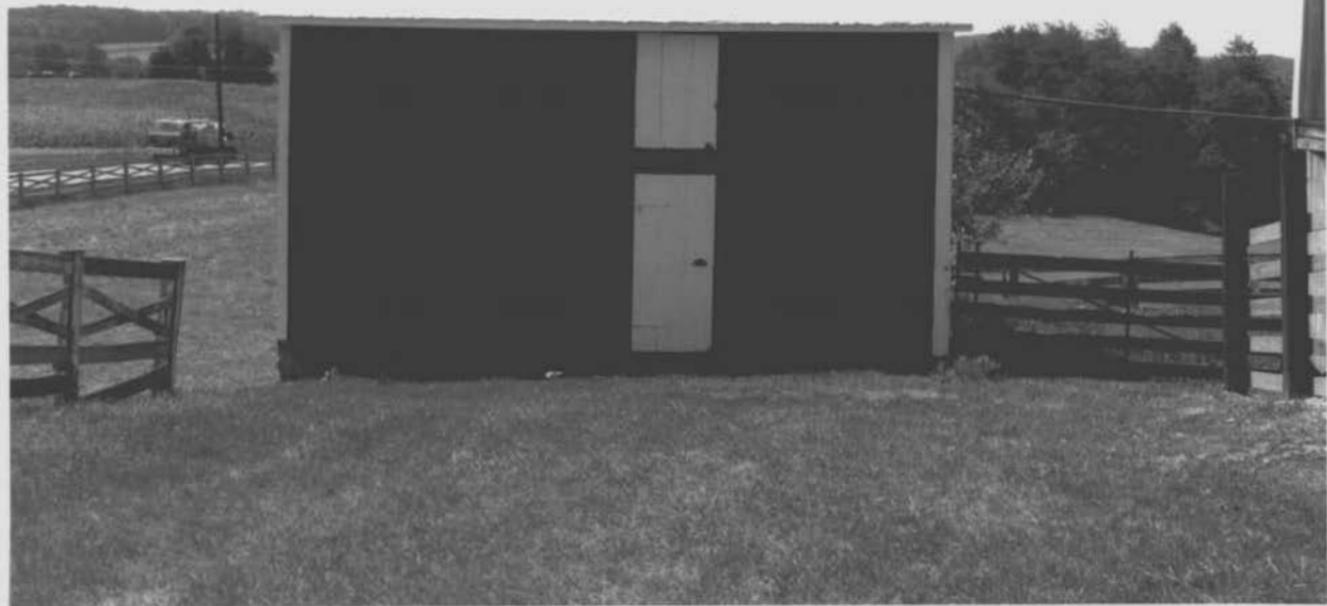
10/10

Hog barn: The hog barn was built in the first quarter of the 20th century. It has vertical siding and a gable roof covered with corrugated metal. The plan is typical of small animal barns, with a feeding aisle across its north side and four pens occupying the rest of the building. A concrete block wallow is attached to the south elevation. A single door is located in the north elevation, with a feed door above it.

Hog barn, north elevation
