F-8-127
Oakland; Hobbs-Smith Farmstead

Survey No. F-8-127
Oakland; Hobbs-Smith Farmstead
Libertytown, Maryland vicinity
Frederick County, Maryland

Maryland Historical Trust State Historic Sites Inventory Form

7.1 Description

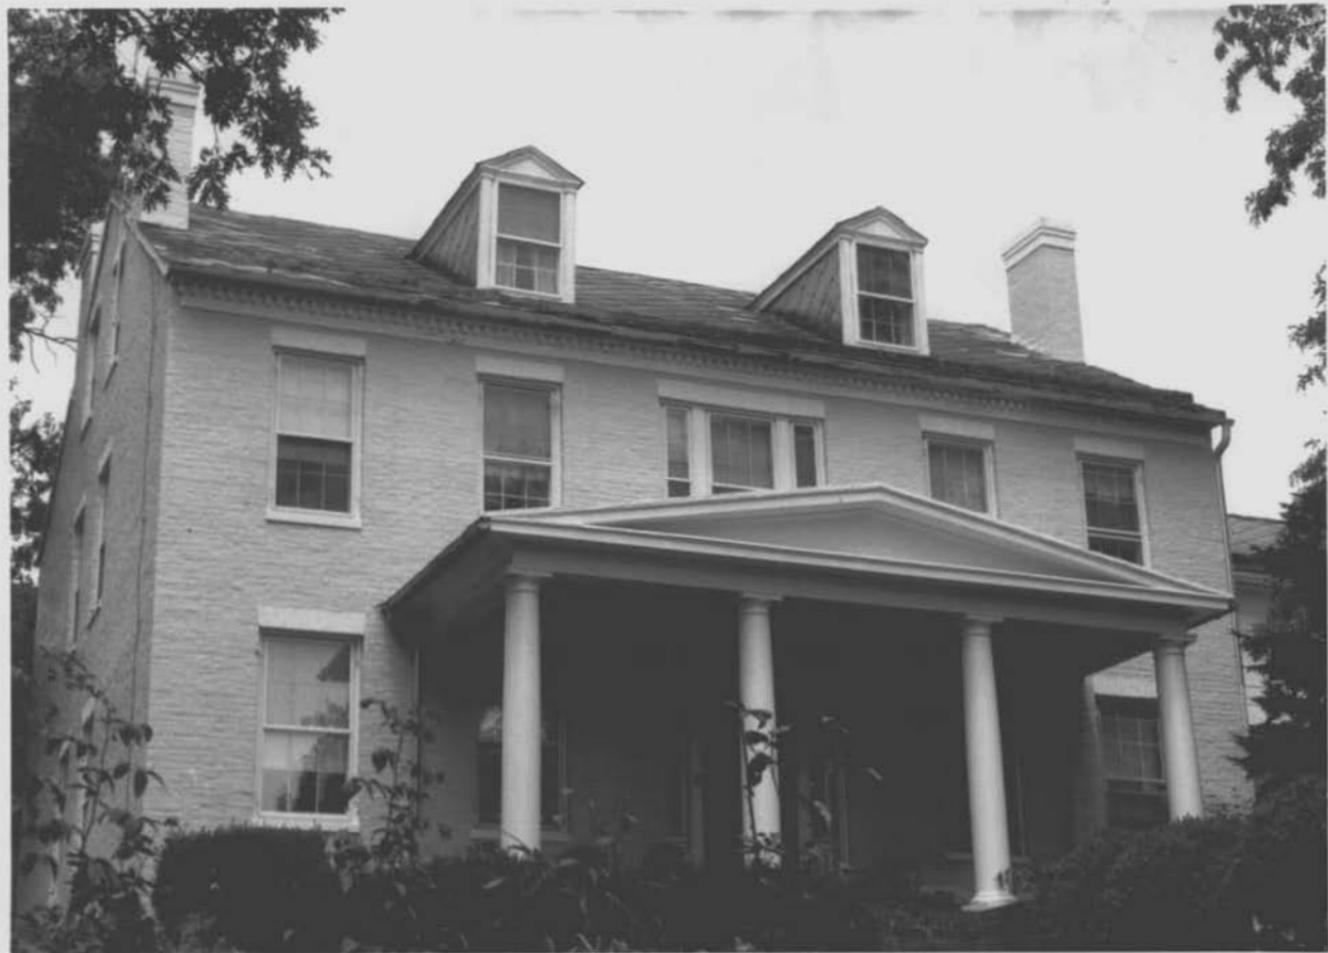
1/11

South elevation

The main dwelling house of Oakland is a five-bay, two-story brick structure with a two-story brick wing placed on the east end of the five-bay section. Both sections are 5-course American bond and are painted cream. A dentil cornice molding is on both sections. The main section has double interior end chimneys and a roof covered on the north by standing seam metal and composition shingles on the south. Two pedimented dormers project from the south slope of the roof; one dormer is located in the north roof. The main facade is dominated by a tetrastyle pedimented portico with Tuscan columns covering the central three bays. The window openings have gauged brick flat arches painted white. The sills are wood. The main entrance has double 8-paneled doors with sidelights and a 7-light transom. The second story center bay has a three-part window with narrow sidelights. The sash is 6/6. The rear elevation of the main section also has five bays with a one-story entry porch at the center entrance. The doorway has no sidelights, but does have a 7-light transom. The slender columns for the porch are placed on brick piers.

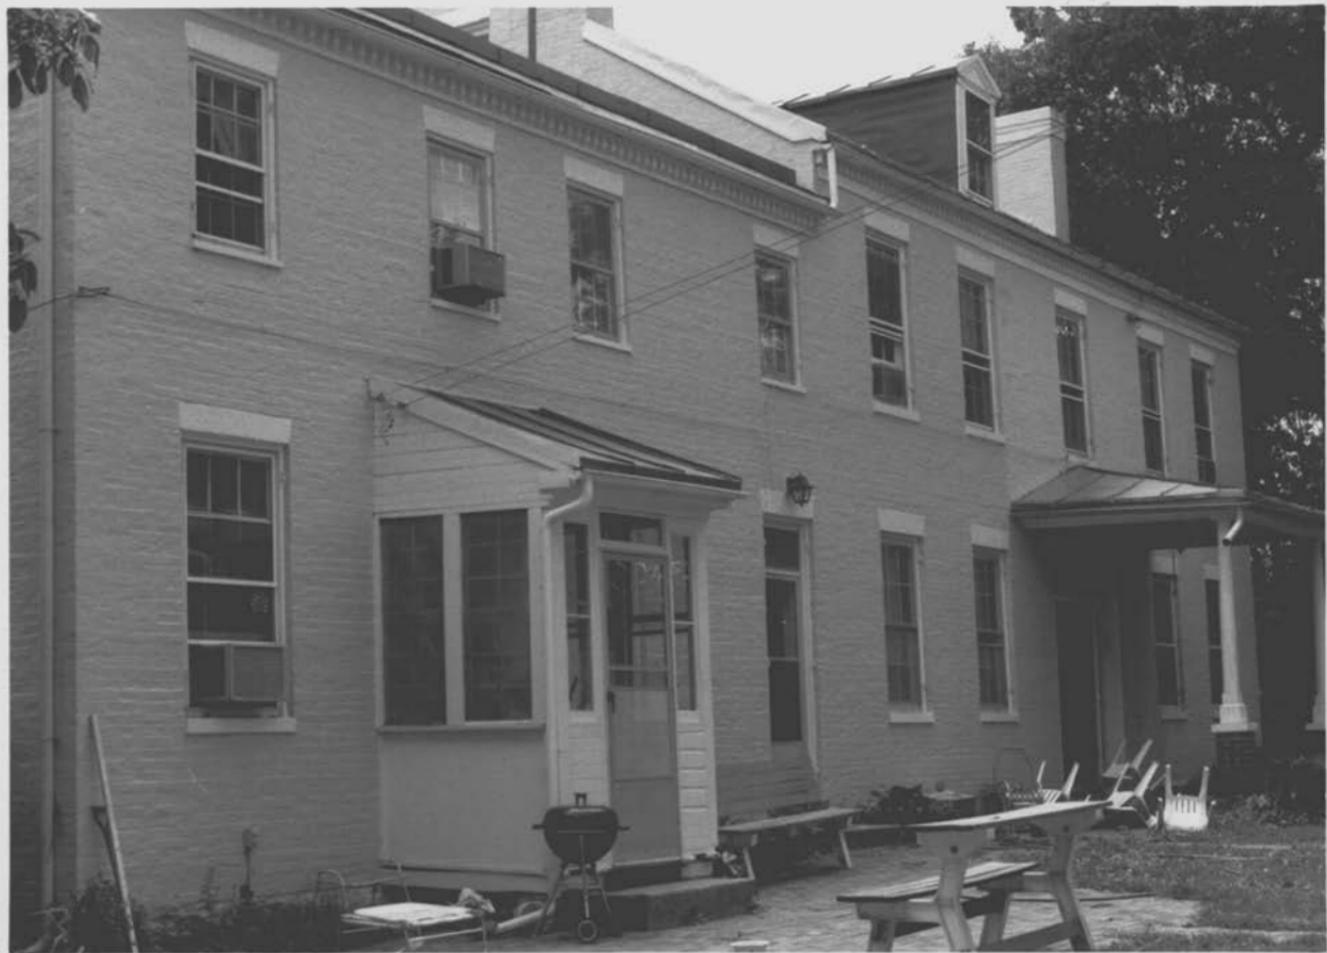
2/11

North elevation

The brick wing is also two stories, but has a lower roofline than the main section. The south elevation is recessed from the plane of the main section front wall; the north elevation is flush with the main section. Originally, the wing had a two-story open porch on the south elevation, much as the side elevations of rear ells on other houses of the same period. In the 1940's, the porch was enclosed with concrete block and metal sash casement windows. The roof of the wing has the same materials as the main section roof. The north elevation has four bays; two contain doorways. The easternmost has a shed-roofed projecting foyer built around it. The westernmost door appears to be an early 20th century alteration of an original window opening. The windows in this elevation are 6/6 in the main section.

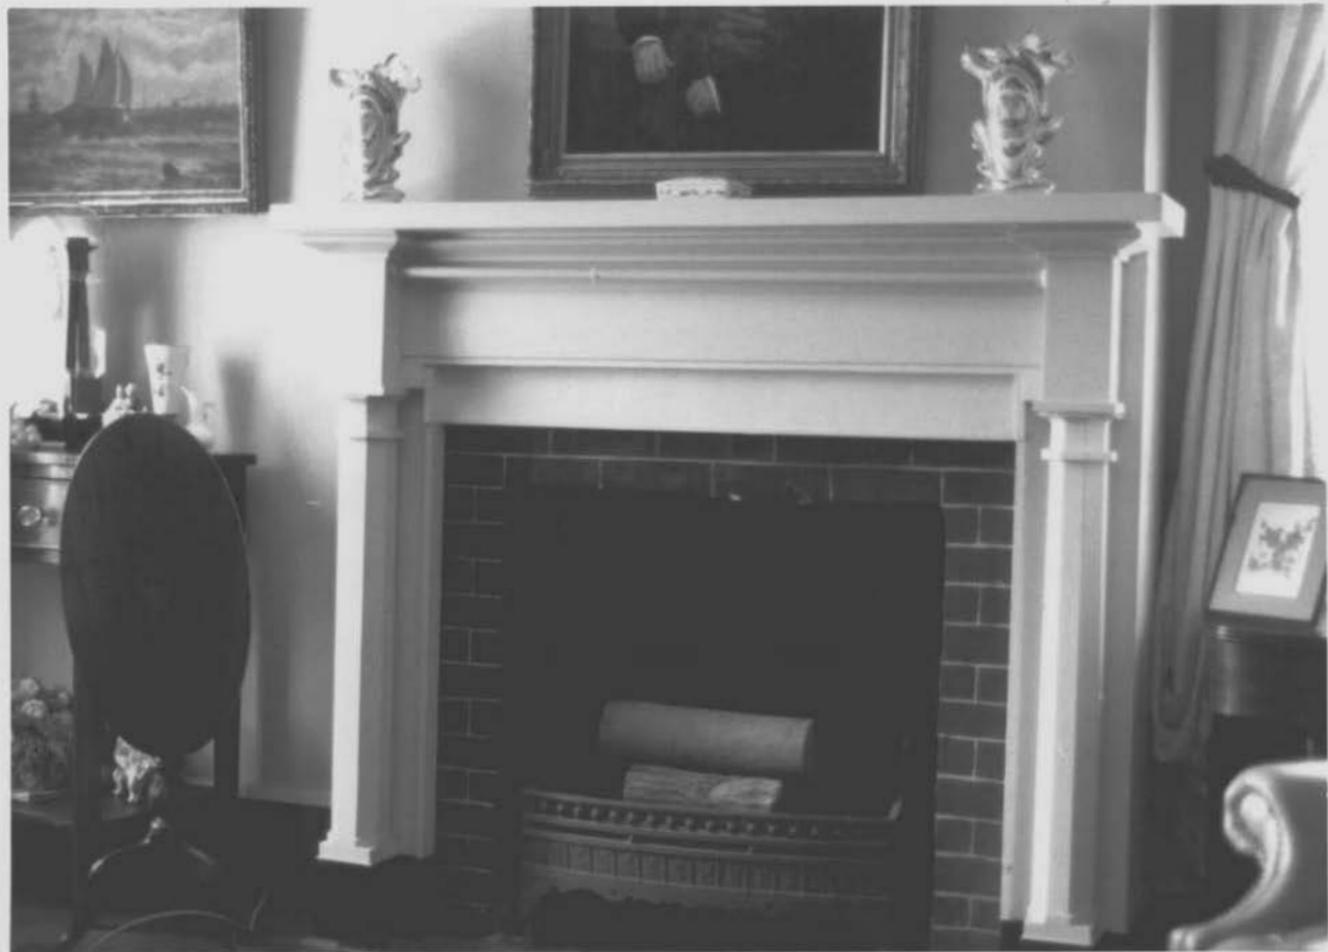
3/11

West plot mantel

The interior plan is a symmetrical center hall plan with two rooms on each side of the hall. The stairs are located on the east wall and have scroll-sawn closer decoration. The trim is plain, with plain corner blocks at the window and doorframes. The flooring is wide boards. Each of the four main rooms on the first floor has a fireplace and Greek Revival mantel with flanking columns. According to the Smith family, the northeast corner room was used as the original kitchen; it is now a formal dining room. The doors have 6 raised panels. The walls are painted plaster.

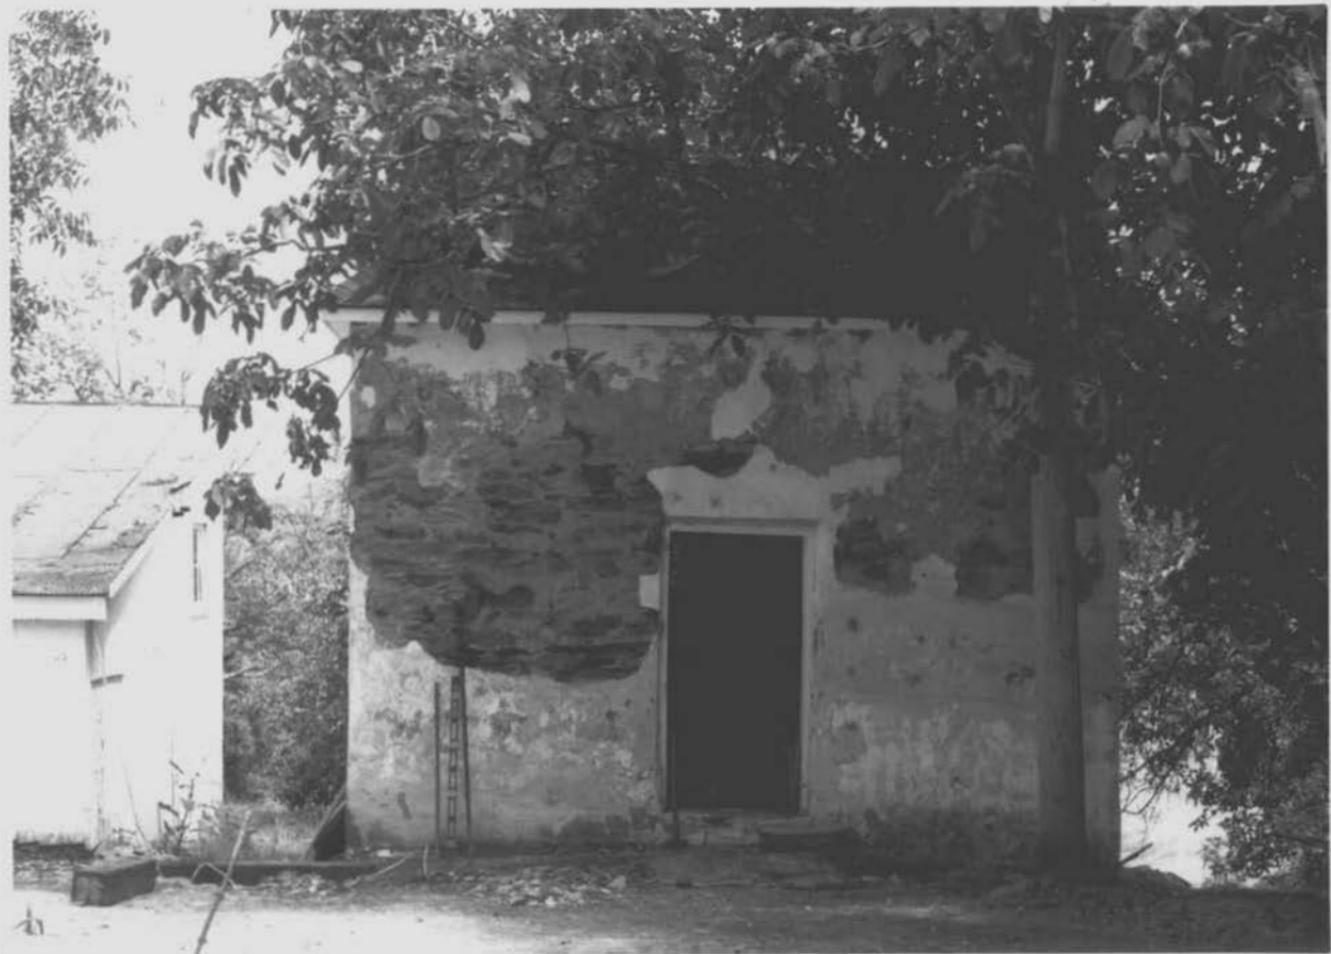
4/11

Smokehouse: This is a square plan, one-story building with plastered and whitewashed walls and a composition hipped roof. The single doorway is in the west elevation. A slit vent is located in the east wall. The smokehouse is probably circa 1850 in date.

Smokehouse, west elevation

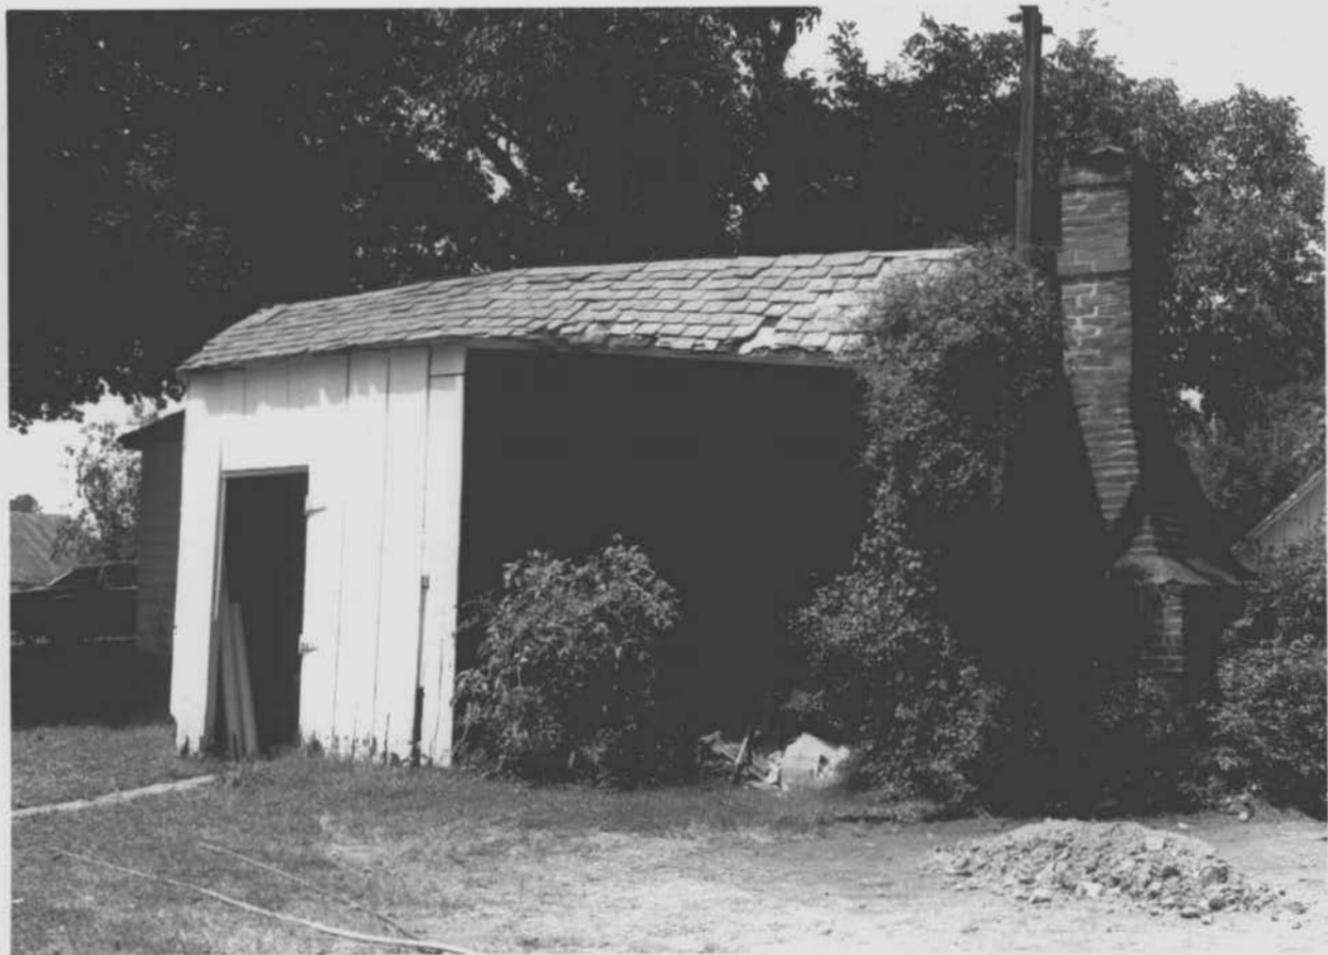
5/11

Summer kitchen: This one-story frame building has a saltbox roof with slate covering on the south elevation. The building is deteriorated and the exterior brick chimney is located on the east end with an open space between it and the opposite end of the building where a single doorway is framed in a remaining section of vertical boards. A farm bell is located on an iron pole at the southeast corner.

Summer Kitchen, south elevation

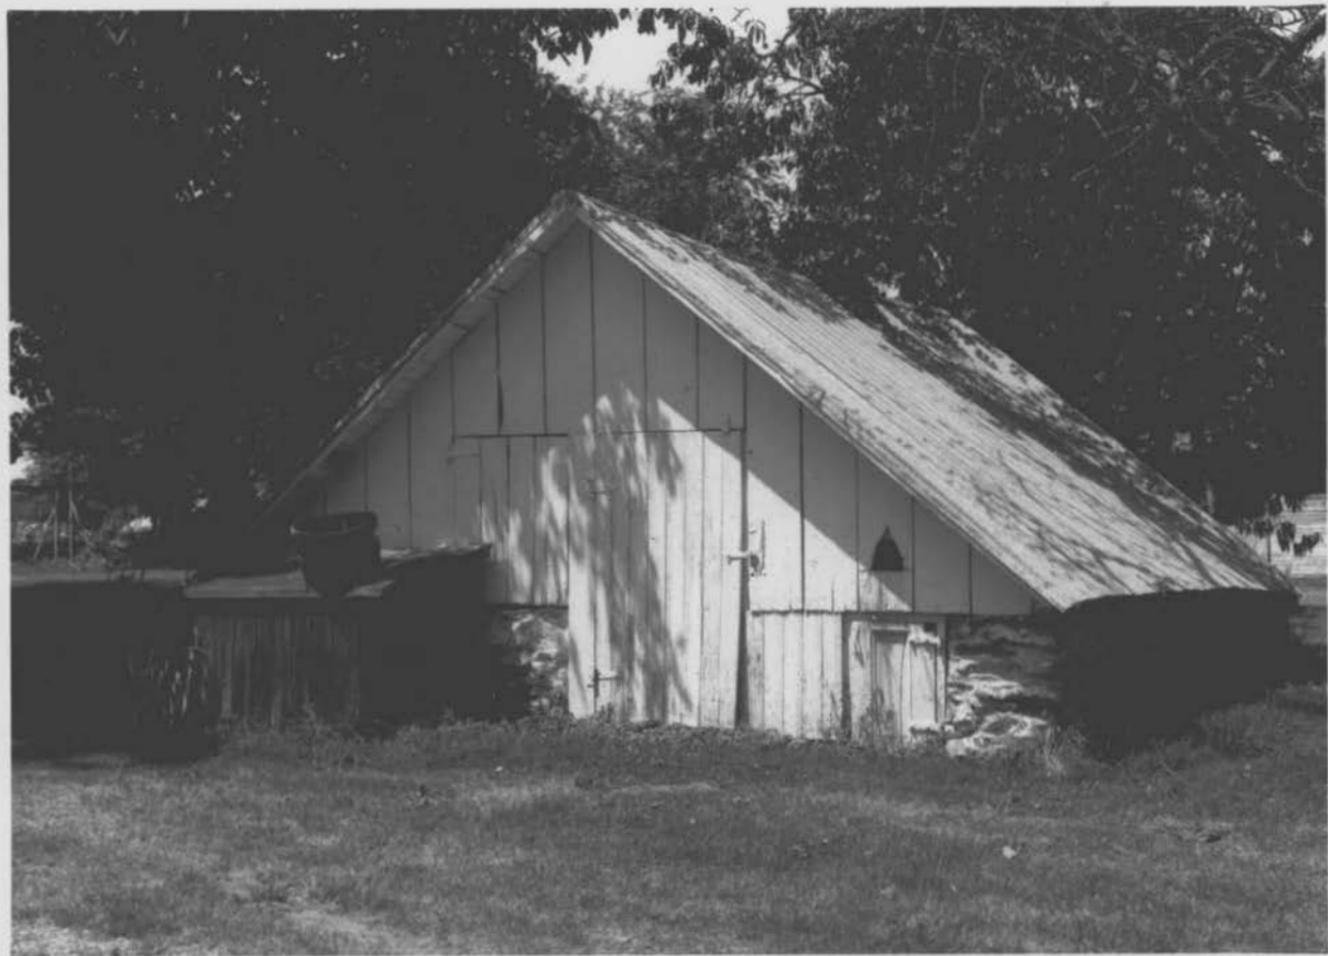
6/11

Ice house: The structure is stone with a rectangular plan and vertical board upper walls in the gable ends of the low roof of standing seam metal. The single entrance is a vertical board door in the south elevation. The ice house dates in the period 1875-1900.

Icehouse, south elevation

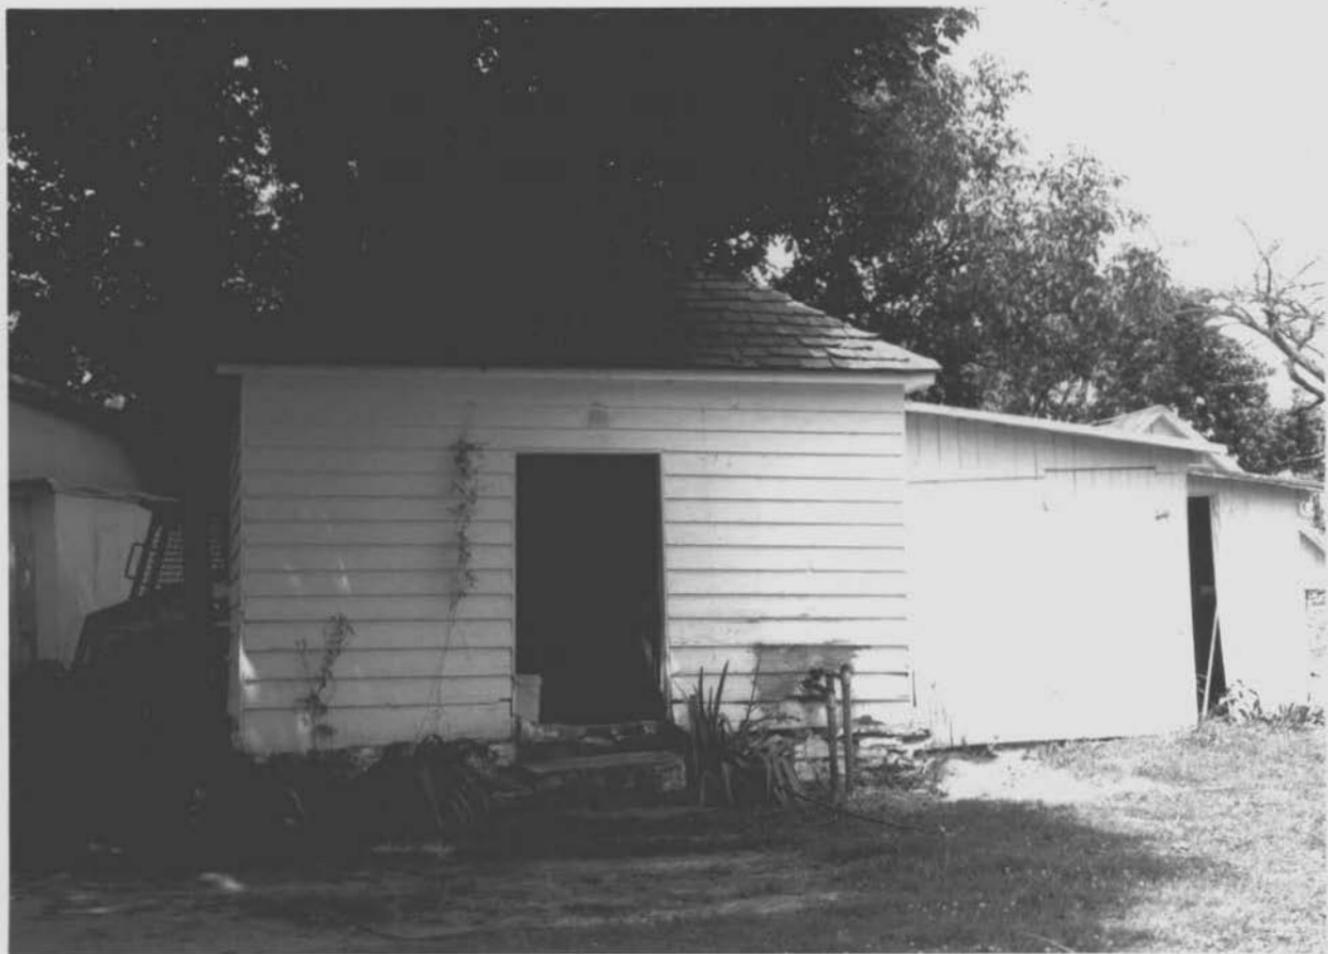
7/11

Dairy/tool shed: This is essentially two adjoining buildings, with the tool shed being attached to the east elevation of the square plan frame dairy. The dairy roof is pyramidal with wood shingle covering. The siding is clapboard. The tool shed has vertical flush board siding. Both probably were built in the last quarter of the 19th century.

Dairy and tool shed, south elevation

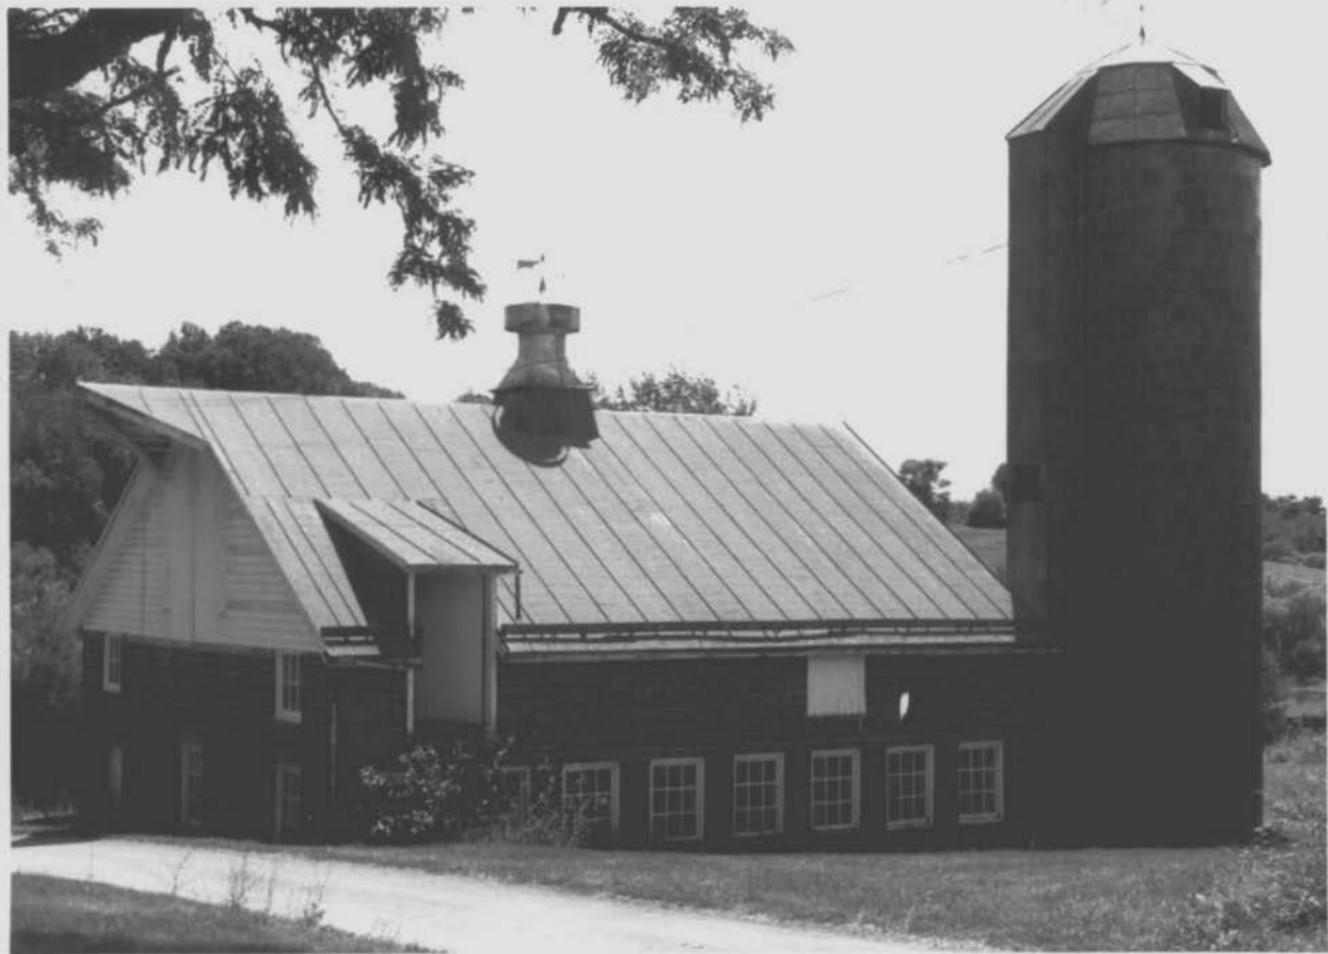
8/11

Dairy barn: This is a circa 1940 terra cotta tile and frame structure with a gambrel roof and a central metal ventilator. The roof is standing seam metal and the main loading doors for feed are in the east elevation facing the driveway. A second loading door is located in the north elevation.

Silo: A terra cotta tile silo apparently built at the same time as the dairy barn and milk house is located at the northwest corner of the dairy barn. It has a standing seam cap with a shed opening in the northeast side.

Dairy barn and silo, north elevation

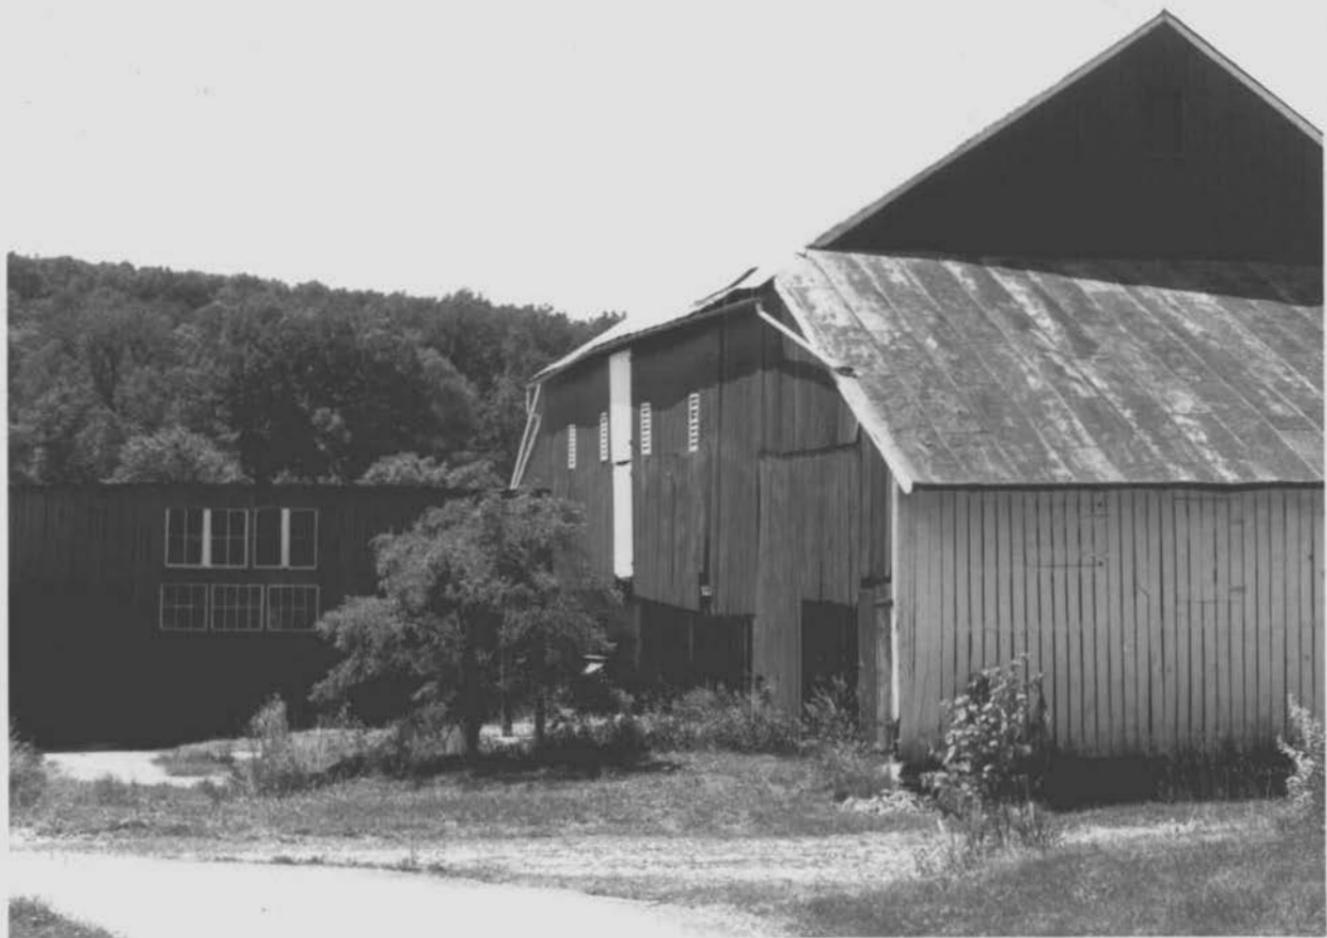
9/11

Bank barn: The original structure of the barn possibly dates from the 1850's. Shed additions are located at the east and west gable ends, housing wagon shed and corn cribs. The roof of the barn is standing seam metal. The south elevation forebay reveals two feeding aisles with a single drive floor on the upper level. The siding is vertical flush boards and louvered vents are on each elevation.

Bank barn, east elevation

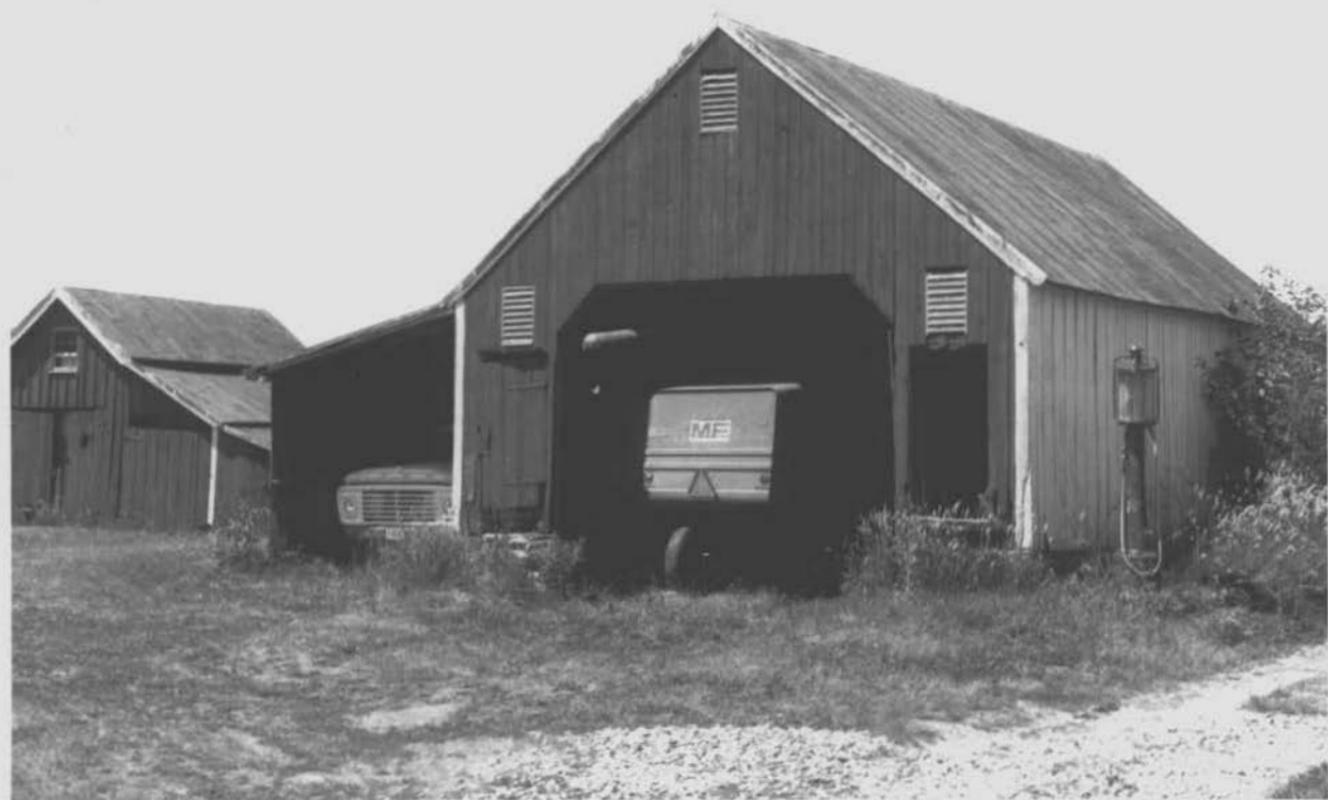
10/11

Corn crib/wagon shed: This building possibly dates from the period 1875-1900 and is a frame building with double bins, vertical siding, and a standing seam gable roof. Next to the corn crib on the southeast corner is an early 1920's gasoline pump with a glass cylinder top.

Corn crib/wagon shed, south elevation

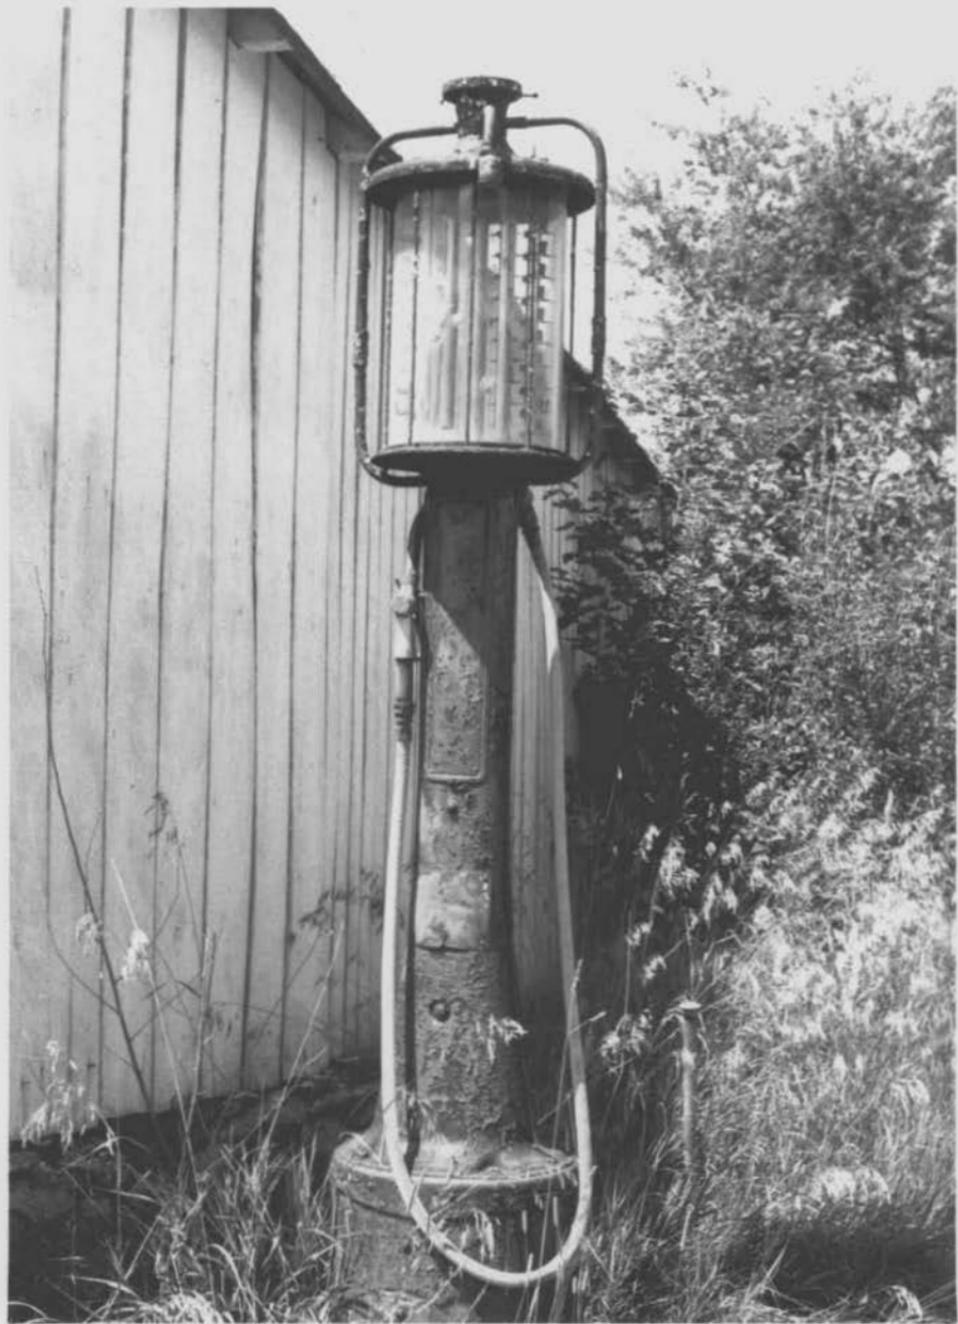
11/11

Gas pump
