F-8-35
Cramer House
Private

Maryland Historical Trust State Historic Sites Inventory Form

BEATTY-KRAMER HOUSE (WITH SPRINGHOUSE
AND SMOKEHOUSE)
CERESVILLE VICINITY
FREDERICK COUNTY, MARYLAND

HABS No. MD-1060

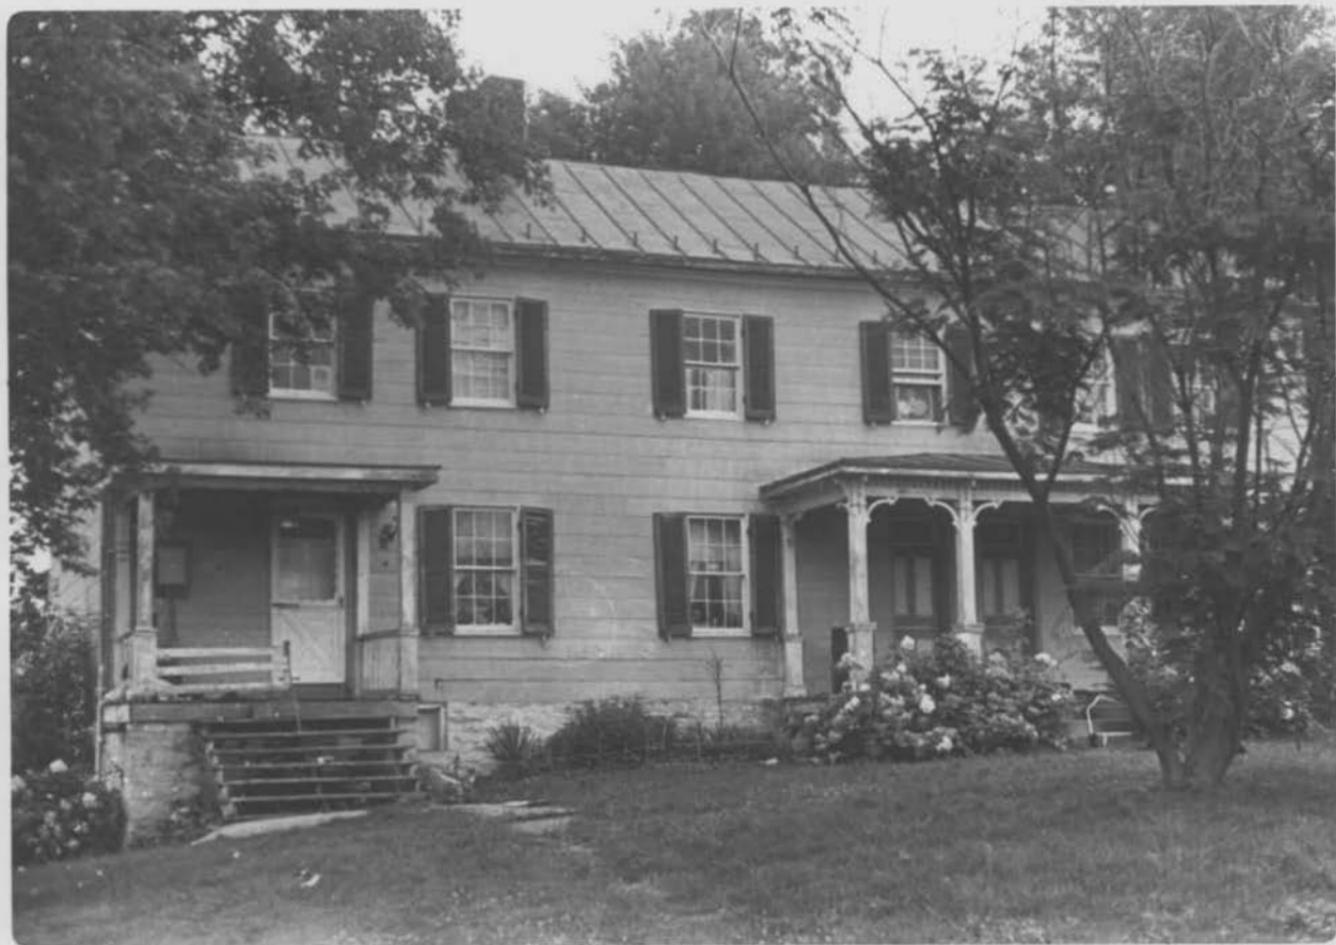
Cramer Hence
north elevation

The Cramer House is a two and a half story log and frame structure covered with asbestos shingles. The west wing of the house, built before the east wing, is a saltbox style structure.

The principal facade is seven bays wide on the first floor and six bays wide on the second floor. Occupying the first, fourth, and fifth bays are the main entrances to the residence. All three entrances are original doors with original hardware. The first bay door is covered with an aluminum screen door. All three entrances feature wooden panelled doors with three light transoms. Occupying the remaining bays on the first and second floors are 6/6 original windows framed by wooden louvered shutters.

The west wing of the structure rests on a stone rubble foundation. The east wing rests on a brick foundation. The entire structure is covered by a standing seam tin roof. Three brick chimneys rise from the structure, one from the east gable end, one from the center of the structure and a corbeled chimney from the west gable. A plain boxed cornice with return was added at a later date to unite the two wings on the facade.

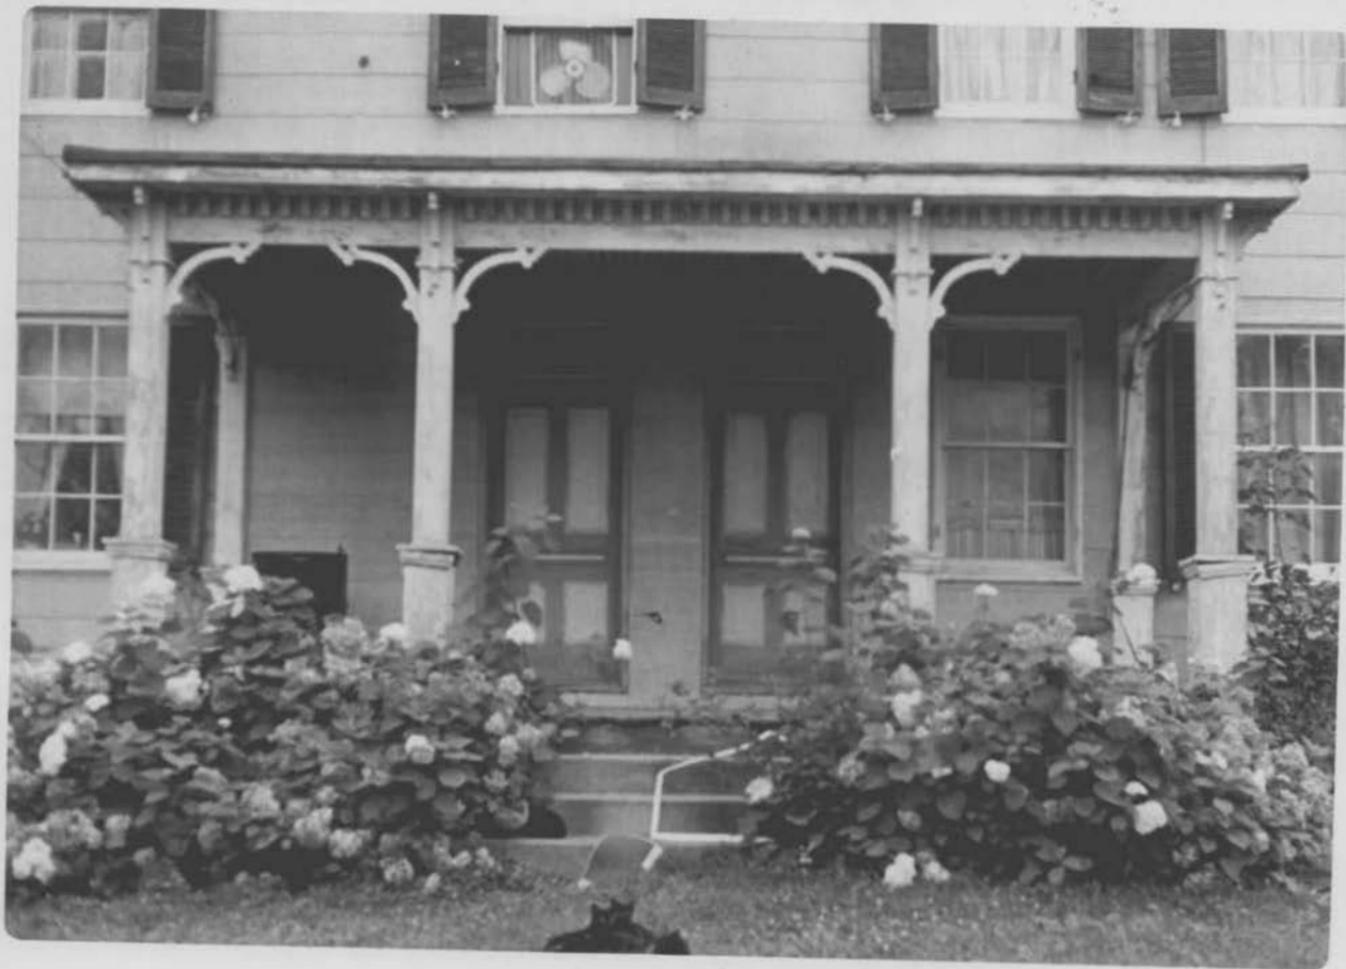
Detail - Porch
E/Wing

Two entrance porches are found on the facade. A one bay entrance porch is located on the west wing of the house. The porch is supported by four plain columns with slatted railing framing the columns. The porch rests on a stone foundation and is covered with a standing seam tin roof. Beneath the roofline is a plain boxed cornice. The second porch added in the 1860's, is the more decorative of the pair. The three bay entrance porch is supported by plain wooden columns trimmed with decorative brackets. A dentil cornice lies beneath a standing seam tin roof.

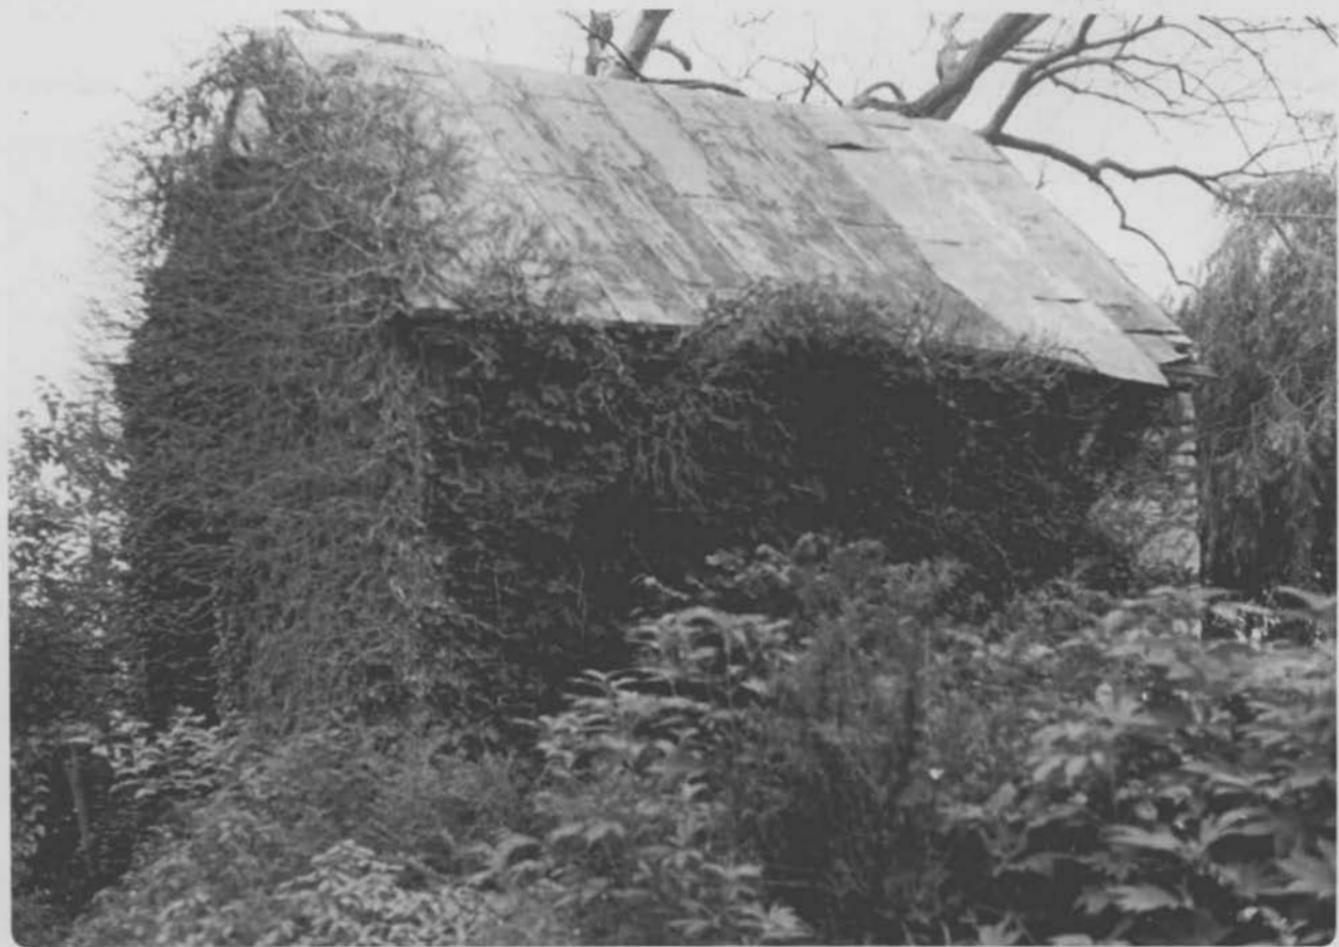
Stone Springhouse

West of the house stands a two-story, stone springhouse. The east gable end of the springhouse is banked into a hill. The basement of the springhouse was once partitioned. The west end contained a water trough, which remains intact. Evidence suggests that a jambless fireplace may once have existed at the east end. The original basement openings--vertical wood bars with exterior shutters--are partially intact.

Access to the first floor was at the east end, up a flight of stairs which no longer exists. The first floor contained a fireplace on the east wall and a ladder stair, also not extant, to the attic in the northeast corner. The room was fully finished with plaster walls and a chair rail. Windows (sash no longer intact) were located in the south and west walls.

To the west of the house is a small stone outbuilding used as a springhouse due to its proximity to Israel's Creek. The structure is constructed of quarried stone, coursed in that section of the structure that faces the front drive. A standing seam tin roof partially covers the original wooden shingles visible on the west side of the roof.
