F-8-77

Ernst-Duncan Farm

Woodsboro vicinity, Maryland

**Maryland Historical Trust  
State Historic Sites Inventory Form**

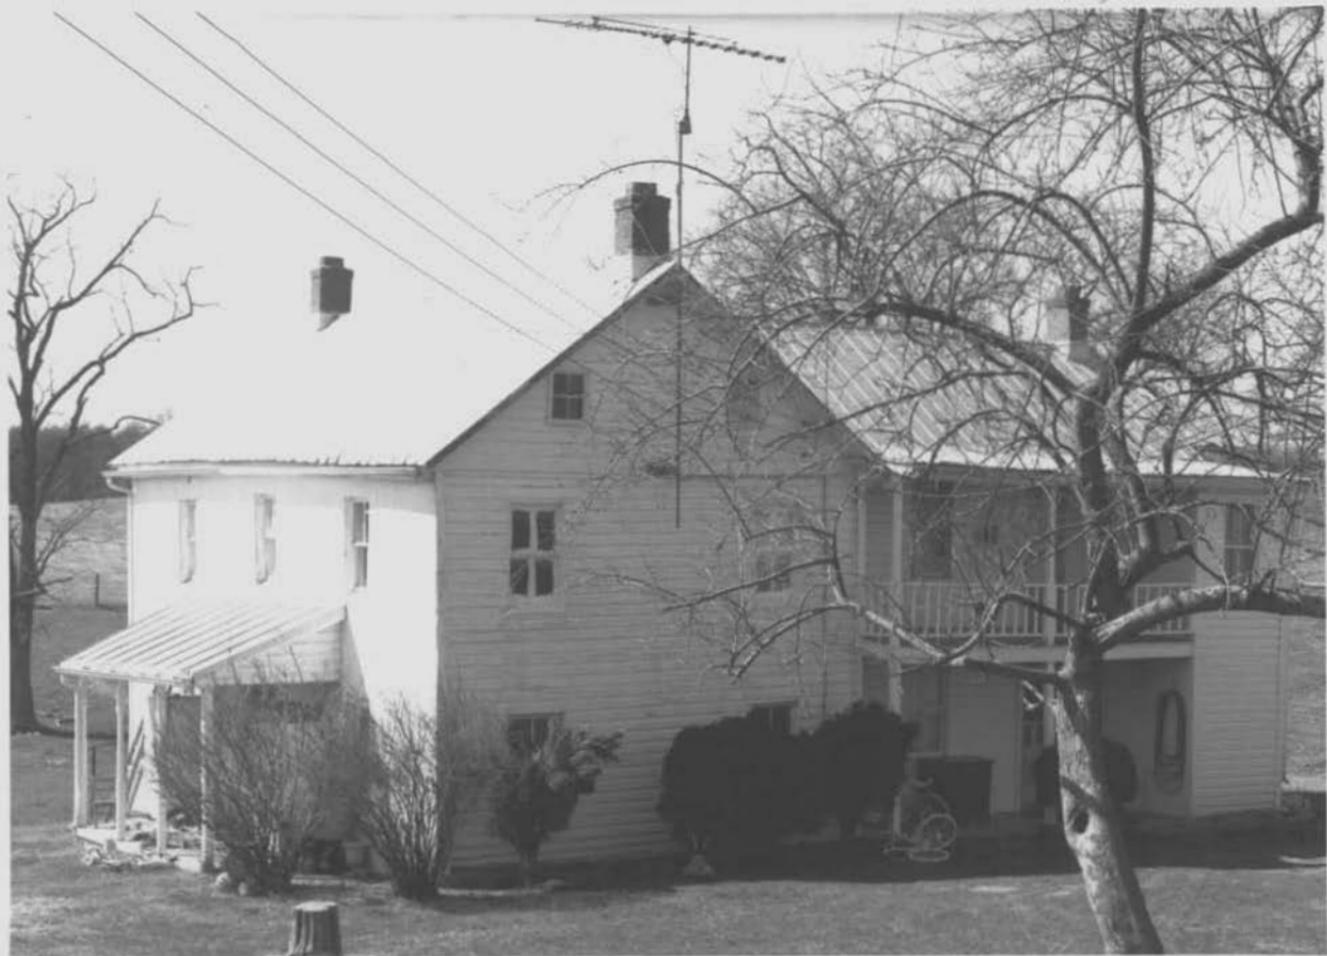
1/3

This house is a 2 story frame building with a side gable roof of standing seam tin that is situated approximately one mile to the west of Route 505 lying in a hollow between valleys in the vicinity of Woodsboro, Maryland. The principal facade faces south and contains three symmetrical bays. Six outbuildings encircle the main house and serve domestic and agricultural functions.

The principal facade is stuccoed and contains an center door with sidelights which is flanked by 2/2 light windows. The second story is symmetrical to the first with three 2/2 light windows. A one story open porch covers the entry bay with a shed roof and simple, turned columns. The gable roof runs east to west and contains two interior end brick chimneys. The west elevation contains stucco to the gable eaves and then has beaded siding to the peak. A two story ell addition extends from the north elevation and rests on a stone foundation. On its west side, it contains three bays with 2/2 light windows and one first story 6/6 light window with center placement. On its north elevation, the ell is stuccoed to the gable eaves and then german-sided to the peak. The east elevation consists of the main block gable end and the ell extension. The gable end is german sided and has two symmetrical windows of 2/2 lights on two stories with two 4 light fixed windows in the attic. The german-sided ell is recessed from the main block which is flush with a 2 story open porch that covers most of the ell. It is enclosed at the end bay with a 2/2 light window in the second story. Both stories have center door openings; the first floor door with a transom light.

Southeast Corner View

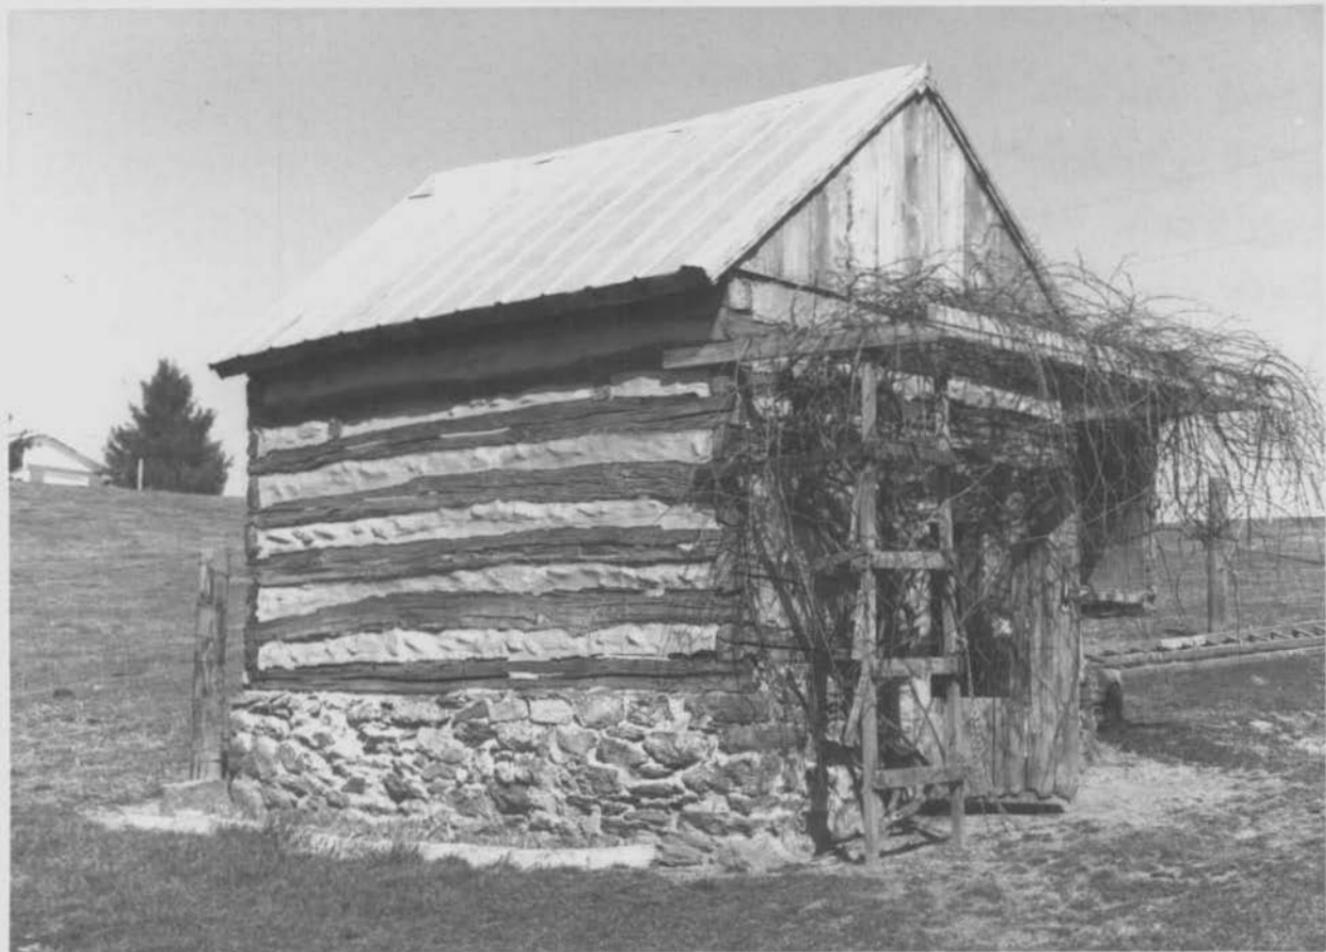
2/3

A cluster of domestic and agricultural outbuildings accompany the main house. A one story log smokehouse lies close to the northeast corner of the main house, facing south. The log construction has V-notching; the gable ends are vertical sided. The building rests on a raised stone foundation. The principal facade is comprised of a front gable roofline of standing seam tin with center door placement. Two horizontal posts run through the interior with the ends showing on the side elevations. A small domestic outbuilding adjacent to the smokehouse is one story with a side gable roofline of standing seam tin. Facing south, it is sheathed in tongue and groove siding. The facade has an off-center door opening. A large corral is situated beyond the small outbuilding. It is comprised of concrete block resting on a stone foundation. A side gable roofline of standing seam tin runs east to west. The principal facade, facing south, has side door placement and two window openings with heavy wood lintels.

10g Smokehouse / Southwest corner

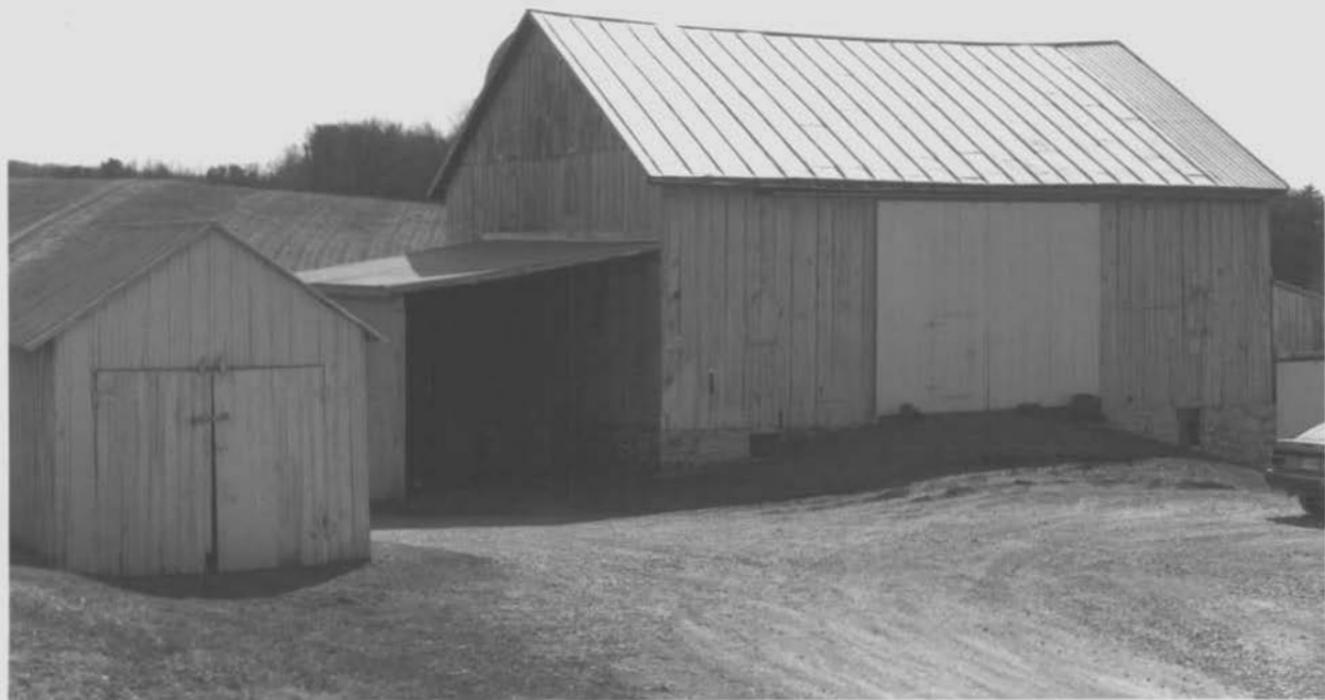
A barn complex is situated to the southeast of the main house. It includes a main barn, a silo, a dairy, a corral, and sheds. The bank barn has vertical siding and rests on a stone foundation. The gable roof of standing seam tin runs east to west. A two part sliding door opening and peaked window coverings in the siding comprise the main (north) elevation. The interior is mortised and tenoned and has hand-hewn timbers. The one story concrete dairy runs 8 bays in length with its principal facade on the east. It has a gable roofline of standing seam. Openings are composed of 4 light fixed windows. A small tractor shed lies to the northeast of the barn complex. Sitting on a concrete block foundation, it has board and batten siding and a side gable roof of standing seam tin.

Bank Barn  $\frac{1}{3}$  Tractor Shed  
North Elevation 3/3
