F-8-91

Bowers-Barton Farm

Johnsville, Maryland

# Maryland Historical Trust State Historic Sites Inventory Form

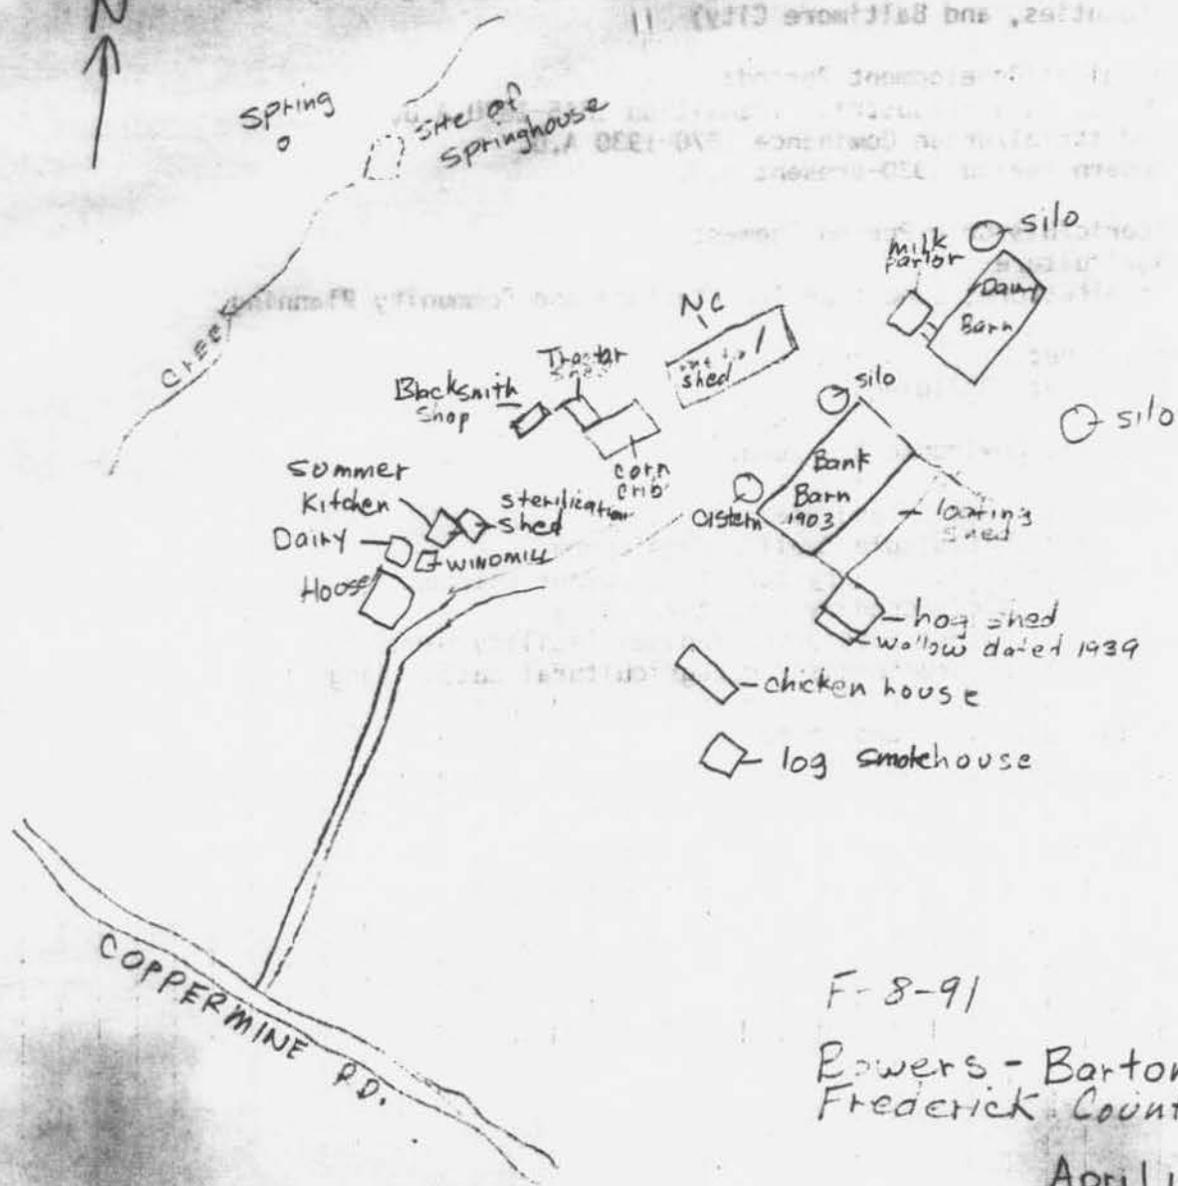
F-8-91

summer kitchen materials  
 from neighboring farm Fox  
 wagon shed near creek, originally  
 house ell 1890  
 house earlier  
 dairy barn 1951

barn: horse stalls  
 horse pens  
 2 feeding aisles  
 for cows  
 slate roof under S.S. metal

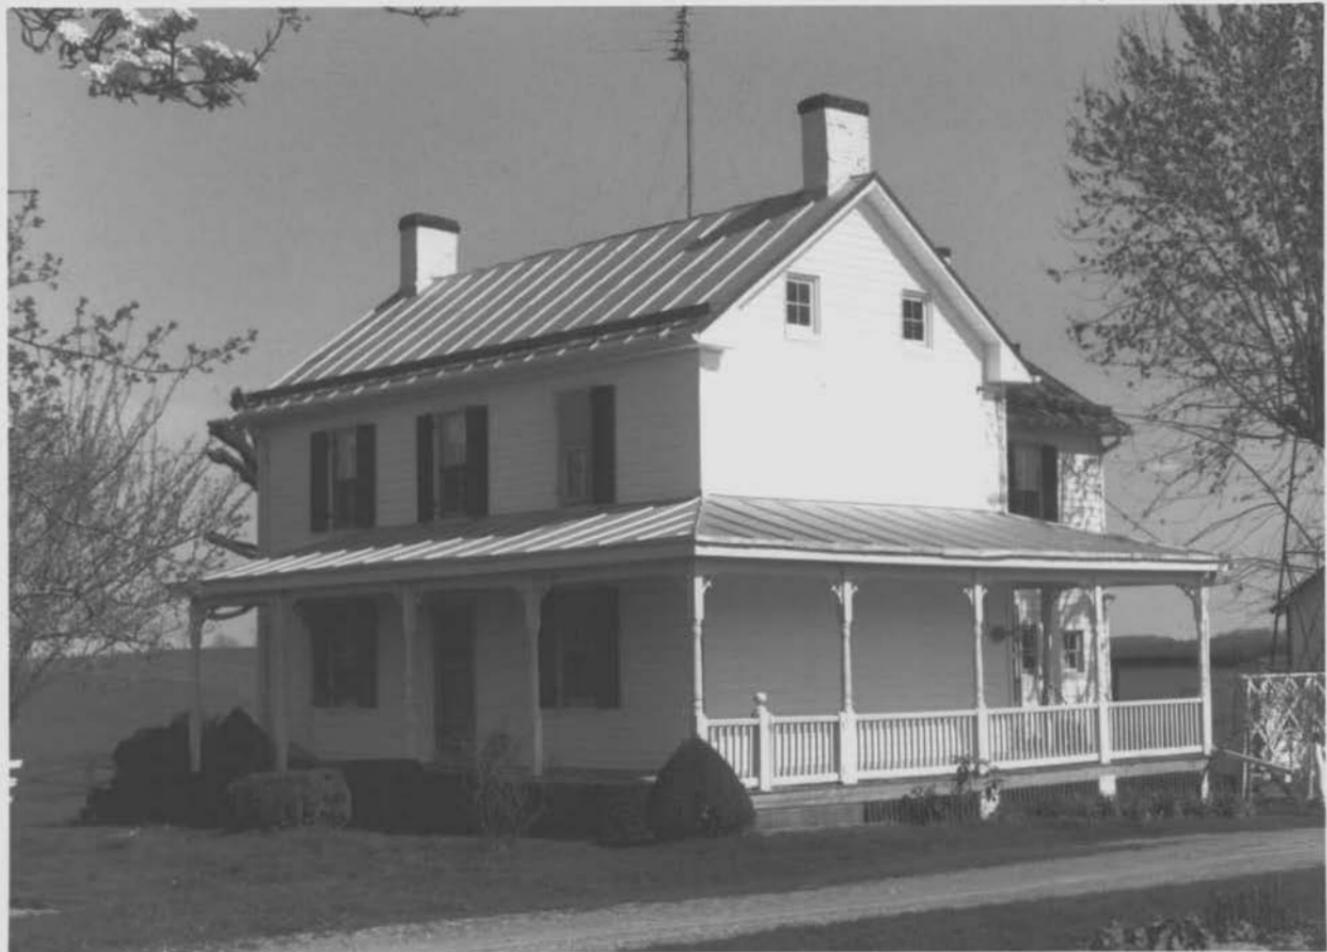
1/5

The house is a two-story, three-bay log dwelling with a center entrance and a one-story shed porch on the southwest and south elevations. A two-story frame rear ell was built in about 1890 according to the current owner. The 2/2 windows are flanked by working shutters. The gable roof is standing seam tin with interior end chimneys. The exterior covering of the house is vinyl over clapboards. The interior of the house was inaccessible for this survey.

House, southwest corner view

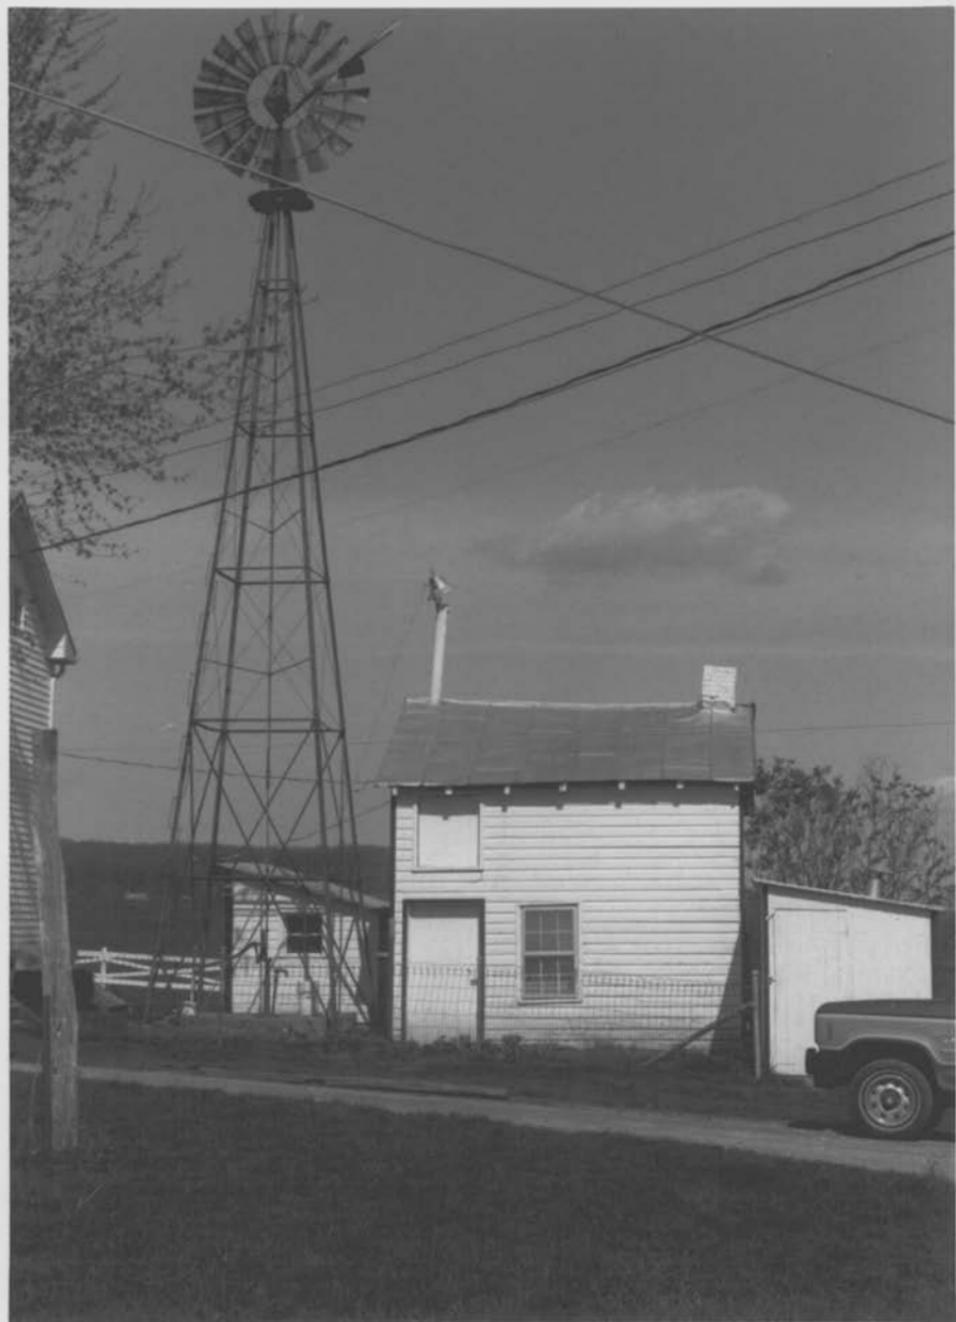
2/5

Dairy: This is a frame, shed-roofed building with german siding located immediately northeast of the ell.

Windmill: The windmill is located immediately south of the dairy over the well. It is in operating condition although not in continuous use.

Summer kitchen: This is a two-story frame building which includes a wash house within the same structure. It has a standing seam tin roof with a brick interior chimney at the east gable end. A single door and window are on the south elevation. The siding is german. The summer kitchen is northeast of the windmill/well. Materials for the summer kitchen were brought from a neighboring farm.

Milkcan Sterilization Shed: This frame shed is located at the southeast corner of the summer kitchen. Its probable date of construction is about 1890. The siding is tongue and groove.

Chicken House: A frame, shed roofed structure with its windowed side facing southwest. It is located about 50 feet southeast of the house. The siding is tongue and groove.

Log Smokehouse: Located south of the chicken house, the smokehouse has vertical flush board siding and a corrugated metal roof. It is probably contemporary with the house.

Domestic outbuildings, view from  
South

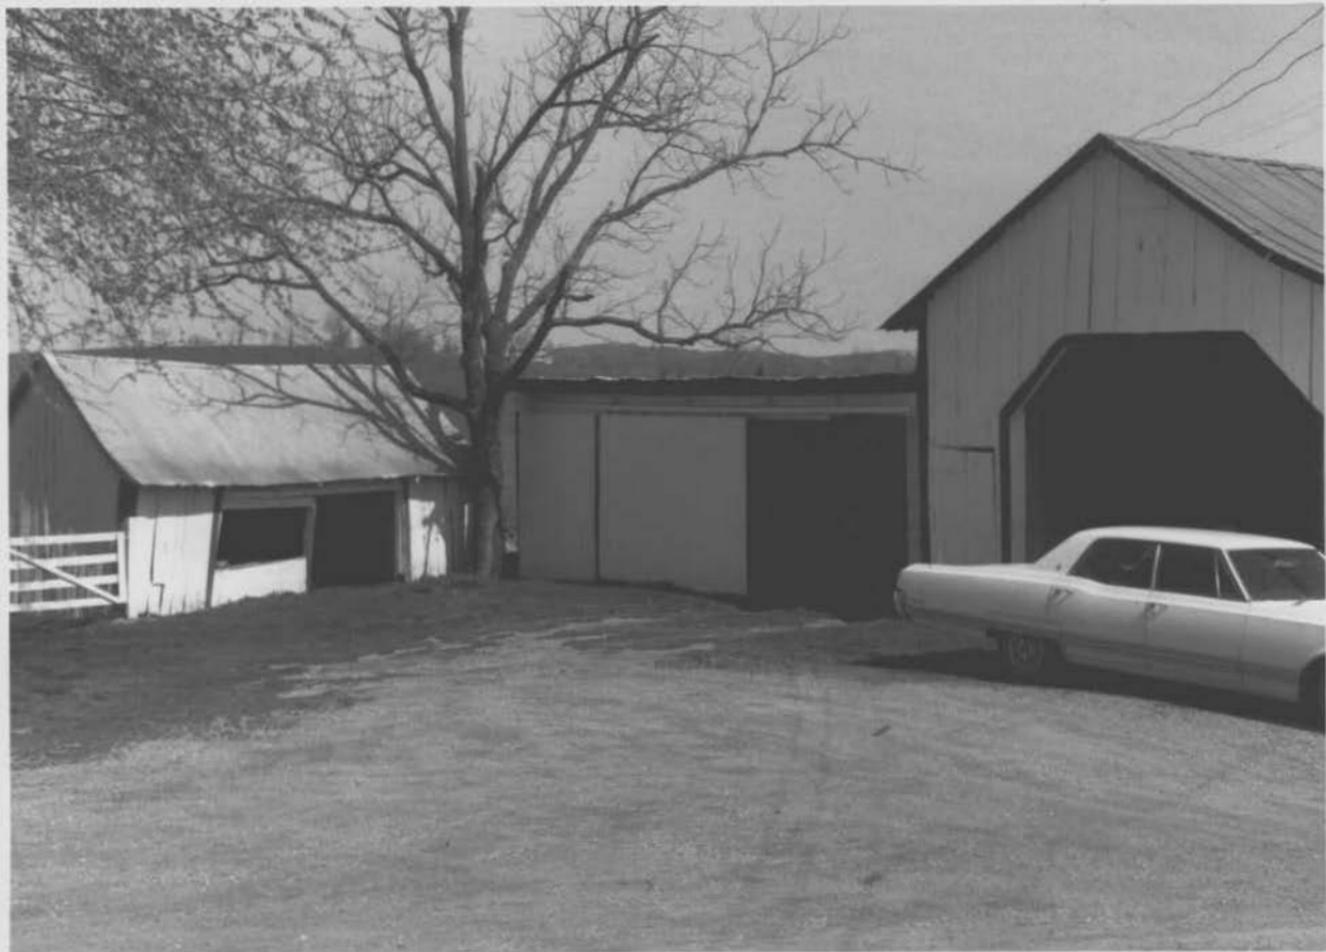
3/5

Blacksmith shop: The 1 story frame blacksmith shop is located about 25 yards northeast from the domestic outbuildings. It has vertical flush board siding and a corrugated metal gable roof. It contains an anvil and a considerable amount of original materials and equipment, although not in use. It is

probably mid 19th century in date. Many of the buildings in the complex have hand-made hardware made in the shop.

Tractor shed: The shed-roofed concrete block shed with sliding doors is located at right angle to the blacksmith shop. The doors appear to date from the last quarter of the 19th century, while the shed is apparently early 20th century.

Corn crib: Adjoining the tractor shed on the southeast is a frame, pull-through double corn crib. With vertical siding and a standing seam roof, it is also dated in the last quarter of the 19th century.

Blacksmith shop, tractor shed, corn crib (L to R)

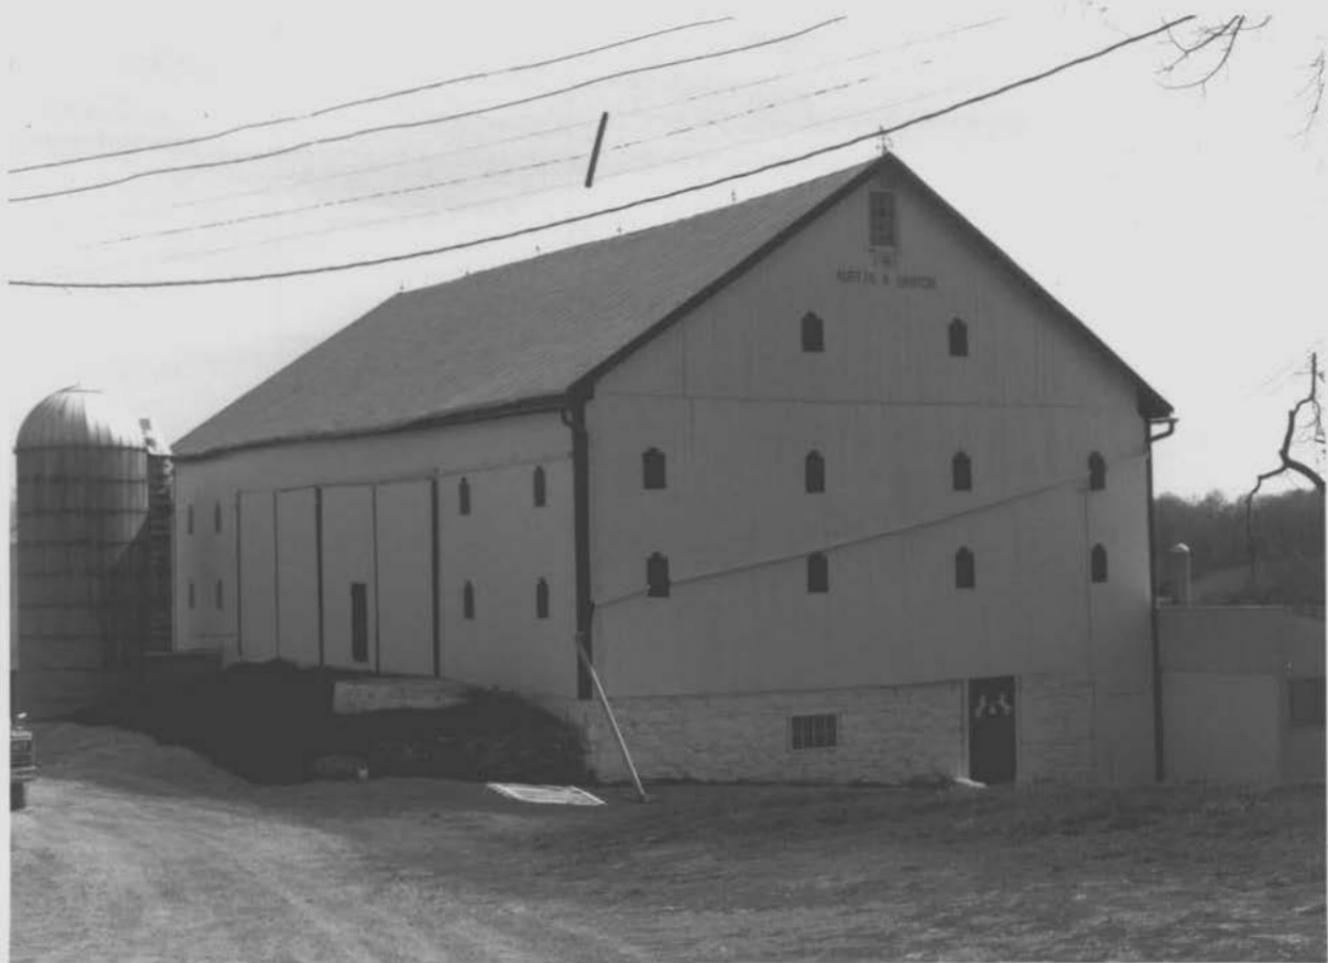
4/5

Bank barn: The frame bank barn was built in 1903 to replace an earlier bank barn which stood north of the house. The foundation is stone and the vertical siding has painted "windows". In the gable is a 6/6 window and the owner's name and the year, 1961, that the farm was purchased from his father. The standing seam metal roof covers the original slate roof. Inside the barn are two cow feeding aisles and a separate horse stall section. On the southeast side is a fiberglass roofed loafing shed. An equipment and wagon shed with a corn crib is on the north end of the barn. A cistern is located near the southwest corner and a concrete silo near the northwest corner.

Bank barn, view from west

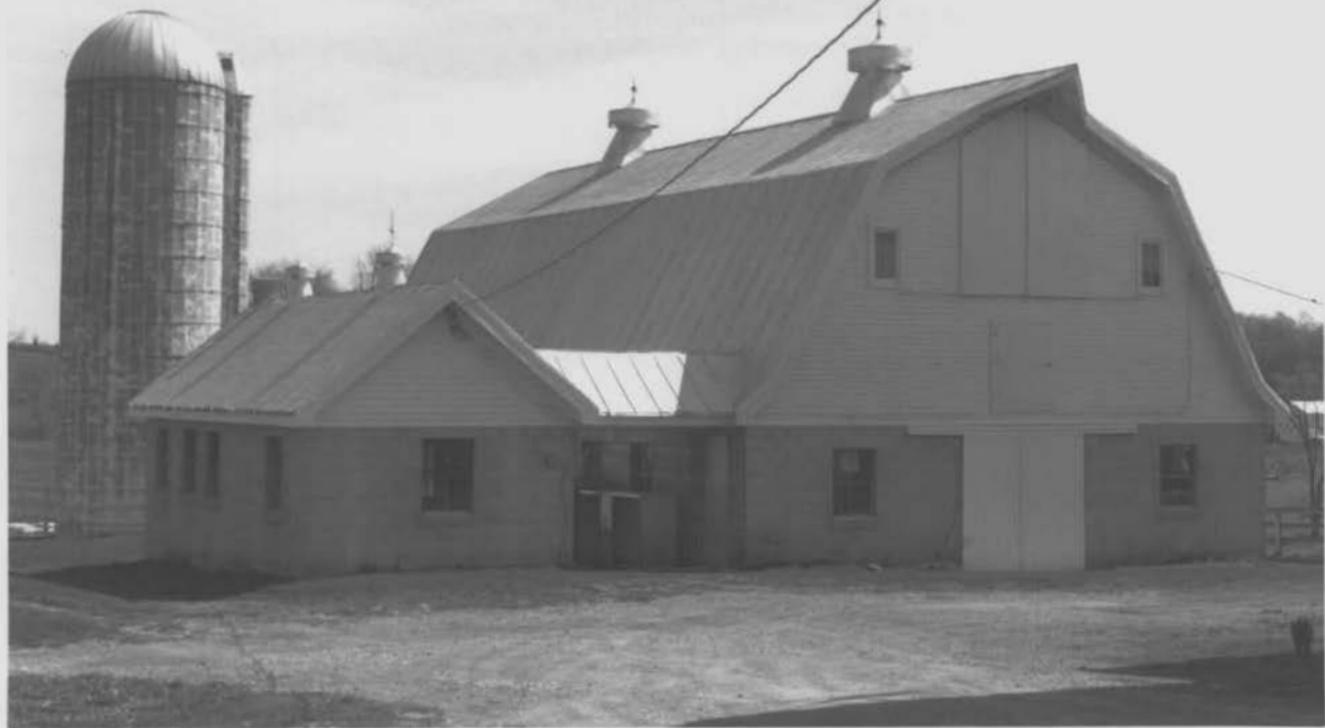
5/5

Dairy barn: A 1951 concrete block dairy barn with a standing seam metal gambrel roof, an adjoining can storage building, and a concrete silo are located northeast of the bank barn.

Dairy barn
