F-8-94

C. Repp Farmstead

Johnsville, Maryland vicinity

Maryland Historical Trust State Historic Sites Inventory Form

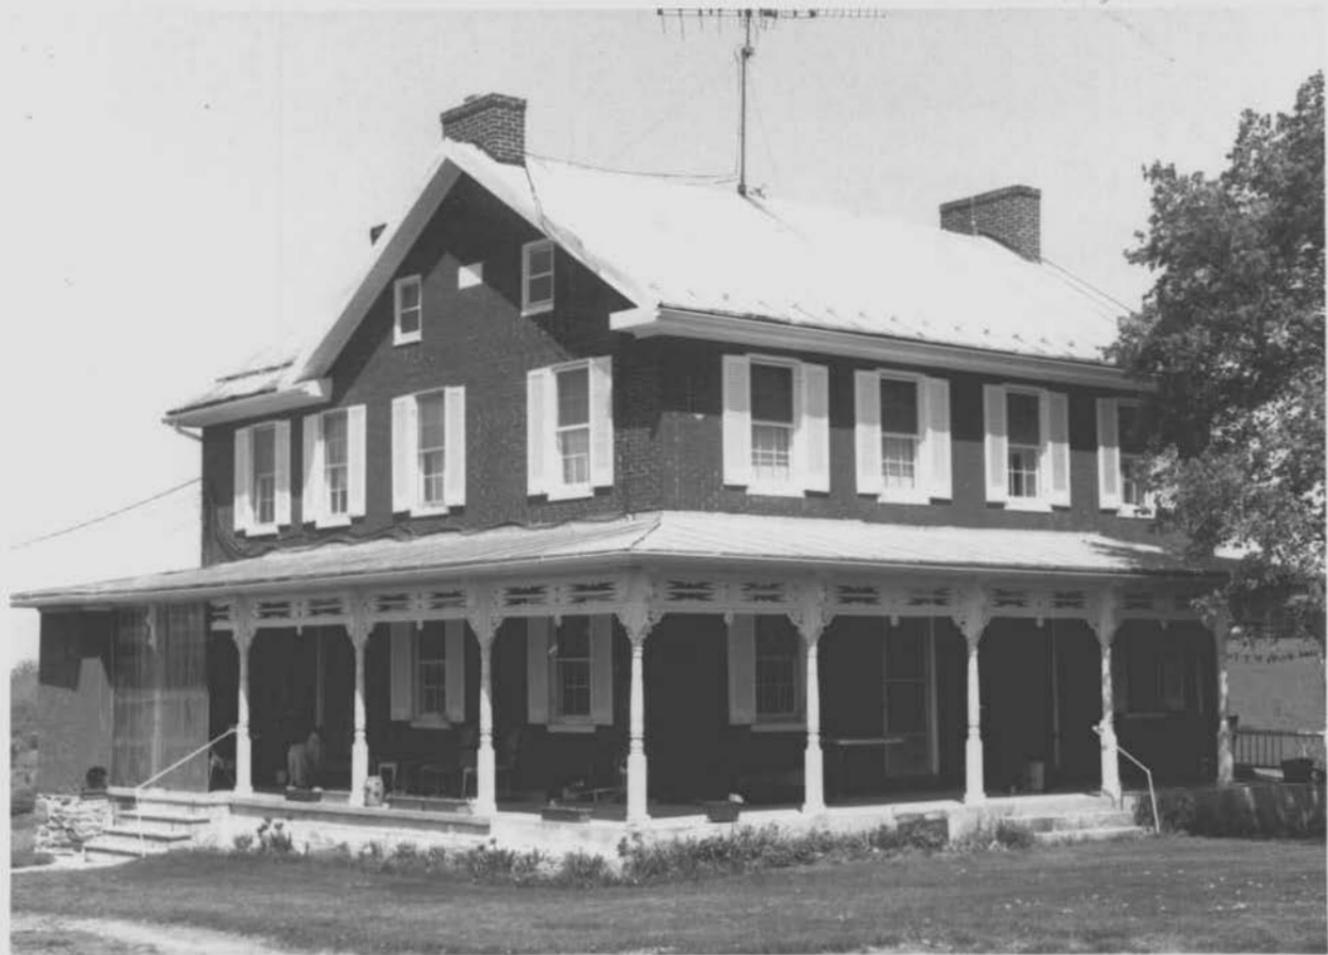
1/4

House, southwest corner view

The dwelling house is a four-bay, two-story building with a rear ell built in 1853, according to a stone in the west gable inscribed "Built by C. Repp and Wife August 1853." A two-story frame addition filling in the angle of the ell was completed in 1990. This addition has vinyl siding, 1/1 aluminum sash, and a concrete block exposed foundation. The principal facade of the house is the south elevation, which is sheltered by a one-story porch extending around to include the west elevation. The porch has elaborately designed scroll-sawn trim and turned columns on a concrete deck, undoubtedly a replacement of the original floor. The porch appears to date from the last quarter of the 19th century. The facade has double entry doors in the style of German houses in the region. The sash is 6/6 and wood louvred shutters flank the windows. The roof was originally wood shingles, which are still in place under standing seam tin. The soffit has been recently covered in aluminum. The interior end chimneys appear to have been rebuilt above the roof. A third chimney is located at the north gable end of the ell. The foundation is stone and is exposed at the north end of the ell.

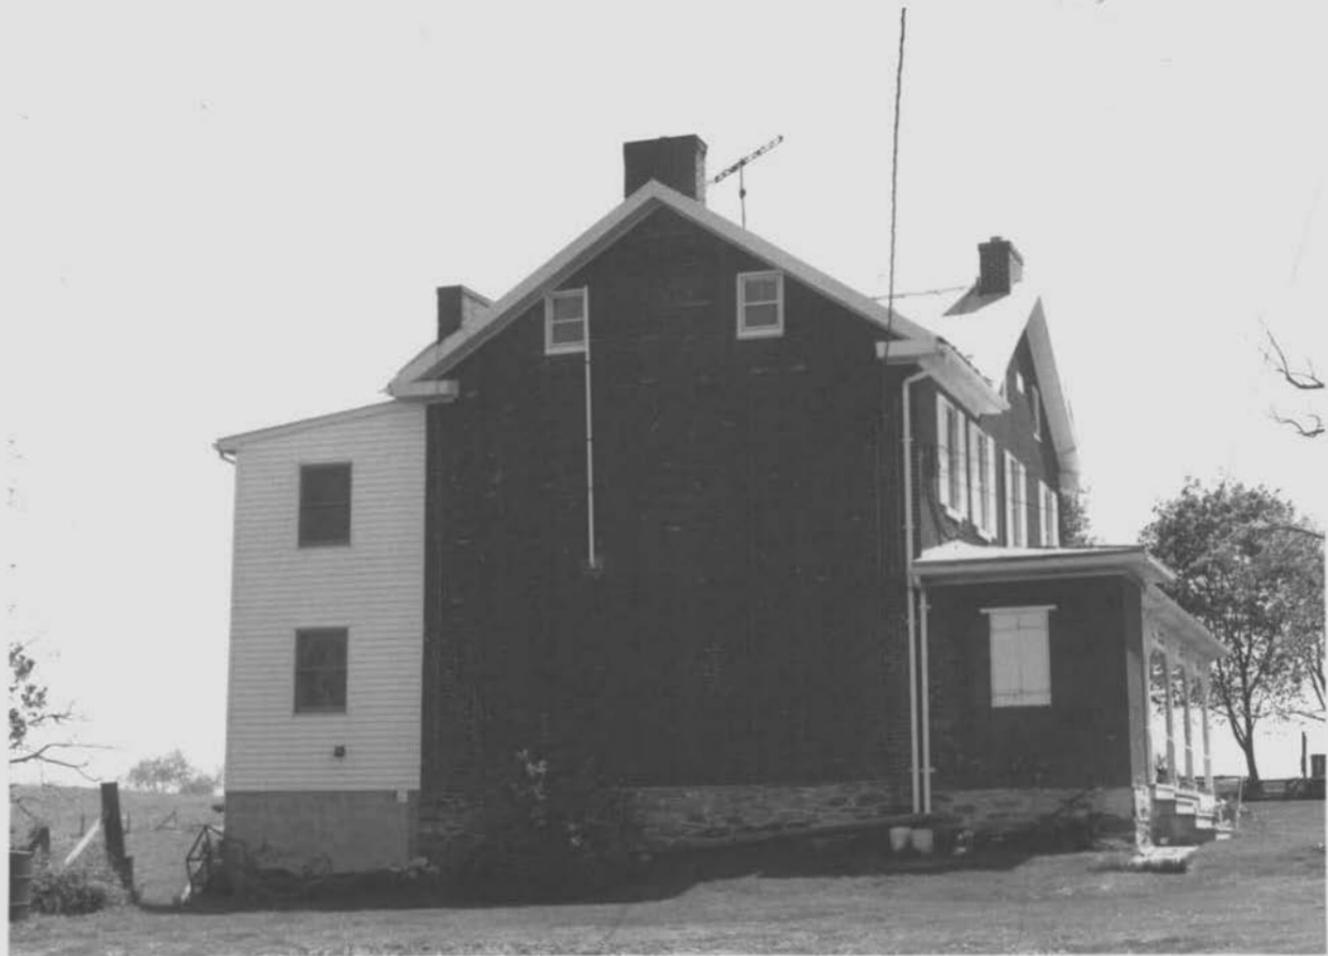
2/4

House, north elevation

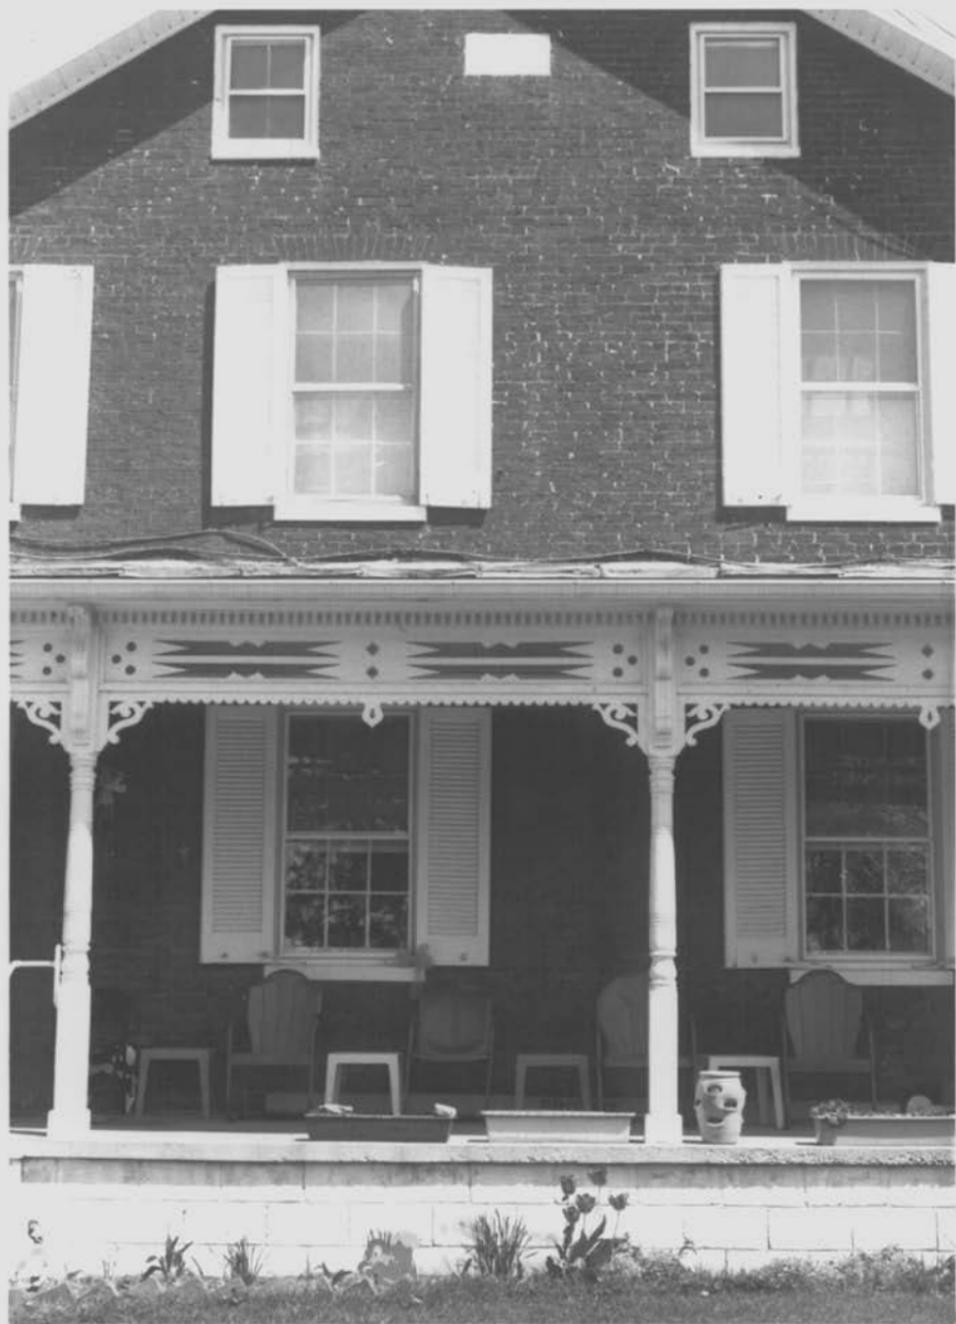
3/4

House, detail of trim

The C. Repp Farmstead exemplifies a typical agricultural group of the second half of the 19th century, containing an 1853 dwelling house, a circa 1899 frame bank barn, and several domestic and agricultural outbuildings. The scroll-sawn decoration on the porch of the house is particularly rare.

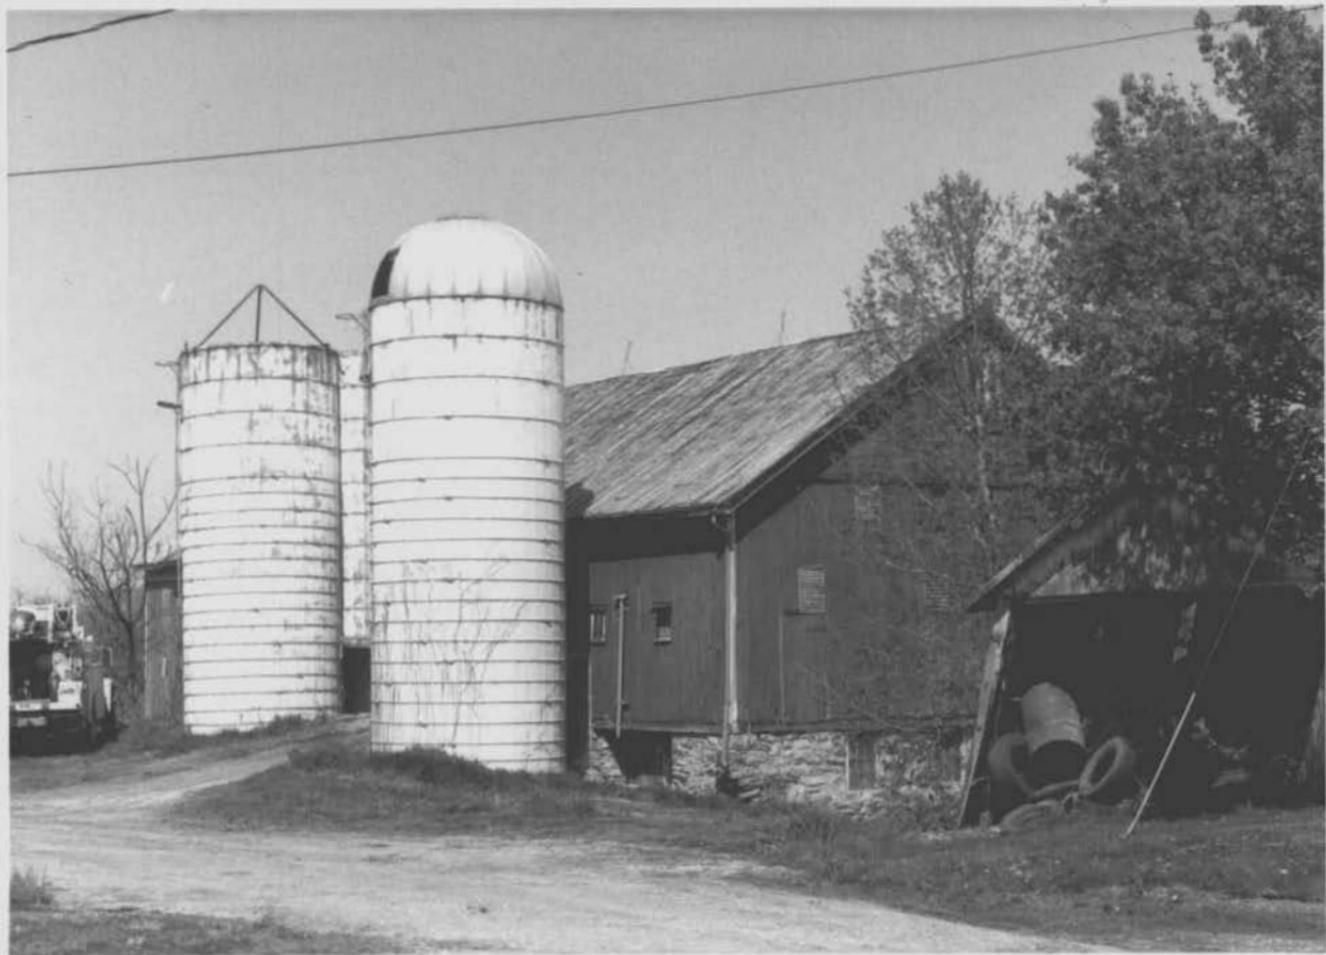
4/4

Bank Barn, south west corner view

Bank barn: The bank barn is a frame building on a stone base erected about 1899, according to Mr. Kemp, the current owner. It has plain louvred vents in the gable ends, a standing seam metal roof, and two concrete tile silos flanking the ramp to the barn floor.
