G-II-C-323

Swartzentruber Farm
Grantsville
Private

INVENTORY FORM FOR STATE HISTORIC SITES SURVEY

Swartzentruber Farm

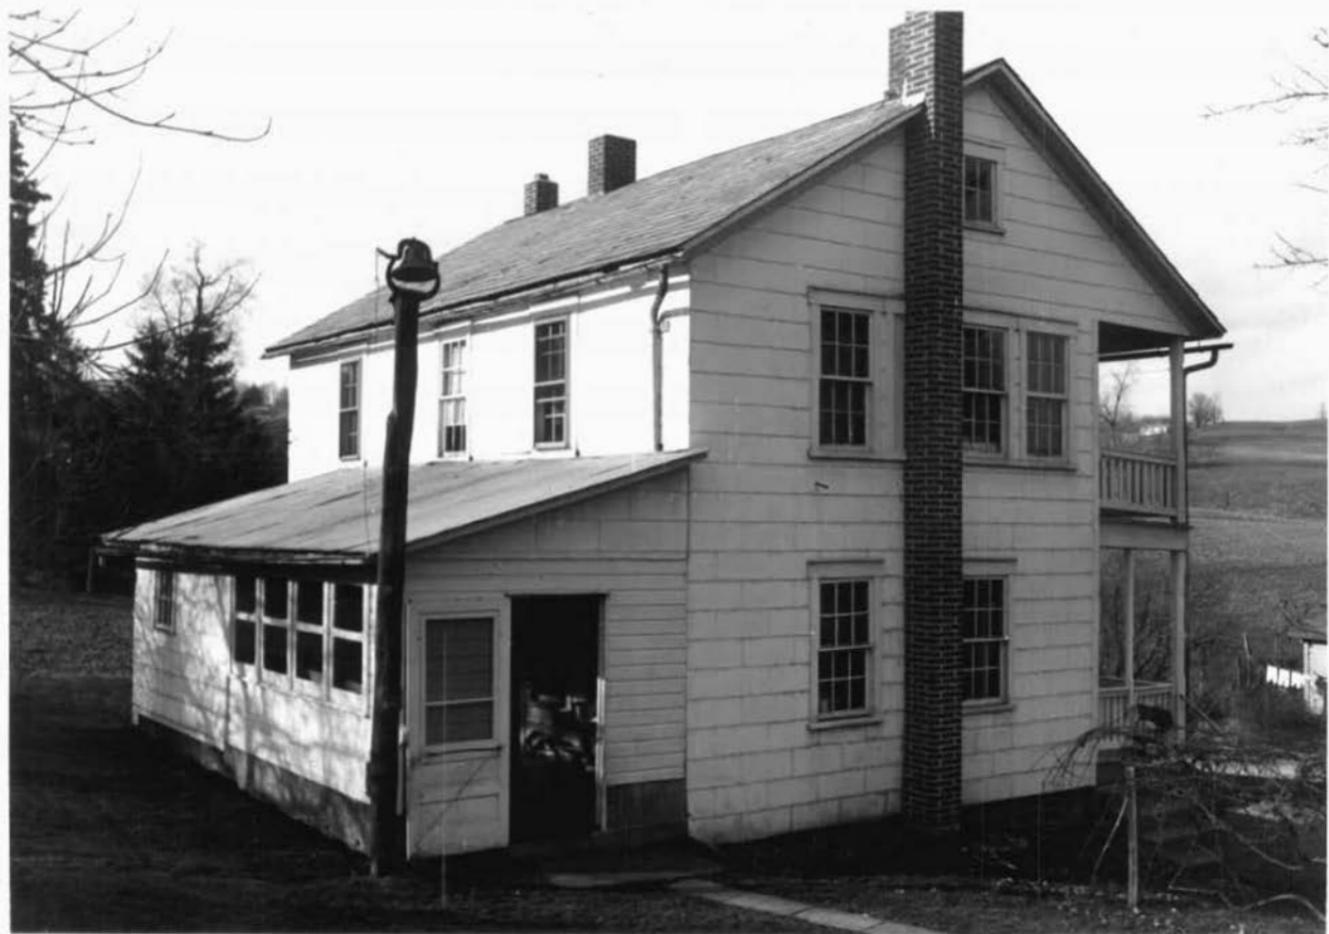
South and East elevation

This three-bay-square two-story frame farmhouse includes a two-story galleried porch inset in the northeast corner. As the land falls away to the north, this side of the cellar is exposed. An enclosed porch covers the south side.

Slate covers the roof and asbestos shingles cover the walls. German siding appears on the walls protected by the porch. The house stands on a stone foundation.

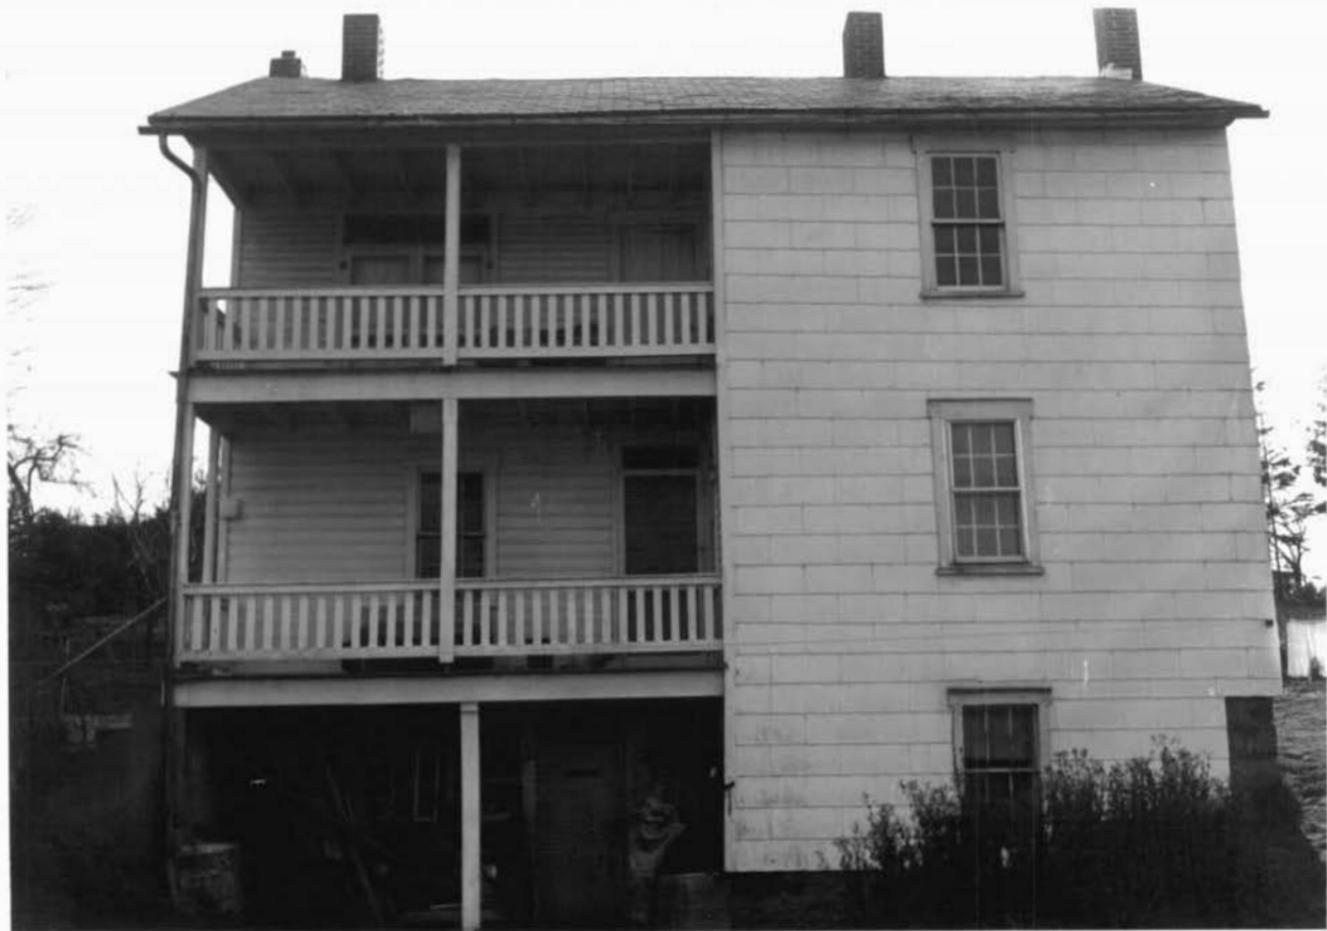
North elevation

6/6 sash windows light the house. Two interior and two exterior brick stove-flue chimneys are located near the central axis of the house. A central door appears on either floor on the north side.
