G-III-B-124

The Art Butler House
Private
Accident

INVENTORY FORM FOR STATE HISTORIC SITES SURVEY

Art Butler House

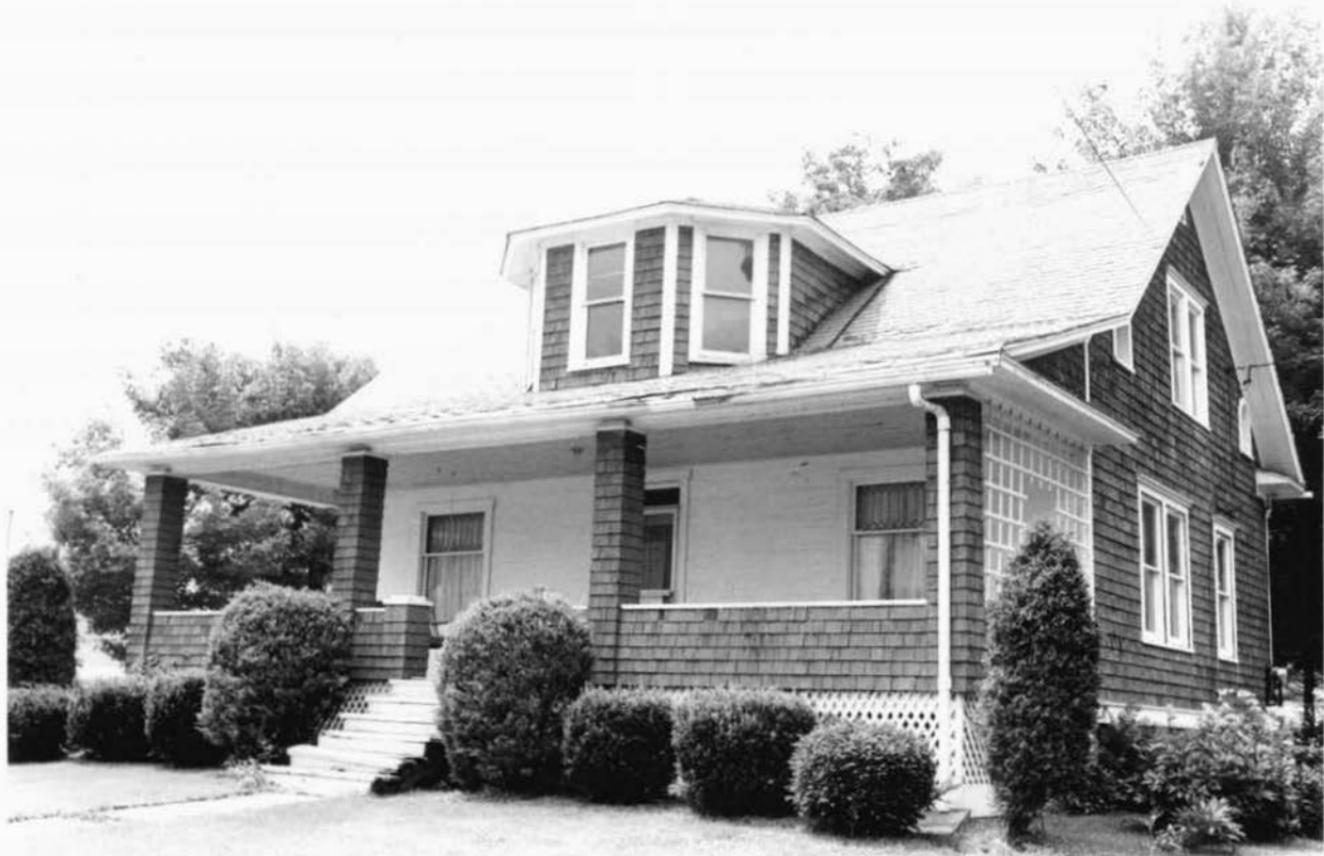
G-III-B-124

The house is a one and a half story, gable-roofed dwelling with a three-bay, center-door facade. The facade points southeast and is covered by a shed-roofed porch. The porch roof forms a catslide with the roof of the house. On the northwest elevation is a shed-roofed kitchen wing.

The house rests on a coursed stone foundation and the walls are covered with horizontal boards. The windows are 1/1 sash, with drip mouldings and plain board surrounds. On the facade the windows have narrow upper sashes filled with leaded eights and large single lower sashes. The facade door has a transom. On either side of the S.W. and N.E. gable ends are small round-arched windows.

The roof is covered with asphalt shingles. At the center of the facade is a five-sided, hipped-roofed dormer. Three of its elevations have 1/1 sash windows. On the N.W. elevation is a gable-roofed dormer. The house has one interior stove chimney on the N.W. slope of the roof, attached to the dormer.

Facade - SE;NE elev.

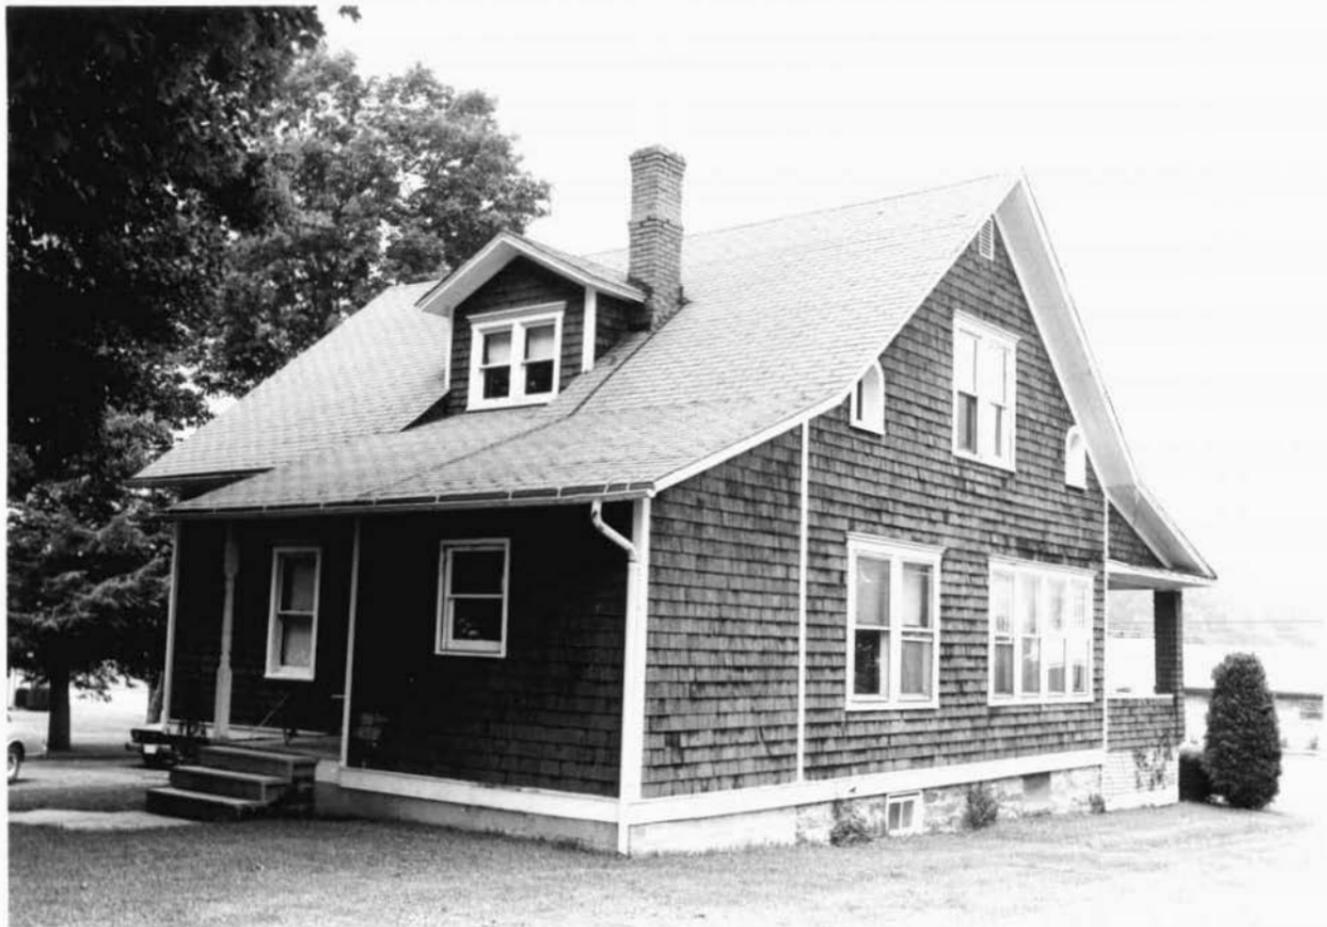
G-III-B-124

NW & SW elevs.
